#### Facility Maintenance Plan

# Green Valley Creek - Paseo del Verano Facility Group

Segment Name (Facility number): Paseo del Verano 1 (1-04-200)

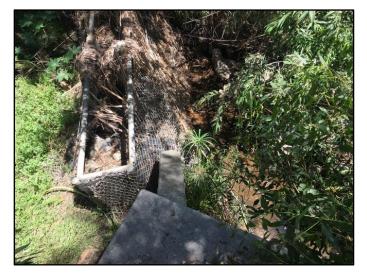
Figure 1: July 2017, riprap structure at outlet structure

Current Conditions Affecting Facility Capacity	Dense vegetation including tree growth was observed. Approximately 2 feet of sediment deposition was estimated on the upstream side of the rock gabion.
Maintenance Recommendation	Remove accumulated sediment, debris and vegetation from basin bottom to restore the as-built condition.  Trim vegetation on side slopes of the basin.  Repair gabion rock-filled barrier walls to as-built condition.
In-Stream Post-Maintenance Erosion Control Recommendation	N/A (basin)

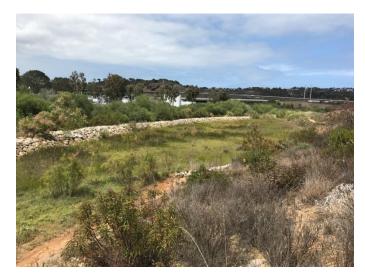
Figure 1: May 2018, looking west into the desilting basin with Penasquitos Creek visible on the outside of the rip rap berm

Current Conditions Affecting Facility Capacity	Moderate vegetation was observed throughout the basin with a minor amount of sediment deposition
Maintenance Recommendation	Remove vegetation from basin inlet and side weir, and restore to the as-built condition.  Remove any accumulated sediment and debris from basin.
In-Stream Post-Maintenance Erosion Control Recommendation	N/A (basin)

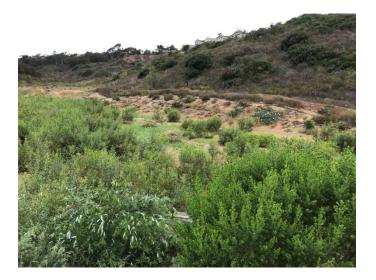
Figure 1: May 2018, looking north east into the detention basin from the south western end with the grated concrete culvert partially visible in the foreground

Current Conditions Affecting Facility Capacity	Dense vegetation including trees and accumulated sediment/debris were observed in the detention basin. The sediment depth was estimated to be approximately 1 foot deep across the basin and inlets and outlets were observed to be
	partially surrounded by vegetation.
Maintenance Recommendation	Remove accumulated sediment, debris, and vegetation from basin bottom, from around inlet structure at the far north end of the basin, and from outflow structure at the south end of the basin to restore the as-built condition.  Remove accumulated debris from storm drain outlet structures upstream of the basin.
In-Stream Post-Maintenance Erosion Control Recommendation	N/A (basin)

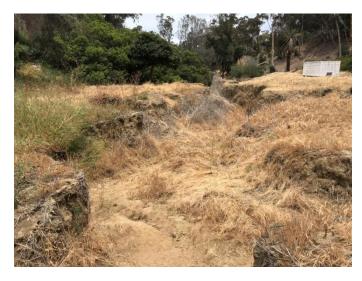
Figure 1: May 2018, looking east from the detention basin at the incised natural flood channel upstream

Current Conditions Affecting Facility Capacity	Light vegetation was observed and sediment accumulation, including sand, silt, and small cobble varied from 0.5 to 5 feet deep
Maintenance Recommendation	Remove accumulated sediment, debris, and vegetation from the desilting basin
In-Stream Post-Maintenance Erosion Control Recommendation	N/A (basin)

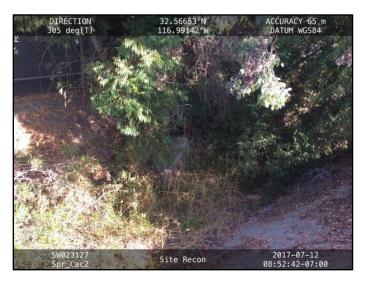
Figure 1: July 2017, standing water and vegetation growth in the basin

Current Conditions Affecting Facility Capacity	Dense vegetation, tree growth, and accumulated sediment and debris were observed in the basin. Sediment depth was estimated to be approximately 2 feet deep across the basin. All inlets and outlets were fully covered by vegetation.	
Maintenance Recommendation	Remove accumulated sediment, debris, and vegetation throughout the basin to restore the as-built condition	
In-Stream Post-Maintenance Erosion Control Recommendation	N/A (basin)

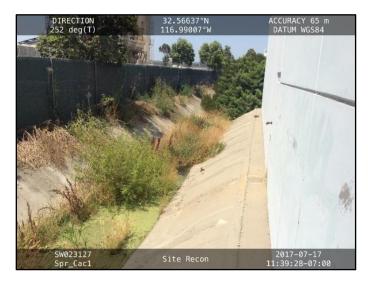
Figure 1: July 2017, sediment, debris deposition and vegetation growth in basin

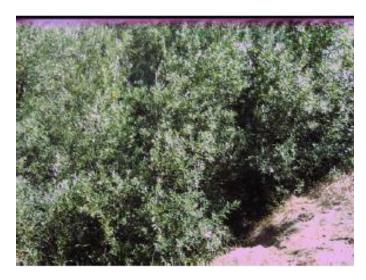
Figure 1: October 2010, looking upstream at the vegetation along the banks

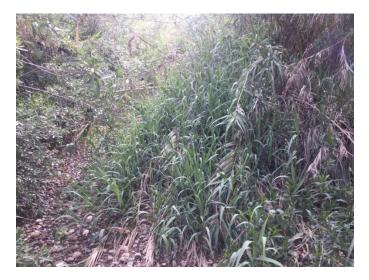
Figure 1: May 2019, looking downstream at vegetation density

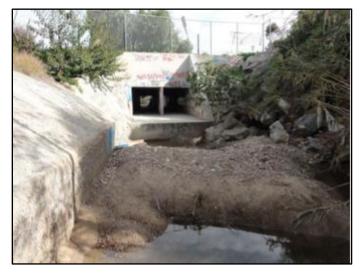
Figure 1: March 2016, looking upstream at the double 6foot wide by 6-foot tall RCB culvert. Note the standing water and erosion at culvert outlet.

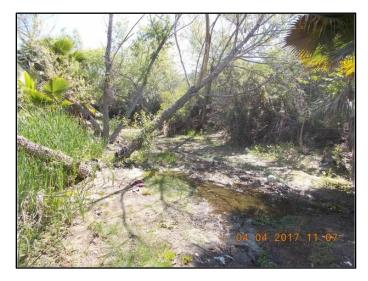
Figure 1: April 2017, looking downstream of Orange Line bridge at vegetation

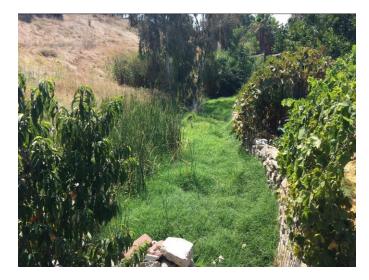
Figure 1: April 2016, looking downstream at the dense grass in channel

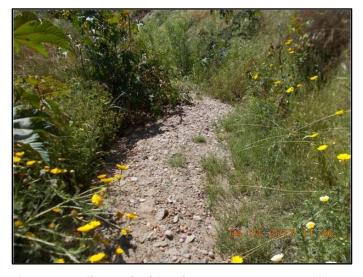
Figure 1: April 2017, looking downstream at vegetation
