APPENDIX A-2

Basin FMPs

Facility Maintenance Plan

Green Valley Creek - Paseo del Verano Facility Group

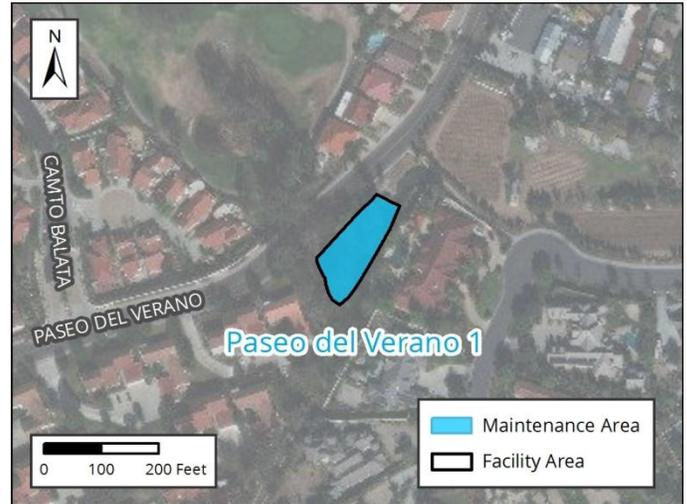
Figure 1: July 2017, riprap structure at outlet structure

Current Conditions Affecting Facility Capacity	Dense vegetation including tree growth was observed. Approximately 2 feet of sediment deposition was estimated on the upstream side of the rock gabion.
---	--

Maintenance Recommendation	Remove accumulated sediment, debris and vegetation from basin bottom to restore the as-built condition. Trim vegetation on side slopes of the basin. Repair gabion rock-filled barrier walls to as-built condition.
-----------------------------------	---

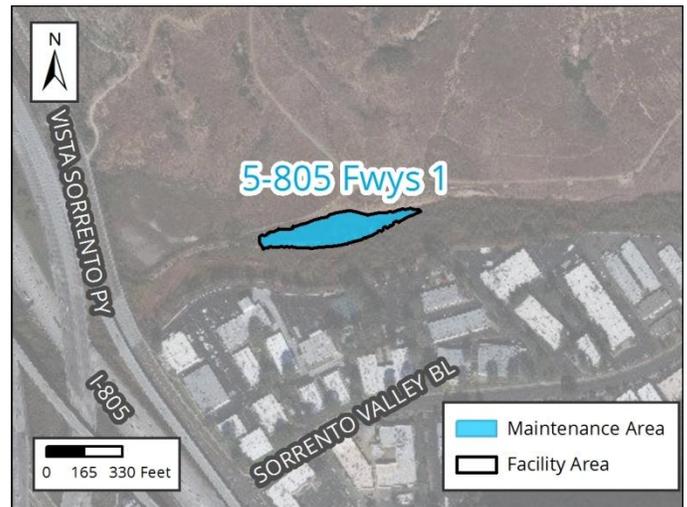
Figure 1: May 2018, looking west into the desilting basin with Penasquitos Creek visible on the outside of the rip rap berm

Current Conditions Affecting Facility Capacity	Moderate vegetation was observed throughout the basin with a minor amount of sediment deposition
Maintenance Recommendation	Remove vegetation from basin inlet and side weir, and restore to the as-built condition. Remove any accumulated sediment and debris from basin.
In-Stream Post-Maintenance Erosion Control Recommendation	N/A (basin)

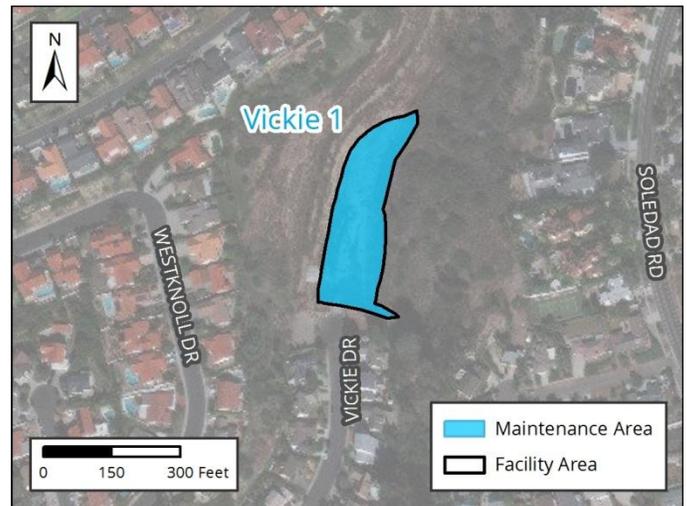
Figure 1: May 2018, looking north east into the detention basin from the south western end with the grated concrete culvert partially visible in the foreground

Dense vegetation including trees and accumulated sediment/debris were observed in the detention basin. The sediment depth was estimated to be approximately 1 foot deep across the basin and inlets and outlets were observed to be partially surrounded by vegetation.

Remove accumulated sediment, debris, and vegetation from basin bottom, from around inlet structure at the far north end of the basin, and from outflow structure at the south end of the basin to restore the as-built condition.
Remove accumulated debris from storm drain outlet structures upstream of the basin.

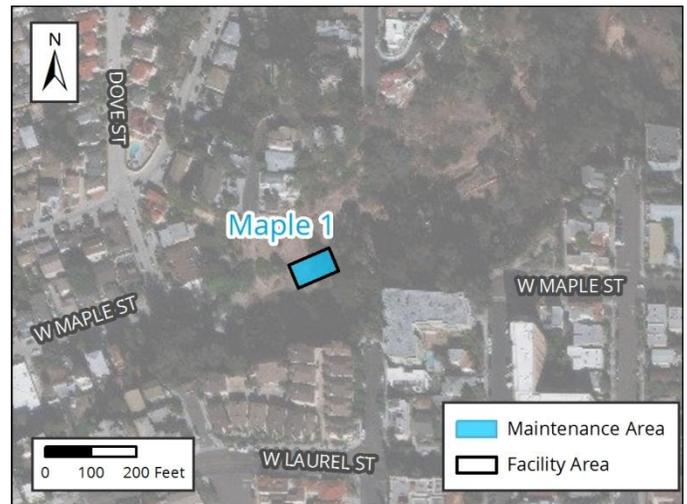
Figure 1: May 2018, looking east from the detention basin at the incised natural flood channel upstream

Current Conditions Affecting Facility Capacity	Light vegetation was observed and sediment accumulation, including sand, silt, and small cobble varied from 0.5 to 5 feet deep
---	--

Maintenance Recommendation	Remove accumulated sediment, debris, and vegetation from the desilting basin
-----------------------------------	--

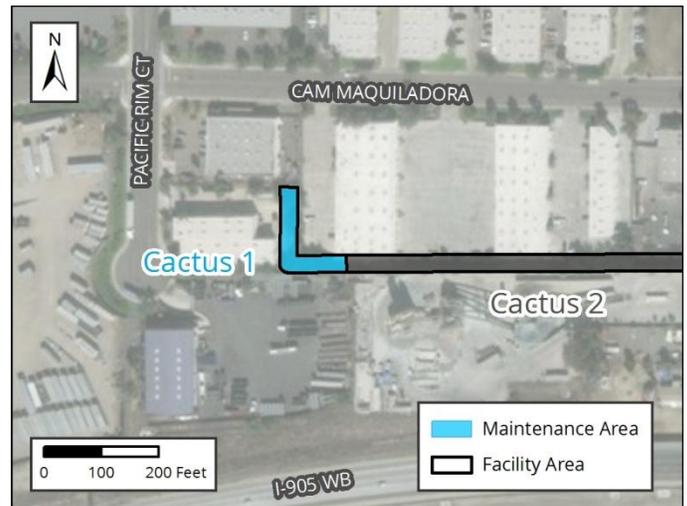
Figure 1: July 2017, standing water and vegetation growth in the basin

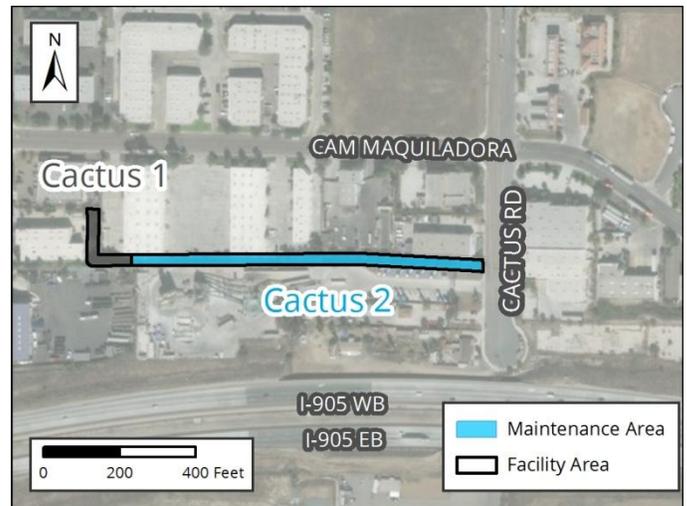
Figure 1: July 2017, sediment, debris deposition and vegetation growth in basin

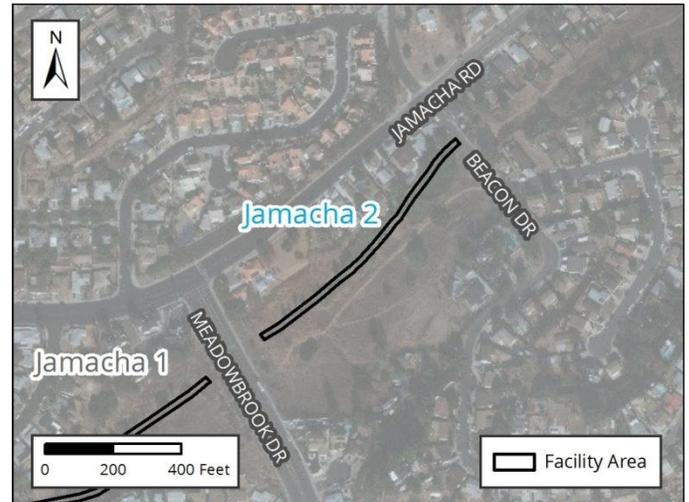
Figure 1: July 2017, downstream of Beacon Drive culvert (3-foot-diameter RCP), looking west. Riprap apron and dense vegetation present.
