A.44 Chollas Creek – 54th Street (No. 5-04-280)

A.45 South Chollas Creek – Southcrest

A.46 South Chollas Creek - Euclid

A.47 South Chollas Creek – Federal

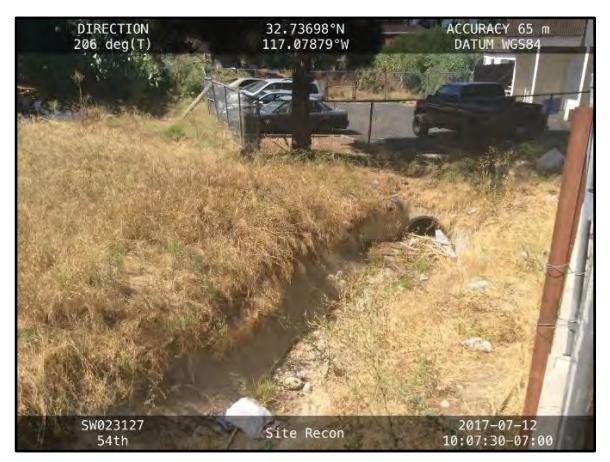
1. 54th St 1: Looking upstream.

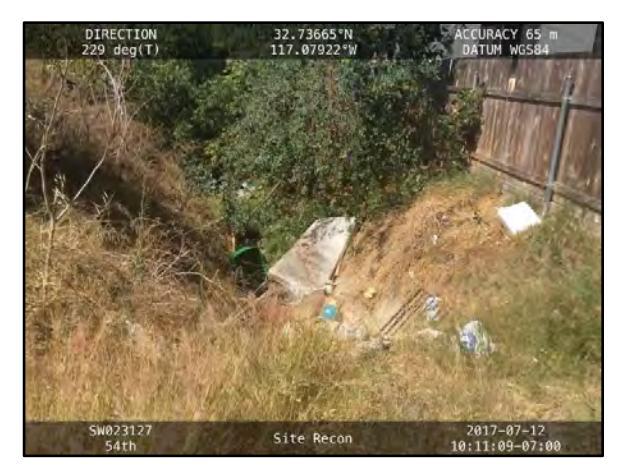
2. 54th St 1: Looking downstream towards the culvert; conveys flows beneath parking lot, then discharges back into ditch.

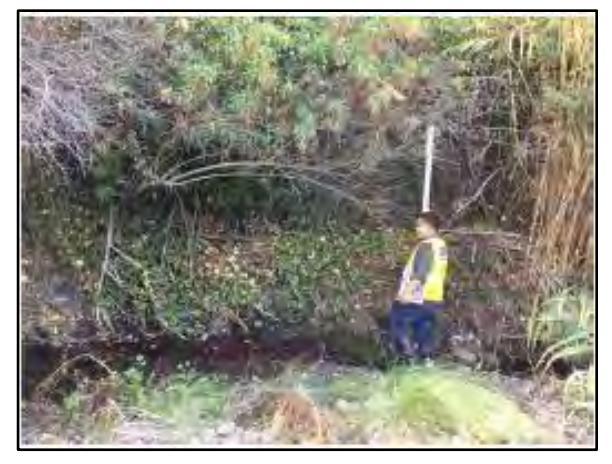
IHHA 8. Federal 1: Downstream portion of Reach 2 looking south at the vegetation left bank (looking downstream).

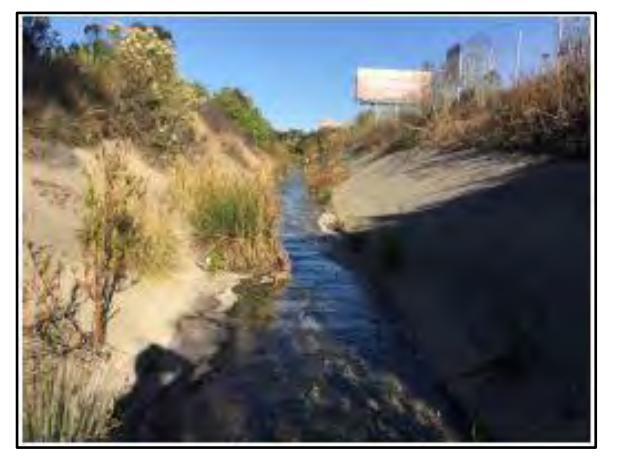
IHHA 15. Federal 2: Downstream portion of Reach 3 looking northeast at the concrete lined channel. Note the minimal vegetation established within the channel.

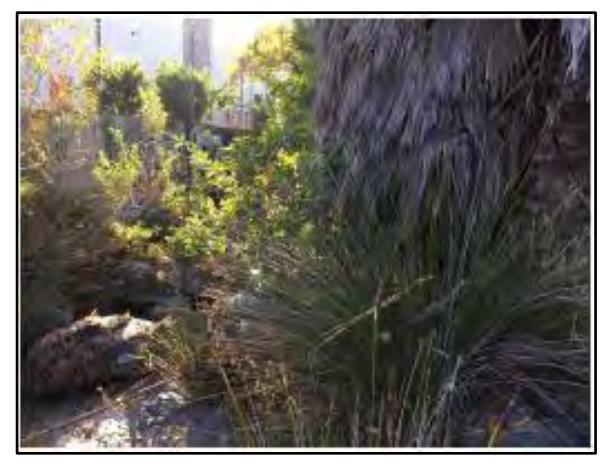
IHHA 14. Federal 1: Upstream portion of Reach 2 looking southwest at the 2-ton riprap channel lining and vegetation within the channel (palm trees and arundo).

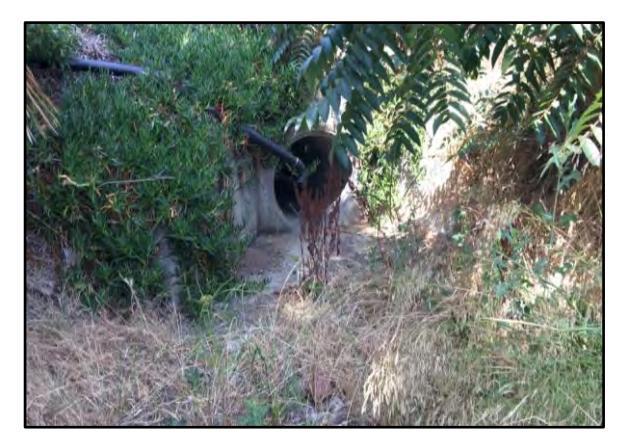
1. Jamacha 3: Looking upstream from Beacon Drive culvert (36-inch-diameter RCP).

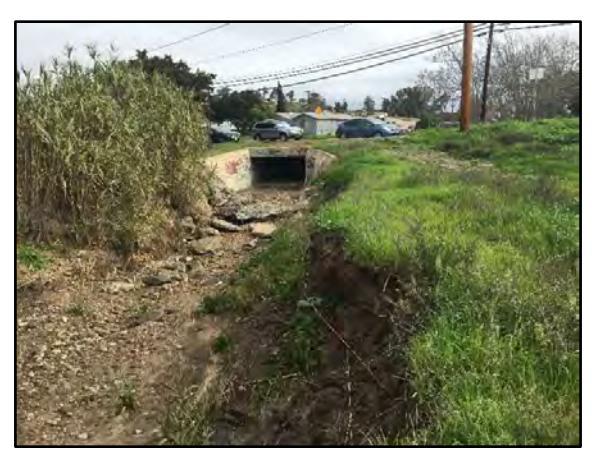
4. Jamacha 1: Upstream of 10-foot-wide by 5foot-high RCB culvert beneath 69th Street facing west.

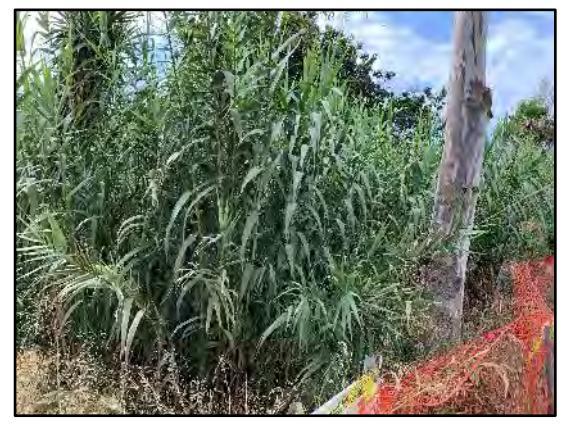
1. Lobrico 1, Reach 2: Dense vegetation present in channel at outlet of 48-inch RCP beneath Lisbon Street, looking southeast (July 2019).

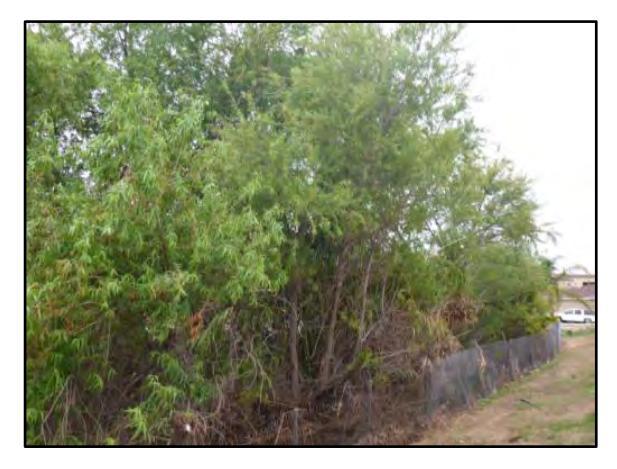
1. Cottonwood 2: Looking downstream of triple 72-inch-diameter RCP culvert beneath Highland Avenue at start of channel.

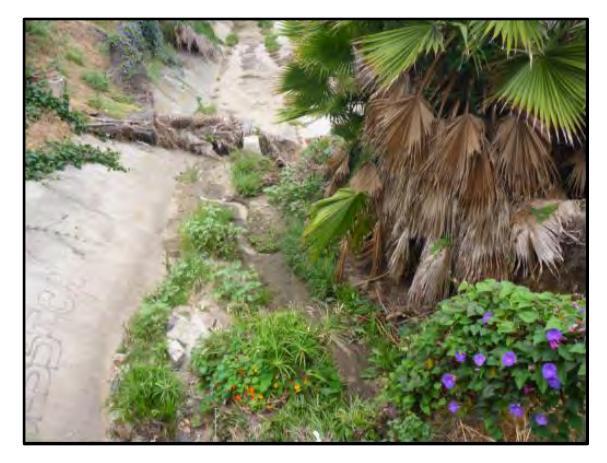
3. Cottonwood 2: Looking downstream at segment; vegetation and palm trees visible.

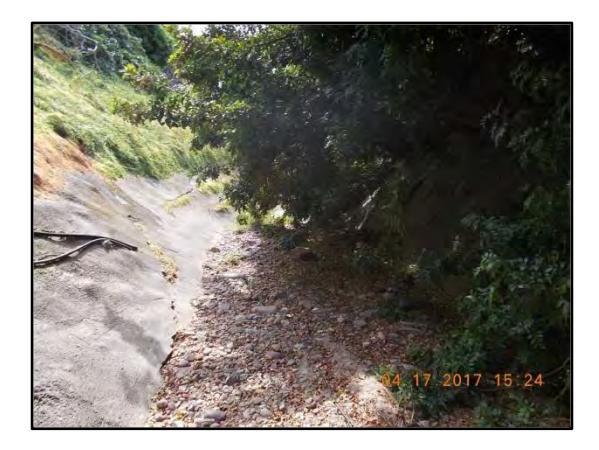
7. Solola 2 (Reach 1): Looking downstream at broken concrete.

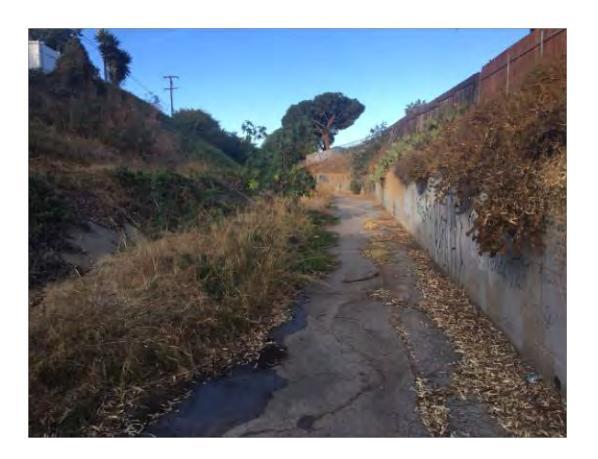
8. Solola 1: Looking downstream at accumulated sediment/debris in concrete channel. (November 2017)

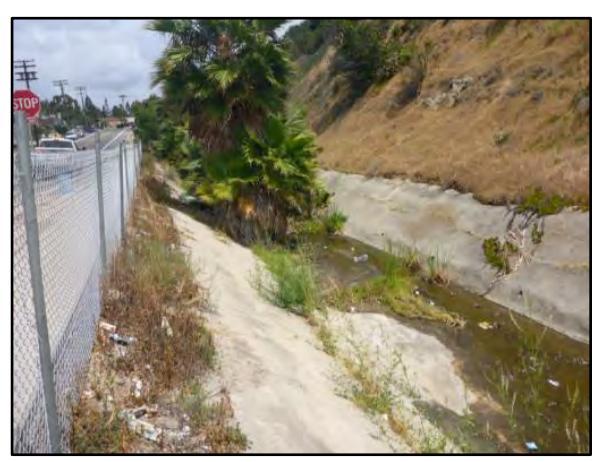
2. Parkside 1: Representative of channel (with moderate vegetation), looking upstream.

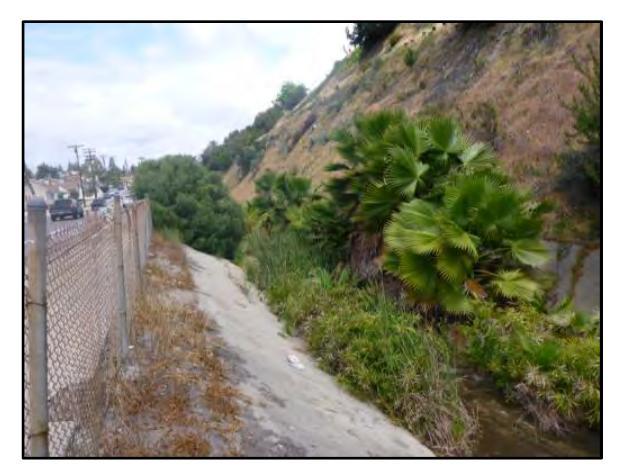
3. Parkside 1: Representative of channel (with dense vegetation), looking upstream.

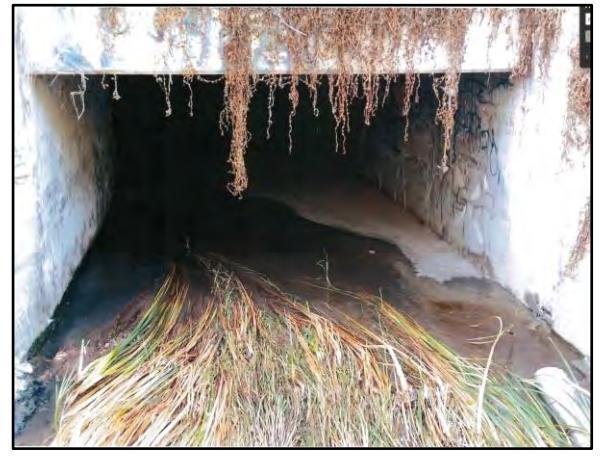
4. Via de La Bandola 11, Map 1: 8-foot-wide by 4-foot-high RCB culvert at downstream end of channel (Station 1418); no observed sediment or vegetation in culvert.

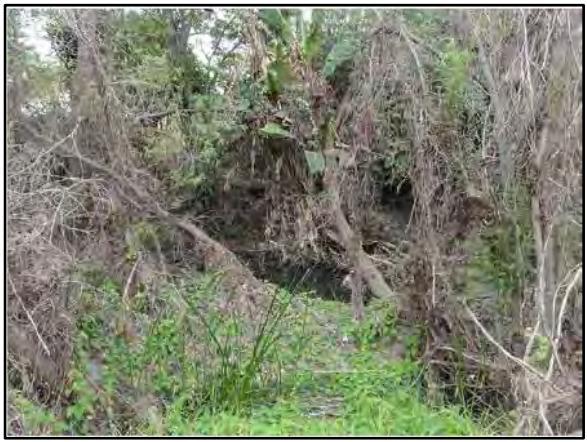
IHHA 1. Smythe 1, Map 2 (Reach 3): Looking upstream toward outlet of triple barrel 8-foot wide by 5-foot high RCB culvert (Station 4127.051).

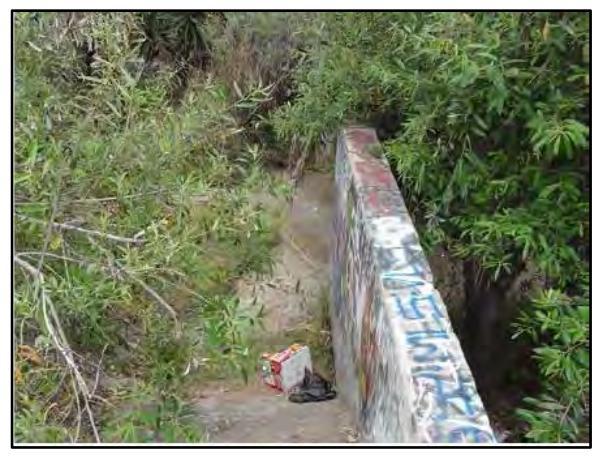
IHHA 4. Smythe 1, Map 2 (Reach 3): Upstream side of concrete check dam from northern bank.

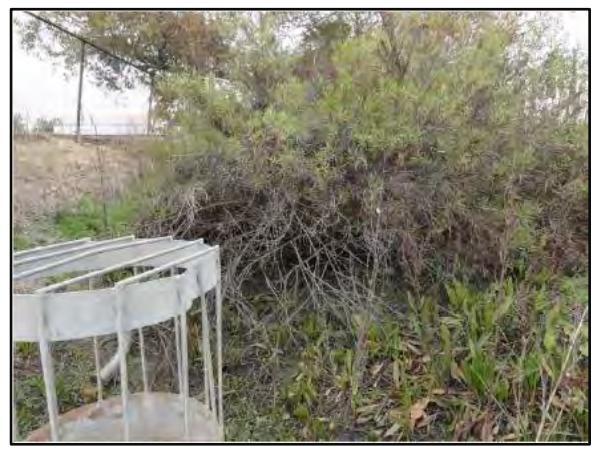
IHHA 2. Siempre Viva 1, Reach 1 (Bristow Channel): 24-inch-diameter CMP riser at the downstream end of Reach 1 (Bristow Channel) looking north (upstream) towards downstream end of dense vegetation.

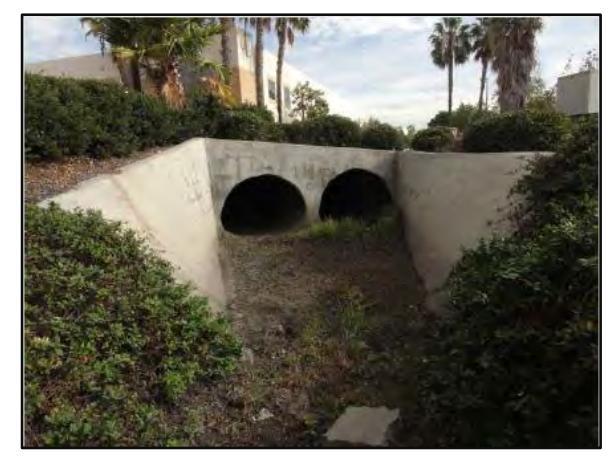
IHHA 5. Siempre Viva 1, Reach 2 (Bristow Channel): Looking west towards the inlet of the downstream pair of culverts.
