## INDIVIDUAL WATER QUALITY ASSESSMENT REPORT

Site Name/Facility:	Nestor Creek Channel
Master Program Map No.:	Map Number 131, 132, 133, 134
Date:	October 9, 2015; Revised January 11, 2017; Revised April 21, 2017; Revised May 2, 2017
<b>Civil Engineer</b> (name, company, phone number):	Rick Engineering Company 5620 Friars Road San Diego, California 92110 (619) 688-1448
<b>Register Civil Engineer Number &amp;</b> <b>Expiration Date</b> (place stamp here):	RCE # 70649 Exp. 06/2017
<b>Instructions</b> . This form must be completed for each	facility prior to the completion of the Individual

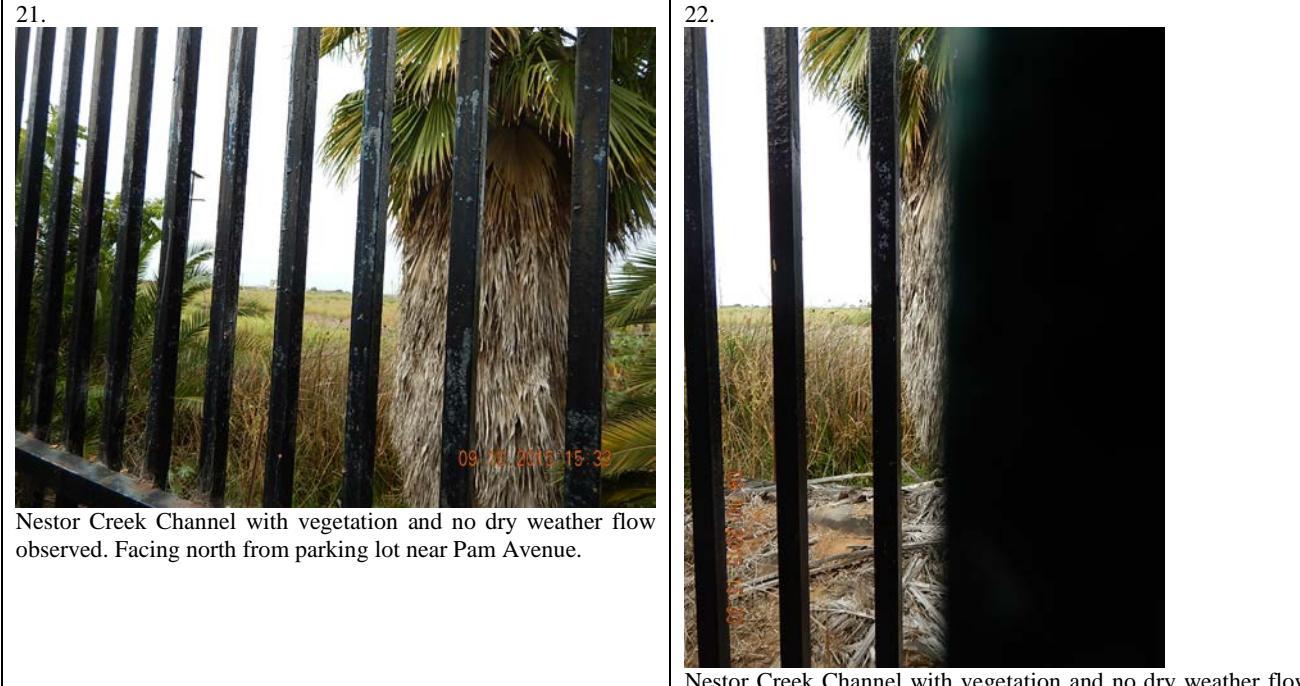
Date of Site Visit: 11/16/16

Nestor Creek Channel with vegetation and no dry weather flow observed. Facing northeast from parking lot near Pam Avenue.
