**UPDATE TO GEOTECHNICAL
INVESTIGATION AND SLOPE STABILITY
ANALYSIS FOR BEYER BOULEVARD**

**SOUTHWEST VILLAGE
VESTING TENTATIVE MAP
SAN DIEGO, CALIFORNIA**

GEOCON
INCORPORATED

**FEBRUARY 16, 2022
PROJECT NO. 06847-42-05**

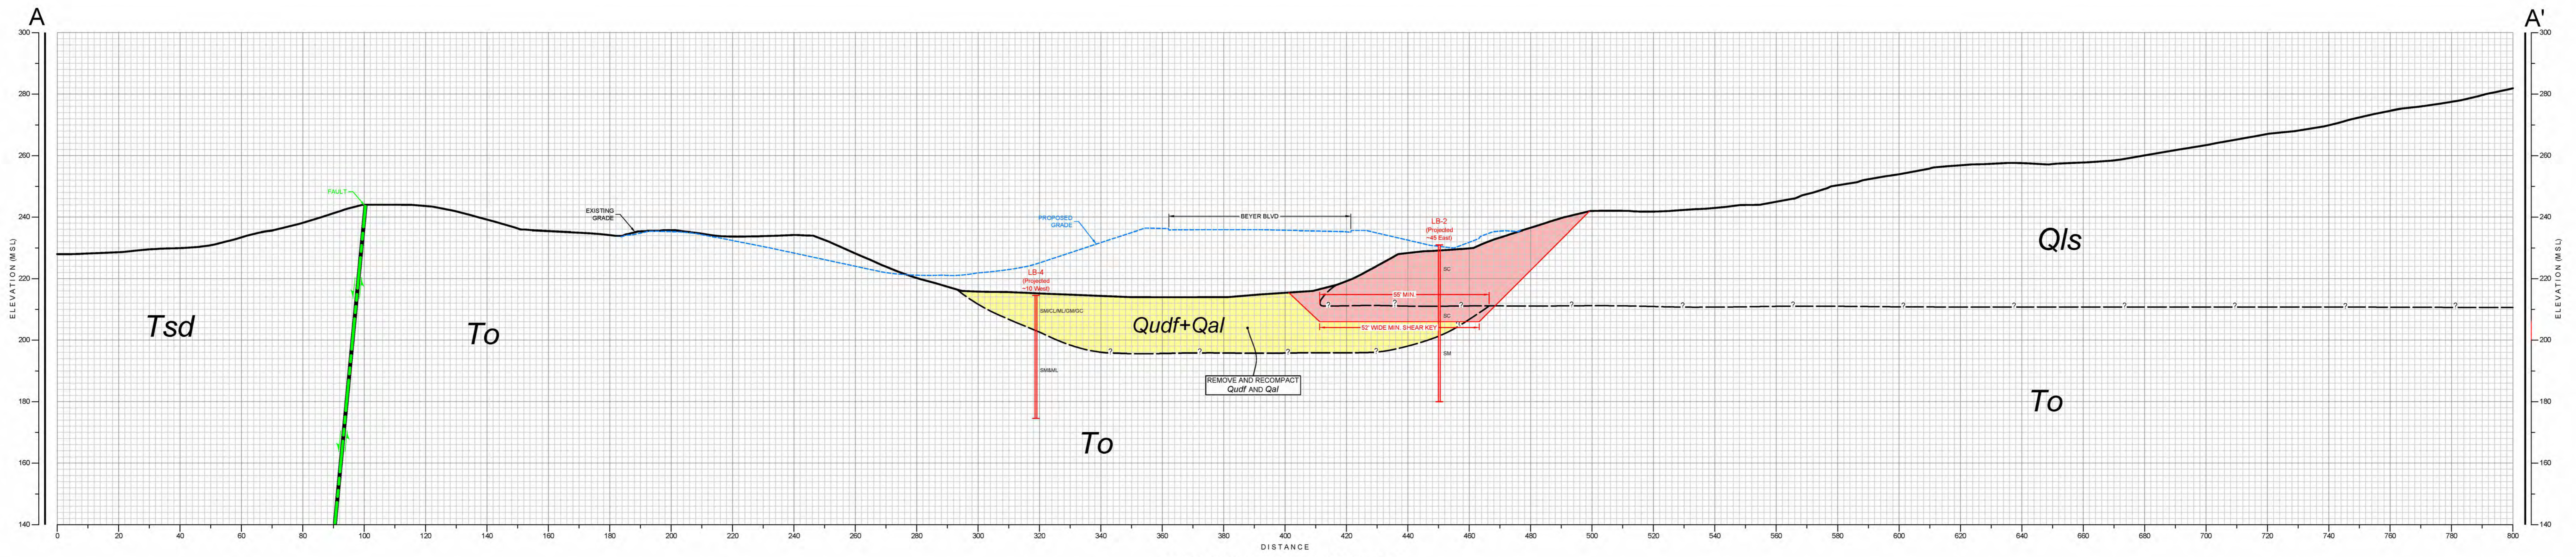
GEOLOGIC CROSS-SECTION A-A'
SCALE: 1" = 20' (Vert. = Horiz.)

Cross Section	Proposed Graded Minimum Factor of Safety		Deformation (cm)	Stabilization Method
	Static	Seismic		
A-A'	1.5	1.0	--	55-foot-wide buttress for landslide
B-B'	3.0	1.75	--	20-foot-wide stability fill
C-C'	1.5	1.1	--	20-foot-wide buttress for BPS and stability fill
D-D'	1.5	1.1	--	30-foot-wide buttress for BPS and 20-foot-wide stability fill
E-E'	1.5	1.2	--	20-foot-wide buttress for BPS and 20-foot-wide stability fill
F-F'	1.5	1.1	--	15 to 20-foot-wide buttress for BPS and 20-foot-wide stability fill
G-G'	1.6	1.2	--	20-foot-wide stability fill
H-H'	1.5	1.2	--	25-foot-wide buttress for BPS
I-I'	2.5	2.0	--	--
J-J'	1.5	0.9	10	--
L-L'	1.5	1.0	--	210-foot-wide buttress for landslide
M-M'	1.5	0.9	2	100-foot-wide buttress for landslide
N-N'	1.6	0.9	10	--
O-O'	1.6	0.9	7	--
P-P'	2.5	1.1	--	--

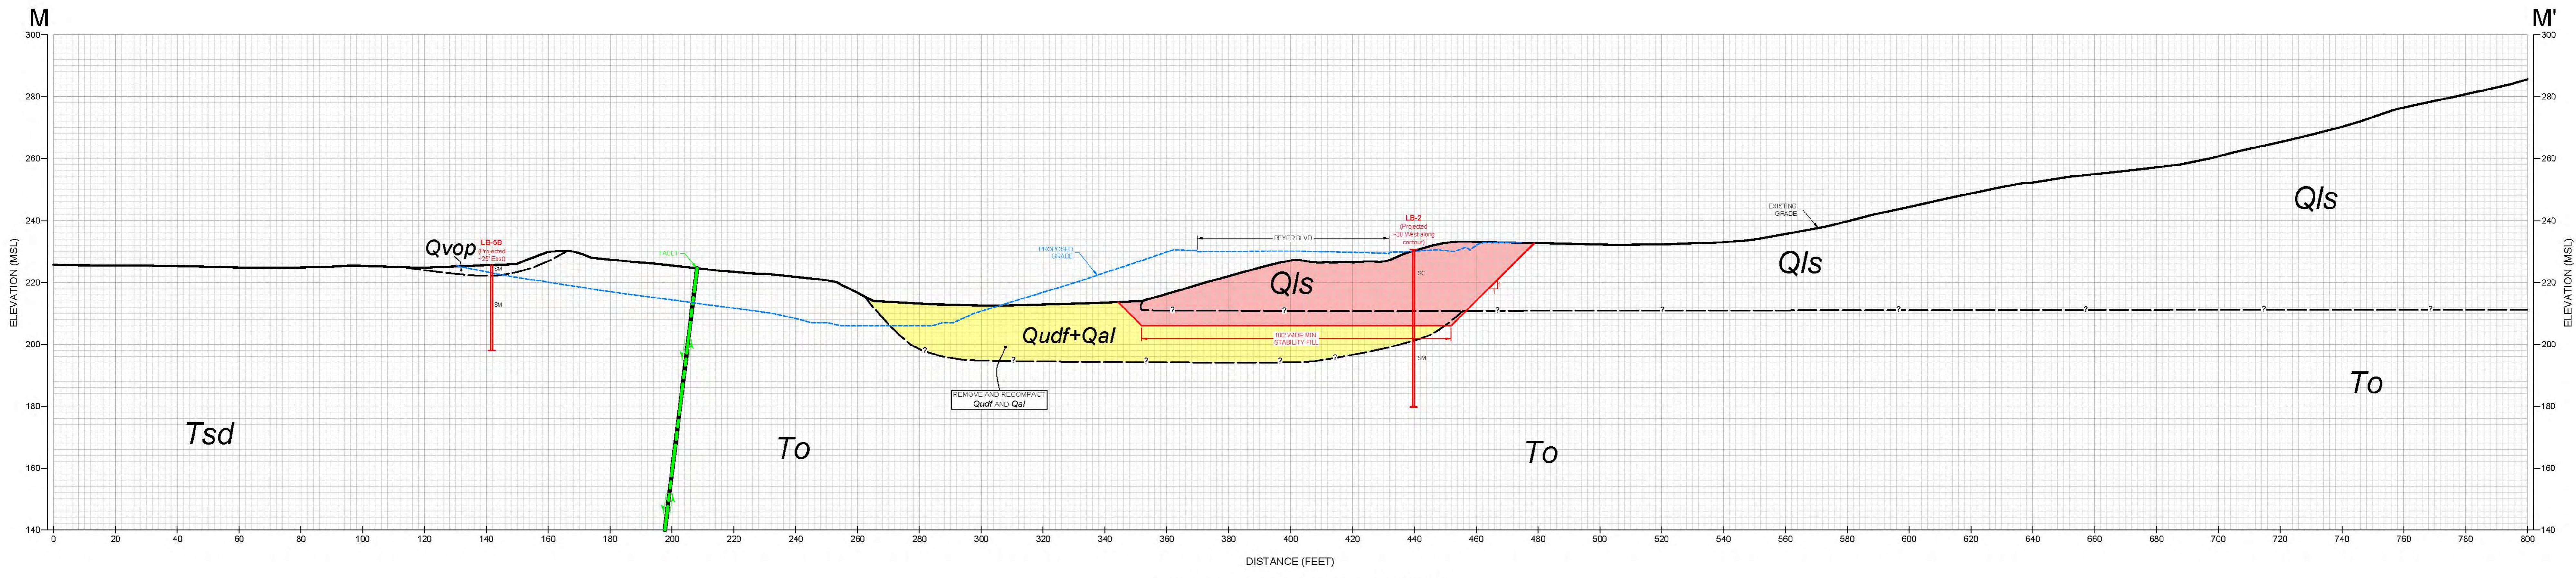
GEOLOGIC CROSS-SECTION M-M'
SCALE: 1" = 20' (Vert. = Horiz.)

calculated on the critical sections. A slope is considered acceptable by the screening analysis if the calculated factor of safety is greater than 1.0 using k_{EQ} , therefore, all of the sections except Cross Sections J, M, N, and O pass the screening analysis for seismic slope stability.

For Sections J, M, N, and O, we performed a displacement analysis using procedures recommended in Special Publication 117A. The seismic slope displacement analysis computes an estimated horizontal deflection using the seismic yield acceleration determined from the slope stability analysis and the maximum ground acceleration, modal magnitude, and modal distance determined from the deaggregation analysis. The computed yield acceleration (horizontal seismic coefficient corresponding to a factor of safety of 1.0) was 0.08g for each cross section (see Figures C-33B, C-40B, C-41B and 44B). The calculated horizontal deflection for each critical failure surface not passing the screening evaluation is estimated to be between 2 and 10 centimeters, which is considered acceptable. Special Publication 117A indicates that displacements less than 15 centimeters are unlikely to correspond to serious landslide movement and damage.

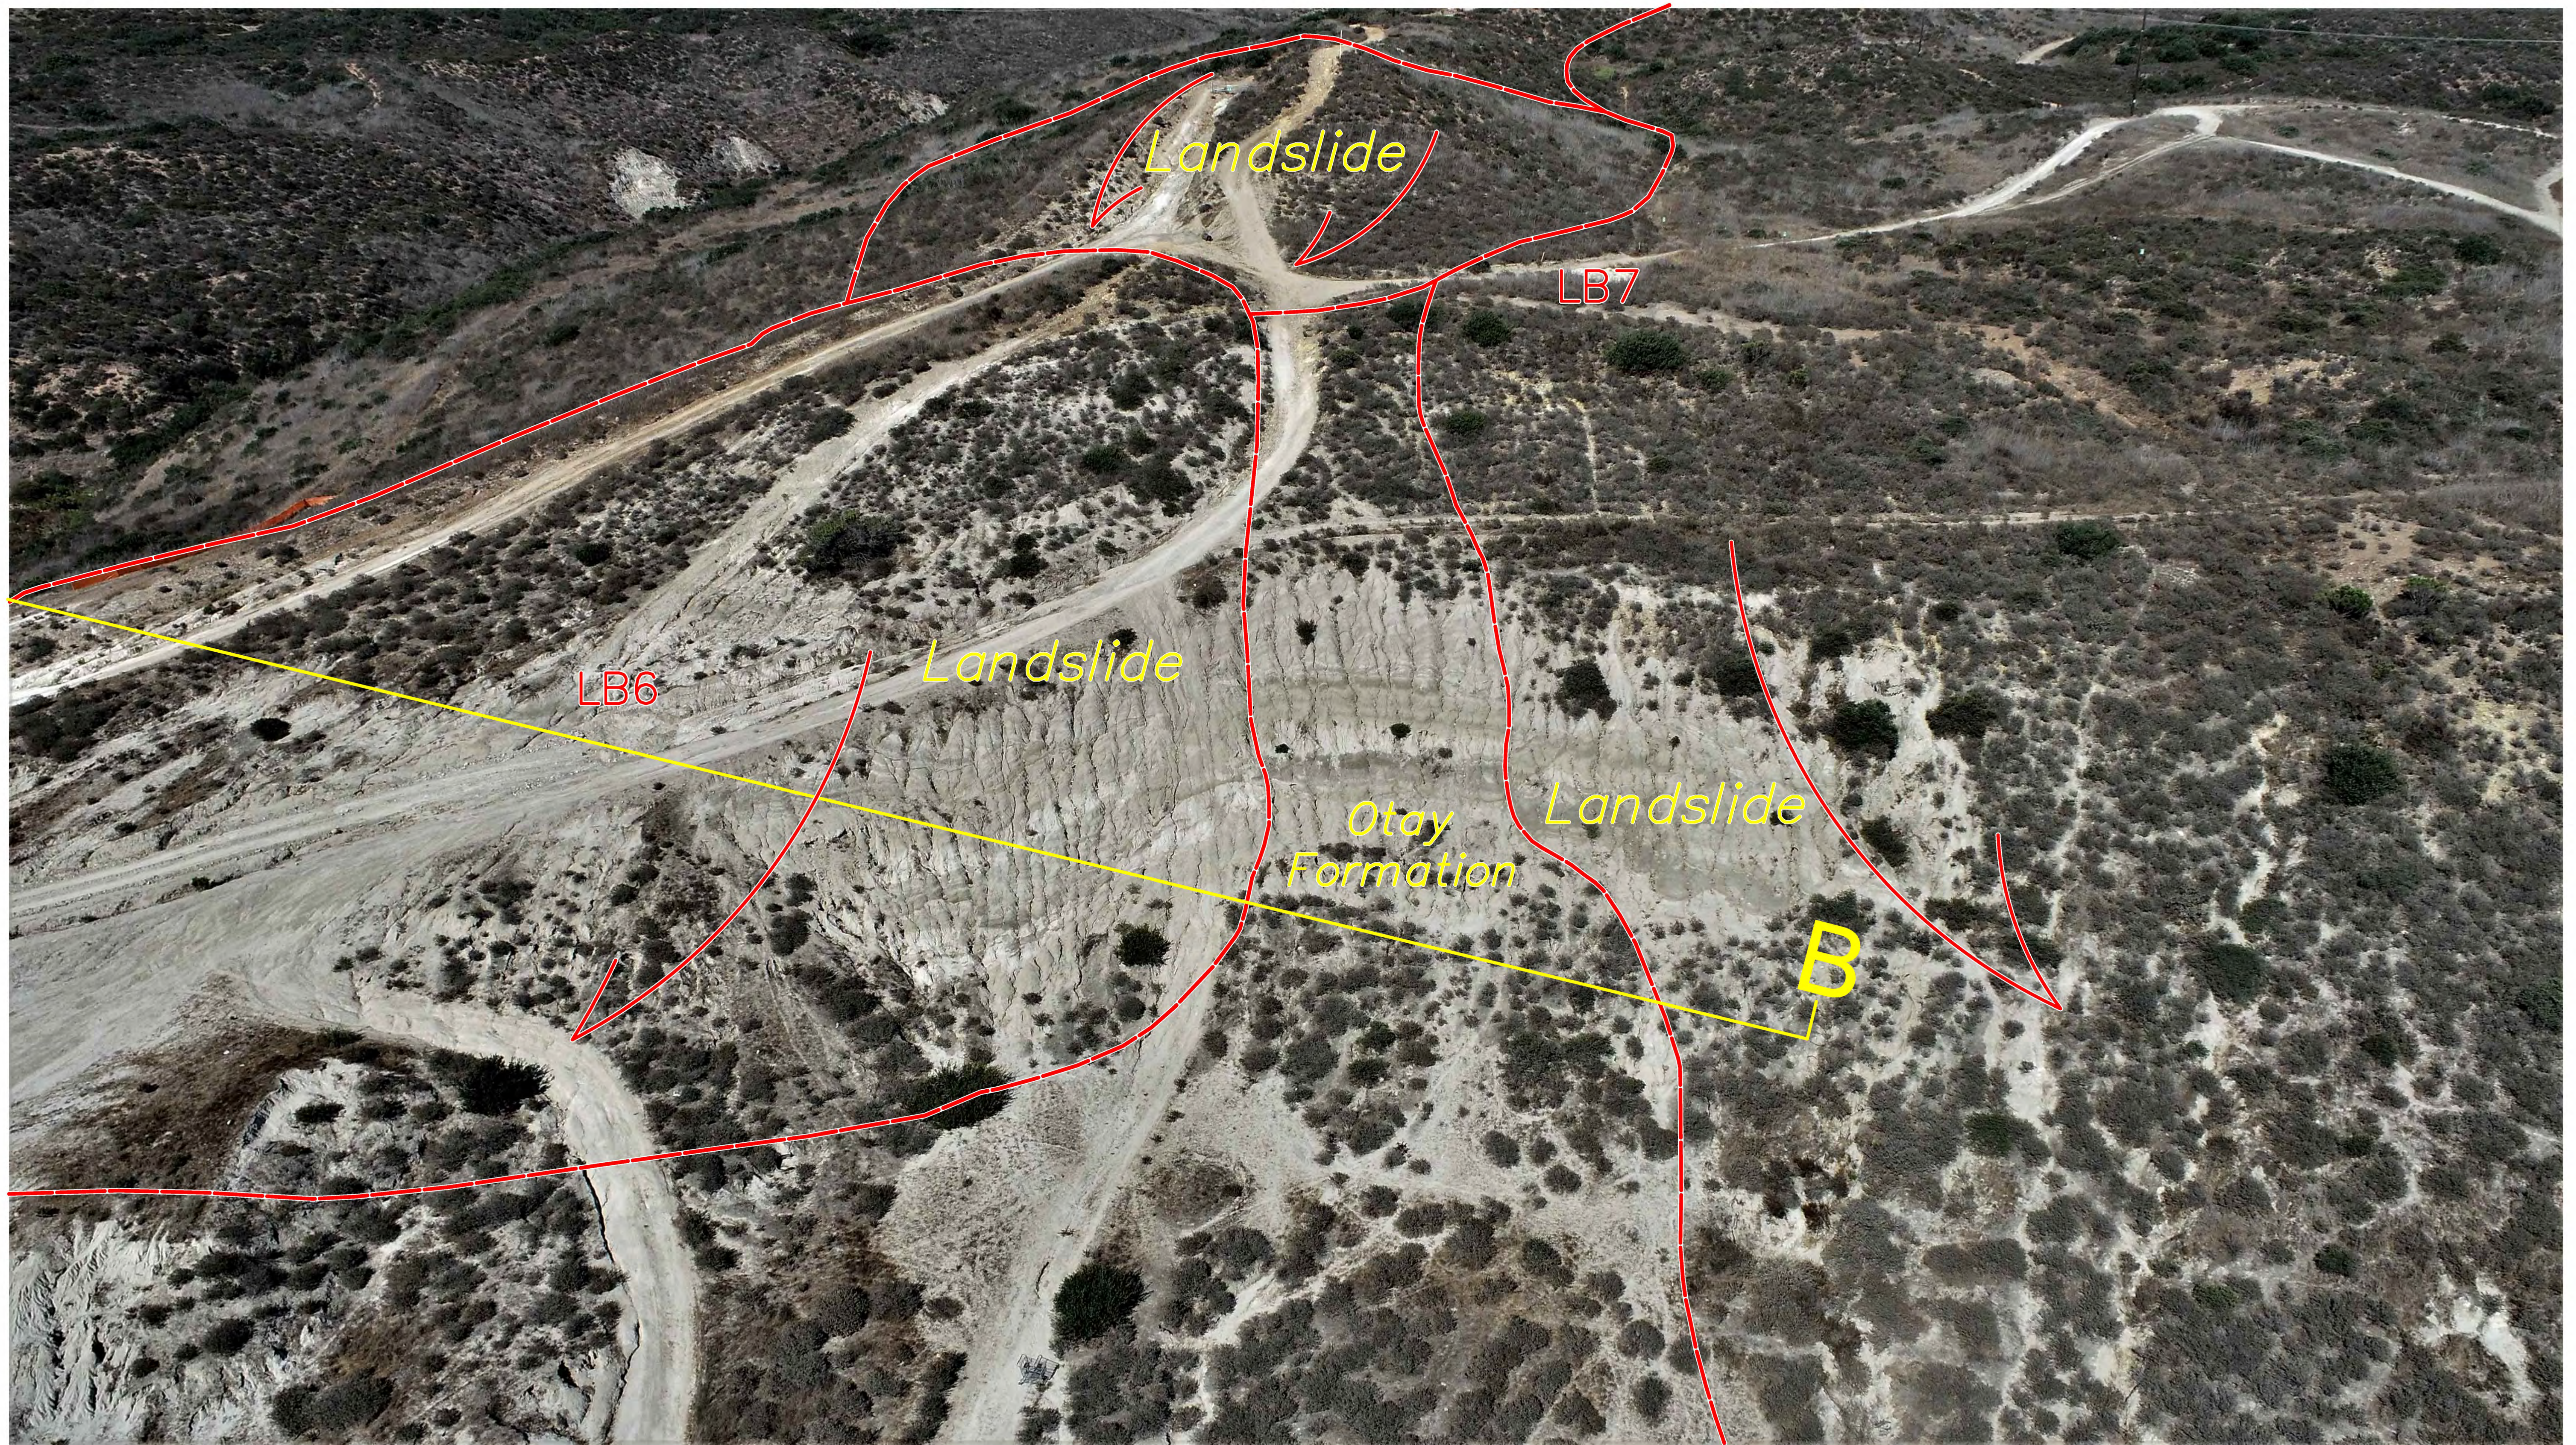
SCALE: NOT TO SCALE DATE: 02-16-2022
PROJECT NO.: 06847-42-05 FIGURE: 11
SHEET: 1 OF 1

The geologic units encountered during our investigation were Landslide Debris, Very Old Paralic Deposits and the Otay Formation. A discussion of these units is contained in our March 2019 report. Information from our previous studies was considered during our current investigation, however, the additional subsurface data enabled refinement and in some cases reinterpretation of the geologic conditions. A revised geologic interpretation along the proposed roadway alignment is presented on the Geologic Map and Cross Sections (Figures 1 through 9). Figures 10 through 12 present photographs of the landslide and adjacent bedrock area in the vicinity of proposed Beyer Boulevard Station 15 through 20. The relationship between the geologic units is exposed in an excavation that was made during grading of a presumed “borrow site”.

BEDDING EXPOSED IN BORROW SITE CUT
BEYER BOULEVARD EXTENSION
SOUTH OTAY MESA
SAN DIEGO, CALIFORNIA
