# 1428 Soledad Avenue

Report No. HRB-26-029

**City of San Diego  
Historical Resources Board  
(HRB) Meeting  
July 23, 2026  
Item #3**

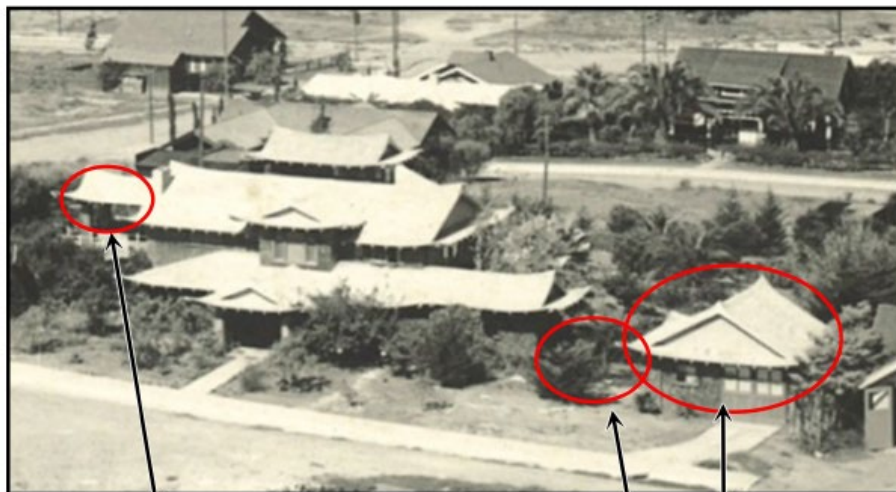
1916 View of the Primary Façade of the Residence and Detached Garage, Facing West

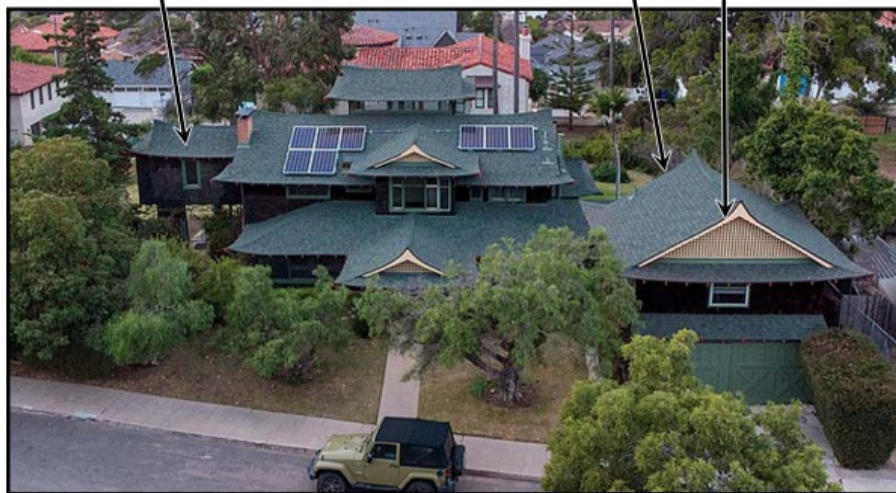
2023 View of the Primary Façade of the Residence and Detached Garage, Facing Northwest

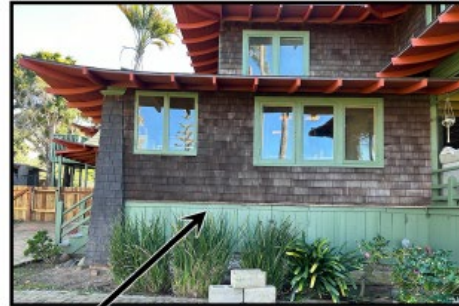
2024 View of the Easterly Enclosed Porch, Facing Southeast

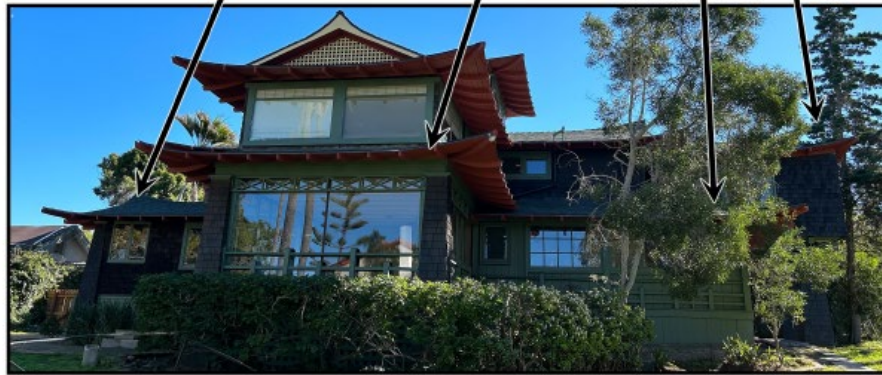
2024 View of the Northwest Façade of the Residence, Facing East

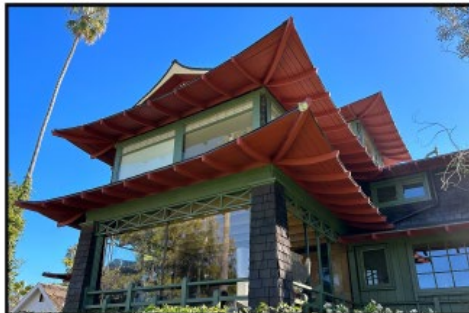
2024 View of the Central Enclosed Porch, Facing East

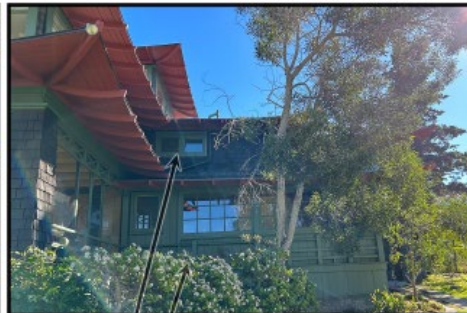
2024 View of the Westerly Enclosed Porch, Facing Southeast

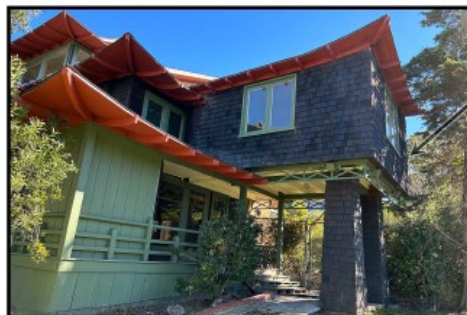
2024 View of the Westerly Second Story Enclosed Porch, Facing East

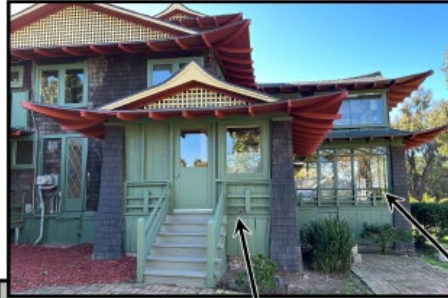
**2024 View of the Easterly Enclosed Porch, Facing Southwest**

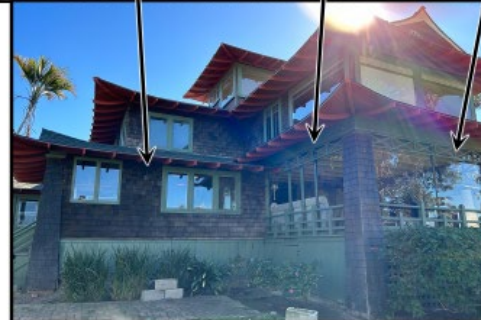
**2024 View of the Easterly Enclosed Porch, Facing South**

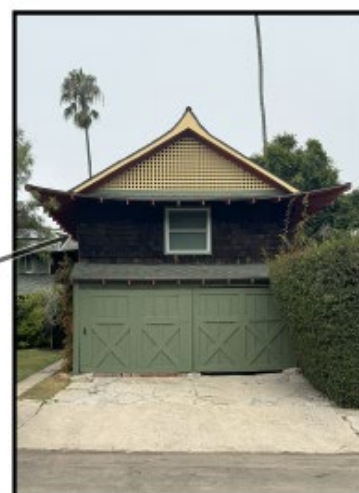
**2024 View of the Primary Façade of  
the Detached Garage, Facing West**

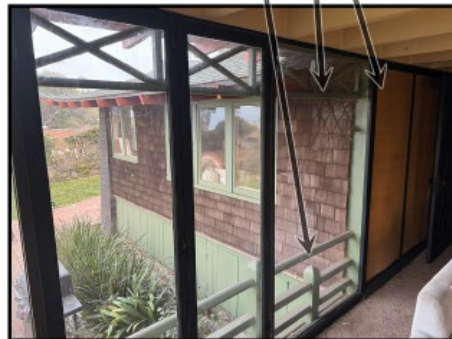
**2024 View of the Central Porch and Enclosed  
 Easterly Porch, Facing East**

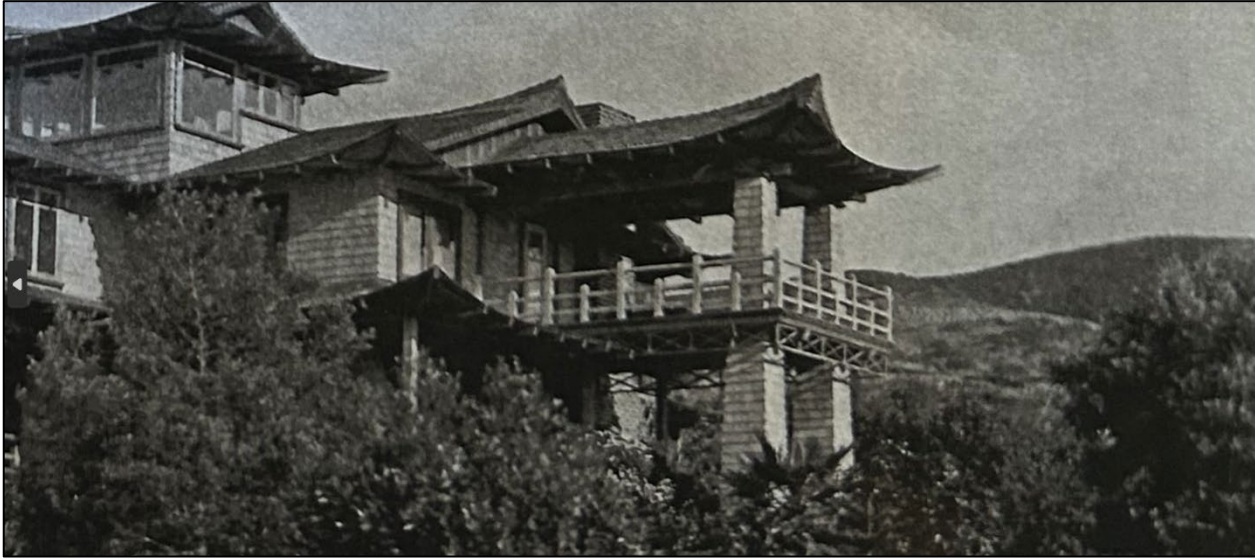
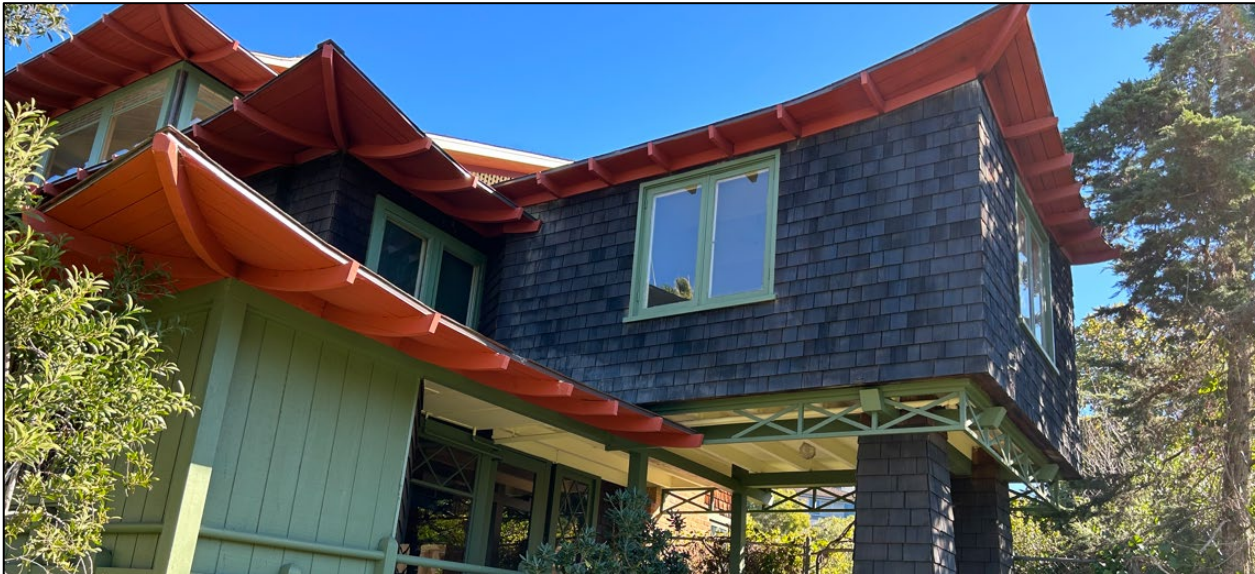
Among the various and extensive modifications detailed above, **four** prominent porches and a sunroom were enclosed or modified at the 1428 Soledad Avenue building
