**REPORT OF GEOLOGIC FAULT INVESTIGATION**

Proposed Lee/DeGuzman Residence  
1855 Spindrift Drive  
La Jolla, California

**JOB NO. 22-13755**

07 July 2023

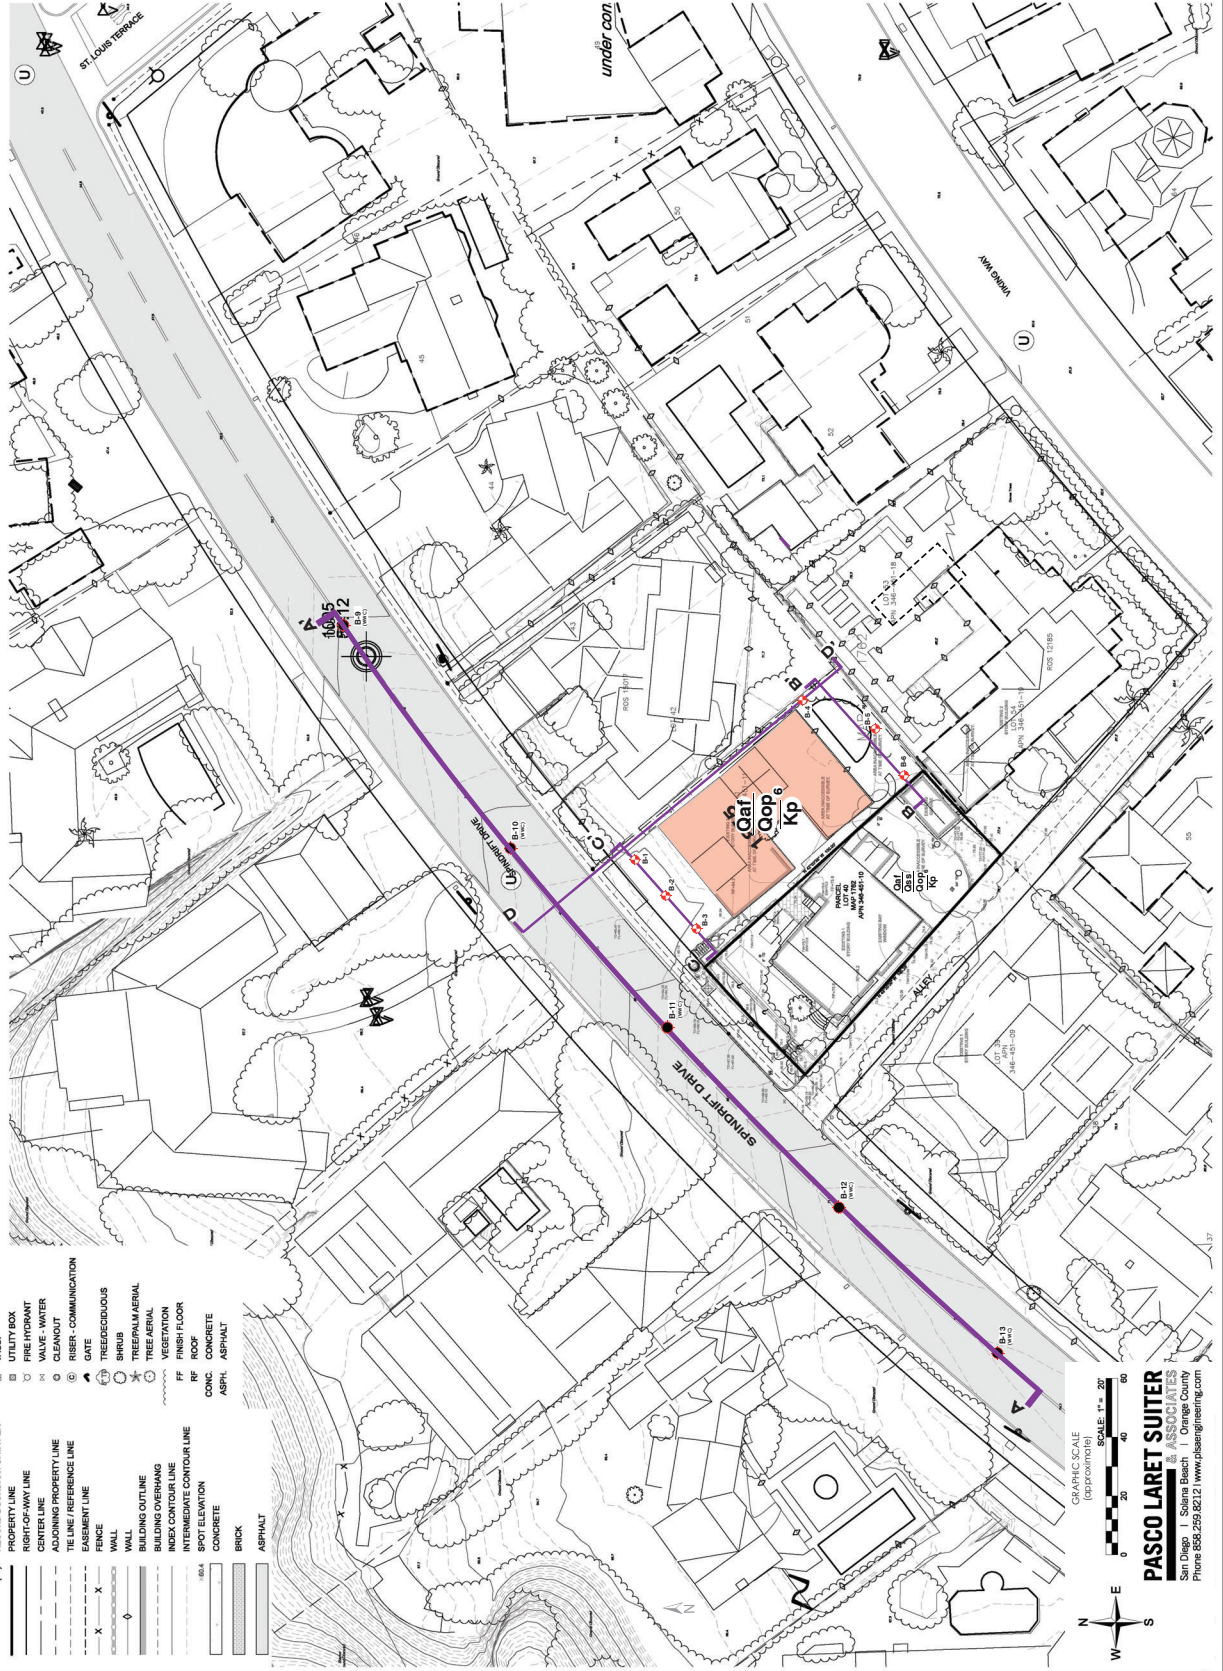
## PLOT PLAN AND SITE SPECIFIC GEOLOGIC MAP

Artificial Fill Soils (Qaf): The entire site is overlain by 3 to 4 feet of artificial fill soils that were encountered in all borings (B-1 to B-6). The observed fill soils consist of fine- to medium-grained silty sands (SM) and clayey sands (SC). The fill soils are moist, light brown to medium brown. The density was observed to be medium dense; landscape fill soils were loose. The fill soils were observed to be mixed in color and utility pipes were observed at shallow depths adjacent to some of the boring cut-out areas. Refer to Figure Nos. IIIa-f for log details.

Based on the elevation points of the Paralic Deposits overlying the Point Loma Formation contact as observed in the bluff face to the west, and the contact points encountered in the borings, the Point Loma Formation surface is relatively flat-lying to very gently dipping to the west. The sediments encountered were generally massive. Based on the continuous, relatively planer surface, we conclude that there is no significant faulting in the immediate area of the subject property. In addition, other evidence of faulting such as shearing, was not observed in the retrieved boring cores.

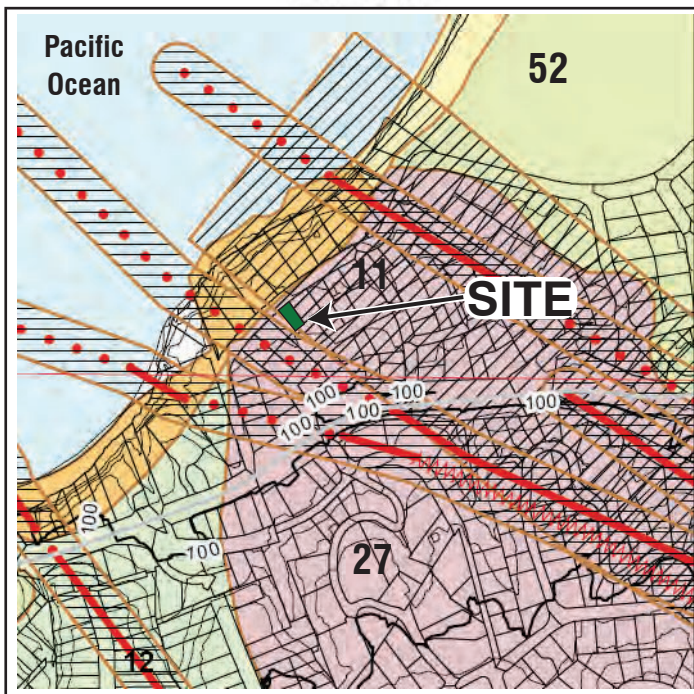
Figure No. III  
Job No. 22-13755

Our review of the City of San Diego Seismic Safety Study -- Geologic Hazards Map Sheet 29, dated 2008, indicates that the site is located in two geologic hazard areas designated as Categories (GHC) 11 and 27. An excerpt of the map is included as Figure No. III. Category 11 is identified as a State of California fault zone, described as "*Active, Alquist-Priolo Earthquake Fault Zone.*" Category 27, also a City of San Diego designation, is identified as a slide-prone formation "*Otay, Sweetwater and others.*" The following discusses issues related to faulting. The potential for landsliding is discussed later under Geologic Hazards.

Regarding GHC 11, based on the previous discussions, it is our opinion that there is no significant faulting within the subject property, which is zoned in GHC 11. We provide on Figure No. IVa the properties in the vicinity of 1855 Spindrift Drive Fault Hazard Zone that are included in the State of California Special Studies Report

Regarding GHC 27, a "slide-prone" category, it our opinion, based on the property location on very gently sloping terrain and the massive structure and density of the underlying geologic units, the risk associated with "slide-prone" is considered nominal. The additional potential geologic hazards not described in this report will be discussed in our geotechnical report, which will be issued separately.

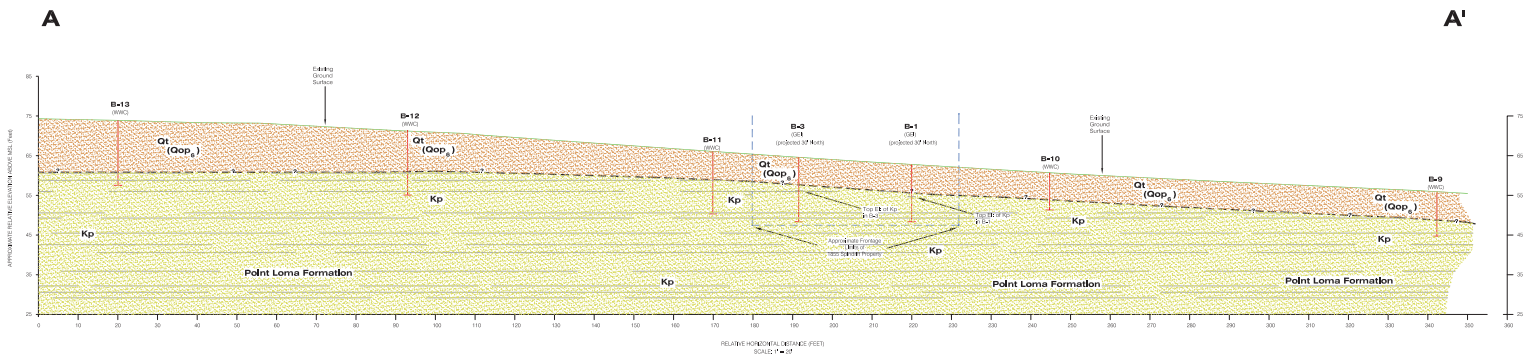
Figure No. Villa  
Job No. 22-13755

anticipated, elevations of the Point Loma Formation surface are very similar to the elevations noted in the Artim and Streiff borings northwest of and adjacent to the site. Cross section A-A' (Figure No. VIIIa), specifically in the area of Station Nos. 170 through 250 feet, depicts the Artim and Streiff borings and the GEI borings. GEI borings B-1 and B-3 are projected about 30 feet northwest to the Spindrift Drive cross section. The cross section reveals that the elevations of the underlying Point Loma Formation surface are essentially the same on Spindrift Drive and in front of the property and in the rear yard of the home. Figure Nos. VIIIb and VIIIC present cross sections B-B' and C-C' across the rear and front yards, respectively, and Figure No. VIIId presents cross section D-D', drawn perpendicular to B-B' and C-C'. Cross section B-B' includes GEI boring data from the adjacent project at 1851 Spindrift Drive. Review of the cross sections noted above indicates a similar surface elevation of the underlying Point Loma Formation (below the Qop6).
