INDIVIDUAL BIOLOGICAL ASSESSMENT REPORT

Site Name/Facility:	Via de la Bandola
Master Program Map No.:	130a
	Pre-Maintenance – 12/9/2014
Date:	Post-Maintenance – 1/20/2016
Biologist Name/Cell	Pre-Maintenance – George Aldridge (HELIX) / 520 343-0046
Phone No.:	Post-Maintenance – Scott Gressard (Dudek) / 858-997-6874

Via De La Bandola Channel Emergency Channel Maintenance, MMP Map 130a

Photograph Log

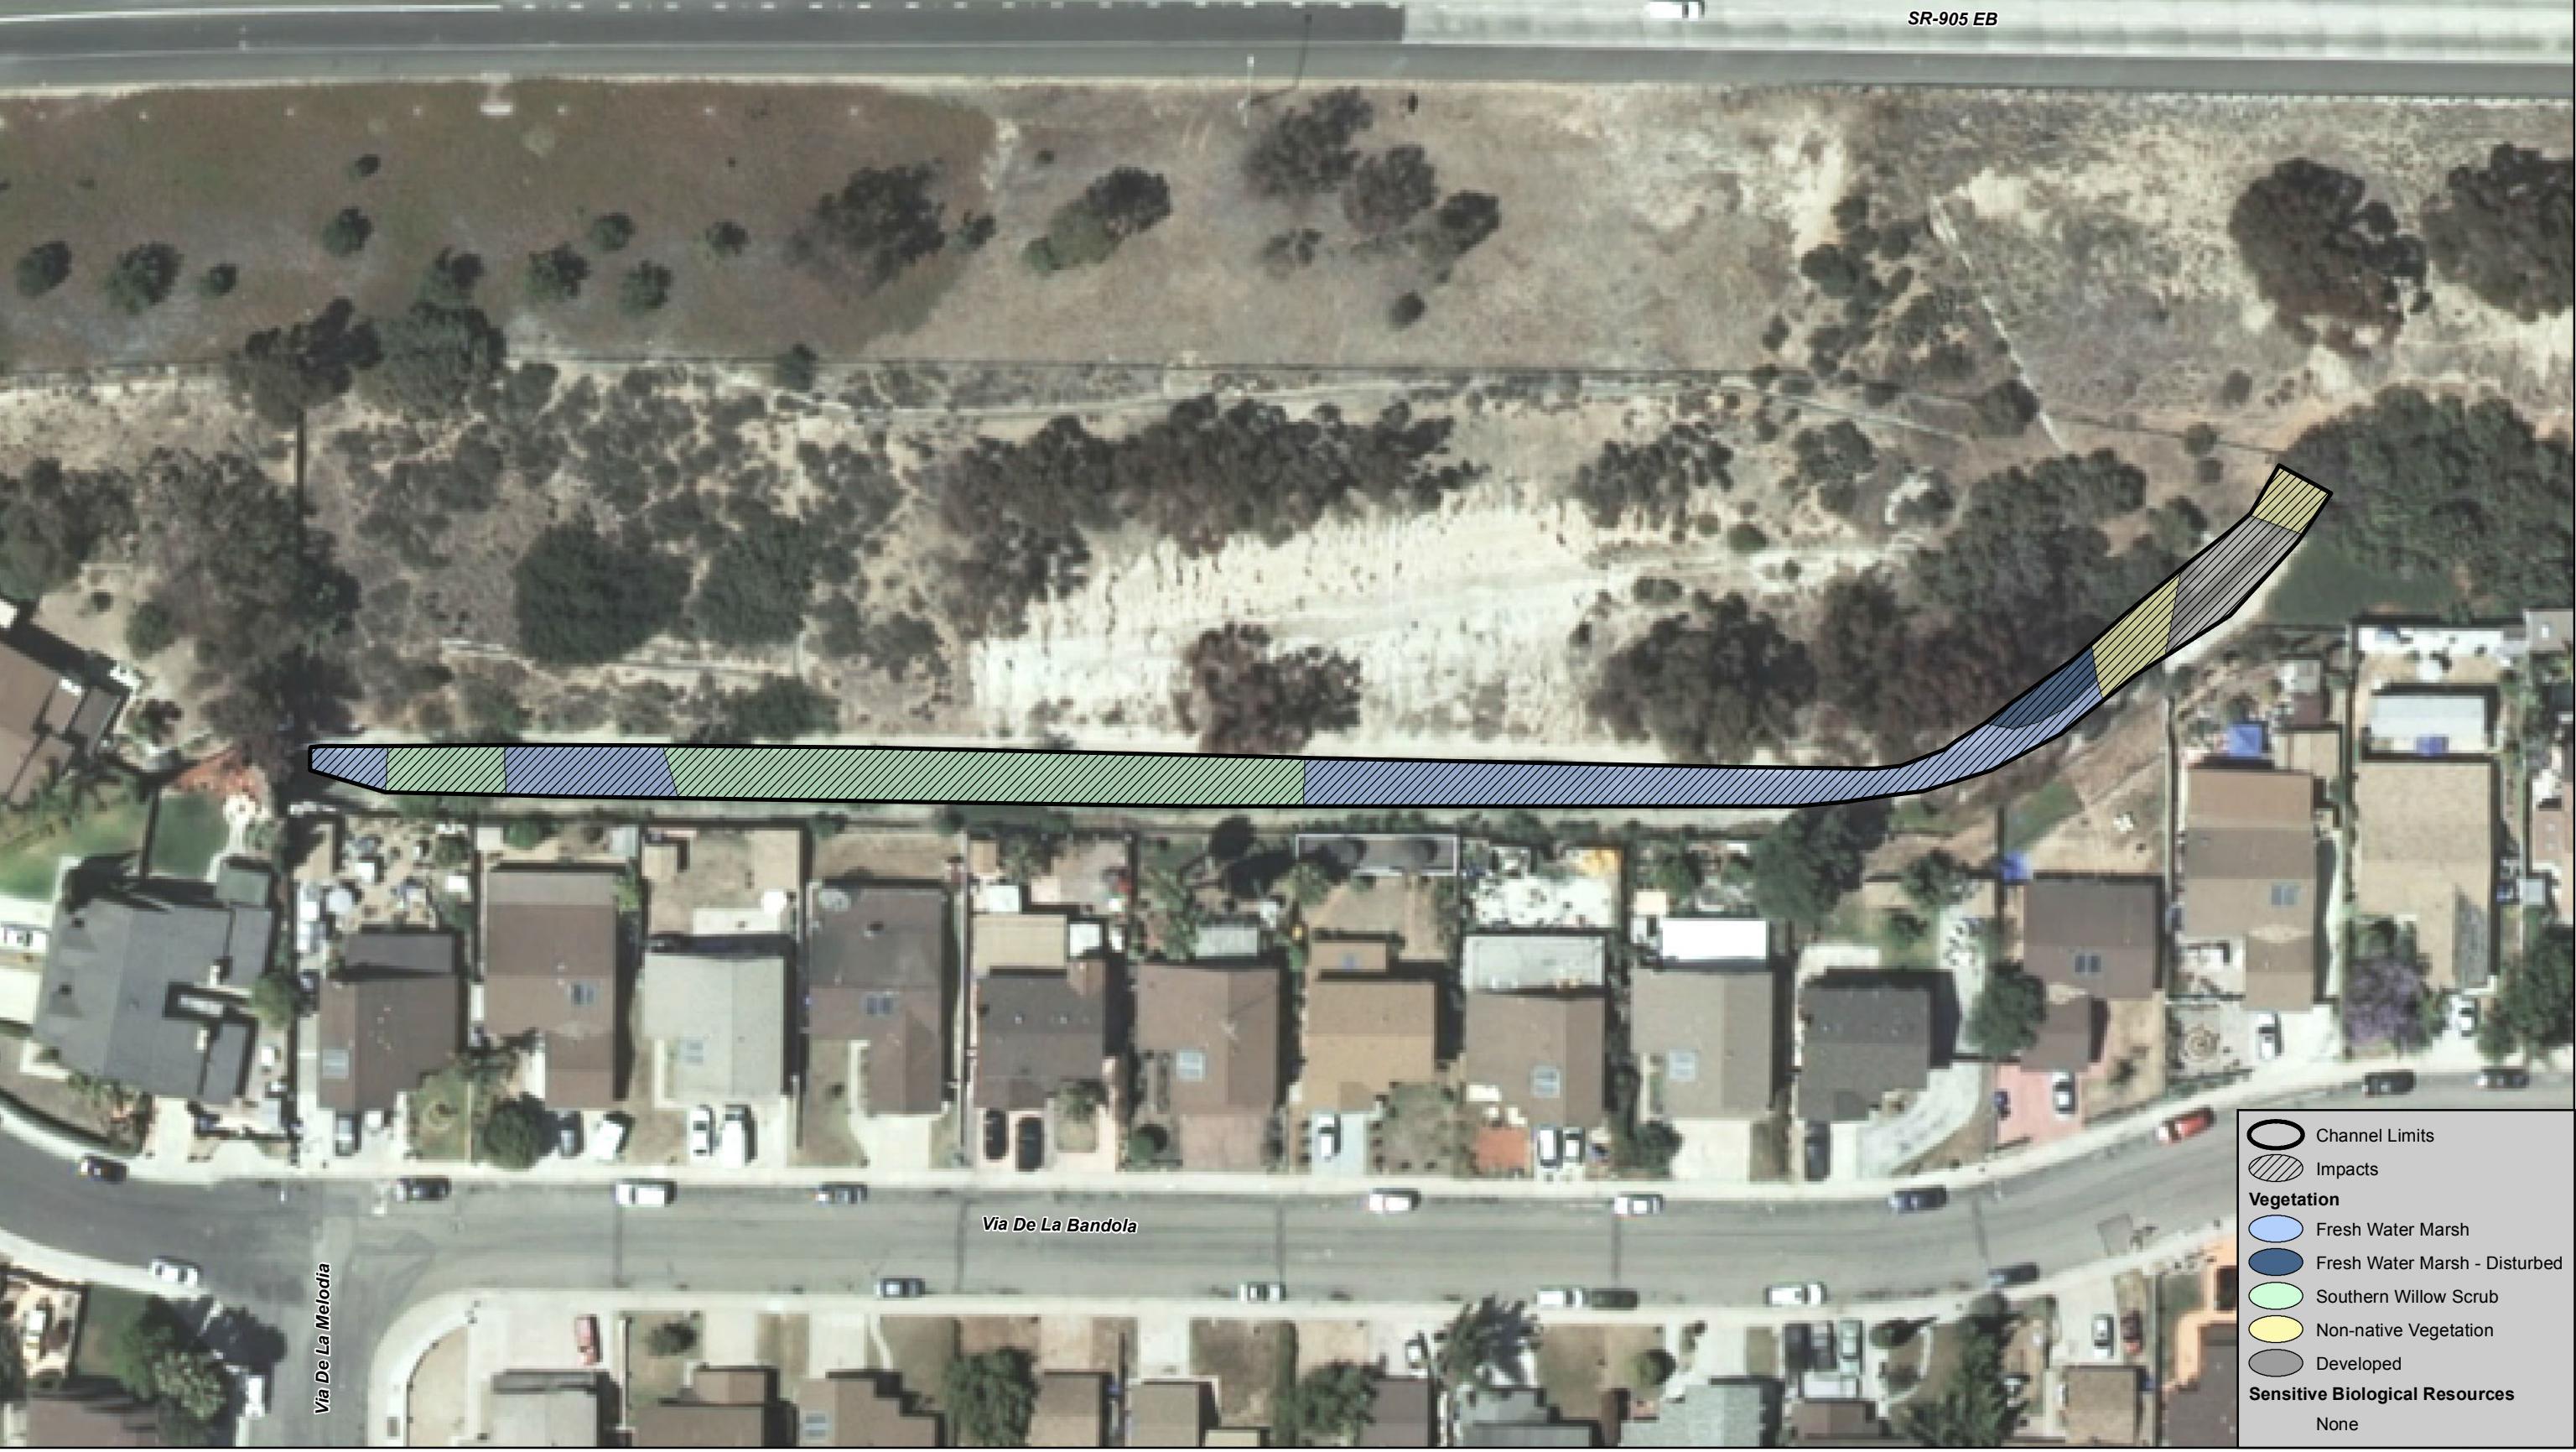
Figure 3

The extent of land cover in the channel is as follows (Figure 3): 4094 sq. ft (0.09 acre) of freshwater marsh; 327 sq. ft (0.01 acre) of disturbed freshwater marsh including acacia, ditch beardgrass, and Mexican fan palm growing among dominant cattail; 3738 sq. ft (0.09 acre) of southern willow scrub; 807 square ft (0.02 acre) of non-native vegetation; and 809 sq. ft (0.02 acre) of developed land (clean concrete channel). The total channel occupies 0.22 acre (acreages listed previously may not total due to rounding). All vegetation grows in soil perched on the concrete bottom of the channel.

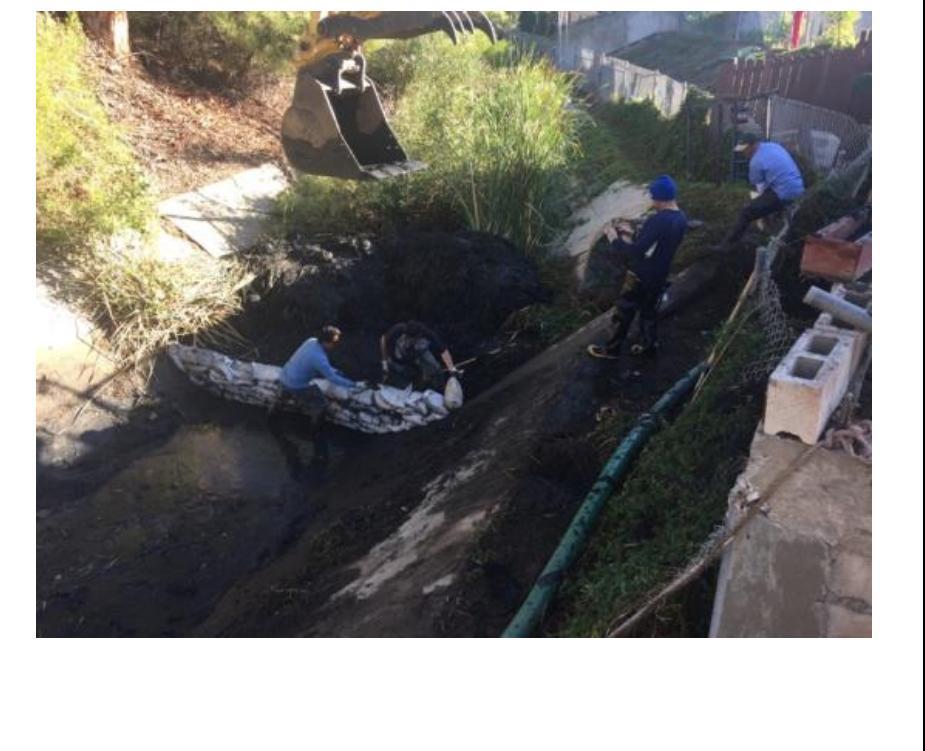
(November 28, 2015)

Photograph 3: Looking east into channel at crews building asandbag berm within channel to keep water out of maintenance area to the west, channel is looking east.

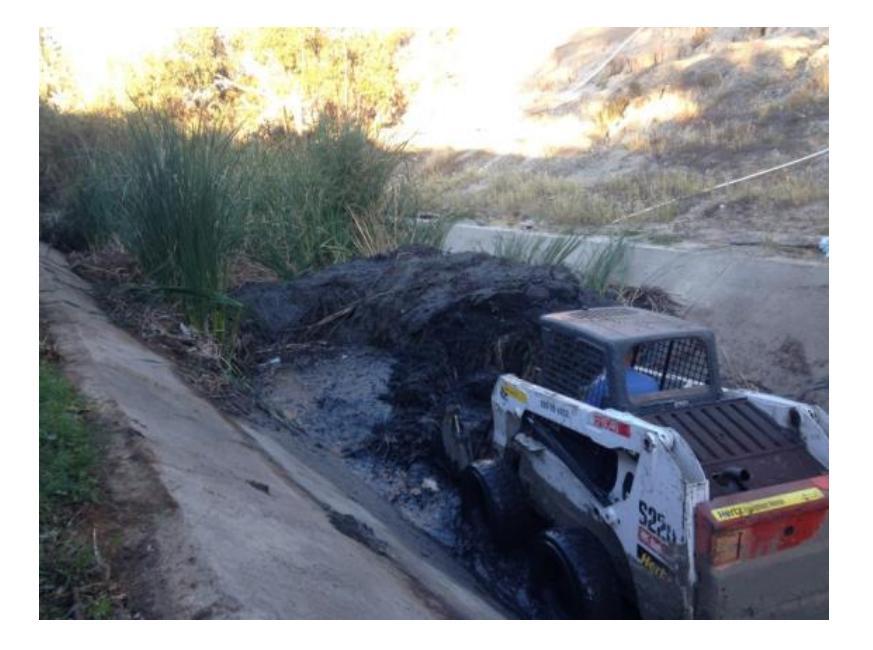
(November 30, 2015)

Photograph 4: Looking west from near the center of the channel at the bobcat removing sediment.

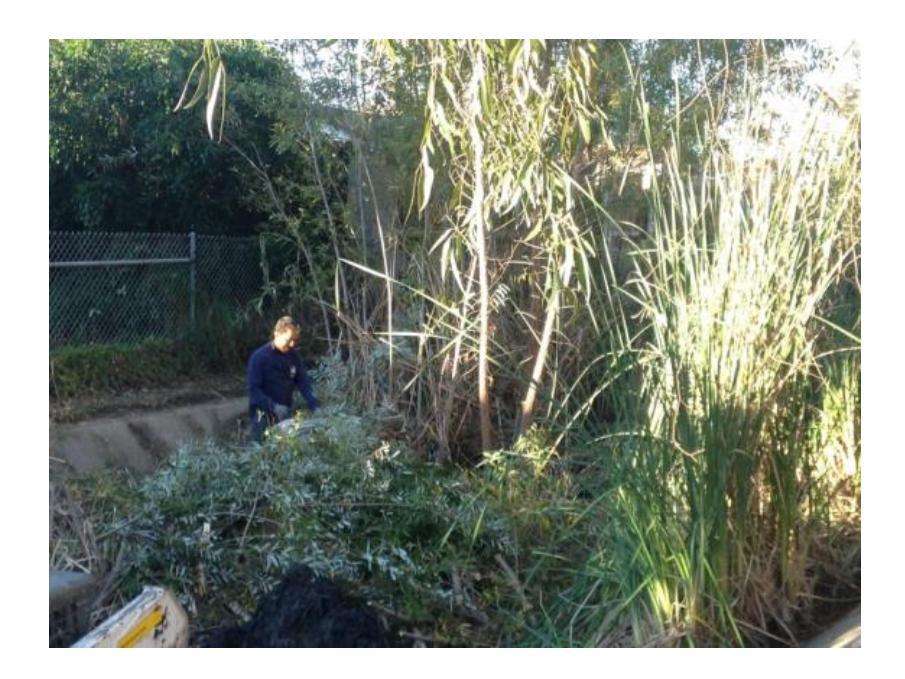
Photograph 5: Crew member using a chainsaw to clear large willows in the channel, channel is looking west.

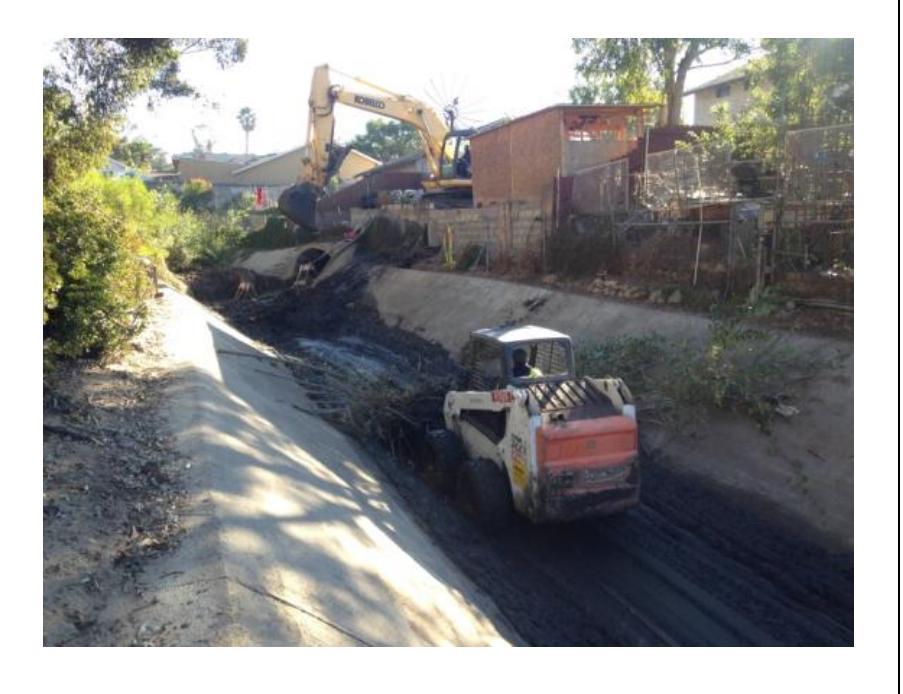
Photograph 6: Looking east from the north side of the channel at crew member using the bobcat to clear sediment and debris.

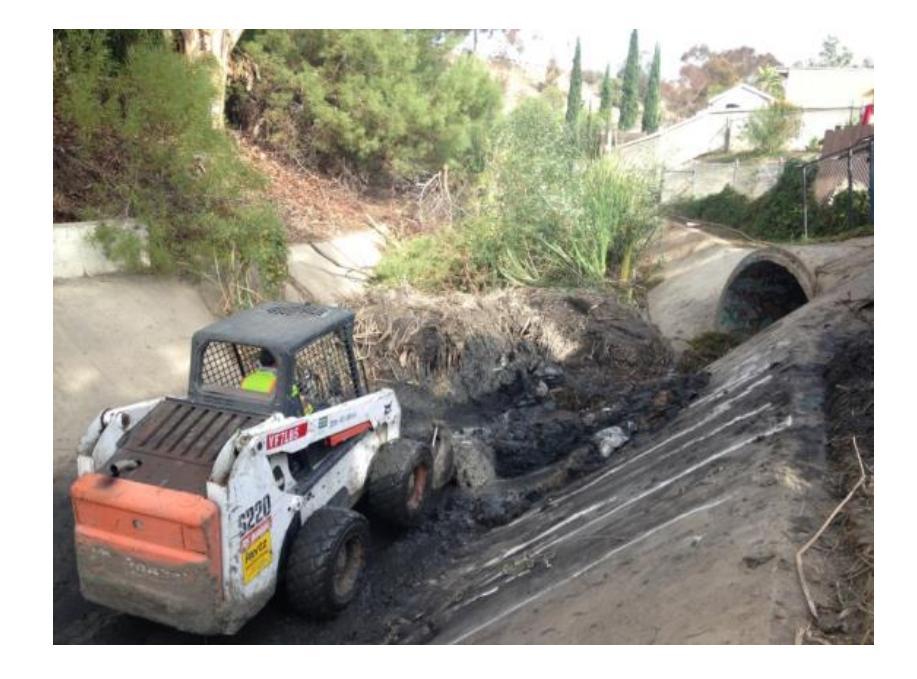
Photograph 7: Looking east from south side of channel at crew member using the bobcat to remove the sandbags from the water pumping area north of 4004 Via de la Bandola.

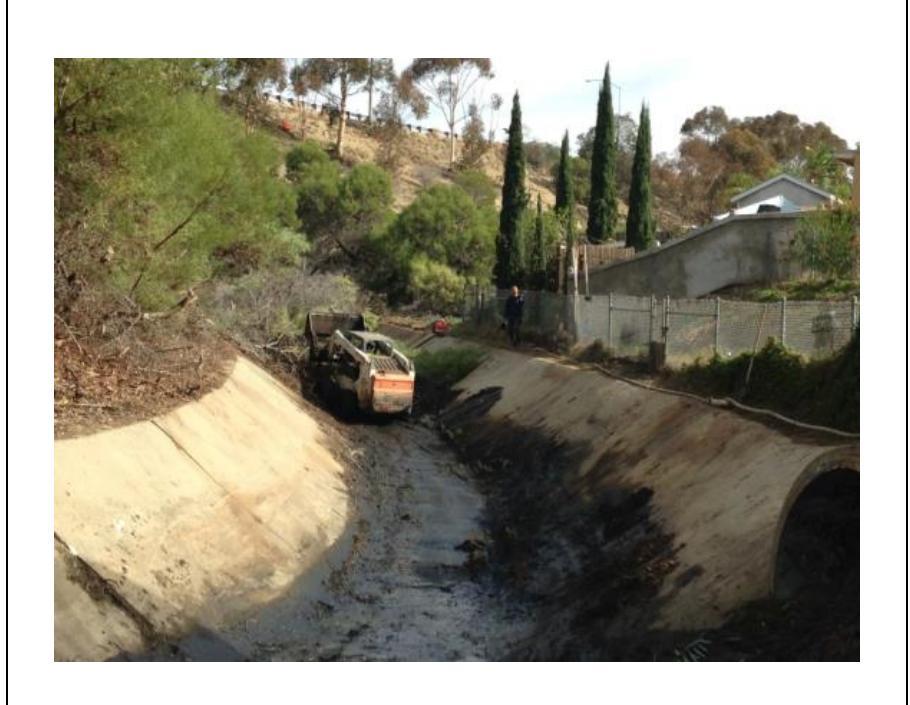
Photograph 8: Looking northeast from south side of channel at crew member using bobcat to clear debris and sediment in the east end of the channel.

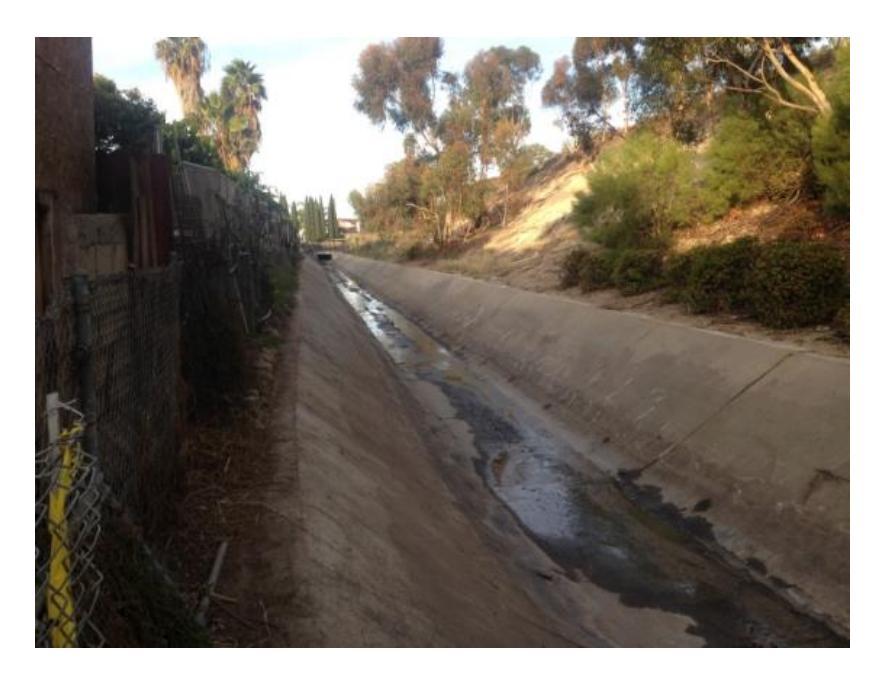
Photograph 9: Looking west from the south side of the channel following completion of maintenance activities.

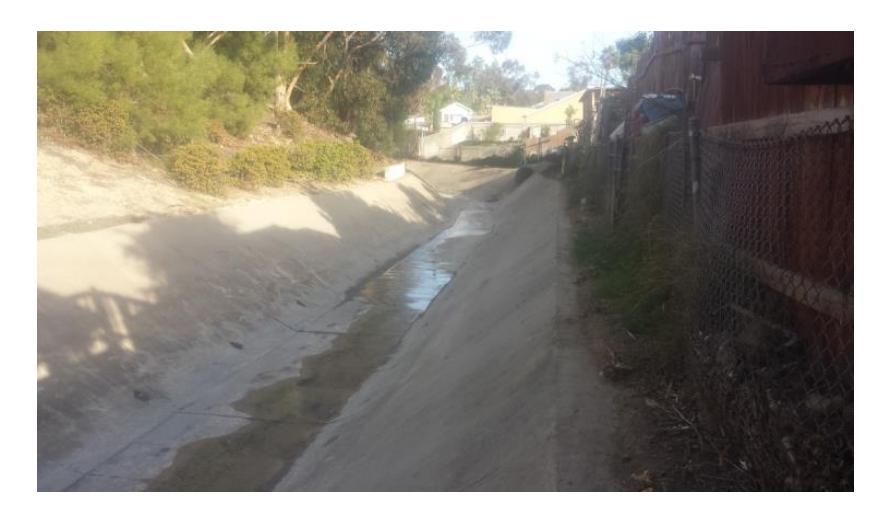
Photograph 10: Looking east from the south side of the channel following completion of maintenance activities.
