INDIVIDUAL BIOLOGICAL ASSESSMENT REPORT

Site Name/Facility:	San Carlos Creek
Master Program Map No.:	54
Date:	May 15, 2018
Biologist Name/Cell Phone No.:	Jasmine Bakker / 619-708-5990

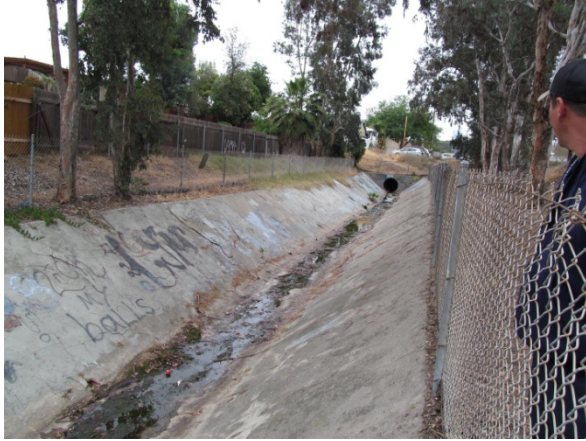
PHOTO NOTES:
Lake Badin section, looking upstream at inlet,
May 5, 2015.

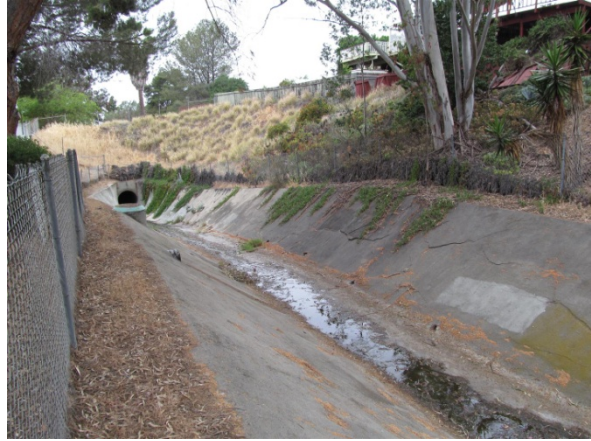
PHOTO NOTES: Lake Badin section,
looking downstream at outlet, May 5, 2015.

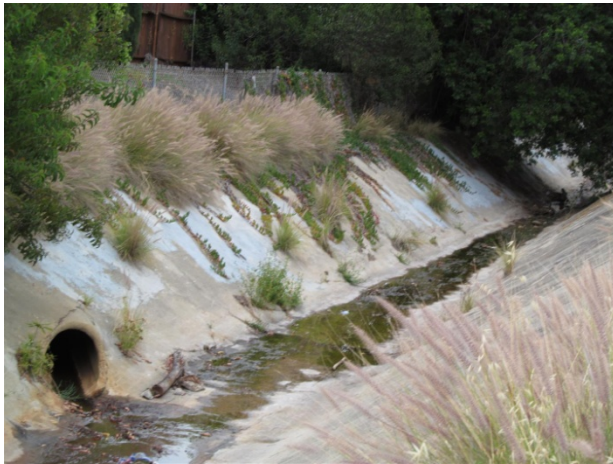
A total of 0.009 acre of freshwater marsh was removed during emergency maintenance in November 2014. This wetland community consisted primarily of cattail (*Typha* sp.) and included two small patches (0.005 acre) of freshwater marsh within the Lake Badin section and one 0.004-acre area of freshwater marsh within the Golf Course section of San Carlos Creek.

PHOTO NOTES:
Lake Badin section, area of freshwater marsh
removal (downstream patch), May 5, 2015.

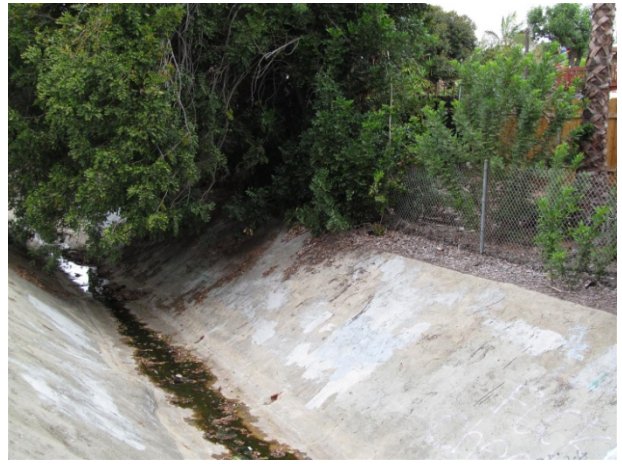
PHOTO NOTES:
Lake Badin section, area of freshwater marsh
removal (upstream patch), May 5, 2015.

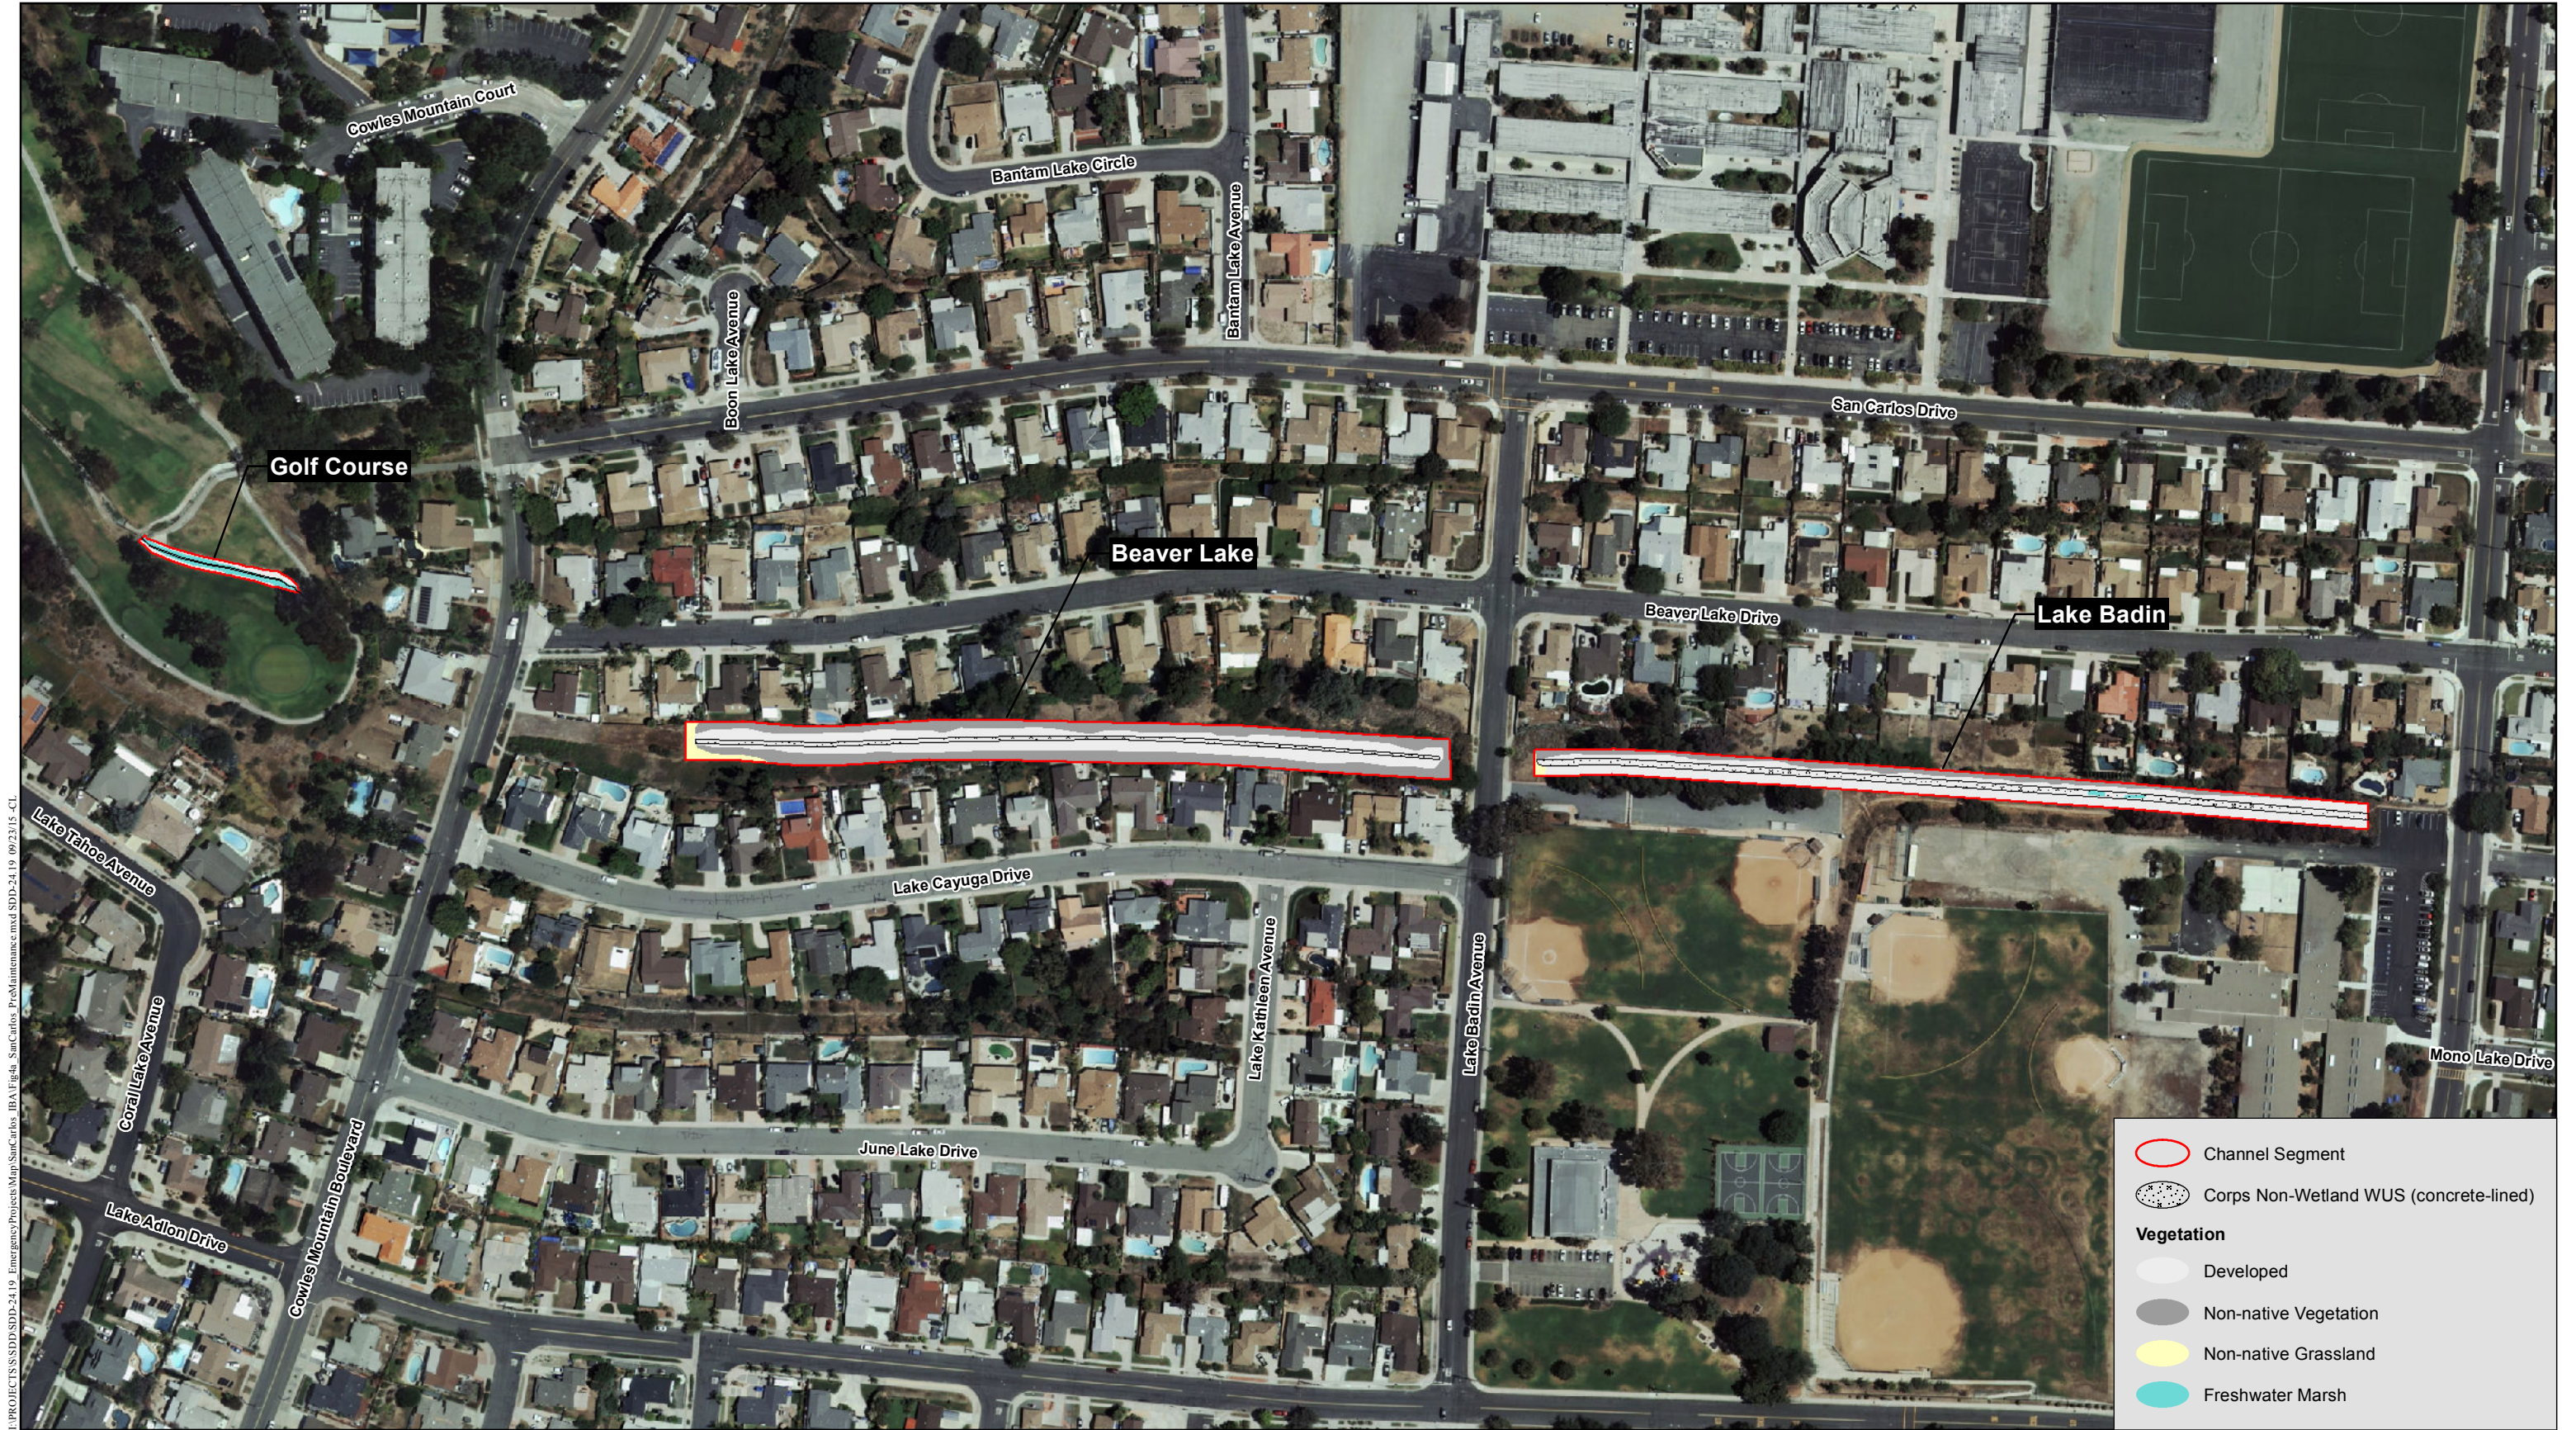
Figure 4a

Freshwater Marsh (0.009 acre pre-maintenance)

Pre-Maintenance

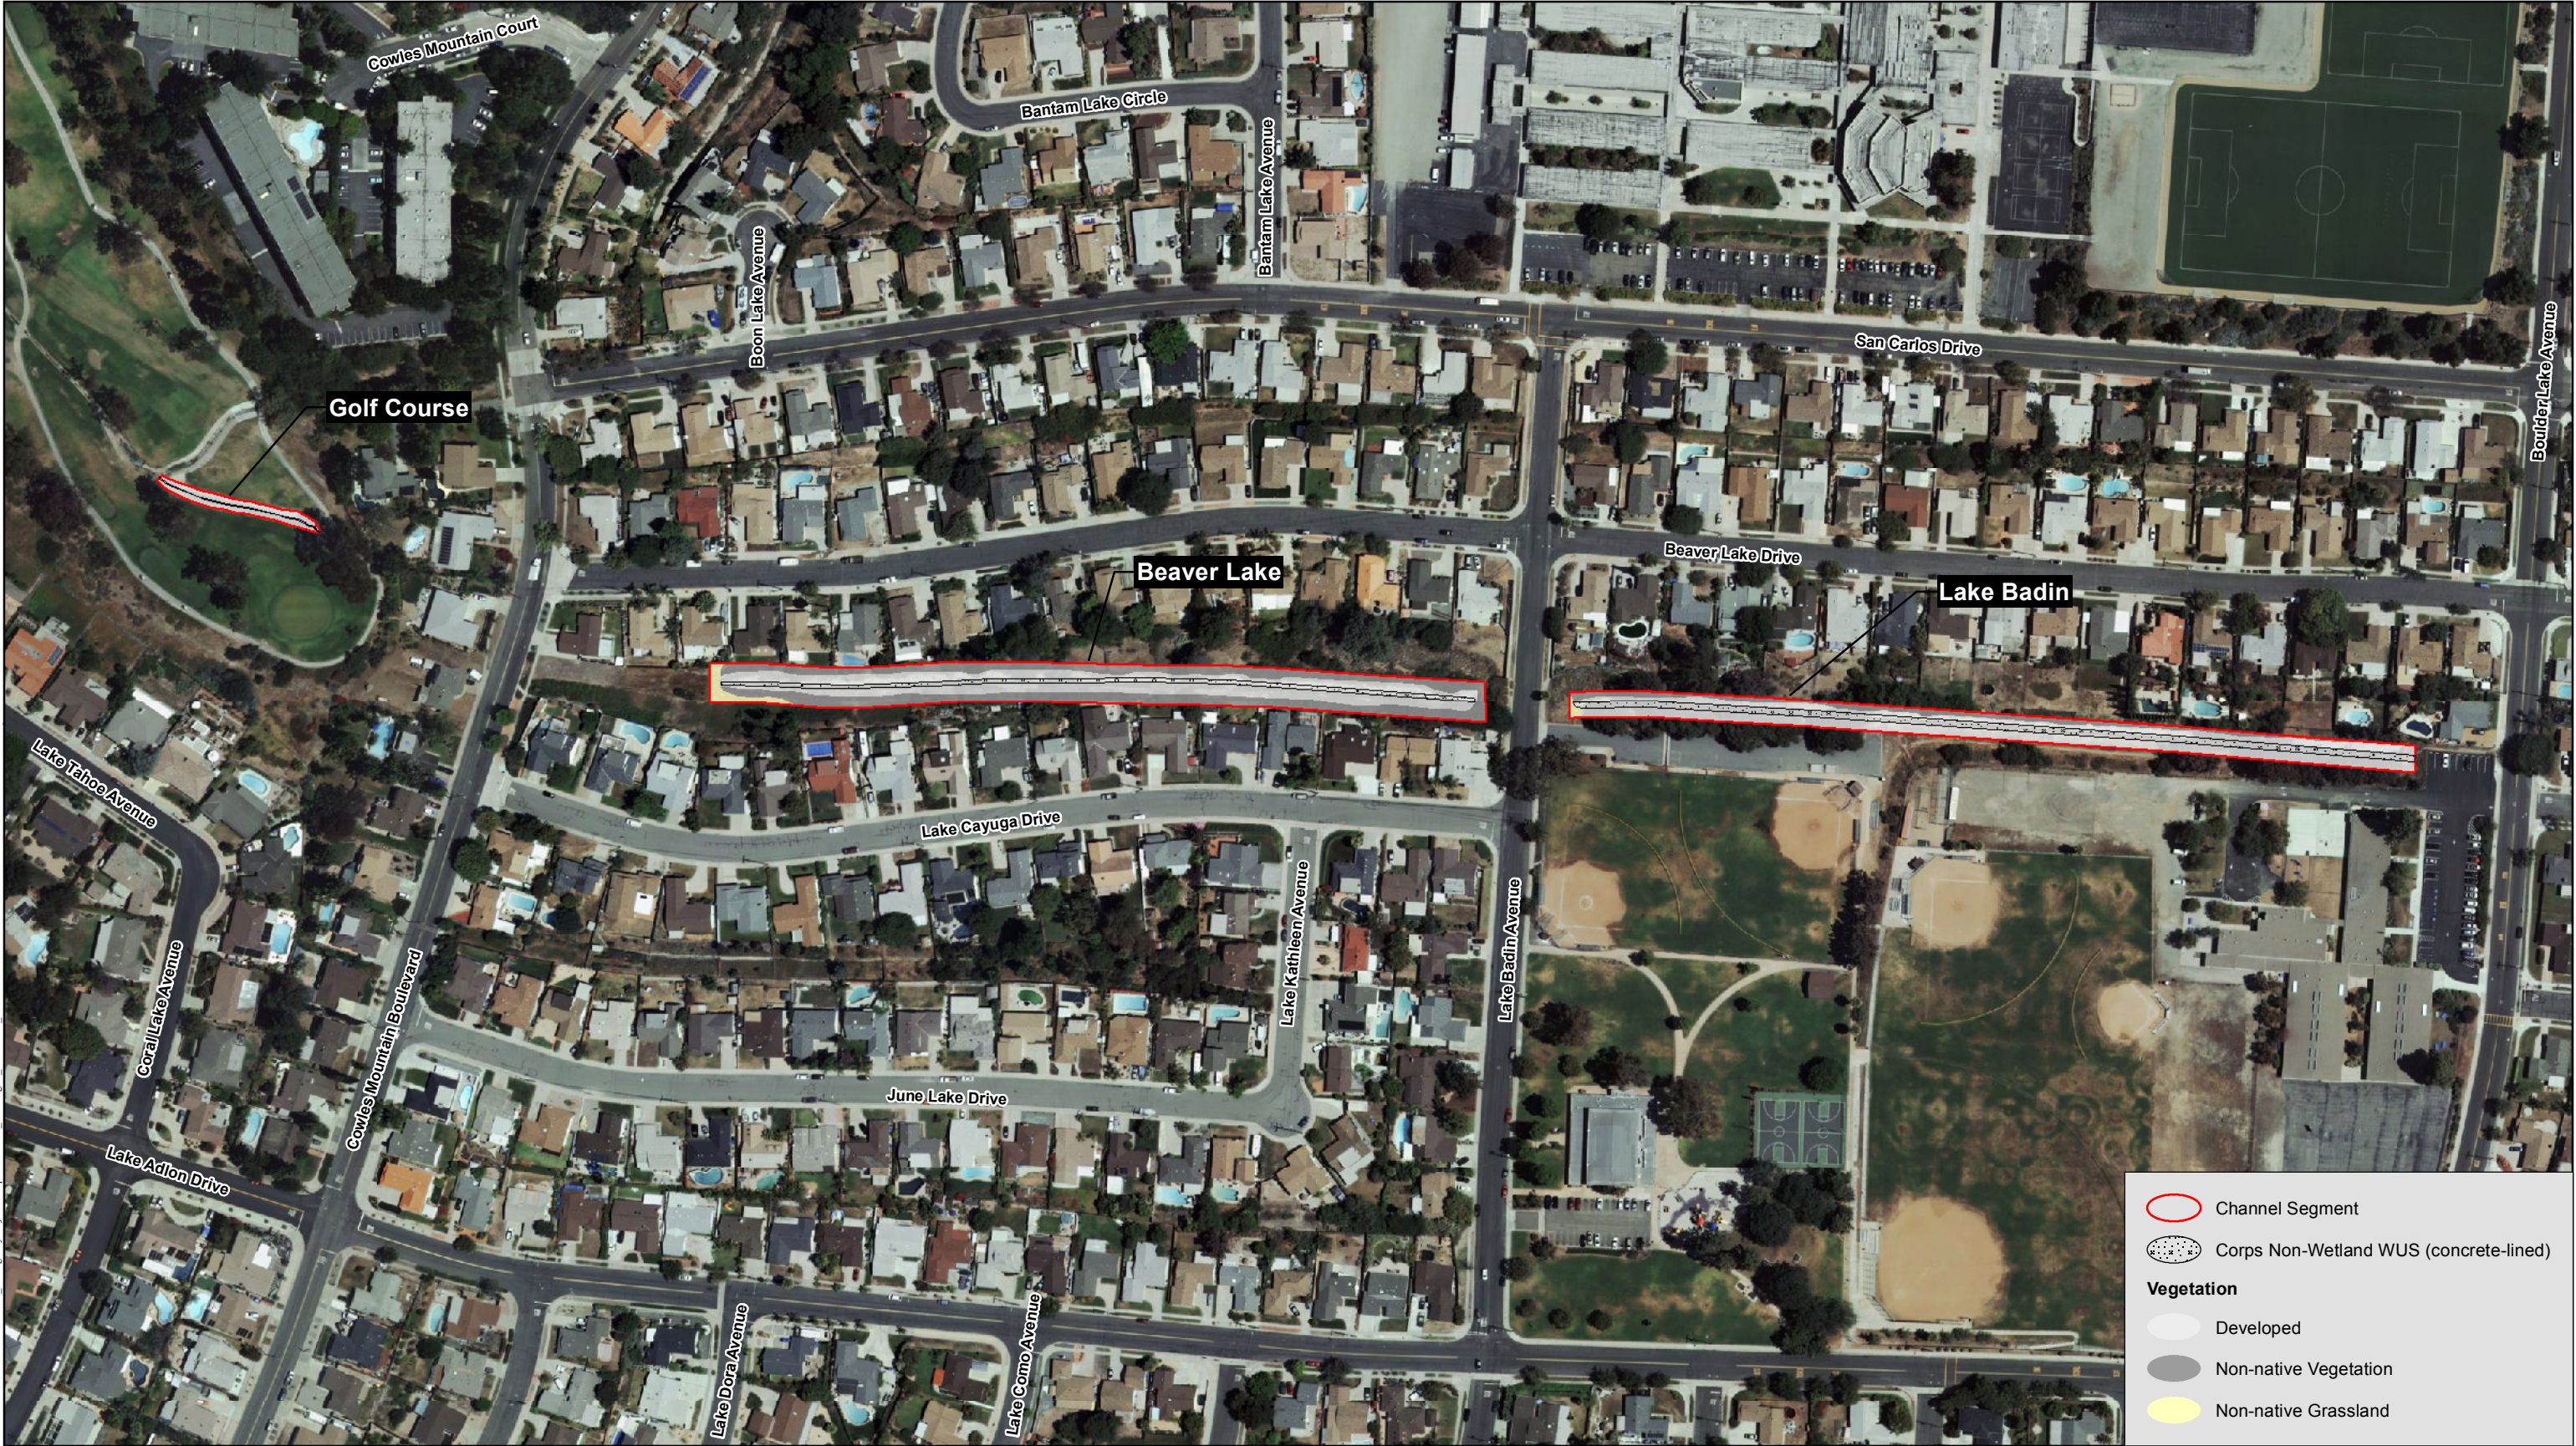
Figure 4b

Developed Land (1.281 acre pre-maintenance and 1.291 acre post-maintenance)

Developed land includes unvegetated portions of concrete-lined channel (both wetland and upland), landscaping from adjacent properties, and the parking lot adjacent to the Lake Badin maintenance area. The removal of freshwater marsh during emergency maintenance resulted in an increase to developed land. Specifically, 0.005 acre of freshwater marsh within the Lake Badin section pre-maintenance became an additional 0.005 acre of developed concrete channel bottom (non-wetland WUS) post-maintenance and thus increased the total developed land within the Lake Badin section from 0.643 acre (including 0.187 acre of wetland) to 0.648 acre (including 0.193 acre of wetland). Similarly, 0.004 acre of freshwater marsh within the Golf Course section pre-maintenance became an additional 0.004 acre of developed concrete channel bottom (non-wetland WUS) post-maintenance and thus increased the total developed land within the Golf Course section from 0.071 acre (0.001 acre of wetland and 0.070 acre of upland) to 0.075 acre (0.005 acre of wetland and 0.070 acre of upland). No changes to the 0.567 acre developed land (including 0.107 acre of wetland and 1.000 acre of upland) occurred within the Beaver Lake section as a result of maintenance.

Post-Maintenance
