Canyon Sewer Cleaning Program And Long Term Sewer Maintenance Program Progress Report

SD Public Utilities

**2016 Annual Report
July 1, 2015 – June 30, 2016**

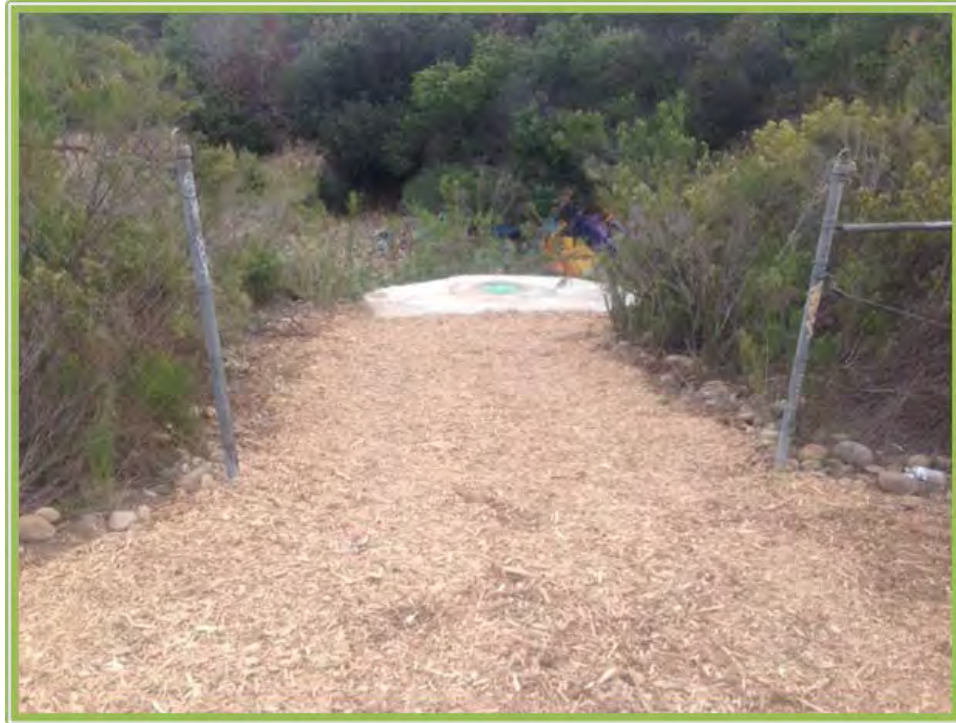
South Chollas –Improved Access Path to Manhole 449

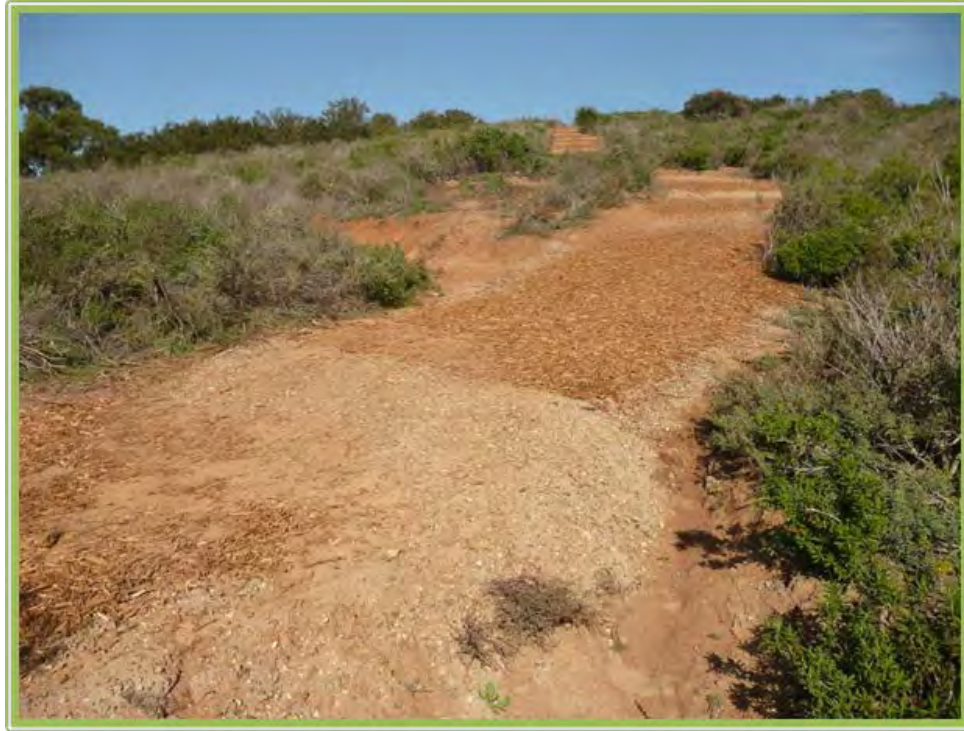
- **Manning Canyon** – Public Utilities Wastewater Collection crews were able to complete repairs to the sewer access path in December 2015. Repairs included the trimming of vegetation to re-establish the 8 foot wide access path, the construction of soil berms every 10-20 feet, and the placement of wood chips. The access path will be monitored for 25 months for erosion.

Manning Canyon Repaired Access Path

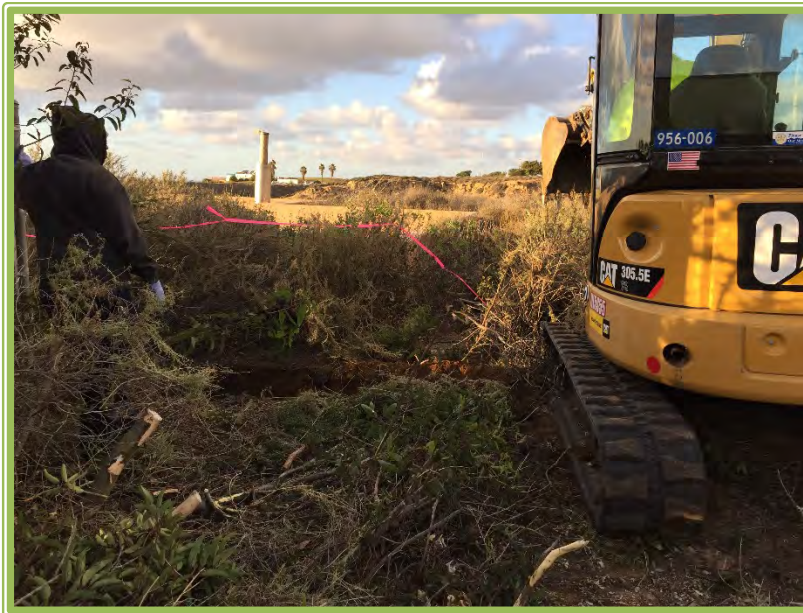
Pump Station 45 Pipe Repair Emergency

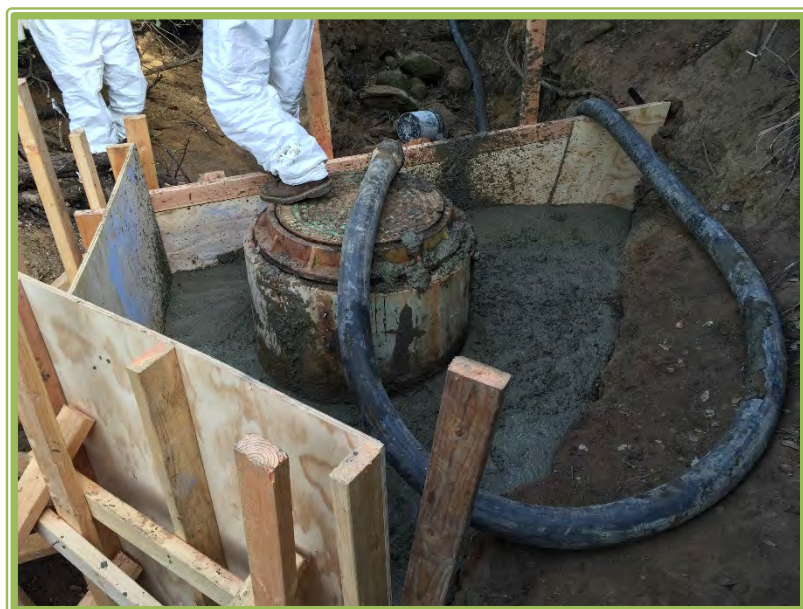
Dakota Canyon Manhole Emergency

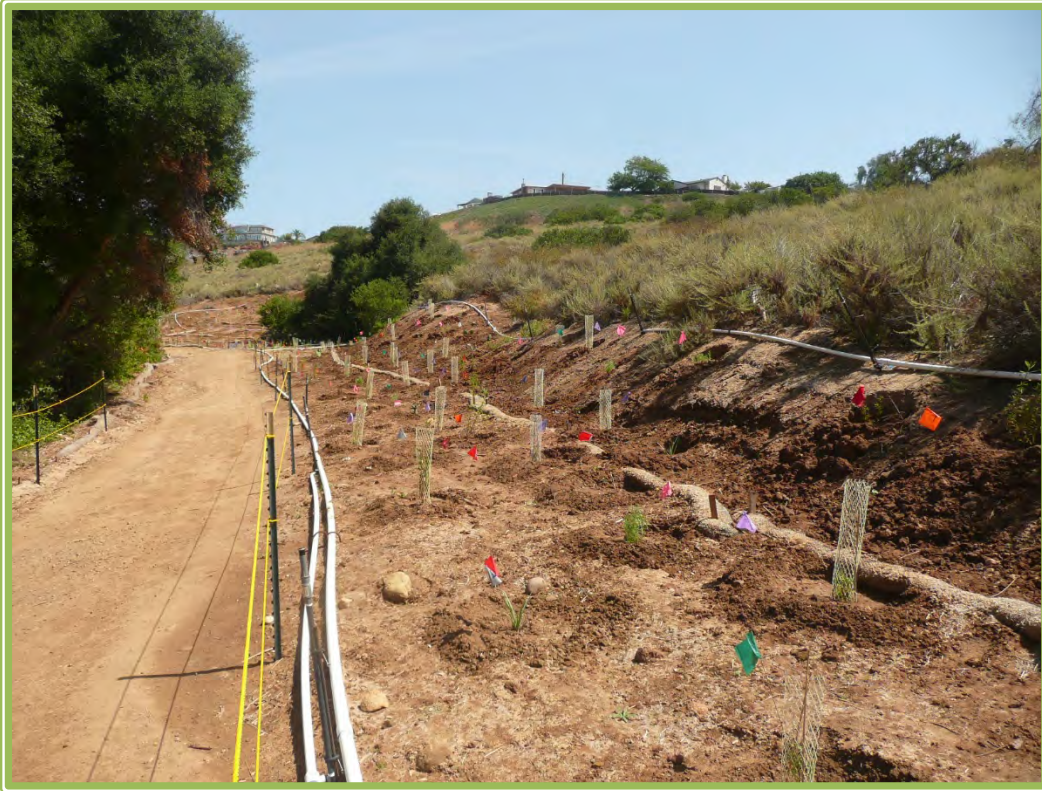
Central Tecolote Sewer Break Emergency Restoration Area

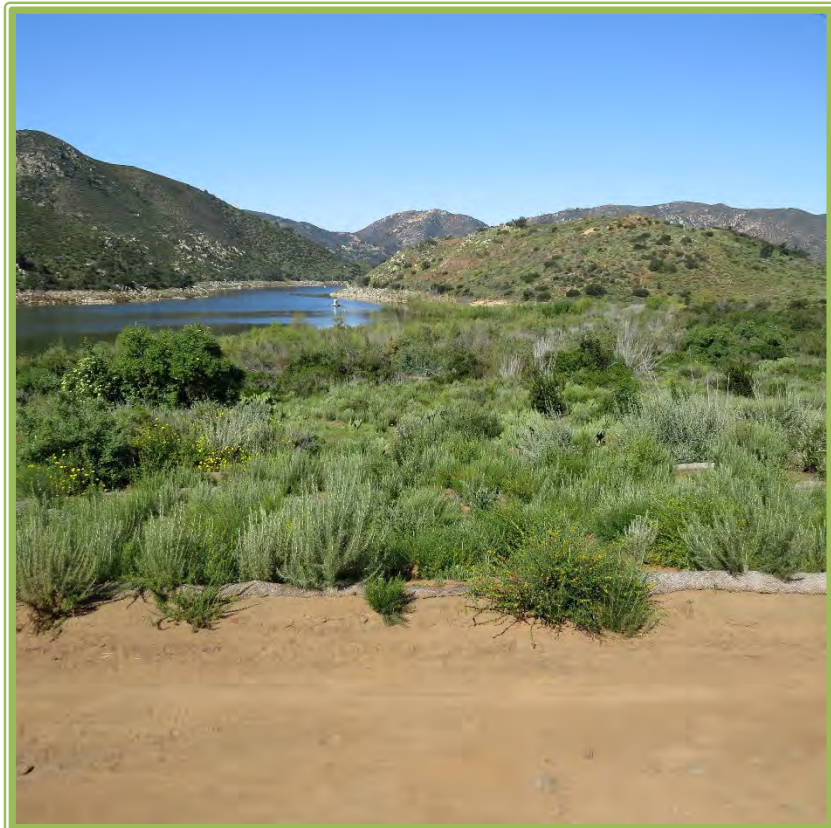
Pump Station 77 Force Main Restoration
