MEMORANDUM

Jeremy Fontaine, Associate Planner; City of San Diego Transportation & Storm Water Department (TSW)
Shelley Lawrence, Biologist- Balk Biological & Shannon Brown, Project Engineer - Dudek
Pre-Construction Memorandum for the 3405 Kite Street Pipe Repair Project in the City of San Diego, California
February 10, 2020
Mayra Medel & Christine Rothman- TSW; Scott Gressard- Dudek; Vipul Joshi- Dudek; Michelle Balk- Balk Biological
Figures 1, 2, & 3 Photo Documentation Report

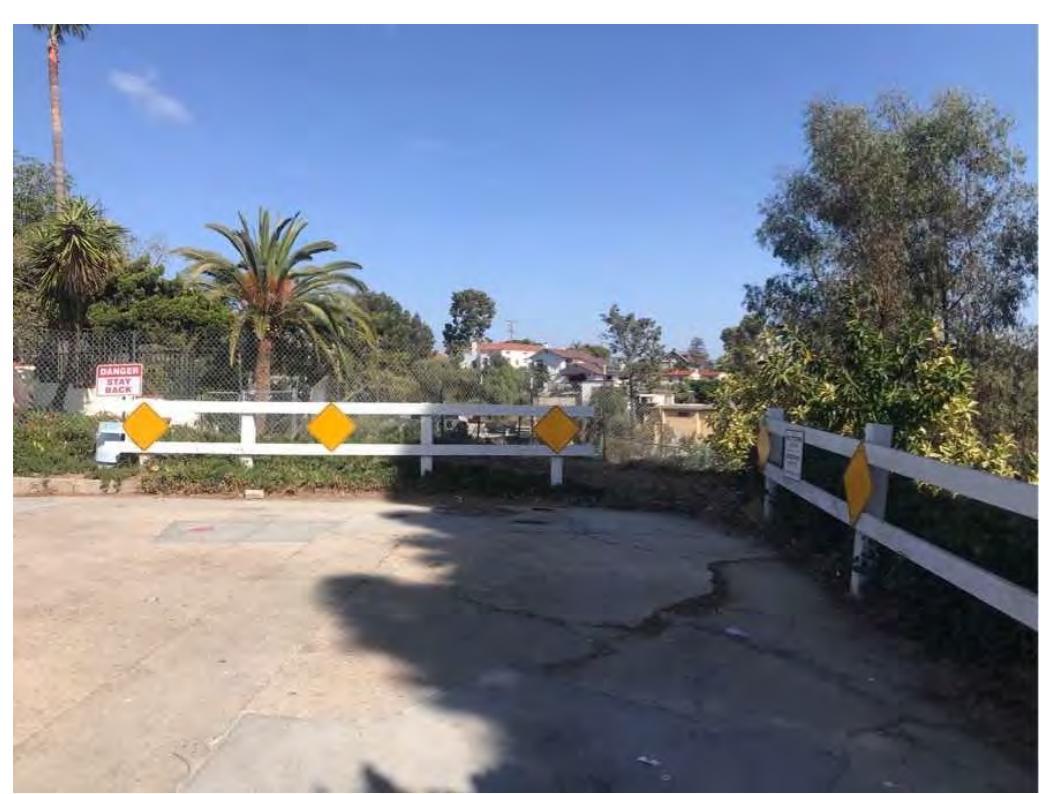
Photo 1. Northeast-facing view of staging area at the corner of Kite Street and W. Upas Street.

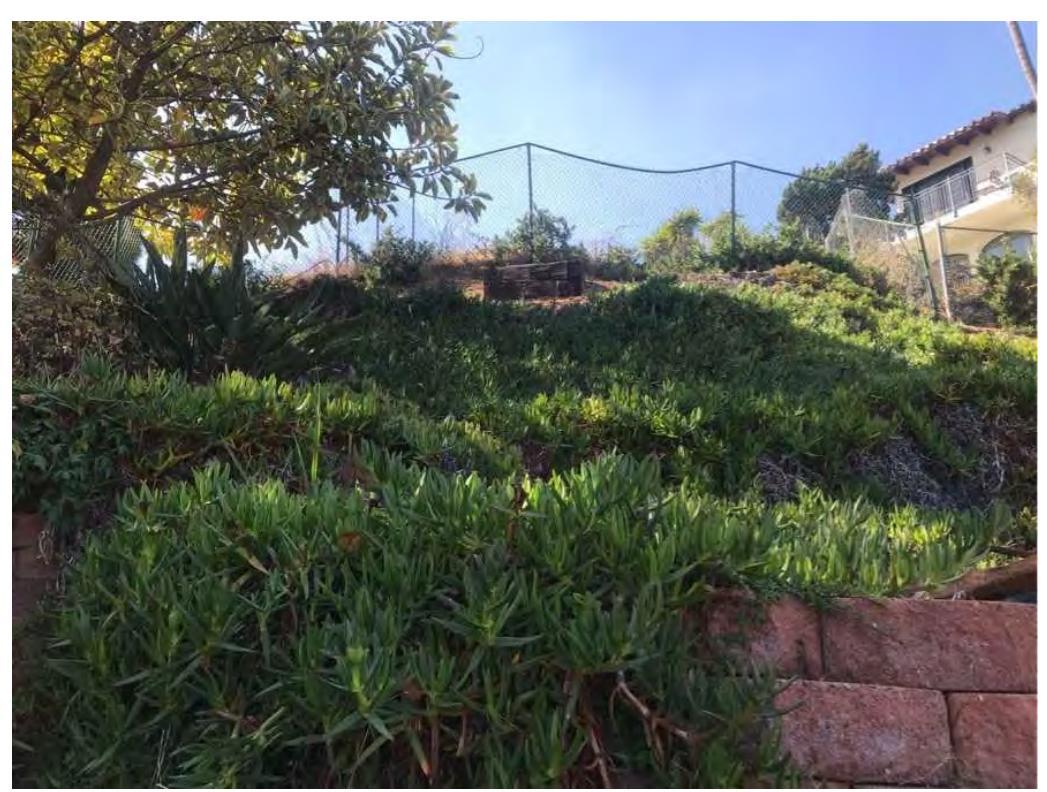
Photo 2. West-facing view of storm drain pipe location.

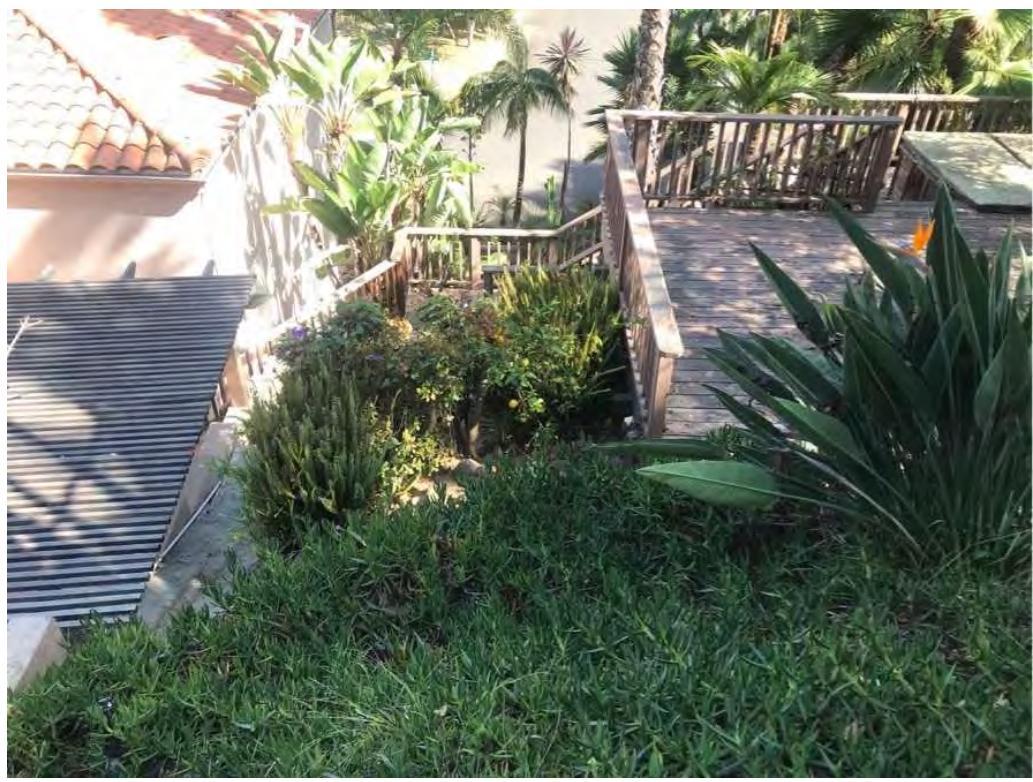
Photo 3. East-facing view of storm drain pipe location.

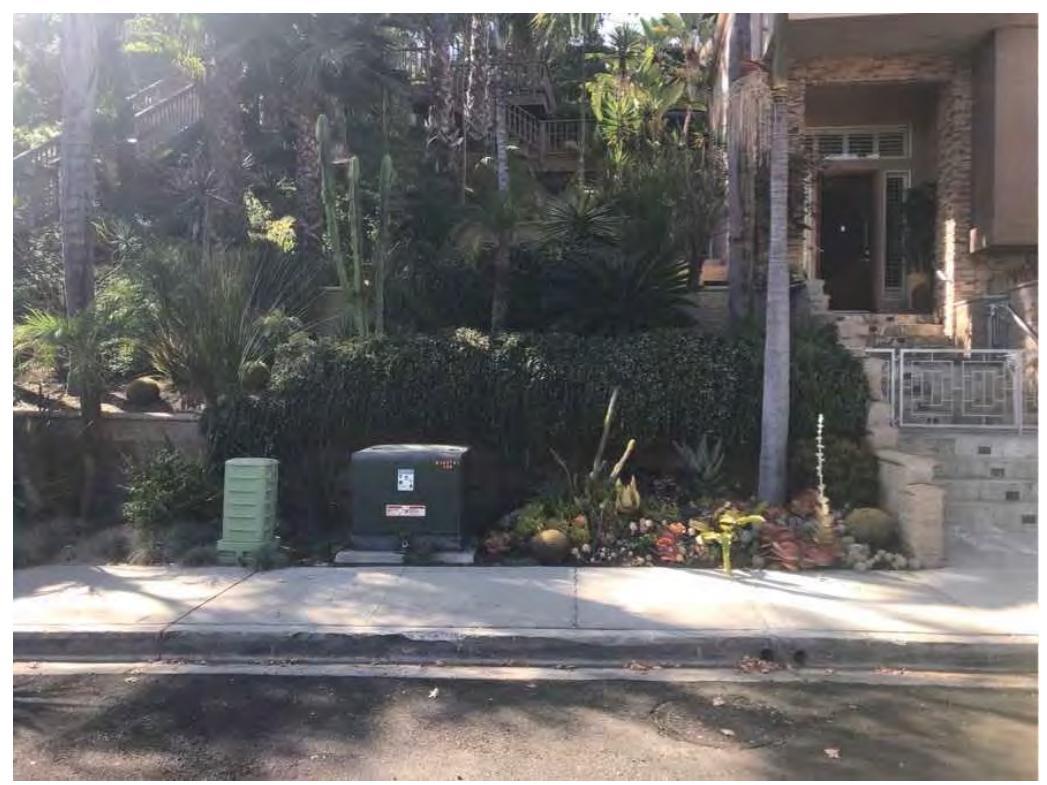
Photo 4. Southwest-facing view of storm drain cleanout location.

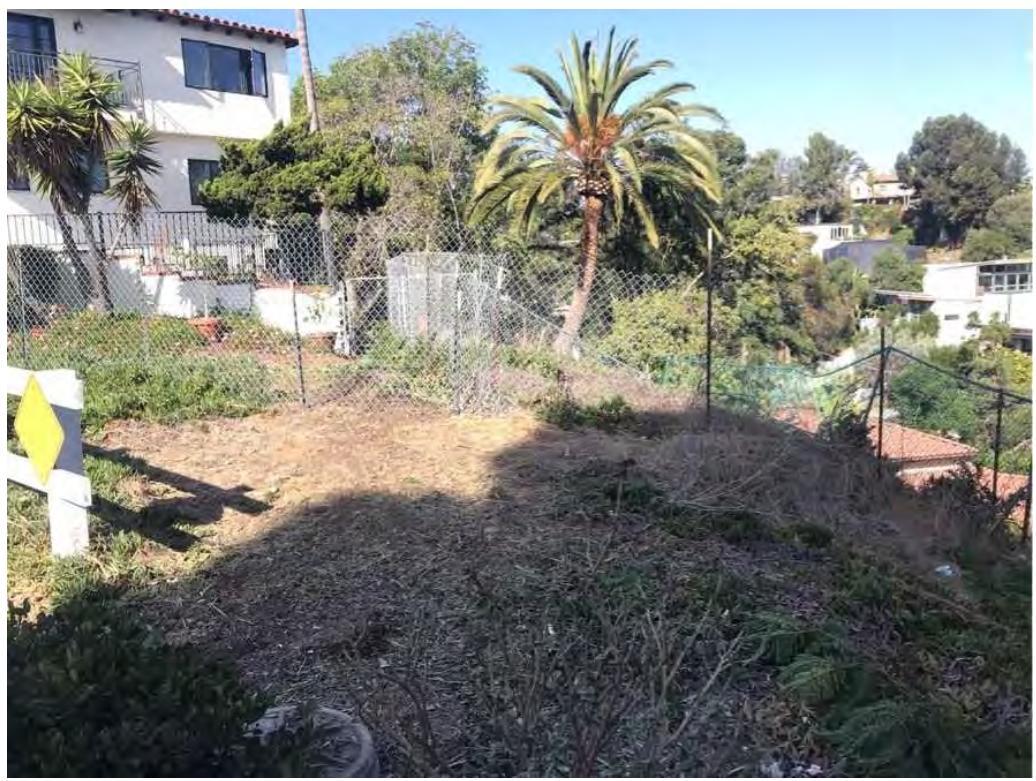
Photo 5. North-facing view of the temporary impact area.

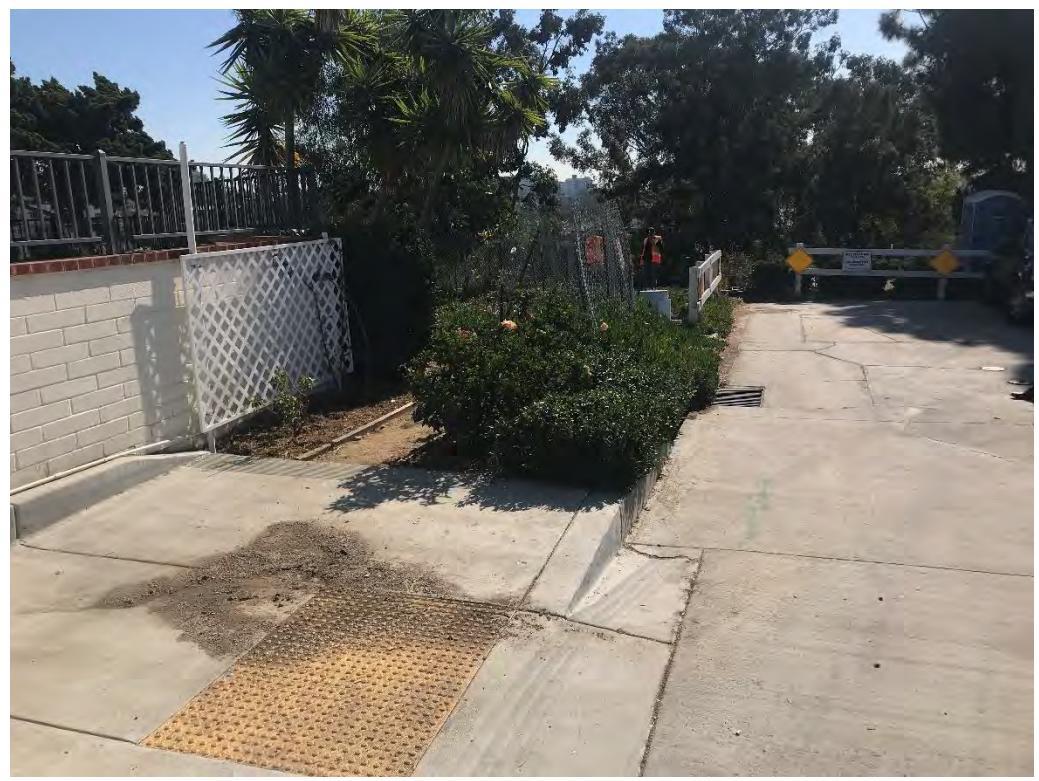
Photo 6. Southeast-facing view of storm drain inlet location.

Multiple 90-pound bags of concrete mix will be mixed on site utilizing wheelbarrows, and the wooden posts for the M-9 barrier will be set in concrete. In addition, any damage to the existing concrete curb inlet structure will be repaired. Work could include minor concrete patching or rebuilding of the 6' by 4' concrete lid with up to 2 cubic yards of concrete.

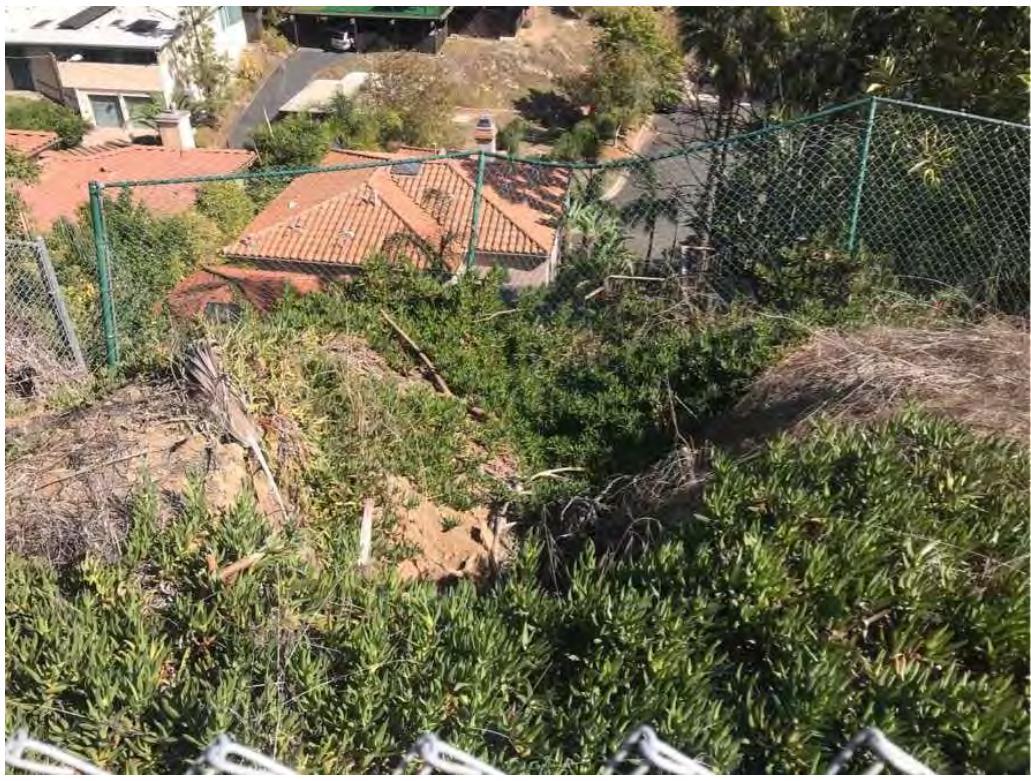
Photo 7. East-facing view of failed storm drain pipe at sinkhole location.

Following the CCTV investigation, up to 50 feet of damaged portions of the exposed storm drain pipe will be removed and replaced with 18-inch high density polyethylene (HDPE) or lined with a cured-in-place pipe liner. The cured-in-place pipe liner will be pulled through the existing downstream CMP using the excavated trench and a downstream cleanout to access the system. If a steam cured liner is to be used, any liquid discharge from the operation will be collected at the downstream access point and disposed of properly. Installation of the 18-inch HDPE shall consist of a crushed rock base, pipe bedding, pipe, and backfill. Base, bedding, and backfill material will be delivered to the site via 12-yard dump truck, and the HPDE pipe via F450 Crew truck. The new HDPE pipe will be cut to size on site with a portable electric handsaw or gas-powered cutoff saw, connected with clamp fittings, and dropped into the trench using an excavator or crane. The pipe will be connected to an existing inlet structure located at the top of the slope at the intersection of Kite Street and West Upas

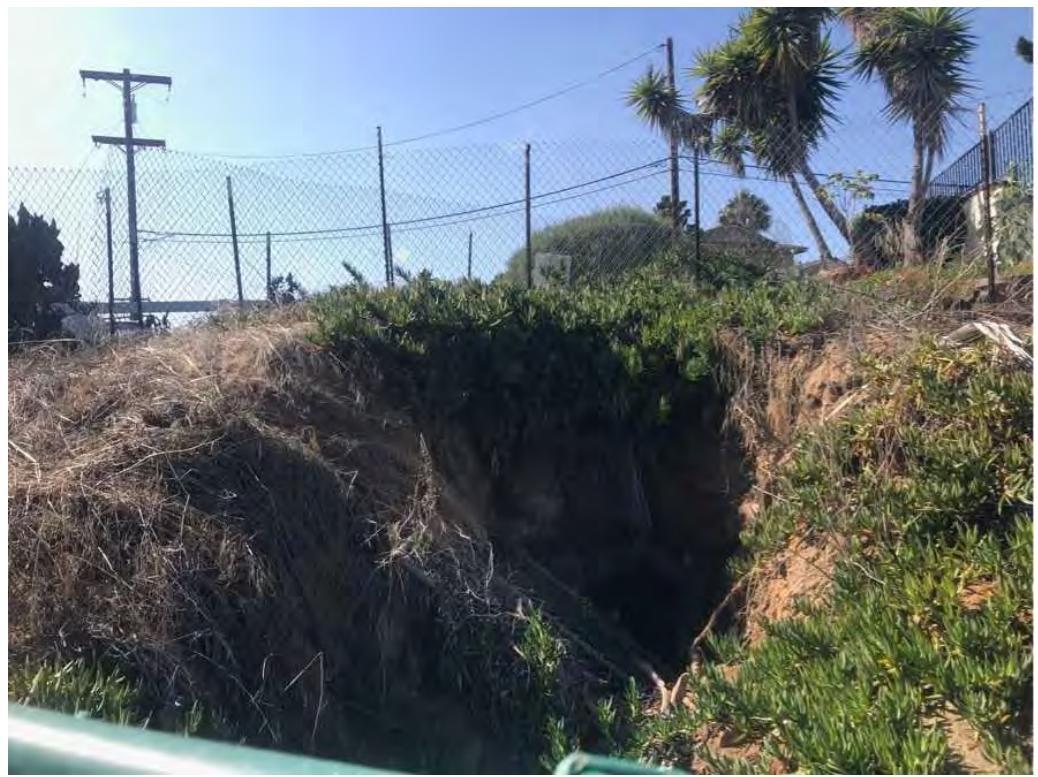
Photo 8. West-facing view of failed storm drain pipe at sinkhole location.

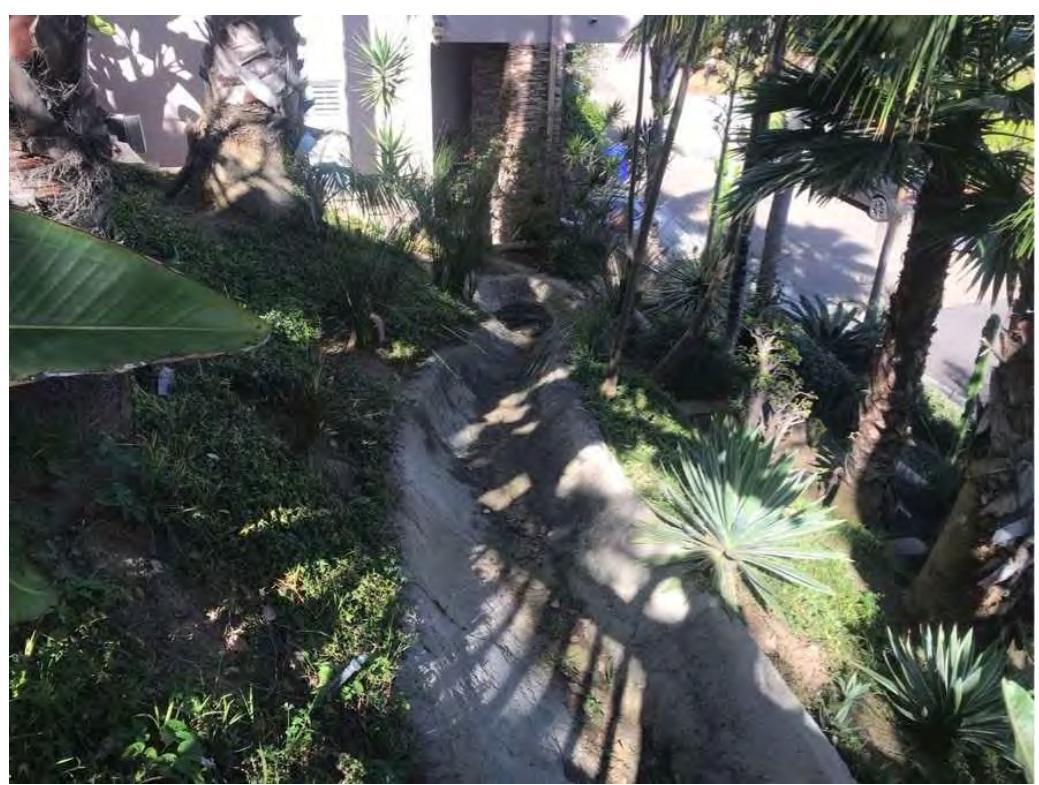
Photo 9. North-facing view of existing concrete brow ditch.
