CALIFORNIA TREE SERVICE, INC.

July 17, 2015

Subject: Bonita Pump Station Project: Tree Risk Evaluation

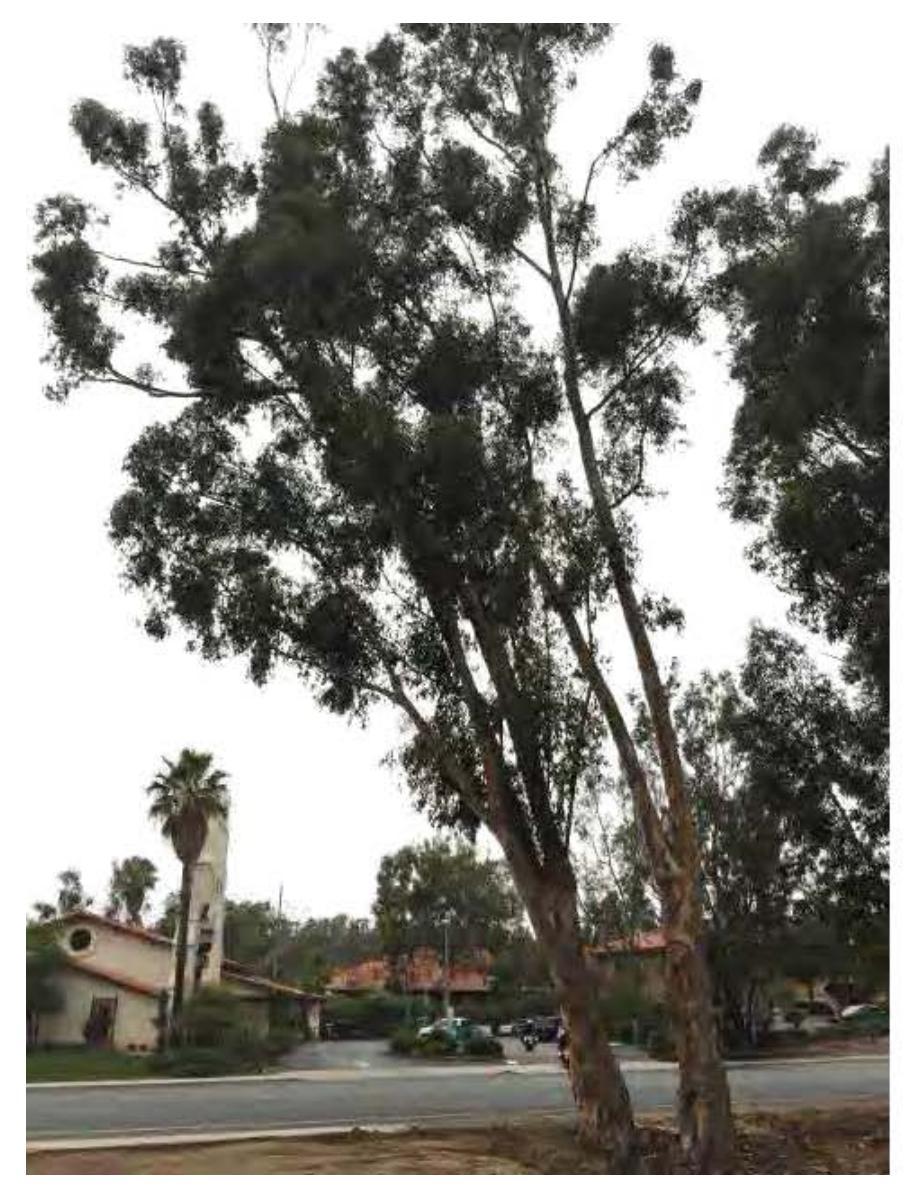
Photograph 1 – View of tree #1

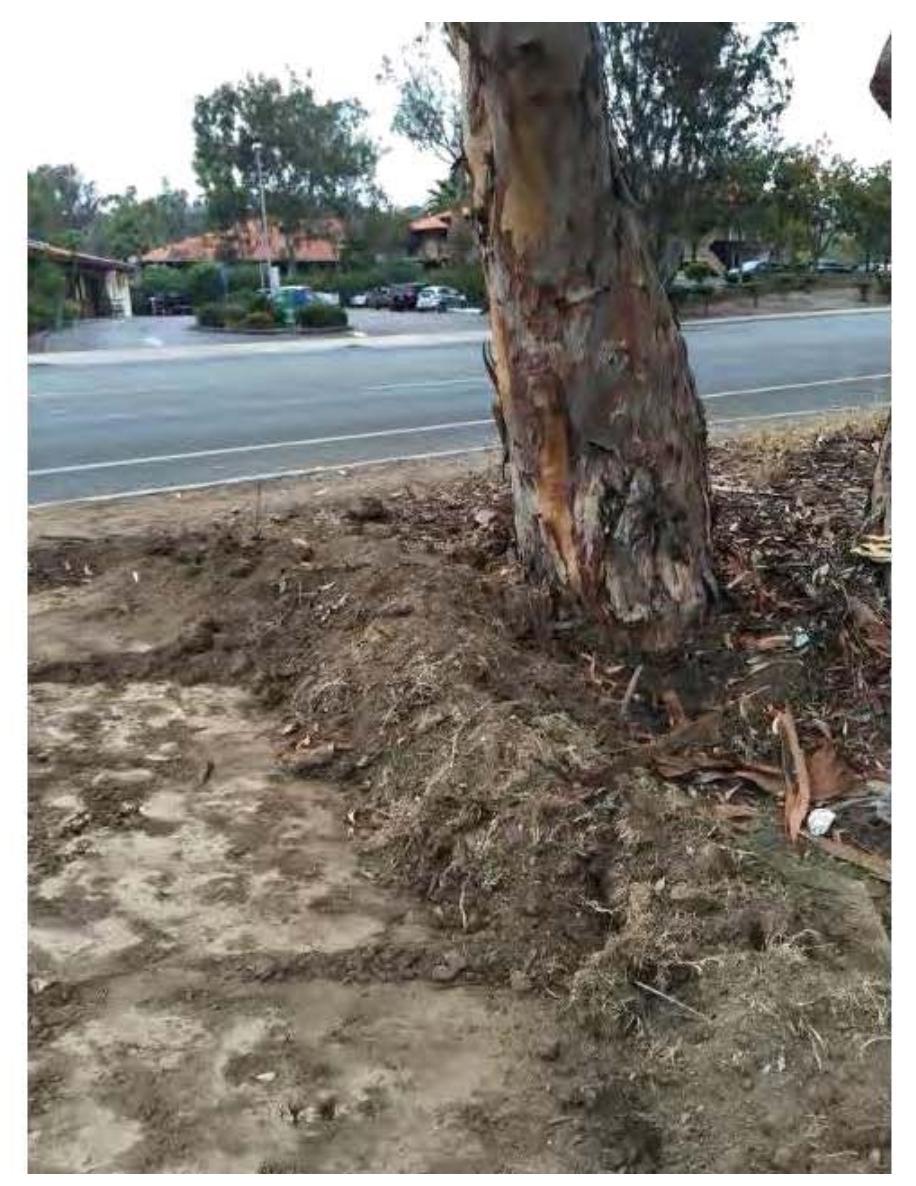
Photograph 2 – View of tree #1 and it's proximity to adjacent construction activities.

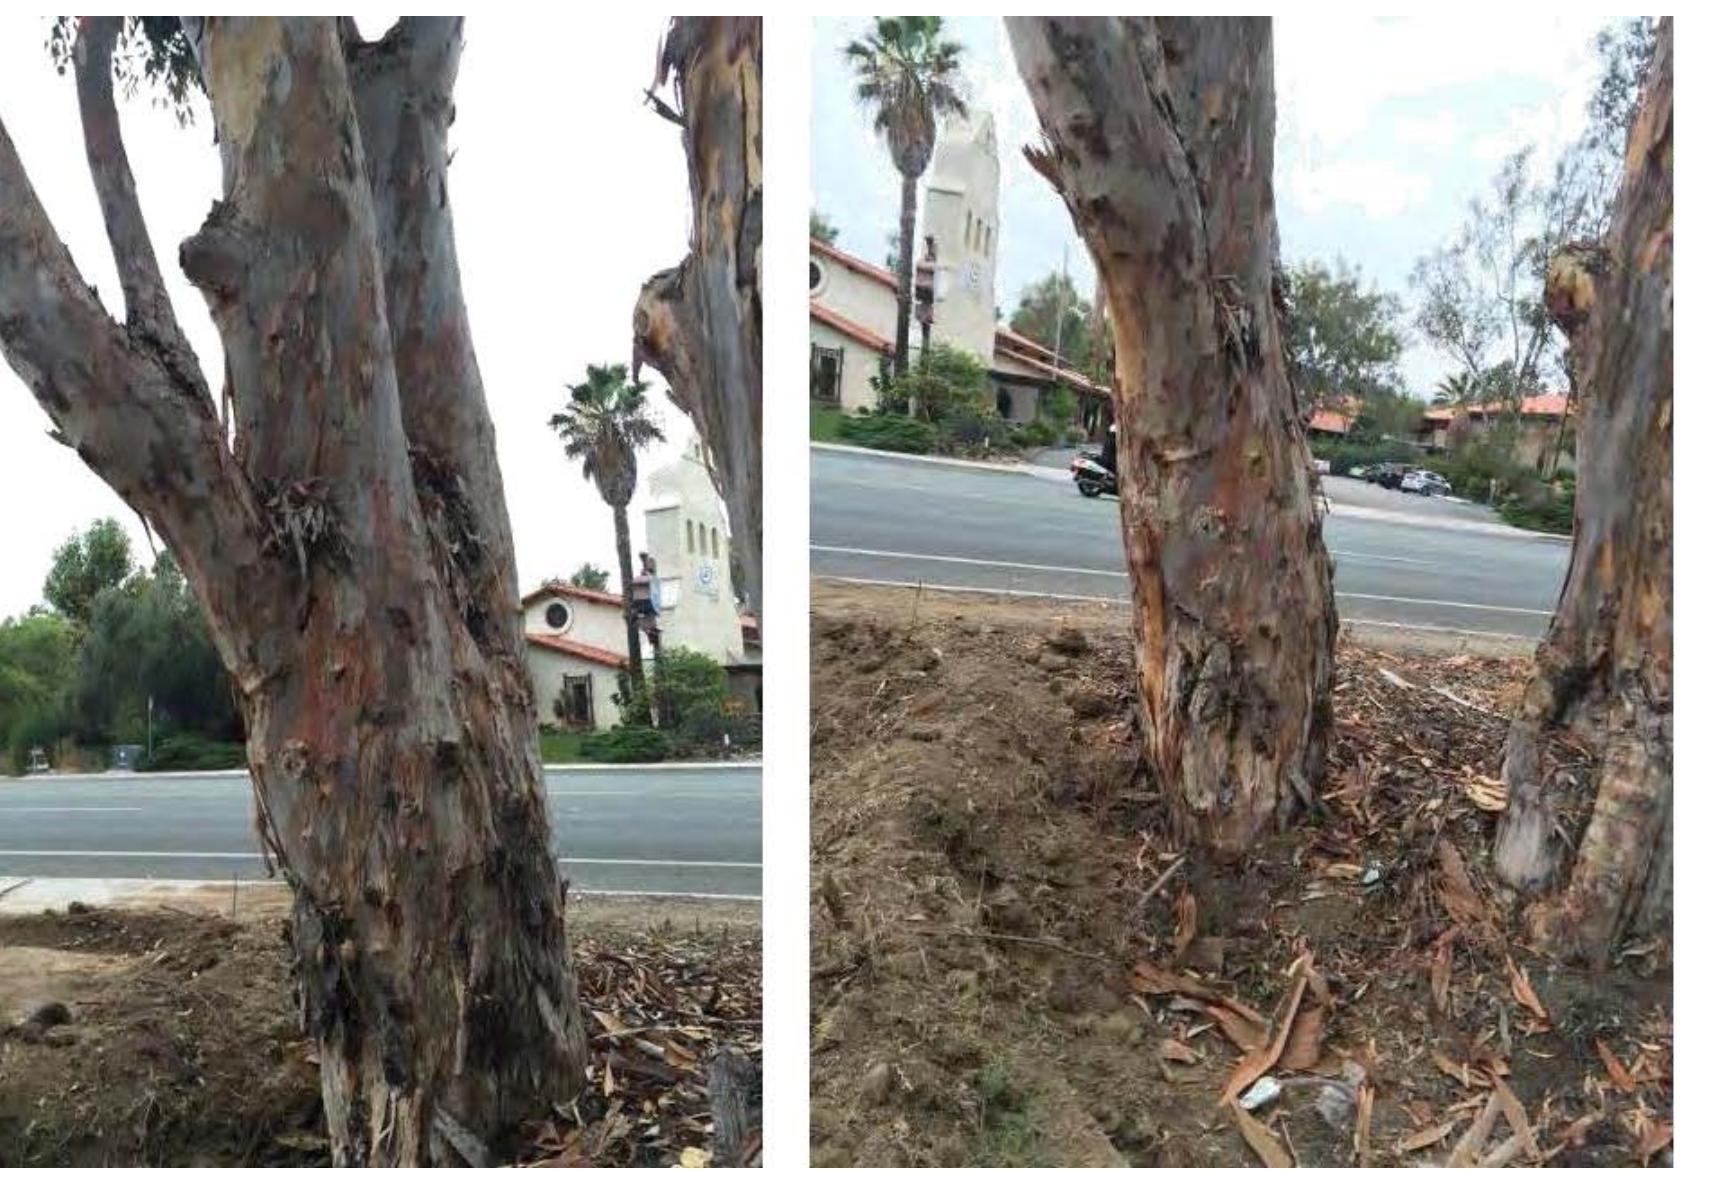
Photograph 3 – View of main stem (tree #1)

Photograph 4 – Alternate trunk view (tree #1)

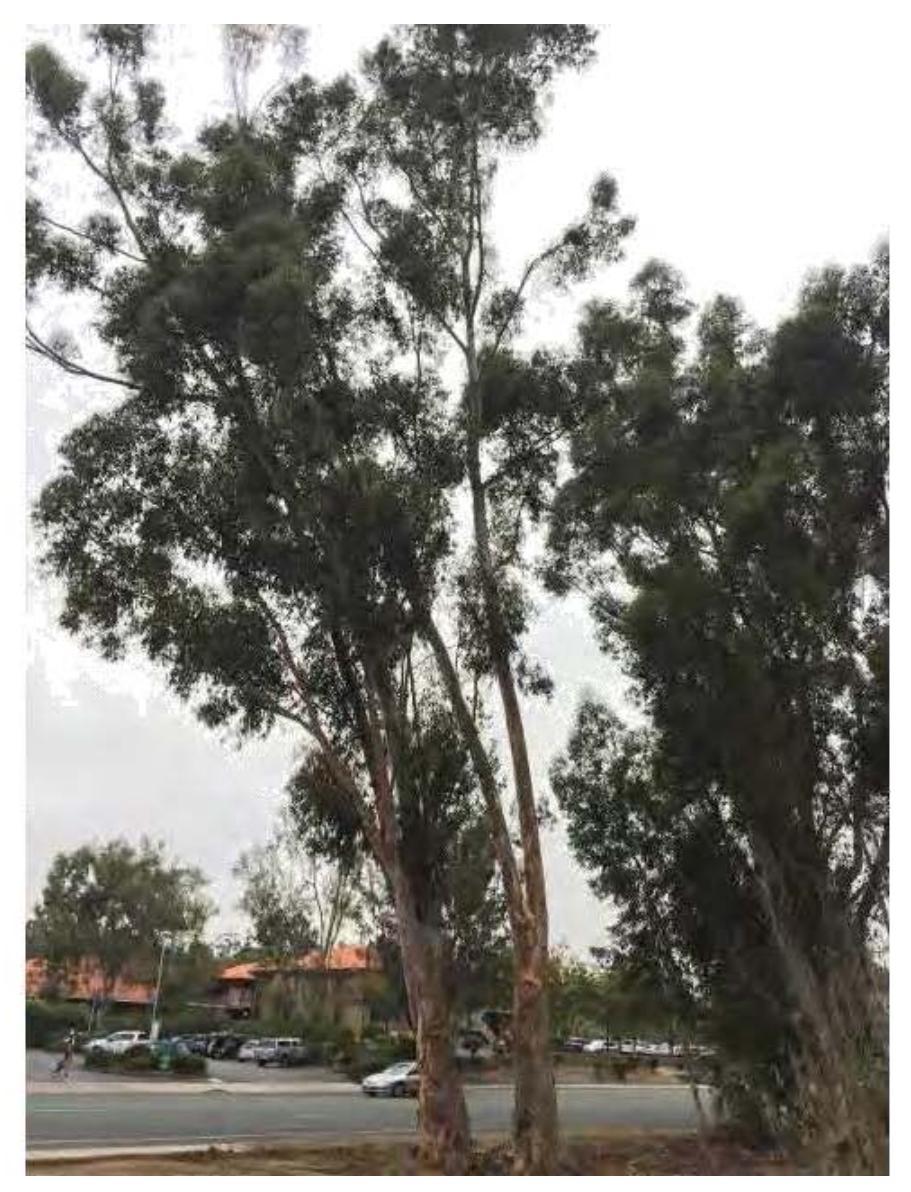
Photograph 6 – View of tree #'s 1 and 2

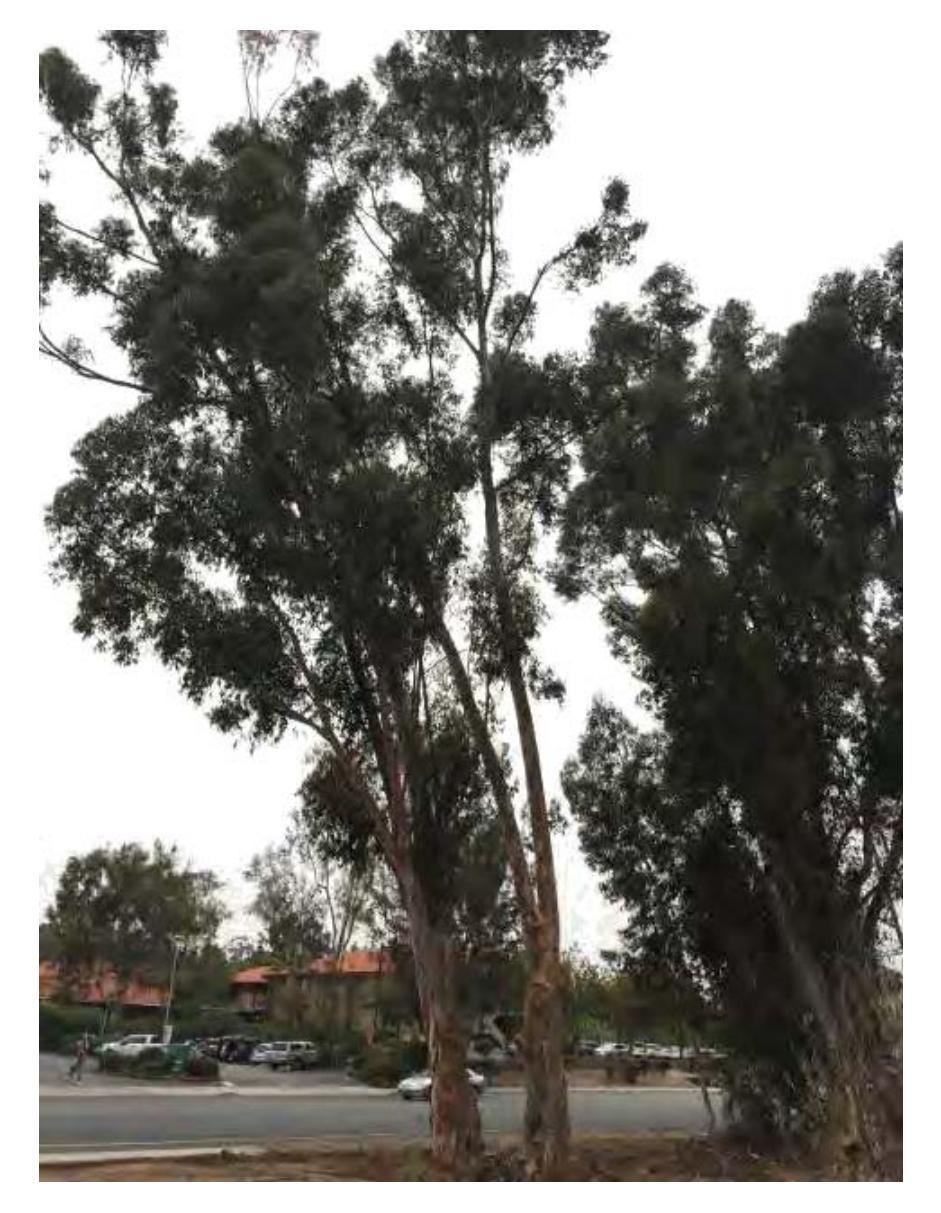
Photograph 7 – View of main stems (tree #'s 1 and 2)

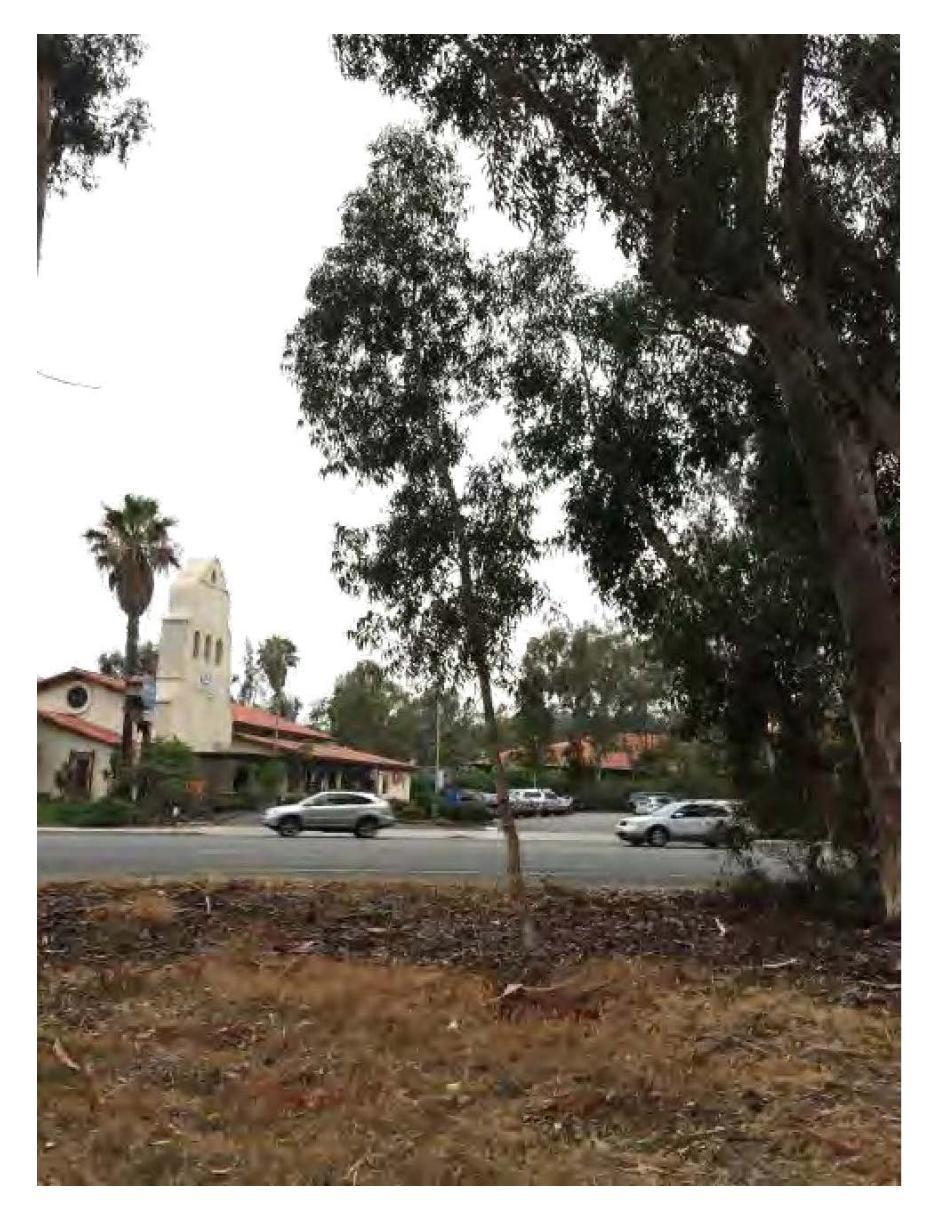
Photograph 9 – View of tree # 3

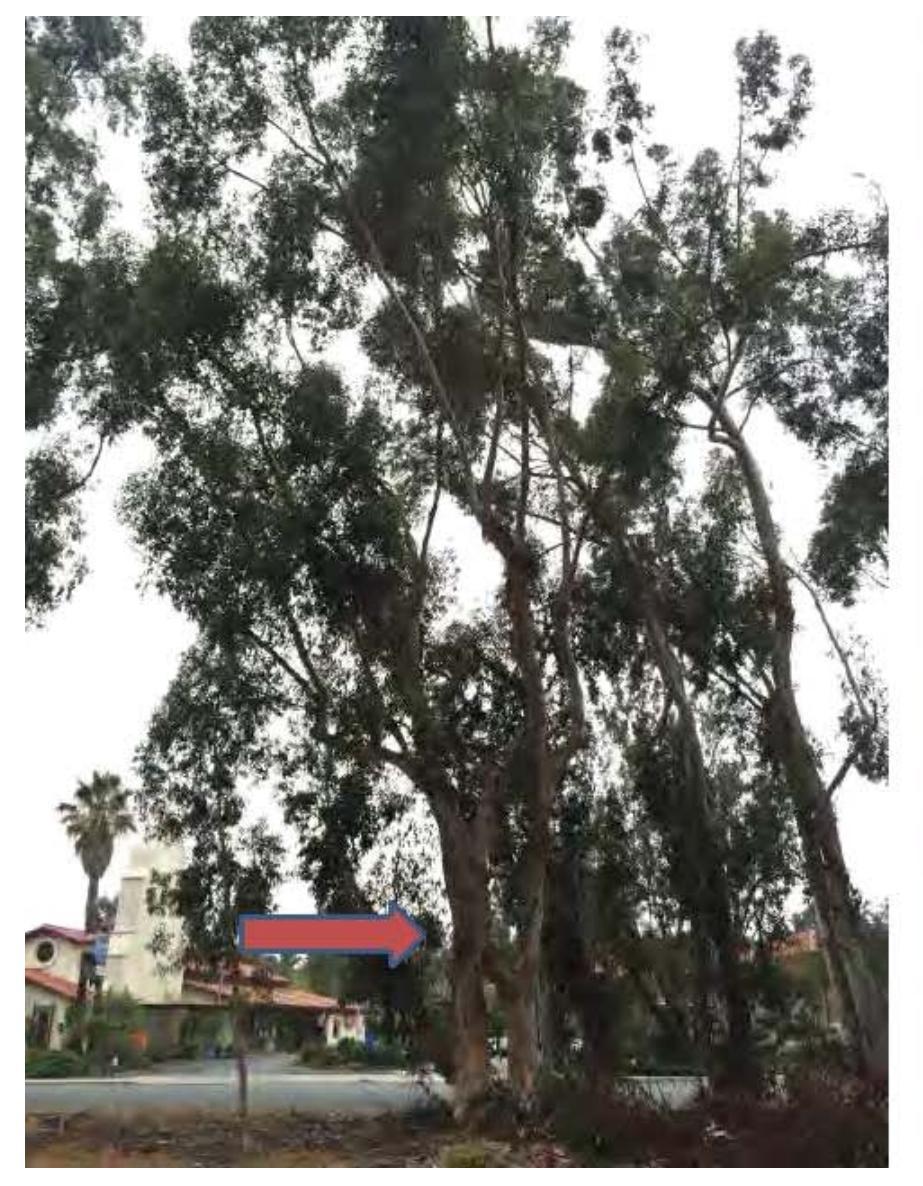
Photograph 11 – View of tree # 4 (red arrow)

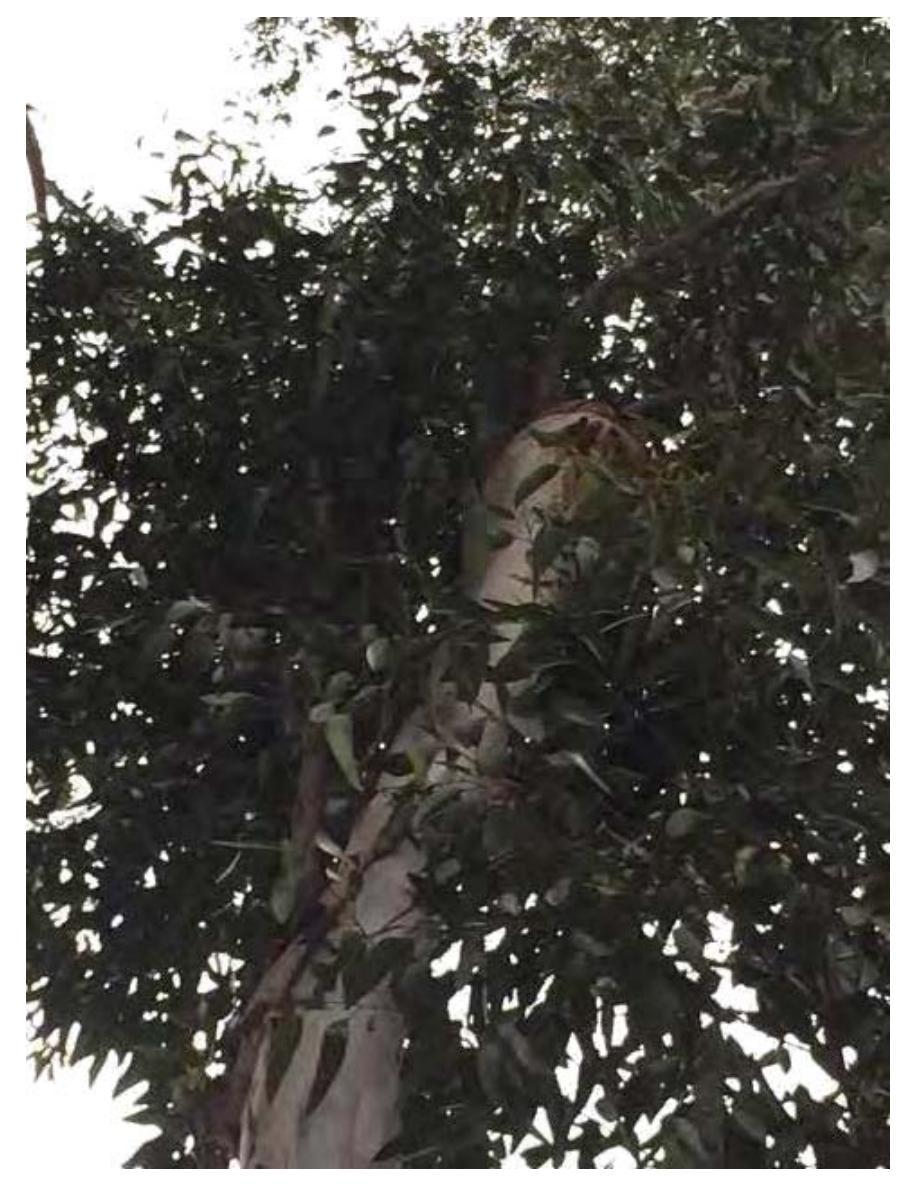
Photograph 15 – View of topped tree with poor architecture (tree #5)

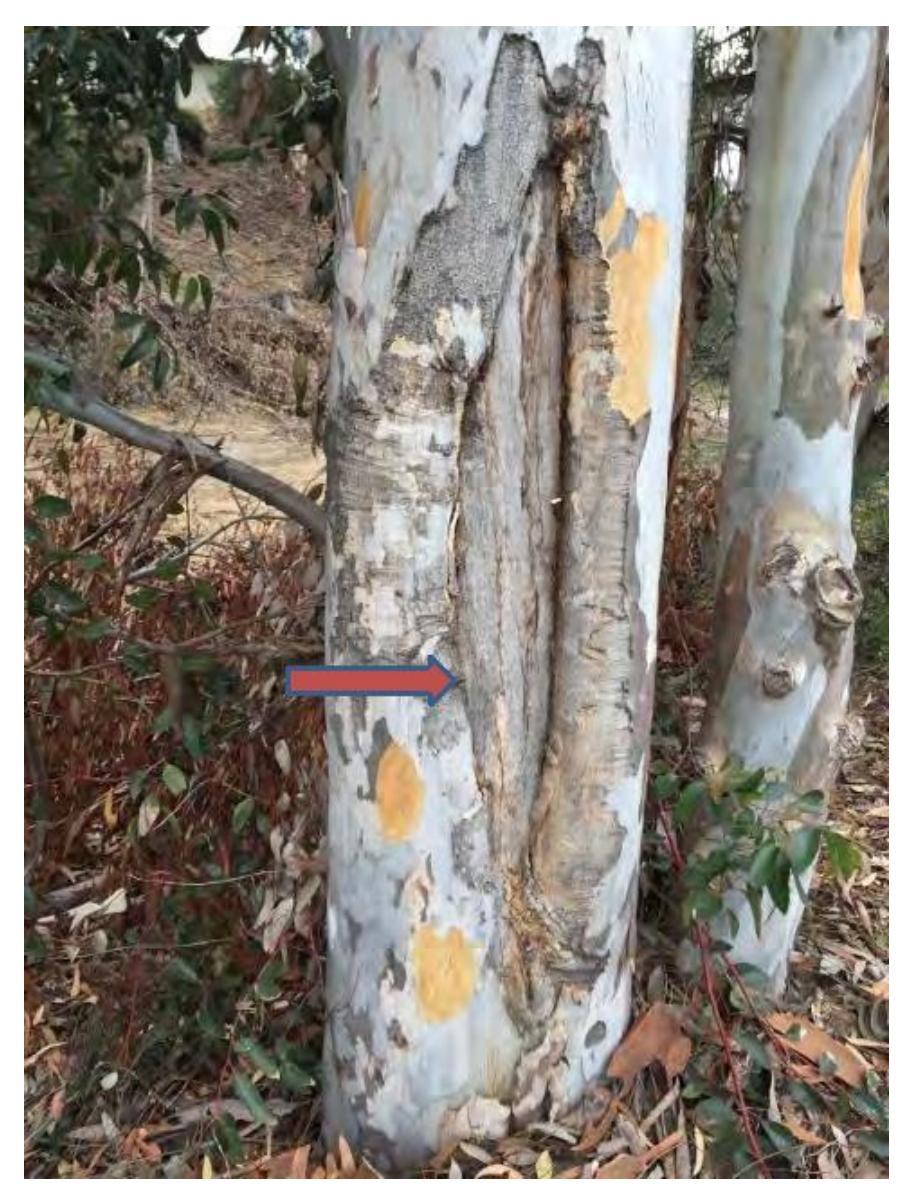
Photograph 18 – Close up view of large basal wound with frass (tree #7)

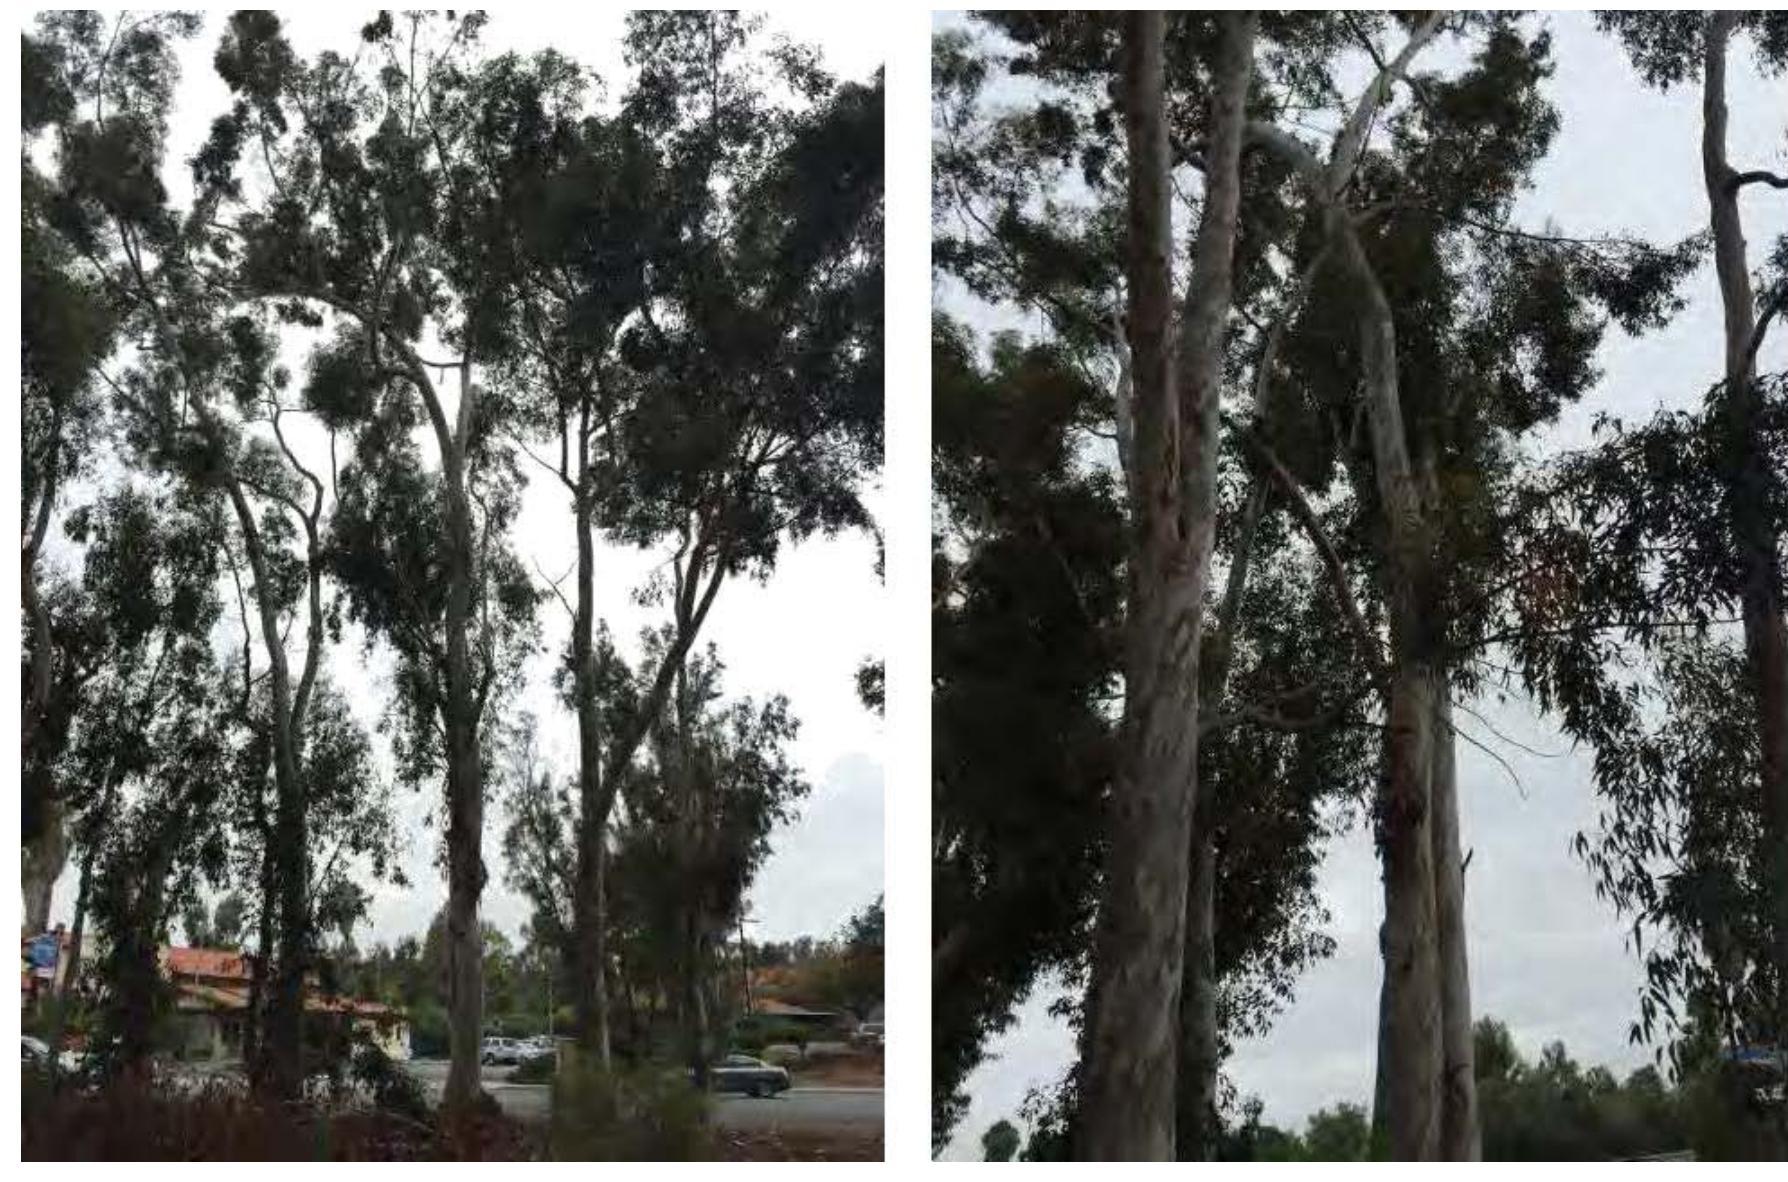
Photograph 21 – View of tree #8

Photograph 22 – View of main stem (tree #8)

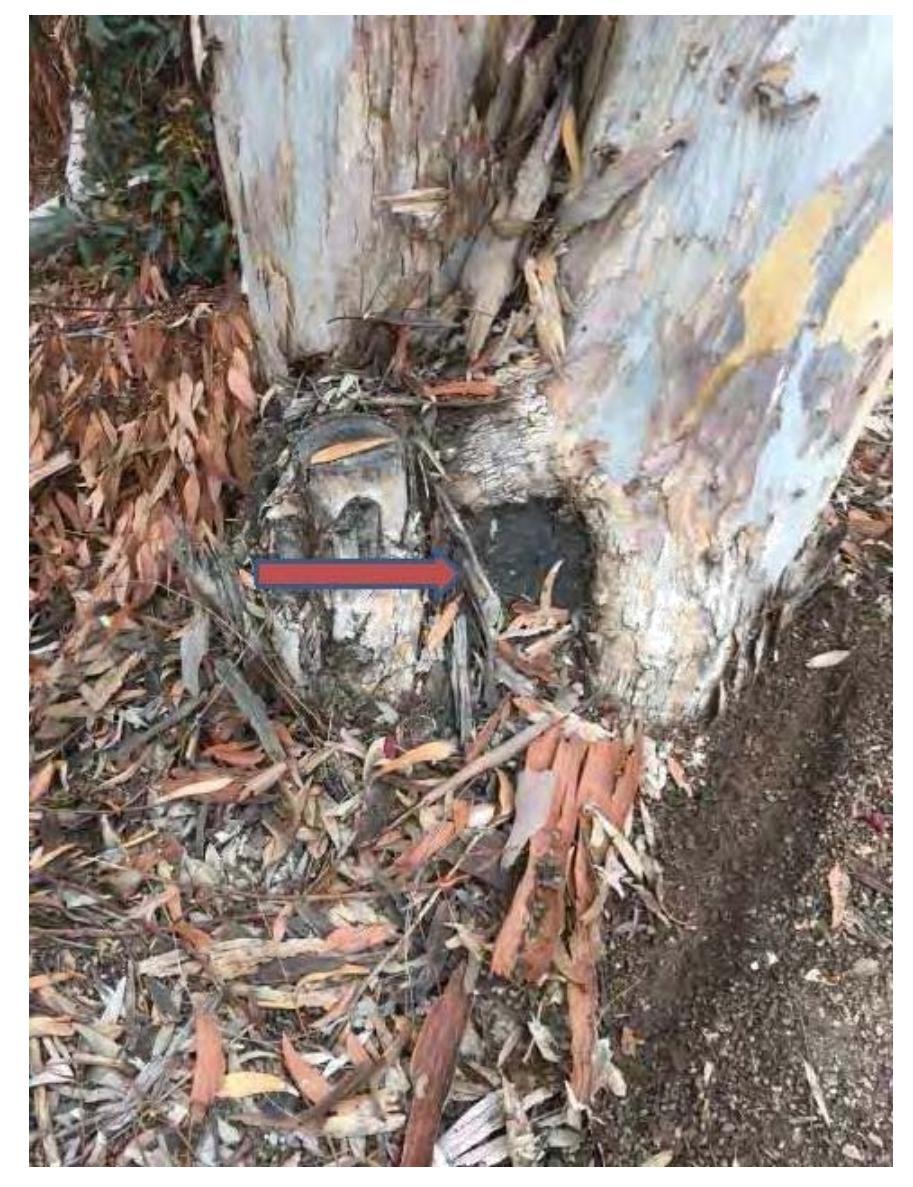
Photograph 23 – View of basal wound (tree #8)

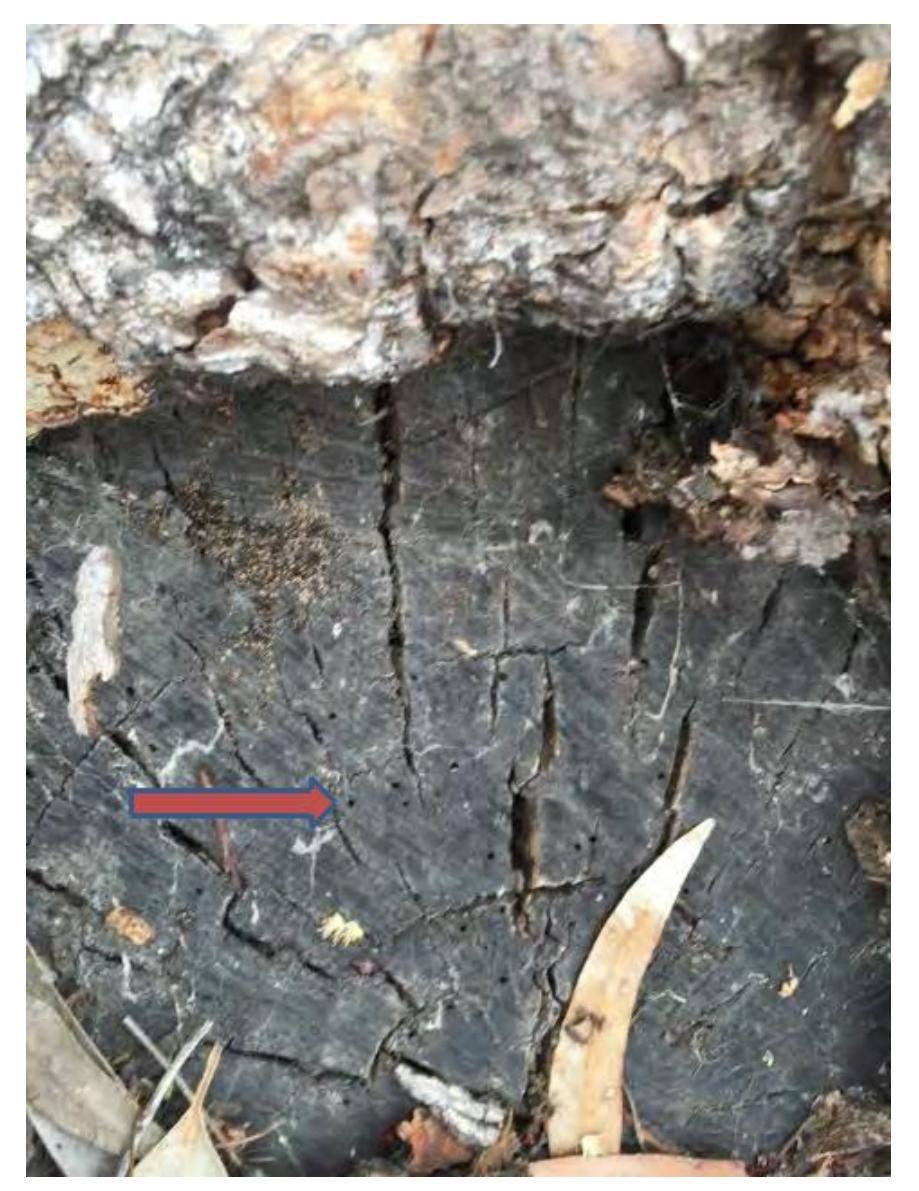
Photograph 24 – Close up view of basal wound with borer activity (tree #8)

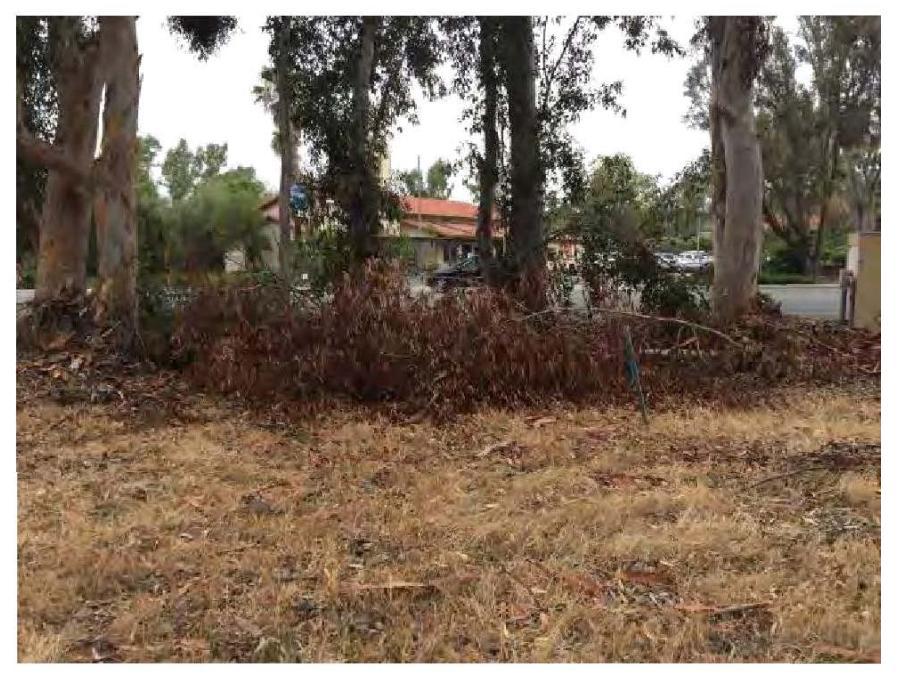
Photograph 26 – View of recent limb failure (tree #9)

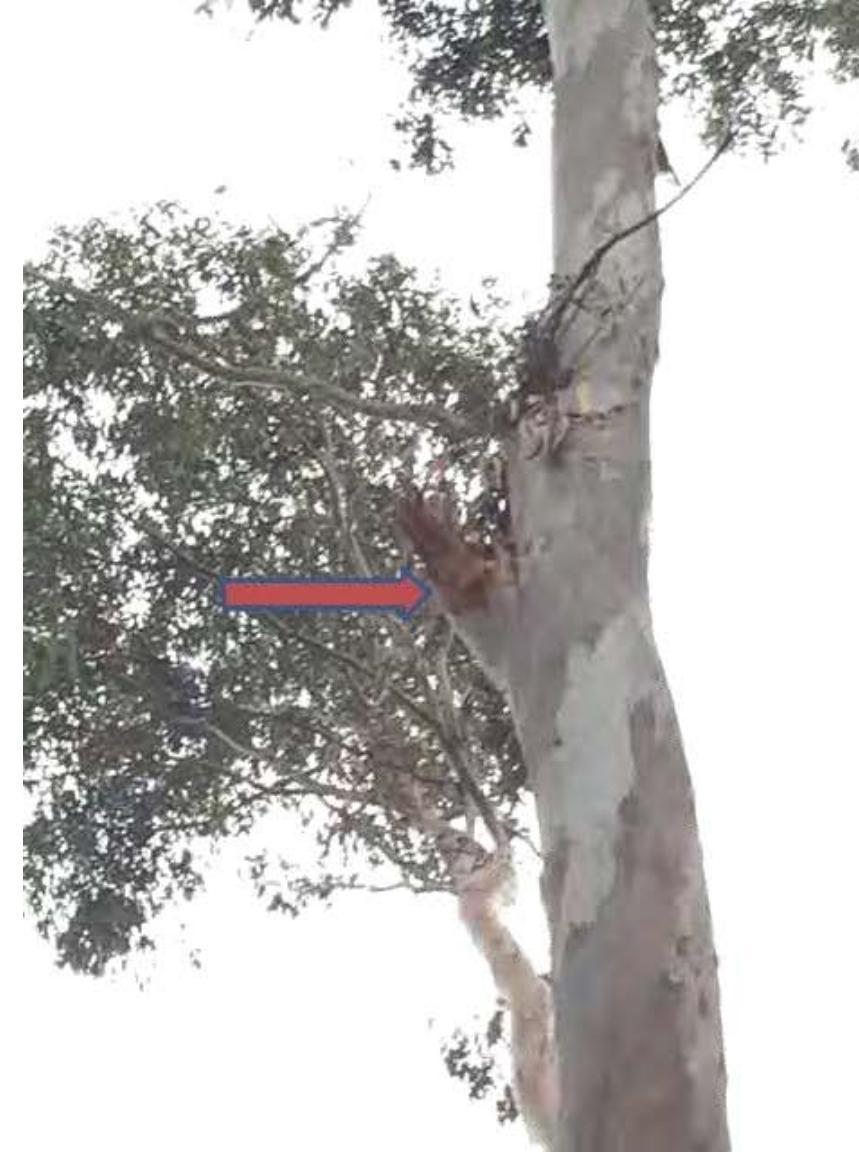
Photograph 27 – View of breaking point of recent failure (tree #9)

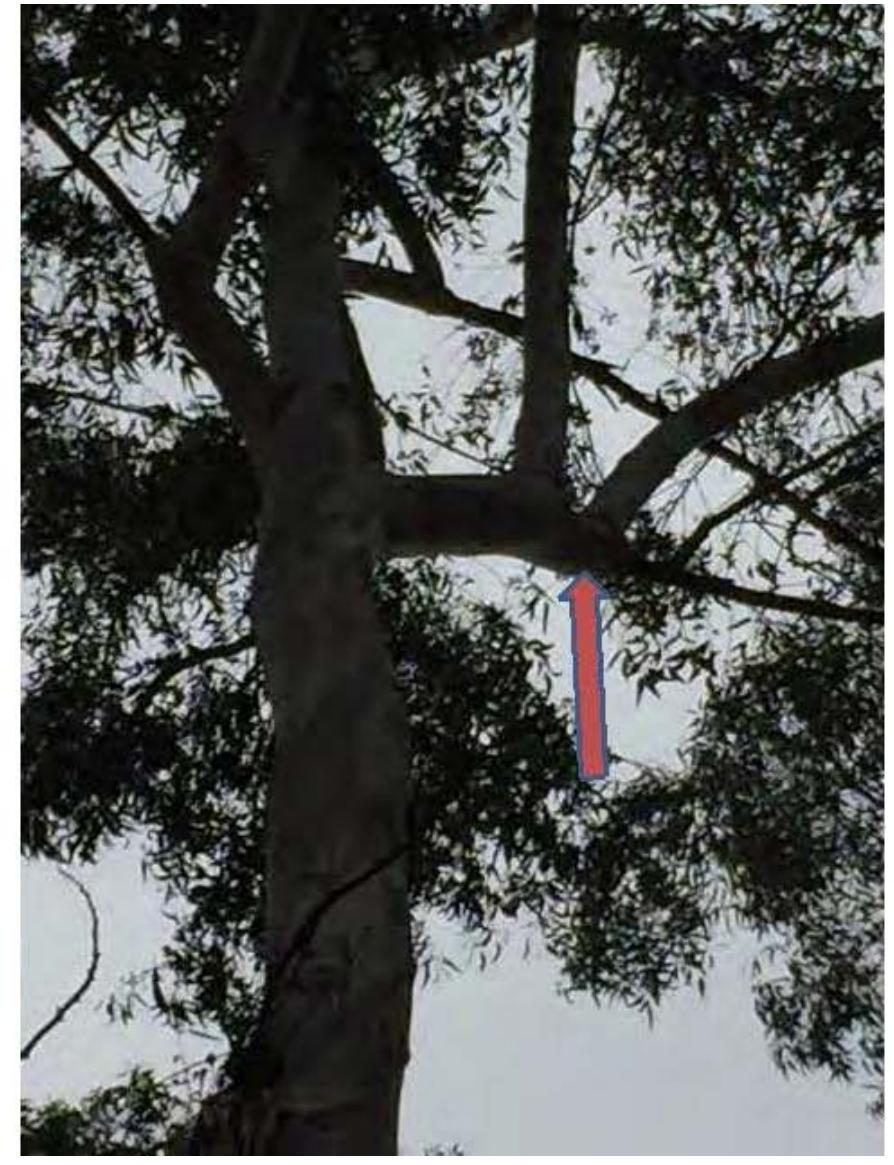
Photograph 28 – View of poor branch architecture (tree #9)

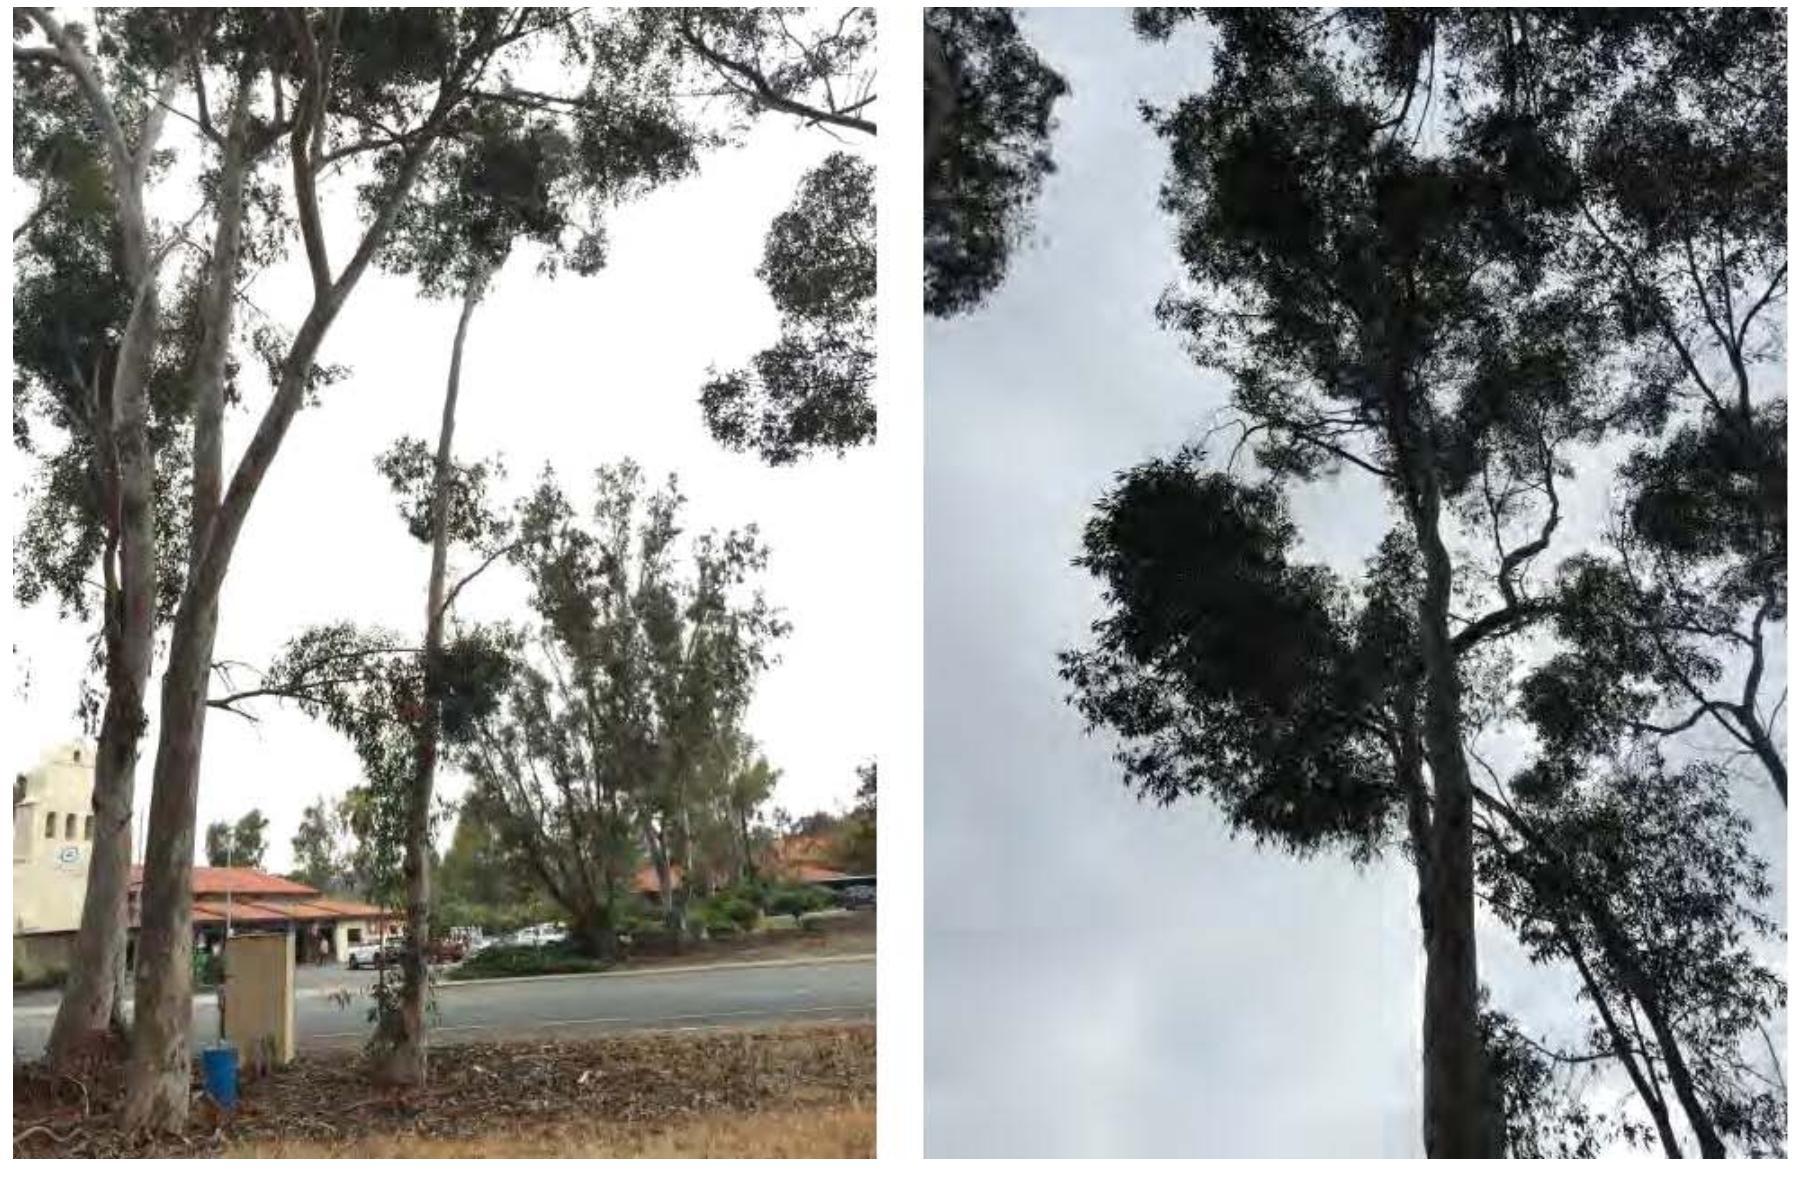
Photograph 31 – View of tree lean over street (tree # 10)

Photograph 32 – View of canopy (tree # 11)

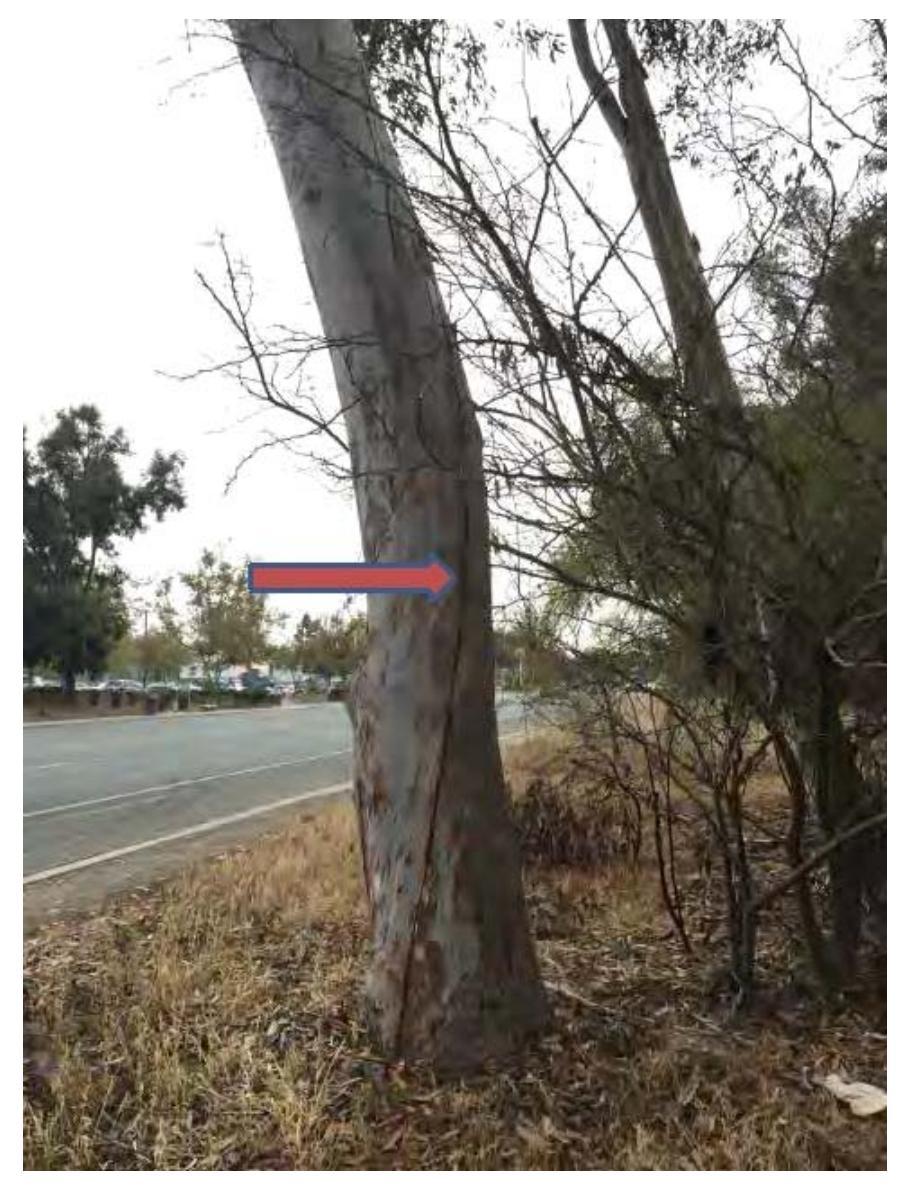
Photograph 33 – View of stem with seam (tree # 11)

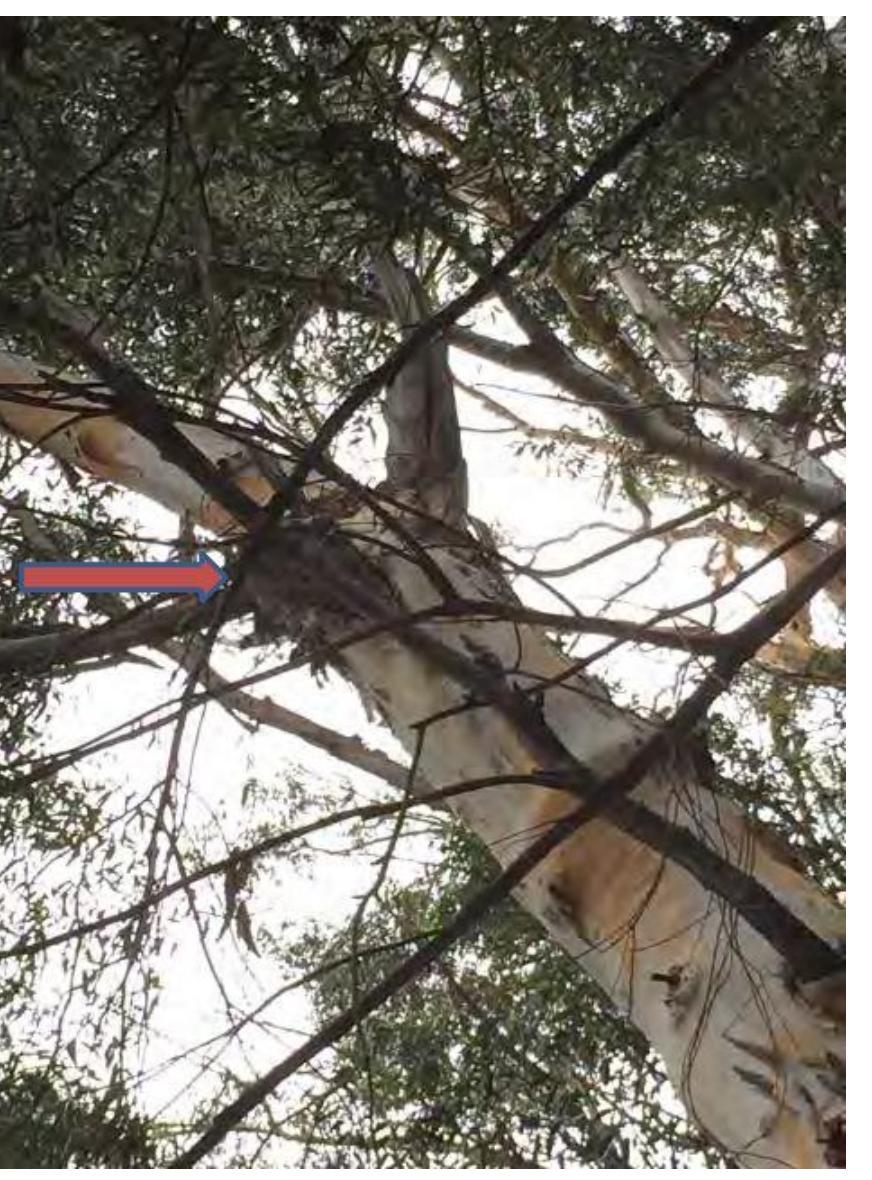
Photograph 44 – View of previous branch failure and dead wood (tree # 16)
