CALIFORNIA TREE SERVICE, INC.

July 17, 2015

Subject: Bonita Pump Station Project: Tree Risk Evaluation

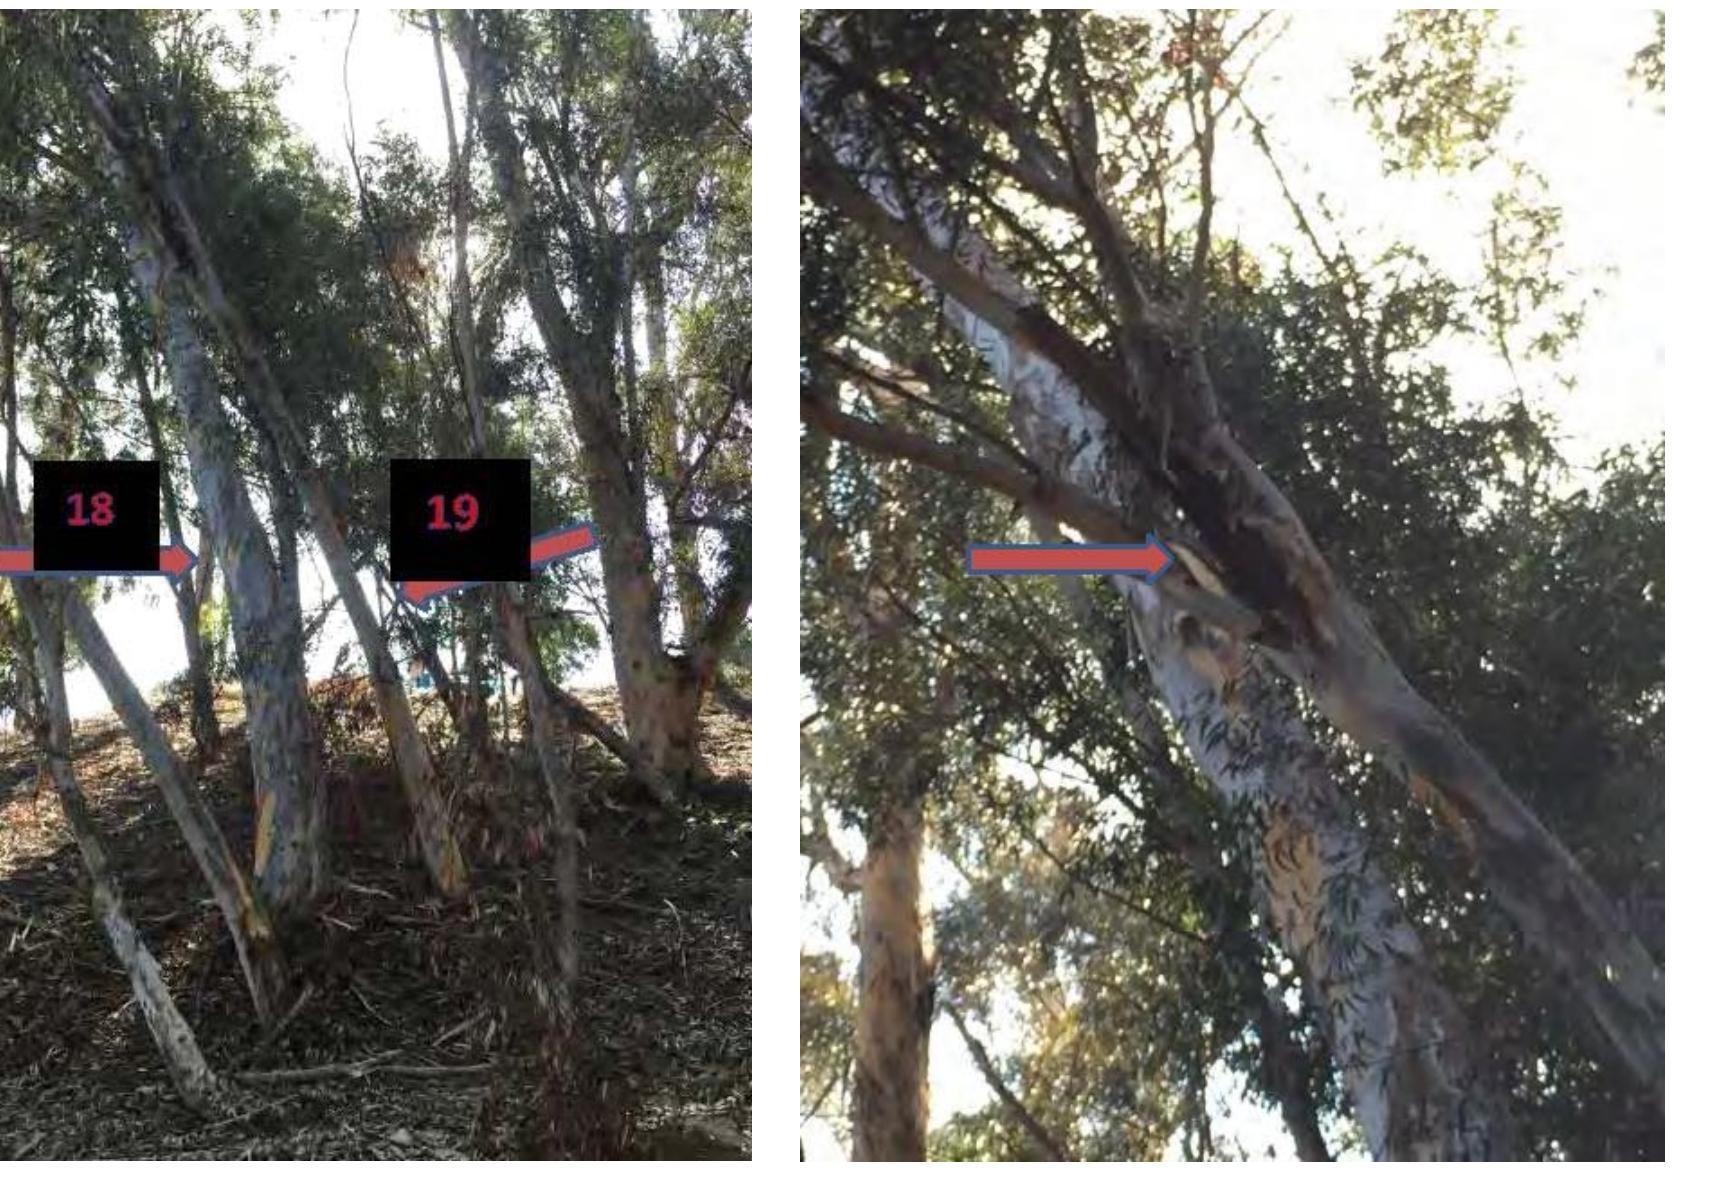
Photograph 49 – View of main stem (tree #'s 18 and 19)

Photograph 50 – View of damage trunk (tree # 19)

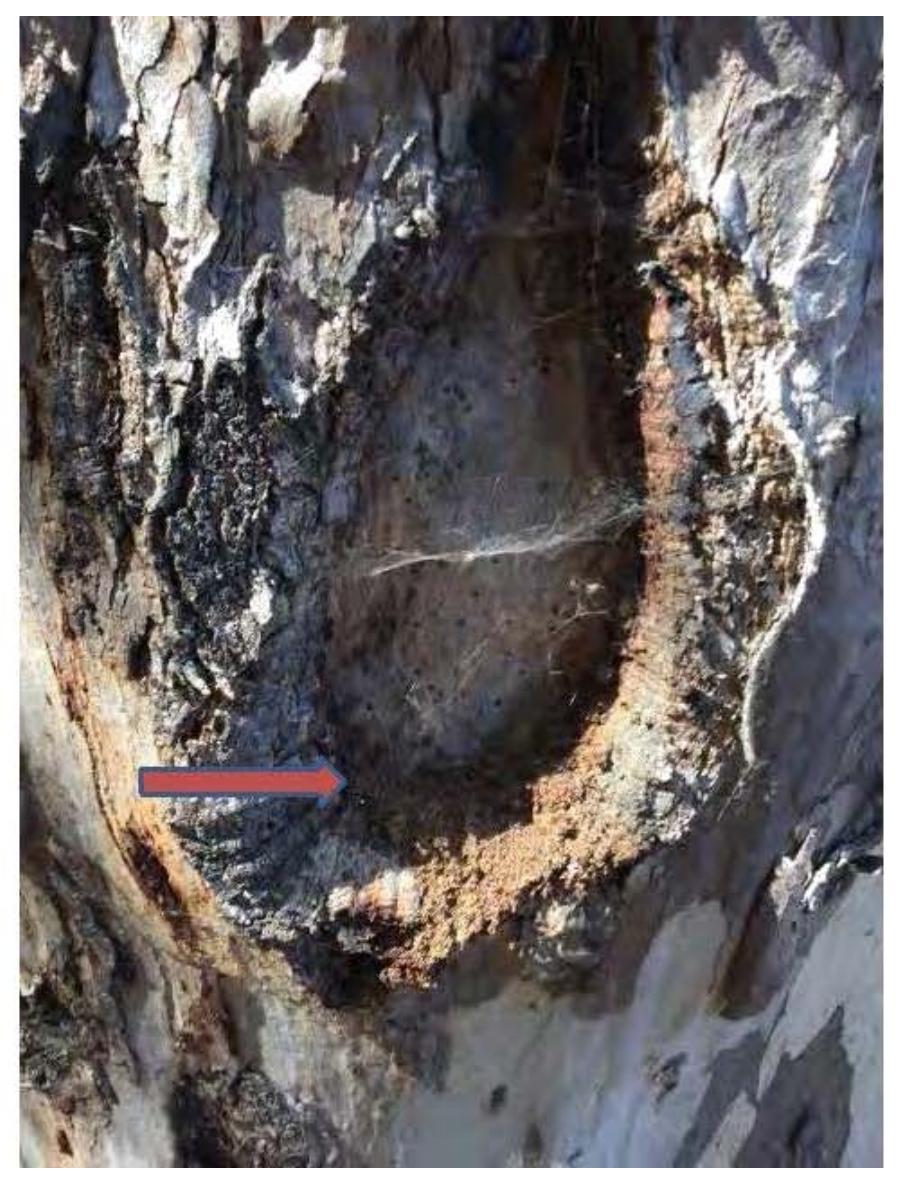
Photograph 54 – Close up view of borer damage (tree # 21)

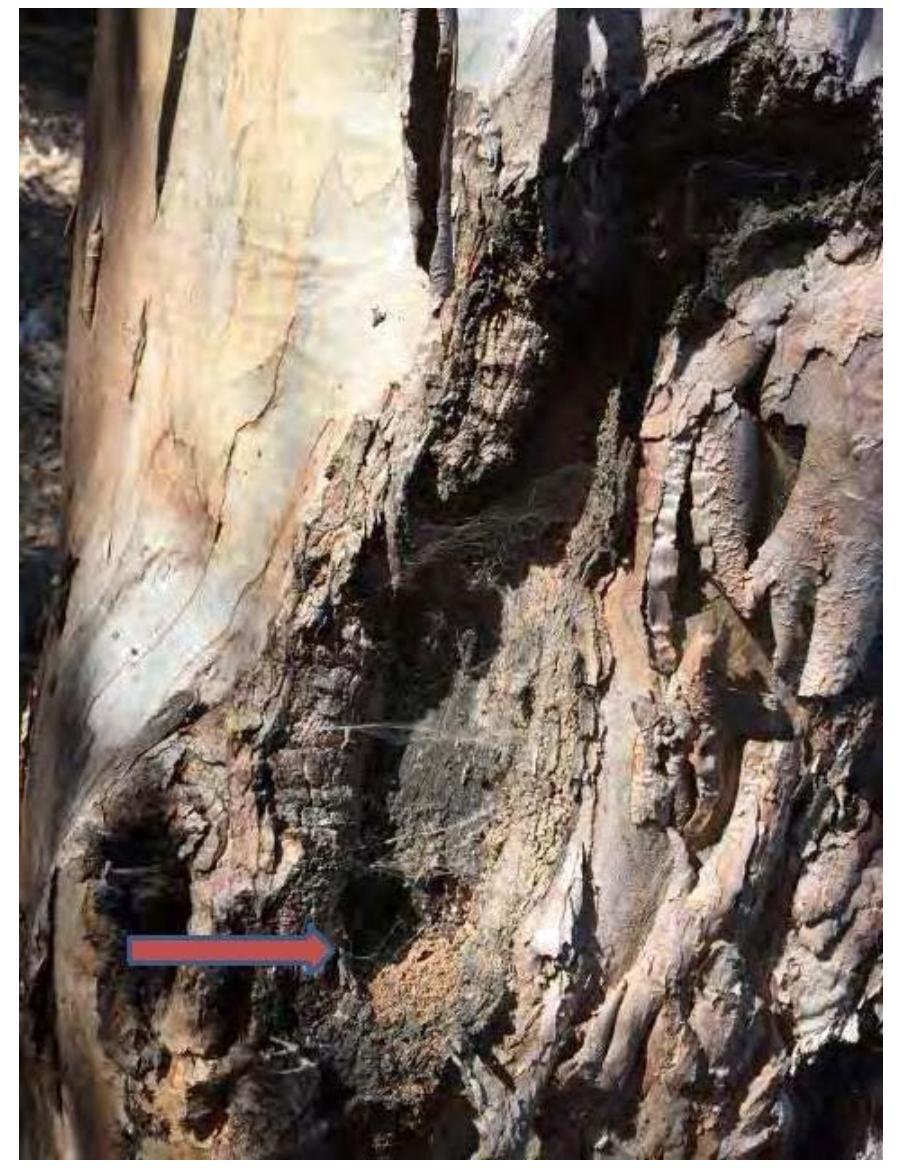
Photograph 55 – Close up view of basal wound with borer damage (tree #21)

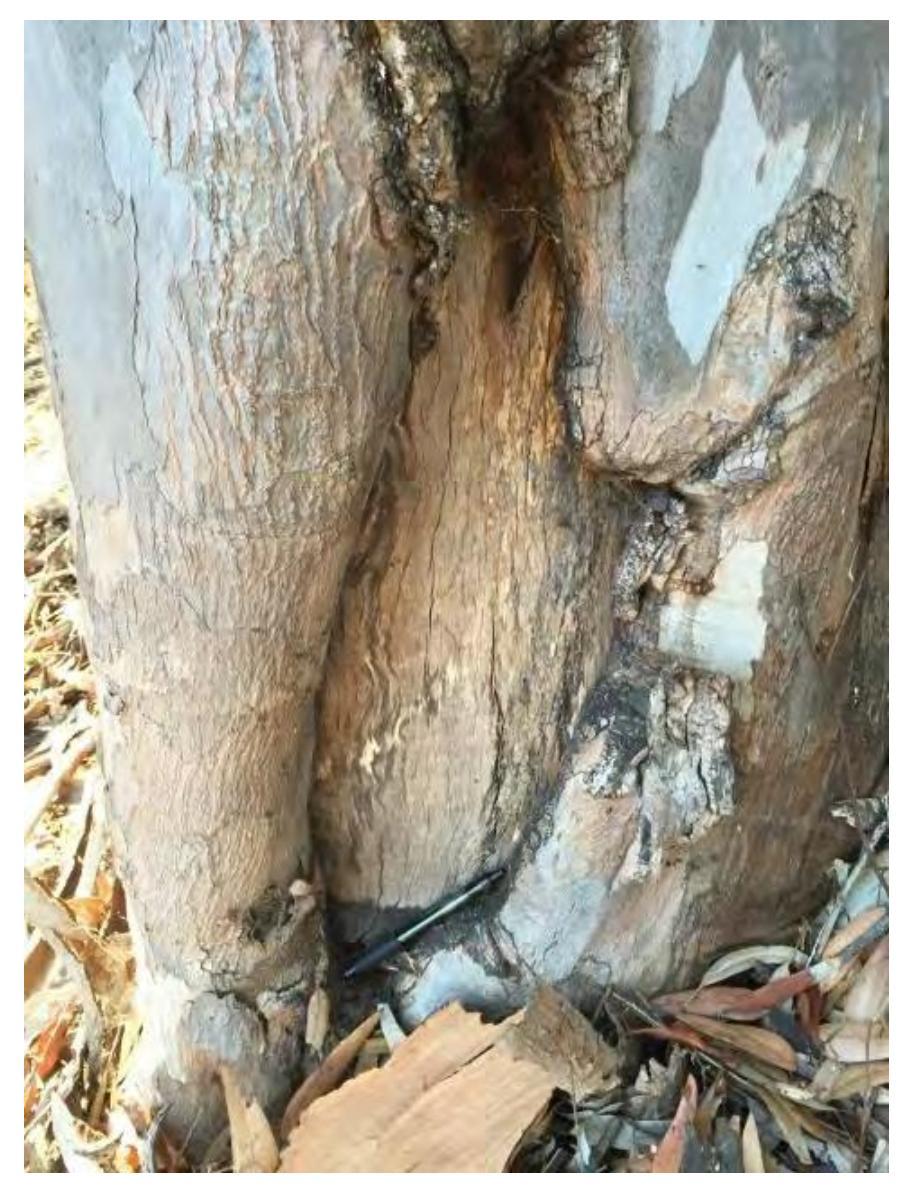
Photograph 56– View of basal wound (tree # 21)

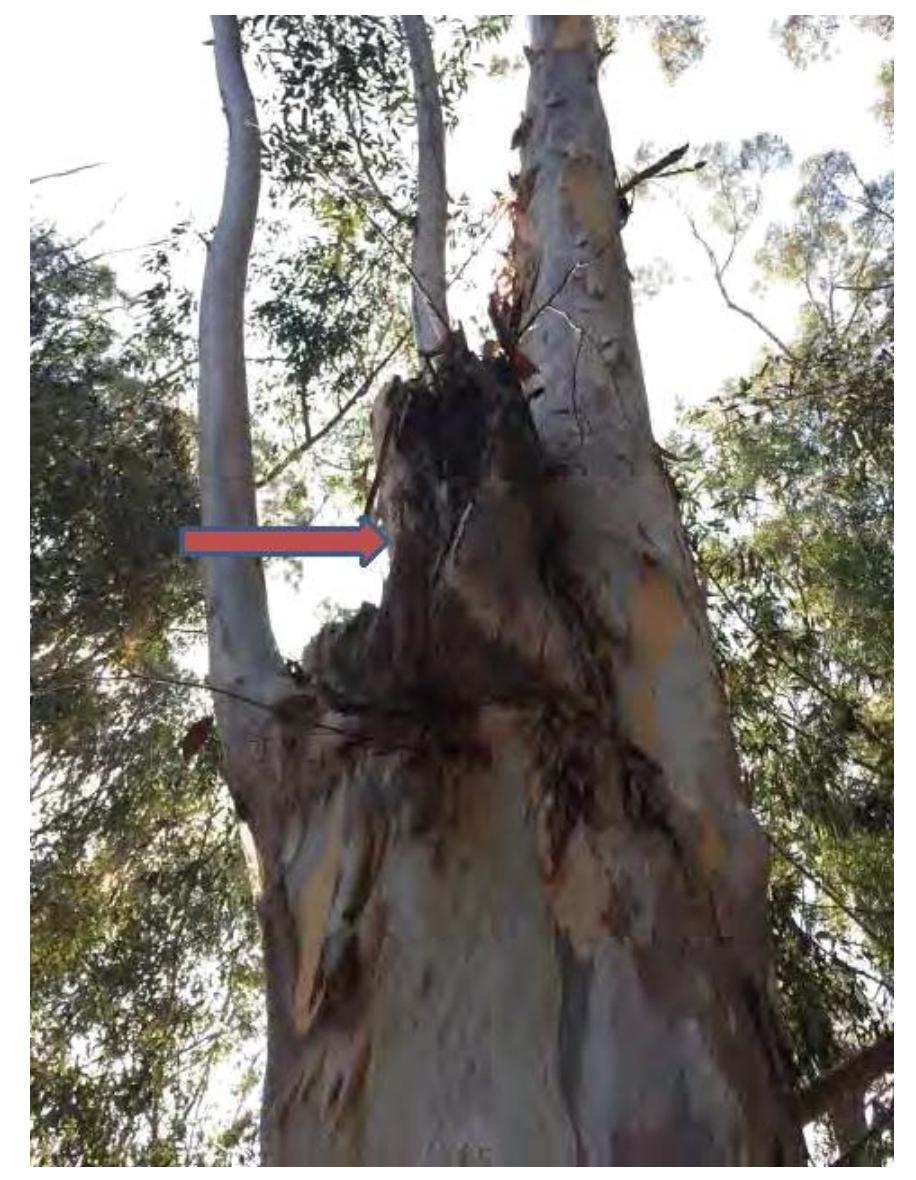
Photograph 57 – View of stem failure and poor branch structure (tree 21)

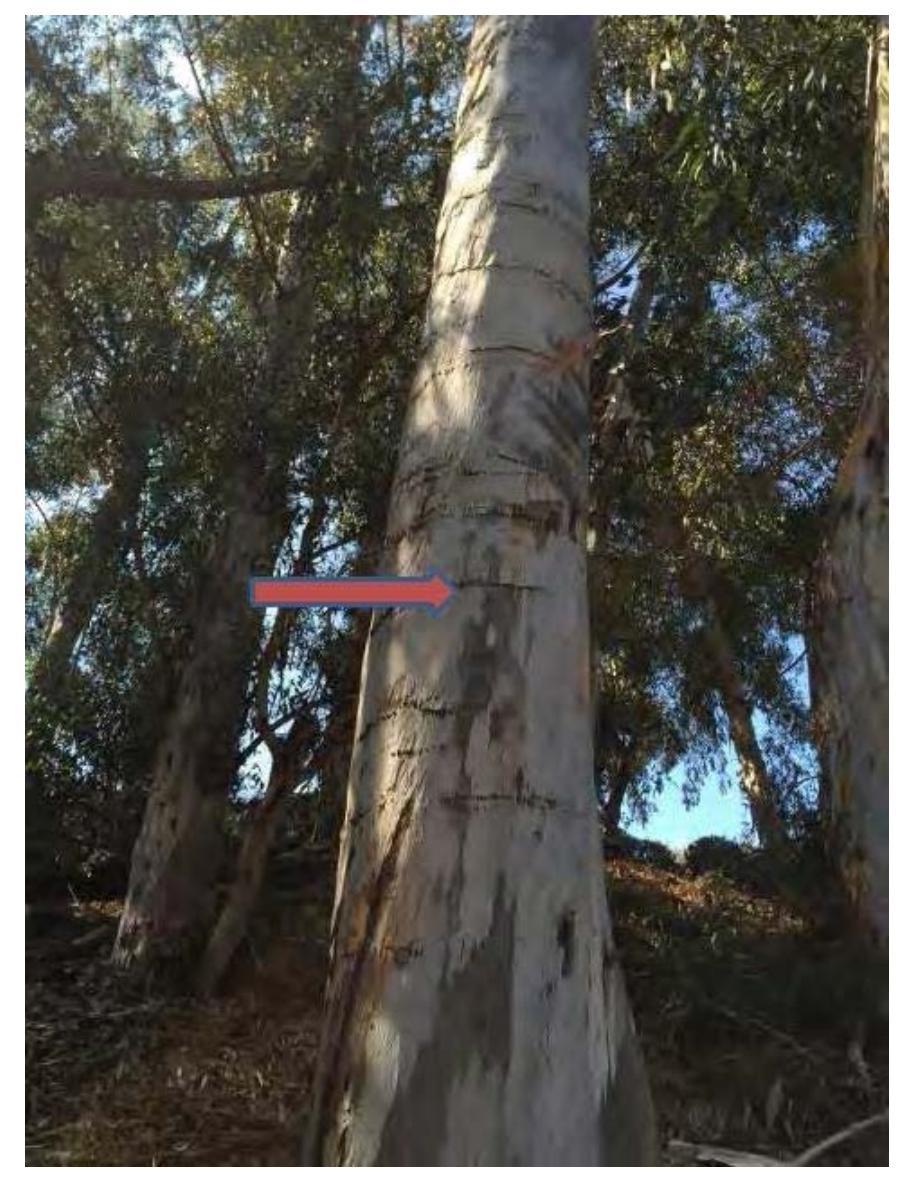
Photograph 63 – View of main stem with woodpecker damage (tree # 23)

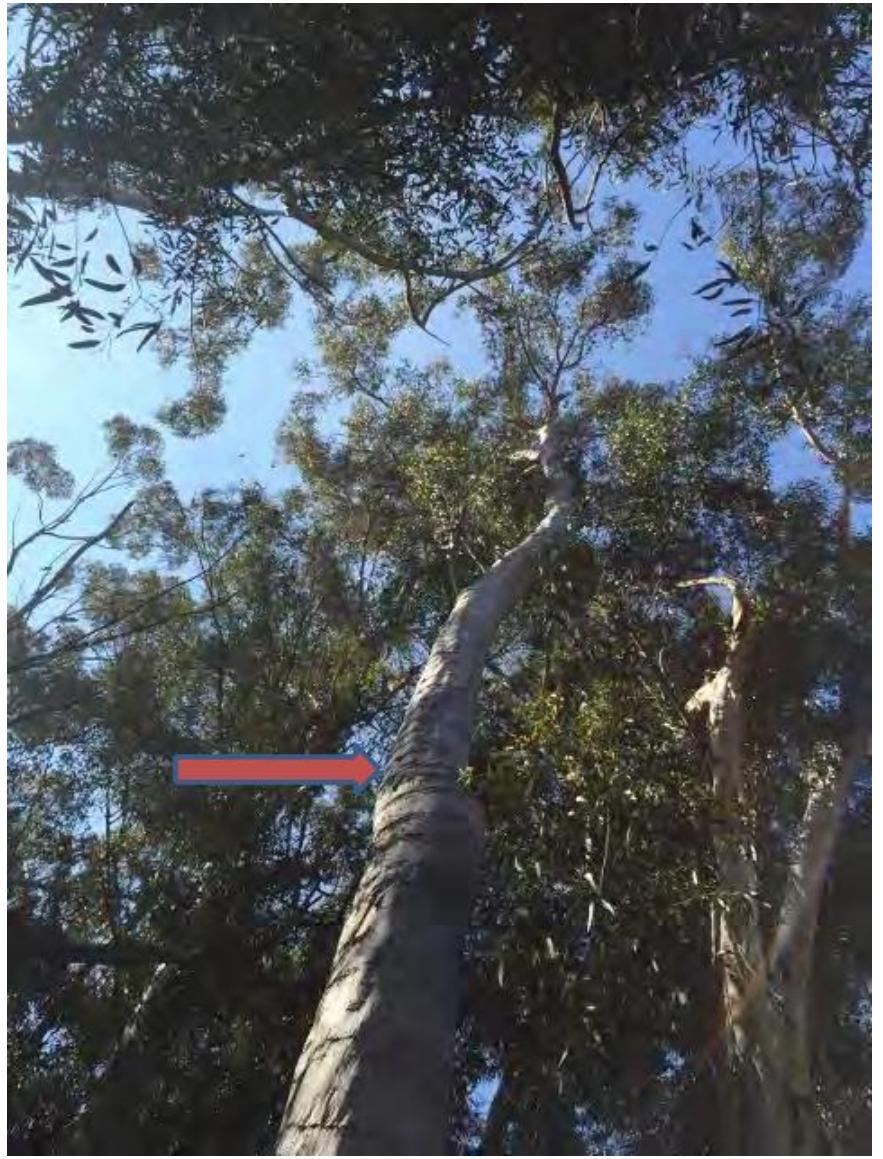
Photograph 64 - View of main stem with woodpecker damage (tree # 23)

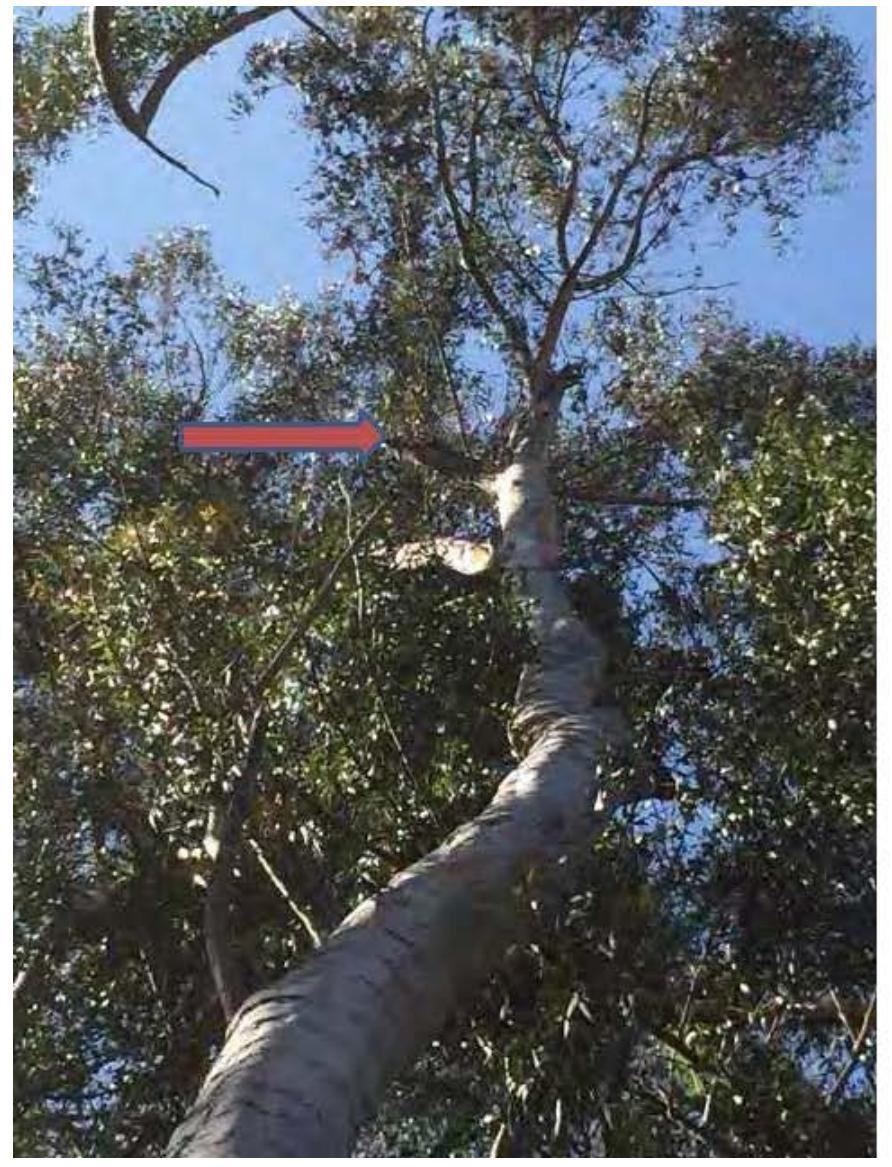
Photograph 65 – View of previous branch failure (tree # 23)

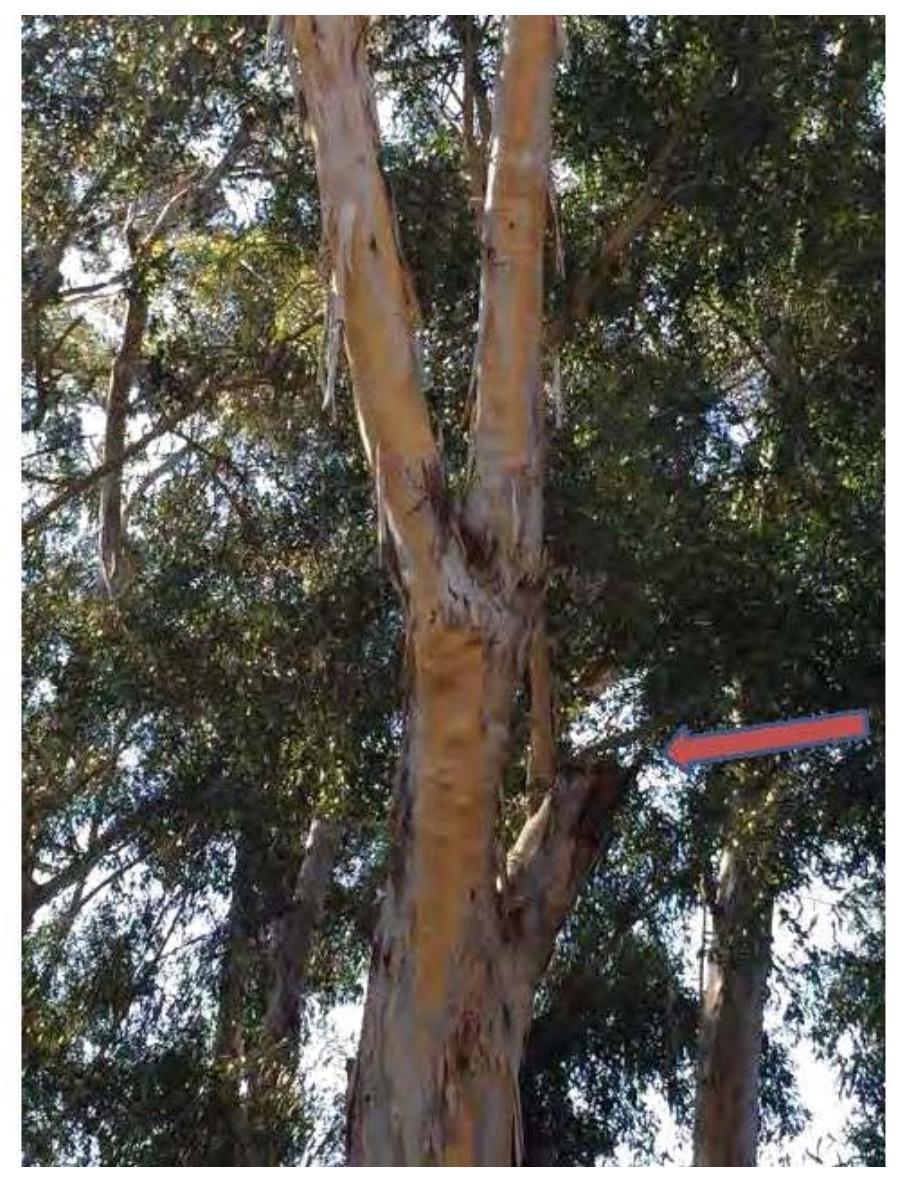
Photograph 68 – View of previous branch failure (tree # 23)

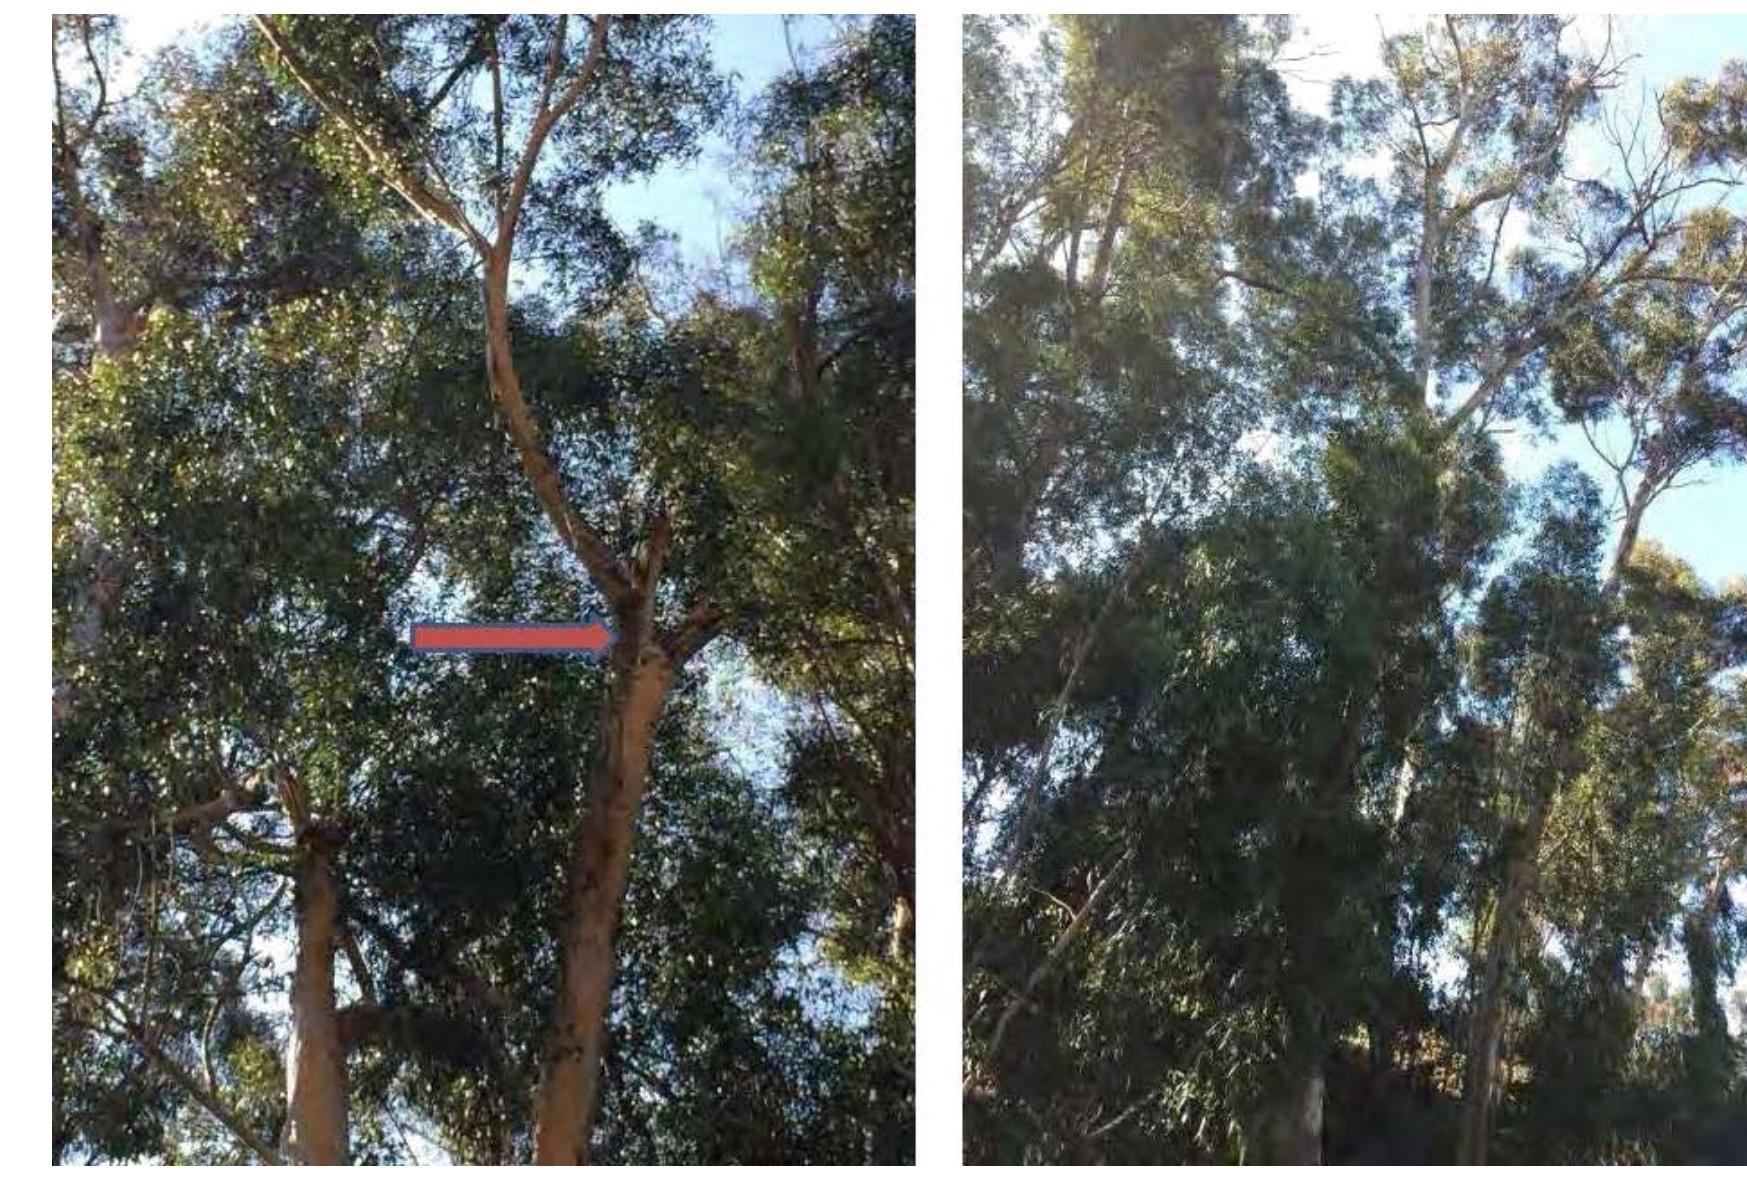
Photograph 69 – View of branch failure (tree #24)

Photograph 70 – View of tree # 25

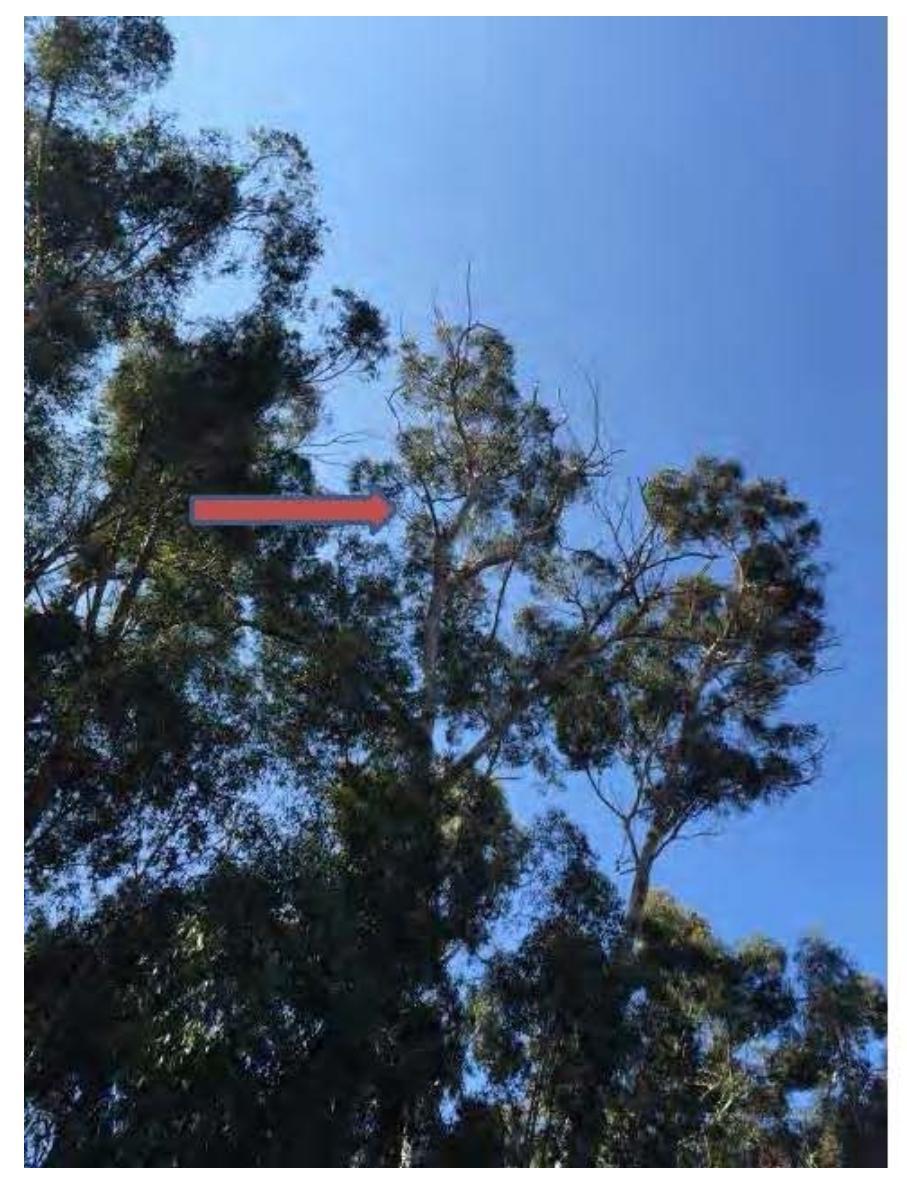
Photograph 71 – View of canopy decline (tree #25)

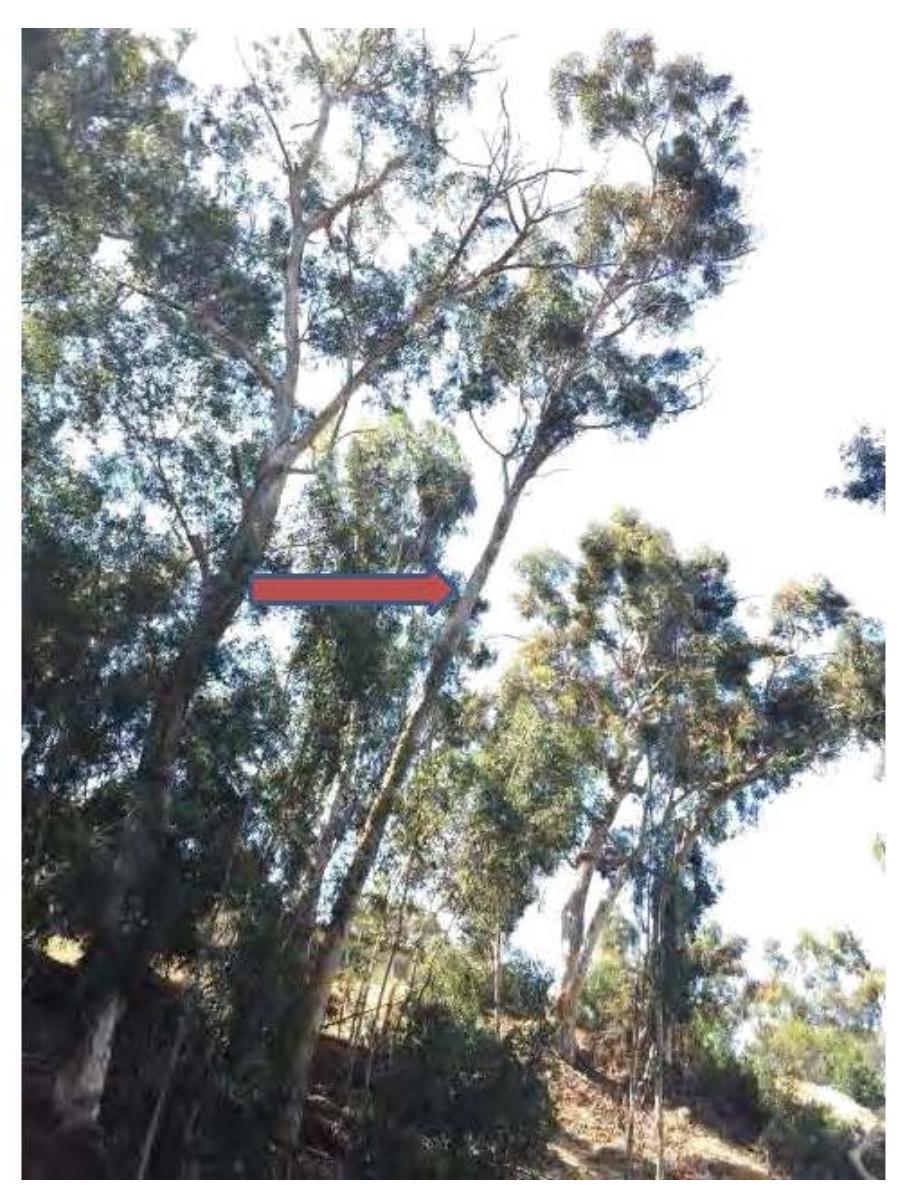
Photograph 72 – View of tree # 26 exhibiting lean

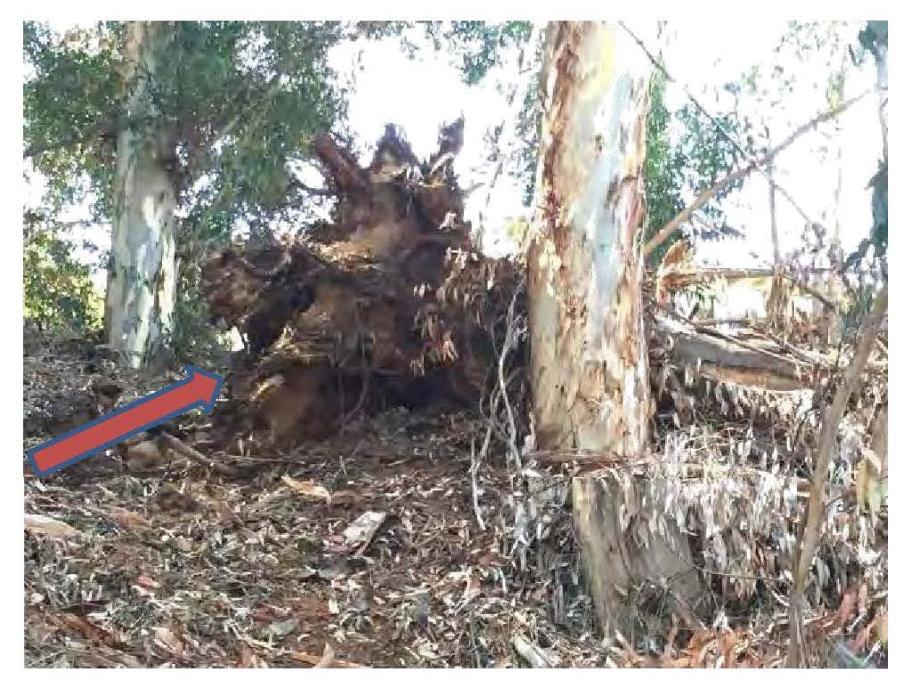
Roots and Root Collar: All of the roots and root collars were buried and not visible for inspection. Root collar depths varied from 1 to 4 inches. Root collars were commonly buried by soil and/or deep leaf and litter layers. It was noted that the roots of tree 1 may have been damaged by construction activities to the southwest. Furthermore, it was noted that all of the observed whole tree failures were a result of substantial root rot. As such, it is anticipated that additional trees throughout the site and/or immediately adjacent to the whole tree failures may have varying levels of root rot. Photograph 74 and 75 of Attachment 3 provide a close up view of the observed root rot.

Photograph 74 – View of whole tree failure with root rot

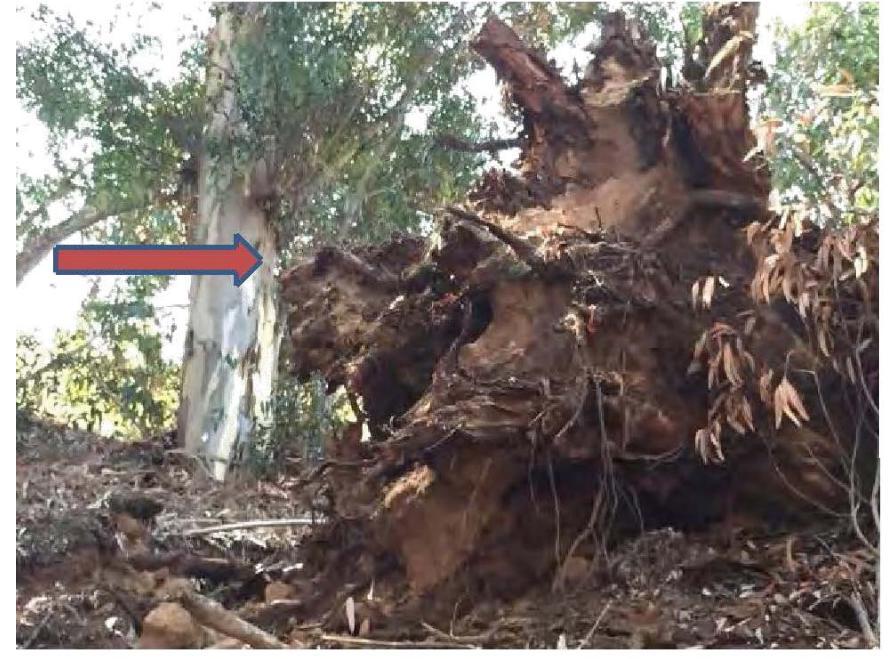
Photograph 75 – Close up view of root rot on recent failure

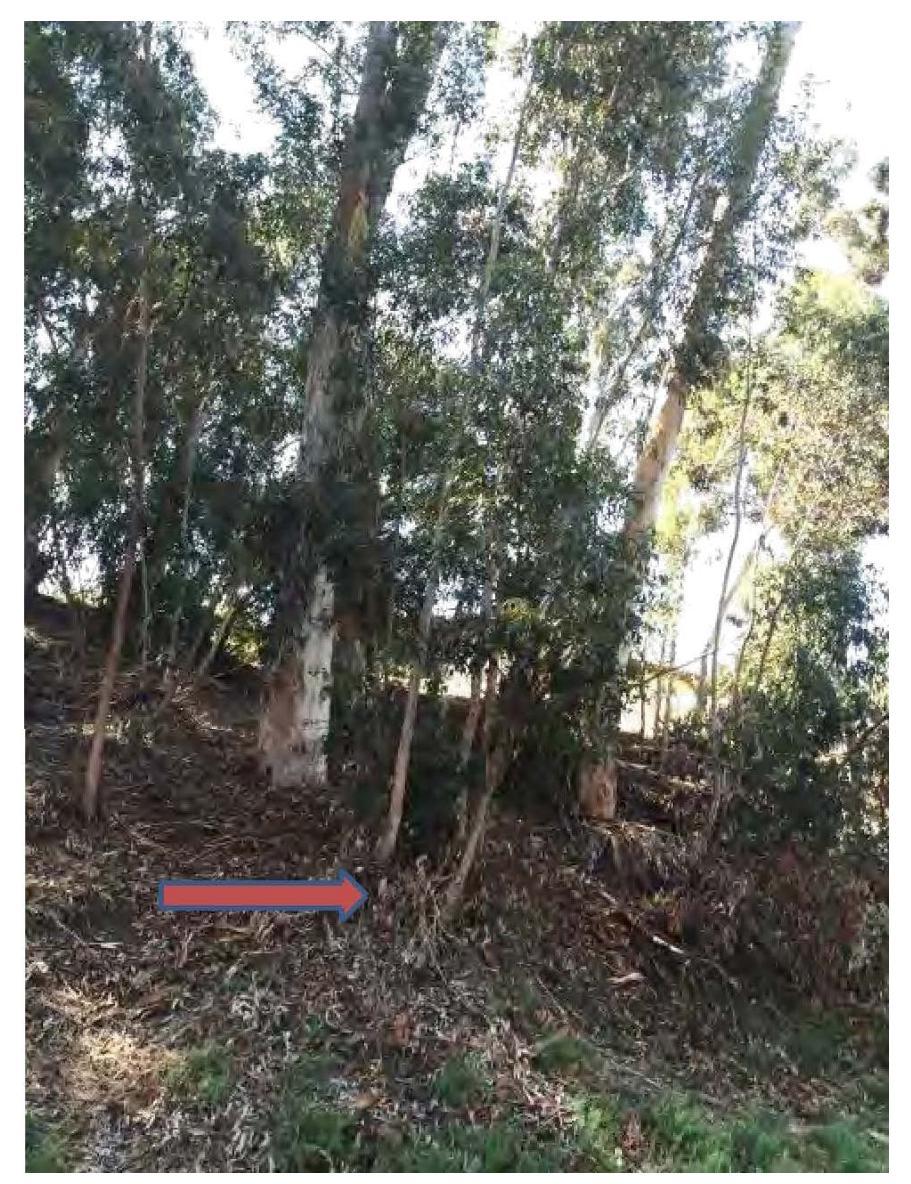
Photograph 76 – View of stump sprout tree with poor structure

- 1. **Stump Sprouts:** An additional 18 stump sprouting trees were observed throughout the site. The stump sprouts are primarily located along the bottom edge of the slope and immediately adjacent to the proposed pump station. Stump sprouts often have poor structural properties and may pose increased risk as they age. It is recommended that the observed 18 stump sprouts be removed.

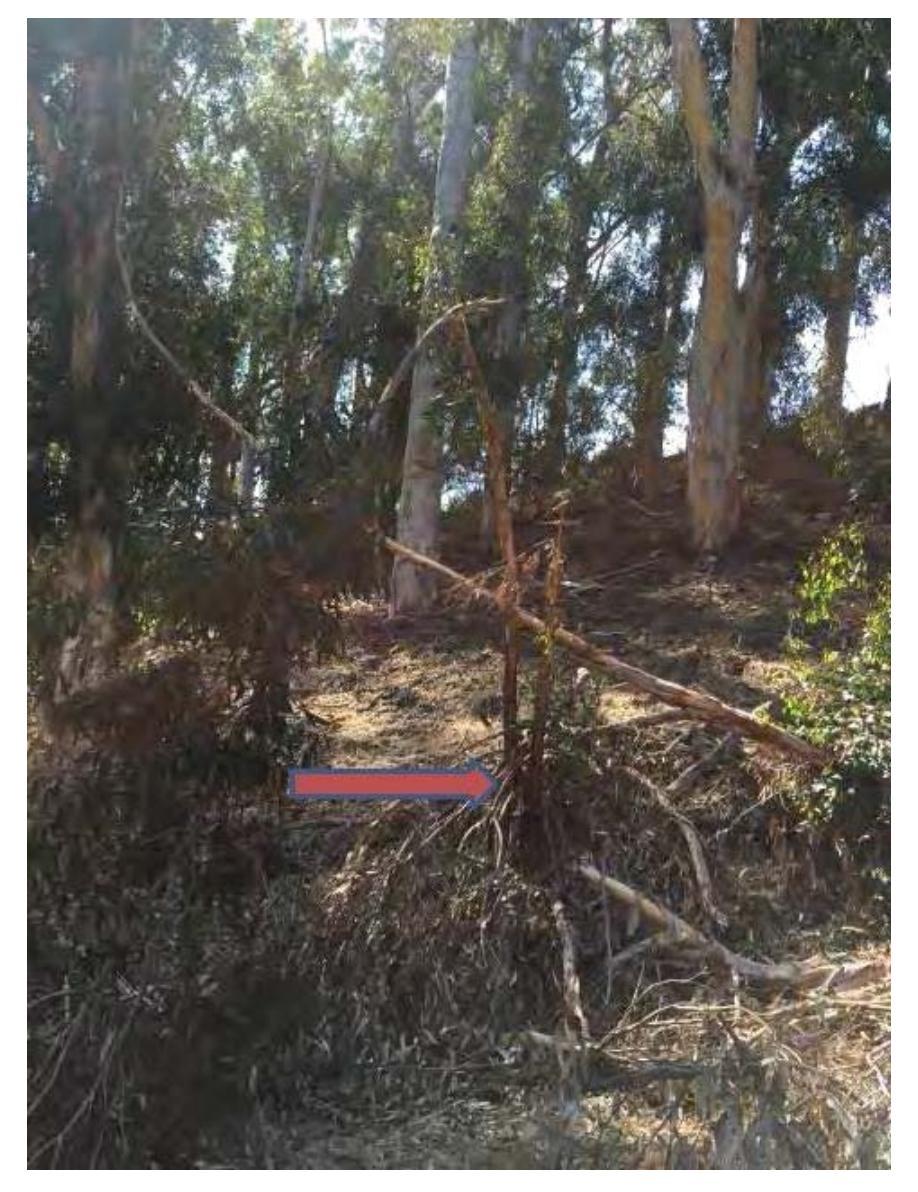
Photograph 77 – View of damage stump sprout from large limb failure

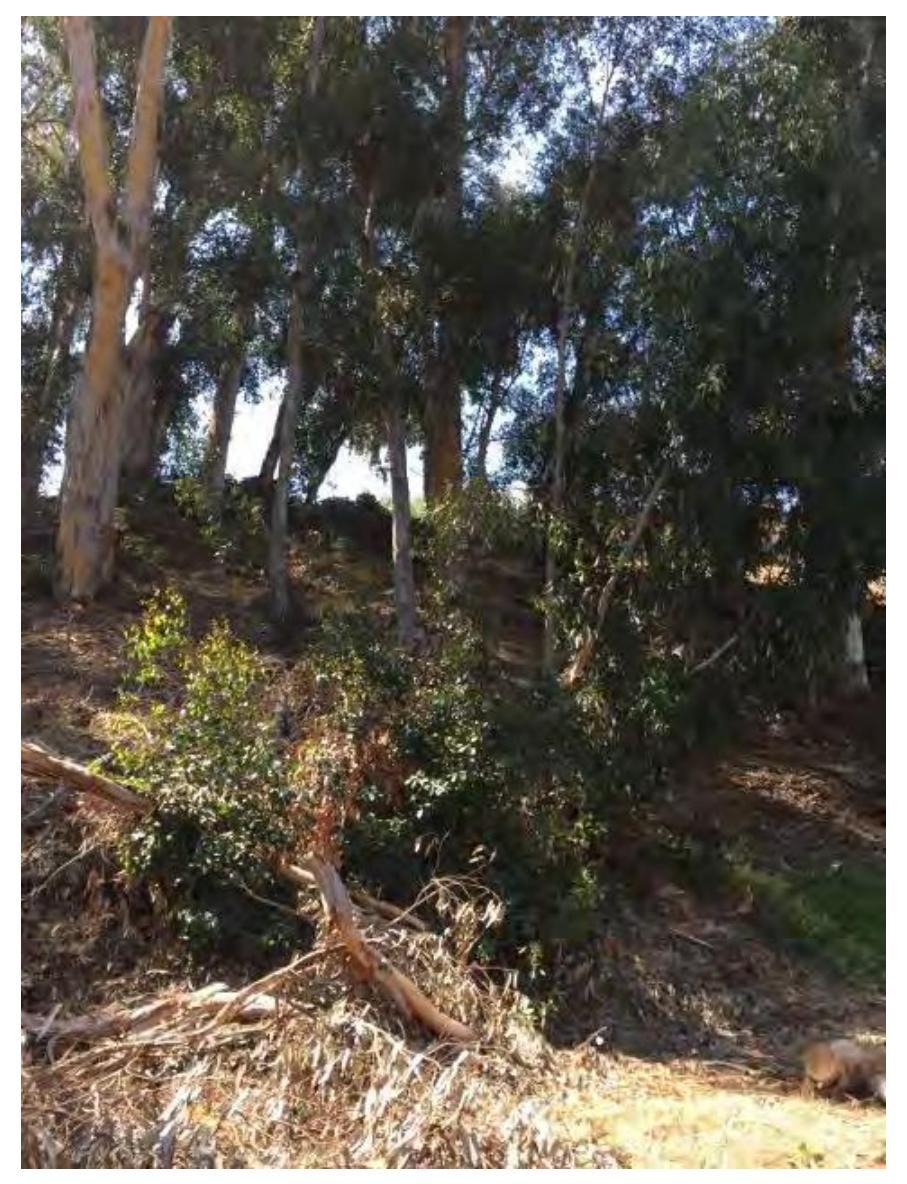
Photograph 78 – View of damage stumped sprout from recent large limb failure

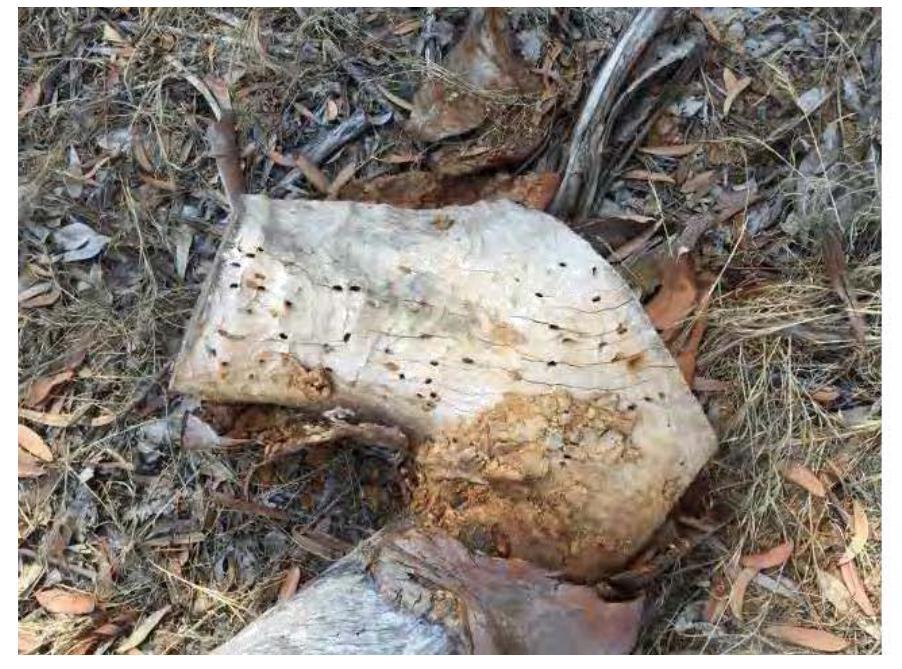
Photograph 88 – View of recent failure with long horned beetle damage

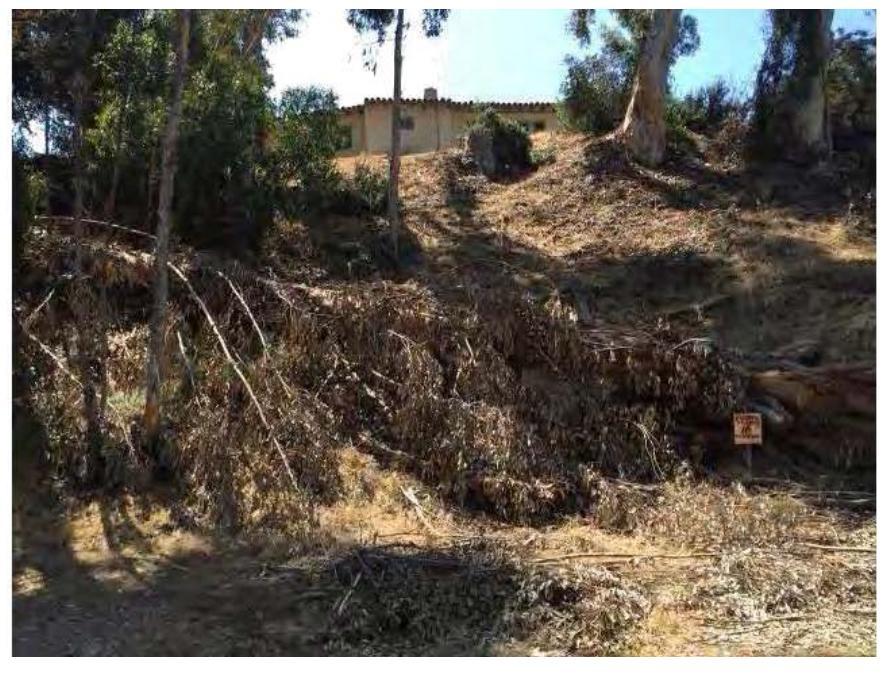
Photograph 89 – View of recent tree failure
