REPORT OF PRELIMINARY GEOTECHNICAL INVESTIGATION

DESSY RESIDENCE 8470 EL PASEO GRANDE LA JOLLA, CALIFORNIA

WAVE RUNUP / SEA LEVEL RISE STUDY Prepared by TerraCosta Consulting Group, Inc. Dated March 21, 2017

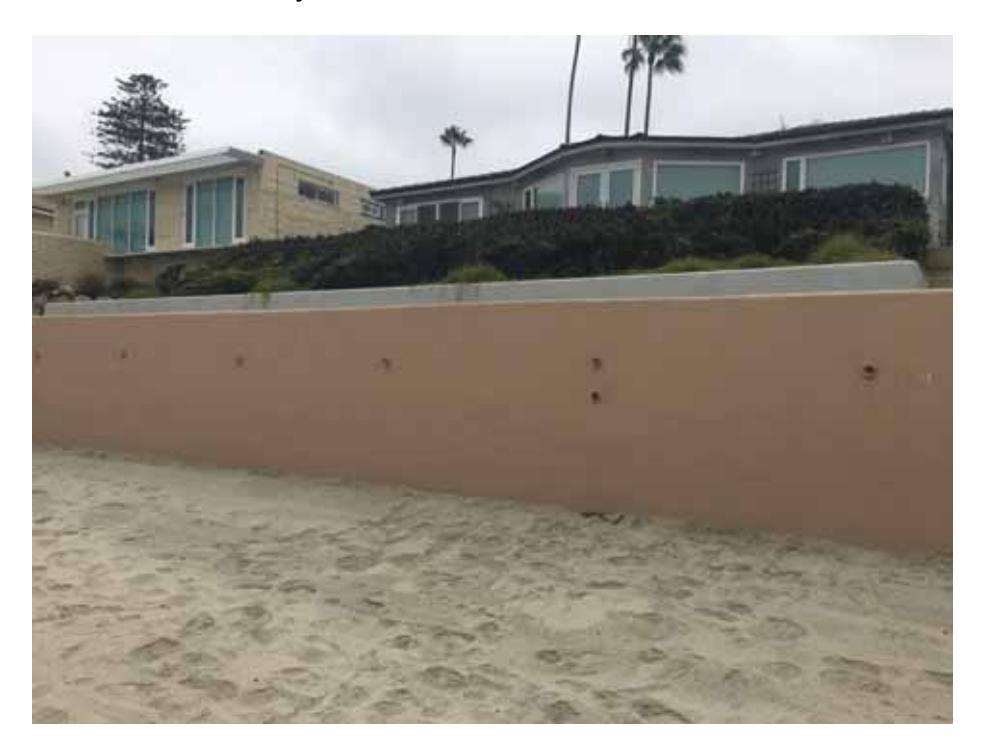
deterioration of the seawall face such as spalling or reenforcing steel rusting. During the site inspection a 3 foot long " bubble level" was placed on the seawall in several locations. The seawall is vertical with no rotated or "out of plumb" sections. The seawall appears to have been maintained over the years. The base of the seawall was observed in March of 2016 when the beach fronting the site was severely eroded. The seawall is founded into an erosion resistant bedrock formation and no signs of undercutting were observed. Figure 2 shows the significant erosion along La Jolla Shores during the 2016 winter. Figure 1 shows that the beach has fully recovered from the March 2016 eroded conditions.

Figure 1. Subject seawall in September 2017 during inspection.

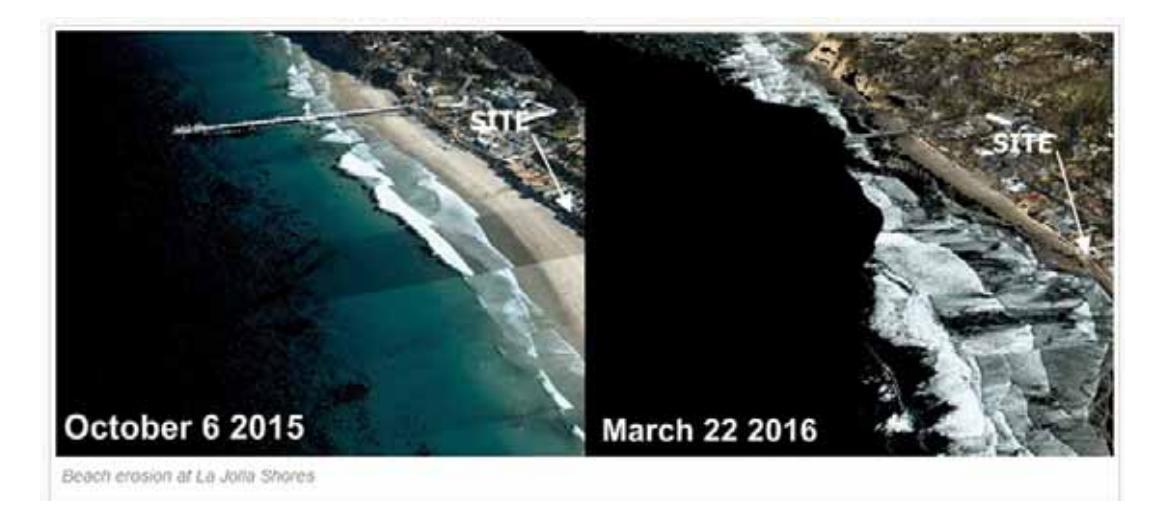
Figure 2. Significant erosion of the beach fronting the seawall in winter 2015 -2016. Note the dark bedrock formation fronting the site.

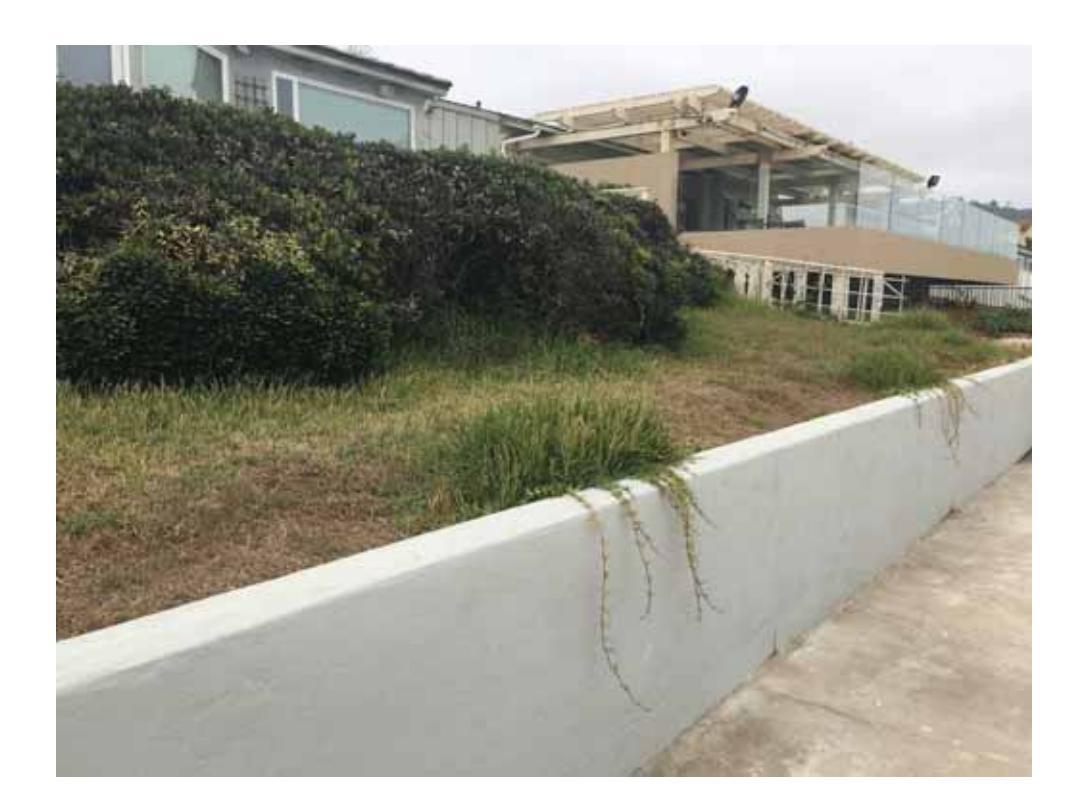
Behind the seawall is a concrete walkway and a \sim 3 feet high concrete retaining wall. This wall was also inspected during the September 2017 inspection. There are no signs of deterioration of the wall face such as spalling, water staining, or reenforcing steel rusting. During the site inspection a 3 foot long " bubble level" was placed on the wall in several locations. The wall is vertical and true. The retaining wall appears to have been maintained over the years. Figure 3 shows the retaining wall during the site inspection.

Figure 3. Retaining wall on the landward side of the walkway during inspection.
