# **Biological Technical Report Addendum**

## **Maple Canyon—Restoration Phase 1 (H176828) Site Development Permit**

**Development Services Department  
Project Number 517439**

**Prepared for  
City of San Diego  
Department of Public Works**

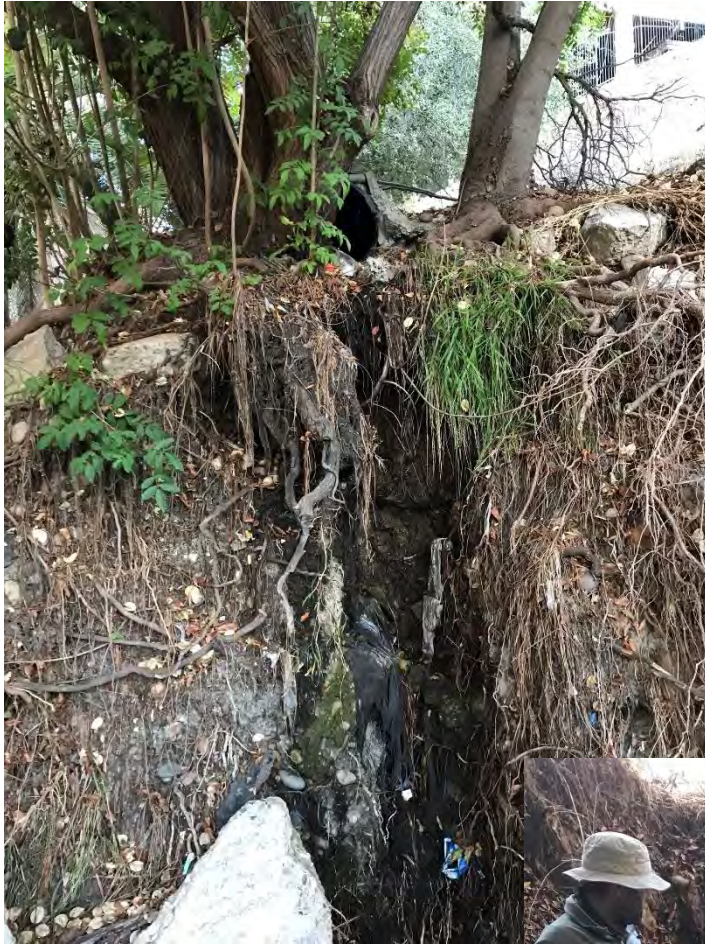
**Photo 1.3:** The broken corrugated plastic SD pipe opening is visible at the base of the tree trunks (upper middle of photo). Water has carved a large hole in the canyon floor.

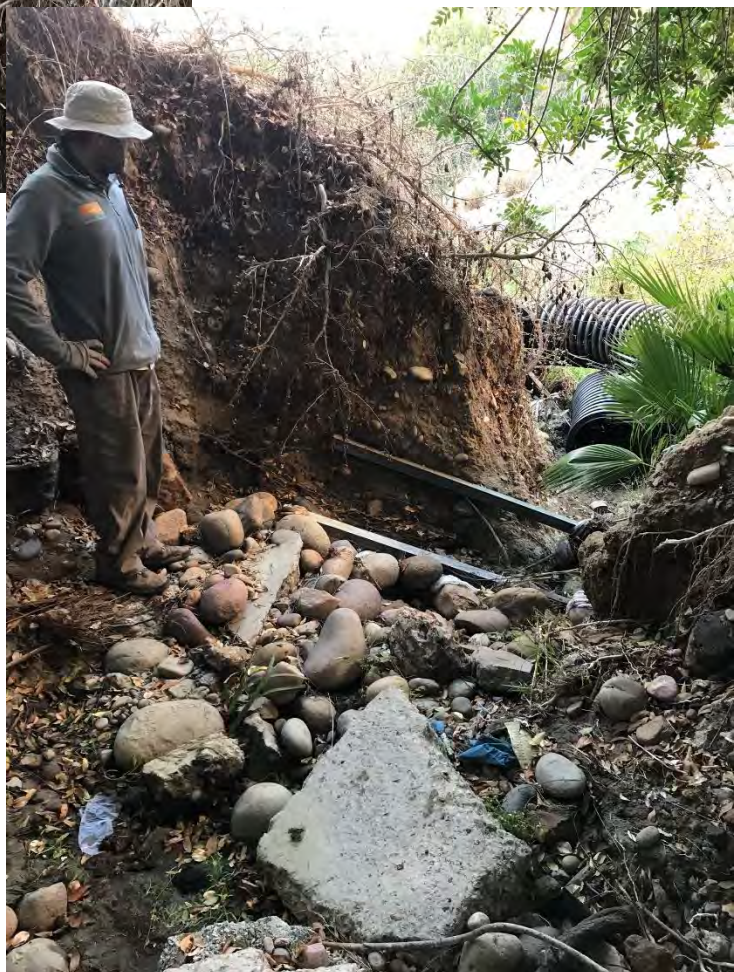
**Photo 1.4:** The erosional hole that has been carved by the broken pipe. Debris including pieces of broken pipe were visible.

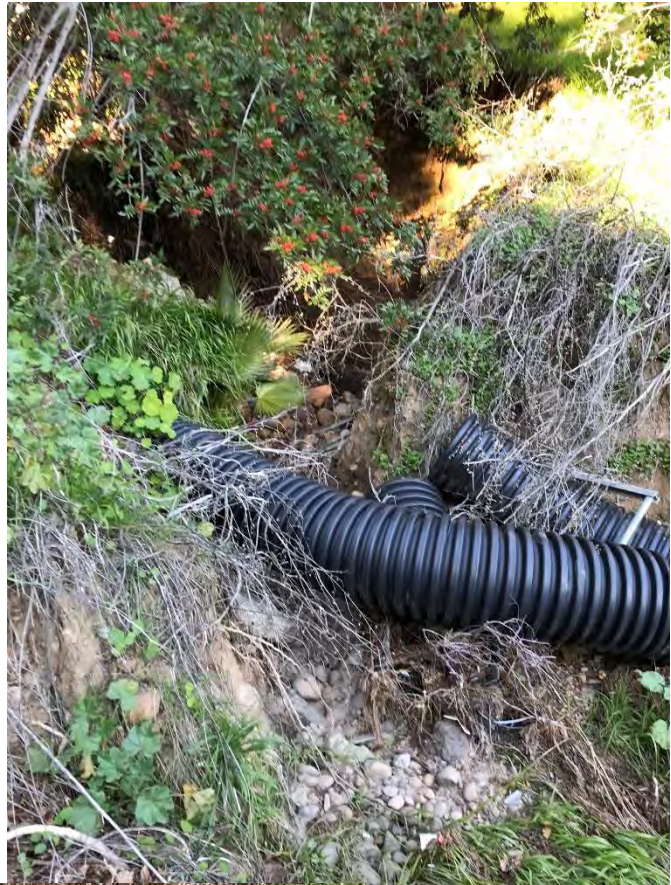
**Photo 1.5:** Chaotic flow and storm drain debris below the broken pipe.

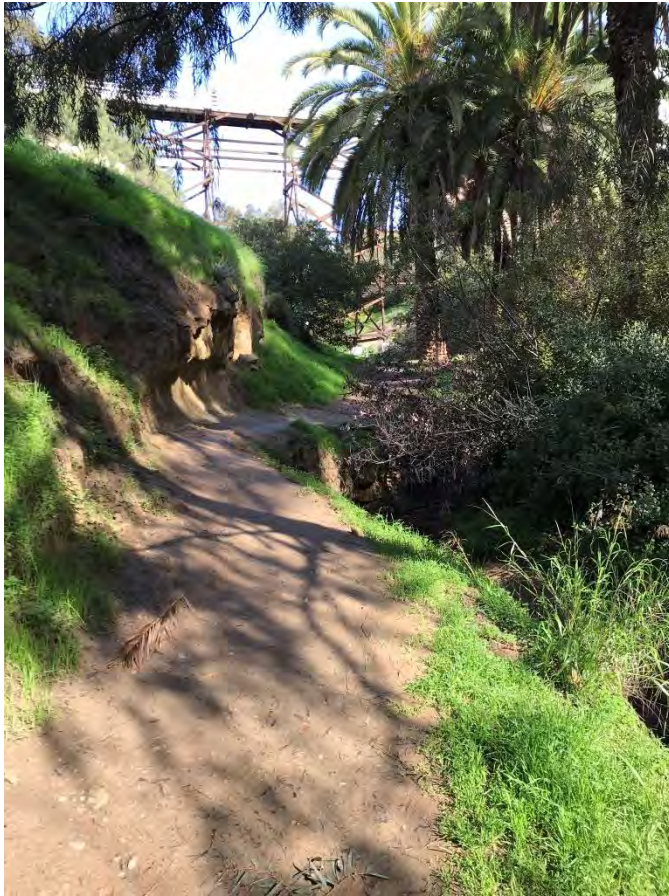
**Photo 1.9:** Looking north up canyon past the Canary Island palms in Photo 1.8, with the Quince Street Pedestrian Bridge in the background. The drainage is undermining the soil beside the trail and will soon cause the collapse of the trail in this section.

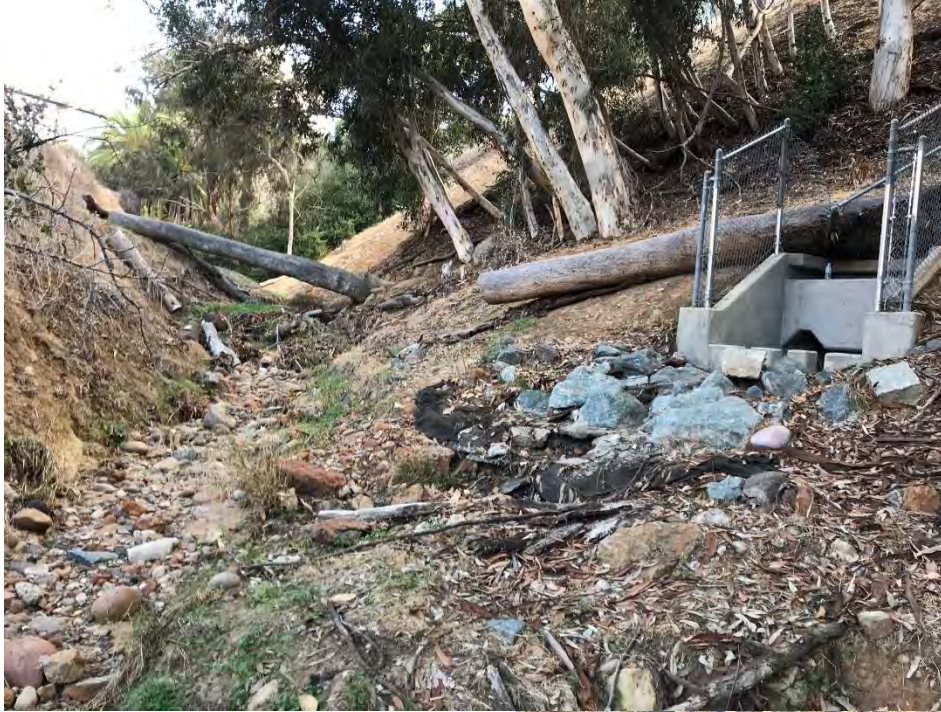
**Photo 1.11:** Existing outfall that will be replaced.

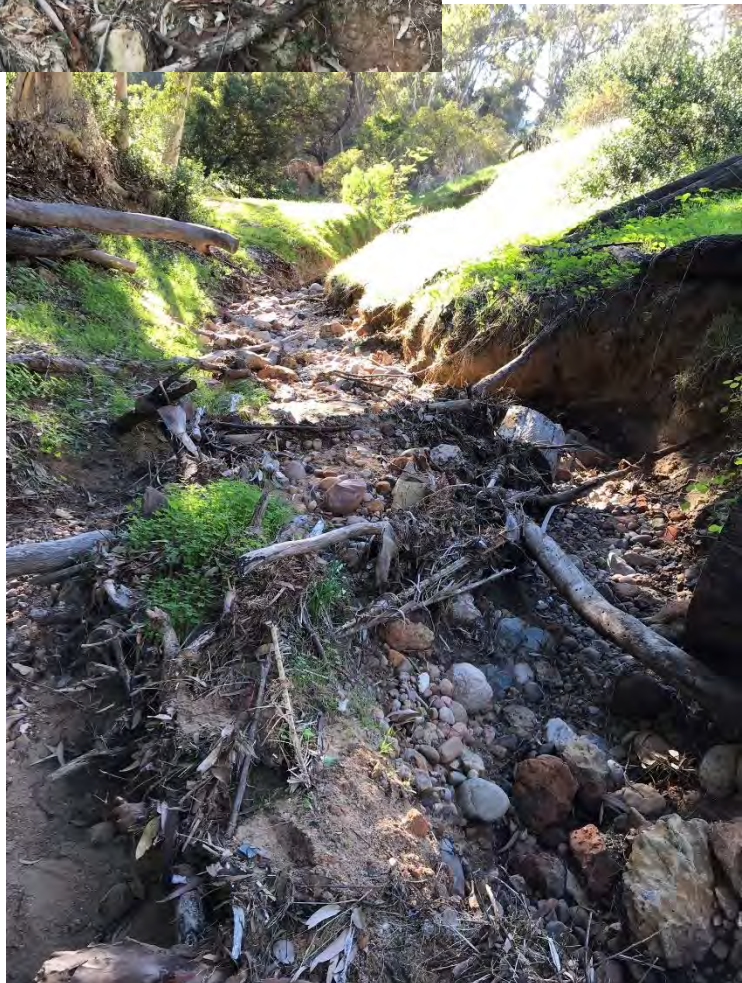
**Photo 1.12:** looking downstream from the outfall area in Photo 1.11 with the widening creek and evidence of recent bank erosion and collapse.

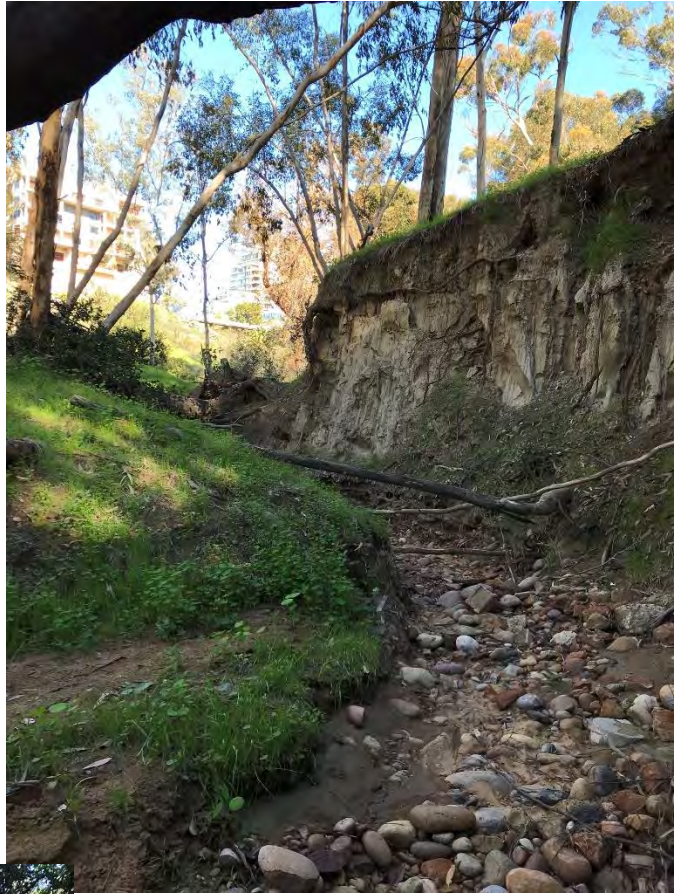
**Photo 1.13:** Looking upstream south of Photo 1.12 at eroded face of bank which has formed from water undermining bank at the base and the soil above collapsing into the creek which carries the material away.

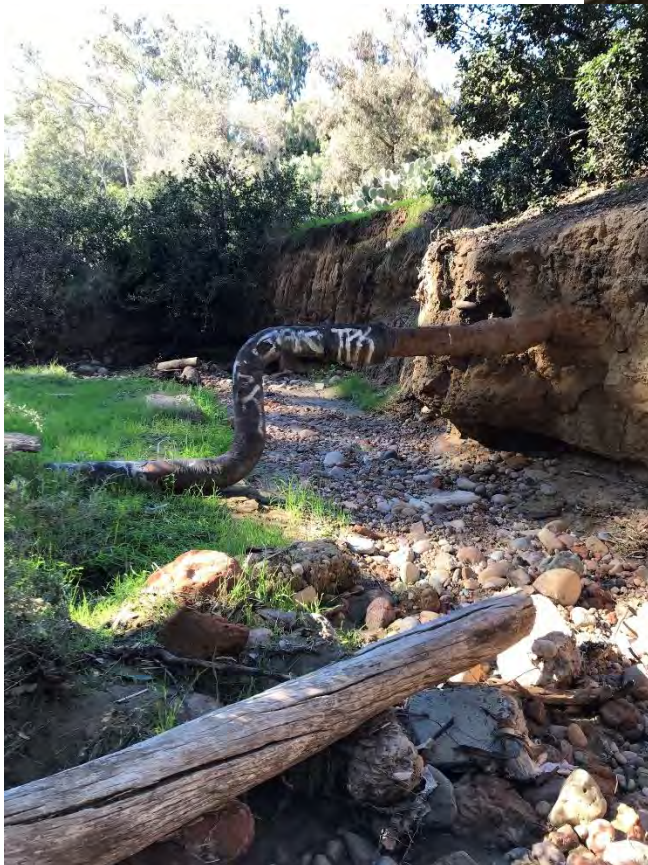
**Photo 1.14:** Looking south from 1.13 at location where creek has eroded soil that supported this sewer line.

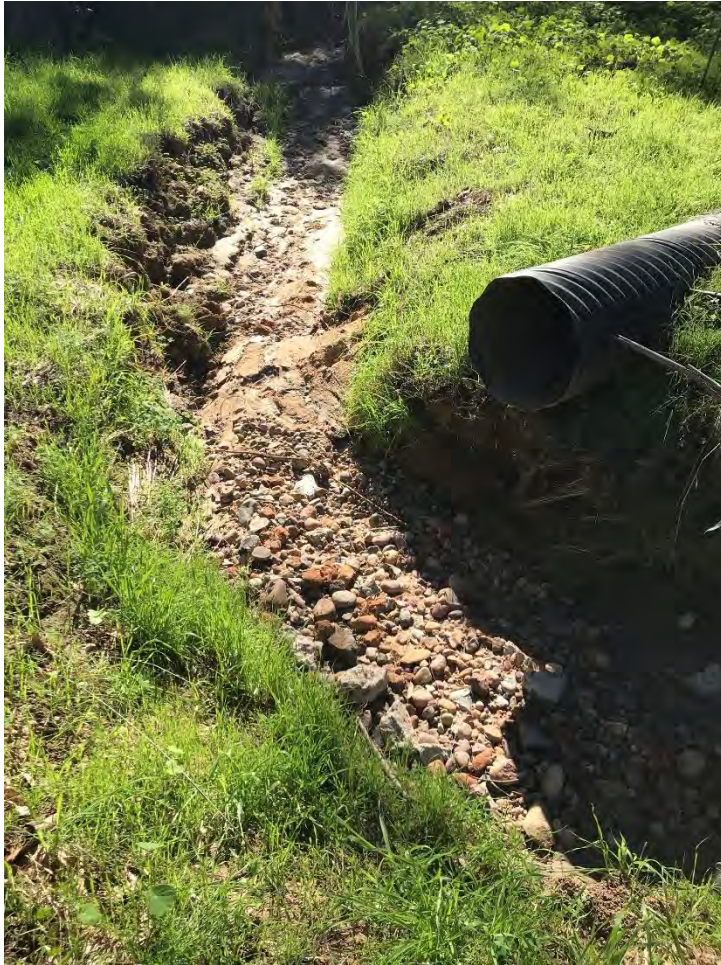
**Photo 1.18:** A CMP, presumably from an SD placed to put water into the creek downstream of the trail crossing. The CMP is titled up so that water does not flow freely.

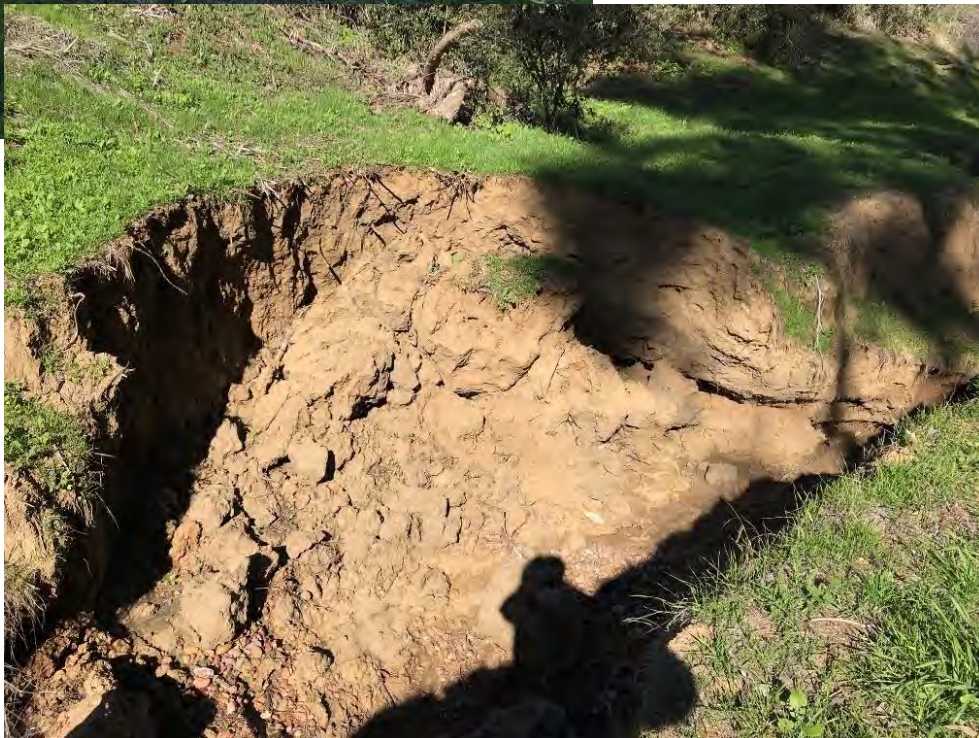
**Photo 1.21:** Collapsing banks in this section of the creek.

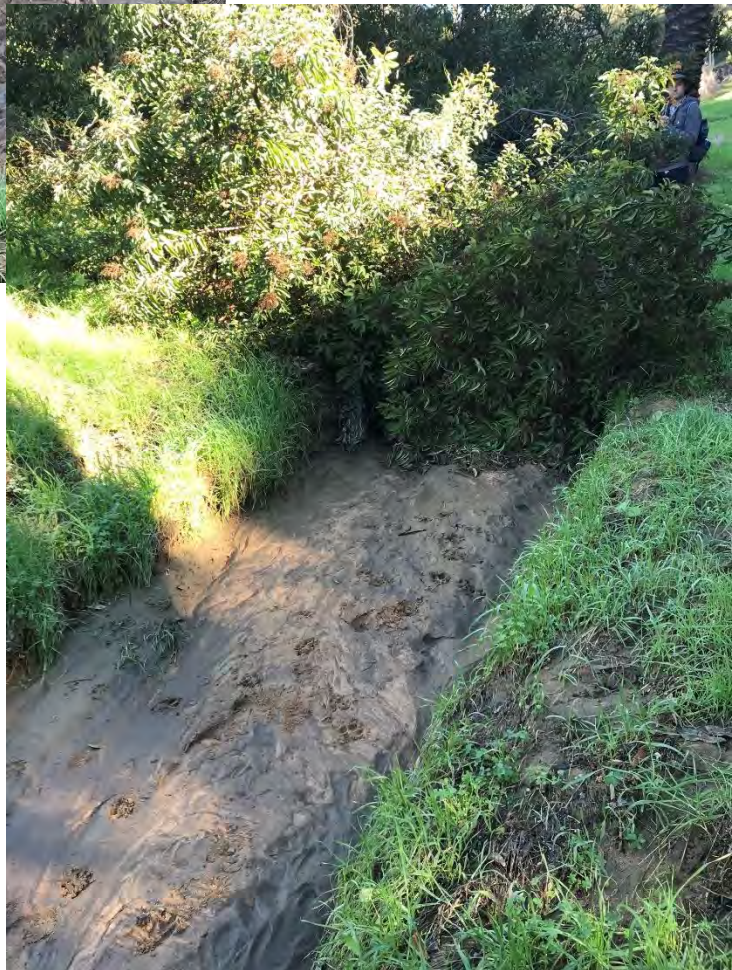
**Photo 1.27:** A laurel sumac has fallen over into the channel in where the bank has been eroded at the start of the final reach.

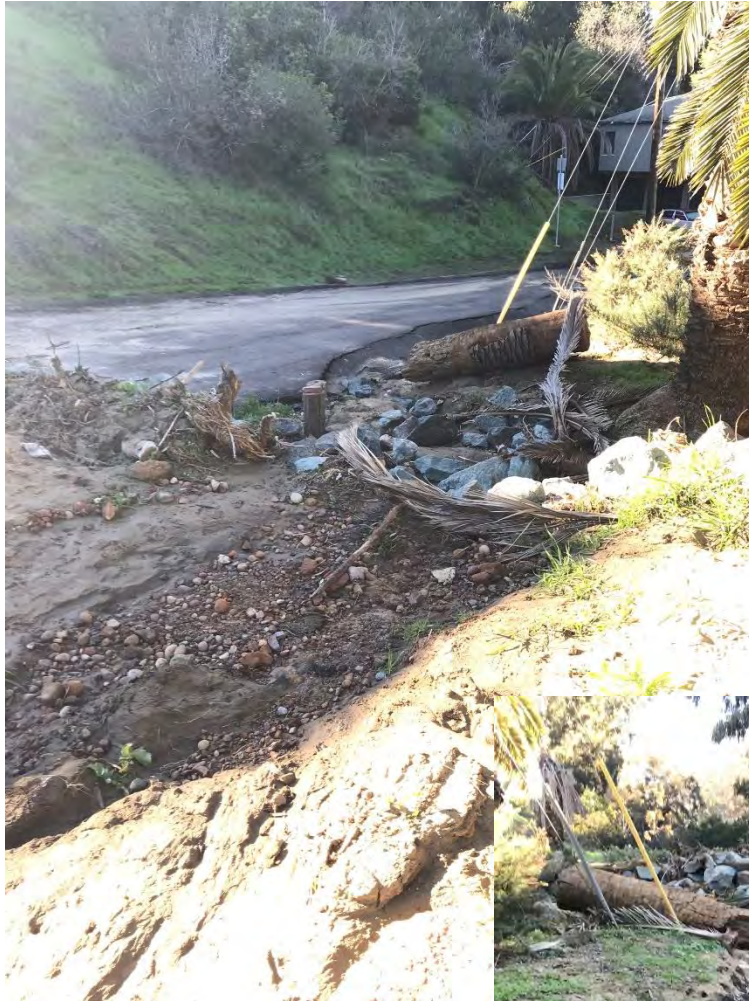
**Photo 1.30:** at the western end of the detention basin the water has overtopped and undermined the riprap.

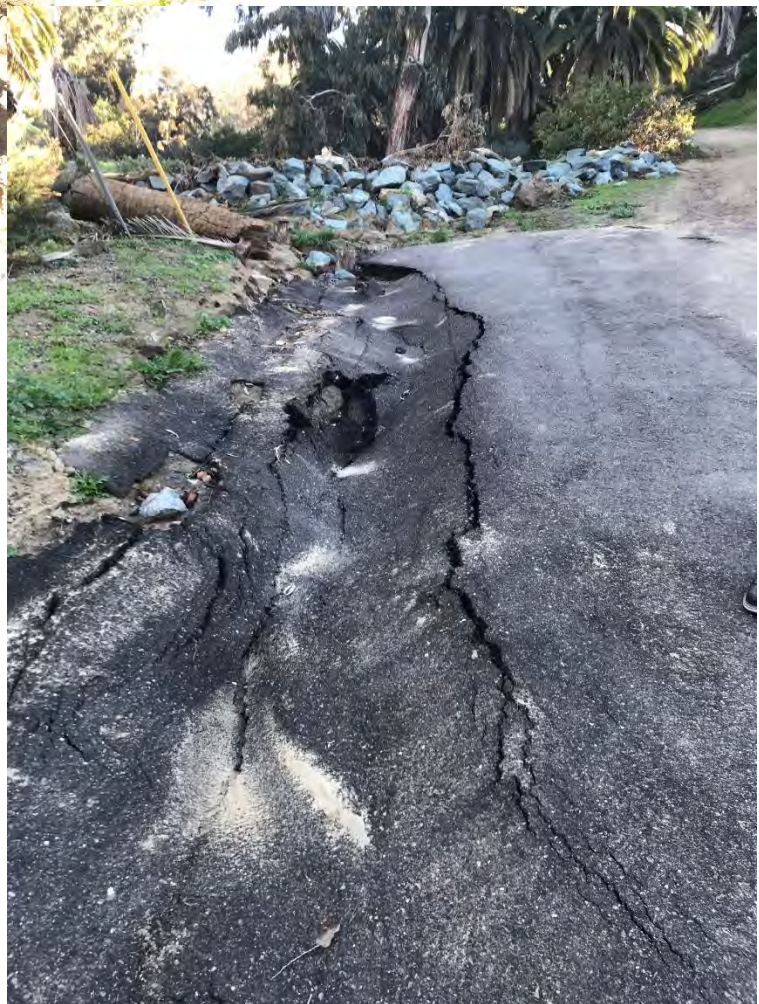
**Photo 1.31:** looking east towards the riprap holding back the sediment-filled detention basin. Water has undermined the asphalt of the controlled access at the western end of the canyon.

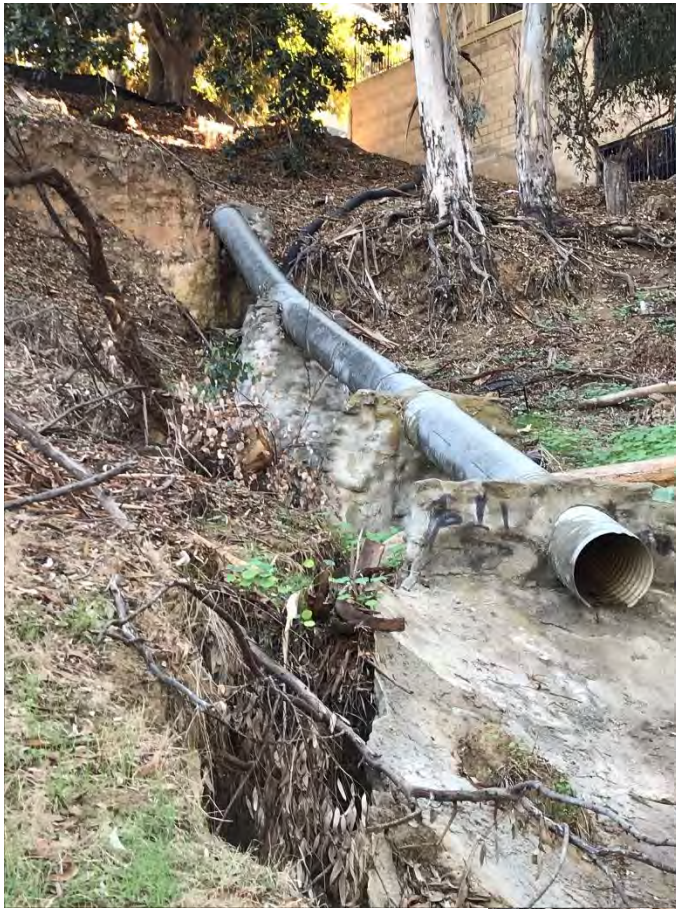
**Photo 3.1:** Close up of outfall of a CMP that is likely from street SD inlet above. Note erosion below where pipe emerges from bank indicating it is broken. As a result, most of the water bypasses the end of the pipe and the concrete that has been poured to carry the water. Cut-off walls have kept the pipe in place, but the pipe is compromised.

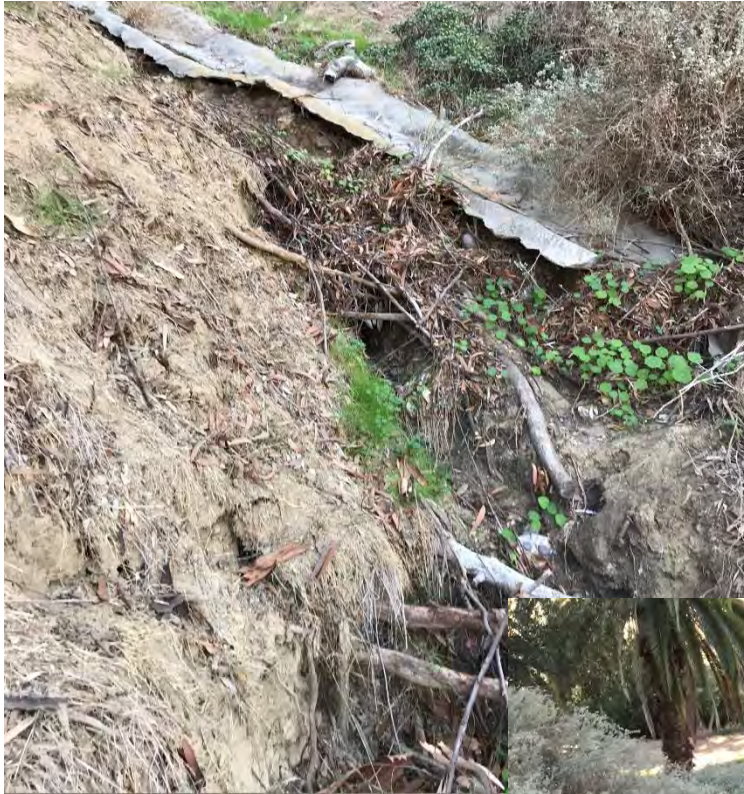
**Photo 3.3:** The end of the concrete which obviously does not carry the majority of the water from above. Water descends down in a chaotic manner beside it.
