April 13, 2021

Atlas No. 180385N Report No. 9R

Subject: Response to Comments – Geissler Engineering Proposed Residences – 7248 Encelia Drive and 7231 Romero Drive La Jolla, California

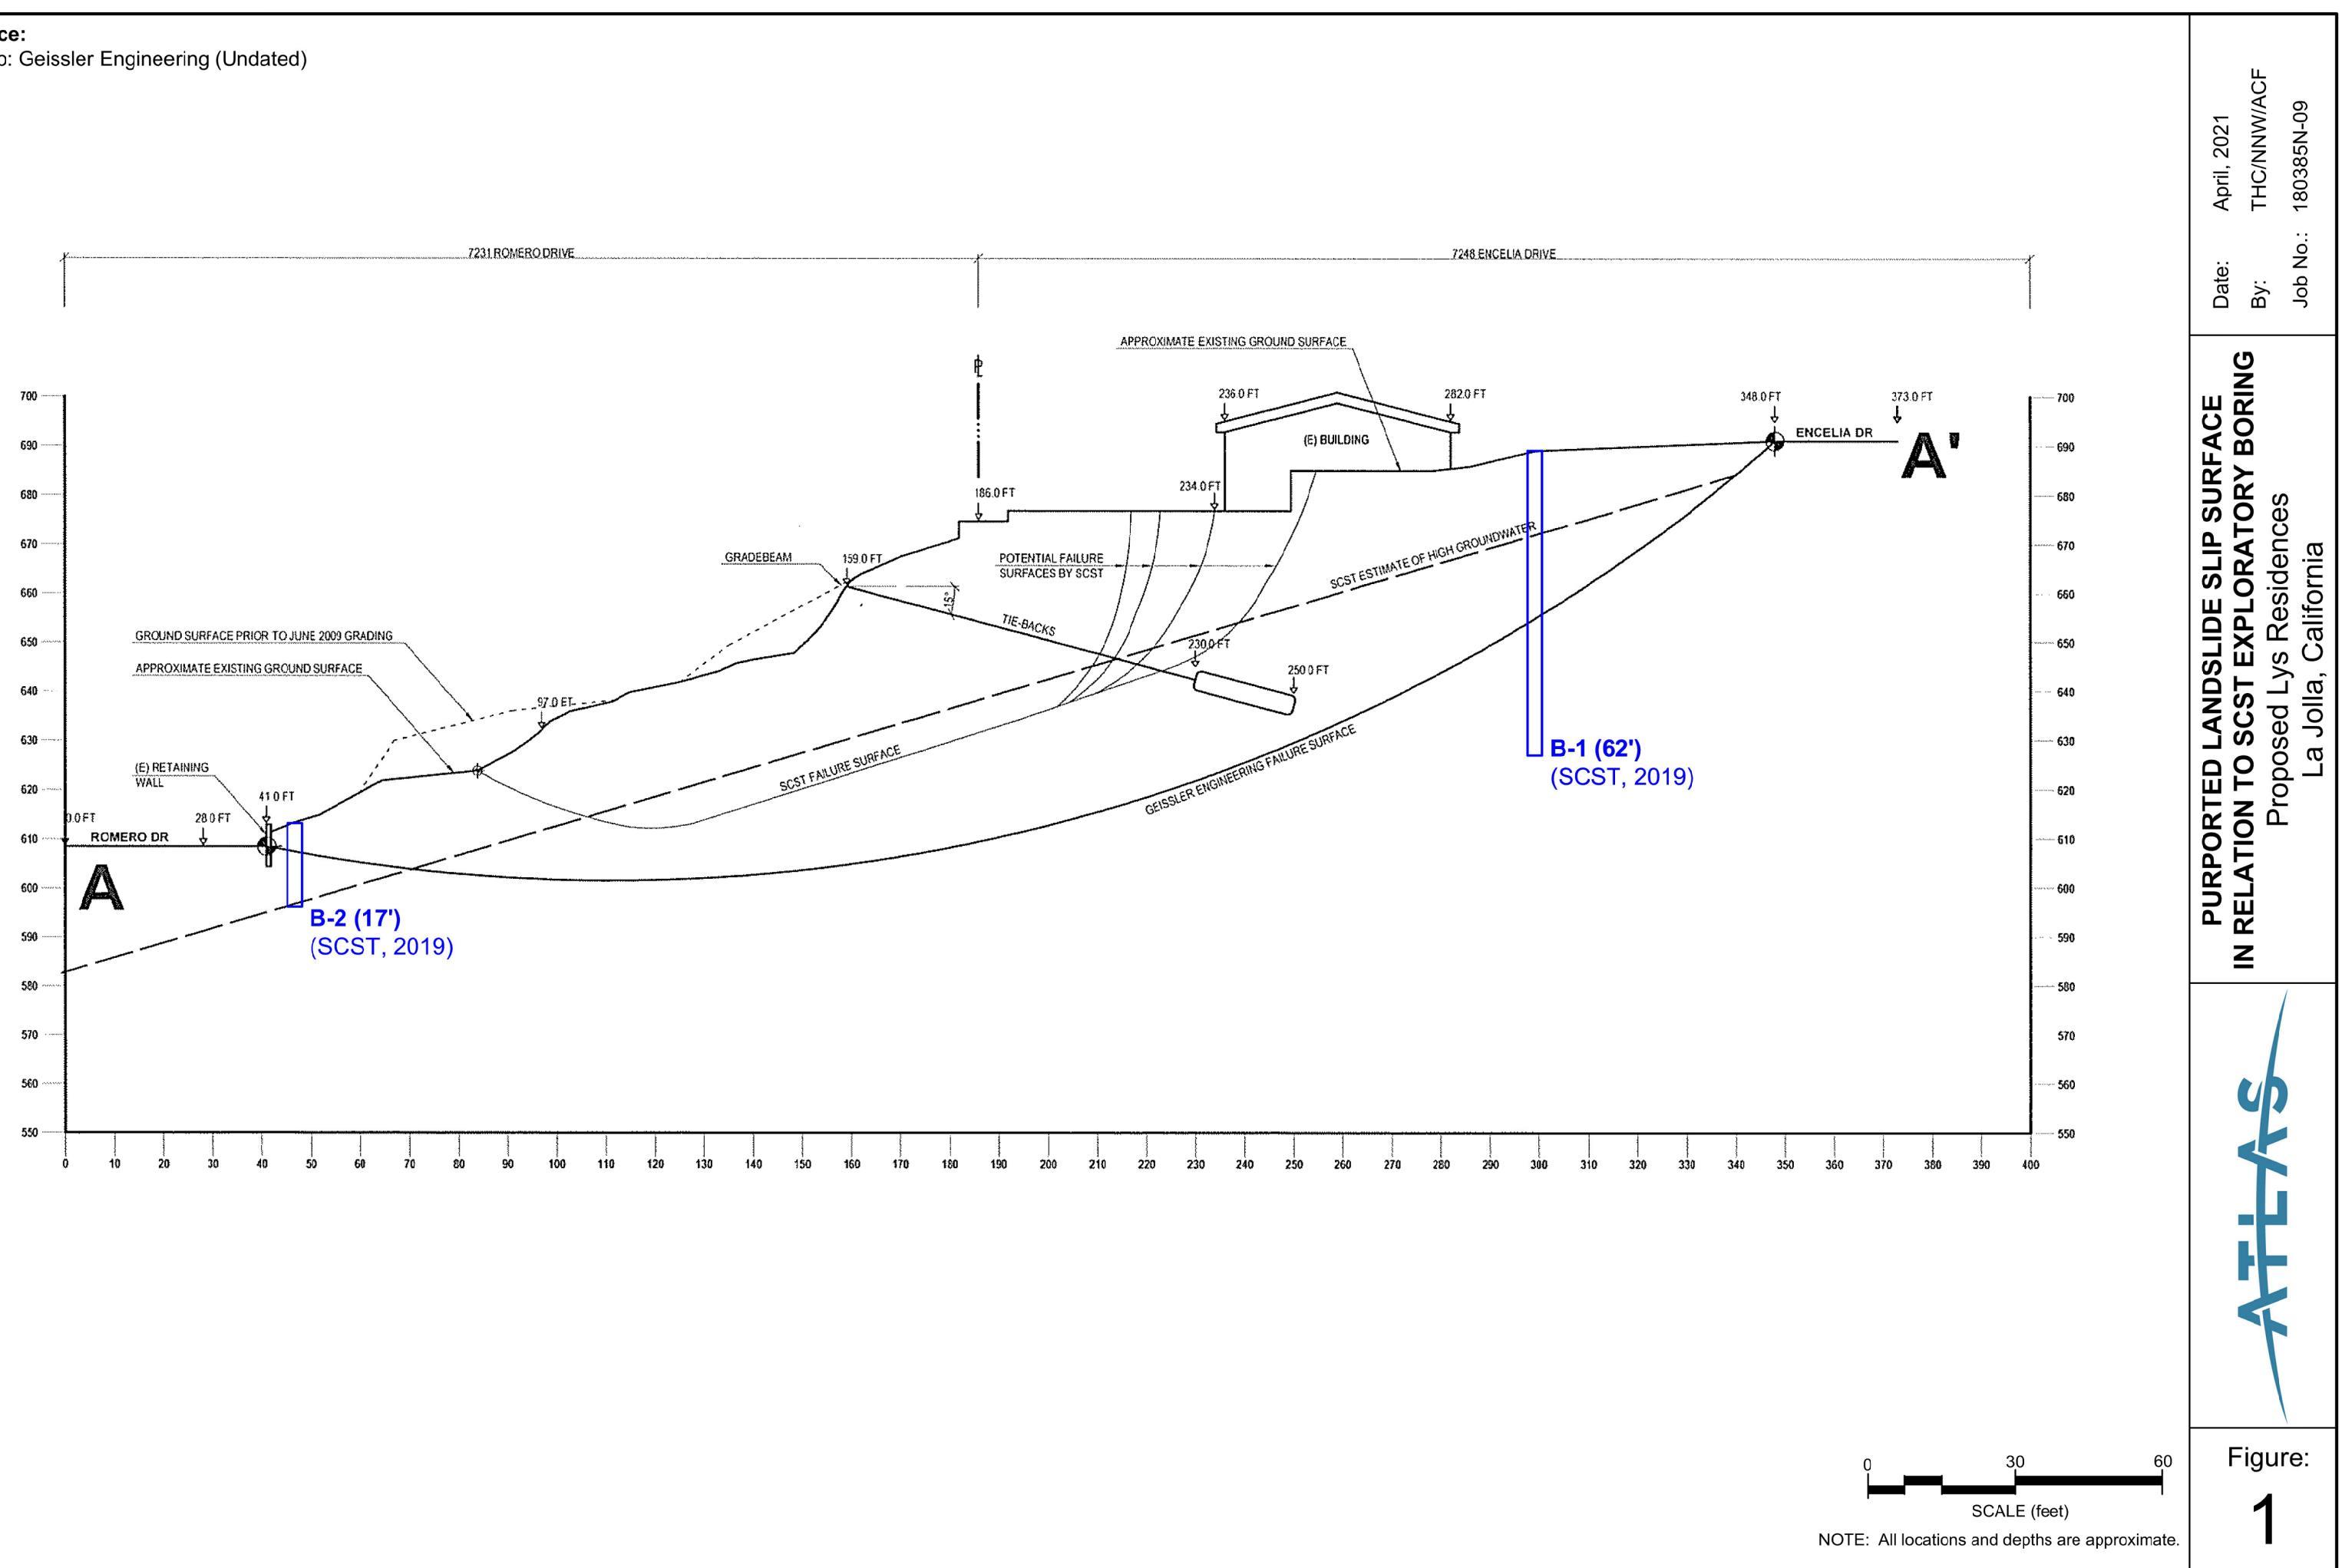
ATTACHMENT 1 REVISED FIGURES FROM THE GEOTECHNICAL REPORT

- In our report dated June 21, 2019 we included data from our Boring B-1. As noted above, this boring was emplaced specifically to address Dr. Geissler's purported "deep-seated landslide." As shown on the attached Figure 1, our 2019 Boring B-1 penetrated by at least 25 feet the landslide surface postulated by Dr. Geissler. Our geologist entered the boring and was lowered down over 60 feet into the boring to carefully assess the geologic strata and look for the postulated landslide failure zone. As noted in our log of this boring, no evidence of shear features indicative of landsliding or soil movement were observed. Further, Boring B-2 was excavated near the toe of the purported "deep-seated landslide" (Figure 1). This boring was excavated by hand to a depth of approximately 17 feet and our geologist also entered this boring to log the geologic strata. Again, we penetrated several feet below the landslide surface postulated by Dr. Geissler. Once again, no evidence of shear features indicative of landsliding or soil movement were observed. Therefore, we are unclear on a basis for this postulated landslide.

- a. "On 3 April 2019, Geissler Engineering recommended that the theoretical failure surface considered...be revised to reflect the fact that the observed failure surface is at least 15 feet deeper than shown in SCST report." Again, as noted in our Response 1, both Borings B-1 and B-2 penetrated below the "deep-seated landslide" postulated by Dr. Geissler and no shear features indicative of landsliding or soil movement were observed. Please recall that Boring B-1 penetrated approximately <u>25 feet below</u> Dr. Geissler's postulated "deep-seated landslide."

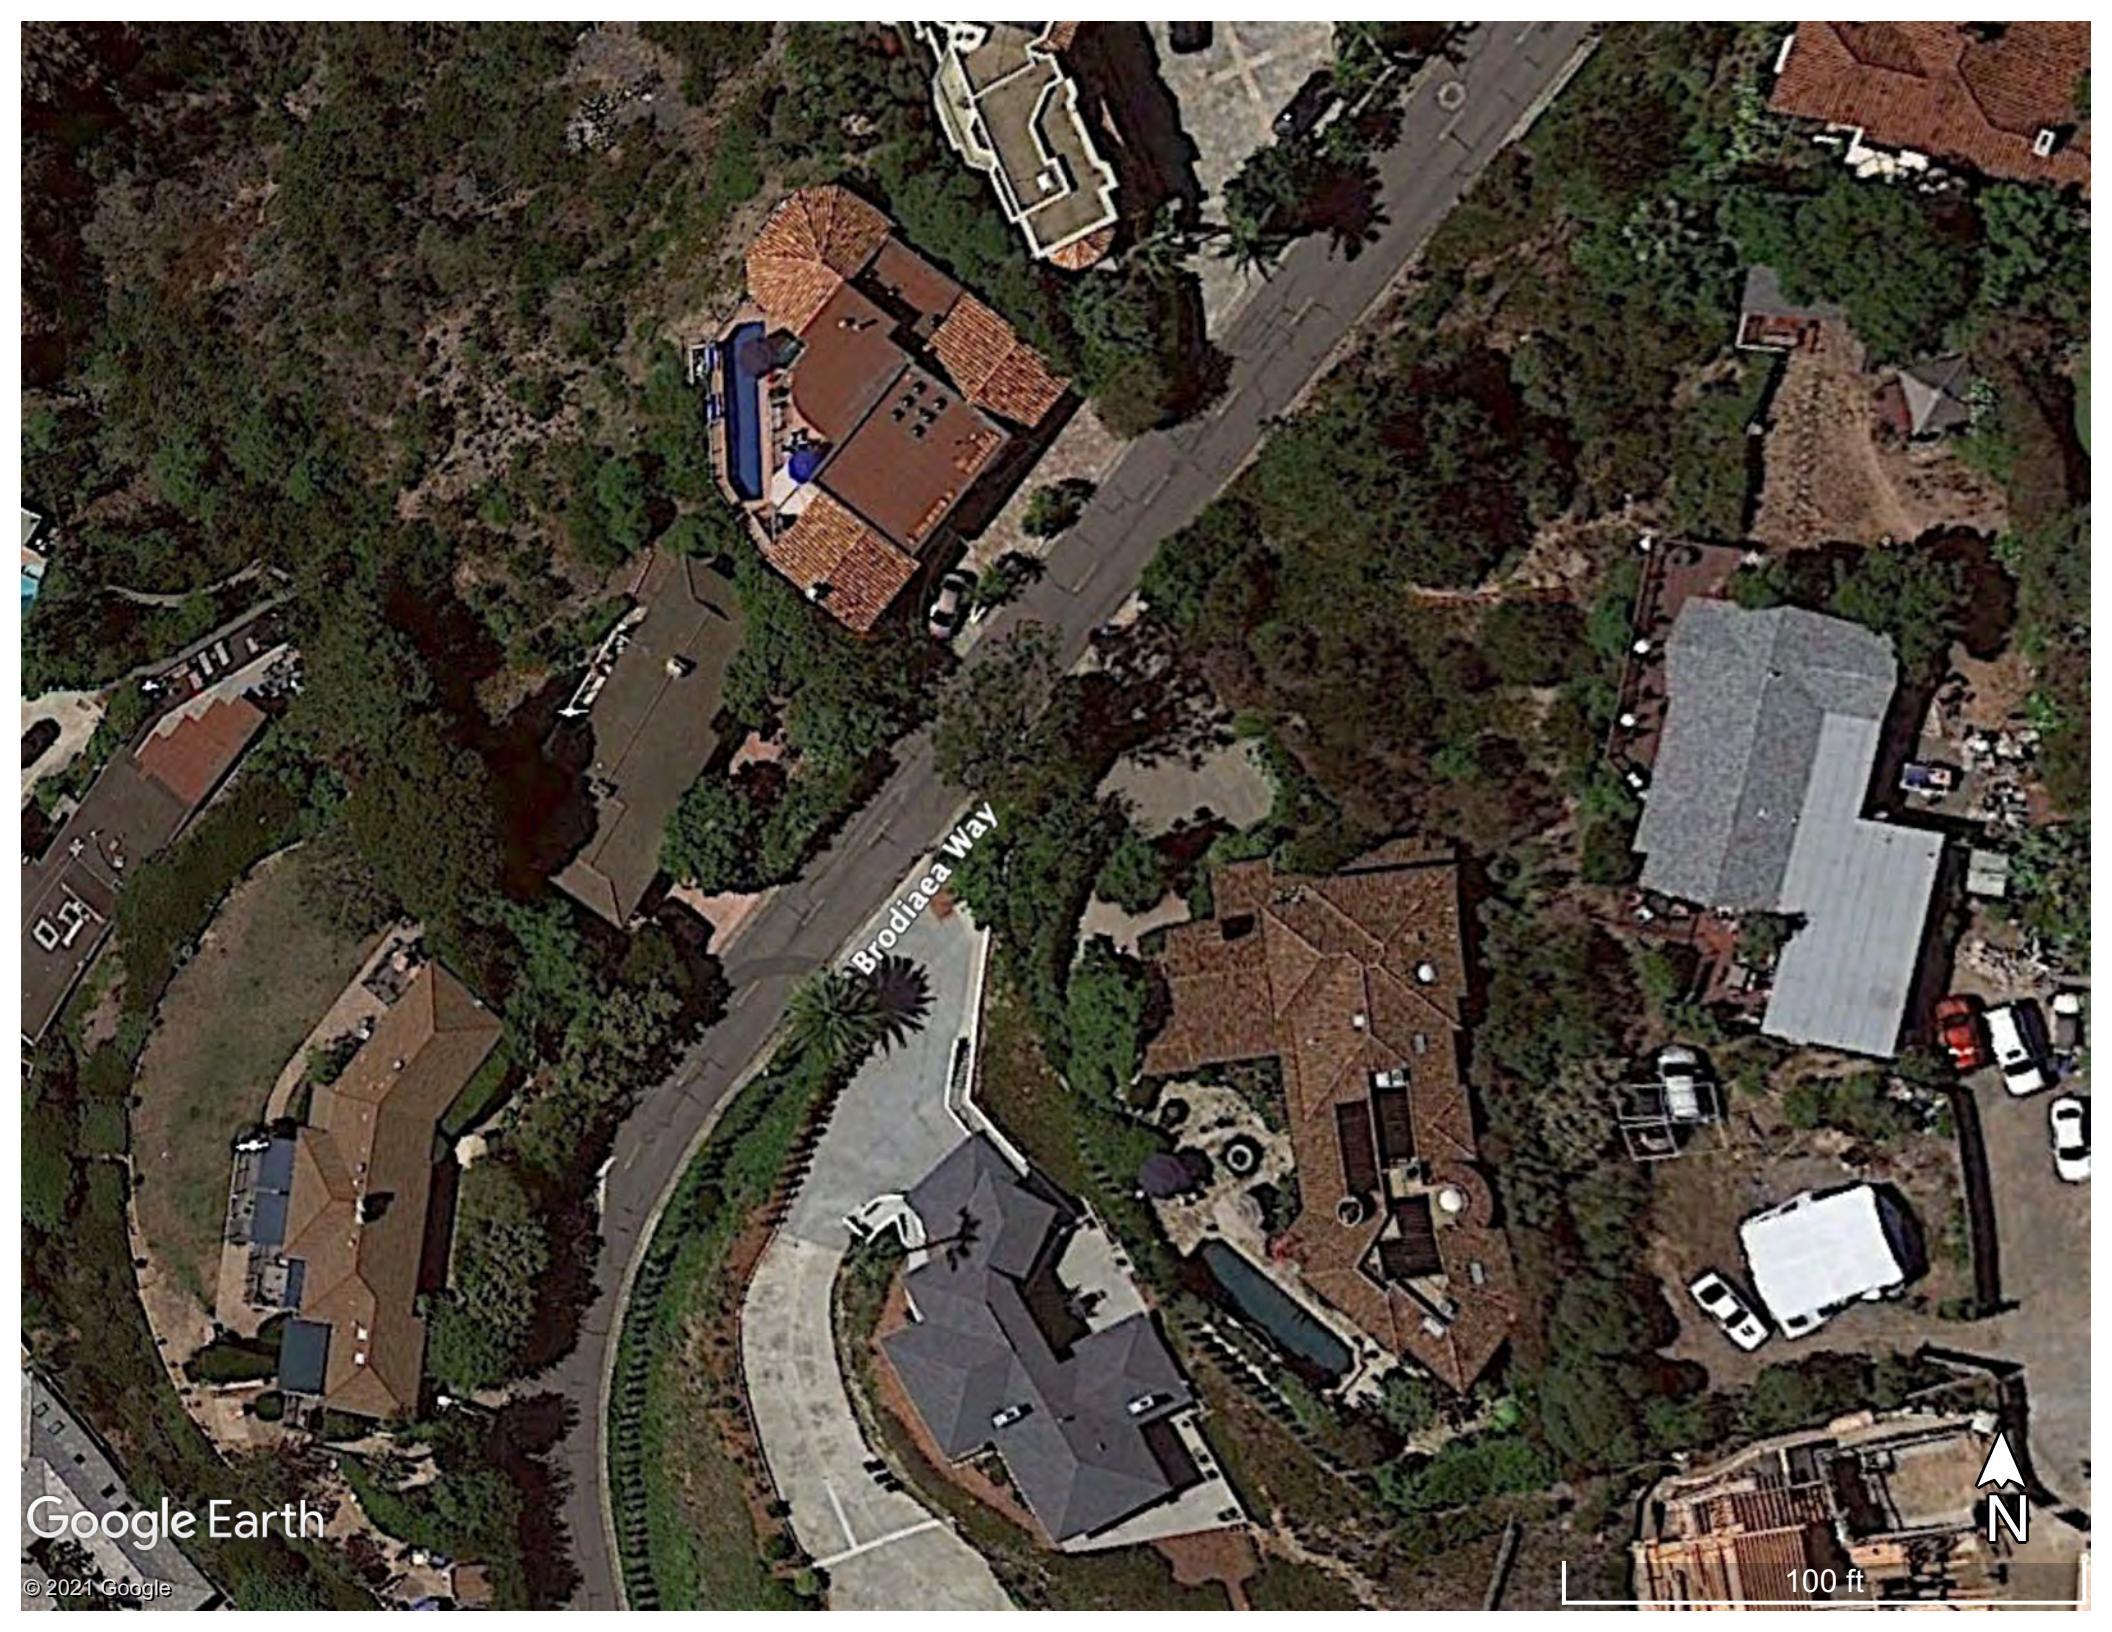
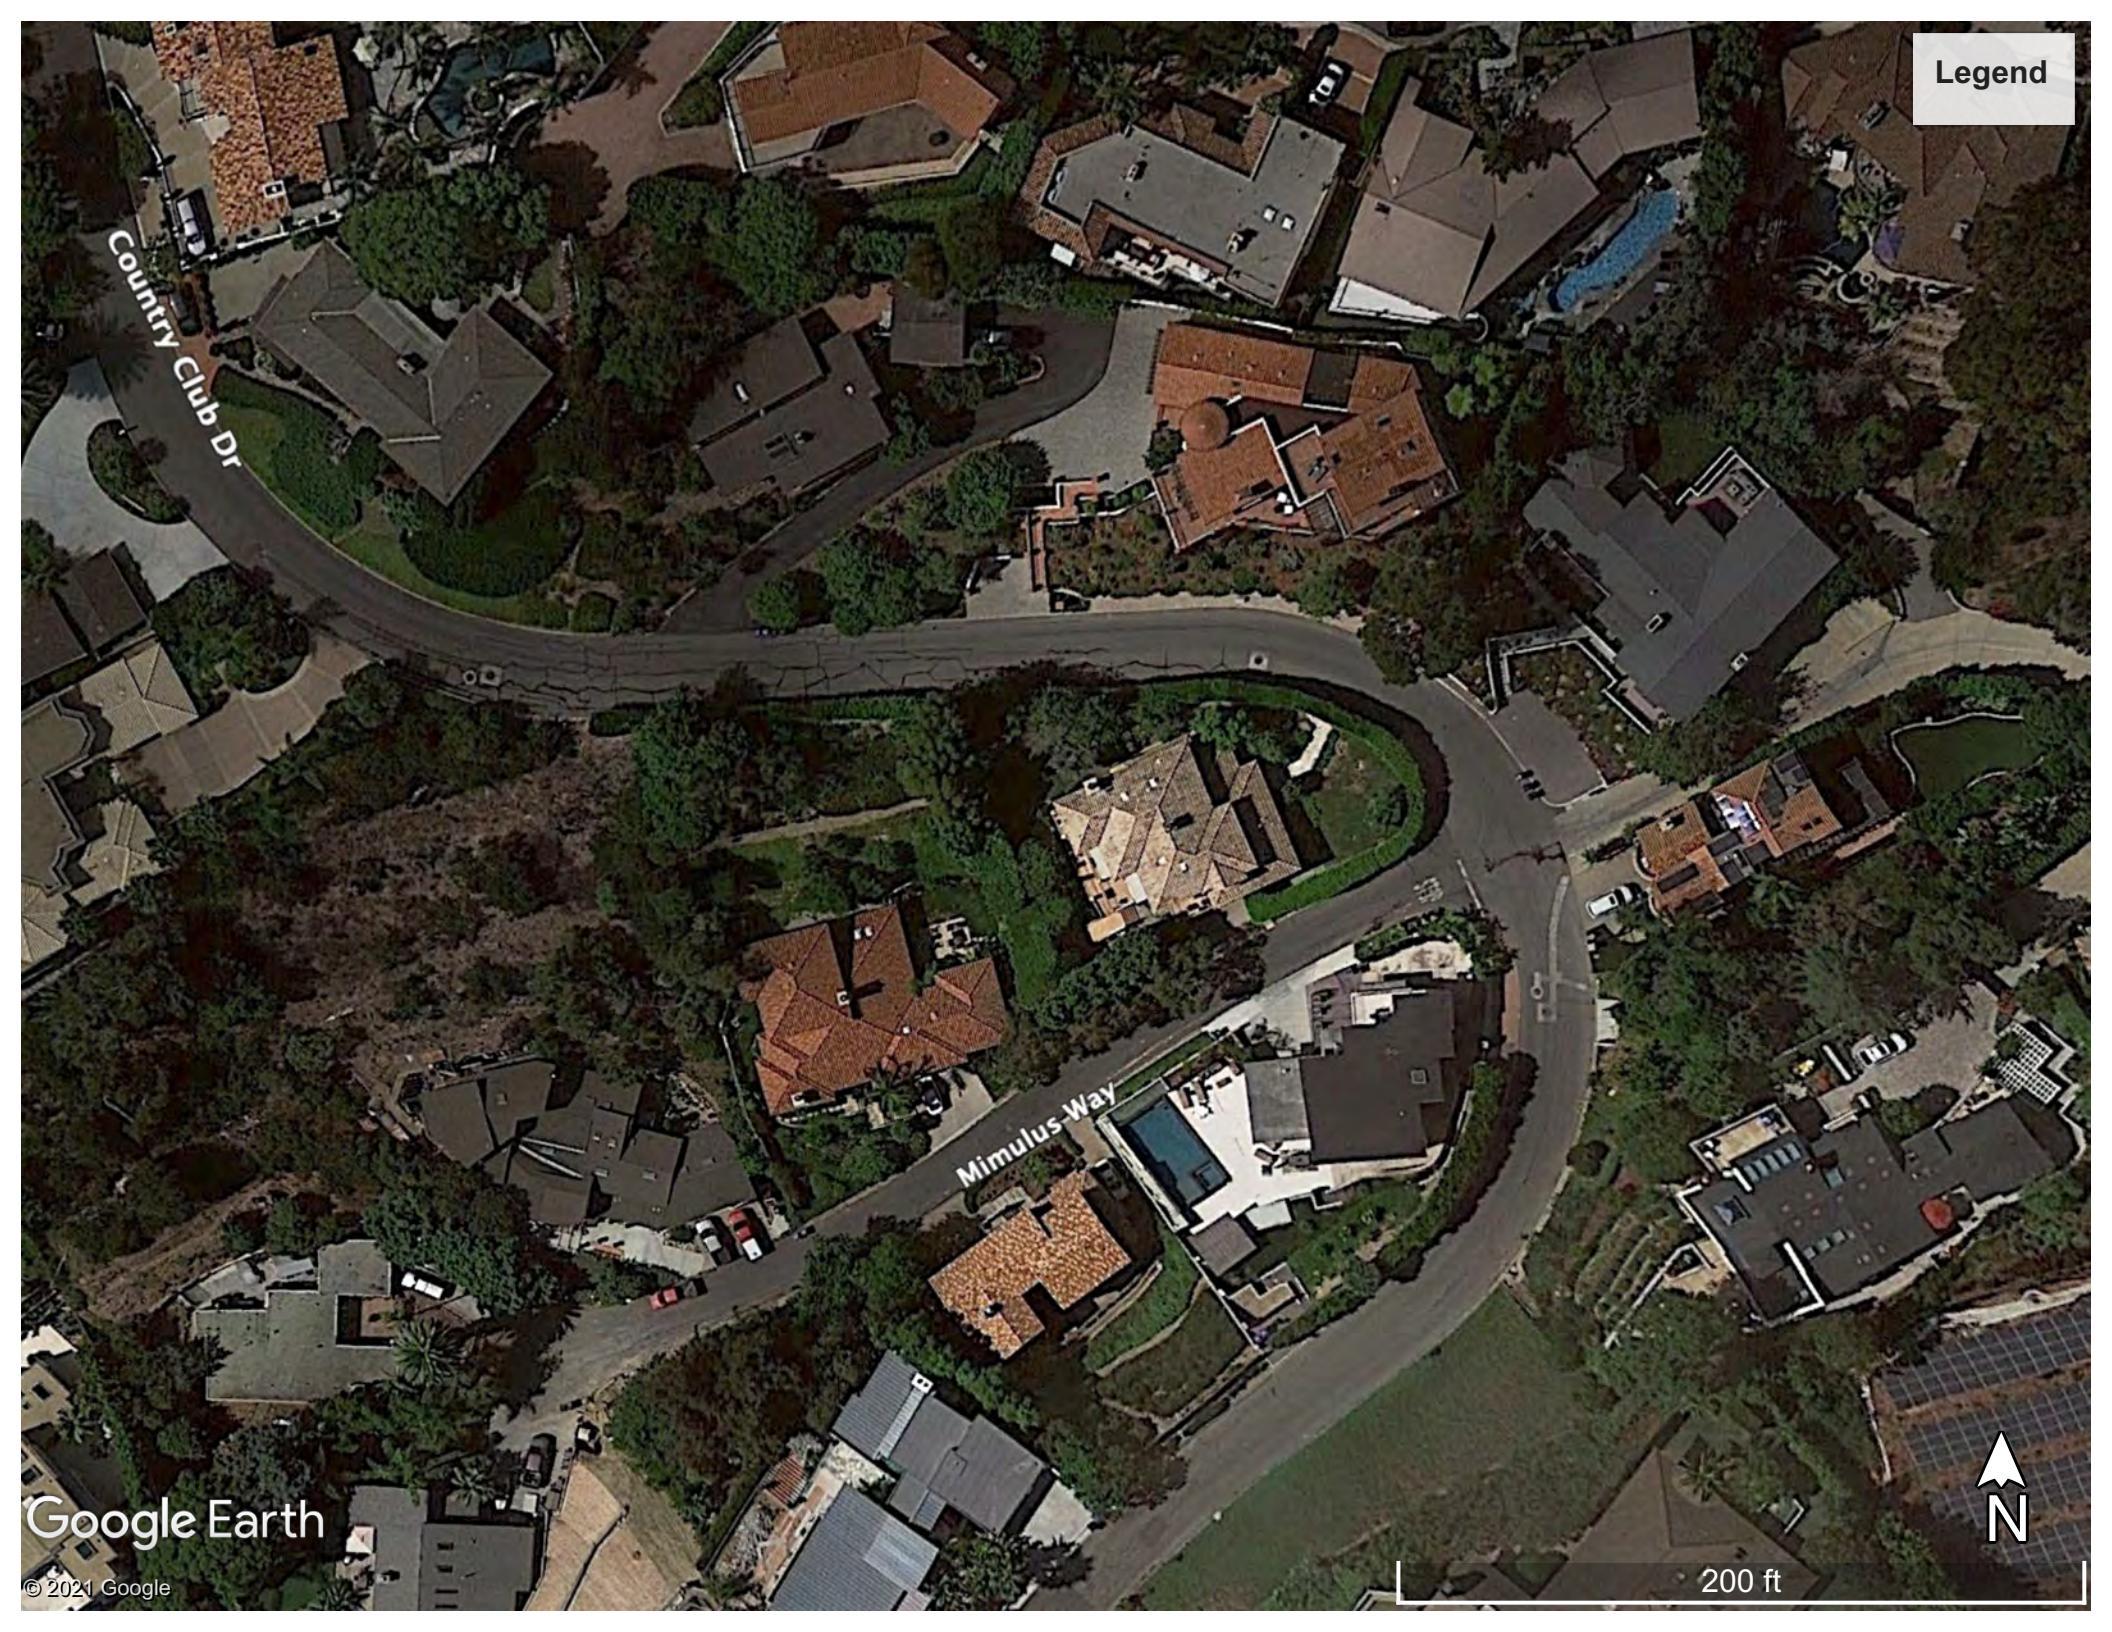
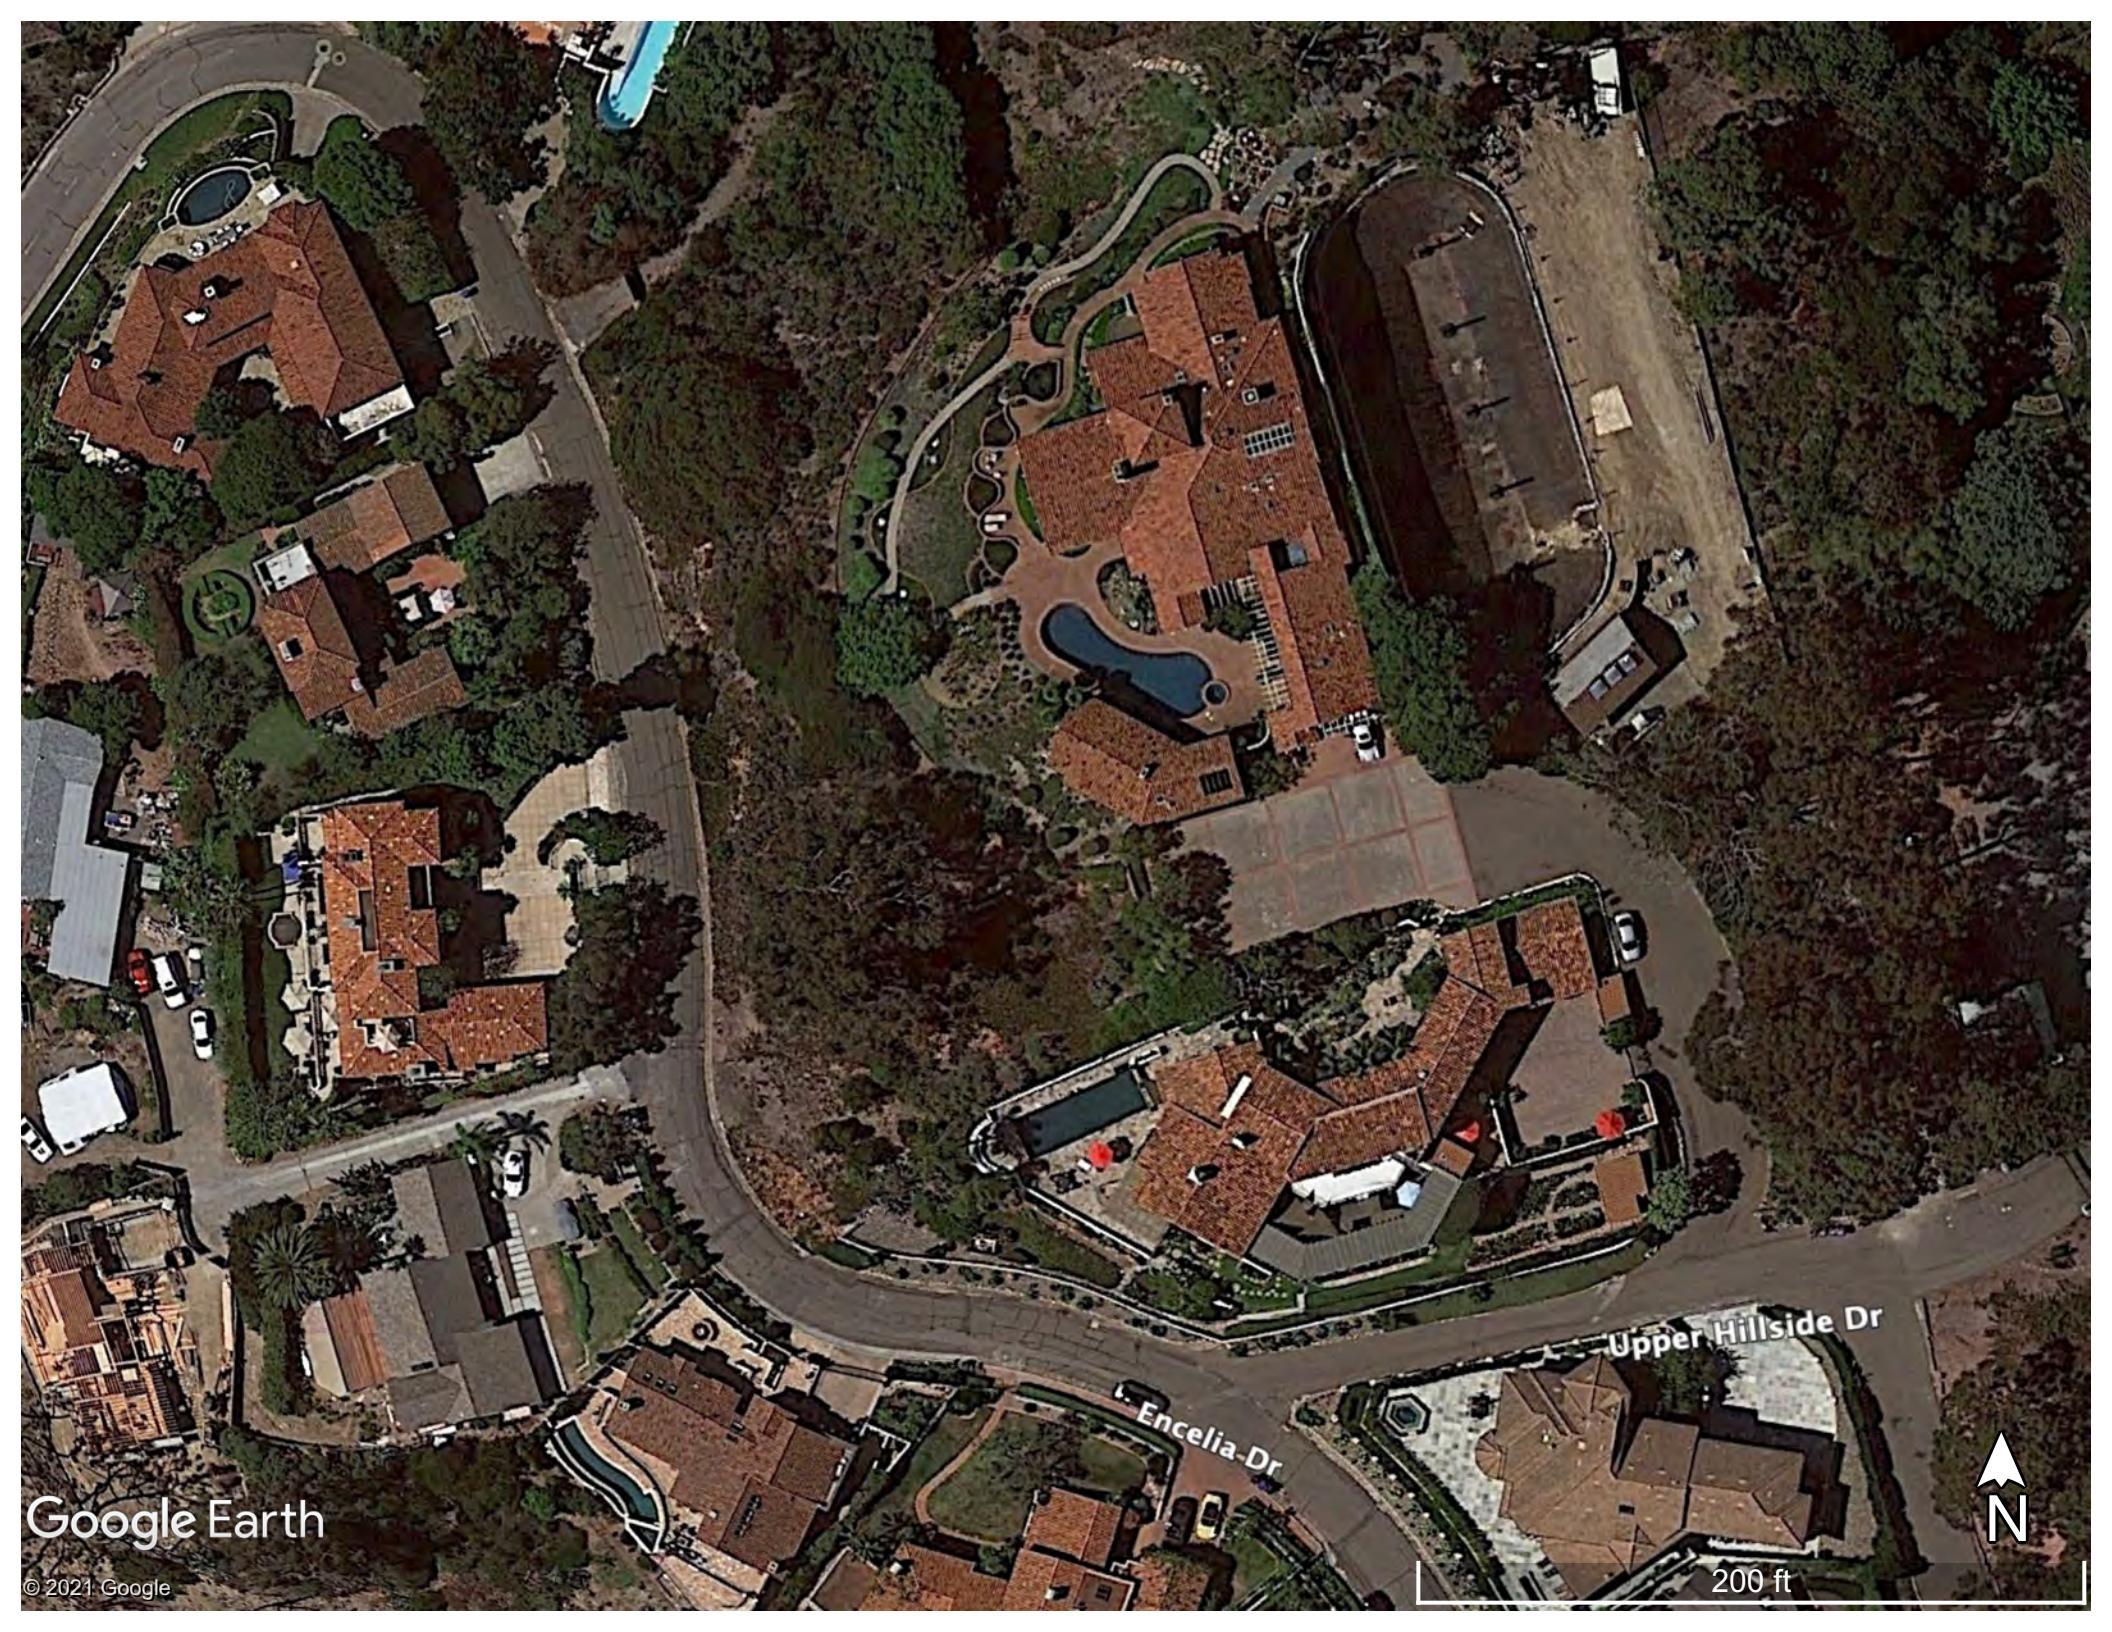
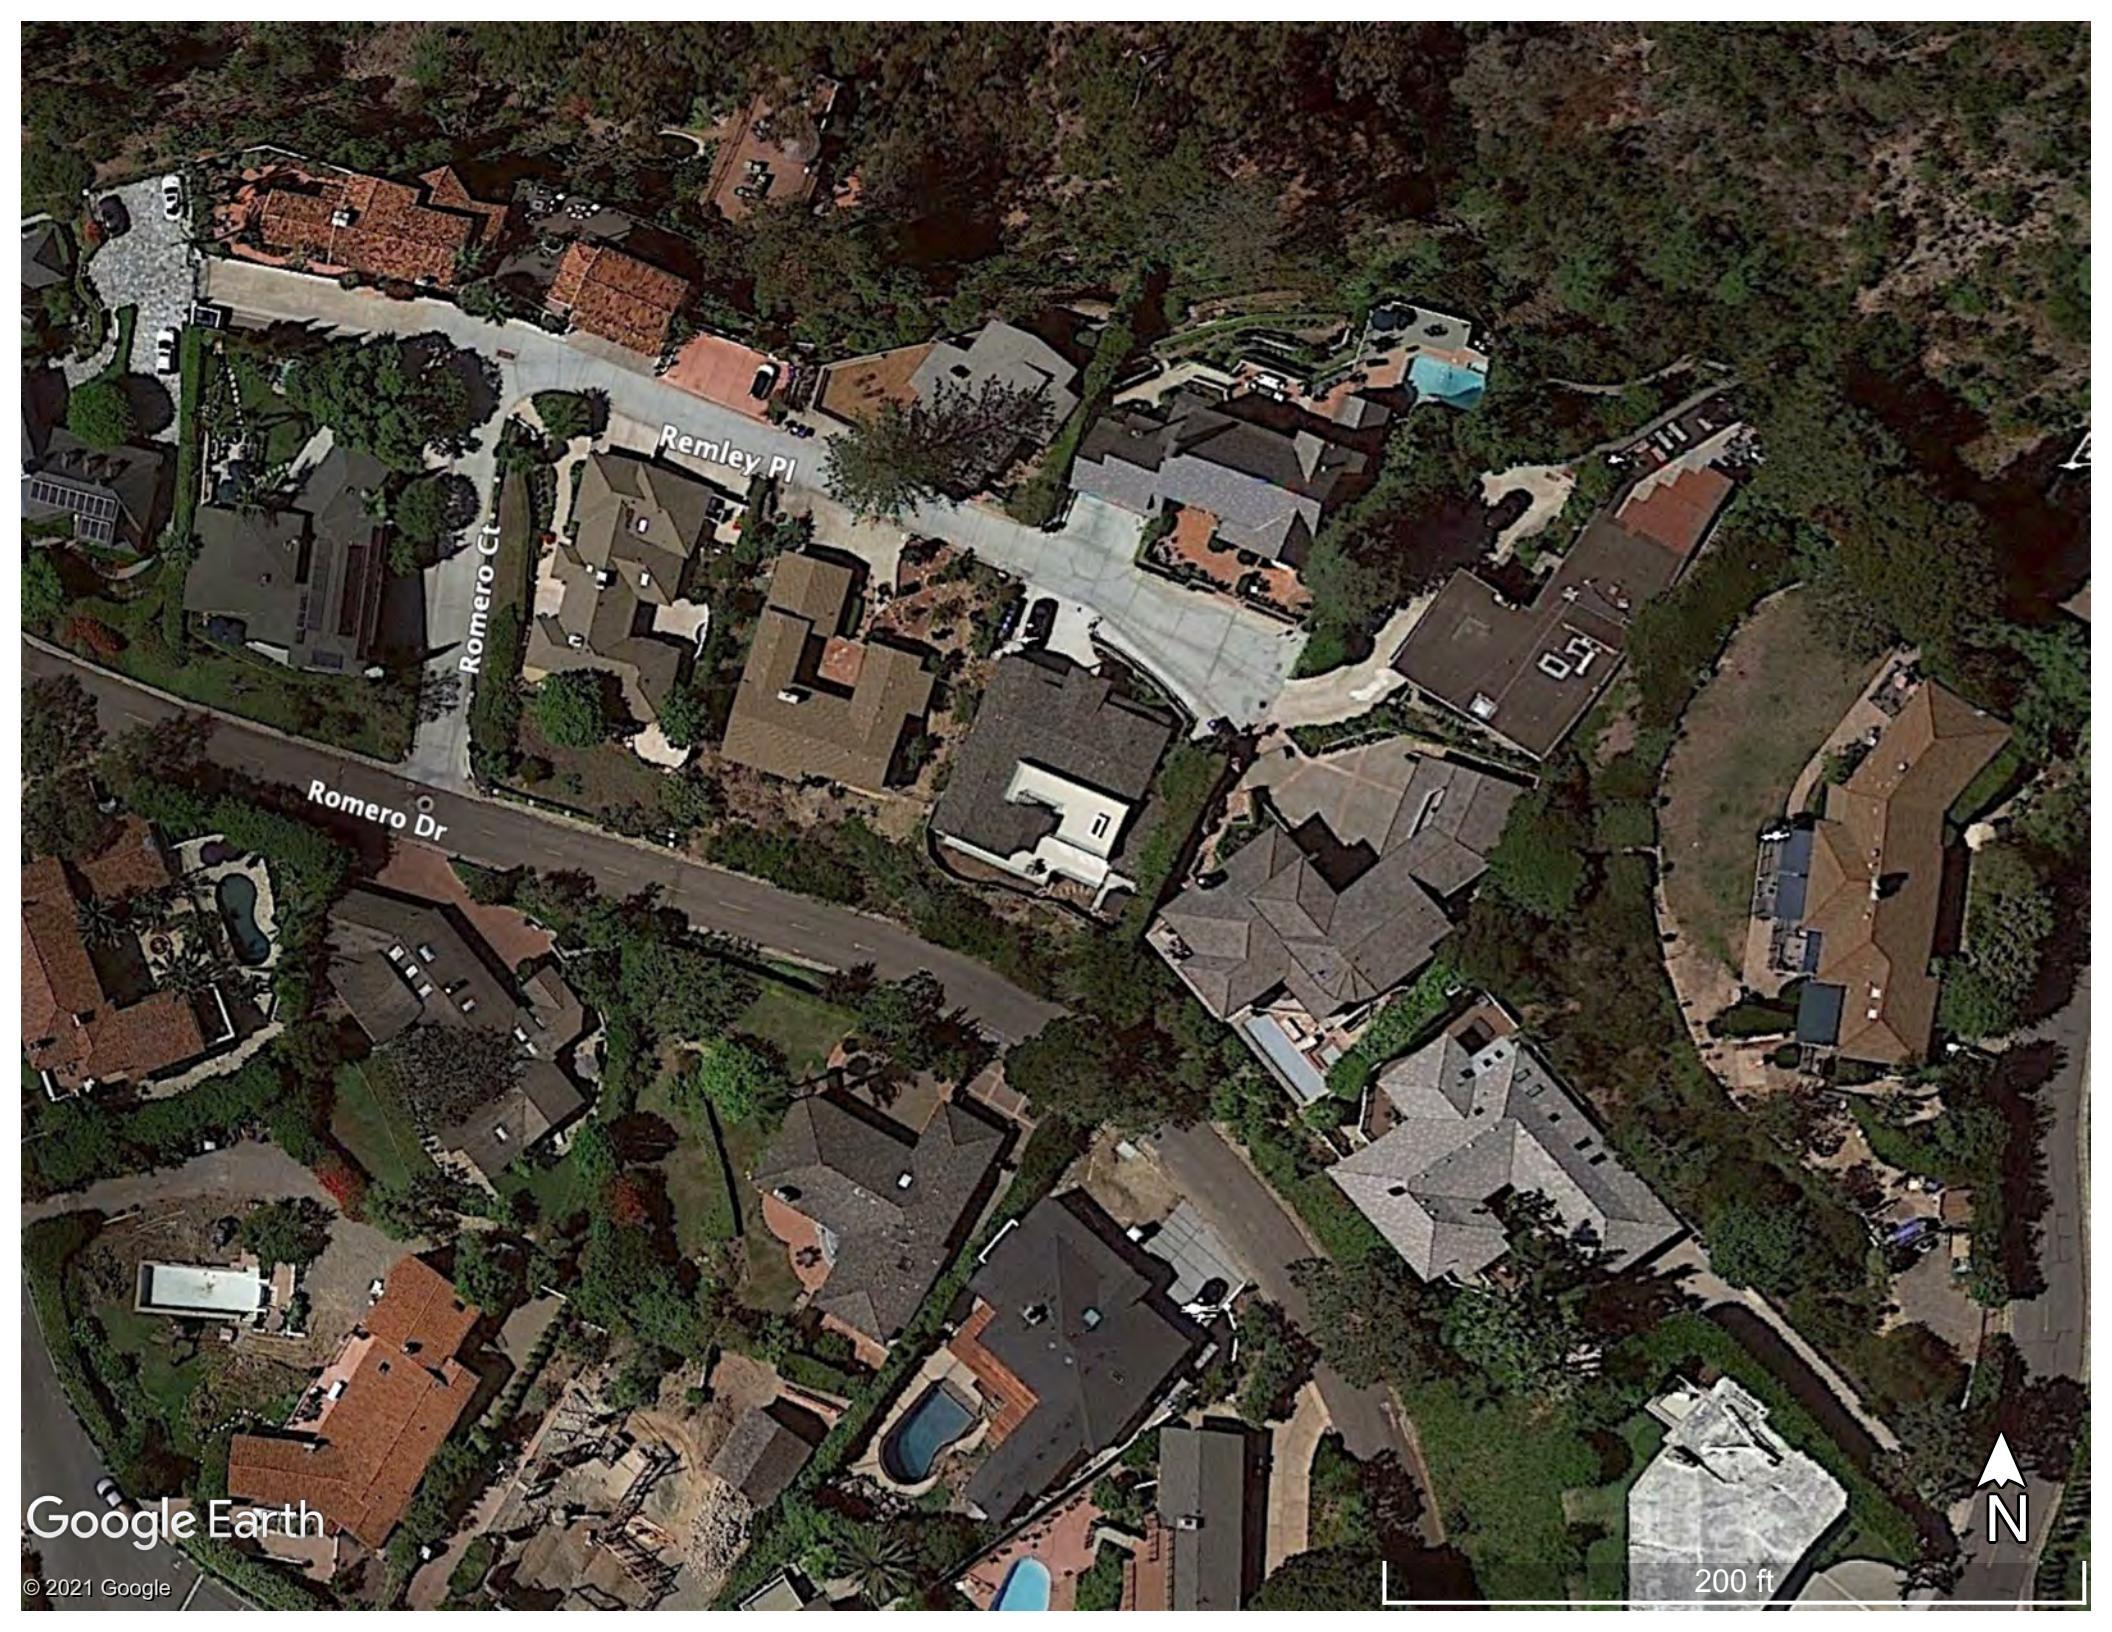
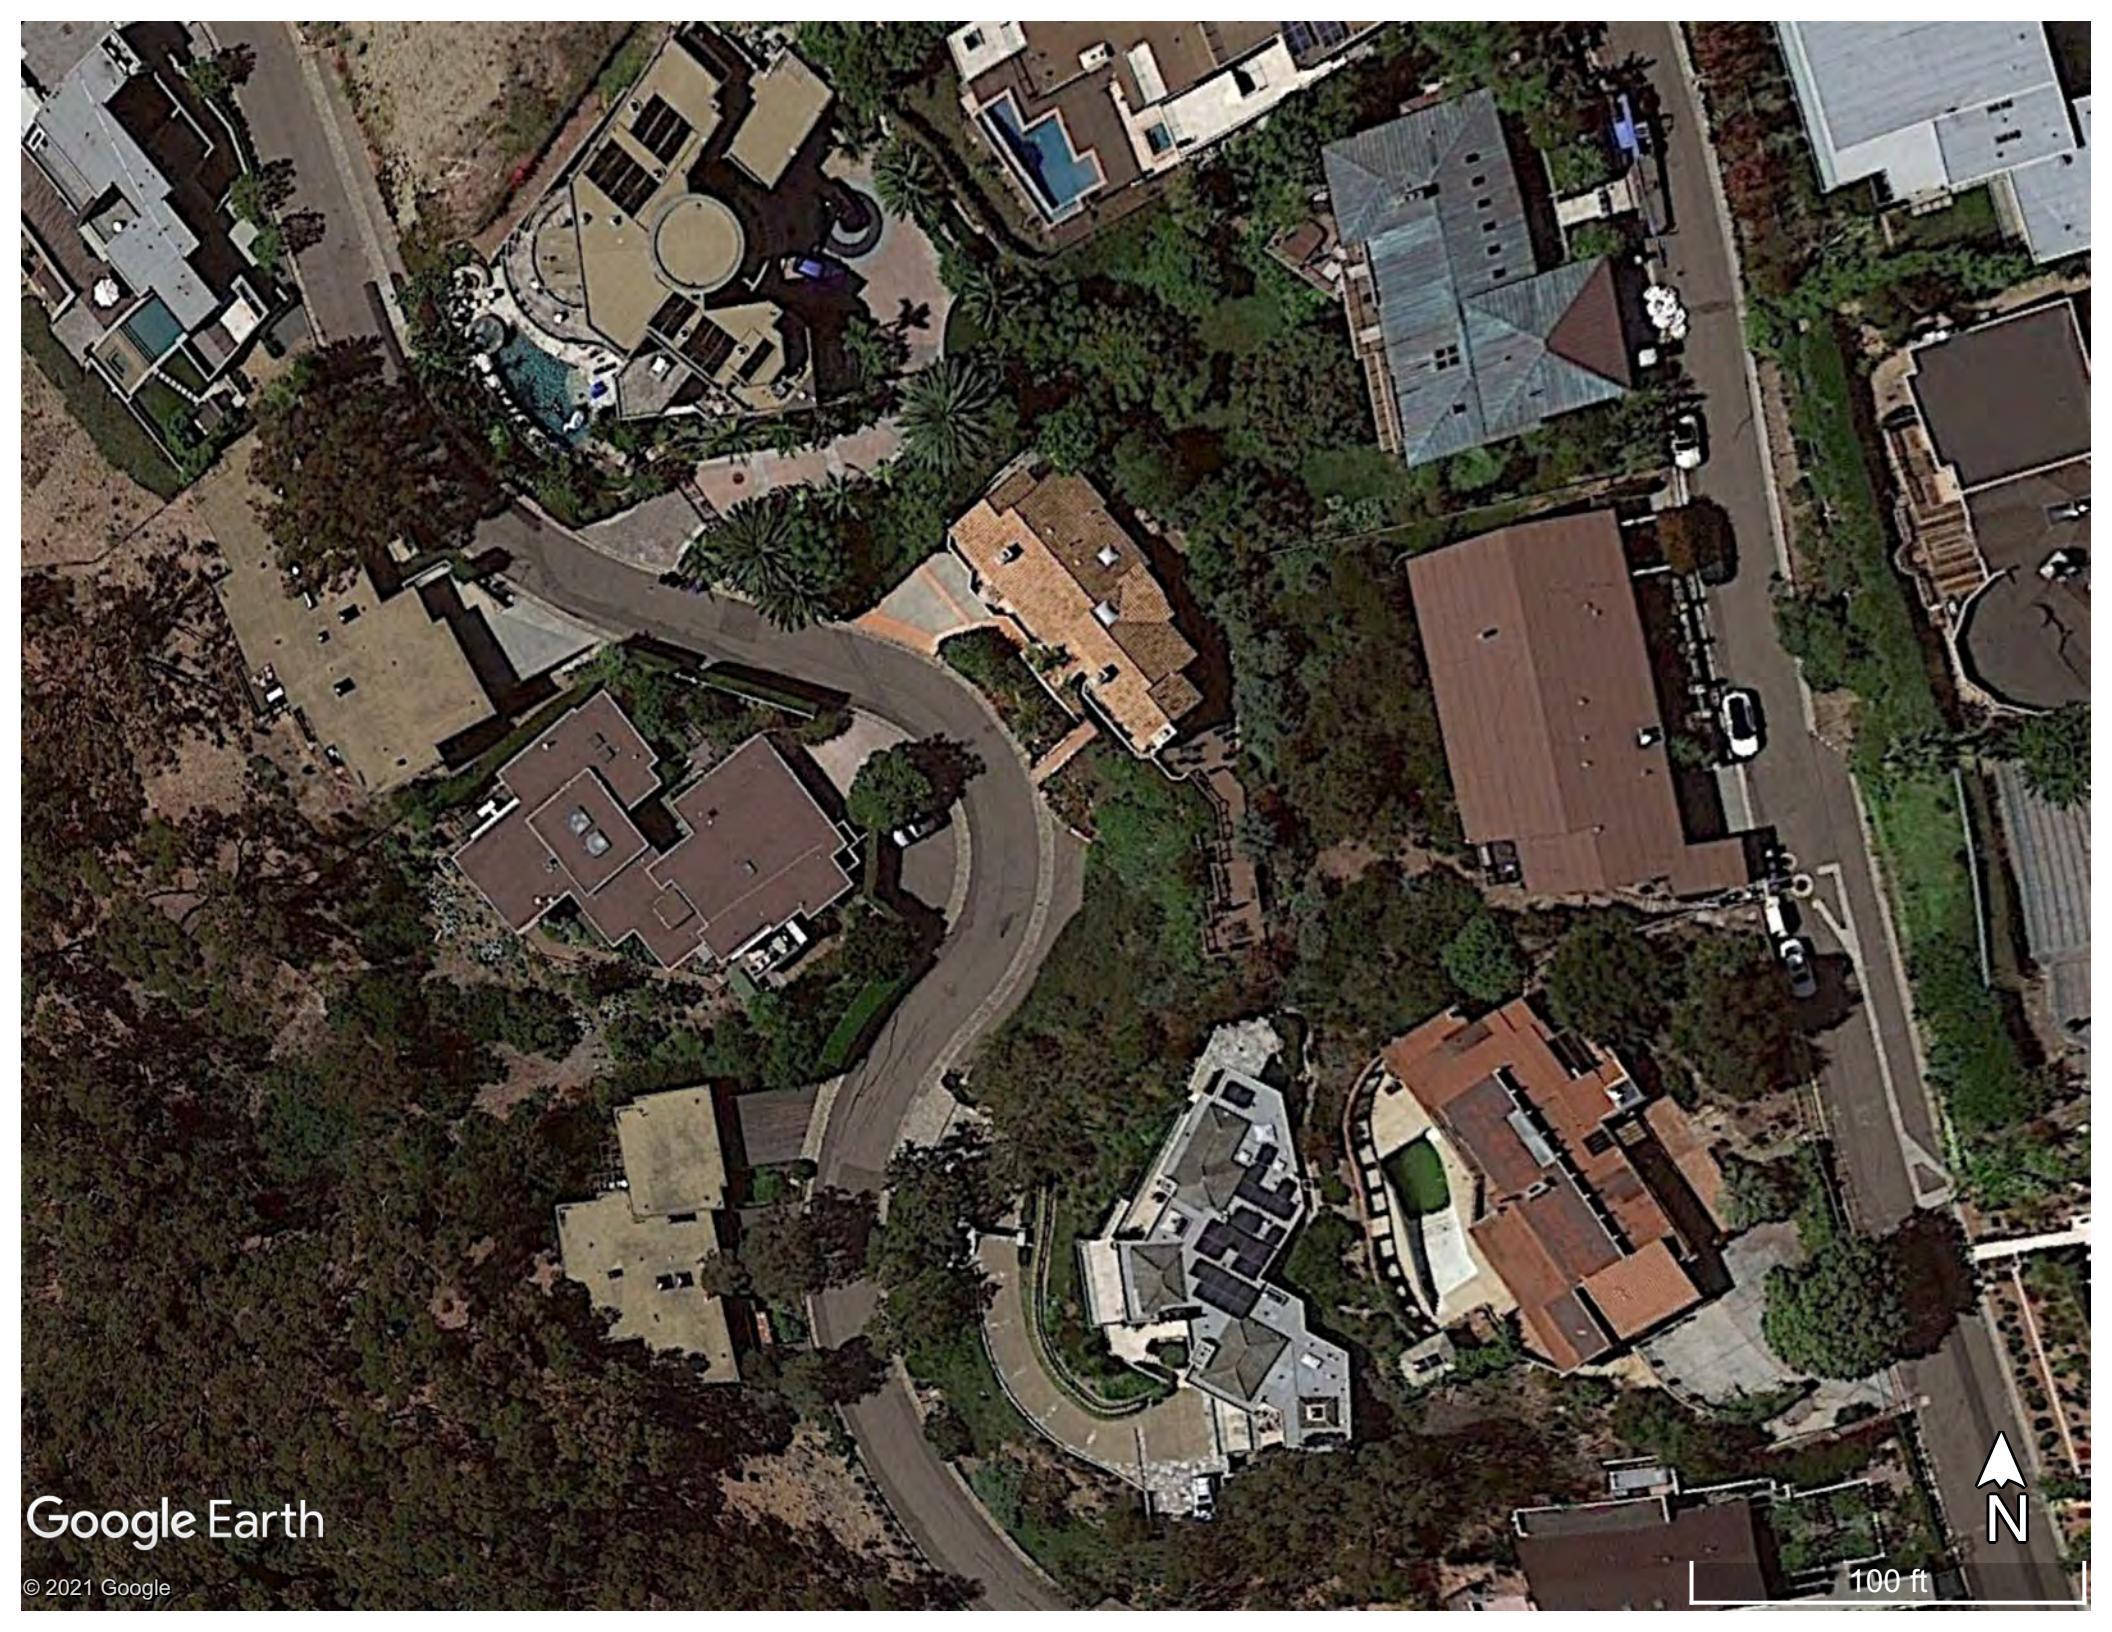
- Dr. Geissler opined that the cracks in Encelia Drive pavement are tension cracks, which are further evidence of a "deep-seated landslide." However, as shown on the attached aerial photos, pavement cracks are ubiquitous in the area (Attachment 1). The attached aerial photos document similar cracks in County Club Drive (west of the site), Romero Drive (south of the site and oriented downslope at an angle that does not coincide with the postulated "deep-seated landslide"), elsewhere on Encelia Drive (north of the site), Brodiaea Way (north of the site and oriented downslope at an angle that does not coincide with the putative "deep-seated landslide"), and Remley Place (north of the site oriented downslope at an angle that does not coincide with the postulated "deep-seated landslide"). Further, during our 2019 evaluation a registered geotechnical engineer and a pavement expert from Atlas visited the area of the pavement cracking called out by Dr. Geissler and indicated that the cracking is not related to tension of the ground, but rather shrinkage cracking of aging pavement, similar to that found in other nearby streets, and found commonly in streets in a given area. Therefore, in our opinion, the presence of pavement cracks in Encelia Drive is not indicative of ground tension cracks or a "deep-seated landslide."

- b. "City Geology staff failed to act on two recommendations by Geissler Engineering" regarding the depth of the failure surface and "tension cracks in pavement along Encelia Drive suggests that the landslide is much larger than expected." As we noted in our Response 2 pavement cracking is ubiquitous in the project area and is not indicative of a "deep-seated landslide" at this site.
