Subject:Response to City of San Diego Geology Review Comments, and
Update to Preliminary Geotechnical Engineering Investigation Reports
1561/1545 Camino Del Rio South; San Diego, California

PRELIMINARY GEOTECHNICAL ENGINEERING INVESTIGATION

We are pleased to submit this preliminary geotechnical engineering investigation report prepared for the Entitlement phase of the project to develop a proposed Home Depot store to be located at 1895 Camino Del Rio South (Mission Valley area) in San Diego, California. This report is considered preliminary since the project details had not been finalized at the time this report was completed. The contents of this report include the purpose of the investigation, scope of services, background information, investigative procedures, our findings, evaluation, conclusions, and recommendations.

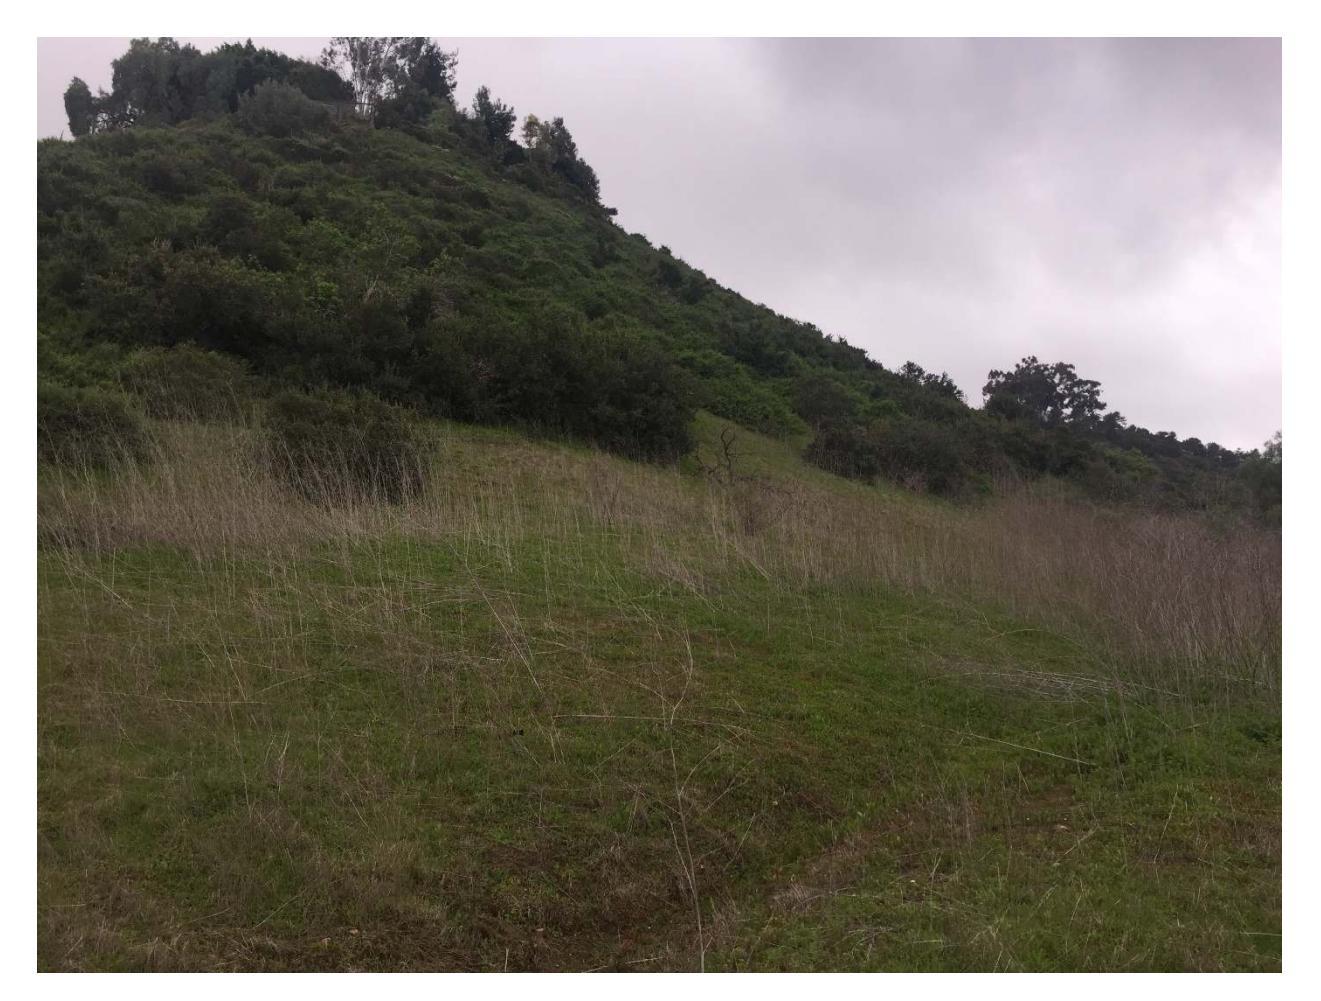
Photograph No. 4 - Looking west at native slope area above the cut slope (near south property line). Evidence of a brow ditch was noted, but ditch does not show any flow. Note that native grasses are not disturbed, and no evidence of erosion or instability was observed.

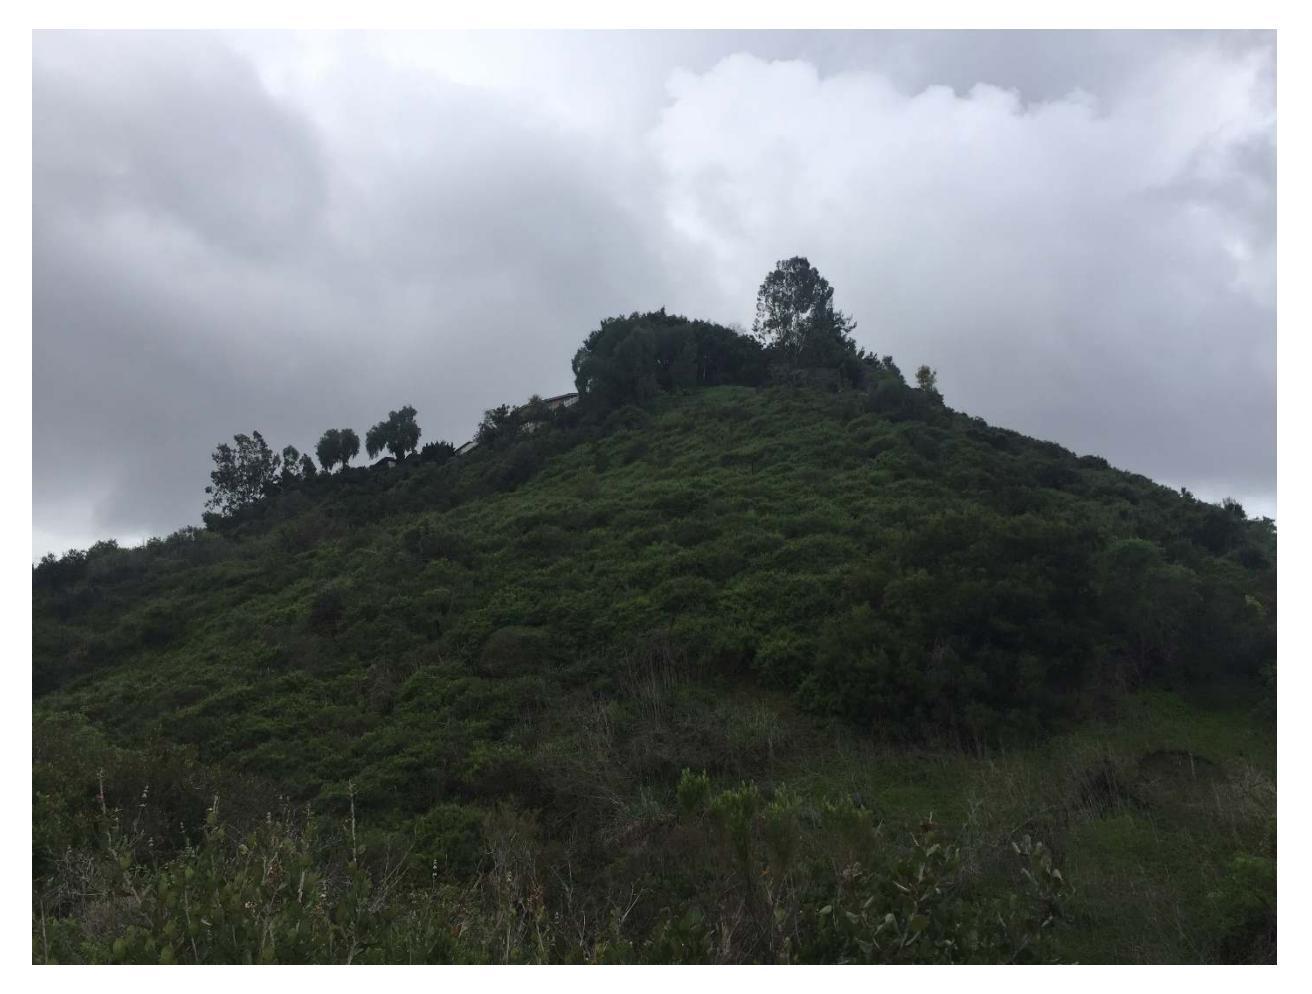
Photograph No. 5 - Looking southwest at the native slope area above the cut slope. Note the lower grass covered area and steeper upper potion are covered with undisturbed vegetation. No evidence of erosion, surface sliding, scarps or other features suggesting any recent slope instability are present.

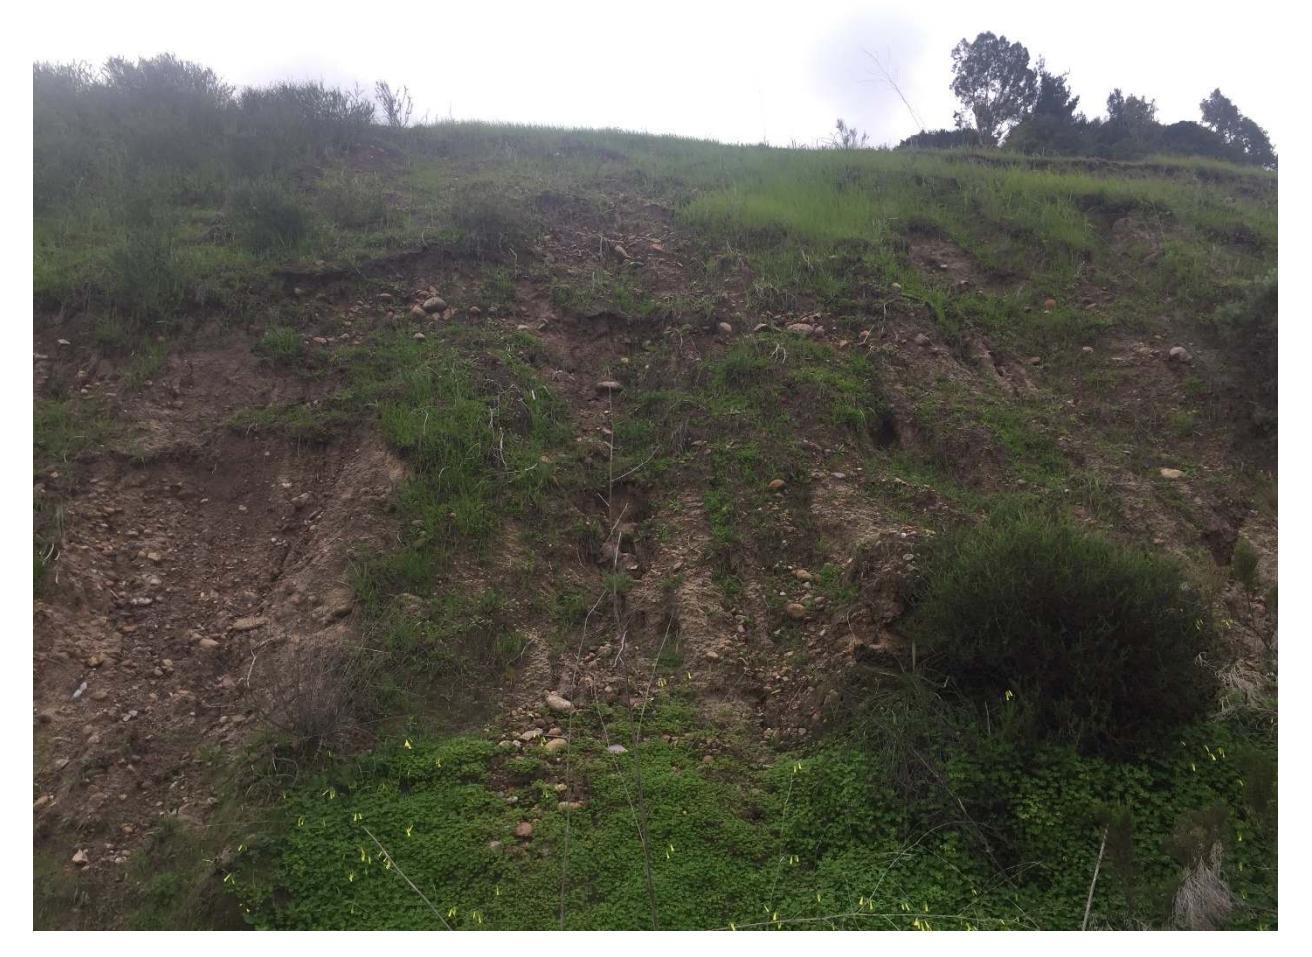
Photograph No. 6 – Looking southwest at east facing drainage canyon slope from the east canyon area. This is the area above the site mapped by Tan (1995) as a slide area. No recent evidence of surface sliding, scarps or other features were noted suggesting recent slope instability.

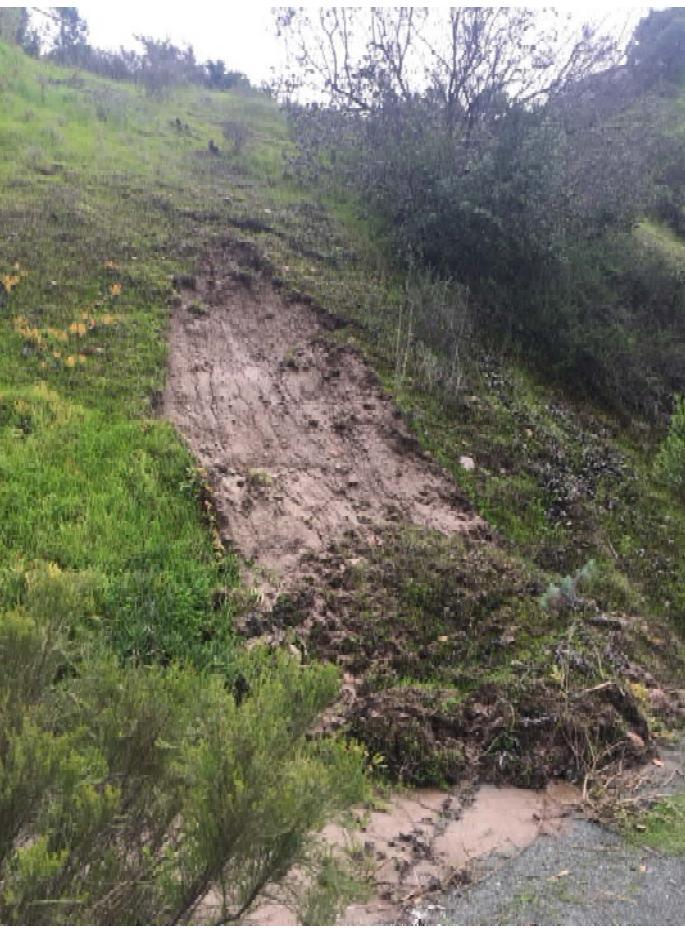
Photograph No. 7 - Looking to the south at the slope section between upper and lower benches. Note surficial slumps, erosion, exposed soils with cobble material.

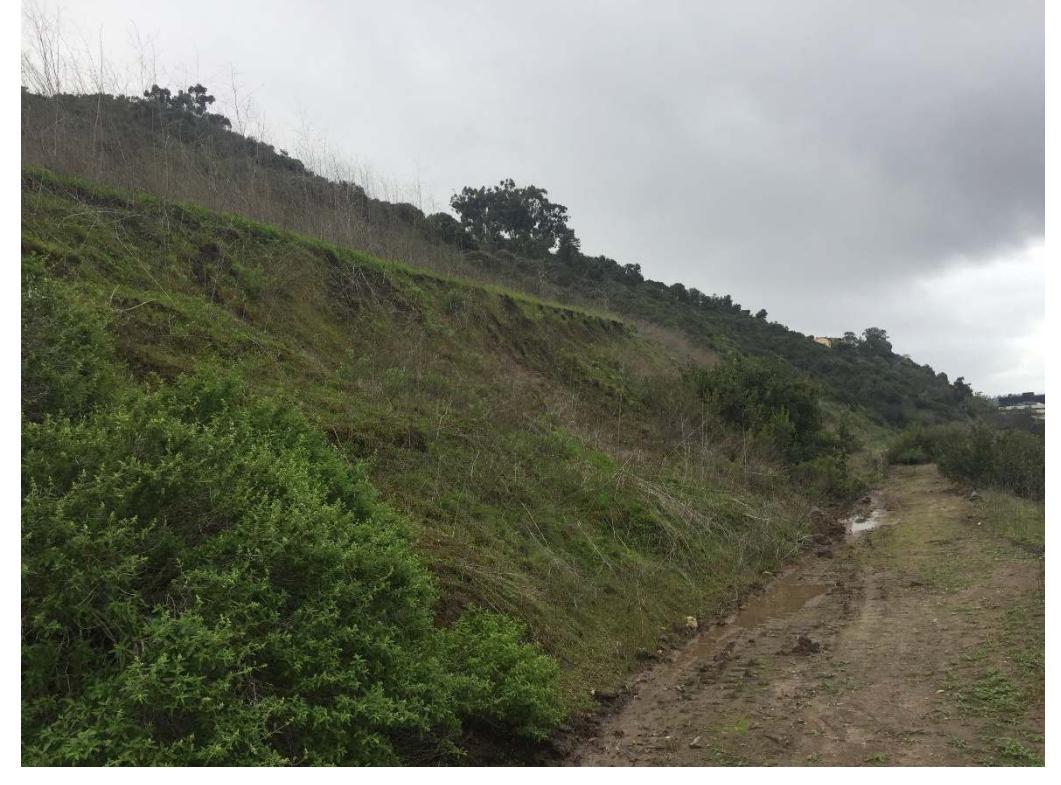
Photograph No. 10 - Showing upper cut slope (section west of drainage). Note abundant cobbles, surface erosion and low cohesive soils

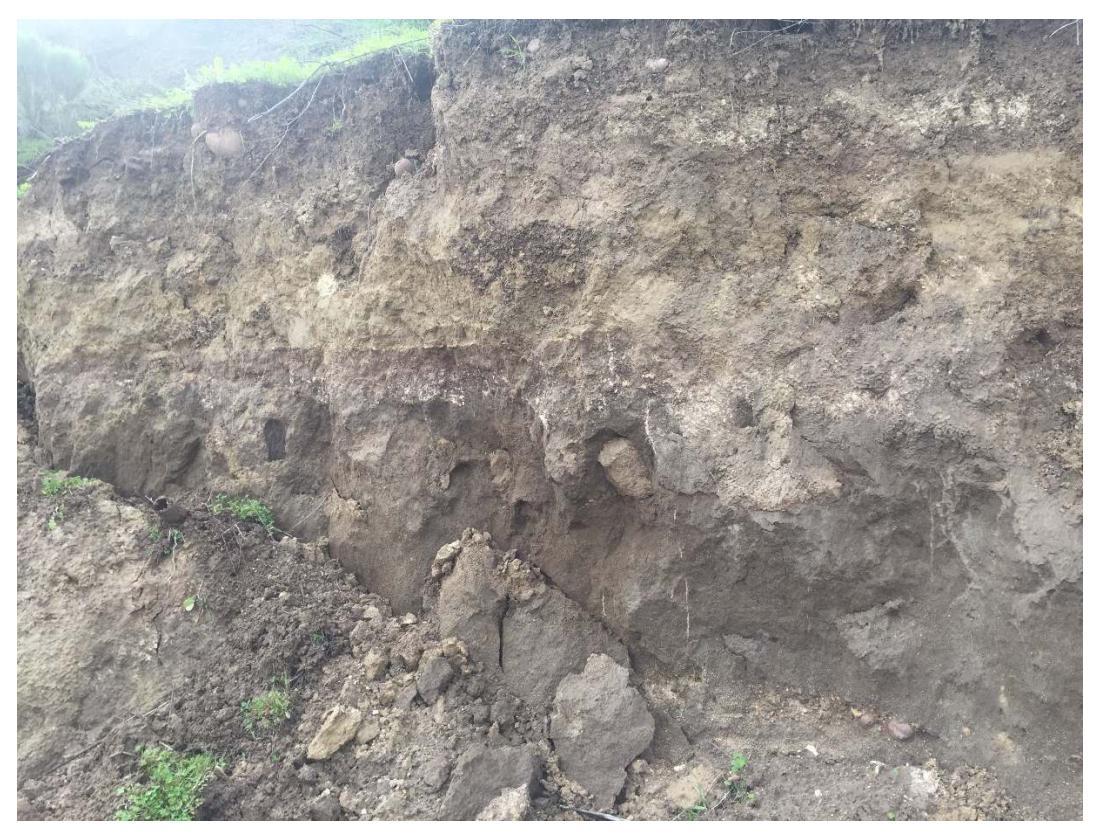
Photograph No. 11 - Showing upper cut slope (west section beyond Photograph No. 10 above). Note some surface slumps but less active erosion as noted in section with more granular materials.
