THE CITY OF SAN DIEGO
Historical Resources Board

DATE ISSUED: March 18, 2014 REPORT NO. HRB-14-023

SUBJECT: **ITEM #10 – 1845 29th Street**

1845 29TH STREET
Photo Comparison of Late 1980s and 2014

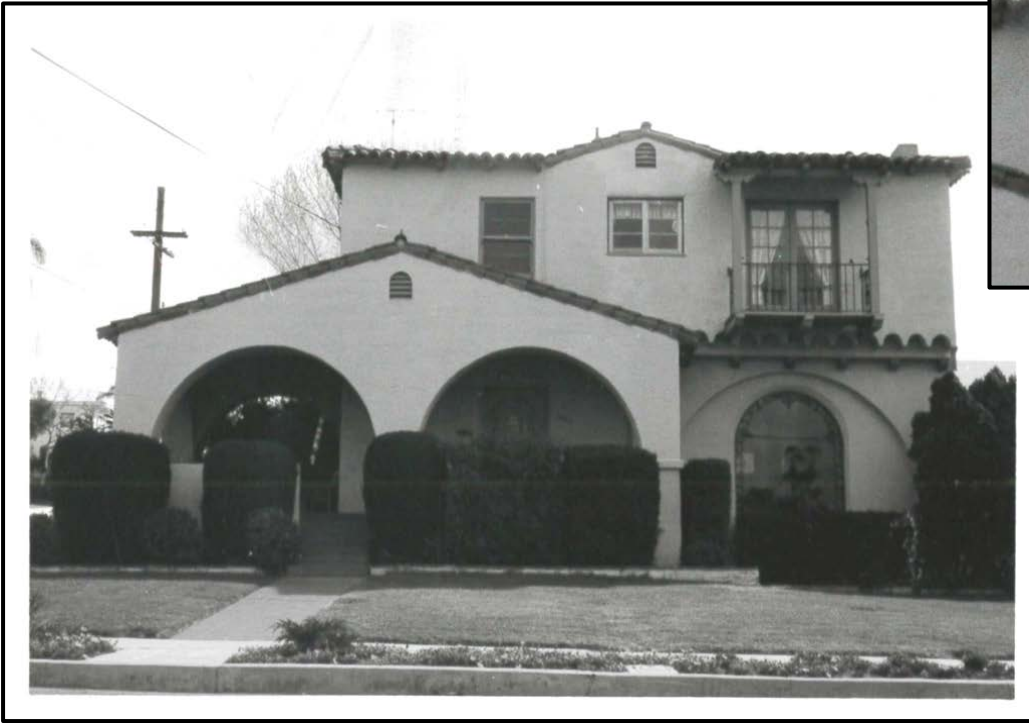
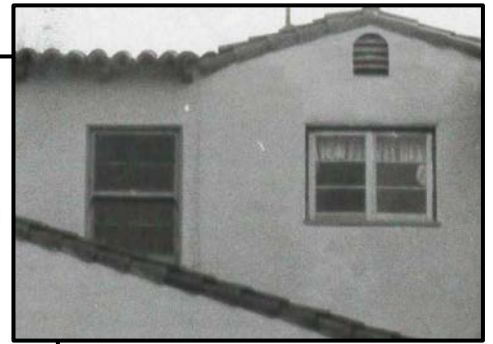
Late 1980s

During the February site visit in preparation of this report, staff noted a significant discrepancy between the existing building and a photo included in the applicant's report taken in the late 1980s. This photo shows a pair of 3-lite casement windows centered under the front gable on the second floor of the main façade. Since the photo was taken, these paired casements were infilled, and the small octagonal window added. A comparison has been provided in Attachment 2. According to the consultant, this was done to accommodate a bathroom remodel. This modification was unknown at the time the building was previously reviewed by staff and the DAS during the restoration efforts. The photo also reveals the presence of wrought iron detailing at the fixed arched window on the main façade, which is no longer present. Additionally, staff noted some discrepancies in the treatment surrounding the windows throughout the house. The windows at the upper level behind the chimney are replacement windows which do not have the wooden sill found on the original window and the restored windows. However, these replacements do have a slightly sunken, beveled treatment (also seen in the 1980s photograph), which is missing on the restored windows that are set flush against the wall. This raises concerns regarding the window restorations and whether they were set appropriately and accurately in the building wall.

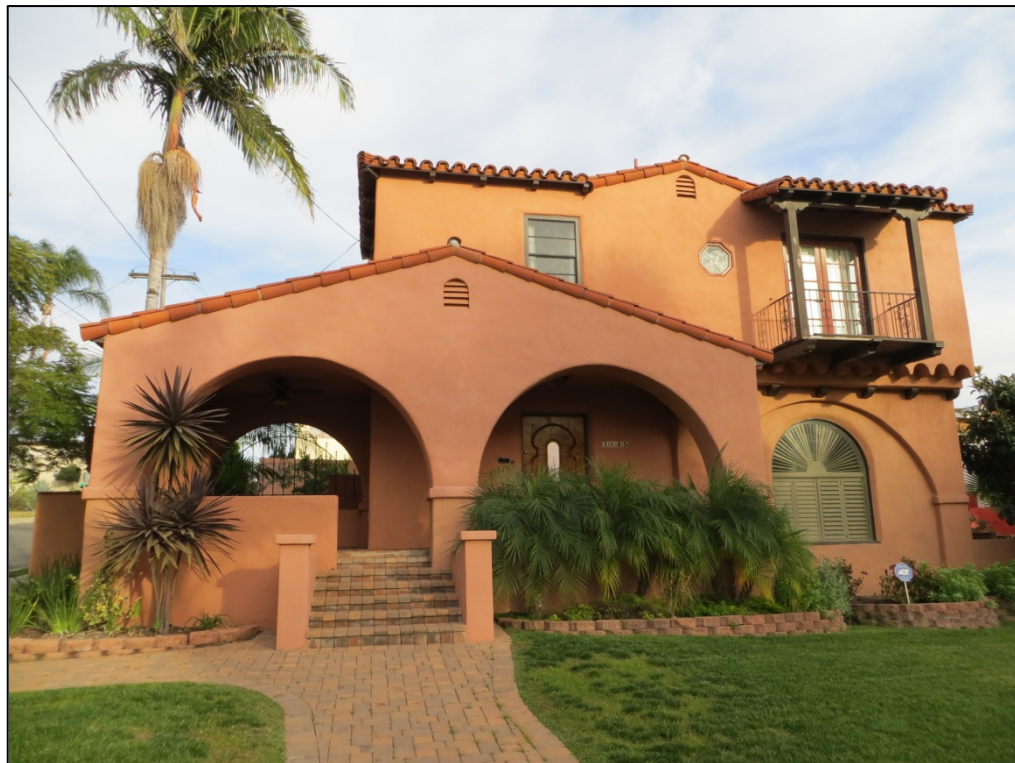
2014

While the owner has undertaken restoration efforts that have significantly improved the design, materials and feeling aspects of integrity, the recent discovery of the window alteration at the front façade; the removal of the wrought iron detailing; and the questions regarding accurate treatment of window surrounds, taken together with the previously known modifications, result in significant cumulative impacts to the building's integrity related to its original Spanish Eclectic design. Therefore, staff does not recommend designation under HRB Criterion C at this time, due to a lack of integrity.
