SAN DIEGO RIVER INDUSTRIAL AREA

North Mission Gorge Road

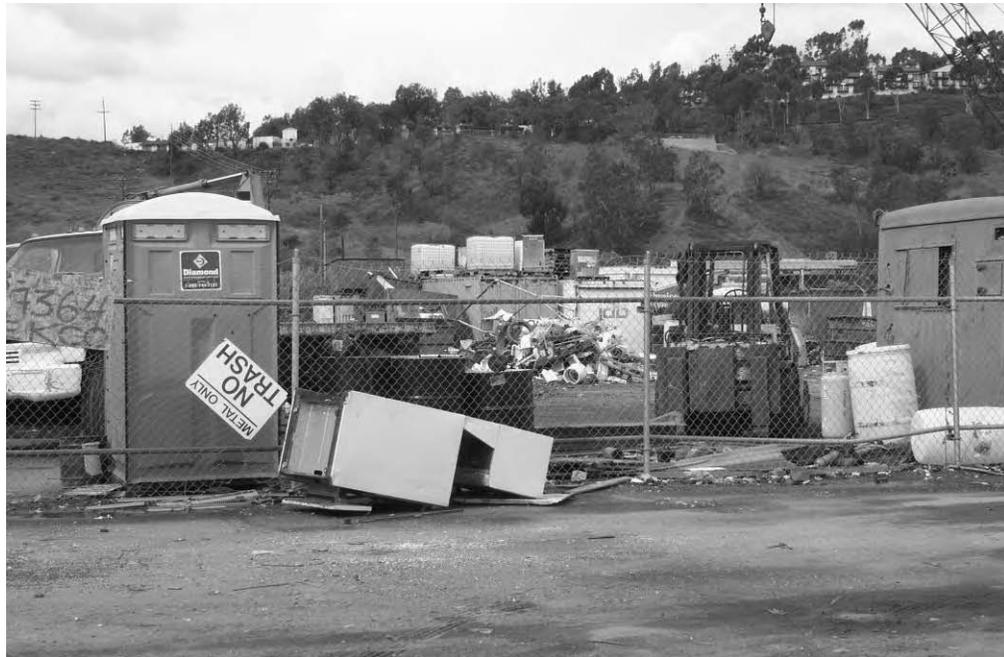
Parcel Number – 455 030 27

Outdoor storage/salvage on dirt lots pollutes the soil and visually detracts from the Project Area, thereby impairing property investments and improvements.

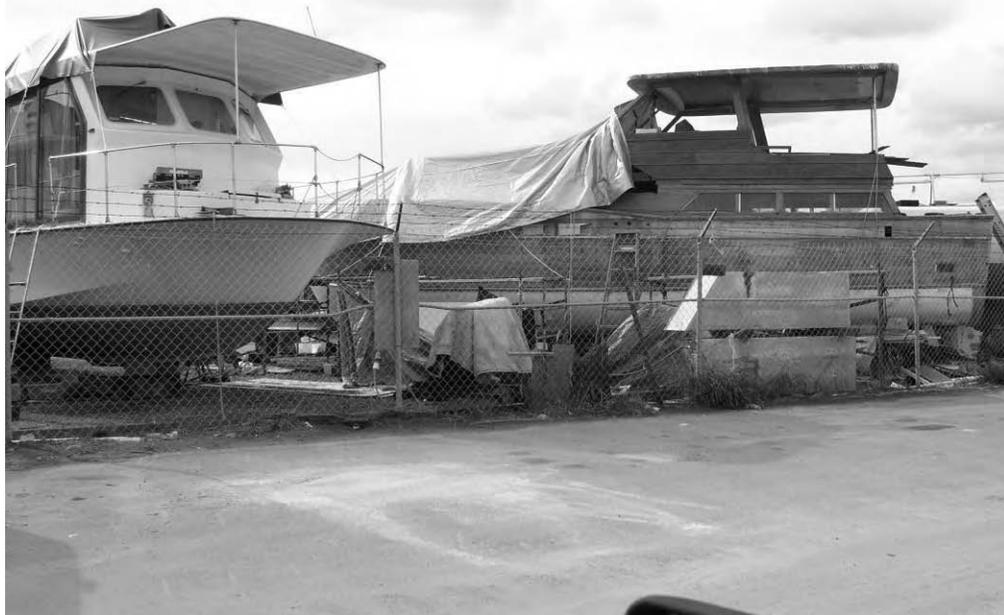
Parcel Number – 455 020 13

Outdoor salvage and manufacturing operations, such as this boat yard, comprise the majority of industrial uses in the north Mission Gorge area.

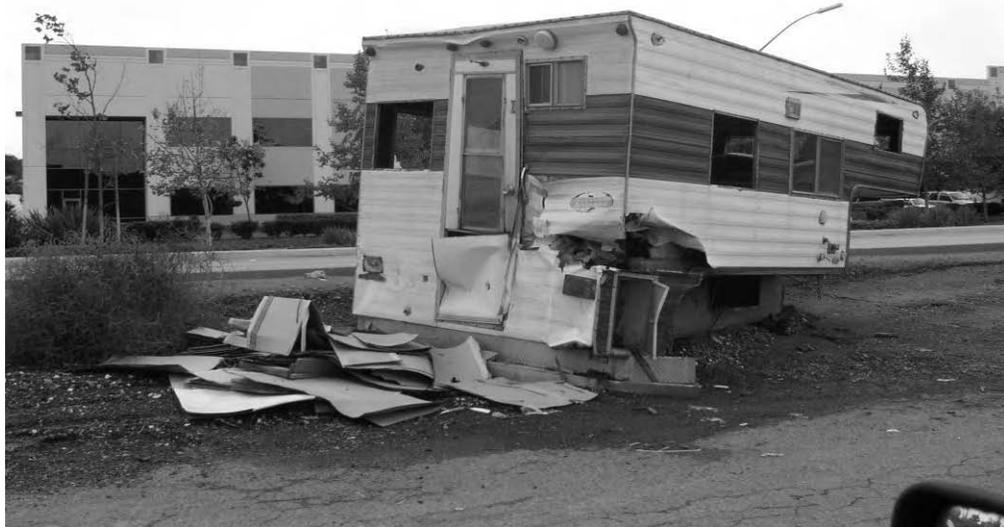
Parcel Number – 455 030 27

The unpaved roads of the north Mission Gorge area attract trash dumping, which visually detracts from surrounding properties. At this site a camper shell and other debris next to Mission Gorge Road are unsightly across the street from this modern industrial complex.

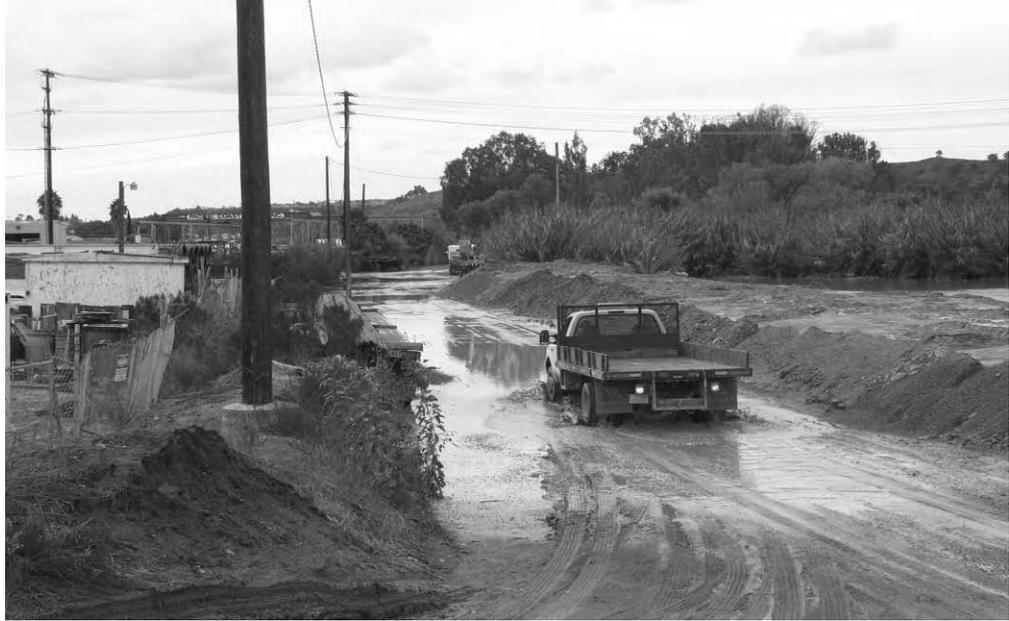
Parcel Number – 455 030 26

Flooding conditions are prevalent in this portion of the Project Area due to its proximity to the San Diego River. Properties to the right are primarily dirt lots for industrial storage that either drain or leach runoff directly into the river.

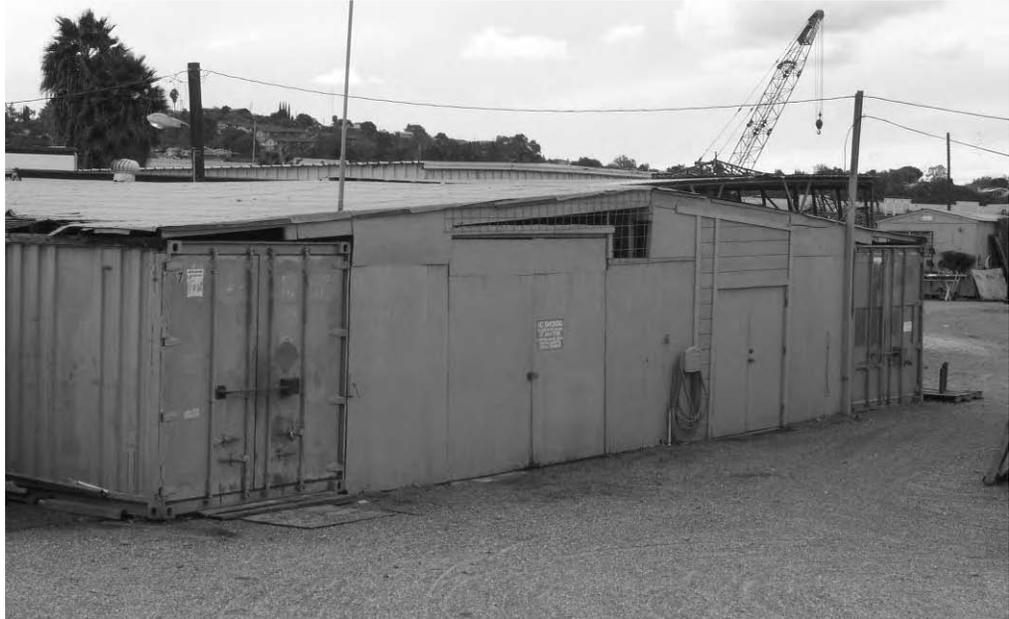
Parcel Number – 455 030 26

Substandard additions with metal storage containers attached to buildings, a violating of the building code. These additions have substandard electrical and ventilation, which present fire and health hazards to workers.

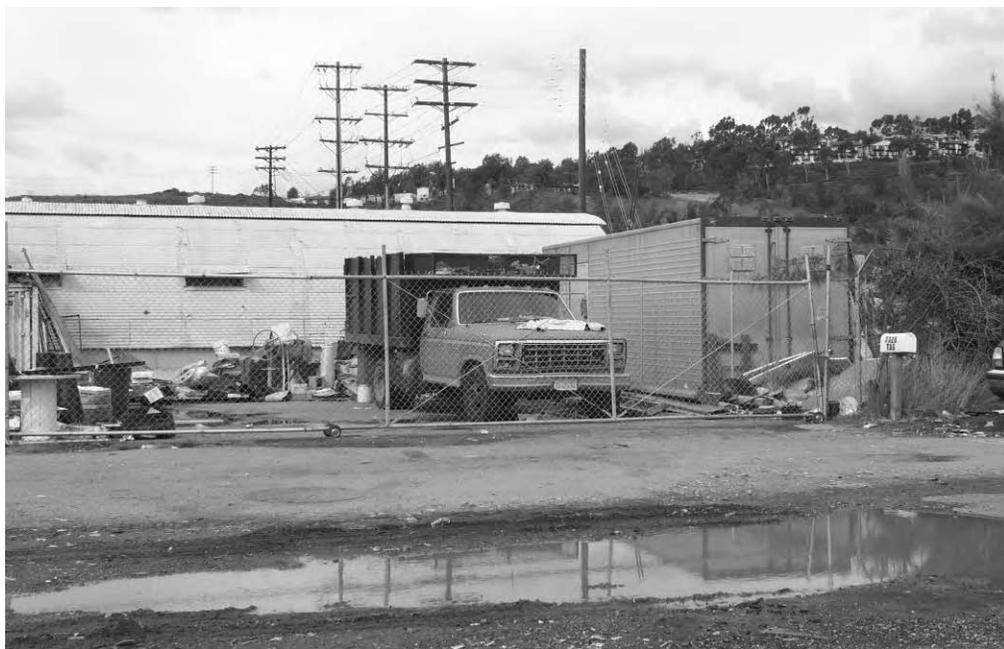
Parcel Number – 455 030 27

Substandard building materials such as corrugated metal flex during an earthquake or fire and compromised structural integrity of buildings and the safety of those working inside.

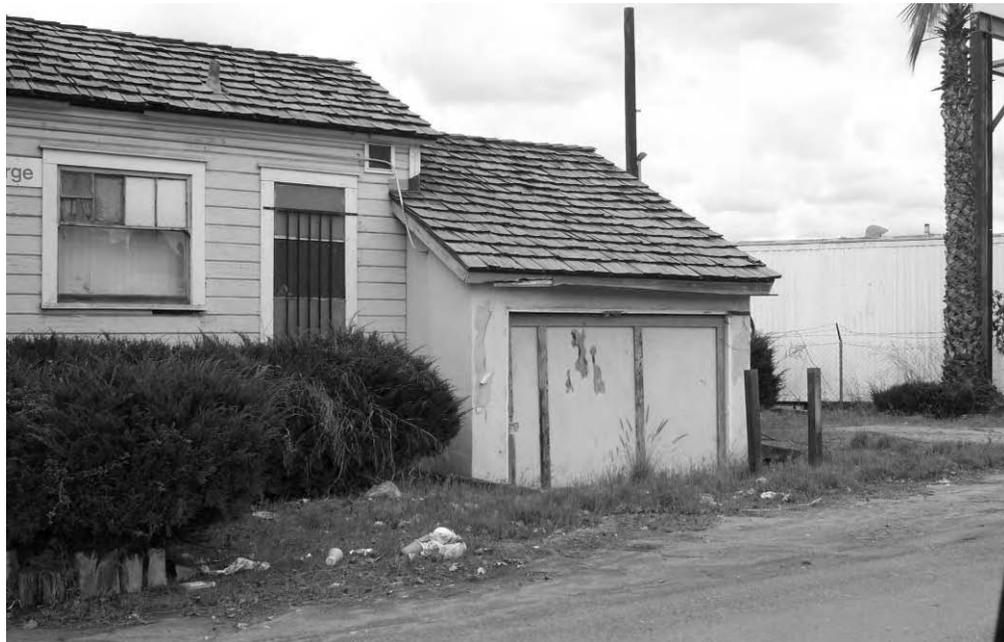
Parcel Number – 458 010 28

The combination of substandard addition and lack of maintenance for this residential structure converted to industrial use contributes to the negative physical appearance of the north Mission Gorge area.

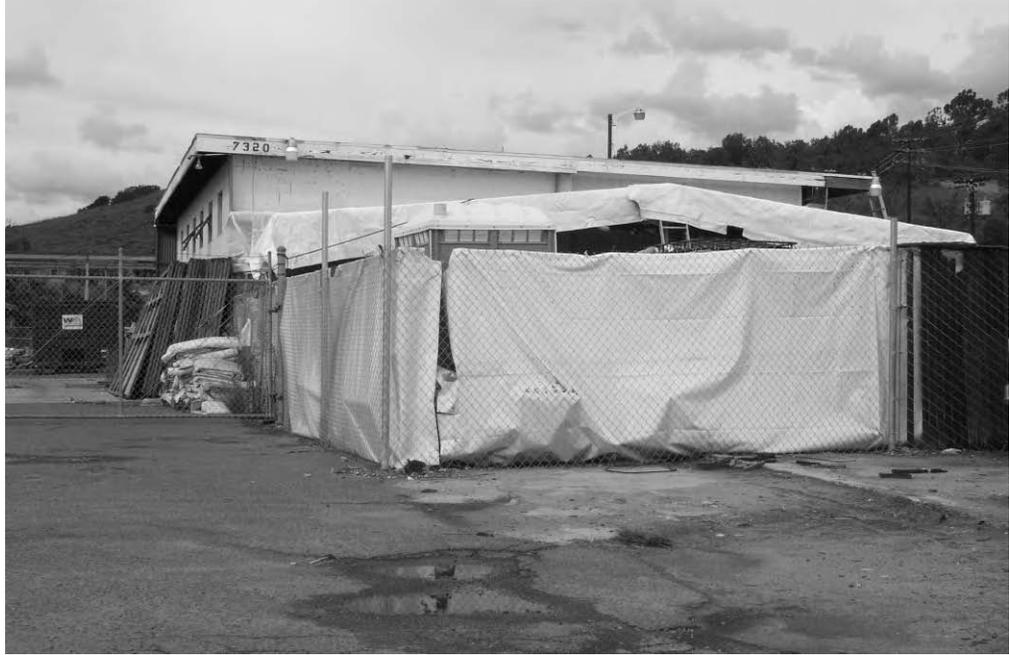
Parcel Number – 458 010 27

This site includes outdoor manufacturing, canvas tarps to obscure outdoor storage and manufacturing. In addition, the site suffers from deferred maintenance.

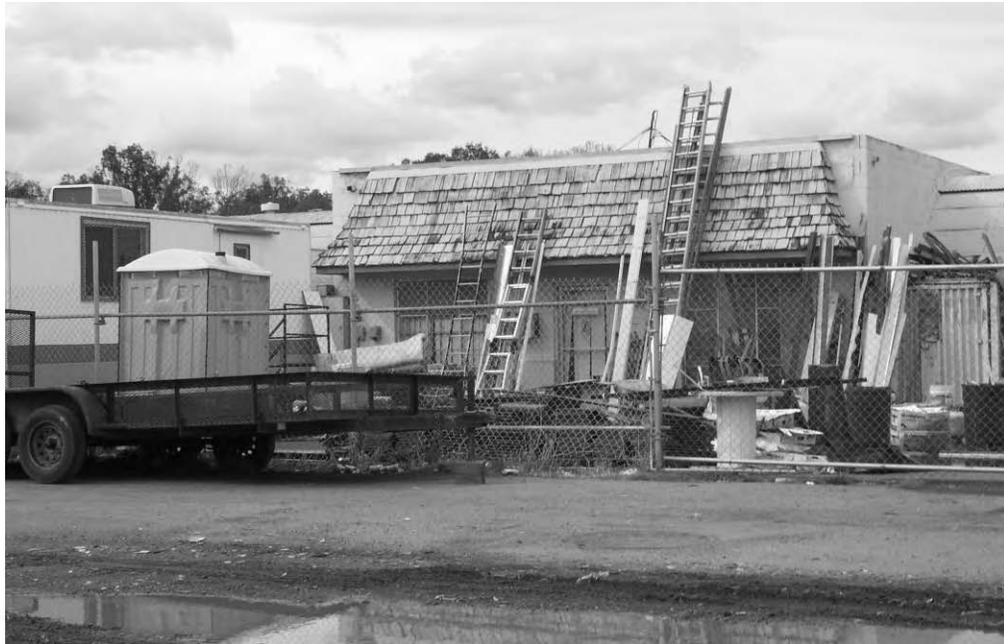
Parcel Number – 455 030 27

Inadequate plumbing and sewer service to property, which is an unsafe and unhealthy condition from stagnant water and outdoor restroom facilities. This wood structure is connected to a corrugated metal structure (on the left) compromising the structural integrity of the entire building during a fire or earthquake. Private investment to bring in public infrastructure for sewer and correct building deficiencies may be cost prohibitive and further impairs investment for improvements to the property.

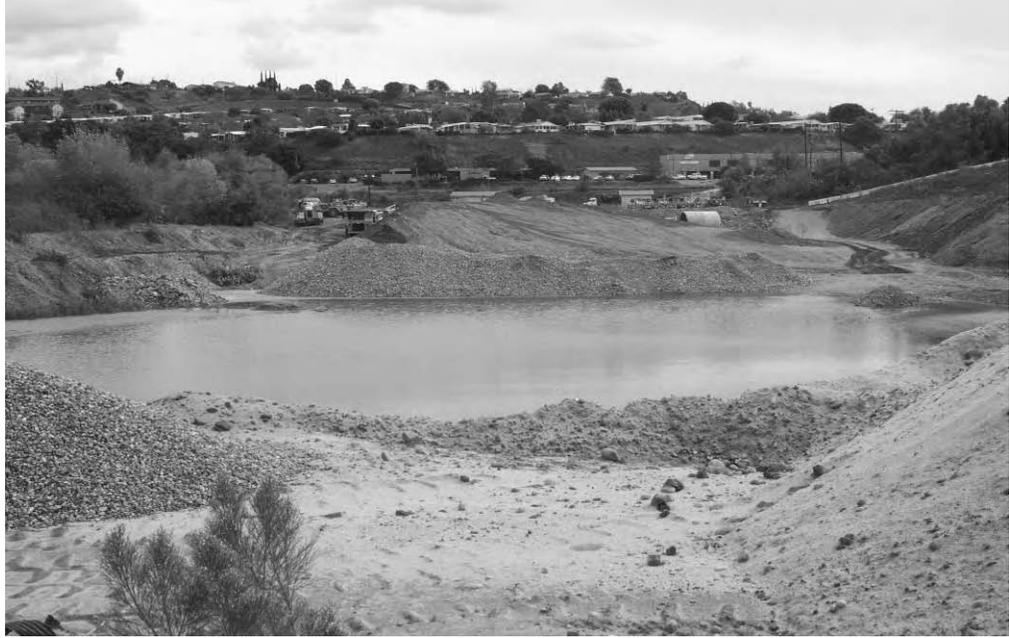
Parcel Number – 455 030 26

Redevelopment of sand and gravel extraction sites will require significant earth infill to raise the site level above the water level of the San Diego River as well as funding for pollutant clean up.

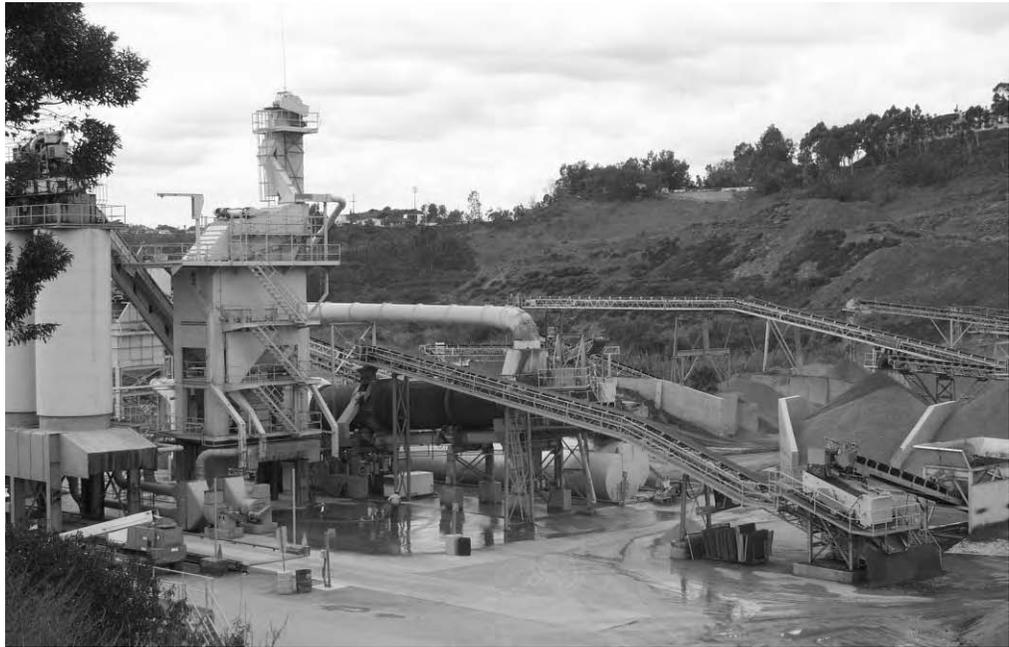
Parcel Number – 455 040 24

Restoring this site for suitable development once operations cease at the concrete manufacturing facility site will be expensive, due to its sensitive environmental location and lack of infrastructure.

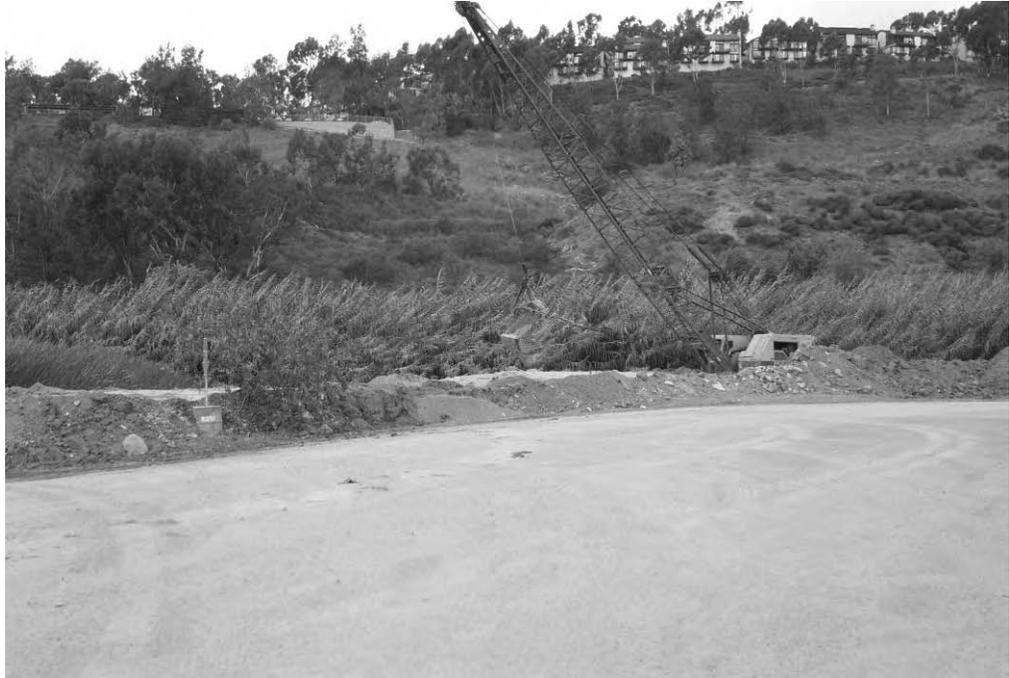
Parcel Number – 455 030 26

Construction of large earthen berms alter the course of the San Diego River and will be expensive to restore to a natural state.

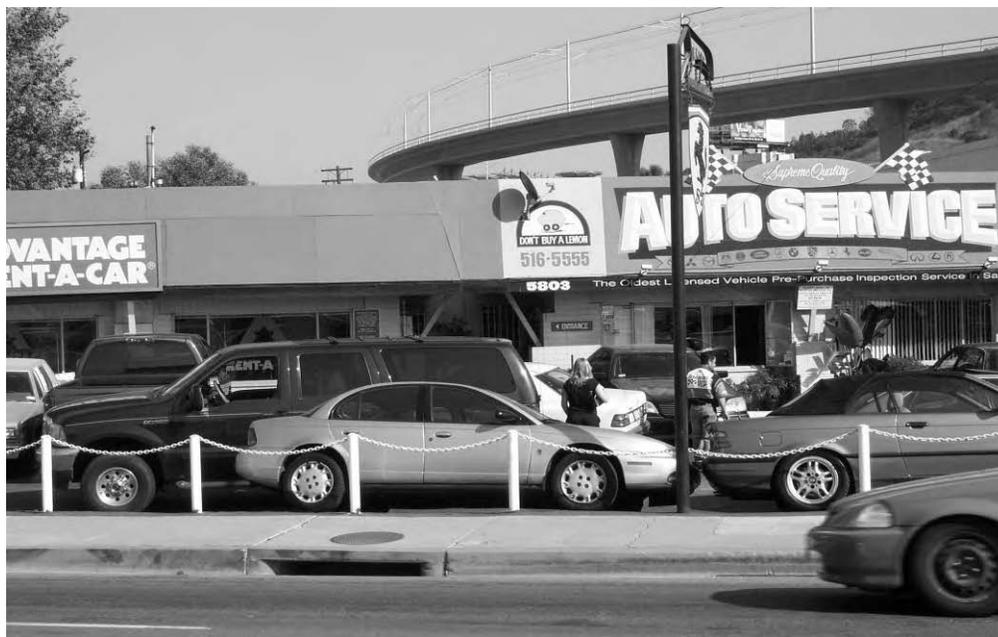
Parcel Number – 461 320 02

Lack of adequate on street parking creates crowded on-site conditions for this rental car operation, which shares the property with an auto repair facility.

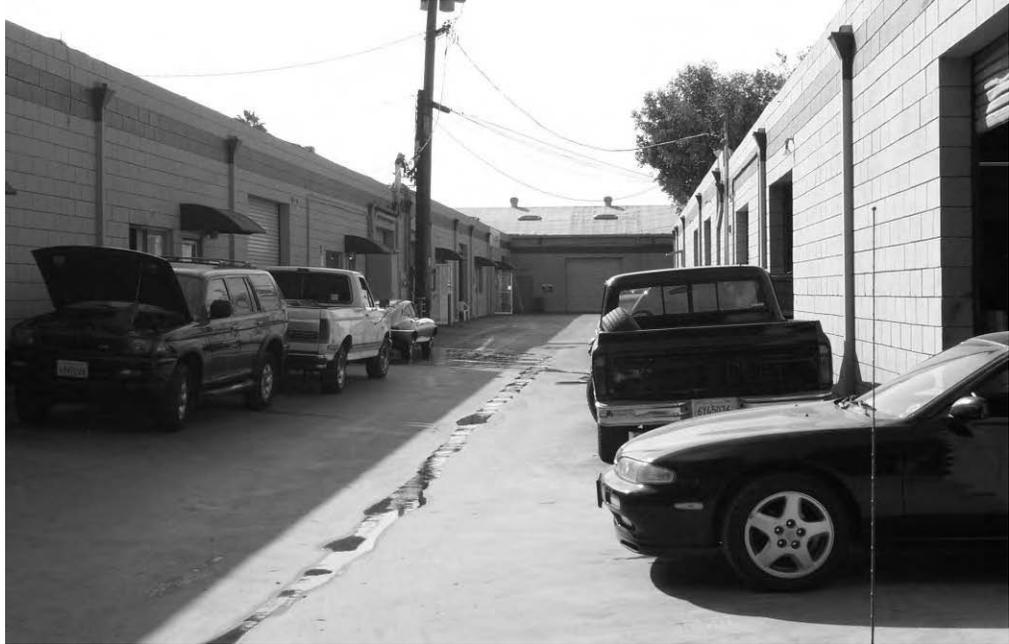
Parcel Number – 461 320 04

Lack of parking causes vehicles to be crowded into the corridor between these repair facilities, which causes an unsafe traffic and fire situation.

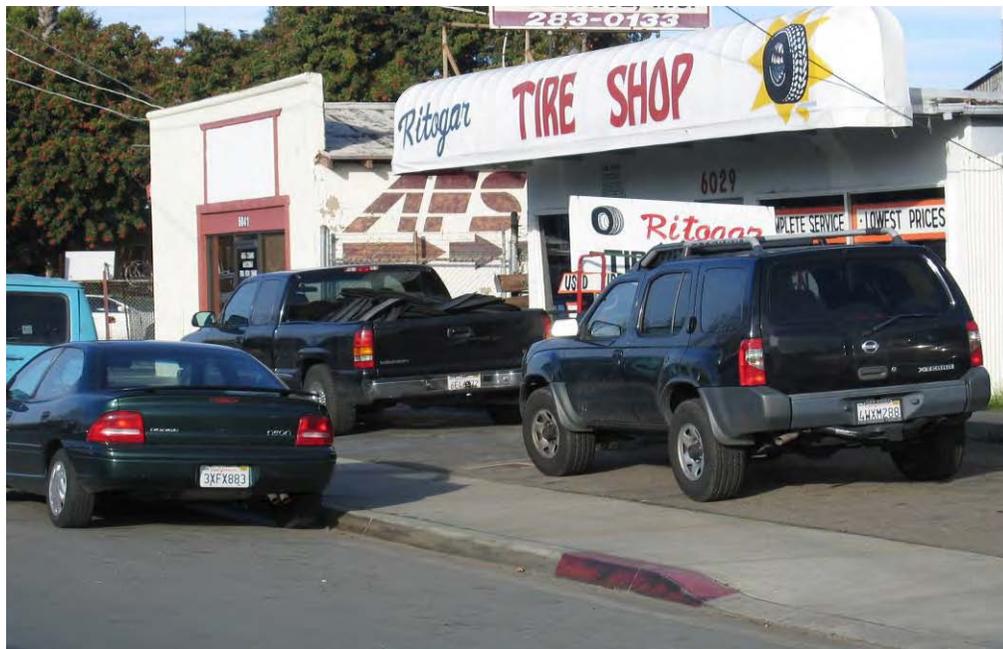
Parcel Number – 461 160 04

Inadequate parking is also caused by small parcel sizes. Here vehicles and outdoor tire displays congest the front of this building making it an unsafe area for pedestrians to walk and vehicles to access the property.

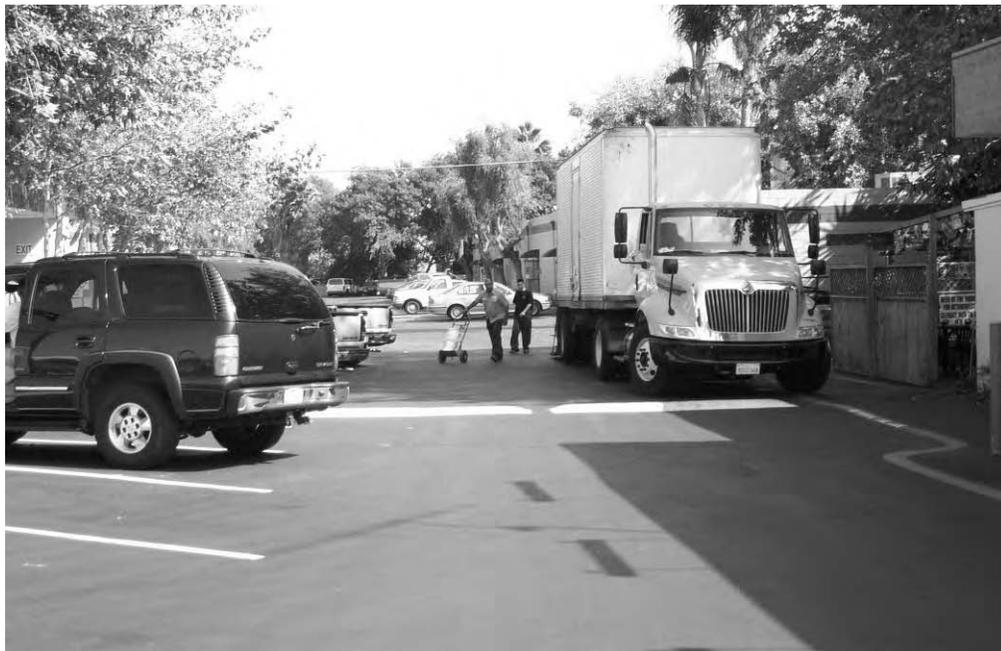
Parcel Number – 461 320 03

Narrow entry ways, which restrict property access are further impaired by delivery vehicles which often block traffic and fire lanes to make deliveries.

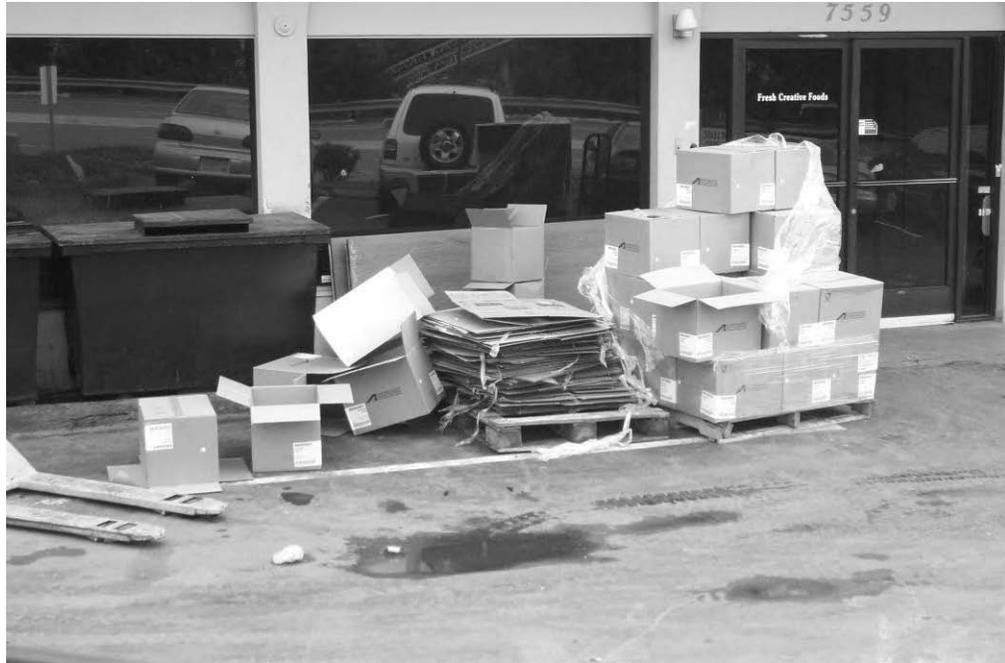
Parcel Number – 456 160 09

The parking places in front of this business have been removed to incorporate a permanent loading area that is stripped out with paint.

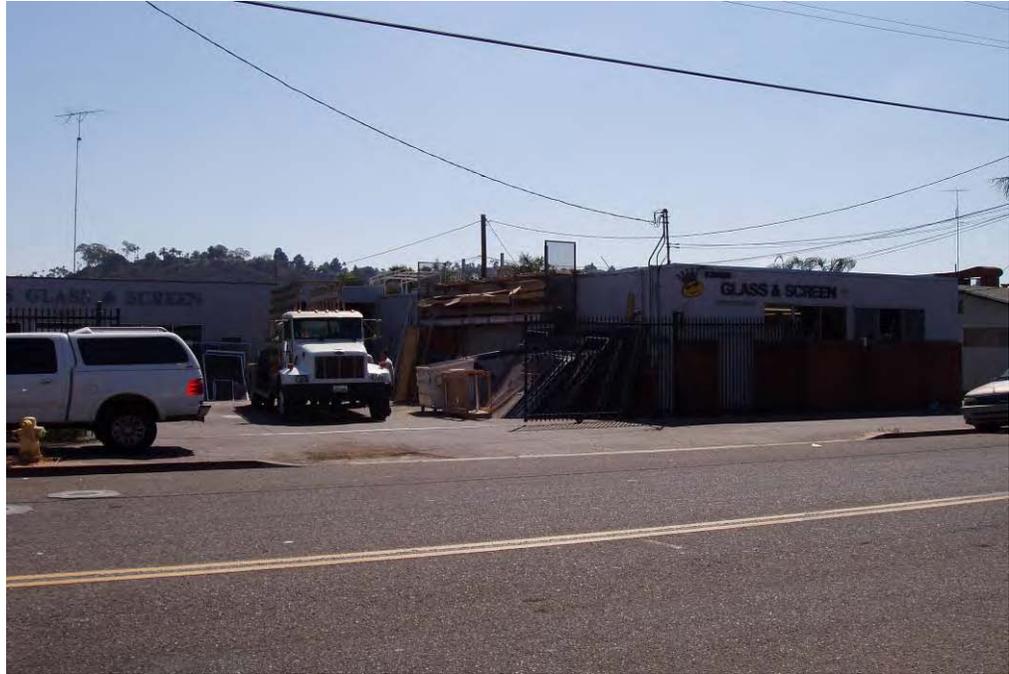
Parcel Number – 461 160 08

This glass and screen installation company has outdoor storage of its materials, where broken glass can also create a hazardous condition. Further, this activity detracts from the overall appearance of the area and reduces on-site parking for employees and customers.

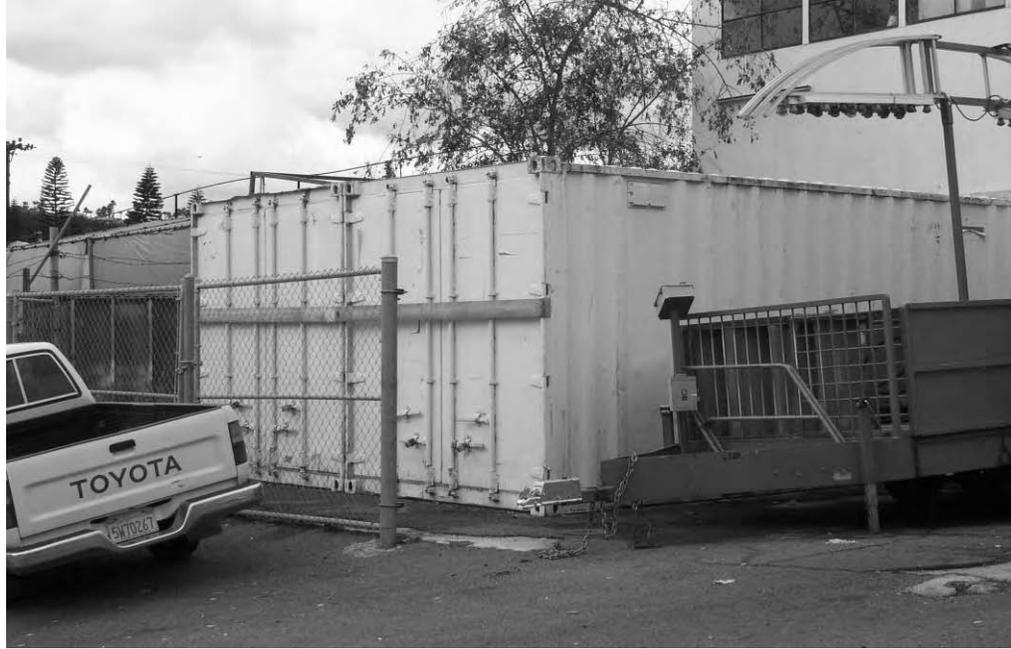
Parcel Number – 458 521 26

This industrial parcel is only 50 feet wide, which is too narrow for modern manufacturing needs. To compensate for the lack of building area the business is using steel containers for storage which reduce on-site parking.

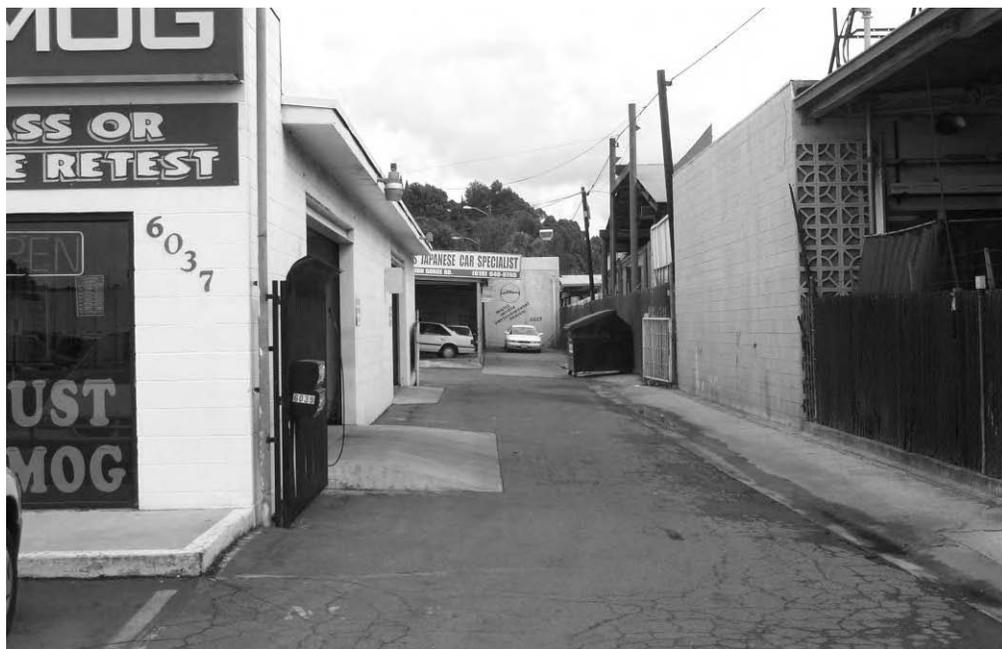
Parcel Number – 461 200 02

Narrow access between multiple businesses is an obsolete and unsafe design that would not meet current development standards.

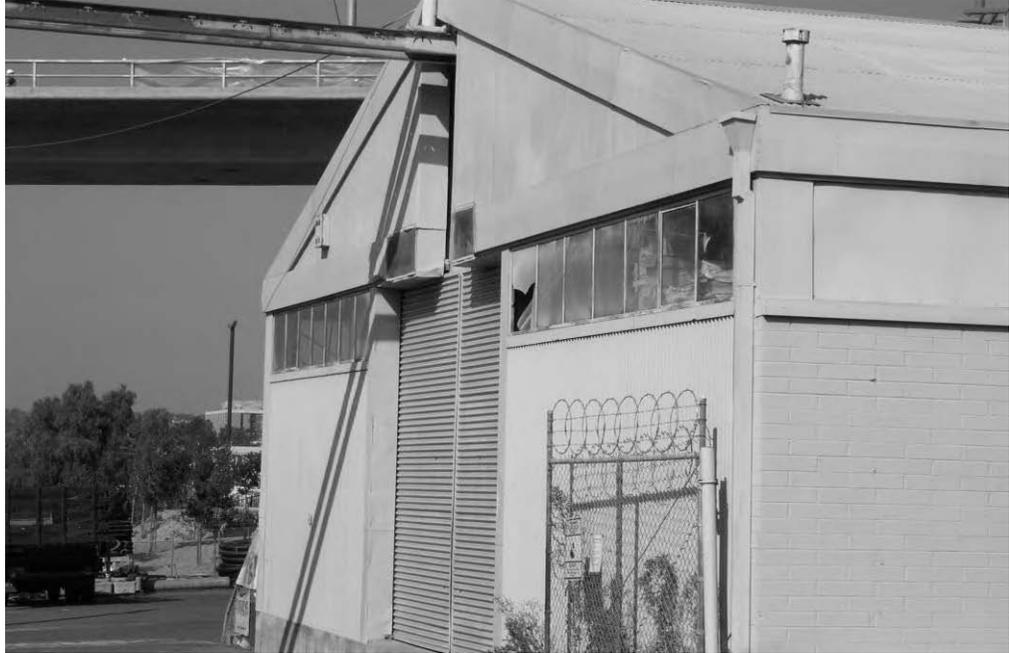
Parcel Number – 461 320 23

Obsolete industrial building with substandard corrugated metal building material.

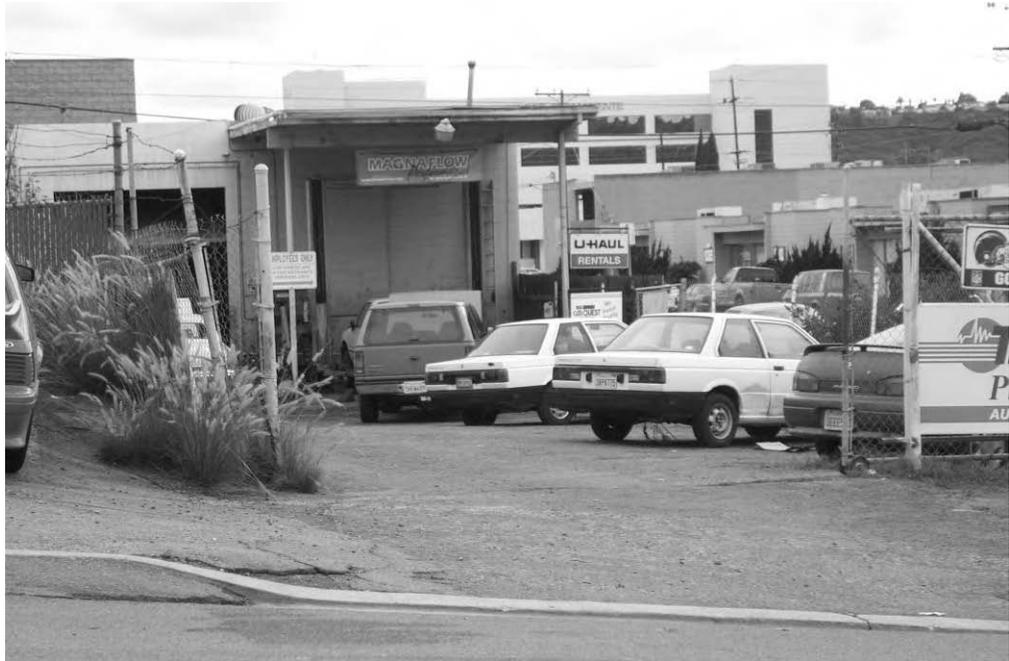
Parcel Number – 458-521-17

The lack of lot area, deterioration along with lack of parking and loading all contribute to the obsolescence demonstrated by this building. It appears to be vacant, thereby establishing the negative economic affect of obsolescence.
