INDIVIDUAL BIOLOGICAL ASSESSMENT REPORT

Site Name/Facility: Alvarado Channel Sections 01 and 02, and 06 and 07 of 07

MSWSMP Map No.: 59, 60, 63, and 64

Date: 4 October 2010

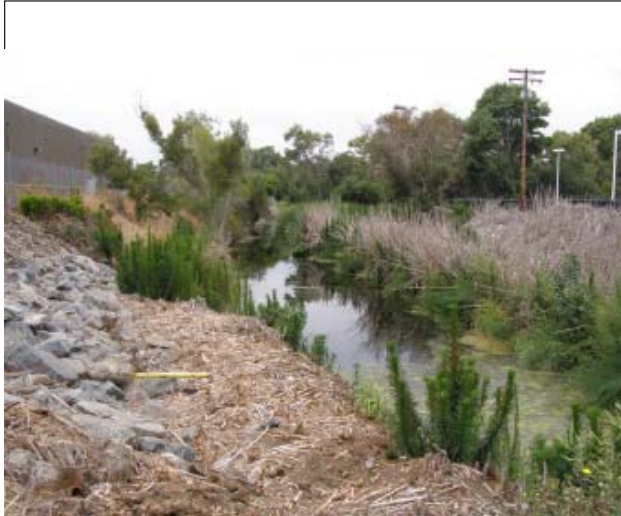
PHOTO NOTES:
Unlined channel with streambed (open water), disturbed wetland, and disturbed habitat present on channel banks. Looking west from half way between west end of Map 59 and Mission Gorge Road.

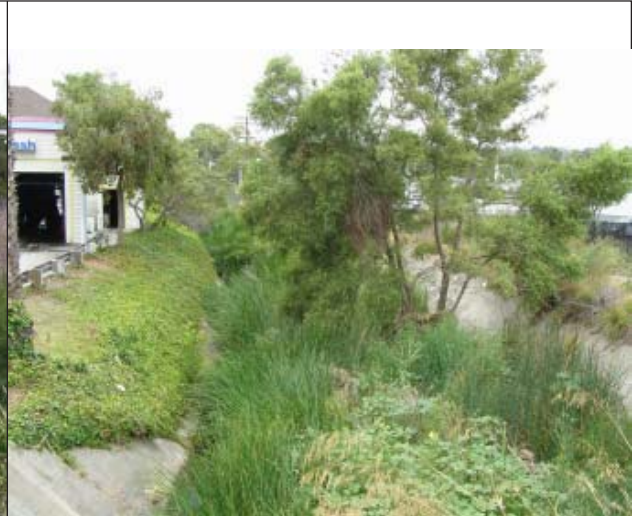
PHOTO NOTES:
Concrete lined channel with freshwater marsh, southern willow scrub, and disturbed wetland. Looking west from Mission Gorge Road.

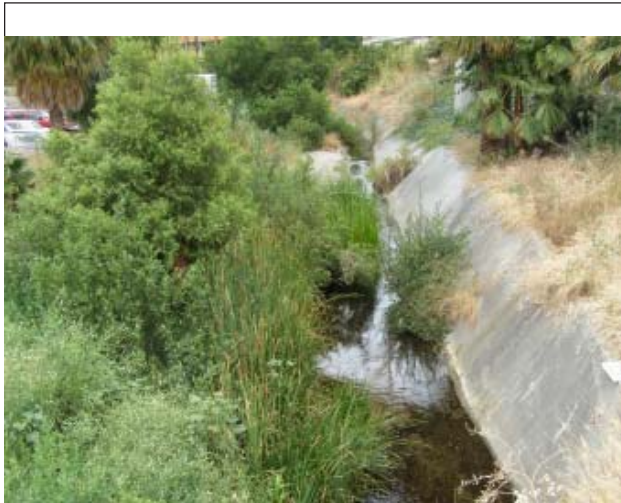
PHOTO NOTES:
Concrete lined channel with southern willow scrub, disturbed wetland, and non-wetland Waters of the U.S. Looking east from Mission Gorge Road.

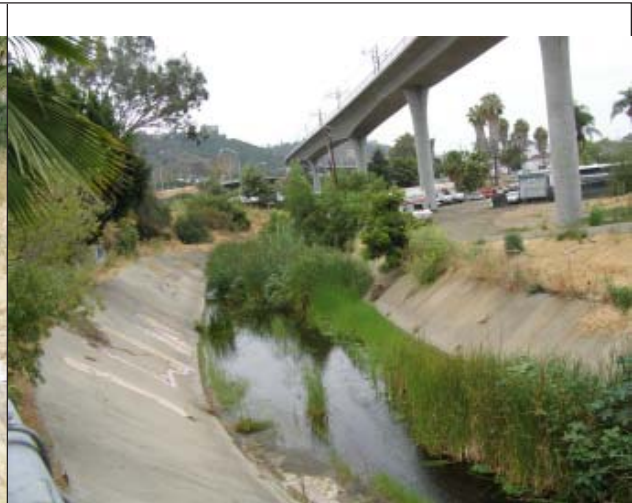
PHOTO NOTES:
Concrete lined channel with disturbed wetland, and non-wetland Waters of the U.S. Looking west from under MTDB Trolley Tracks.

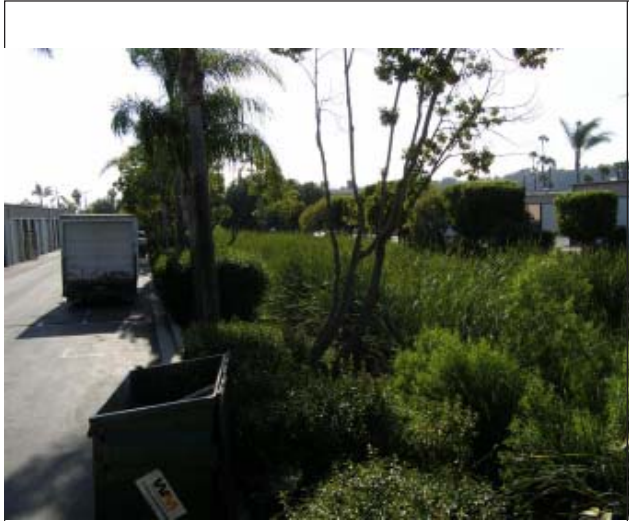
PHOTO NOTES:
Concrete lined channel with freshwater marsh. Looking west along south side from eastern end of Map. This channel begins at west end of box culverts.

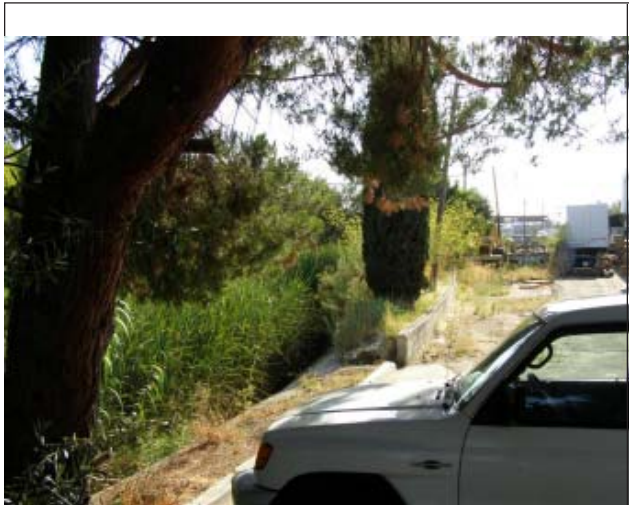
PHOTO NOTES:
Concrete lined channel with freshwater marsh. Looking west along north side from 375 feet west of eastern end of Map.

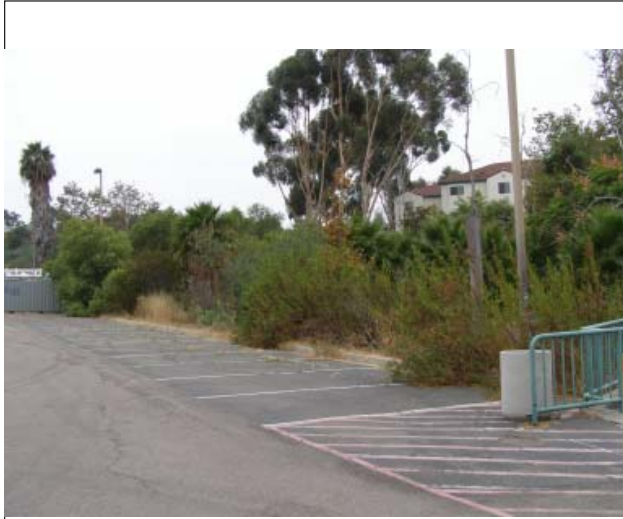
Unlined channel with mule fat scrub and disturbed Diegan coastal sage scrub along upper channel bank, disturbed southern riparian forest in central part of channel. Looking south, along eastern side of channel, from SDSU parking lot near northern end of Map 63 study area.

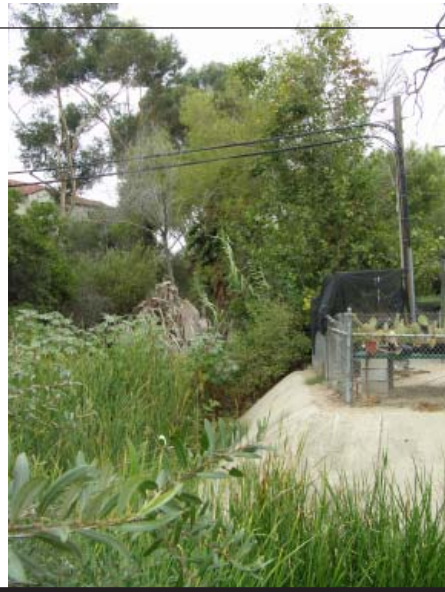
Foreground with freshwater marsh is part of Map 64. The disturbed southern riparian forest in the background is the south end of Map 63. The channel is either unlined, or rip rap lined and buried sediment. Looking north from parking lot adjacent to west end of Map 64.

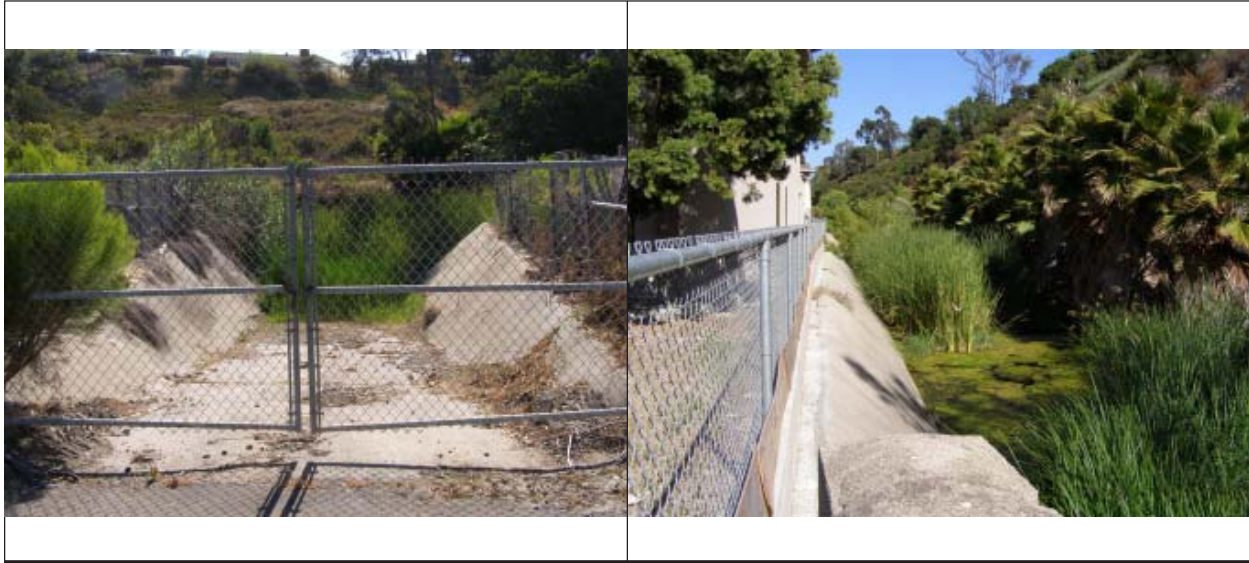
Concrete lined access ramp to Map 64. Located at western end of Map 64. Looking west, from adjacent parking lot.

Channel is concrete lined on the bottom and along north side. South side appears to be unlined or rip rap lined and buried in sediment. Freshwater marsh and non-wetland Waters of the U.S. are present in channel bottom. Disturbed wetland present along southern edge of channel. Looking east along north side of channel near west end of Map 64.

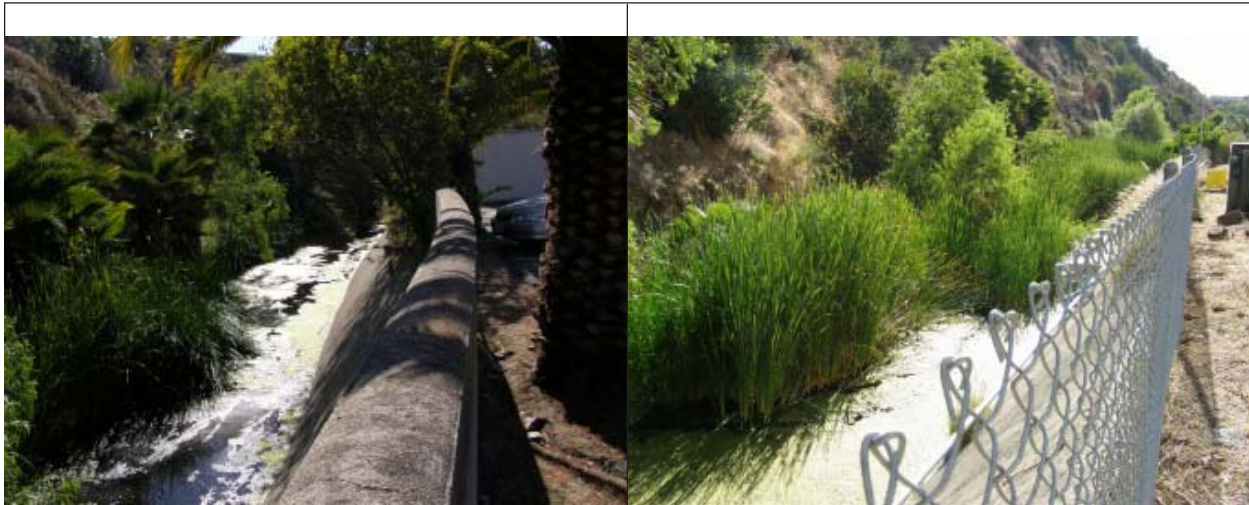
Channel is concrete lined on the bottom and along north side. South side appears to be unlined or rip rap lined and buried in sediment. Freshwater marsh and non-wetland Waters of the U.S. are present in channel bottom. Disturbed wetland present along southern edge of channel. Looking west from near west end of Map 64.

Channel is concrete lined on the bottom and along north side. South side appears to be unlined or rip rap lined and buried in sediment. Freshwater marsh, southern willow scrub, and non-wetland Waters of the U.S. are present in channel bottom. Looking west along north side of channel from east end of Map 64 study area.
