The City of San Diego M E M O R A N D U M

SUBJECT: Sole Source Agreement for Emergency Repairs for Cook's Crack Sea Cave Soil Stabilization

COASTAL EROSION ASSESSMENT AND CAVE SOLUTION FEASIBILITY ANALYSIS COAST BOULEVARD AND COOK'S CRACK SEA CAVE SAN DIEGO, CALIFORNIA

GEOTECHNICAL SURVEY & EVALUATION COOK'S CRACK SEA CAVE SAN DIEGO, CALIFORNIA

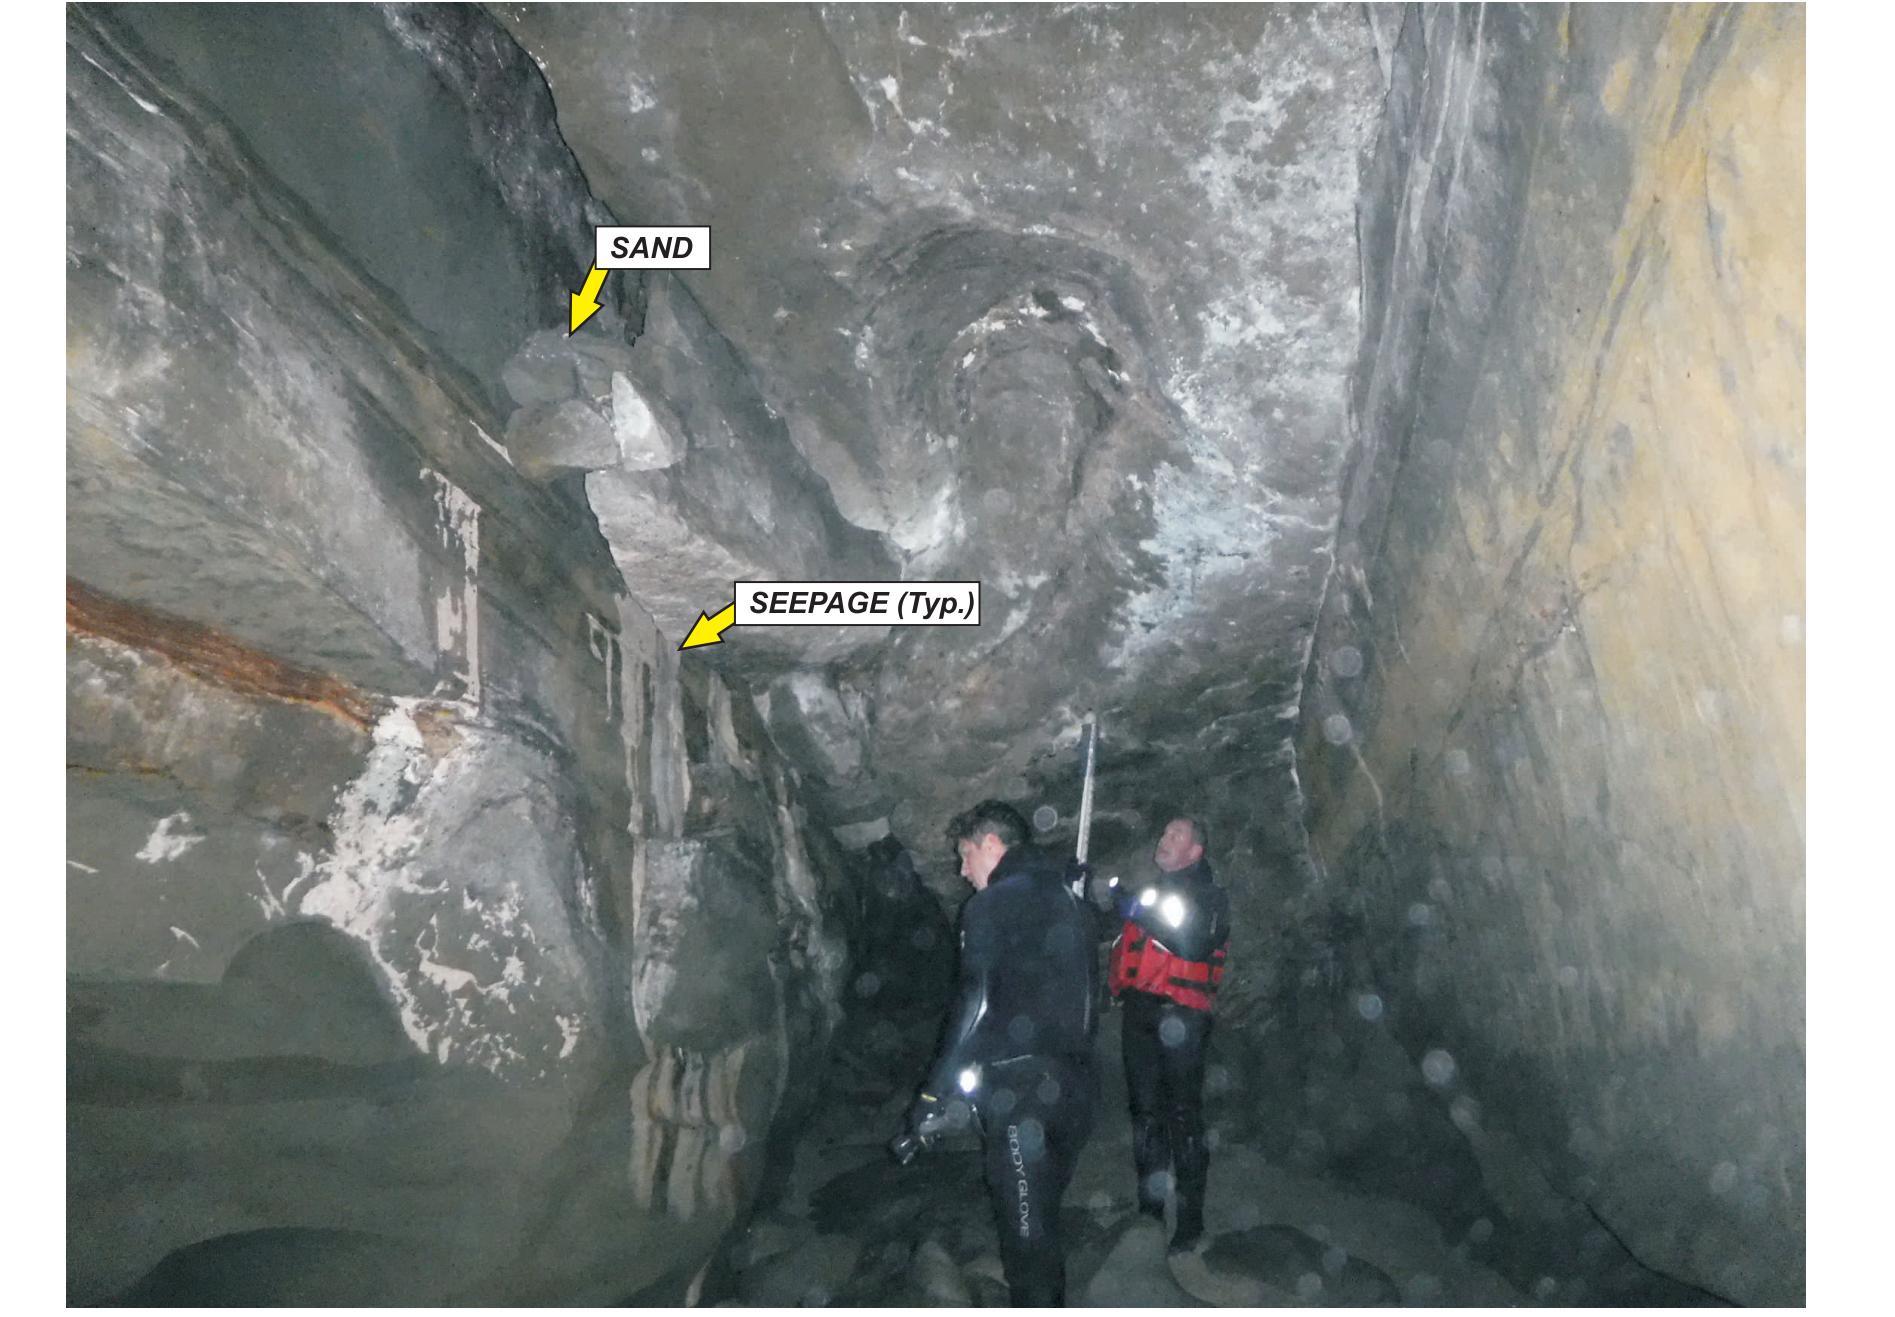
рното NC **1**

As indicated on Photo 1, the Cook's Crack Sea Cave is located on a cliffed section of the La Jolla shoreline, with the bathymetry immediately fronting the sea cave, although somewhat variable, around -3 feet MLLW. Photo 4, taken during our survey during a tidal low with the water level at about -0.2 foot MLLW, shows an indentation into the cliffed shore face of about 9 feet prior to actually entering the 4½-foot-wide mouth of the sea cave that is still not visible in Photo 4. The width of this indentation is also about 9 feet, and provides

We anticipate that the contractor would fill the cave in relatively horizontal lifts, and after the tops of the geobags have been reached, the exposed seaward face of the open jointed roof of the Cook's Crack Sea Cave (see Photo 1) would then be architecturally shaped to blend in with the surrounding formational bedrock to recreate the architectural appearance of the faulted roof rock. Once the cave is filled, the ten to twelve 4-ton rocks could be lifted back out of the mouth of the cave, returning the cliffed section to that shown in Photo 4.

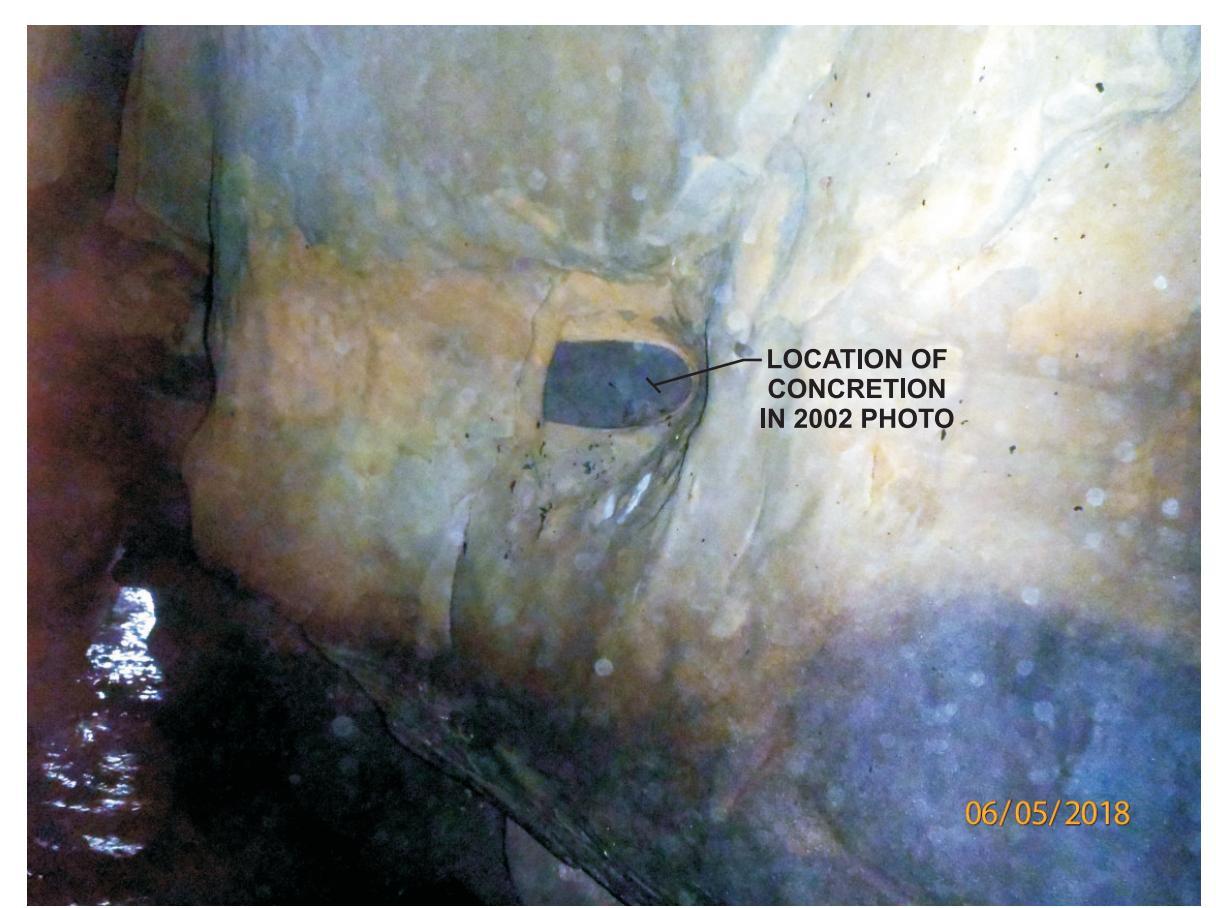
PHOTO 2: NOTE LARGE CONCRETION IS GONE, AND WALLS HAVE ERODED BACK AND WIDENED.

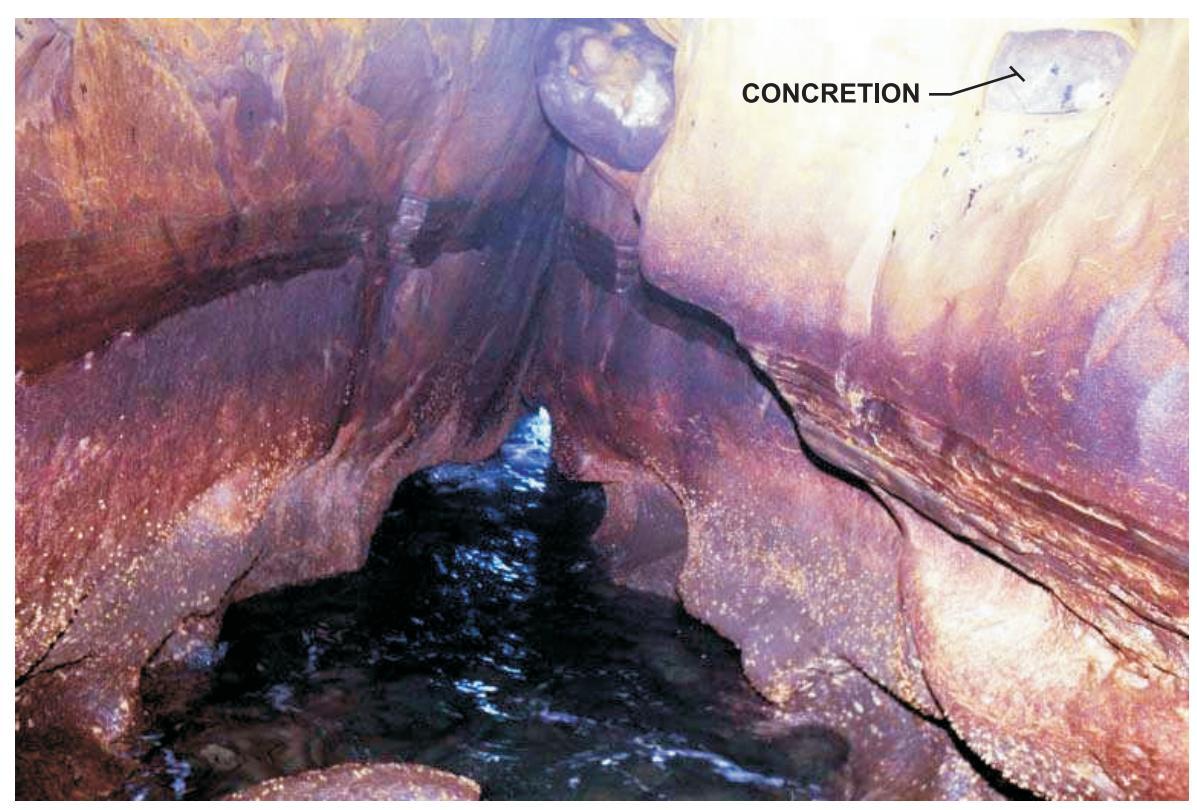
PHOTO 2A: (2002) LOOKING OUT. NOTE EXISTING CONCRETION AT UPPER EDGE OF PHOTO.

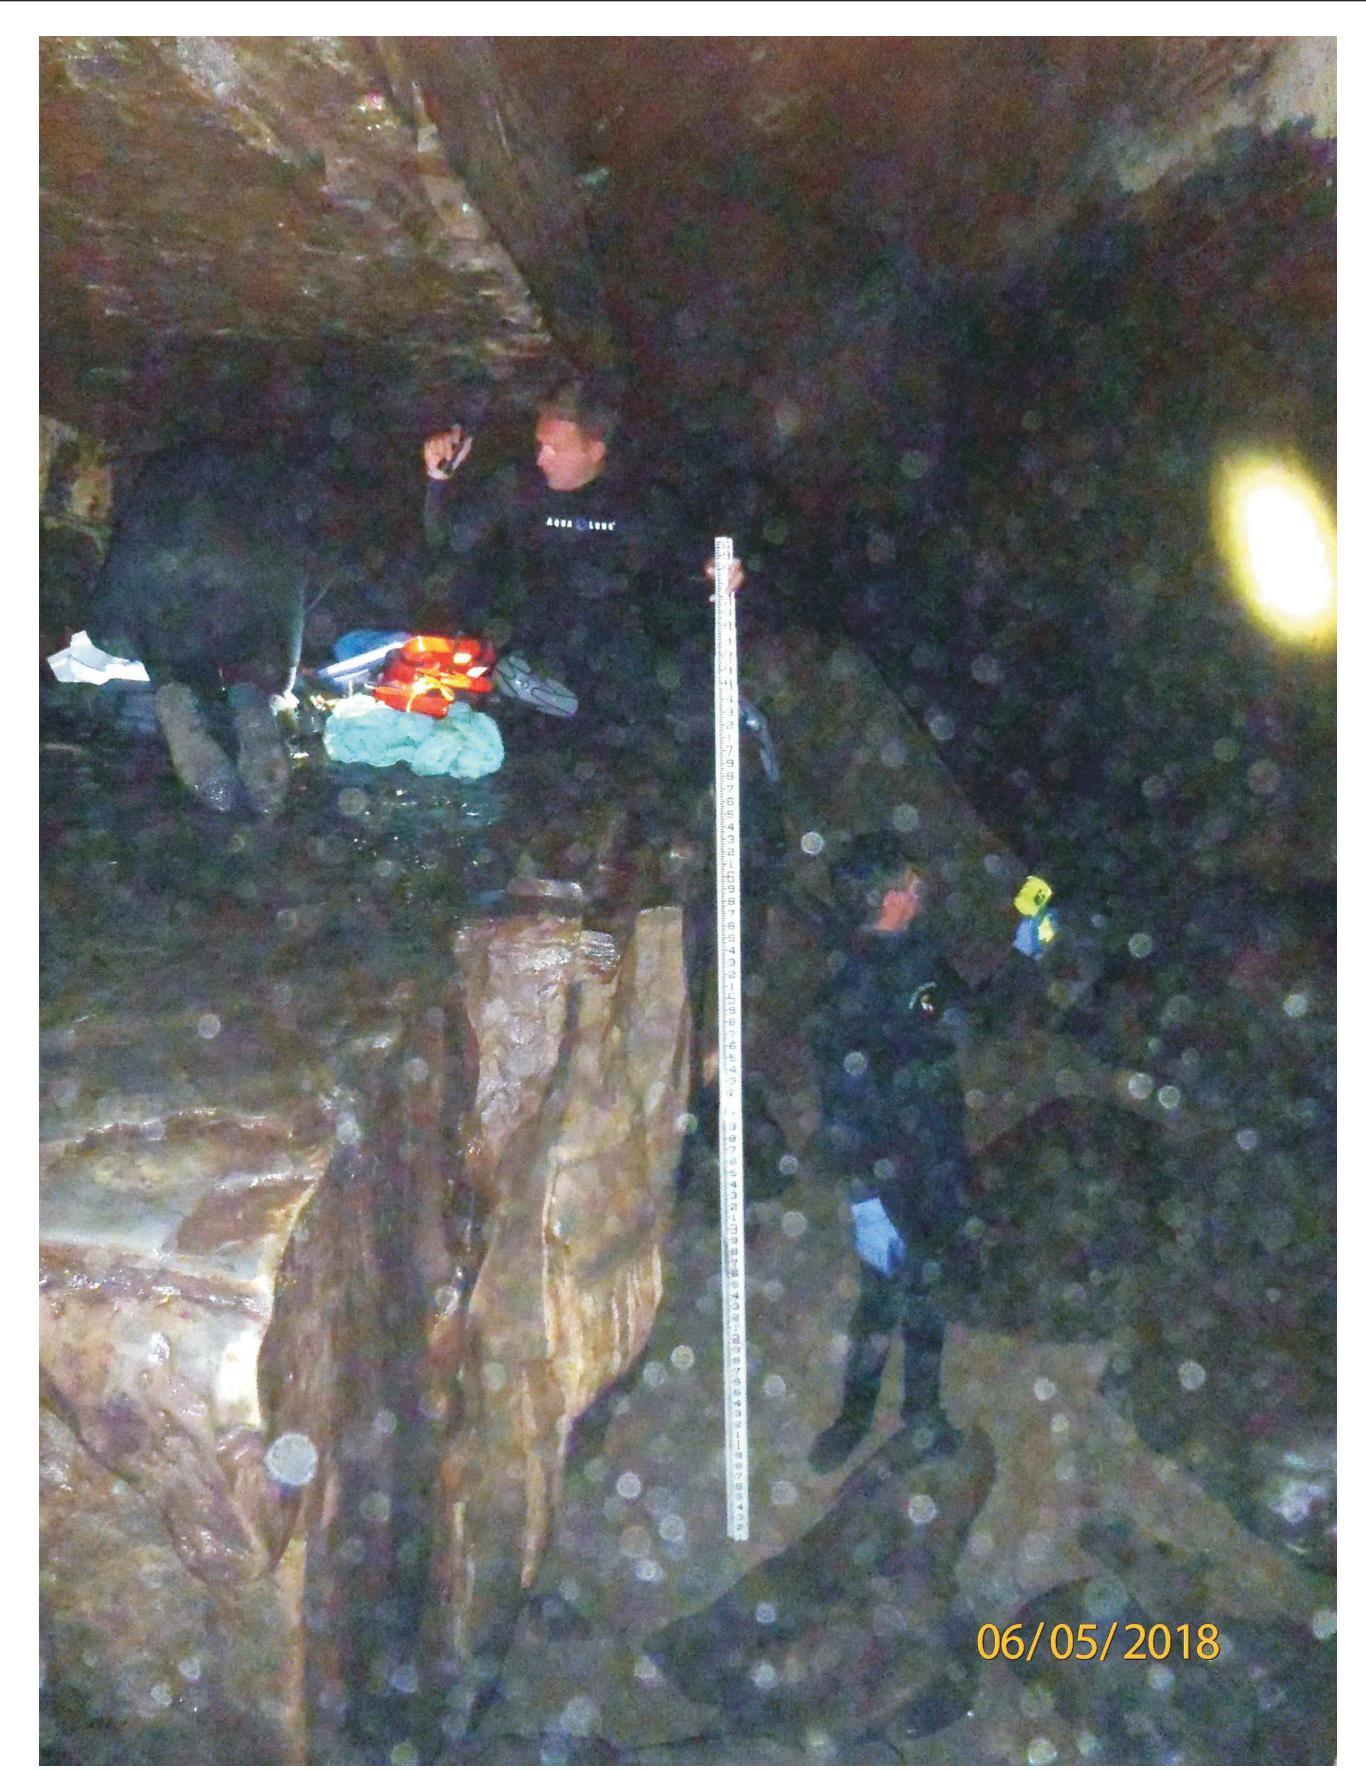
PHOTO 3: MAIN BLOCK SEEN IN 2002 SURVEY STILL MOSTLY INTACT. A CAVITY HAS DEVELOPED, UNDERMINING THE SOUTHERLY SIDE OF THE BLOCK.

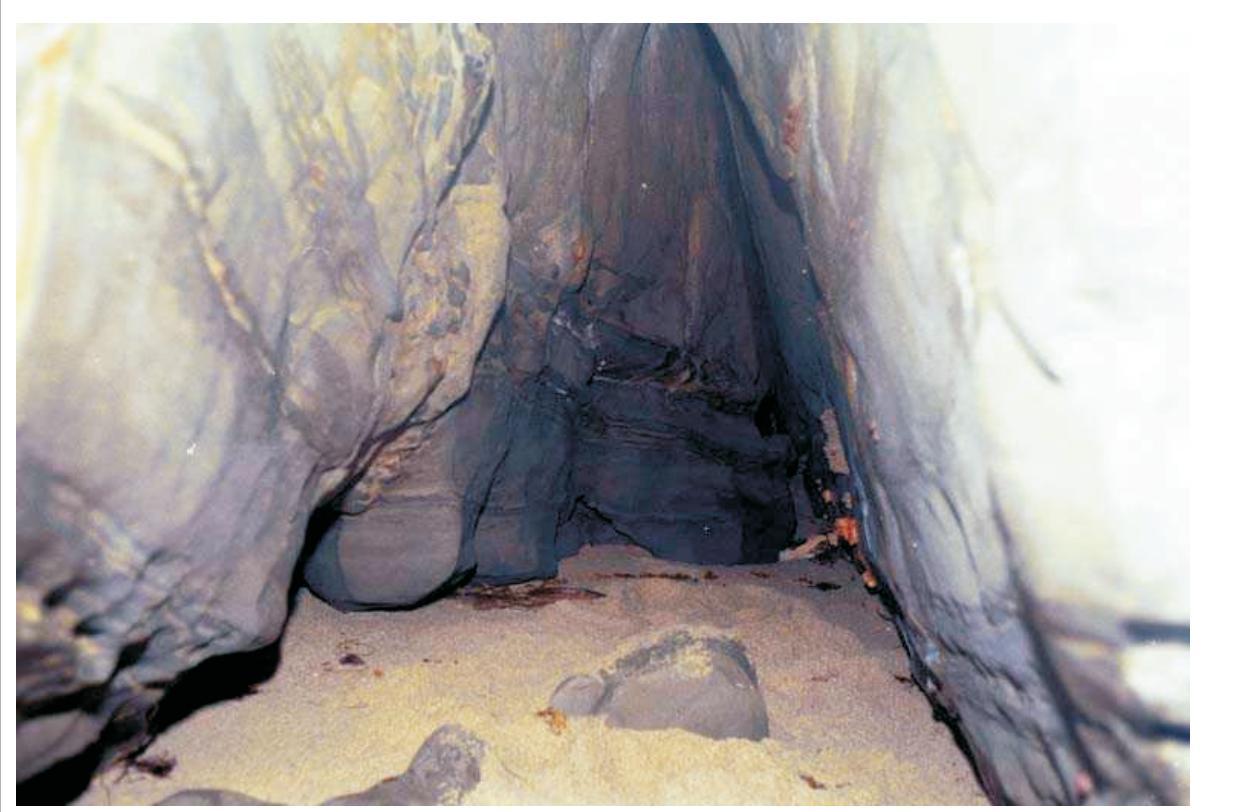
PHOTO 4: TAKEN IN 2002.

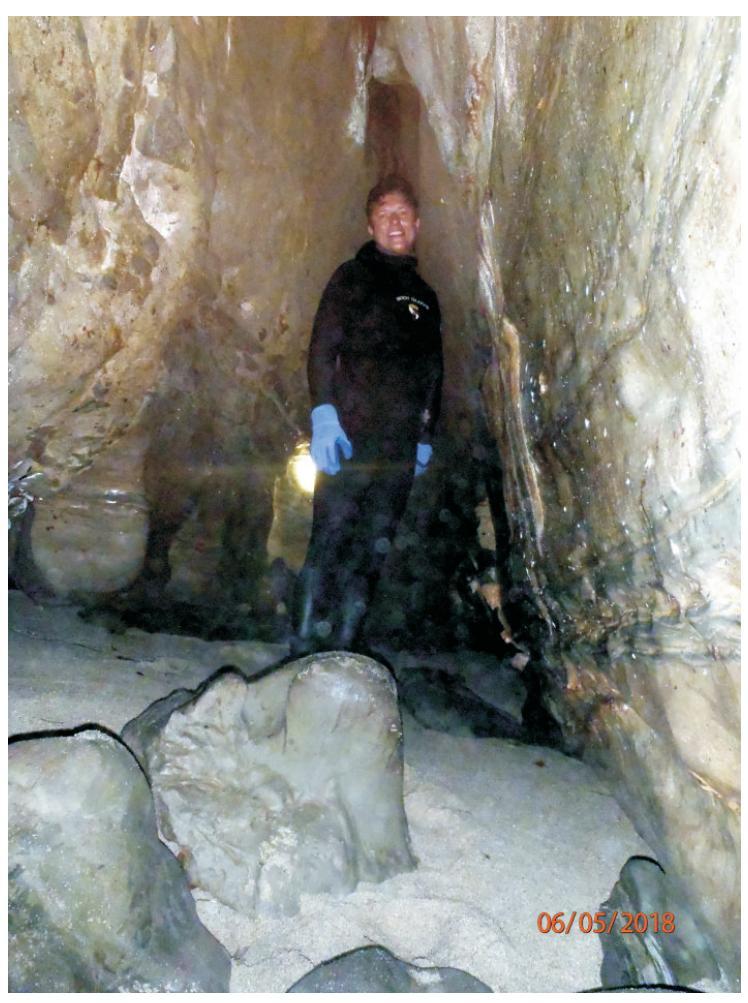
PHOTO 4A: NOTE SAND LEVEL HAS DROPPED1.5 TO 5 FEET.

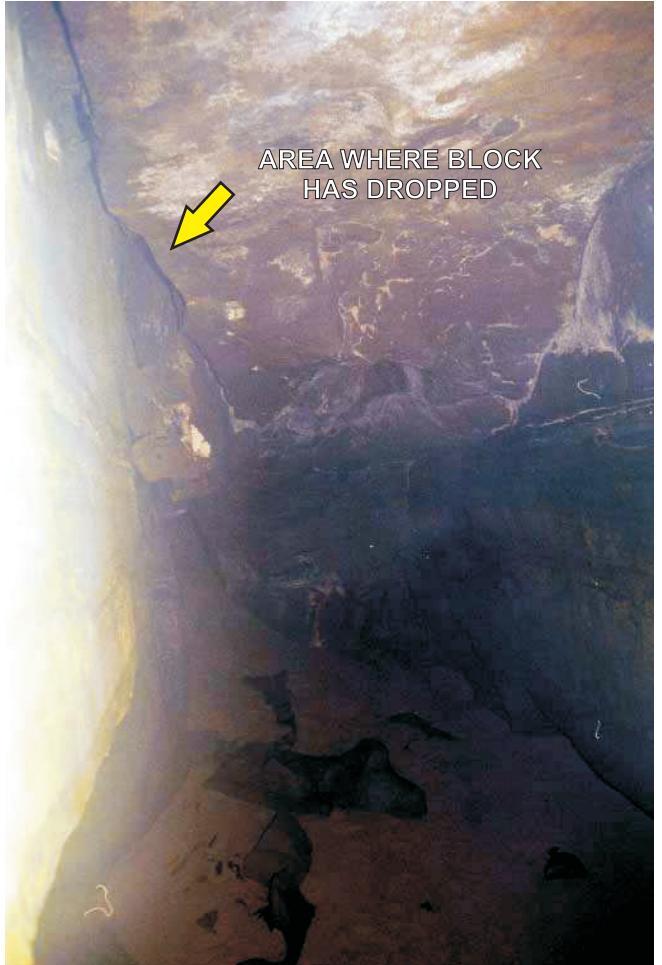
PHOTO 5: (2002) NOTE AREA PRIOR TO RECENT ROOF BLOCK FAILURE.

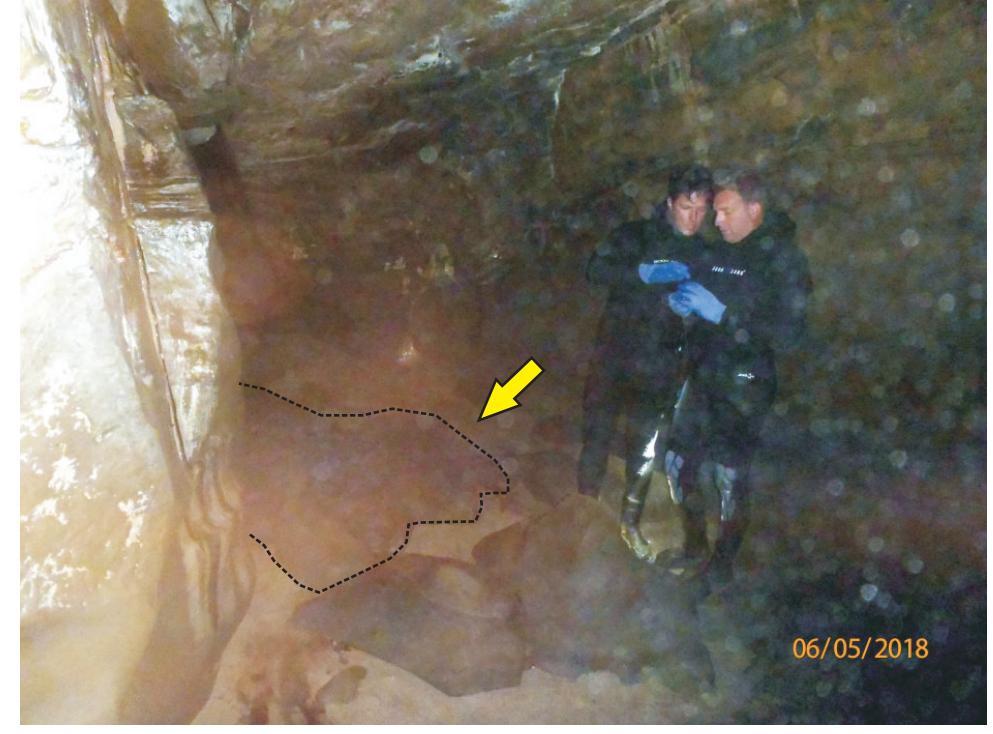
PHOTO 5A: NOTE APPARENT RECENT ROCK DEBRIS (ARROW).

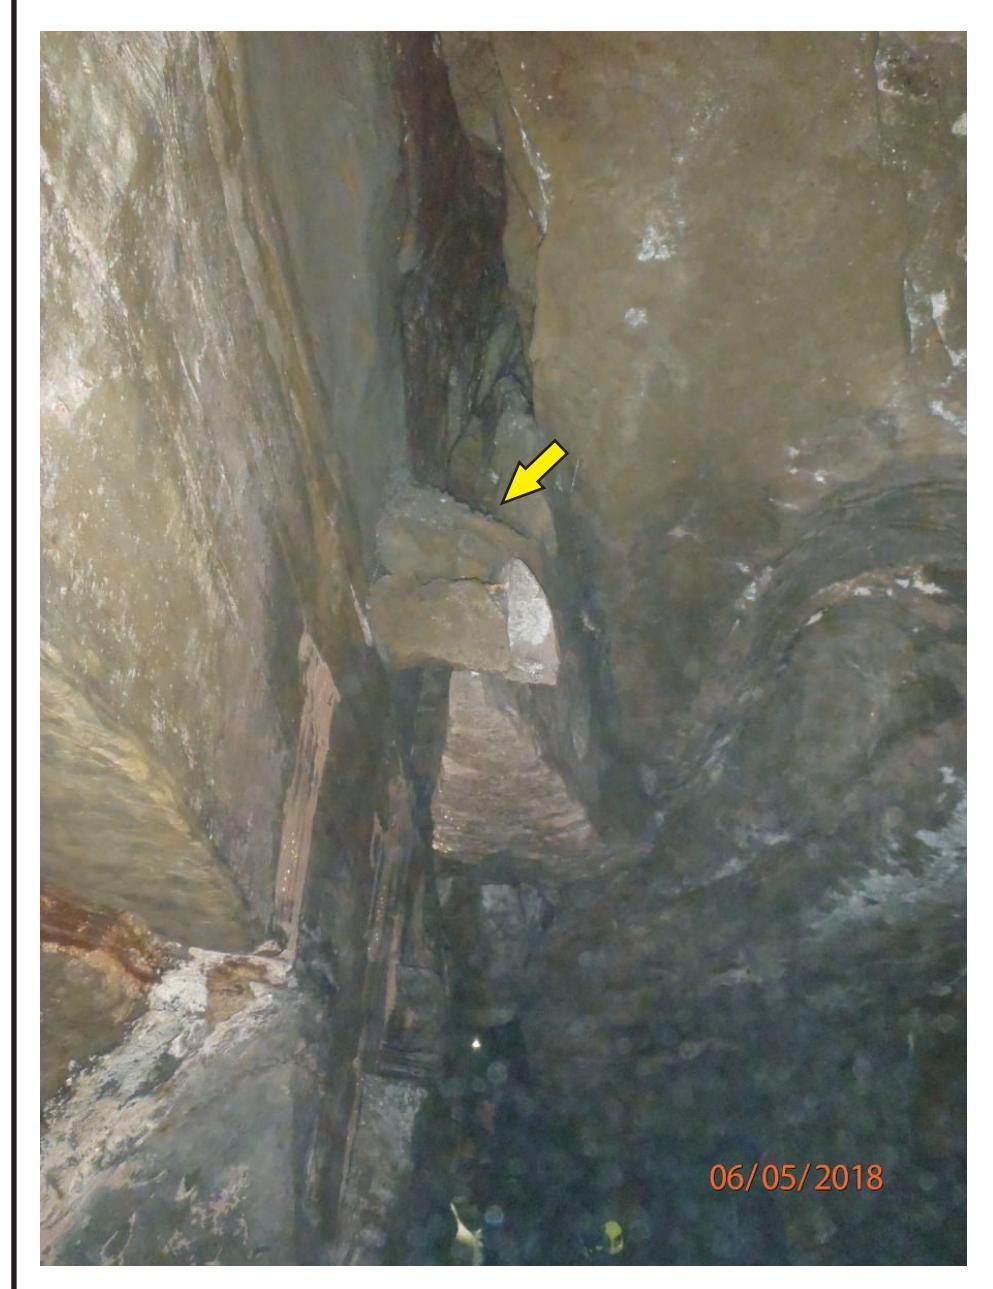
PHOTO 6: ARROW INDICATES DOWN DROPPED BLOCK. NOTE SAND ON TOP OF BLOCK.

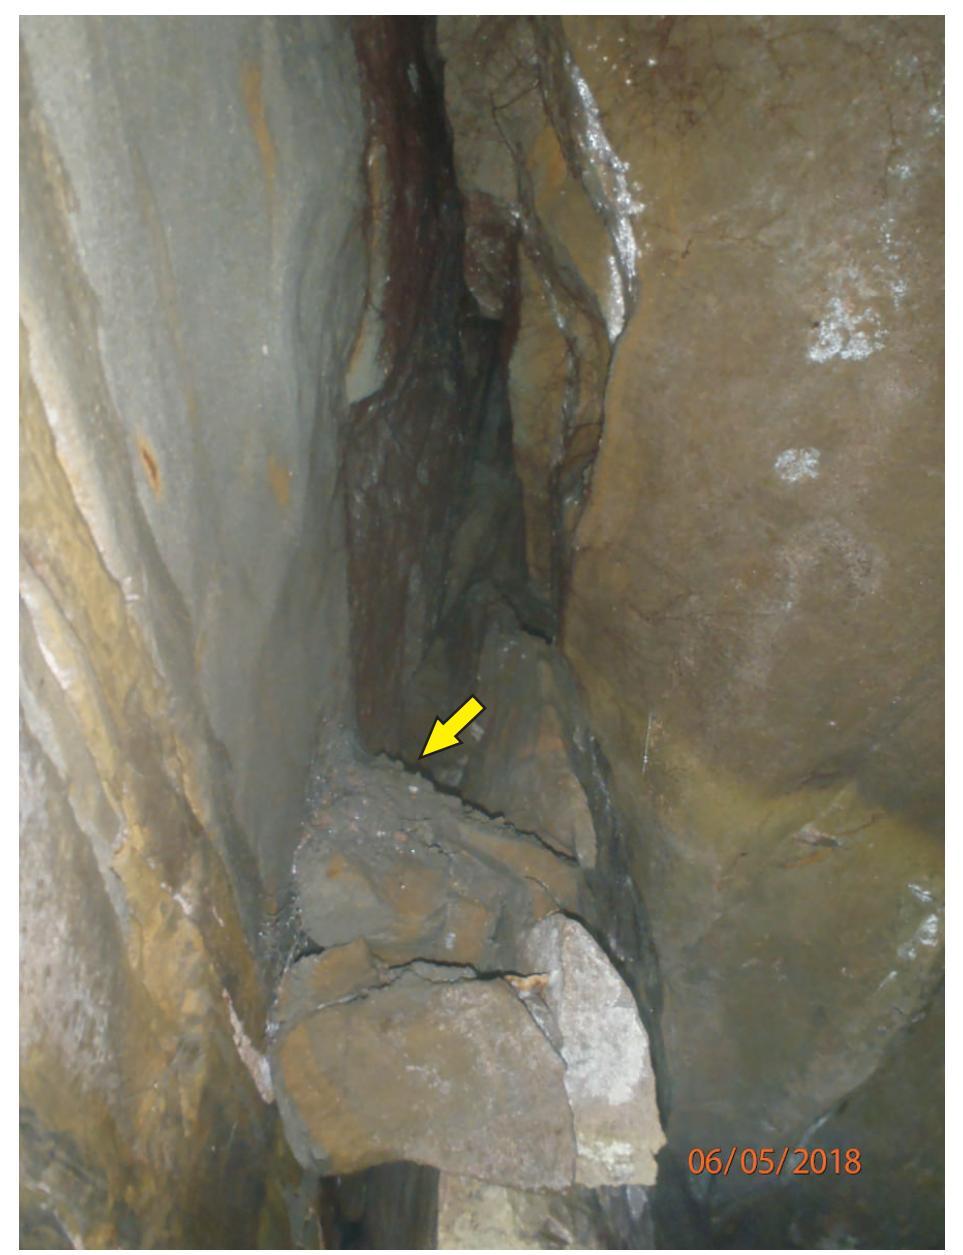
PHOTO 6A: NOTE SAND PIPING FROM OVERLYING TERRACE DEPOSITS (ARROW).

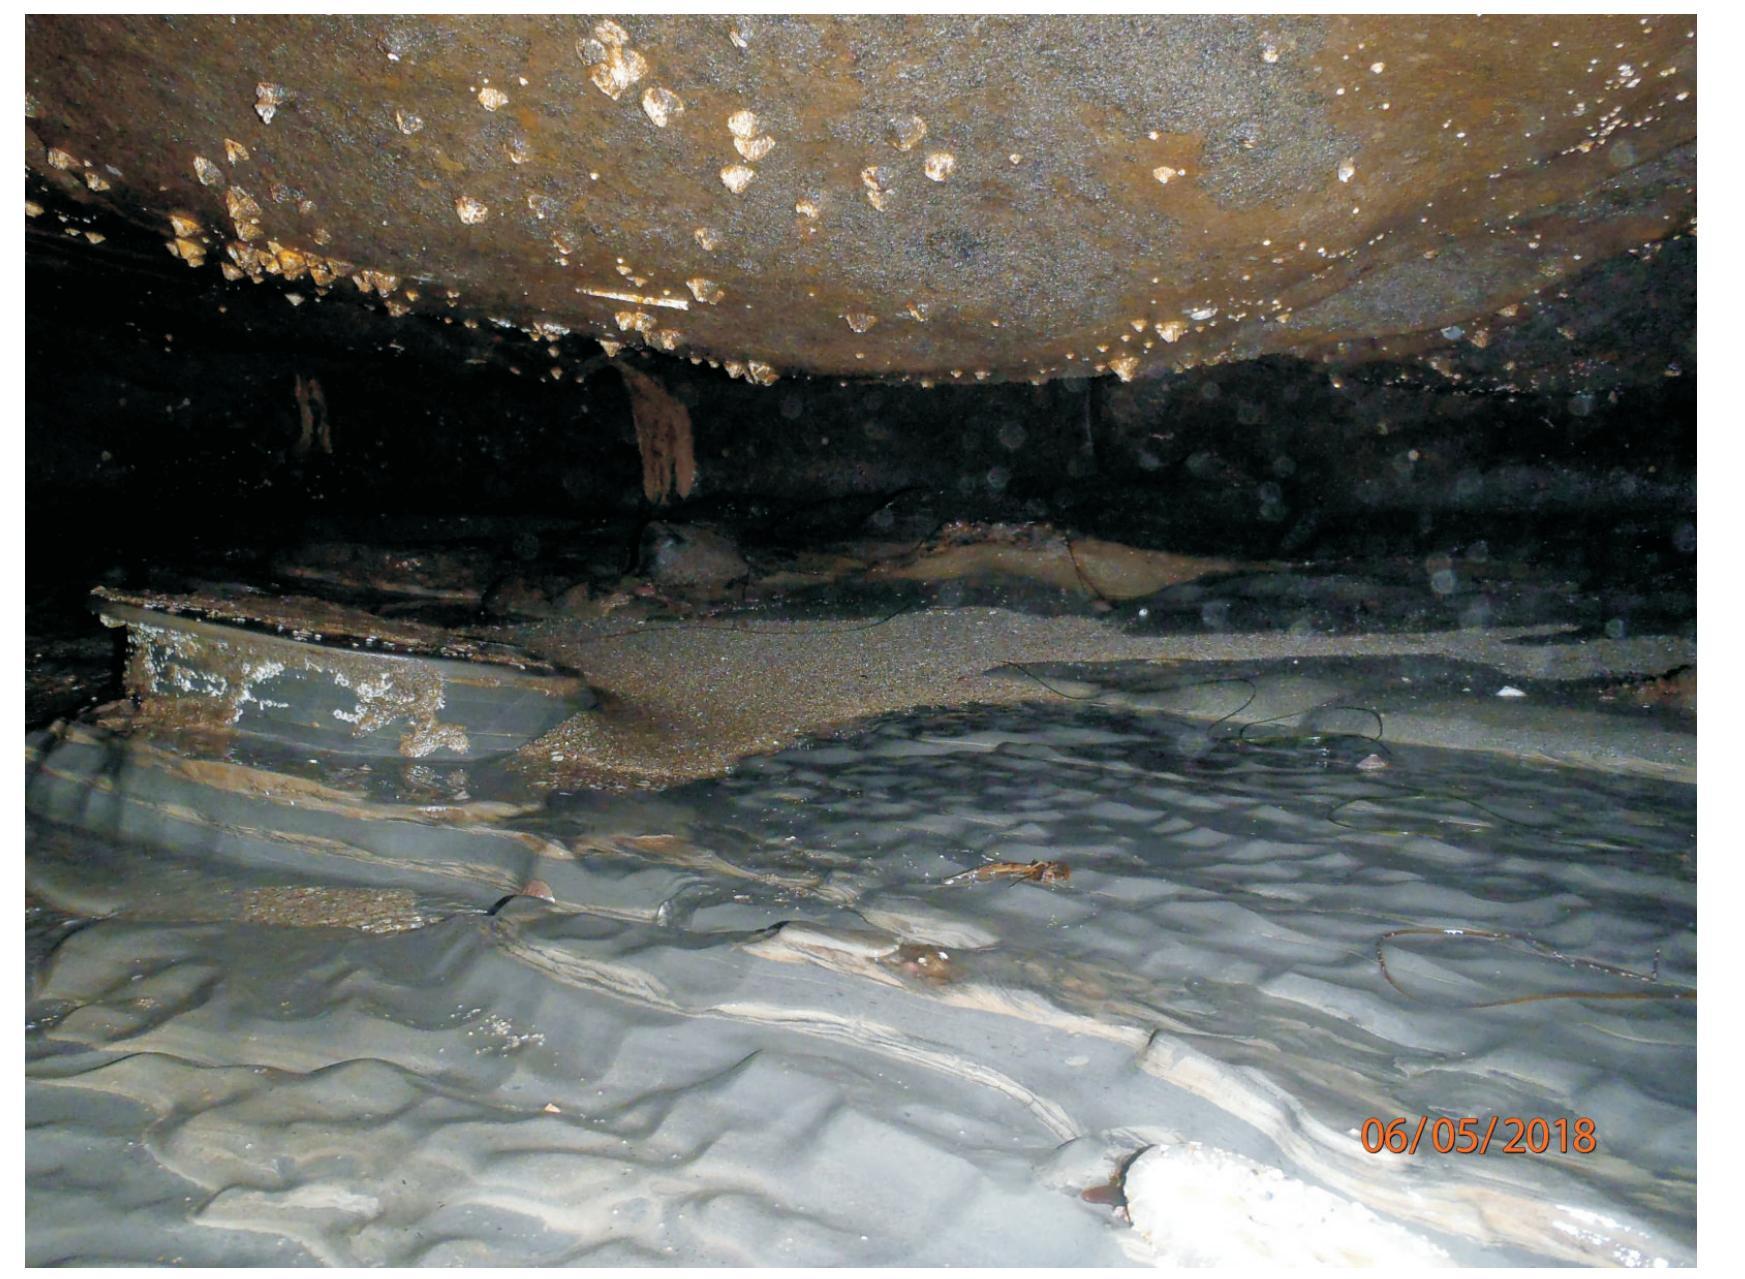
PHOTO 8: NORTHWEST CAVE EXTENSION
