# Master Storm Water System Maintenance Program Annual Report

City of San Diego

Transportation & Storm Water Department Storm Water Division

September 2015

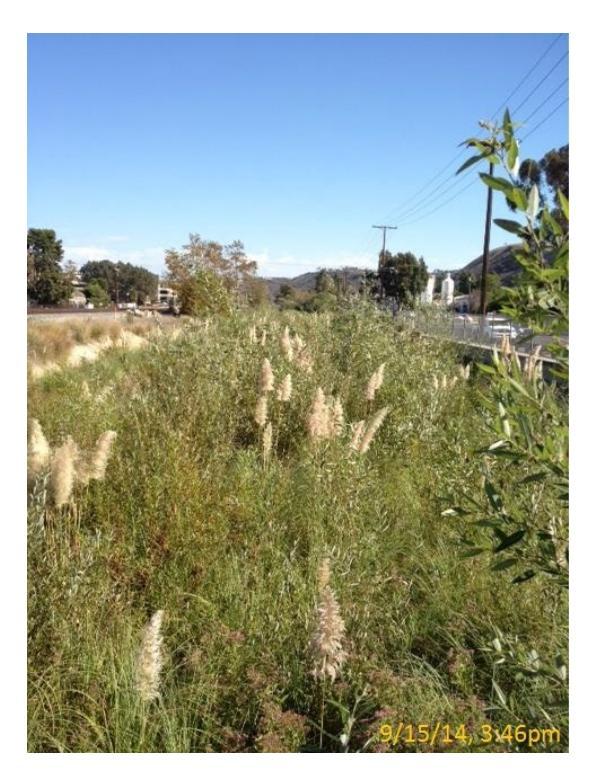
The Sorrento/Soledad/Flintkote Channel Maintenance Project was fully permitted in March 2014 to remove 125 – 175 cubic yards of accumulated vegetation and sediment from the 11000 Roselle Street/11100 Flintkote Avenue Channel (MMP Map 9; also referred to as Reach<sup>3</sup> 7), a concrete lined facility, and 2,000–4,000 cubic yards of accumulated vegetation and sediment from the Soledad Canyon/Sorrento Creek Channel (MMP Maps 11 and 12; also referred to as Reach 3)Prior maintenance occurred under emergency conditions in 2011 in Reach 3. Vegetation and sediment coverage were noted at 40% and 60%, respectively, and, based upon post-maintenance photographs, over 95% of vegetation and 80% of sediment was removed. In the 2013 IHHA for Reach 3, it was observed that sediment deposited along the channel bed varied from approximately 18 inches at its downstream end to a very minimal amount at the upstream end. Some sections contained pebbles and cobbles up to 3 inches in diameter, mixed in with silty sands that were observed to a depth of 12 inches. In general, the downstream end, where the sediment deposition is the deepest, supported the most dense vegetation. Based on pre-maintenance and post-maintenance photos, this accumulation of vegetation and sediment equated to approximately 80% sediment coverage and approximately 10% vegetation coverage.

Photo 1. Sorrento Creek Reach 3 Pre-Maintenance 9/15/14

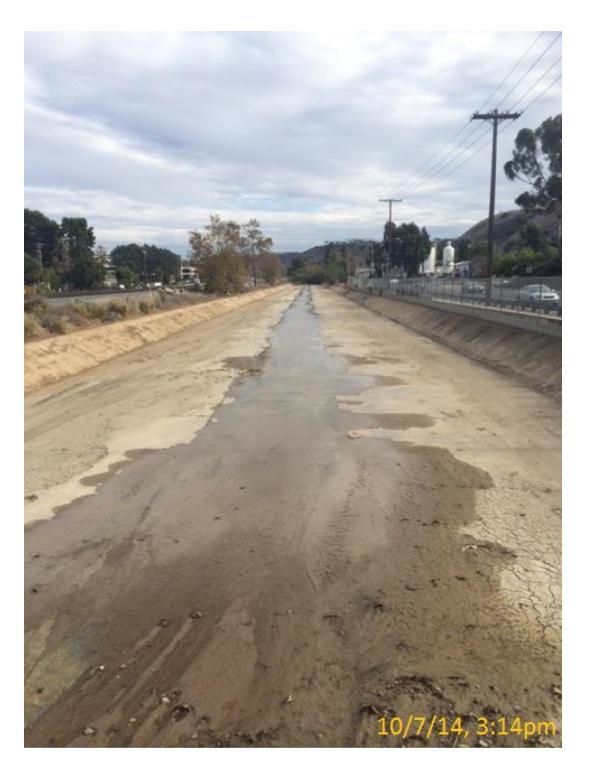
Maintenance was conducted in Reach 7 in FY2014 and included the removal of 108.10 tons of material from 0.12 acres. More details regarding this maintenance event can be found in the FY2014 MMP Annual Report. Project maintenance activities during FY2015 were completed for a 2,300 linear feet portion of Reach 3 between September 16 and October 2, 2014. During this period, crews removed approximately 3,135 tons of sediment and vegetation from the channel using mechanized equipment. Approximately 770 linear feet of the site was revisited during a second maintenance effort which took place March 11 through March 14, 2015, and included the removal of an additional 343 tons of material, bringing the total amount of vegetation and sediment removed from Reach 3 to 3,478 tons. All BMPs (gravel bags, authorized access routes, etc.) were implemented during maintenance and removed following completion of maintenance. Photographs showing pre- and post- maintenance vegetation are included in Appendix C. Maps displaying pre- and post-maintenance vegetation are included in Appendix D.

Photo 2. Sorrento Creek Reach 3 Post-Maintenance 10/7/14

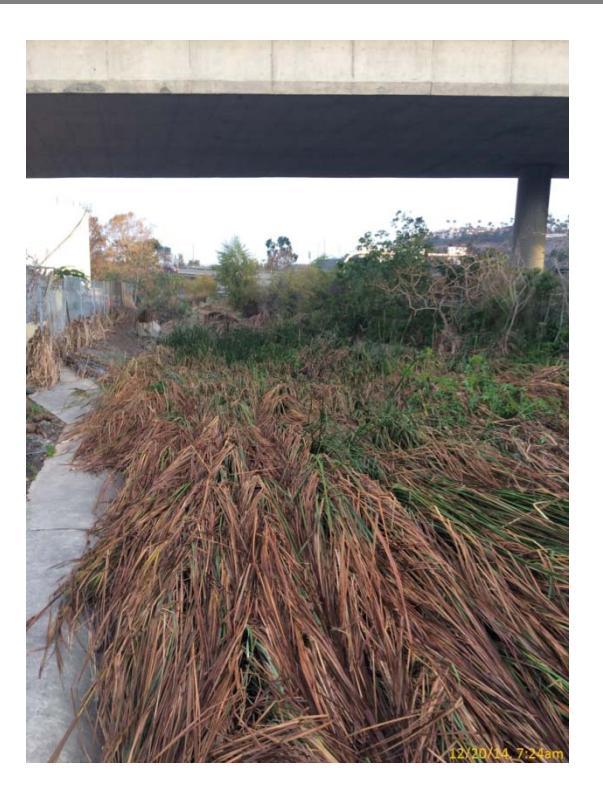
The pre-project IHHA results indicated that Murphy Channel could not contain a 2-year storm event in the pre-project condition. With sediment and vegetation removed, the conveyance capacity increased to convey the 5-year storm event in Reach 1 and the 50-year storm event in Reach 2.

Photo 3. Murphy Canyon Creek Channel Pre-Maintenance 12/20/14

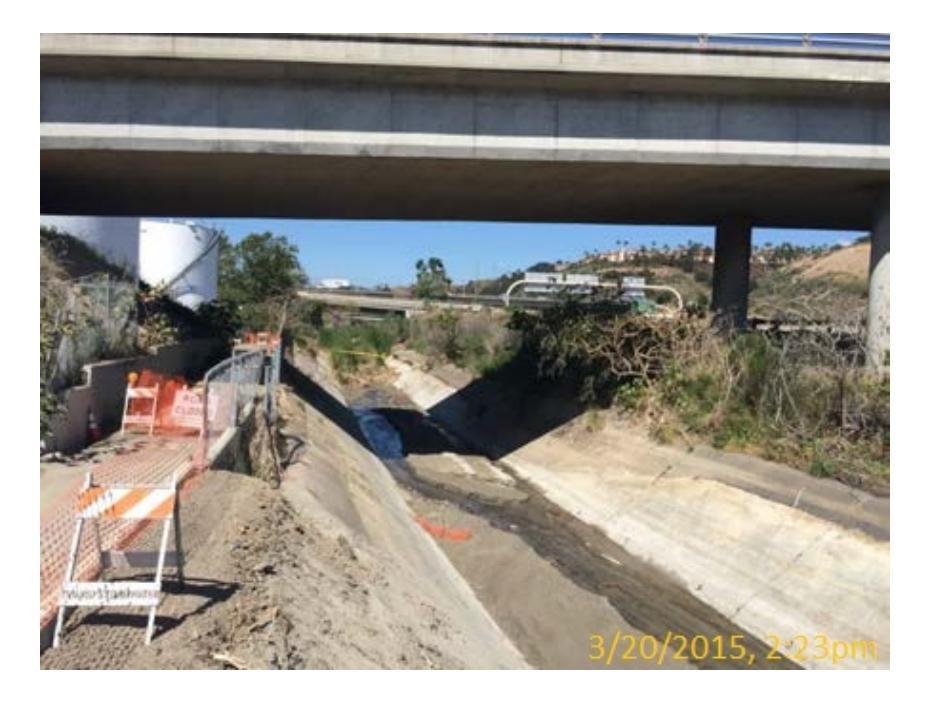
Project maintenance activities were completed in Reaches 1 and 2 from December 22, 2014 to March 14, 2015 removing approximately 10,324 tons of material. In Reach 1, 0.87 acre (1,554 linear feet) was excavated, 0.02 acre was cleared of vegetation only, and 0.20 acre was not maintained due to inundated conditions. The entire length of Reach 2, which is a concrete-lined segment, was maintained through excavation of approximately 206 linear feet. Where sediment was removed, depths ranged from three to six feet. A portion of an existing bike path in a disturbed, upland location had been undermined prior to the start of work and was repaired at the conclusion of the project. Access points used along the side of the channel were restored to adjacent bank elevations and revegetated with an erosion control seed mix.

Photo 4. Murphy Canyon Creek Channel Post-Maintenance 3/20/15

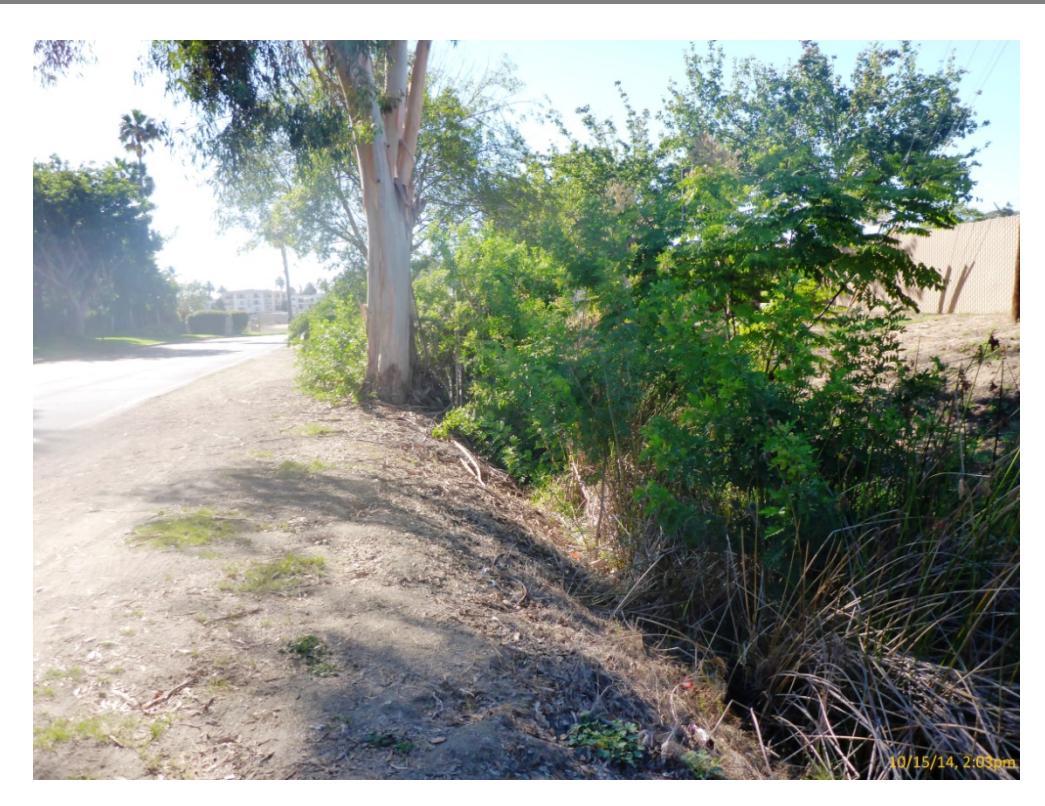
Prior maintenance activities in this channel pre-date the current documentation and tracking system for record keeping. Thus records of what occurred during past maintenance events are not presented in this report. However, the IHHA for the FY 2015 maintenance event describes vegetation and sediment accumulation observed during site visits in August 2012 and September 2013 and the conditions in the MBHS and PBO sections were slightly different. In 2012, sediment mixed with organic material was noted as having a depth of approximately three to four inches and well-established and dense freshwater marsh vegetation and non-native grasslands were observed within the MBHS channel. Additionally, the outlet of the existing 27-inch RCP storm drainpipe that discharges into the channel was significantly obstructed by the vegetation growth within the concrete channel and the side slope west of the MBHS channel, ornamental vegetation, mainly unmaintained ice plant had overgrown to the degree that it had covered the channel's west side in its entirety and, in some instances, had covered the

channel bottom and reached the east side of the channel. Comparatively, the PBO channel had similar vegetation growth, including iceplant growing from one side of the channel to the other, and sediment (also mixed with organic material) was recorded as approximately six to seven inches. In 2013, the sediment accumulation in the entire MBHS/PBO channel was unchanged, but the vegetation was noted as being significantly denser and taller since the previous visit Based upon photos in the IHHA, the premaintenance coverage for both vegetation and sediment can be considered approximately 100%.

Photo 5. Mission Bay High School and Pacific Beach/Olney Street Channels Pre-Maintenance 10/15/14

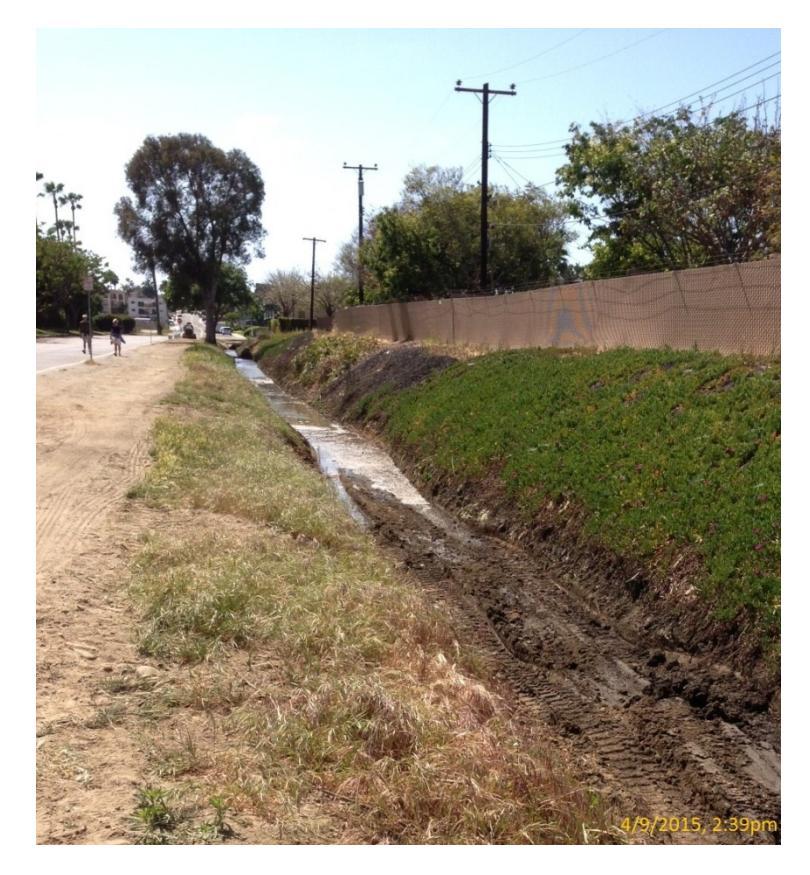
During the FY2015 maintenance event, 1,972 linear feet of material have been cleared in order to increase the conveyance capacity and reduce the extent of flooding in severe storm events. Approximately 420 tons of material have been removed and legally disposed of thus far in the maintenance period. The channel was accessed through previously disturbed staging areas, and all BMPs were implemented as part of the MMP protocol. The project is ongoing and is anticipated to be completed by fall 2015 and incorporates mitigation measures to protect nesting birds during the general avian nesting season. Photographs showing pre- and post- maintenance conditions of the channel are included in Appendix C. Maps displaying pre- and post-maintenance vegetation are included in Appendix D.

Photo 6. Mission Bay High School and Pacific Beach/Olney Street Channels Mid-Maintenance 4/9/15

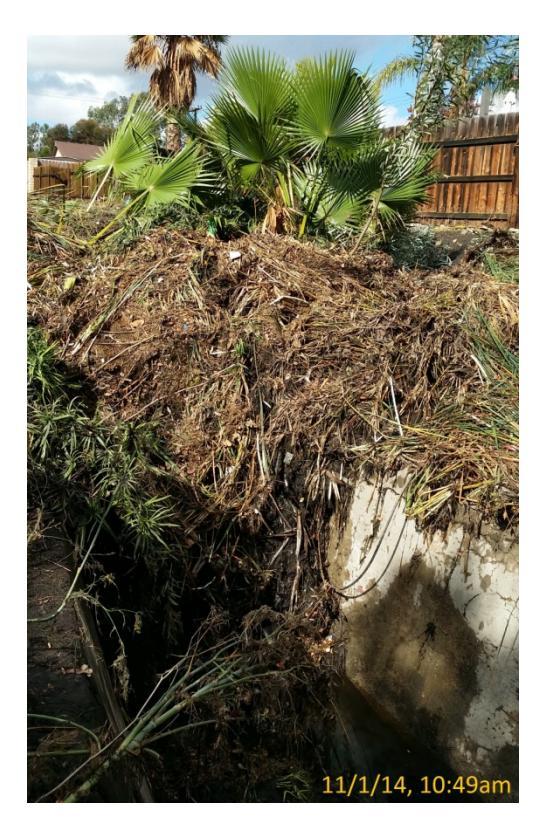
Photo 7: San Carlos Creek Channel Emergency Pre-Maintenance 11/1/14

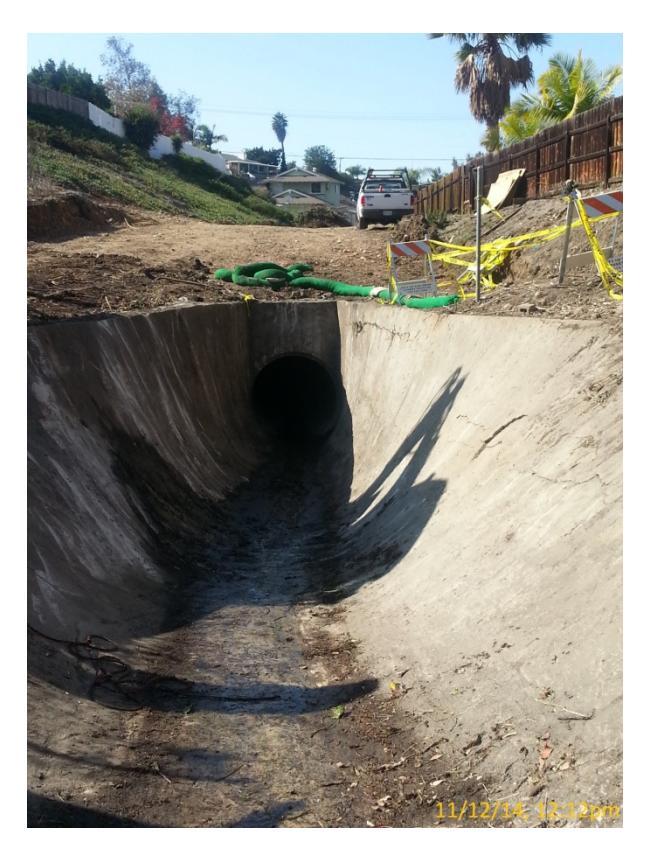
Photo 8: San Carlos Creek Channel Emergency Post-Maintenance 11/12/14
## September 2015

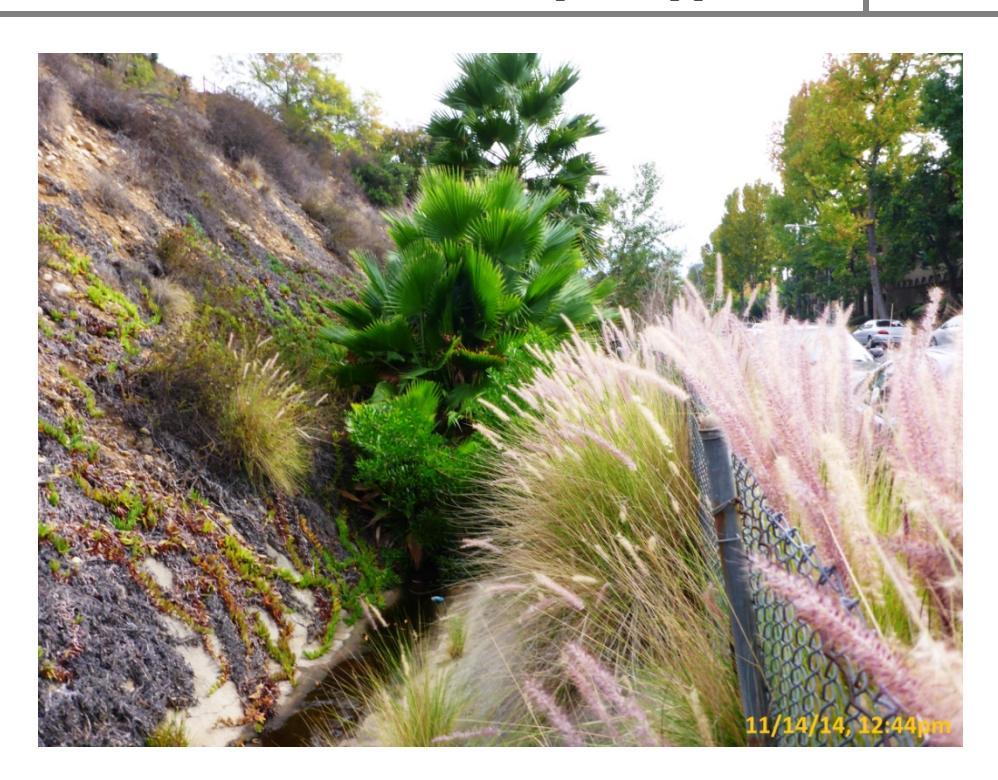
Before maintenance, the Reservoir Drive Channel and associated culvert were had significant build-up of debris and vegetation growing on the concrete lining of the channel. The potential for this relatively loosely rooted material uprooting and causing flooding downstream was evaluated and resulted in emergency maintenance. Post-emergency maintenance, the channel and culvert are able to function as designed.

Photo 9: Reservoir Drive Channel Emergency Pre-Maintenance 11/14/14

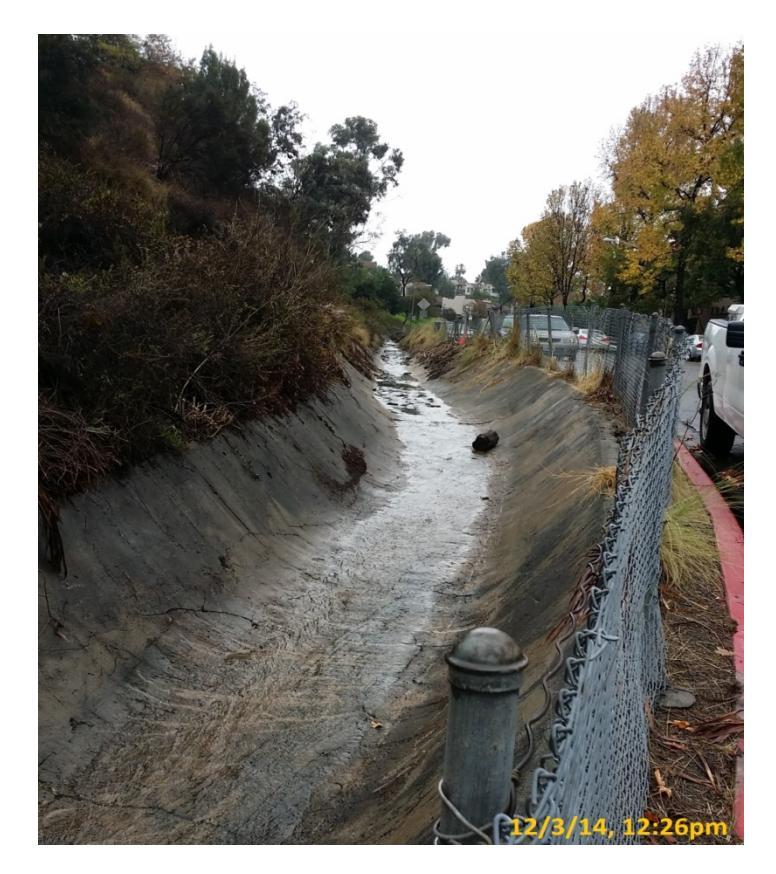
Photo 10: Reservoir Drive Channel Emergency Post-Maintenance 12/3/14

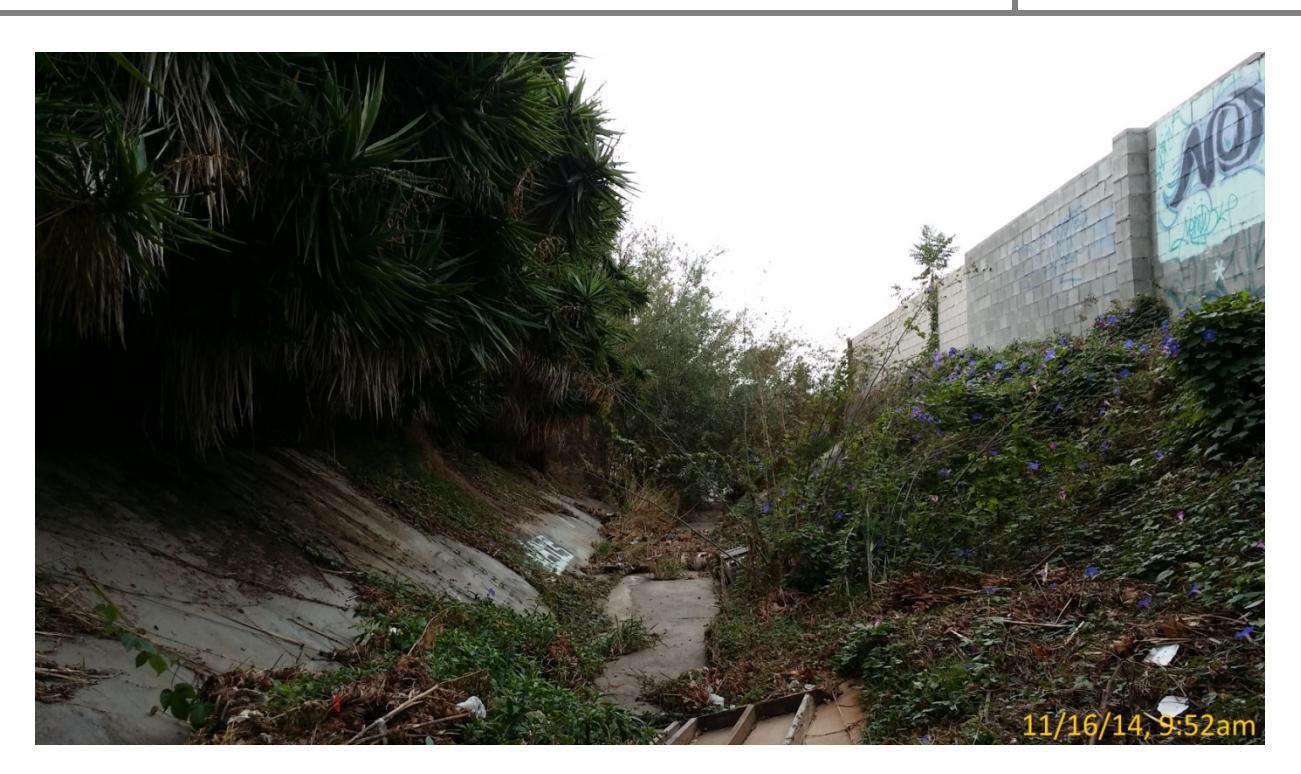
Photo 11: Smythe Channel Emergency Pre-Maintenance 11/16/14

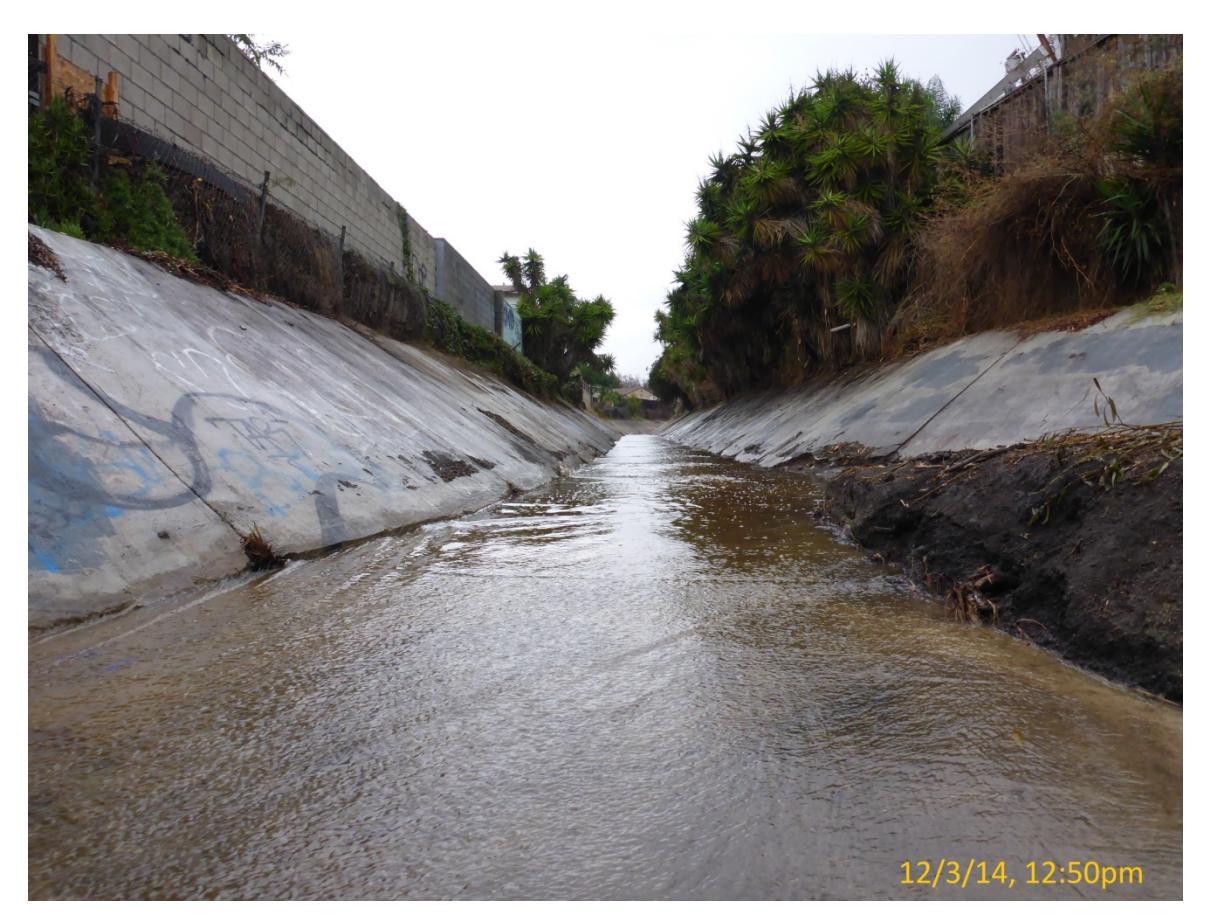
Maintenance and a post-maintenance inspection on took place in December 2014. The survey confirmed that all vegetation and accumulated sediment had been removed from the concrete-lined portions of both reaches. As recommended, the southern willow scrub vegetation in earthen-bottom portions of the northern reach was undisturbed, but trash had been removed. The conveyance capacity was restored to the design capacity in the concrete portions.

Photo 12: Smythe Channel Emergency Post-Maintenance 12/3/14
