# City of San Diego Aerial Deposition Study, Phase III

Source Evaluation of TMDL Metals in the Chollas Creek Watershed

## Final Report

**Weston Solutions, Inc.**  
2433 Impala Drive  
Carlsbad, California 92010

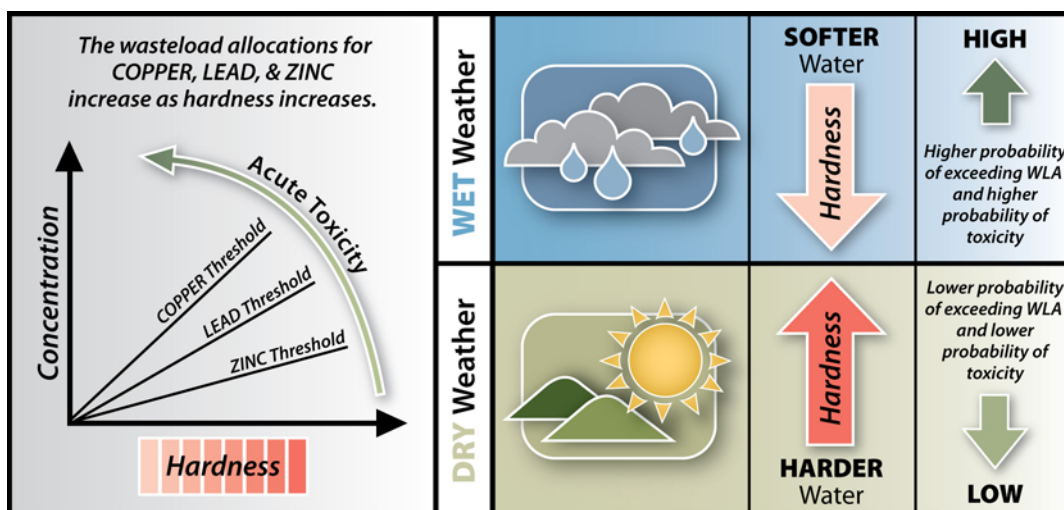
**Figure 1-3. Impact of Hardness as a Dominant Variable in the Dissolved Metals Total Maximum Daily Load**

natural buffering mechanisms that would increase hardness are not present in many segments of the creek. The lower hardness generally observed in wet weather storm flows decreases the WLA, and therefore, very low concentrations of dissolved metals have a higher probability of exceeding the WLA. The observations for dry weather flows have indicated that hardness is generally higher in these flows and is less likely to exceed the WLA. Additionally, dry weather flows are relatively infrequent and are typically a result of municipal water over irrigation, which has considerably higher hardness. This is likely the result of the higher mineral content in imported water used for irrigation and other activities that result in dry weather urban runoff.

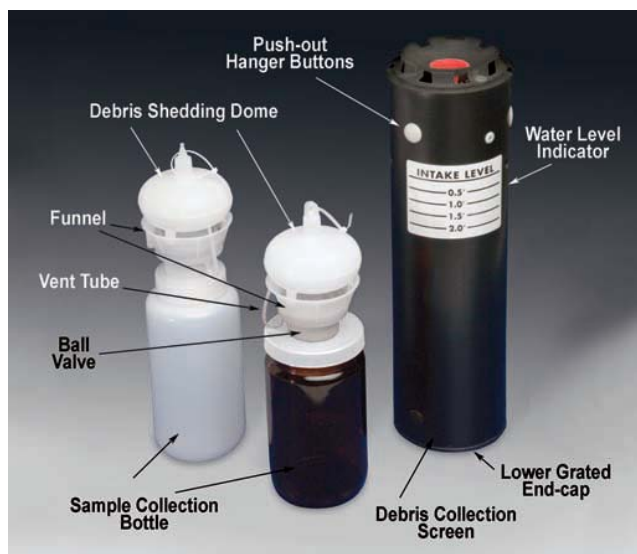
Figure 2-1. Nalgene First Flush Sampler Product Diagram

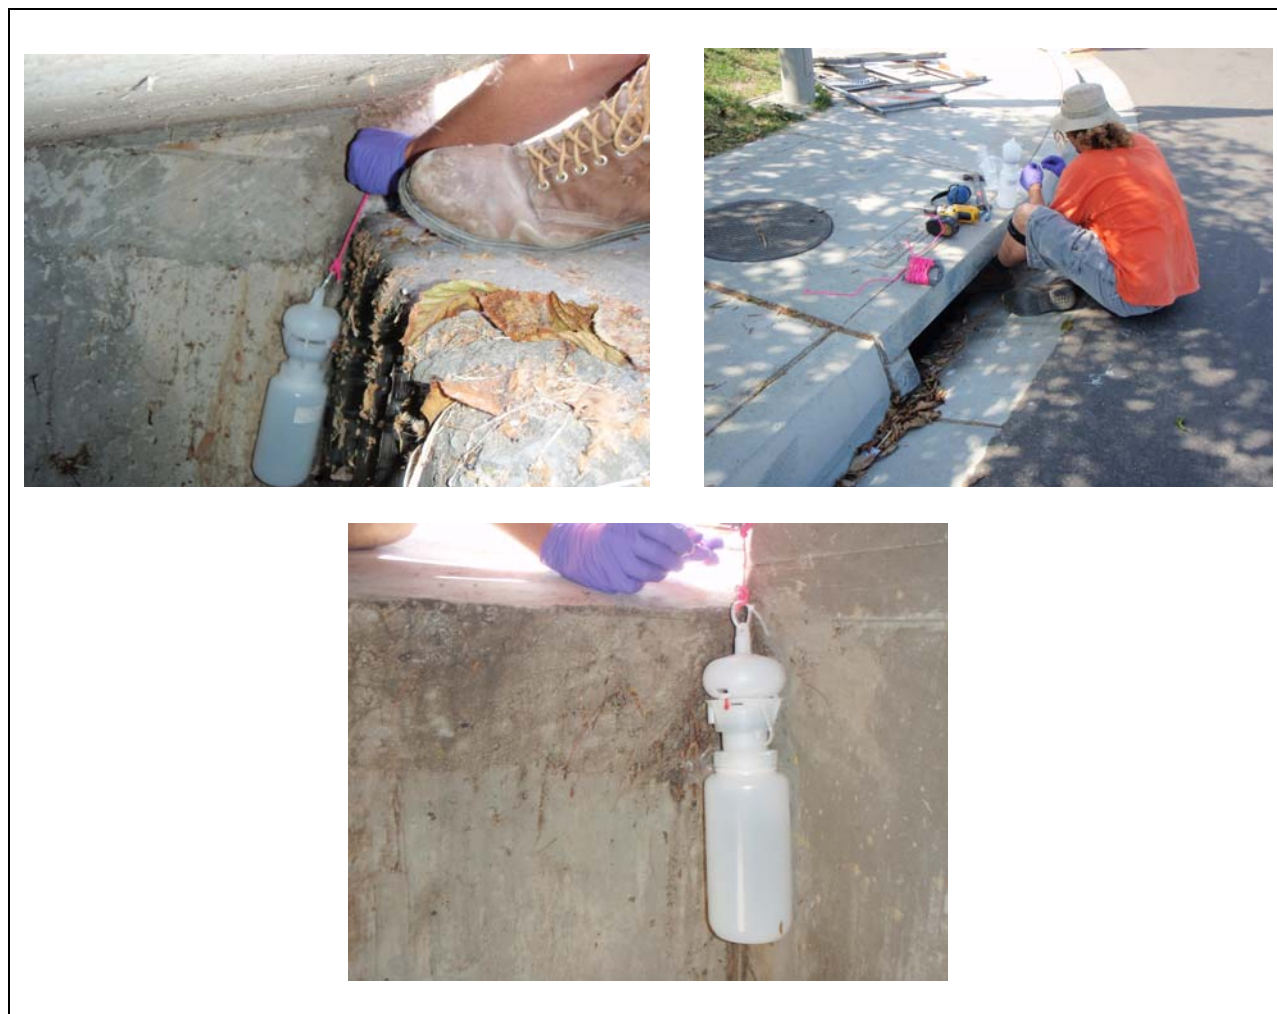
**Figure 2-2. Example of Nalgene Sampler Installation**

First flush samplers were installed into selected storm drain inlets 12–24 hours prior to a storm event. After a storm event, samplers were retrieved immediately, properly labeled, documented, and sent to the lab for analyses.

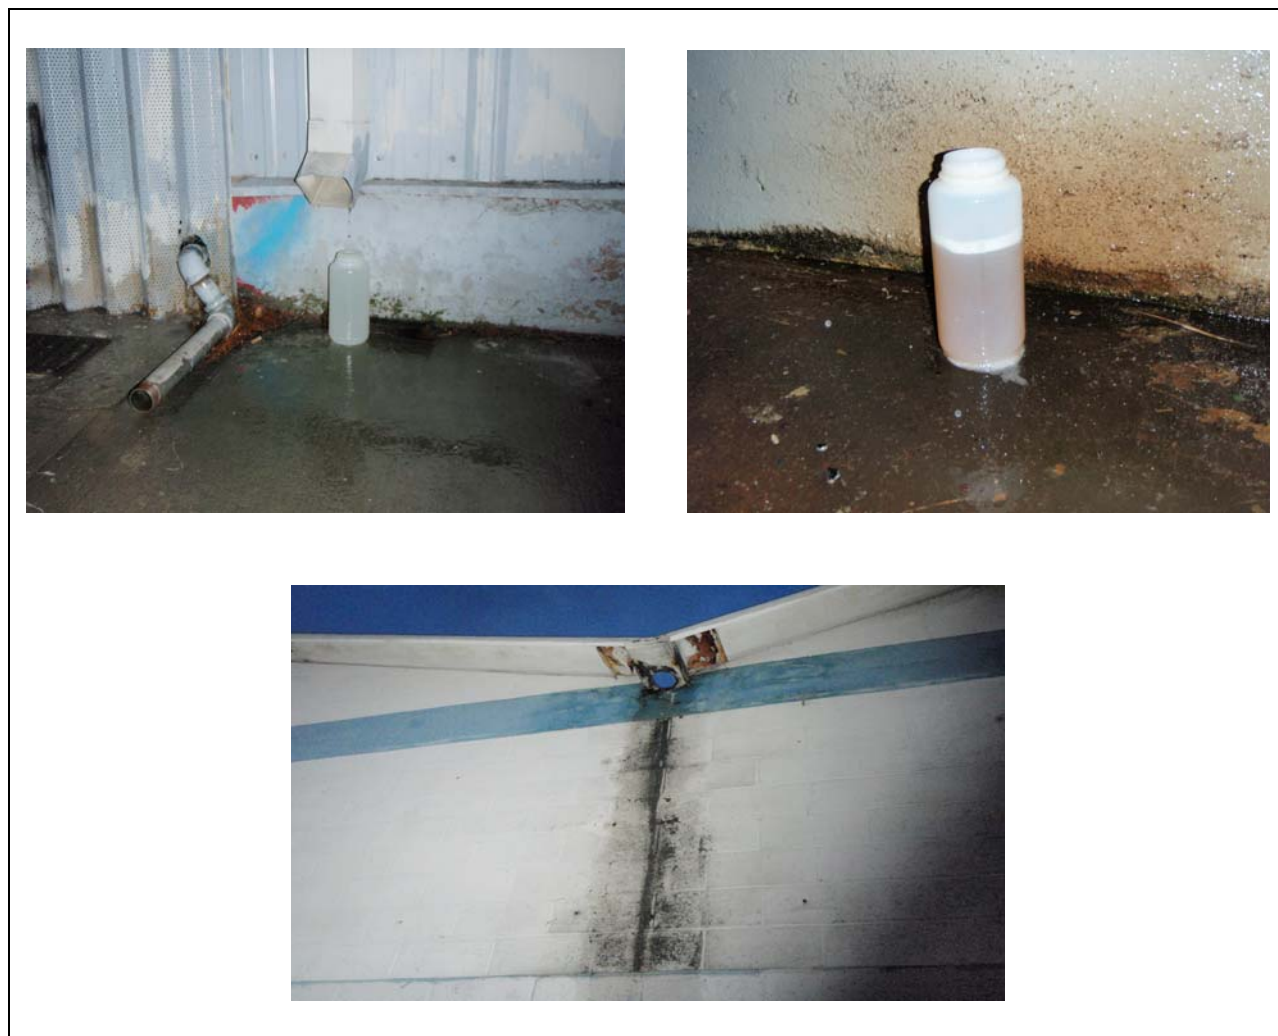
**Figure 2-4. Rooftop Runoff Samples from Locations with Observed Surface Stains**

Storm water from a number of rooftops created sufficient amounts of flow, which allowed several samples to be collected. Samples were collected by inserting a pre-cleaned 1-L, HDPE sample bottle beneath a draining rain gutter or down spout. While sampling the rain event, photographs and GPS locations were recorded along with sample times.

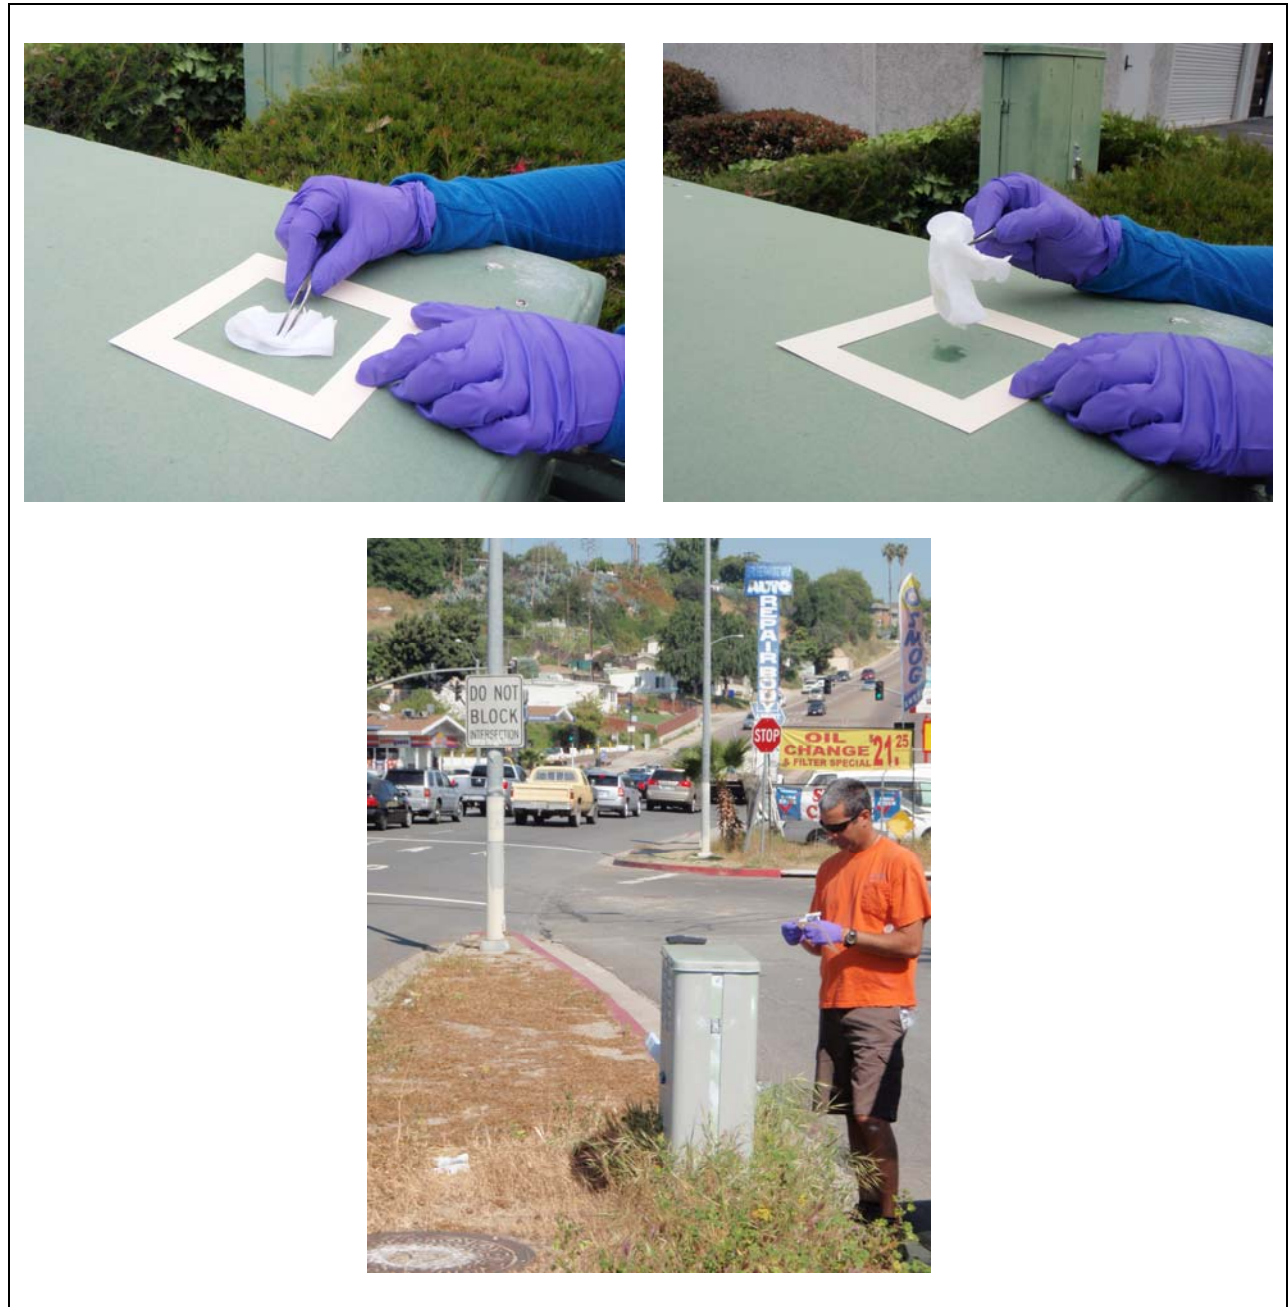
Figure 2-5. Examples of Ghost Wipe Sampling

A total of 27 surface wipe samples were collected on the City of San Diego right-of-way directly adjacent to facilities with high potential emission sources to determine elemental source signatures from those sites. Wipe samples were also collected from residential areas to determine analytical signal differences. The samples were obtained from existing surfaces that appeared to be free of rust or cracked painted surfaces (Figure 2-5). The wipes were also conducted by using light wiping as opposed to more intense scrubbing that would alter the structure wiped. The sampling team underwent training to ensure comparability prior to the monitoring event. Although some bias may be introduced by the surface wiped, it is assumed that the material wiped was representative of that which was attributable due to aerial deposition and not due to the surface structure. The overall purpose was to characterize dust samples in-situ and to evaluate if analyte signatures were evident in relation to high deposition rate areas from the Phase II study. The use of the wipe techniques were employed to determine if differences in particulate and metals deposition rates within Chollas Creek Watershed were related to the locations with areas where water quality concentrations were above WQOs.

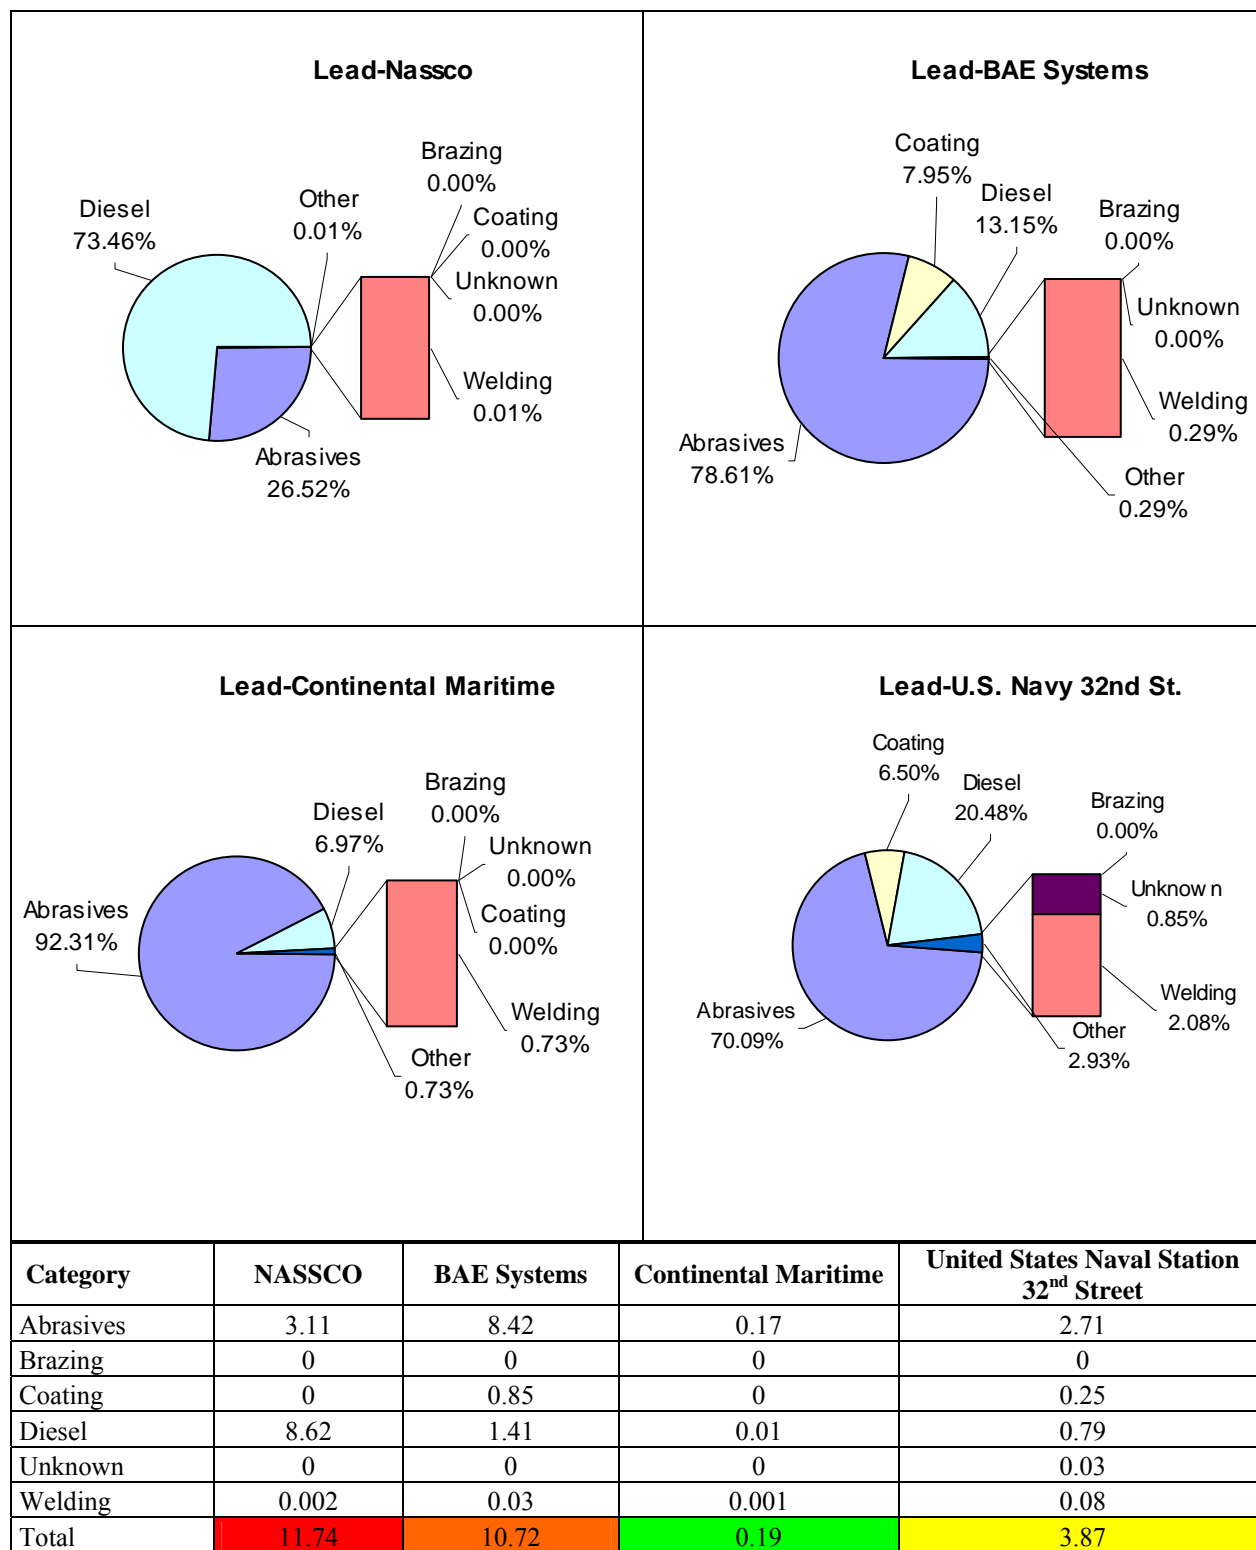
Colors indicate emissions loads from highest (red) to lowest (green).

**Figure 3-5. Lead Emissions by Product Categories from Facilities in the Chollas Creek Watershed (as reported to SDAPCD, 2000–2007)**

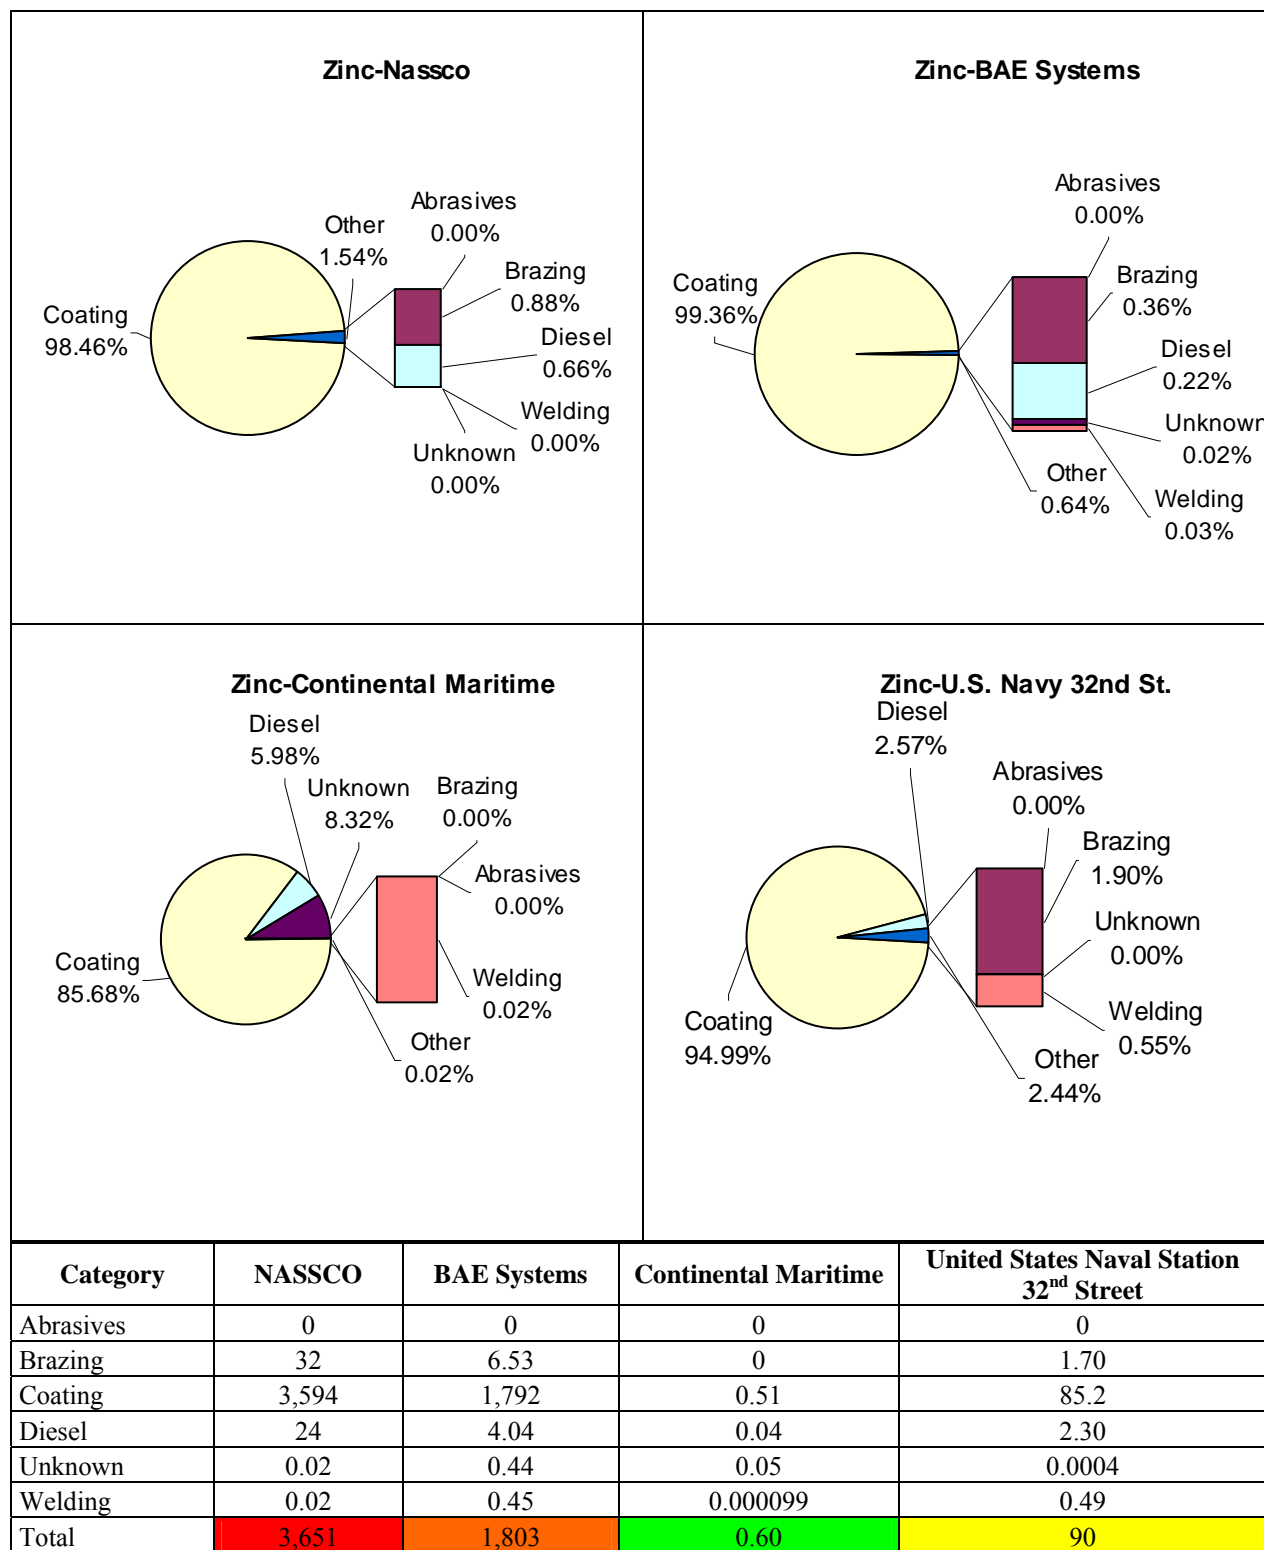
Colors indicate emissions loads from highest (red) to lowest (green).

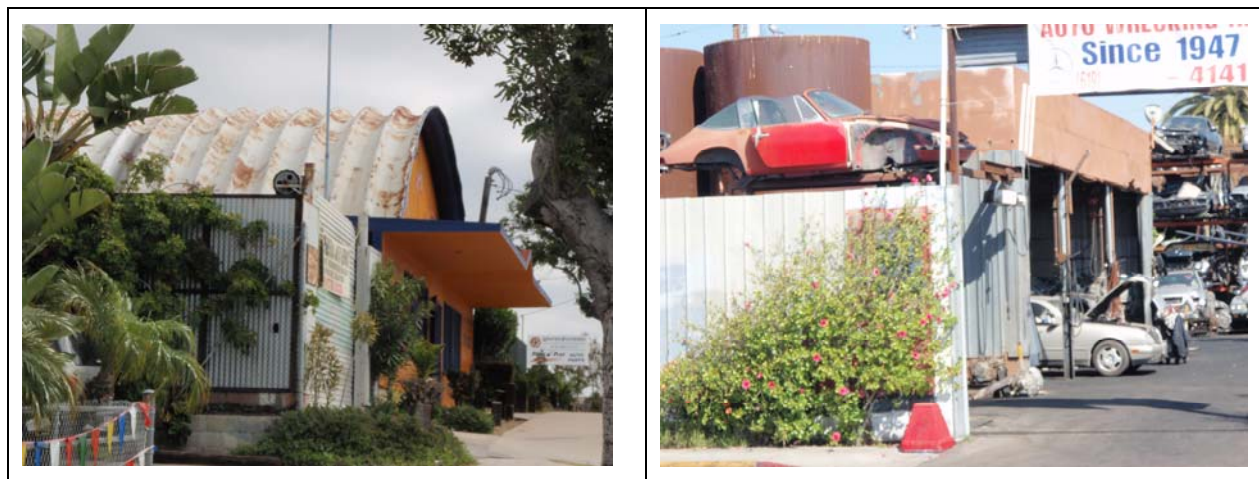
**Figure 3-9. Facilities with Metal Structures in Poor Condition (rust and staining evident)**

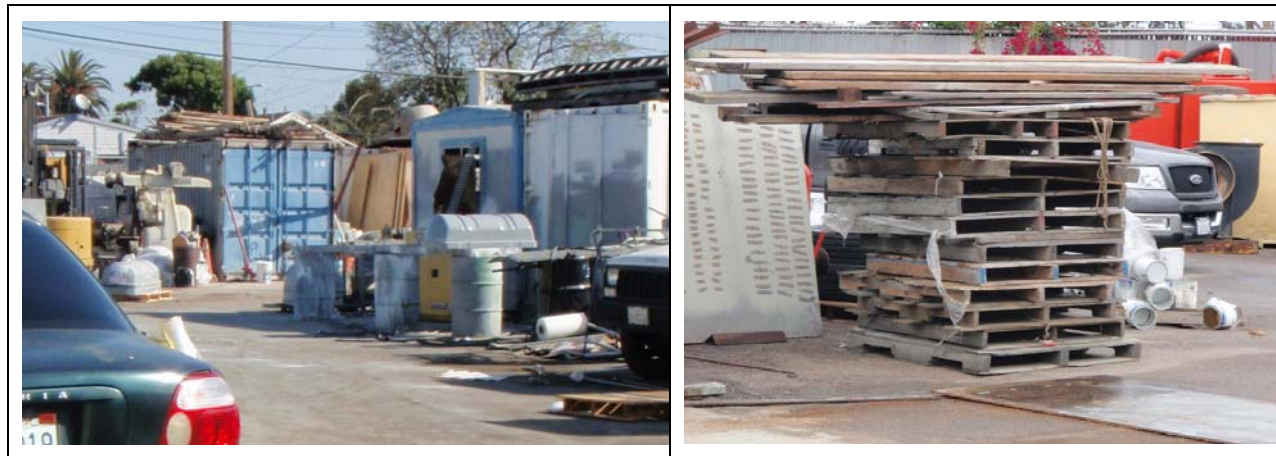
**Figure 3-10. Facilities with Outside Storage Presenting a High Potential for Metals Loading**

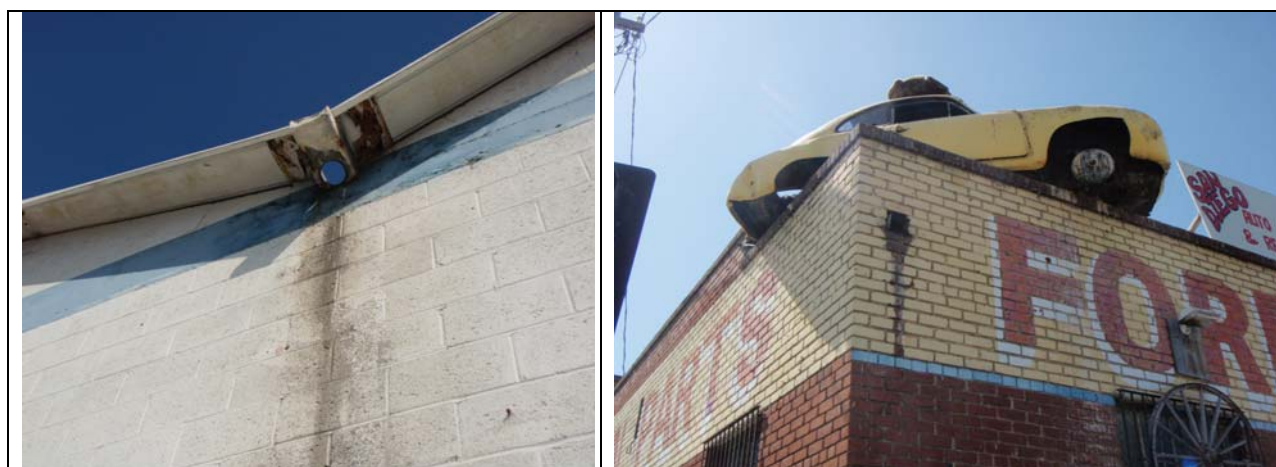
**Figure 3-11. Facilities with Staining on Parcels from Rooftops Draining Directly to City Streets**

Field reconnaissance of Priority Sector 1 was more intensive than the remaining four priority sectors due to its high volume of industrial and commercial facilities and aging infrastructure. The lower watershed area near Main Street was a key focus area because it consisted mostly of heavy industrial facilities with high potential for water quality impacts. Commercial Street was another area of high interest in Priority Sector 1 due to its dense makeup of industrial and commercial facilities. A variety of different facilities were observed in this priority sector, including tire shops, auto repair shops, recycling yards, welding, painting, and scaffolding facilities. Many of the parcels in Priority Sector 1 had aging infrastructure in poor to fair condition. Several facilities were observed with rusty metal roofs and rusty outside metal storage (Figure 3-9). Several storage yards were also noted for having rusty metal debris, paint cans, drums, and other materials with potential for contributing metals to receiving waters during storm events (Figure 3-10). Staining was also observed on several parcels' roofs, gutters and drains, and/or pavement. Many of the facilities roof drains also drained directly to city streets or sidewalks with no buffer zone (Figure 3-11).

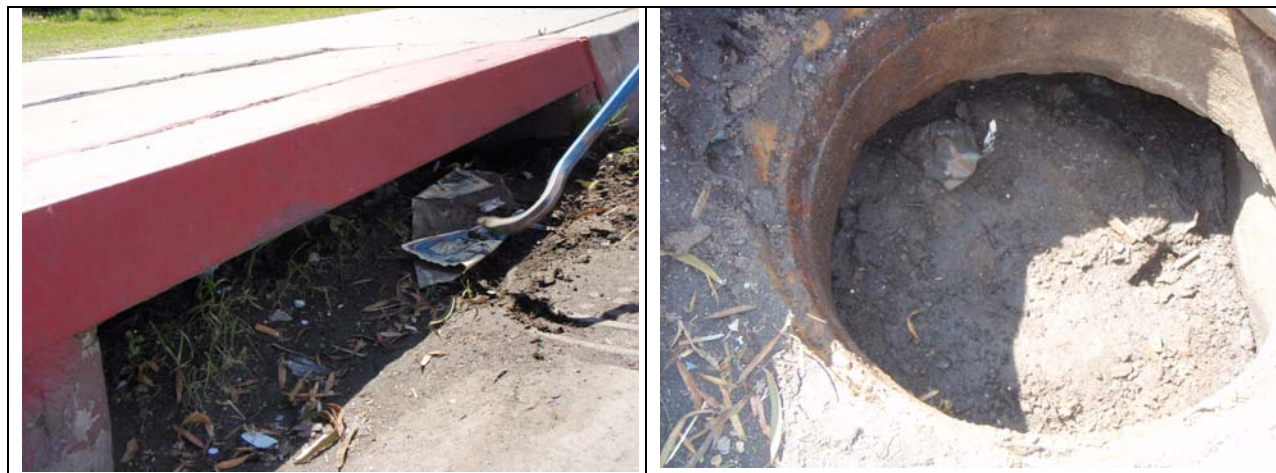
**Figure 3-12. Storm Drain Inlet with Dirt and Debris (southwest corner of 32<sup>nd</sup> Street and Commercial Street)**

A total of 19 commercial/industrial storm drain inlets were identified for sampling throughout Priority Sector 1. Several inlets were observed with varying amounts of trash and debris ranging from fairly clean to excessive and in need of cleaning. One inlet located on the southwest corner of 32<sup>nd</sup> Street and Commercial Street was identified as an ideal location for a field sample location due to its connection to Commercial Street just upstream of the historic mass loading station site (SD8(1)). However, the drain inlet was observed to be completely filled with dirt and sampling could not be performed at this site (Figure 3-12). This storm drain has the potential to contribute particulates and metals directly to the creek during storm events. Additionally, the site is not indicated on the City of San Diego's GIS storm drain layer. The site information was passed on the City of San Diego Stormwater Department, Operations & Maintenance Division to be added to their maintenance list.

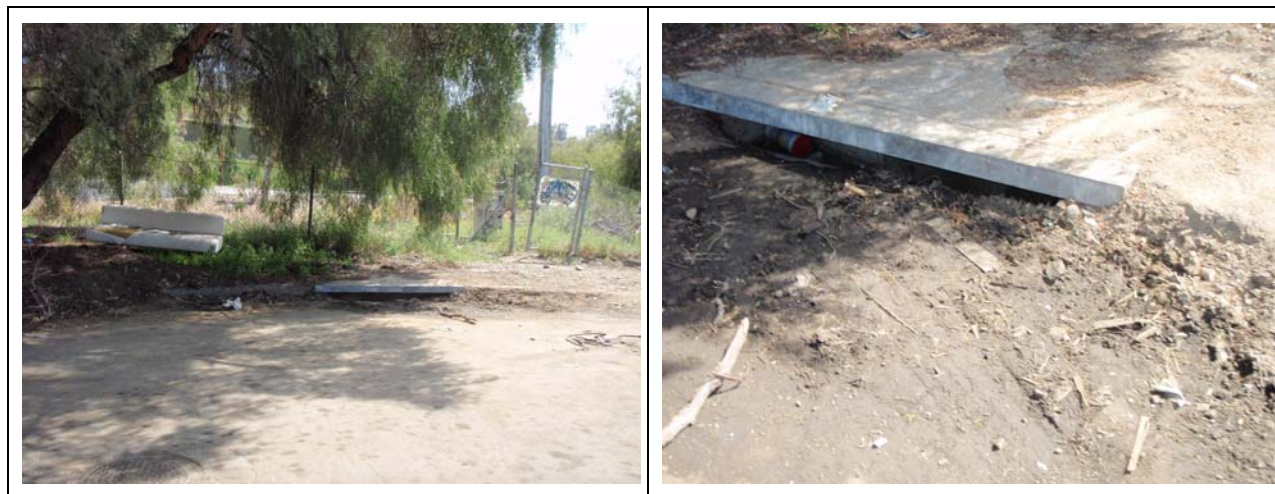
**Figure 3-13. Storm Drain Inlet with Dirt and Debris Drains Directly into Chollas Creek  
(38<sup>th</sup> Street and Ash Street)**

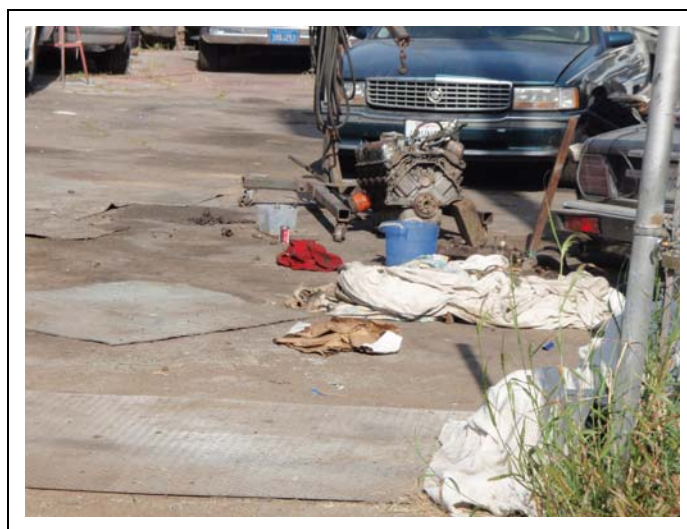
**Figure 3-14. Rusty Metal Debris in Outside Automotive Repair Facility**

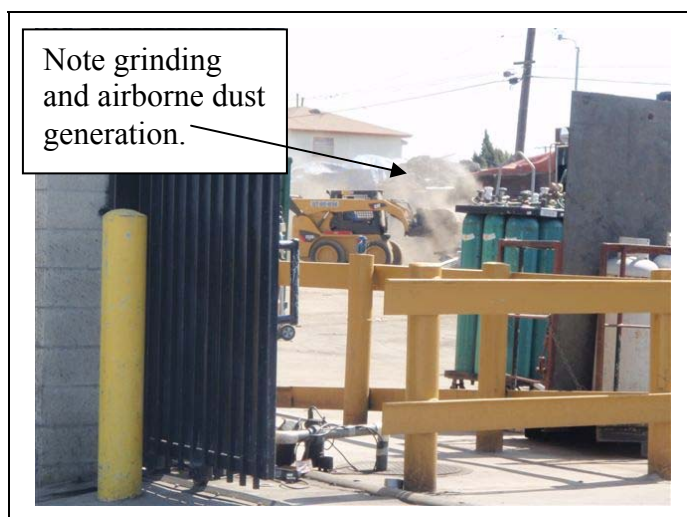
**Figure 3-15. Evidence of Mobile Emissions Source**

Several sites identified as emission sources in the GIS desktop exercise were noted and field verified as accurate. However, some emission sources were also verified in the field to be fireplace exhausts from multifamily residential housing or other non-emission related ductwork. Several facilities were also observed to have mobile emission sources from the activities conducted on site during operations such as recycling and transfer of products (Figure 3-15).

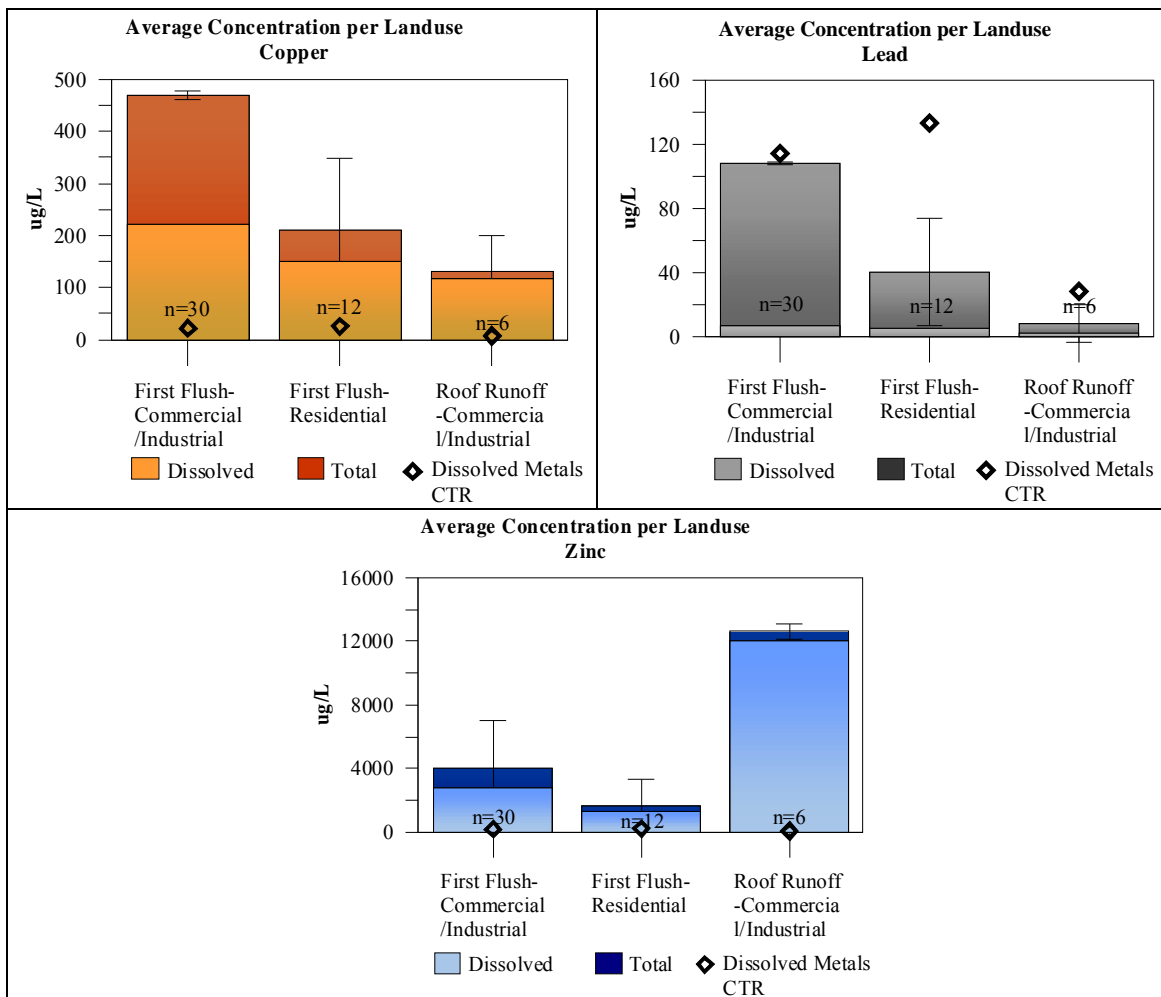
**Figure 4-5. Average Concentration of First Flush Runoff and Metal Roof Runoff Concentrations by Land Use for Copper, Lead, and Zinc**

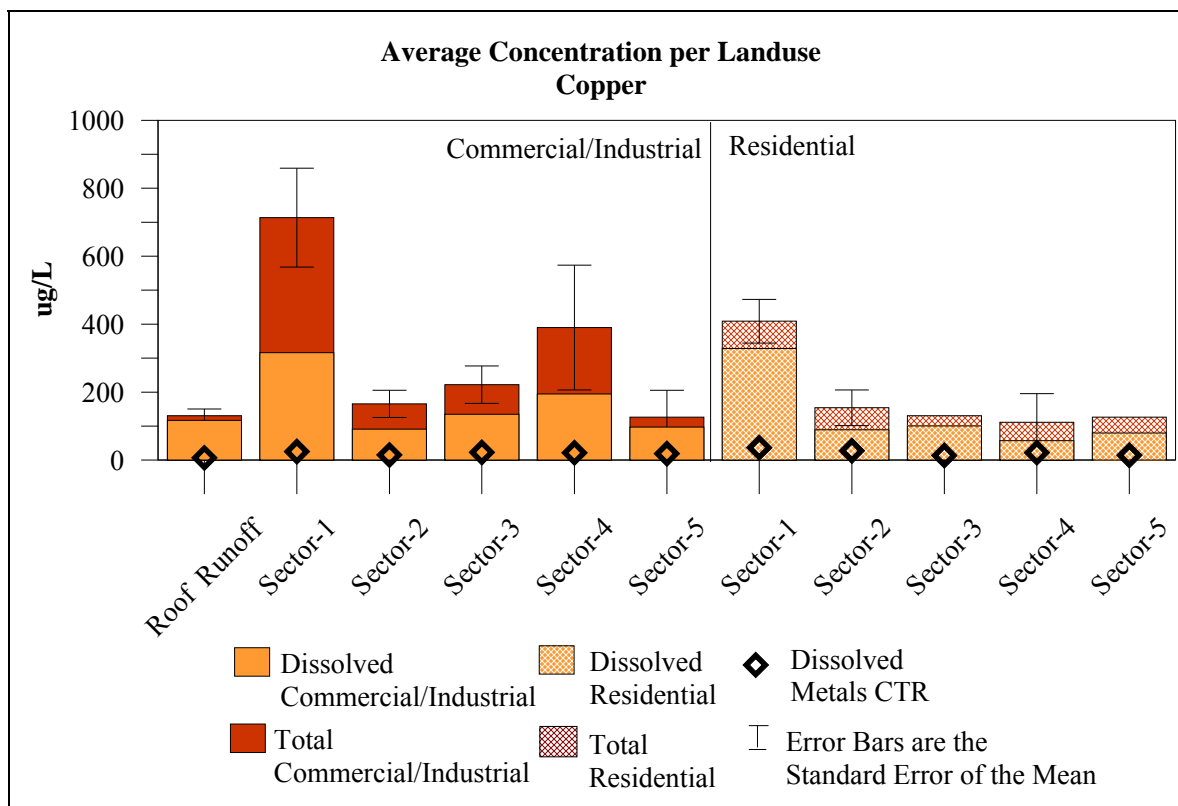
**Figure 4-7. Average Total and Dissolved Copper Concentration per Sector and by Land Use**

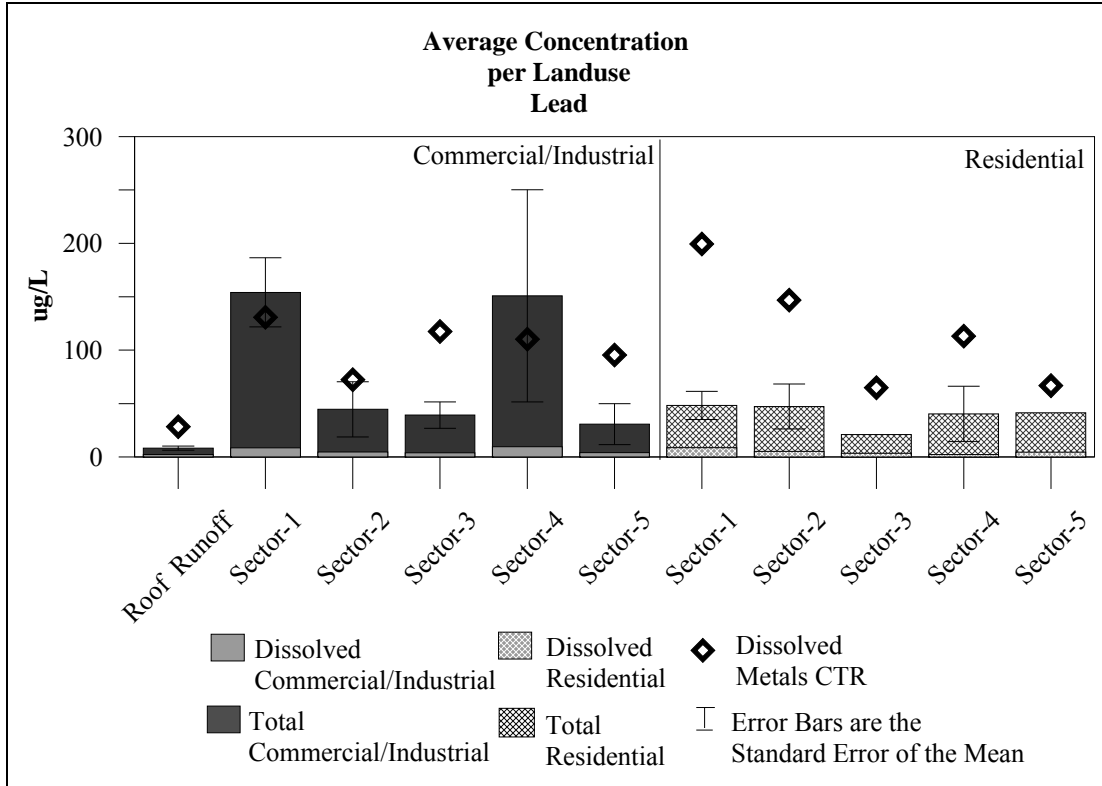
Figure 4-8. Average Total and Dissolved Lead Concentration per Sector and by Land Use

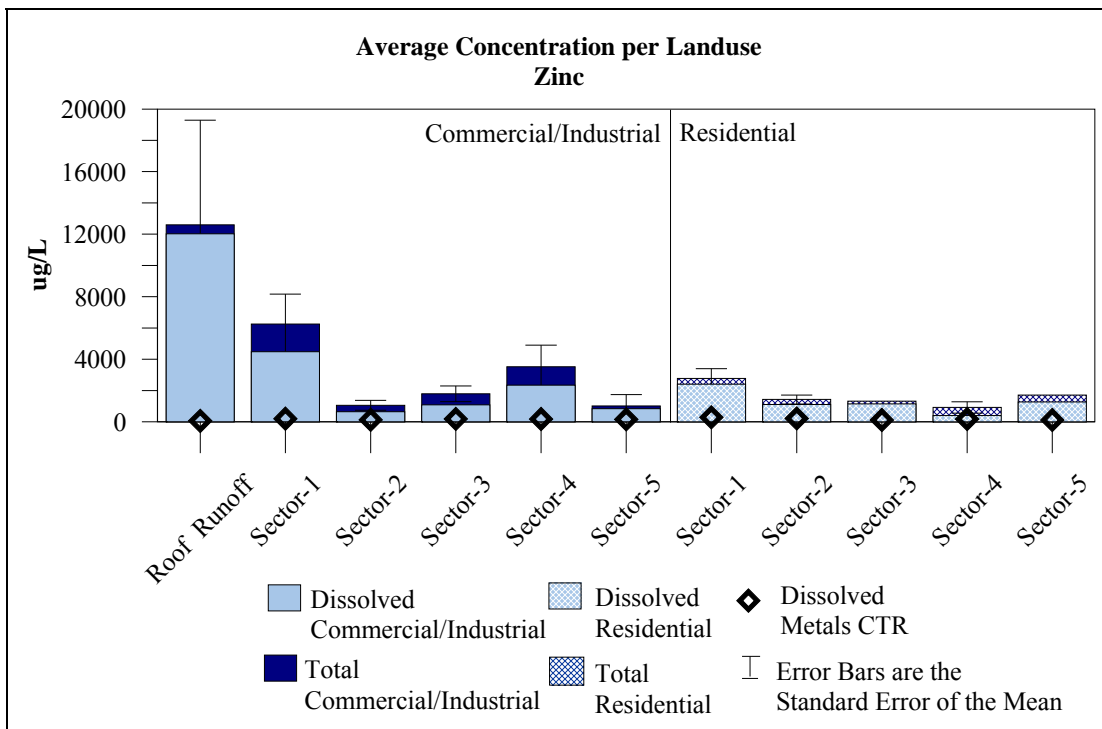
Figure 4-9. Average Total and Dissolved Zinc Concentration per Sector and by Land Use

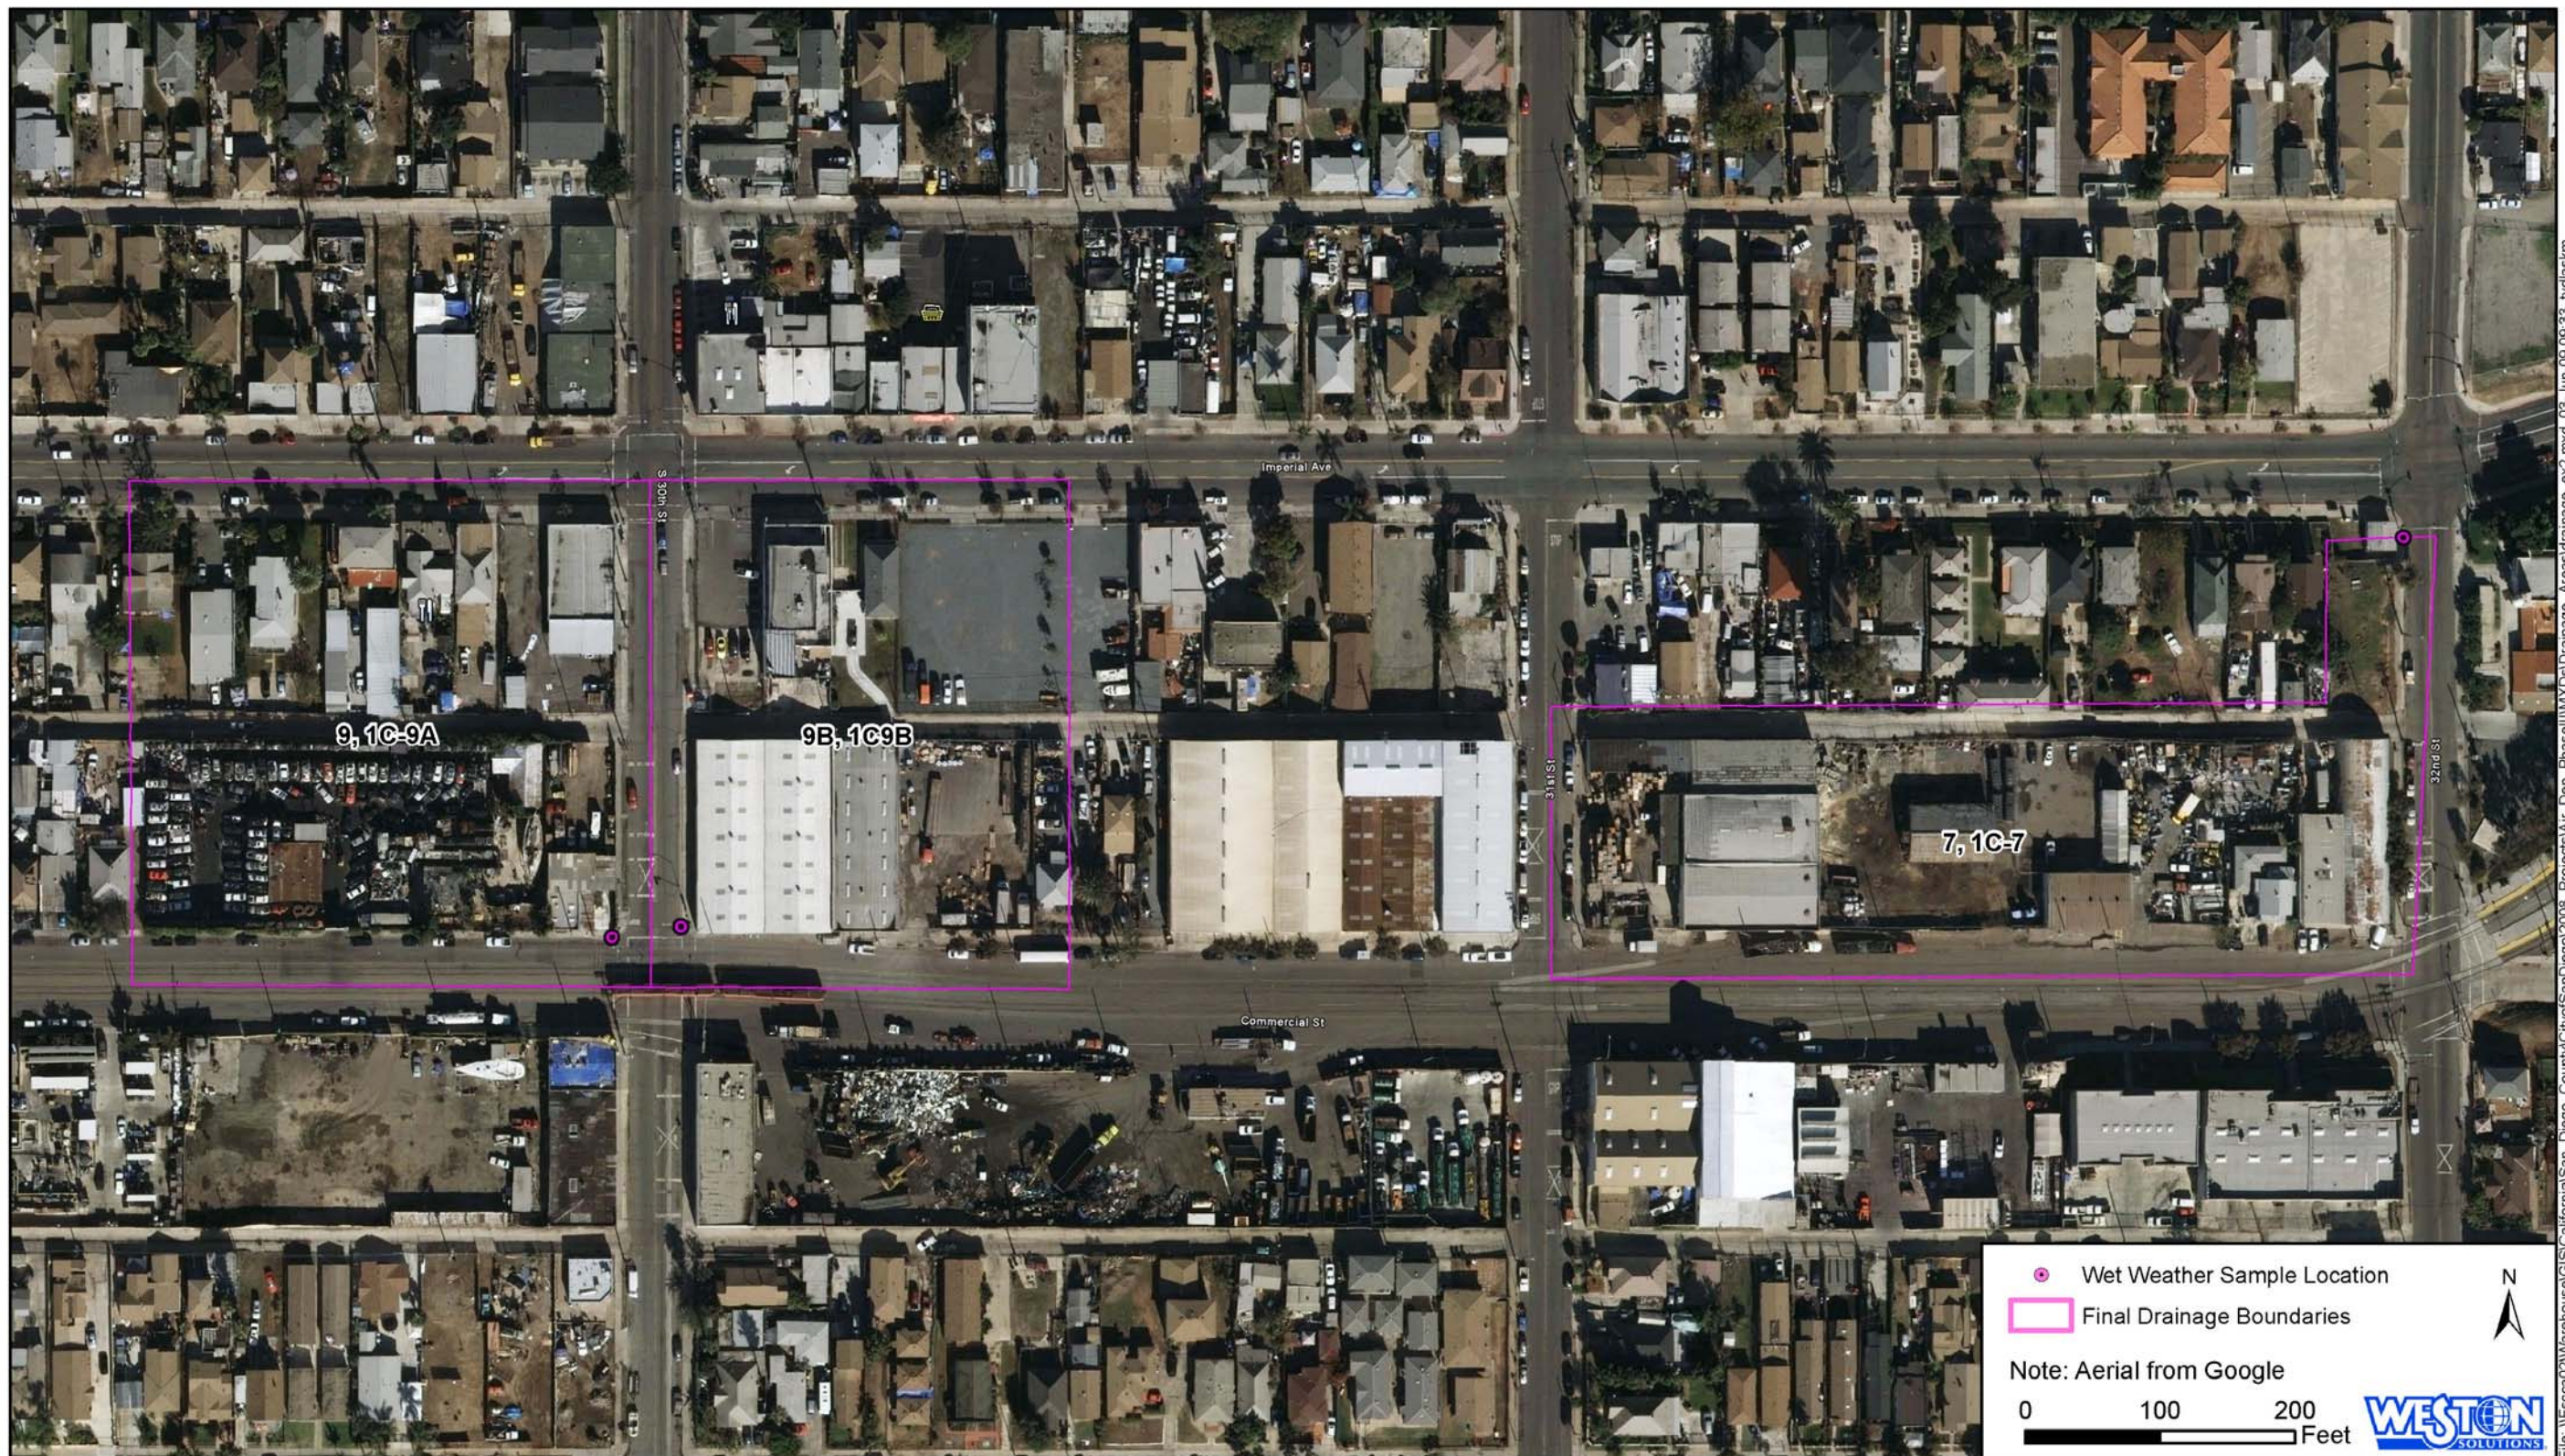
Figure 4-10. Example Map of Drainage Areas for Three Monitoring Sites

Using aerial imagery, approximate area and percent cover were calculated in GIS for rooftop, pavement (e.g., road and parking lot), outside storage, and bare soil/vegetation delineated areas within each drainage area. Table 4-4 shows the results of the GIS desktop interpretation of land cover as well as these data represented as impervious (i.e., pavement, rooftop, and outside storage) and pervious surface percentages. Drainage areas ranged in size from 0.96 acre to 14.99 acres and impervious surface from 48–100%.
