# City of San Diego Aerial Deposition Study, Phase III

Source Evaluation of TMDL Metals in the Chollas Creek Watershed

## Final Report

**Weston Solutions, Inc.**  
2433 Impala Drive  
Carlsbad, California 92010

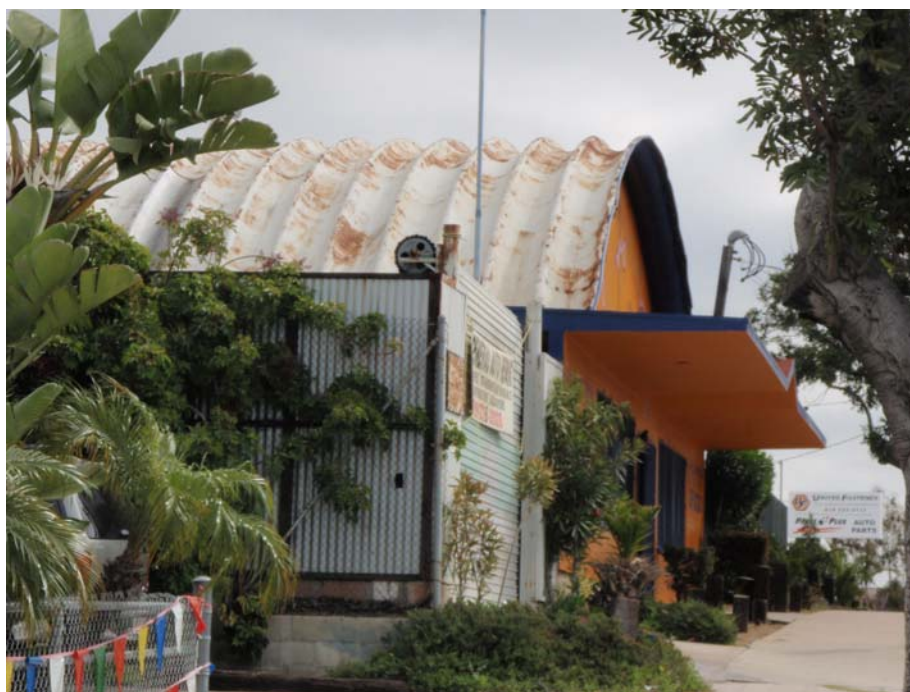
Zinc concentrations from metal rooftops were significantly higher than street level zinc concentrations. Zinc in street level runoff was also highly correlated with the number of metal rooftops (Figure 5-3). Concentrations of zinc in runoff from rusty metal roofs were as high as 500 times the waste load allocation for zinc. Approximately 30 of 162 metal roofs were identified as poor condition in the Chollas Creek watershed commercial and industrial areas, the majority of them occurring in Priority Sector 1. Priority Sector 1 is also one of the oldest and most industrialized areas of the City of San Diego with many World War II era facility structures.

**Figure 5-3. Example of Area of Influence on High Zinc Concentrations in Storm Water Runoff from a Commercial/Industrial Drainage Area in Priority Sector 1**

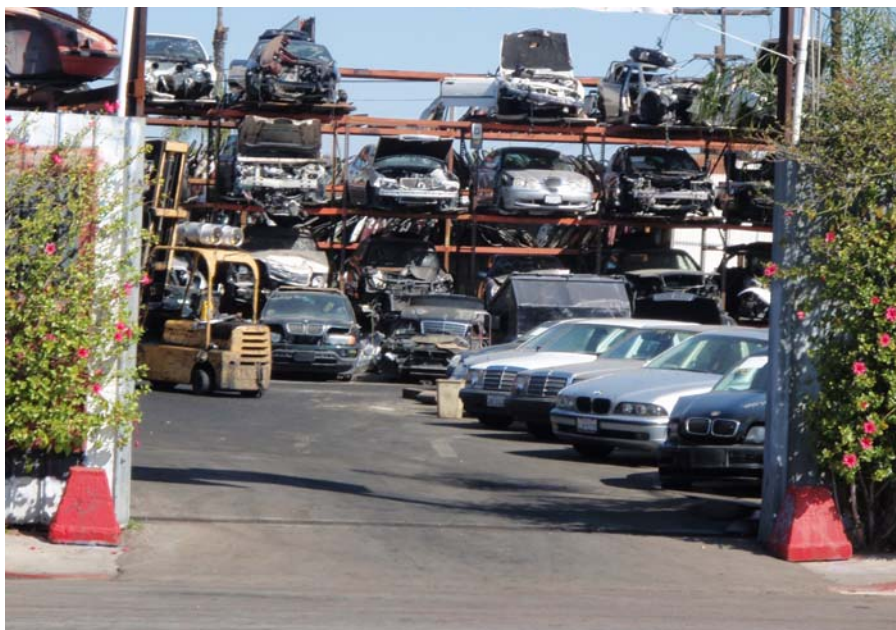
Other identifiable sources included uncovered outdoor metal storage and automotive activities. Elevated copper, lead, and zinc results could be explained from a drainage area in Priority Sector 1 with uncovered outdoor metal storage and stained pavement areas from runoff (Figure 5-4).

**Figure 5-4. Example of Area of Influence on High Metals Concentrations in Storm Water Runoff from a Commercial/Industrial Drainage Area in Priority Sector 1**

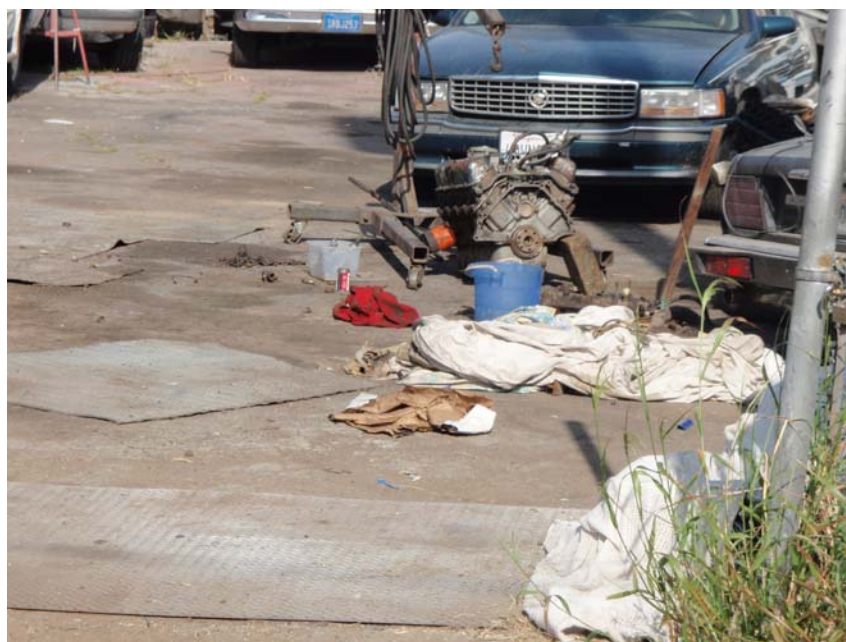
Another example of elevated copper, lead, and zinc results from a drainage area in Priority Sector 4 could be explained by the drainage observed from outdoor automotive maintenance activities occurring with no storm water management practices (Figure 5-5).

**Figure 5-5. Example of Area of Influence on High Metals Concentrations in Storm Water Runoff from a Commercial/Industrial Drainage Area in Priority Sector 4**
