MISSION BAY Clean Beaches Initiative Bacterial Source Identification Study

Final Report

The City of San Diego

September 15, 2004

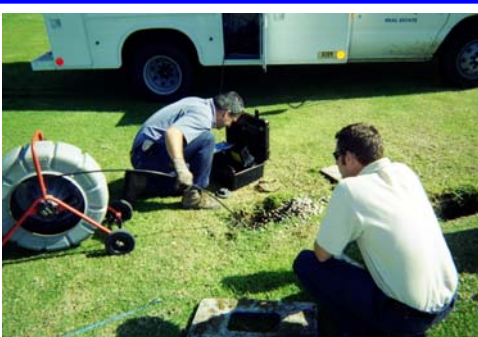
A typical CCTV investigation of a sewer lateral line in Mission Bay Park

In Task 1, a total of 16 comfort stations (restrooms) around the 12 investigation sites were evaluated to determine if leaking infrastructure from these facilities was a source of bacteria to the bay. The lateral lines of the comfort stations, which carry sewage to the sewer mains, were visually inspected with a closed-circuit television (CCTV) system to assess their physical condition. The inspections revealed the integrity of the lateral lines of all of the comfort stations investigated were intact and were not a likely source of bacteria to the bay. The sewer mains themselves were not inspected as part of this study because they had been replaced within the last two decades.

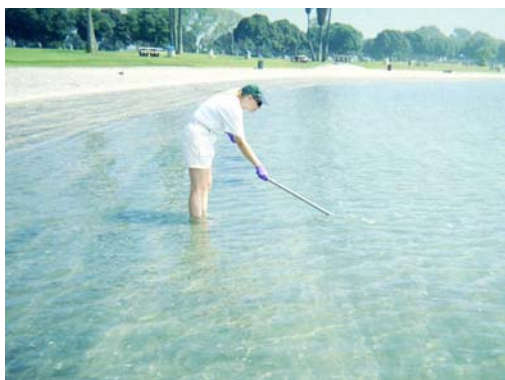
Sampling receiving water at Bonita Cove

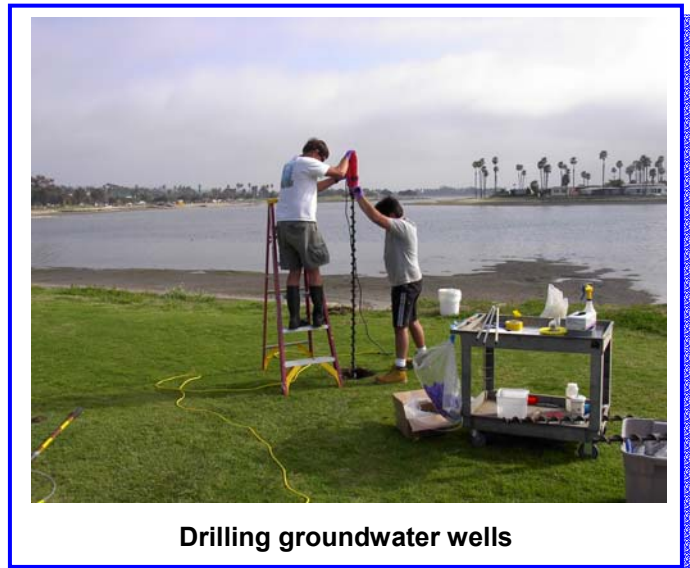
Drilling groundwater wells

Three sites were assessed in the Fate and Transport study: De Anza Cove, Visitor's Center, and Leisure Lagoon. At each site, a series of three wells was drilled along a transect in line with the beach face spring, perpendicular to the bay receiving waters. At each well, three sampling probes attached to sterile tubing were inserted into the soil at depths of 4, 7, and 12 feet below the surface of the ground. Groundwater was extracted from each of the wells using a peristaltic pump and fecal coliform and enterococcus bacteria were enumerated.

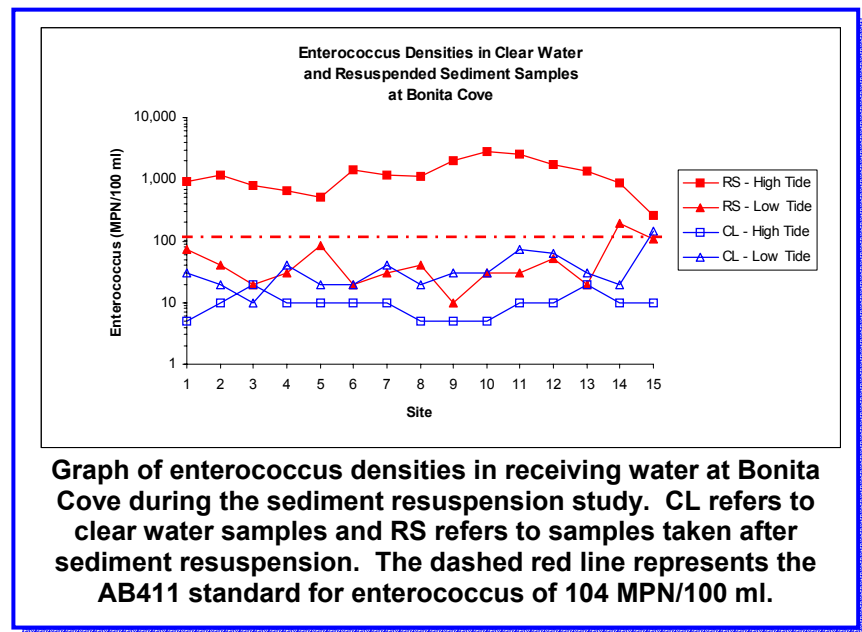
Graph of enterococcus densities in receiving water at Bonita Cove during the sediment resuspension study. CL refers to clear water samples and RS refers to samples taken after sediment resuspension. The dashed red line represents the AB411 standard for enterococcus of 104 MPN/100 ml.

The results of the resuspension study indicate that the bacterial reservoir maintained in the beach face sediments within the upper intertidal zone are released to the receiving waters when they are disturbed. When the experiment was repeated in the lower intertidal zone, there was no difference between the “clear water” and resuspended beach sediment samples, reflecting the low bacterial densities found in the lower intertidal beach face sediments. These results suggest that upper intertidal beach face sediments can act as a source of bacteria to the receiving waters of Mission Bay when the sediments are resuspended. This mechanism is thought to be a substantial source of indicator bacteria at several sites in Mission Bay.

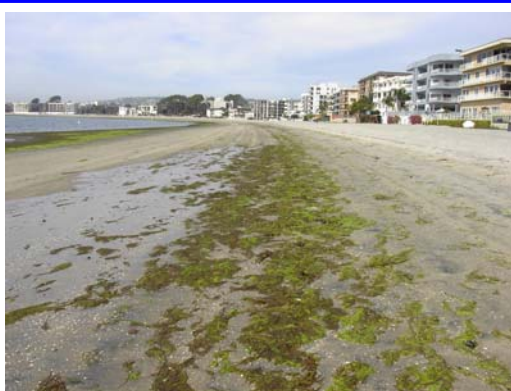
Wrack line on beach at Riviera Shores

In the wrack line investigation, samples of the wrack were collected over an eleven day period after the wrack had been deposited on the beach by a high, spring tide. Bay water did not make contact with the wrack during the sampling period. Wrack samples were collected from two sites (Riviera Shores and Visitor's Center) and analyzed for fecal coliform and enterococcus bacteria. The results indicated that, at both sites, indicator bacterial densities were maintained at elevated levels for the entire eleven day period, suggesting that the wrack line acted as a bacterial reservoir.

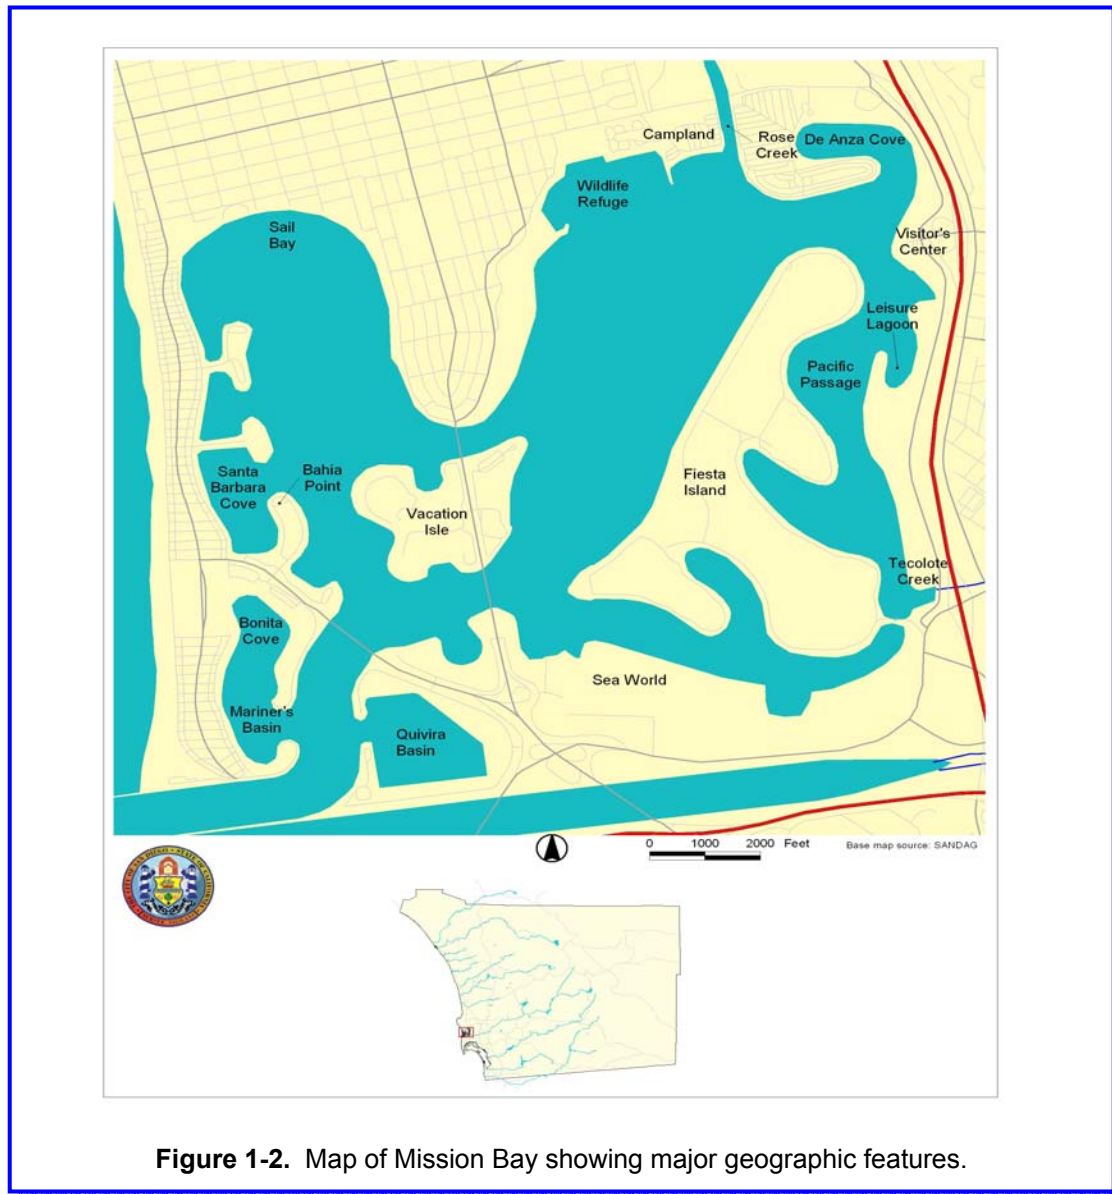
Figure 1-2. Map of Mission Bay showing major geographic features.

Mission Bay is connected to the ocean through a large rip-rapped channel on the bay's southwest corner (Figure 1-2). Tidal flushing is thought to be fairly good near the channel, but circulation is restricted in the eastern portion of the bay, particularly near the mouth of Tecolote Creek. The Mission Bay watershed encompasses three hydrologic areas that drain to the eastern portion of the bay via Rose and Tecolote Creeks. In addition, there are approximately 100 storm drains that carry urban runoff to Mission Bay.

Mission Bay is considered by many to be one of the most beautiful areas in the City of San Diego. Located just north of downtown San Diego, Mission Bay and the park that surrounds it is used year-round for walking, jogging, picnicking, and a variety of water contact sports, including swimming, sailing, water skiing, and fishing. Mission Bay Park is the largest known human-constructed aquatic park in the world, encompassing over 27 miles of shoreline (Corrao Brady and Hirsch 1995). In the 1940s, the marshland that was located where Mission Bay is now was dredged to form the existing bay and park. As it is today, the bay itself encompasses numerous smaller bays, coves, inlets, and stretches of beach that make it such a desirable place for aquatic recreation (Figure 1-2).

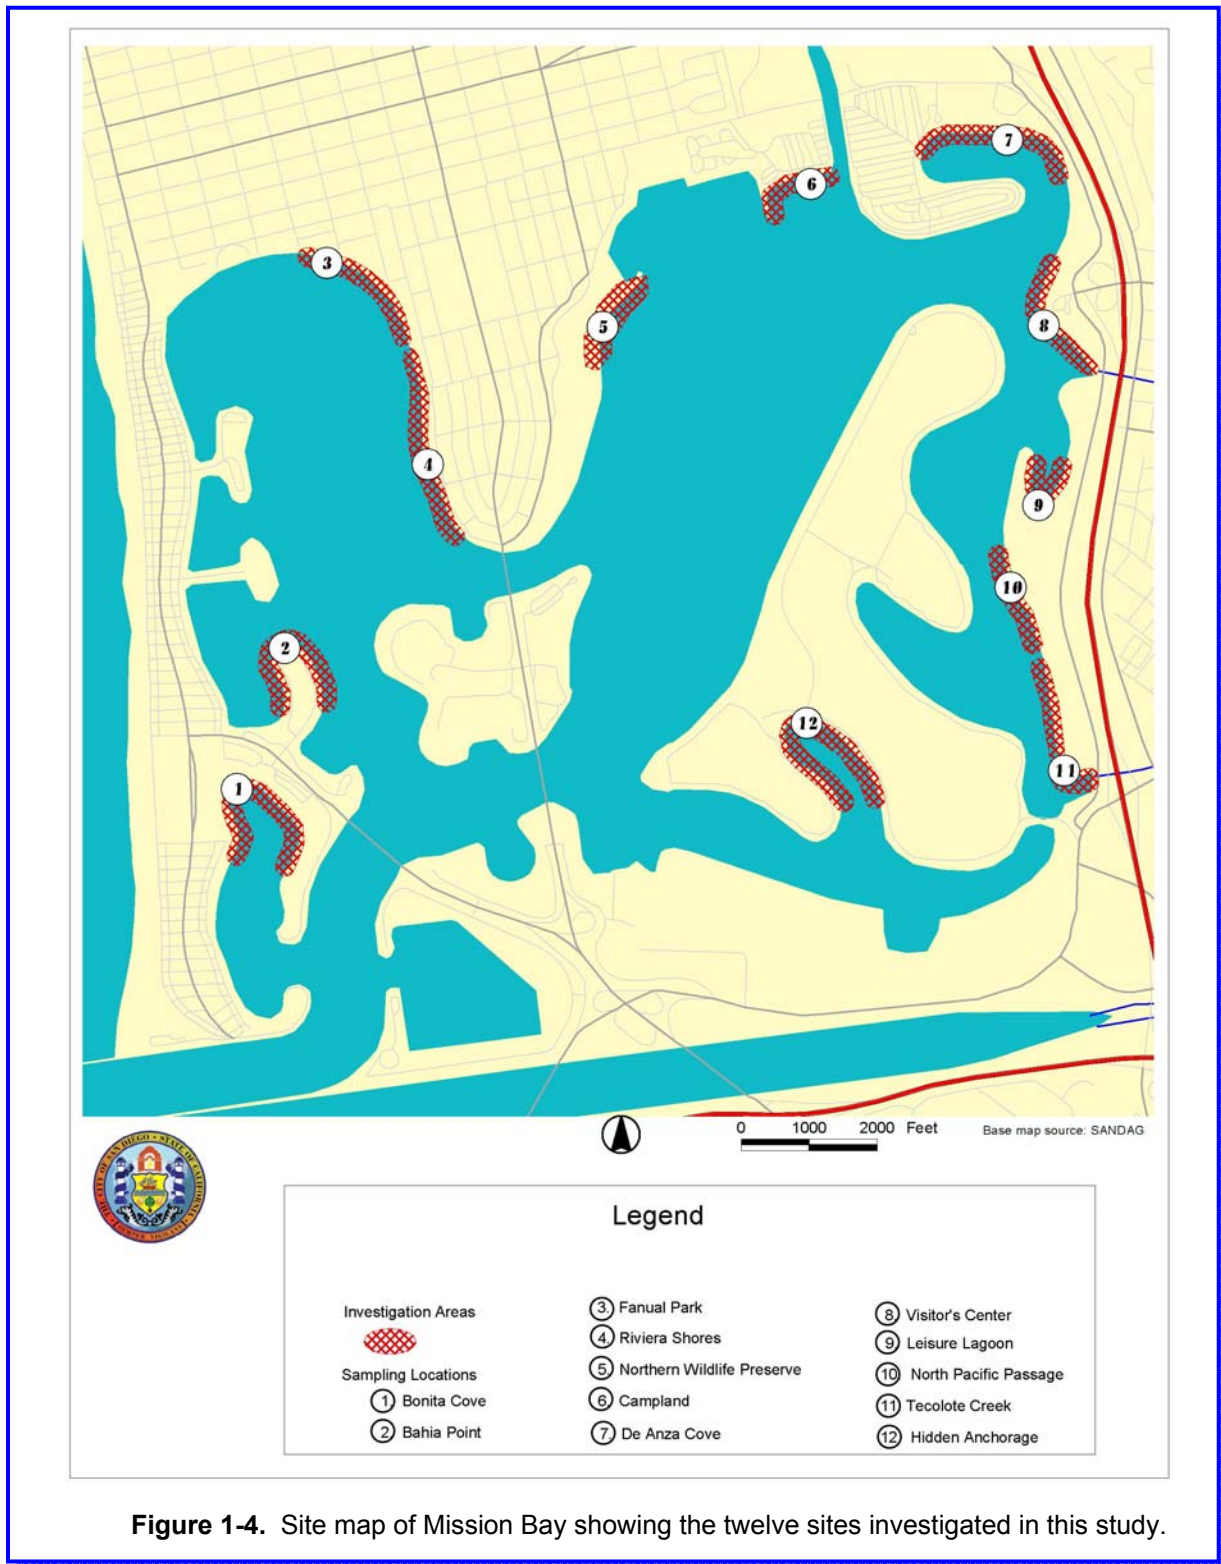
Figure 1-4. Site map of Mission Bay showing the twelve sites investigated in this study.

The results of the MEC (2001) study were used to identify the 12 sites that were assessed in Phase I of the Mission Bay Bacterial Source Identification Study. They are shown in Figure 1-4. In addition, many of the concepts outlined above were used to assess the bacterial origin, density, and mechanisms of transport to the Mission Bay receiving waters.

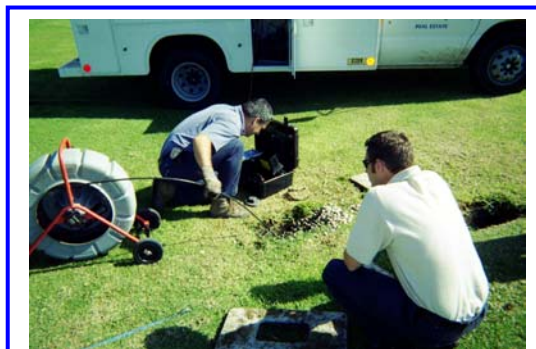
A typical CCTV investigation of a sewer lateral line in Mission Bay Park

Following the camera investigation, the tape was reviewed for pipe integrity. The tape was digitized on a compact disc for future reference and a report was generated for each facility outlining any areas of concern. All of the CCTV work was completed by experienced technicians and engineers at Affordable Pipeline Services, a sub-contractor on the project.

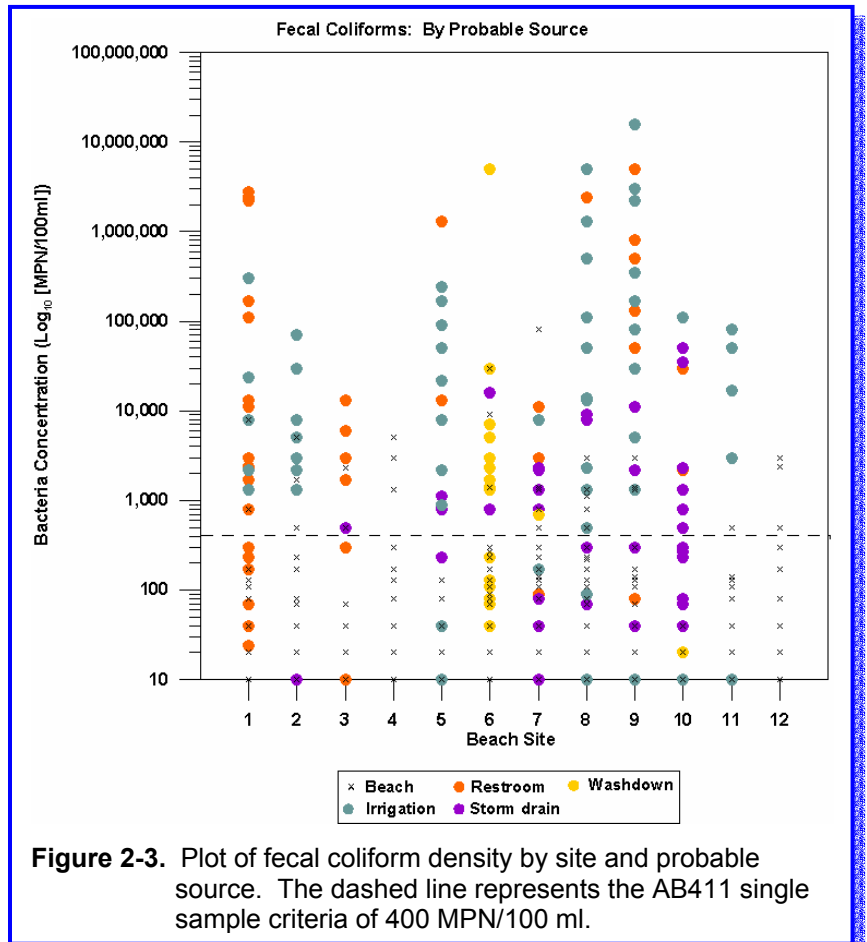
The fecal coliform data collected from spot samples and receiving water site samples during the Visual Observations Task are presented graphically in Figure 2-3. The dashed line at 400 MPN/100 ml in Figure 2-3 represents the AB411 criteria single sample limit for fecal coliform bacteria. The general pattern observed for total coliforms is also evident for the fecal coliform densities. However, a larger proportion of the spot samples exceeded the AB411 criteria. The criterion was also exceeded in the site samples at least once for all sites except Wildlife Refuge (Site 5) and North Pacific Passage (Site 10). As with the total coliform data, De Anza Cove (Site 7) and Visitor's Center (Site 8) had the greatest number of exceedances of the AB411 criterion for fecal coliforms.

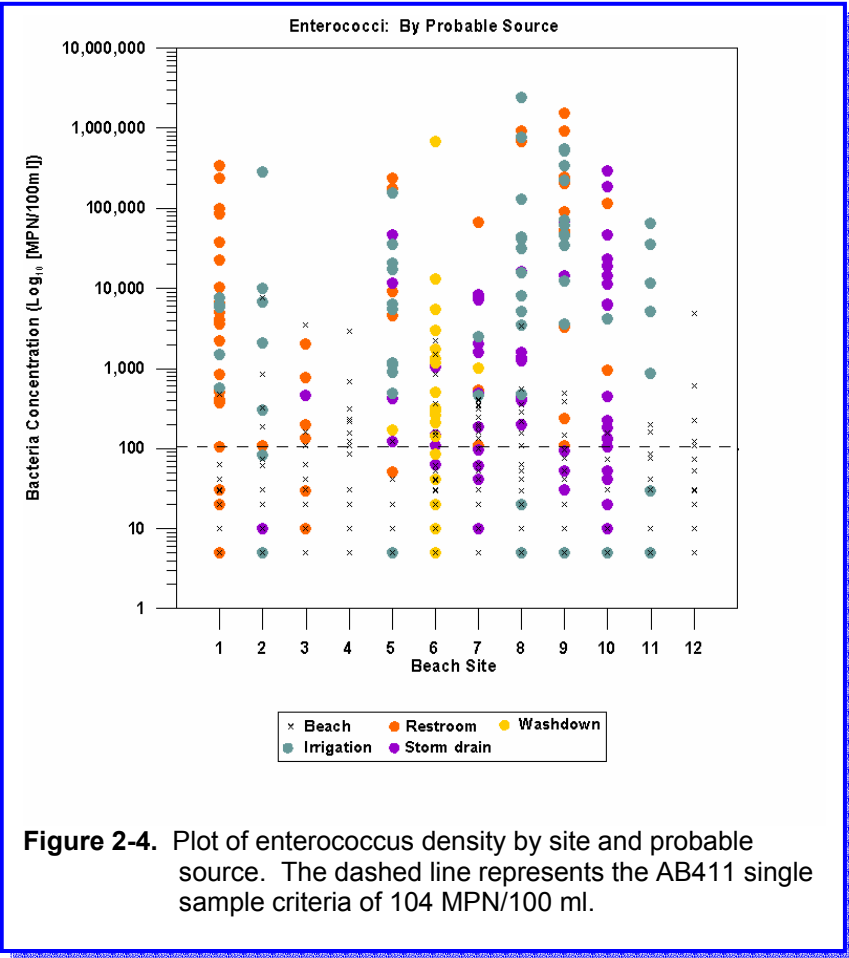
A summary of the enterococcus densities in spot samples and receiving water site samples are presented in Figure 2-4. The dashed line in Figure 2-4 at 104 MPN/100 ml represents the AB411 single sample criterion for enterococcus. Of the three indicators, the criterion for enterococcus was exceeded most frequently in this study in both spot samples and site samples. For spot samples, the enterococcus densities were elevated in all of the source categories sampled. In receiving water samples, the AB411 criterion for enterococcus was exceeded at least once at all 12 sites. The greatest number of exceedances of the enterococcus criterion occurred at De Anza Cove (Site 7). Surprisingly, the site with the next highest number of exceedances was Riviera Shores (Site 4), which had relatively low densities of total and fecal coliforms.

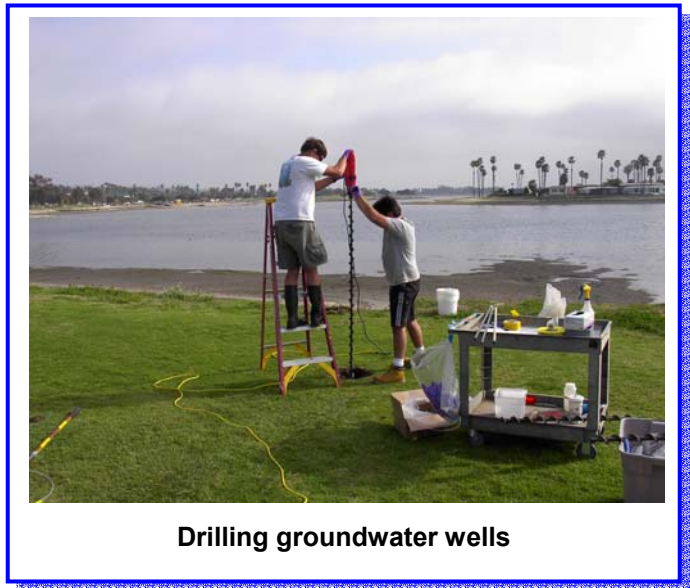
Drilling groundwater wells

Three sites were assessed in the Fate and Transport study: De Anza Cove, Visitor's Center, and Leisure Lagoon (Figure 2-1). At each of the three sites, a series of three wells was drilled along a transect in line with the beach face spring, perpendicular to the bay receiving waters. Well 1 was positioned 25 feet from the edge of the grass/sand interface, Well 2 was positioned 12.5 feet from the edge of the grass, and Well 3 was positioned at the edge of the grass adjacent to the beach face. At each well, three sampling probes attached to sterile tubing were inserted into the soil at depths of 4, 7, and 12 feet below the surface of the ground. Groundwater was extracted from each of the wells using a peristaltic pump and fecal coliform and enterococcus bacteria were enumerated.

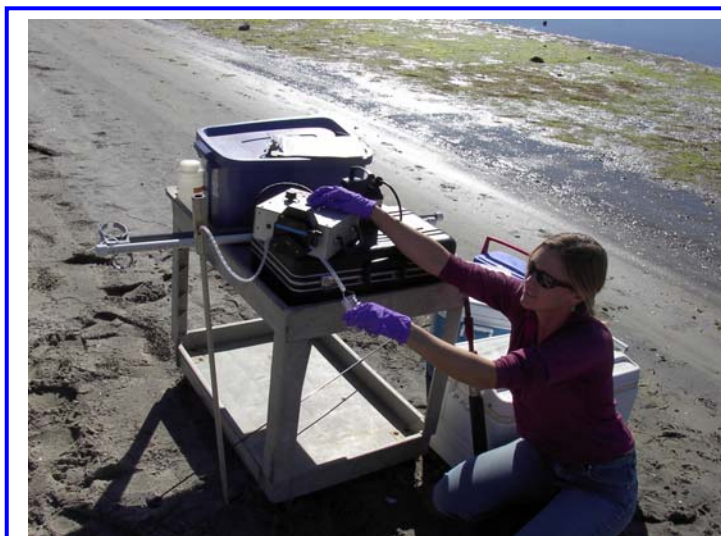
Groundwater sampling from beach face spring

In addition to the samples extracted from the wells, groundwater was also sampled from the beach face spring at each site. Groundwater samples from the beach were taken approximately ten feet above the top edge of the spring, measured along the beach face, at a depth of 12 to 24 inches below the surface of the beach face. Samples were taken using a four-foot long sampling rod connected to a six inch long, sterilized probe that was hammered into substrate. Groundwater was extracted with a peristaltic pump via sterile tubing connected to the probe.

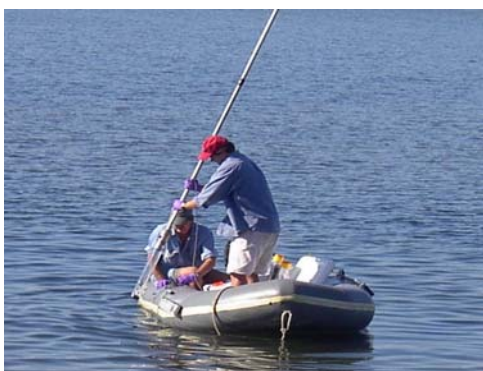
Collecting sediment cores from Tecolote Creek delta

During both surveys, sediment cores were taken from an inflatable raft (Zodiac) at six randomly selected stations within each delta. Sediment cores were taken with a hand core that consisted of 10-foot long aluminum push rod attached to an aluminum block connected to a sterile 3 inch diameter sterile, plastic tube approximately 20 inches long. After the cores had been extracted and capped, they were transferred to shore for processing. The tube was cut with a reciprocating saw equipped with a sterilized blade, approximately 2 cm above the top of the sediment layer. The top 1 cm of the sediment core was then removed with a sterile spoon and placed into a sterile 100-ml plastic bottle and capped. Surficial sediments from each of these cores were analyzed for indicator bacteria (fecal coliform and enterococcus). The same procedure was used to extract sediment from a depth of four inches from the first three cores at each delta.

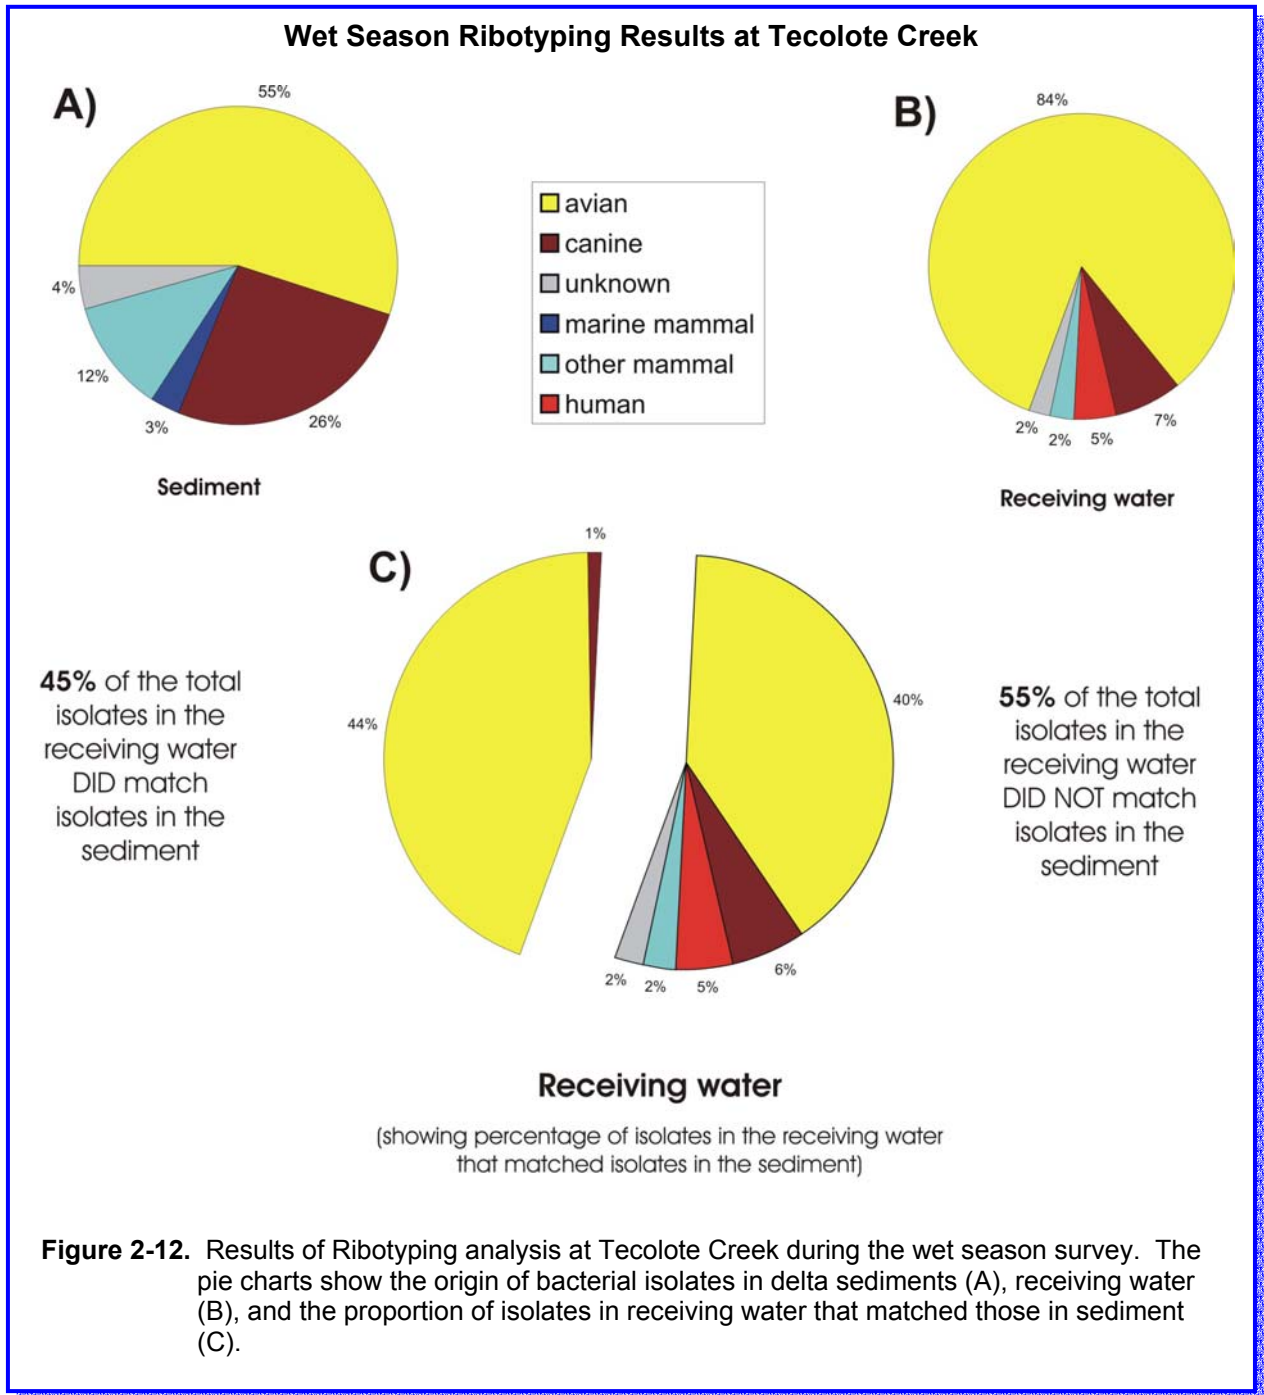
Figure 2-12. Results of Ribotyping analysis at Tecolote Creek during the wet season survey. The pie charts show the origin of bacterial isolates in delta sediments (A), receiving water (B), and the proportion of isolates in receiving water that matched those in sediment (C).

At Tecolote Creek, *E. coli* isolates were obtained only during the wet season survey. In the sediment, a total of 69 isolates were obtained. Of these 55% were of Avian origin, 26% were of Canine origin, and 15% were from other mammalian sources (Figure 2-12). In the receiving water at Tecolote Creek, Ribotyping analysis determined that the majority (84%) of isolates were also of Avian origin. We next searched for matches between the Tecolote Creek sediment and receiving water-derived Ribotype data sets (Figure 2-12C). Strikingly, we found that 45% of the isolates obtained from the receiving water did match isolates identified in the sediments.

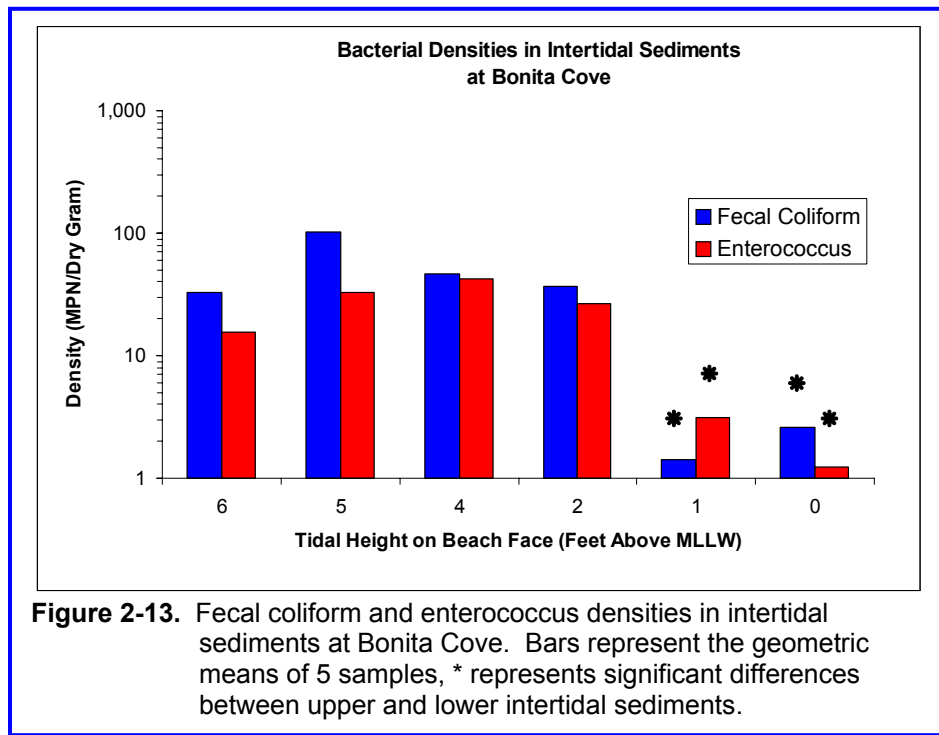
The results for Bonita Cove are presented below to illustrate the pattern of indicator bacterial densities observed in intertidal sediments. The results of the intertidal sediment studies at Bonita Cove are presented in Figure 2-13. Fecal coliform densities in intertidal sediments were similar at tidal heights of +6, +5, +4, and +2 feet above MLLW, with geometric means of the five transects ranging from 32.5 to 101 MPN/g dry sediment. At tidal heights of +1 and 0 feet above MLLW, fecal coliform densities dropped dramatically, with geometric means of 1.4 and 2.6 MPN/g, respectively. Mean fecal coliform densities in the upper intertidal sediments (+6, +5, +4, and +2 feet above MLLW) were significantly greater ($p < 0.0001$) than those in the lower intertidal sediments (+1 and 0 feet above MLLW). Enterococcus densities in intertidal sediments showed a similar pattern to that observed for fecal coliforms.

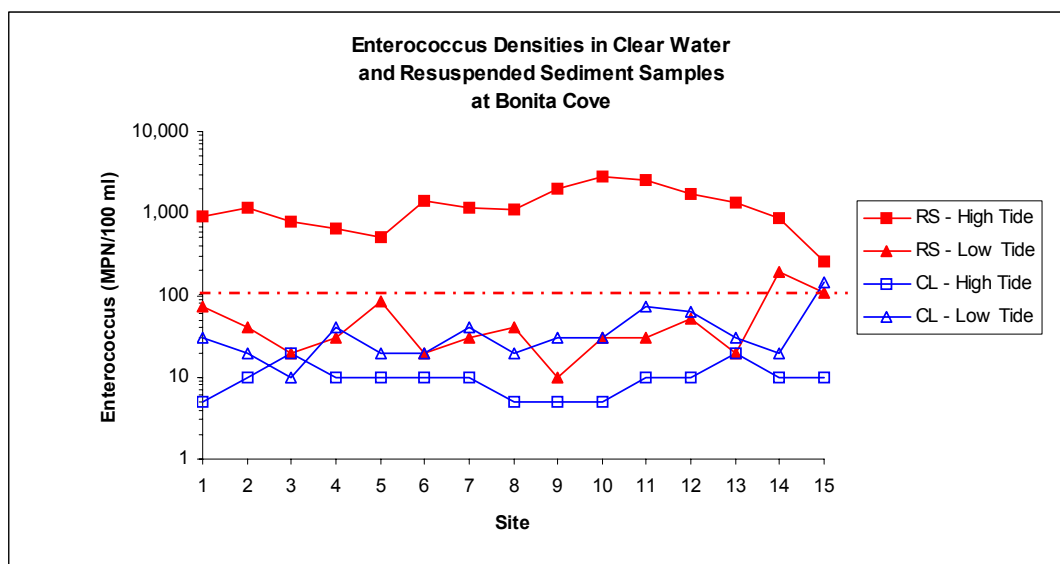
Figure 2-14. Graph of enterococcus densities in receiving water at Bonita Cove during the sediment resuspension study. CL refers to clear water samples and RS refers to samples taken after sediment resuspension. The dashed red line represents the AB411 standard for enterococcus of 104 MPN/100 ml.

During the sediment resuspension study conducted at low tide at Bonita Cove, there was no significant difference ($p > 0.05$) between the mean clear water and resuspended sediment bacterial densities for either fecal coliform or enterococcus. In contrast, when the study was repeated during high tide, there was a marked difference in bacterial densities between the clear water and resuspended sediment samples. For enterococcus, the geometric mean density of the clear water samples was low at high tide (9.1 MPN/100 ml), similar to the results observed during low tide. However, after sediment resuspension at high tide, the enterococcus geometric mean density had increased two orders of magnitude to 1,096 MPN/100 ml. At all 15 stations the resuspended sediment samples at high tide were one to two orders of magnitude greater than the corresponding clear water samples ($p < 0.0001$). These results are shown graphically in Figure 2-14.

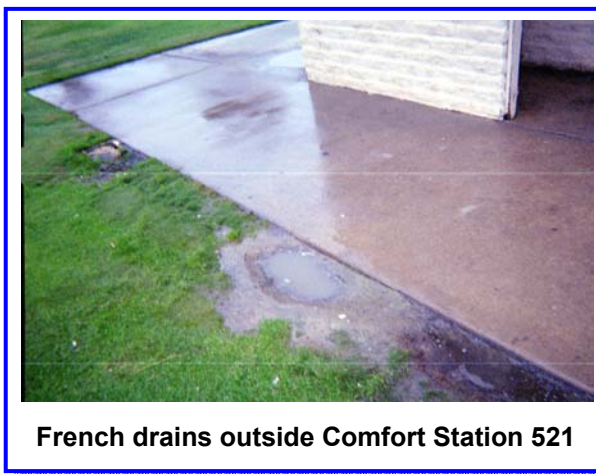
French drains outside Comfort Station 521

The comfort stations in Mission Bay were usually washed down with hoses in the early morning during the study period. At Bonita Cove, excess water was observed coming out of the comfort stations and flowing across the concrete foundation pad. Pools of water were often observed where the concrete met the grassy area of the park, even late in the afternoon, hours after the washdown had occurred. French drains were present on the bay side of Comfort Station 521 on the North end of Bonita Cove, but they appeared to be draining very slowly. The drains lead to a leach field that was approximately 60 feet from the beach. The high levels of bacteria found in the ponded water resulting from daily cleaning of both comfort stations at Bonita Cove represented a potentially significant source of bacteria to the bay. However, there was no evidence of a direct pathway on the surface of the grass from the comfort stations to the receiving waters.

In October 2002, a recommendation was made to the City of San Diego Park and Recreation Department to examine the comfort station washdown procedures at all of the comfort stations in Mission Bay Park. A best management practice (BMP) of containing the washdown water within the confines of the comfort station was implemented, where drains inside the comfort station could then convey the wash water to the sanitary sewer system. The weekly monitoring activities confirmed washdown runoff was confined to the comfort stations and not flowing across the concrete to grassy areas. Thus, this BMP program instituted by the City in the spring of 2003 appeared to have been effective at eliminating this source of bacteria to Mission Bay.

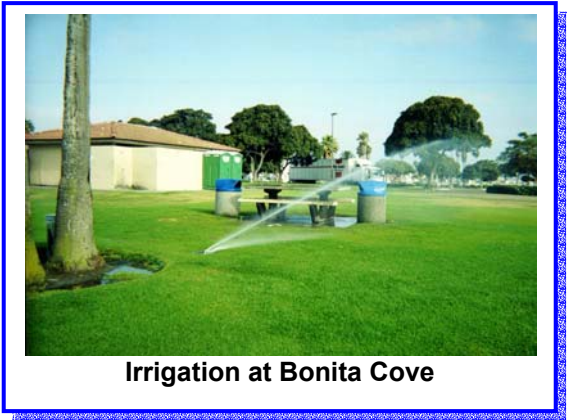
Irrigation at Bonita Cove

Ponded water in the grassy areas of the park around Bonita Cove occurred from excessive irrigation. In the fall of 2003, samples collected of this ponded water contained high densities of all three indicator bacteria (Table 3-2). In all cases, the areas of ponded water (and associated water quality samples) were not directly influenced by the comfort station washing procedures described above. During the visual observations, there were no obvious human fecal sources that could account for the high levels of indicator bacterial densities. Visual observations did indicate a large bird population, particularly on the eastern side of Bonita Cove and birds were frequently observed in the grassy areas of the park. Samples collected from the puddles as part of the Microbial Source Tracking Task in Phase II indicate that the majority of the enteric bacteria in the puddles at Bonita Cove and other areas in the park originate from birds. These results are detailed in Appendix F.

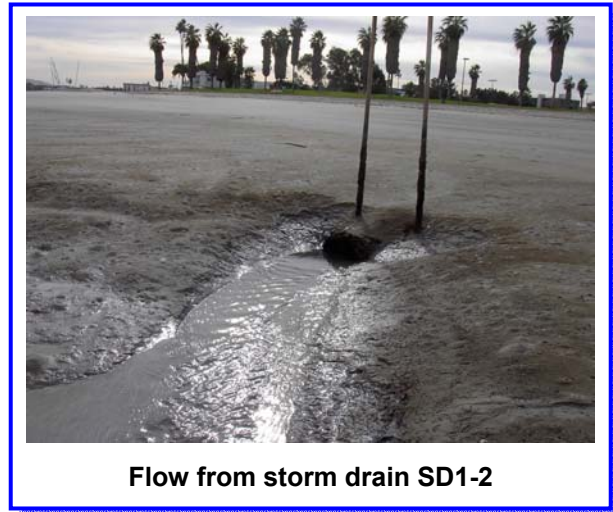
Flow from storm drain SD1-2

Storm drains were identified as a potential source (and mechanism of transport) of bacteria to Bonita Cove. Six storm drains discharge directly to Bonita Cove, and one storm drain discharges to the Mission Bay Channel directly south of Bonita Cove. However, there are only three storm drains in the immediate area surrounding the AB411 monitoring site (Figure 3-1). Inspections of the storm drains and diversion system were conducted on April 2, 2003. The inspections found malfunctioning infrastructure such as clogged diversion systems and tide flex valves. Problems associated with the diversion structures for storm drains SD1-2 and SD1-3 were particularly egregious and prevented the diversion of dry weather flow to the sewer system. Appendix I provides a thorough discussion of the results of this inspection.

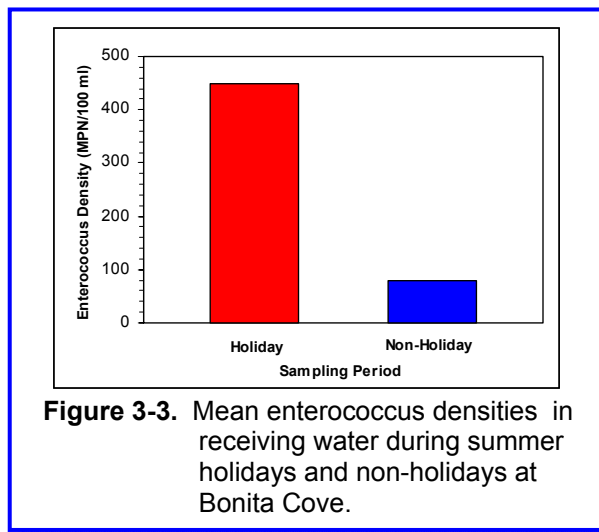
Figure 3-3. Mean enterococcus densities in receiving water during summer holidays and non-holidays at Bonita Cove.

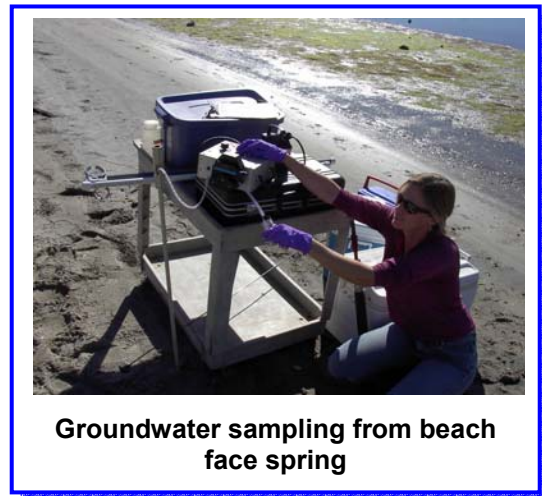
Groundwater sampling from beach face spring

As with other sites in Mission Bay, none of the four samples collected from the groundwater spring at Bonita Cove contained indicator bacteria. These results suggest that groundwater seepage through the beach face is not a source of bacteria at this site.

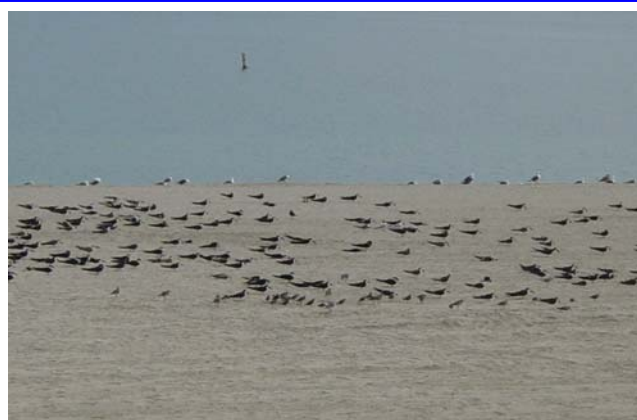
Birds in the upper intertidal zone at Bonita Cove

inundated by seawater) to a much greater extent than the lower intertidal zone, which allows for a greater period of time for the accumulation of fecal matter. The results of the microbial source tracking study at Bonita Cove indicate that the vast majority of enteric bacteria found in the receiving waters originated from birds. In addition, birds and bird feces were observed frequently on the beach face in the upper intertidal zone. The lower intertidal zone is submerged more frequently than the upper intertidal zone, preventing the accumulation of bird feces. In addition, seawater tends to limit survival of both fecal coliform and, to a lesser extent, enterococcus bacteria. As a result, bacterial densities are lower in the lower intertidal zone sediments and sediment resuspension has a negligible effect on bacterial densities in the water column.

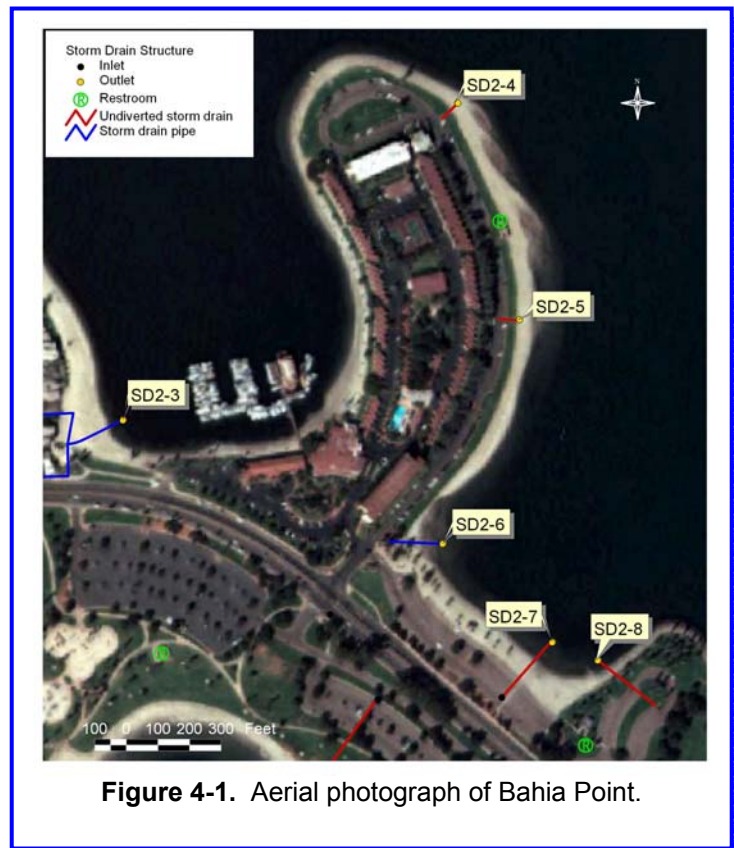
Figure 4-1. Aerial photograph of Bahia Point.

Bahia Point is a peninsula located on the western side of Mission Bay (Figure 4-1). It is surrounded by Santa Barbara Cove to the west and Ventura Cove to the southeast. To the south, West Mission Bay Drive separates Bahia Point from Bonita Cove. The Bahia Hotel occupies most of the peninsula. Parking lots and a small strip of grass lie between the hotel and the beach. Although there are no major drainages that discharge in the area, there are two storm drains that discharge on the peninsula and several others that discharge into Santa Barbara Cove and Ventura Cove. Storm drains SD2-4 and SD2-5 drain the parking lots and the grassy areas of the peninsula and they are not part of the MBSIS. The AB411 monitoring site for Bahia Point is located directly in front of storm drain SD2-4. Additional AB411 sites in the area are located in front of storm drains SD2-3 and SD2-7. There is one comfort station at this site located approximately 400 feet south of storm drain SD2-4.

There is only one comfort station that serves Bahia Point: Comfort Station 834, located at the northern end of the peninsula (Figure 4-1). Although several observations were made of runoff resulting from washdown procedures at this comfort station, only one sample was collected. This sample had extremely high levels of total coliform bacteria (5,000,000 MPN/100 ml). Fecal coliforms were not detected and the enterococcus density was slightly above the AB411 criteria (108 MPN/100 ml). There is no grass buffer strip between the comfort station's concrete foundation and the beach sand at Bahia Point. Therefore, runoff from the washdown procedures drained directly to the sandy beach and was considered a potential source of bacteria to Mission Bay. However, visual observations made during the weekly monitoring conducted during the winter of 2002/2003 confirmed that BMPs initiated to confine runoff from washdown procedures to within the structure were working and had been effective in eliminating this source of bacteria to Mission Bay.

Four of the storm drains at Bahia Point are not diverted to the sewer system (see Figure 4-1). During the Visual Observations Task, the gutters leading to the storm drains were frequently full of organic debris from lawn maintenance practices. In addition, excess irrigation water was observed flowing through storm drain SD2-4, which discharges in front of the AB411 monitoring site. One sample was collected from storm drain SD2-4 and bacterial densities were very high for all three indicators (2,400,000 MPN/100 ml, 8,000 MPN/100ml and 285,100 MPN/100 ml for total coliform, fecal coliform and enterococcus, respectively). Although only one sample was taken from the storm drains at this site, the presence of high bacterial densities in the grass, organic debris in the gutters, and observations of excess irrigation water suggest that the un-diverted storm drains at Bahia Point, particularly storm drain SD2-4, were likely sources of bacteria to the receiving waters.

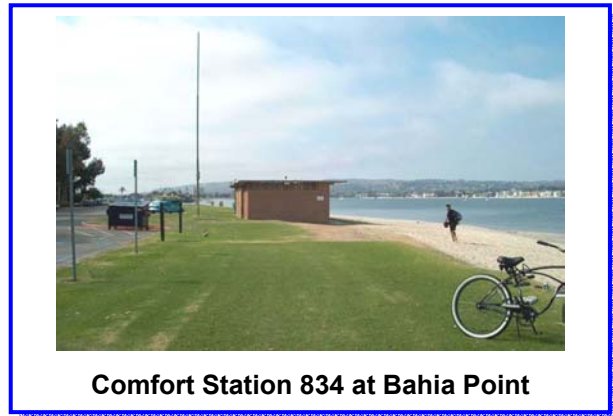
Comfort Station 834 at Bahia Point

The lateral lines that serve Comfort Station 834 were inspected by closed-circuit television during Task 1 of this study to confirm their structural integrity. These inspections were conducted on September 19, 2002. The results of the inspection showed the lateral line leading from the comfort station to the sewer main was in good condition with the exception of some mild corrosion in a section of cast iron pipe. Thus, the sewer infrastructure is not considered to be a source of bacteria to the area's receiving waters.

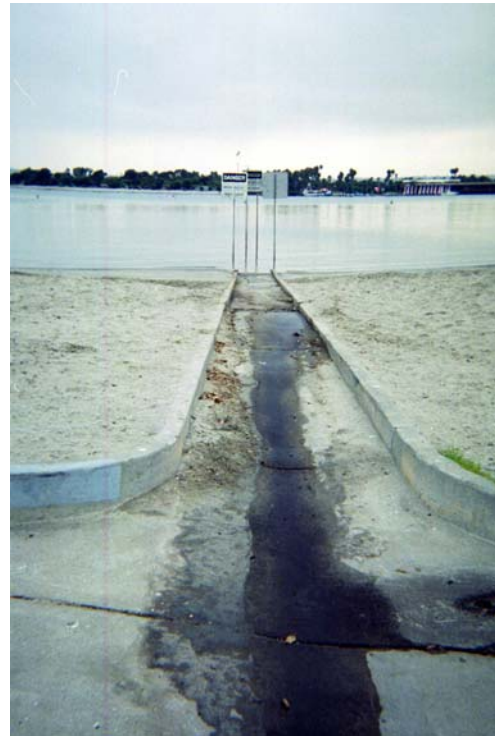
Un-diverted storm drain at Bahia Point

Based on the information collected in Phase I of this study, the most likely source of elevated bacterial densities at Bahia Point appears to be the runoff from the un-diverted storm drains SD2-4 and SD2-5. The drainage area for these storm drains is small, but they convey water from the grassy areas of the park during irrigation, which contain high levels of indicator bacteria. Bacterial densities may also increase as water flows to the storm drains from leaf litter and organic matter in the gutters at Bahia Point. High levels of indicator bacteria were measured from these storm drains during Task 3. In addition, the AB411 monitoring site is located directly in front of the discharge point of storm drain SD2-4. In the spring of 2003, the City Park and Recreation Department was made aware of the organic debris that accumulated in the gutters at Bahia Point and the excessive irrigation that helped convey it to the receiving waters of Mission Bay. As a result, management actions were taken to reduce this source of bacteria. Since that time there have been no exceedances of AB411 criteria at Bahia Point (the enterococcus data is summarized in Figure 4-1), suggesting that the management actions taken by the City have been successful in reducing or eliminating bacterial loads at this site.

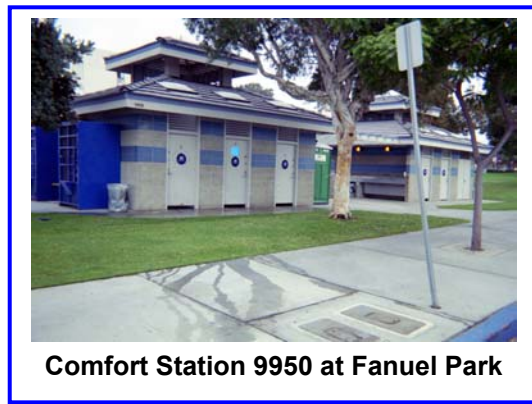
Comfort Station 9950 at Fanuel Park

One Comfort Station serves Fanuel Park: Comfort Station 9950 at the end of Fanuel Street. Unlike other comfort stations around Mission Bay, the comfort station at Fanuel Park contains several individual toilets, each occupying a private restroom. Cleaning of the comfort station occurred by washing out each individual restroom then sending any residual water to the french drains located adjacent to the comfort station facility. Due to the absence of drains within each restroom, the BMP discussed in Section 3 (Bonita Cove) to contain washdown runoff was not attainable. Therefore, this was the only site where runoff from washdown procedures continued.

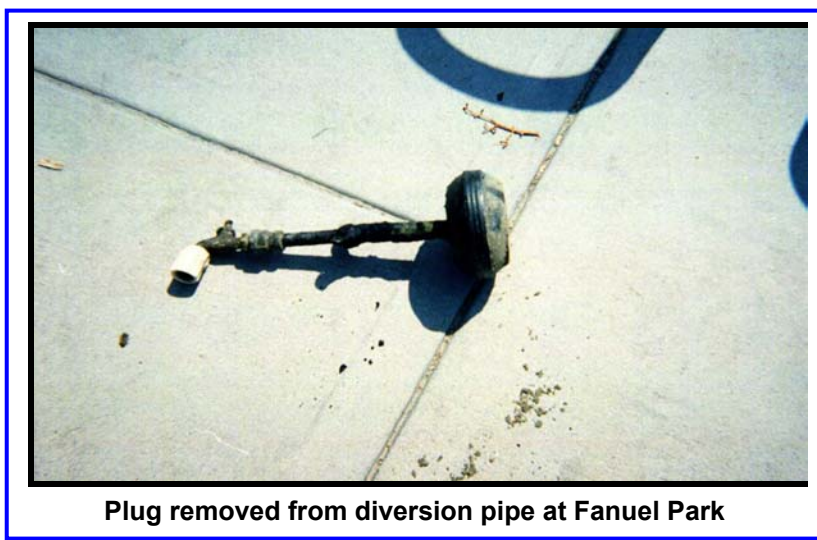
Plug removed from diversion pipe at Fanuel Park

Four storm drains discharge to Sail Bay in the vicinity of Fanuel Park (Figure 5-1). A detailed inspection of the storm drains and their diversion structures was completed on February 27, 2003. The inspection found a suite of problems associated with the MBSIS diversion structures, including un-diverted flow, missing tide flex or check valves, inflatable plugs inserted into diversion lines, and large volumes of water entering the storm drains downstream of the diversion structures from dewatering activities (see discussion below). Appendix I provides a detailed discussion of the results of the inspection.

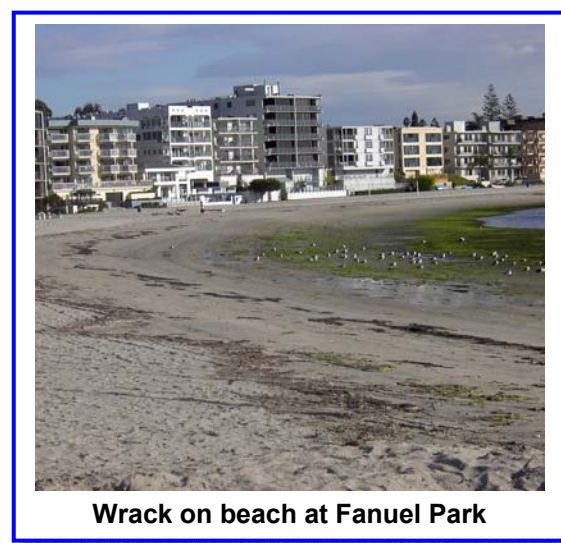
Wrack on beach at Fanuel Park

As with Riviera Shores, a heavy wrack line consisting of organic material from Sail Bay tends to accumulate on the beach at Fanuel Park. The results of the wrack line study conducted at Riviera Shores, which lies adjacent to Fanuel Park, suggest that the wrack line tends to amplify the bacterial load. In this way, the wrack line found at Fanuel Park is also a likely source of indicator bacteria to the receiving waters at this site.

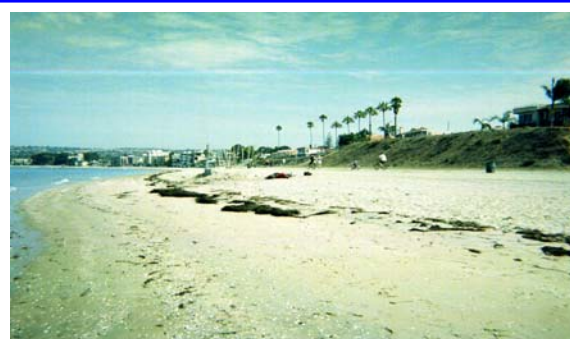
Riviera Shores beach showing accumulation of wrack line

Based on these results and the observation that a wrack line tends to accumulate along the beach in the upper intertidal zone at Riviera Shores, a follow-up study was conducted to determine the extent to which the wrack line affects bacterial densities in the receiving water. The complete study can be found in Appendix H.

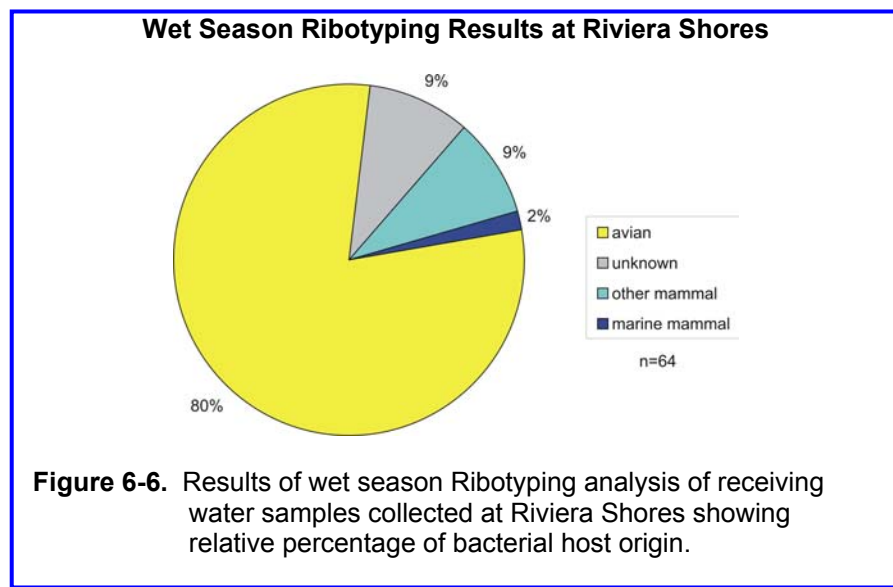
Figure 6-6. Results of wet season Ribotyping analysis of receiving water samples collected at Riviera Shores showing relative percentage of bacterial host origin.
