MISSION BAY Clean Beaches Initiative Bacterial Source Identification Study

Final Report

The City of San Diego

September 15, 2004

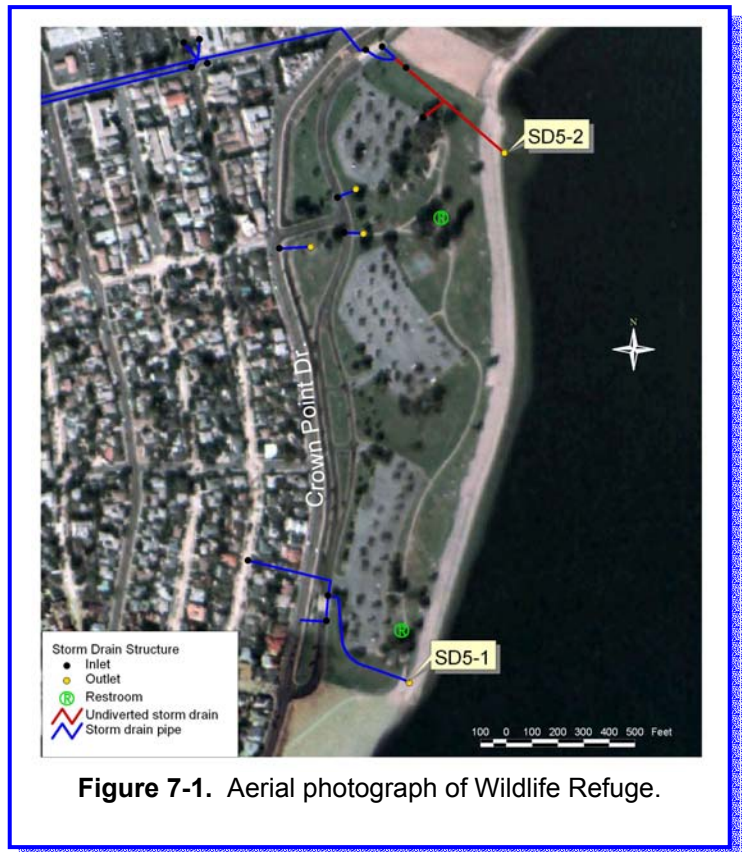
Figure 7-1. Aerial photograph of Wildlife Refuge.

The Wildlife Refuge site is located on the northeast side of Crown Point, directly south of the Kendall Frost Wildlife Reserve (Figure 7-1). Along with Campland, it is closest of the 12 sites to the Wildlife Reserve. During the summer months this is a popular beach for swimming, jet skiing, and other aquatic activities. Directly behind the beach is a large grass park containing three large parking lots. There are no major creek drainages that discharge to the immediate area around Wildlife Refuge, but the site has two large storm drains that discharge to the beach. Storm drains SD5-1 and SD5-2 are part of the MBSIS and they have diversion structures on the east side of Crown Point Drive. However, downstream of the diversion structure for storm drain SD5-2 are two large inlets that convey excess water from the grass and adjacent parking lot directly to the bay. The AB411 monitoring site is located directly in front of the terminus of storm drain SD5-2. There are two comfort stations at this site, located on either end of the grass park.

There are two storm drains that discharge to the eastern shoreline of Crown Point near the Wildlife Refuge site: SD5-1 on the southern end of the site and SD5-2 on the northern end (Figure 7-1). Both of these storm drains are diverted as part of the MBSIS. On April 28, 2003 the storm drain diversion systems were inspected and documented to be functioning properly (see Appendix I for complete report). However, storm drain SD5-2 has two entrances in the grassy area of the park downstream of the diversion structure. Excess irrigation water enters these drains and is conveyed directly to the receiving waters. During the Visual Observations Task, five samples were collected from the discharge of storm drain SD5-2. Four of the samples exceeded the AB411 criteria for each of the indicator bacteria. The fifth sample only exceeded the enterococcus criterion. Table 7-3 summarizes the results.

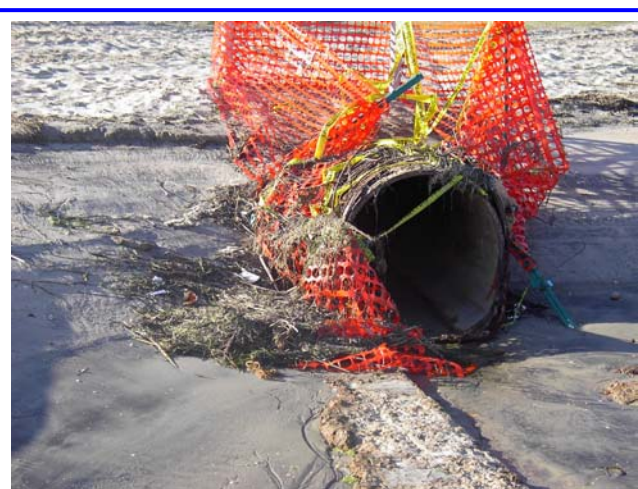
Storm drain SD5-2 at Wildlife Refuge

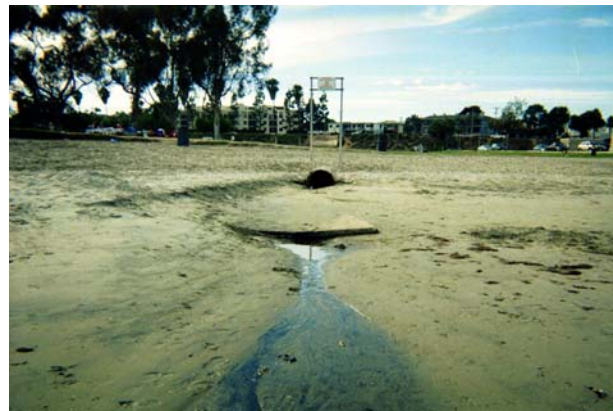
Groundwater spring below storm drain SD5-2

A groundwater spring discharges along the beach face near the terminus of SD5-2. Bacterial levels were not measured in the effluent from this spring, but it was considered to be a potential bacterial source due to the proximity to the park area where high bacterial densities were measured. Groundwater monitoring was conducted at this site as part of the Phase II Microbial Source Tracking Task. The results are discussed below

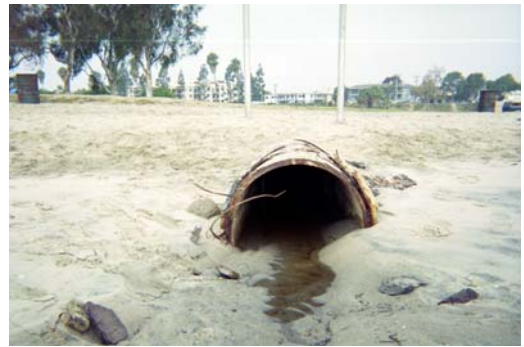
Storm Drain SD5-2 conveys irrigation runoff to Wildlife Refuge

Perhaps the most interesting finding of the investigations conducted at Wildlife Refuge was the very low levels of indicator bacteria in the receiving waters from January through October, 2003. During this time there was only one exceedance of AB411 criteria for any of the indicator bacteria, which is much lower than any similar time period in the last ten years (see Figure 7-2 for the enterococcus results). In January, 2003 storm drain SD5-2 was under construction and the terminus of the storm drain was blocked with beach sand, eliminating flow to the receiving waters. The extent to which the effluent from storm drain SD5-2 contributes to elevated bacterial densities in the receiving water at Wildlife Refuge is unclear. However, the high bacterial densities measured in the irrigation water and effluent associated with the storm drain coupled with the very low densities measured in the receiving water when the storm drain was blocked suggest that effluent from storm drain SD5-2 contributes to elevated bacterial densities in the receiving water at this site.

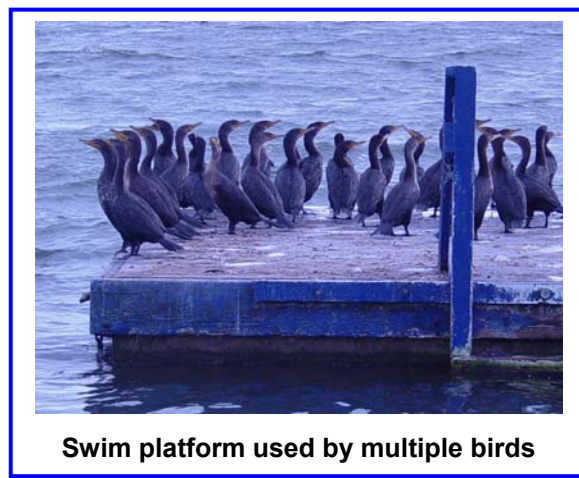
Swim platform used by multiple birds

Observations made during the follow-up study suggested that the large bird population at the Campland beach and surrounding area was the most obvious source of bacteria to the site. A swim platform used primarily during the summer was frequently populated by a large number of double-crested cormorants (*Phalacrocorax auritus*) and other birds. Large numbers of birds were also observed on the Campland boat docks and beach. Associated with the large bird population was a high density of bird fecal matter on the docks, swim platform, and beach.

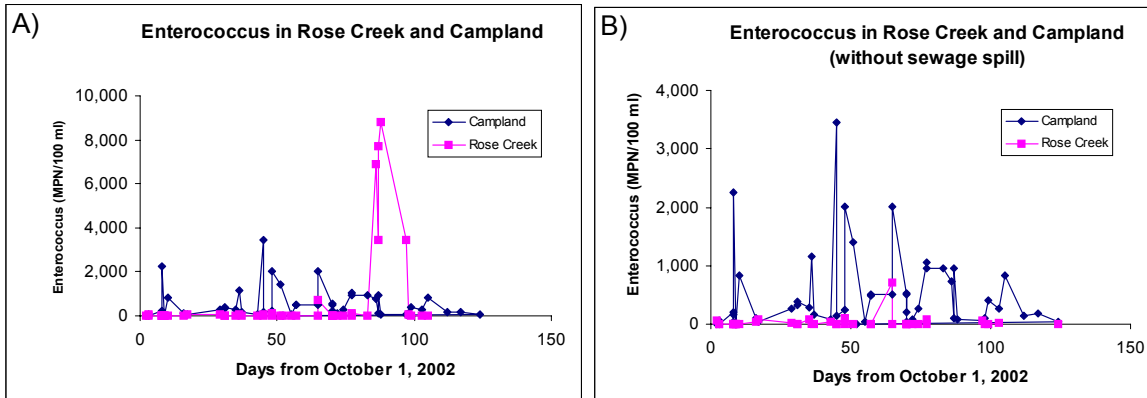
Figure 8-6. Comparison of enterococcus densities in receiving waters collected from Rose Creek and from the Campland AB411 monitoring site with (Graph A) and without (Graph B) data from a sewage spill in Rose Creek in late December 2002.

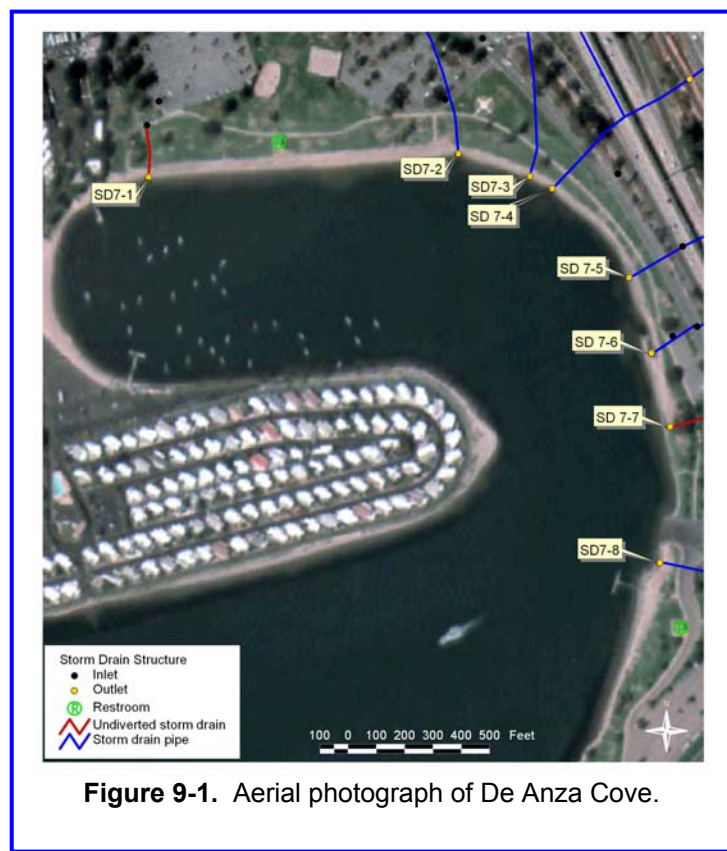
Figure 9-1. Aerial photograph of De Anza Cove.

De Anza Cove is a small embayment located in the northeast corner of Mission Bay (Figure 9-1). It is bounded on the east and north by East Mission Bay Drive. There is a grass buffer strip between the road and the bay on the east side and a larger grass park and parking lots on the north side of the cove. This area of Mission Bay Park is used heavily by park visitors, particularly during the summer months. The peninsula that forms the west and south end of De Anza Cove is a mobile home complex known as De Anza Harbor Resort, with numerous individual units. De Anza Cove is also one of the three areas in Mission Bay with boat mooring facilities. Typically, the area is home to 20 to 30 moored boats. There are no major creeks that discharge directly to De Anza Cove, but there are numerous groundwater springs that discharge at the beach along the east side of the cove. In addition, there are eight storm drains that discharge to the area. All but two of these are part of the MBSIS (shown in red in Figure 9-1). The primary AB411 monitoring site is located directly in front of storm drain SD7-2. De Anza Cove has one comfort station, located midway along the northern shoreline.

There is one comfort station that serves De Anza Cove. Comfort Station 10087 is located midway along the northern shore of the site (Figure 9-1). Runoff generated from washdown procedures at this comfort station was not observed during the Visual Observations Task and no samples were collected. In addition, during the weekly monitoring conducted from November, 2002 through March, 2003 there were no observations that indicated that comfort station runoff generated from washdown procedures was leaving the comfort station at De Anza Cove.

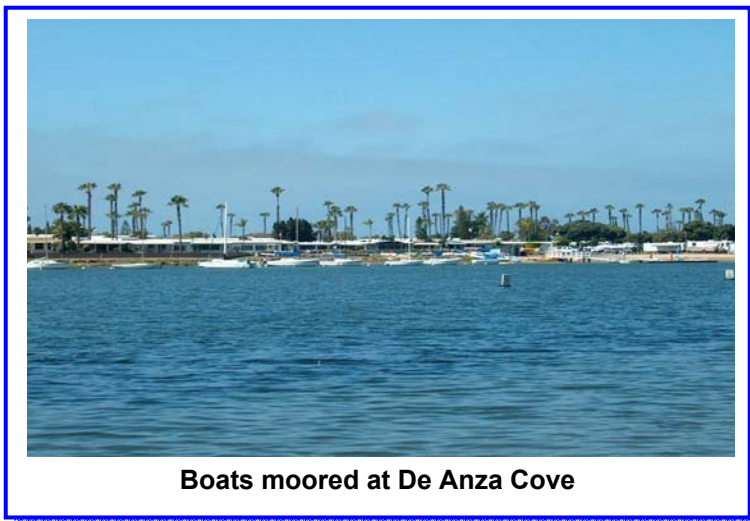
Boats moored at De Anza Cove

Very low densities of all three bacterial indicators were detected throughout the boat mooring study at De Anza Cove. Over 90% of the samples collected from around the anchored boats were below or equal to the detection limit for all three indicator bacteria. Only one sample collected during the study exceeded AB411 criteria; it was collected from the beach and had a total coliform density of 1,300 MPN/100 ml and a fecal coliform density of 140 MPN/100 ml. However, there was no apparent connection between the high densities at the beach in this single sample and illicit discharge from the boats. The results of the study suggested that illegal sewage dumping from boats moored in De Anza Cove was not a chronic source of bacterial contamination at the beach. However, since the sampling duration was limited, and illegally dumping is likely episodic (if it is occurring), the potential for moored boats as a source of bacterial contamination to adjacent beaches can not be ruled out.

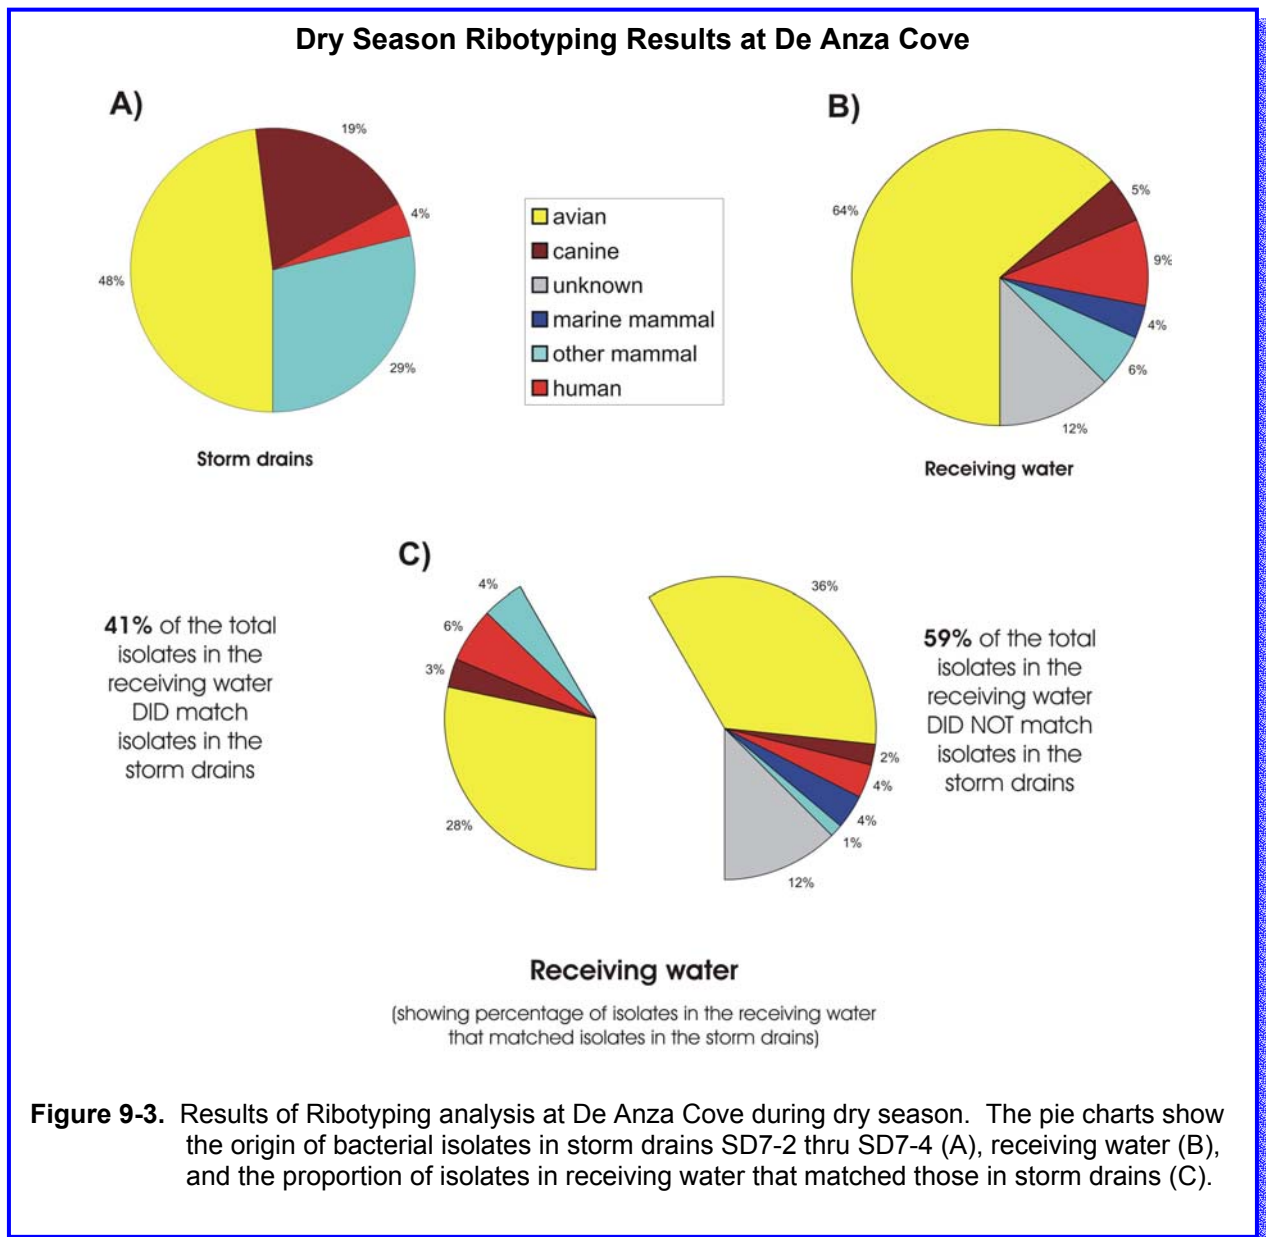
Figure 9-3. Results of Ribotyping analysis at De Anza Cove during dry season. The pie charts show the origin of bacterial isolates in storm drains SD7-2 thru SD7-4 (A), receiving water (B), and the proportion of isolates in receiving water that matched those in storm drains (C).

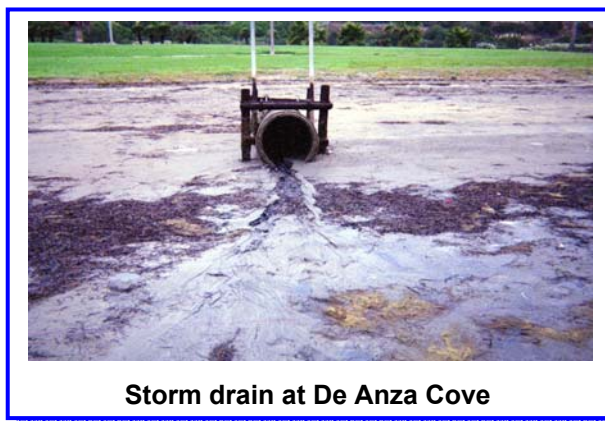
Storm drain at De Anza Cove

sediments in the lower intertidal zone (likely the upper intertidal as well) act as a reservoir for bacteria that when disturbed, are released to the water column. Finally, and most importantly, there are more storm drains that discharge to De Anza Cove than any other single area in Mission Bay. Numerous lines of evidence from this study indicate that storm drains are a major contributor to elevated bacterial densities in the receiving waters at De Anza Cove, including high indicator bacterial densities in storm drain effluent, clogged diversion structures that allow large amounts of dry weather flow to reach the bay, elevated bacterial densities in intertidal sediments adjacent to the storm drains, a strong connection between storm drains and receiving water as a result of microbial source tracking techniques, and maintenance of an environment conducive to bacterial growth. Although other bacterial sources should be addressed when considering ways to reduce levels of indicator bacteria densities in De Anza Cove, the storm drains and maintenance of the MBSIS diversion structures should be a primary focus.

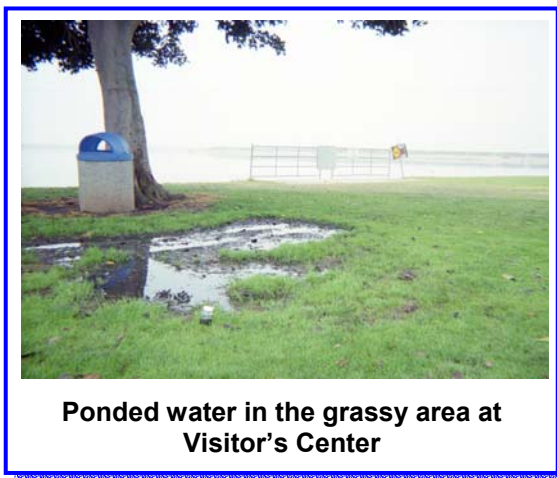
Ponded water in the grassy areas of the park and paved surfaces surrounding Visitor's Center occurred from excessive irrigation. A total of 16 samples were collected from this ponded water. The bacterial densities in these samples were highly variable. Enterococcus densities ranged from 5 MPN/100 ml to over 2 million MPN/100 ml. Table 10-1 summarizes the results of these samples.

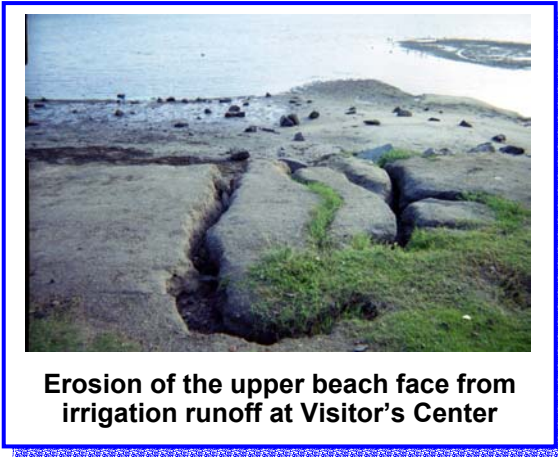
Bacteria associated with the irrigation water in the grassy area of the park can reach the receiving waters at this site through street runoff, which is conveyed directly to the bay through storm drain inlets below the diversion structures of storm drains SD8-1, SD8-2, and SD8-3. In addition, erosion of the banks at the Visitor's Center site was a common observation during the Visual Observations Task. This suggests that sheet transport of irrigation water from the grass surface to the bay occurs at this site. Transport of bacteria from the grass to the bay via groundwater was determined to be unlikely at Visitor's Center and other sites in Mission Bay (see Phase II below).

Erosion of the upper beach face from irrigation runoff at Visitor's Center

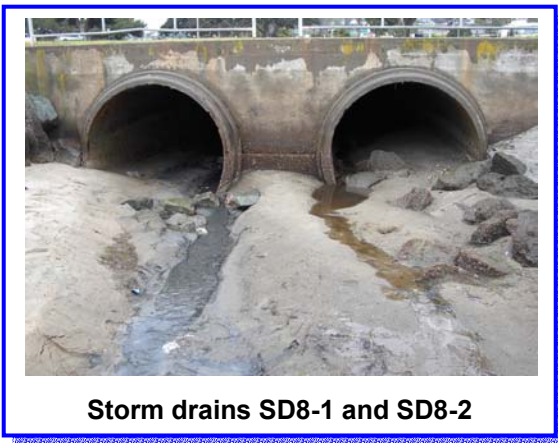
During Phase I, storm drains were identified as the major potential source (and mechanism of transport) of bacteria at Visitor's Center. Three storm drains discharge to the receiving waters at this site: storm drains SD8-1 and SD8-2 at the northern end of the site and Cudahy Creek (SD8-3) at the southern end (Figure 10-1). The MBSIS diversion structure for storm drains SD8-1 and SD8-2 is located on the east side of Interstate 5 near Morena Drive. During the Visual Observations Task and subsequent monitoring in Phase II, this diversion structure was functioning properly by diverting dry weather flow to the sewer. However, just downstream of the diversion structure is a freshwater spring that is present year-round and flows through storm drain SD8-1. In addition, there is significant groundwater infiltration to the storm drain system in this area. As a result, there is a constant, year-round flow of freshwater flowing to Mission Bay of approximately 5 g.p.m. via storm drain SD8-1. Seven samples were collected from this storm drain during the Visual Observations Task. All of them exceeded AB411 criteria. The results are summarized in Table 10-2. The high bacterial densities and constant freshwater flow associated with storm drain SD8-1 indicate that this storm drain is a significant source of bacteria to the Visitor's Center site.

Storm drains SD8-1 and SD8-2

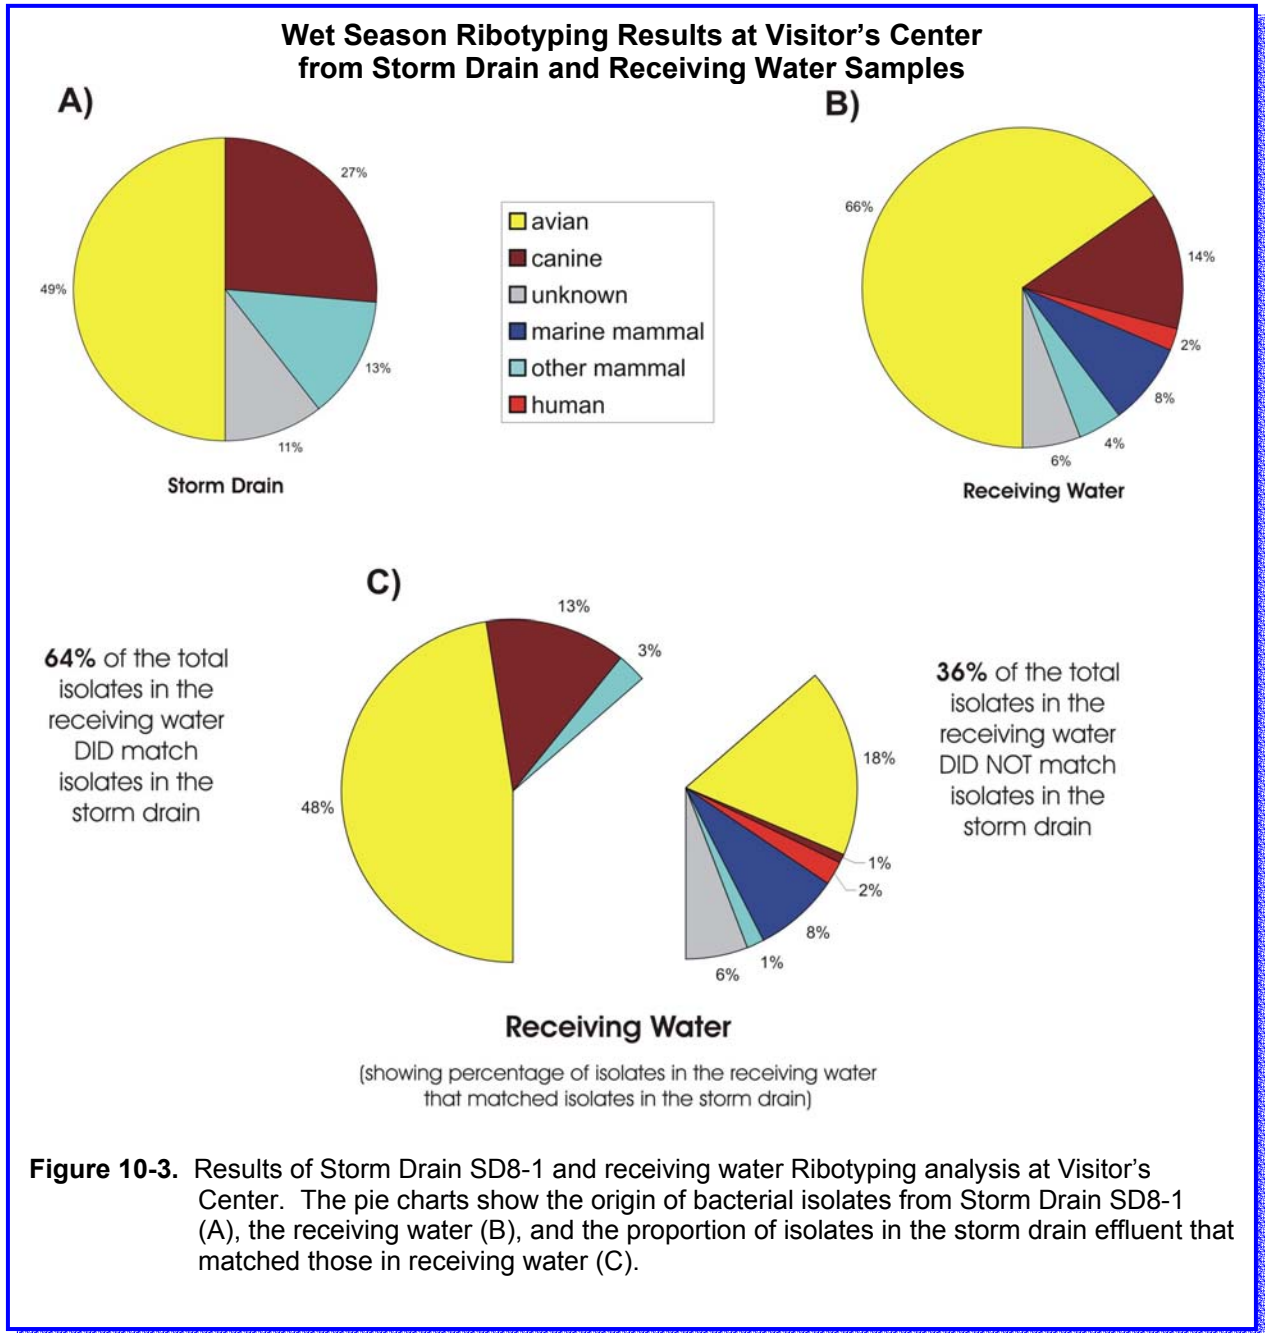
Figure 10-3. Results of Storm Drain SD8-1 and receiving water Ribotyping analysis at Visitor's Center. The pie charts show the origin of bacterial isolates from Storm Drain SD8-1 (A), the receiving water (B), and the proportion of isolates in the storm drain effluent that matched those in receiving water (C).

We next asked what proportion of the combined Spring/Storm Drain Ribotypes could be traced to the receiving water Ribotype data set (Figure 10-3C). Interestingly, we found that a substantial 64% of the receiving water-derived Ribotypes were shared with those found in the Spring/Storm Drain Ribotype data set. Nearly all of the isolates that were common to both areas originated from Avian or Canine sources.

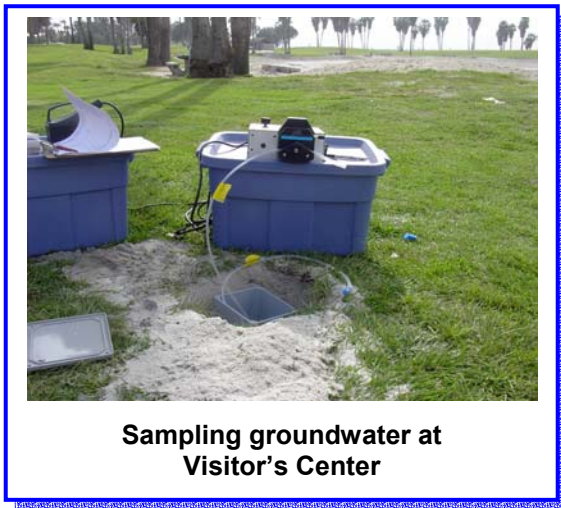
In addition to the constant effluent emanating from storm drain SD8-1 and Cudahy Creek at Visitor's Center, this site also has several freshwater springs along the beach face. At the end of Phase I, these springs were identified as a potential source of bacteria to this area. This potential was assessed at Visitor's Center in the Fate and Transport Study conducted at this site in March, 2004. In this study, samples were collected from soil cores and groundwater wells in the park, and groundwater springs on the beach face. The complete results of the study are presented in Appendix F and summarized in Table 10-4.

Sampling groundwater at Visitor's Center

The results of the study revealed that the grassy areas of Visitor's Center, as well as other locations in Mission Bay Park, contain a large reservoir of both fecal coliform and enterococcus bacteria. The origin of the bacteria was determined to be avian (see Appendix G). However, an analysis of bacterial density with depth from the soil core samples indicated that the migration of bacteria from the park surface to the groundwater is limited to the upper 18 inches of soil by layers of clay and other fine-grained material. Virtually no indicator bacteria were found in the groundwater wells or the beach face springs at Visitor's Center or the other sites investigated in the fate and transport study. In addition, none of the samples collected from groundwater at the beach face springs during the Microbial Source Tracking Task at Visitor's Center contained indicator bacteria. These results indicate that the grassy area of Visitor's Center and the soil directly beneath it contains a large reservoir of indicator bacteria, but the bacteria is not transported to the receiving waters of Mission Bay via groundwater seepage through the beach.

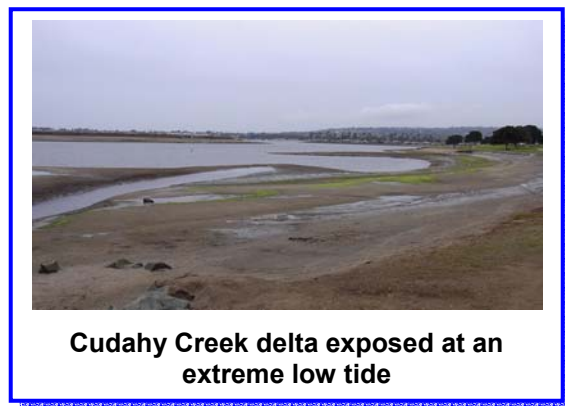
Because there is a large delta built up at the mouth of Cudahy Creek and consistently elevated bacterial densities have been measured in Cudahy Creek effluent, the sediments in the Cudahy Creek delta were assessed as part of the Sediment Investigation Task. The goal of the study was to determine the extent to which bacteria deposited at the mouth of Cudahy Creek impacted the receiving waters at Visitor's Center. The complete report is presented in Appendix G and summarized below.

Two surveys were conducted: one at the end of the dry season (October, 2003) and one during the middle of the wet season (January, 2004). Sediment cores were collected by boat at the surface and from a depth of four inches. During the dry season survey, sediments at the mouth of Cudahy Creek (i.e., the creek delta) contained very low levels of indicator bacteria (Table 10-5). These results suggest that the delta sediments at Cudahy Creek during the dry season are an unlikely source of bacteria to the AB411 receiving water monitoring site at Visitor's Center. The wet season survey was conducted in January, 2004 after several storms had impacted the area. Fecal coliform densities in surficial sediments were similar to those during the dry season, but the mean enterococcus density during the wet season survey was 38 times greater than the mean dry season density ($p < 0.0006$).

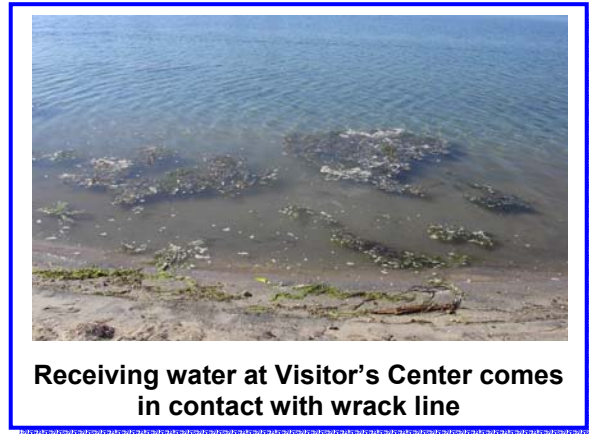
Another potential reservoir of bacteria that was identified at Visitor's Center was the wrack line that accumulates on the beach face at this site. The wrack, or organic debris such as eel grass and algae, tends to accumulate at the high tide mark on the beach and is particularly heavy along the east side of Mission Bay from Visitor's Center to De Anza Cove. As a follow-up study to the investigative tasks conducted in Phase II, the Visitor's Center wrack line was assessed in February, 2004 to determine the extent to which it acted as a reservoir for indicator bacteria. The complete study is presented in Appendix H.

Samples of the wrack that was deposited on the beach during a spring tide were collected over an 11-day period during the subsequent neap tide and analyzed for indicator bacteria. The results of the study, as summarized in Section 2, indicate that the wrack line at Visitor's Center acts as a substantial reservoir of indicator bacteria at this site. Elevated enterococcus and, to a lesser extent, fecal coliform densities appear to be maintained for a prolonged period of time within the wrack matrix. The study also showed that the indicator bacteria maintained within the wrack during neap tides are re-distributed to the receiving waters when subsequent spring tides come in contact with it. In this way, the wrack line acts to amplify the load from the original source by maintaining elevated densities over time and impacting receiving water bacterial densities at Visitor's Center.

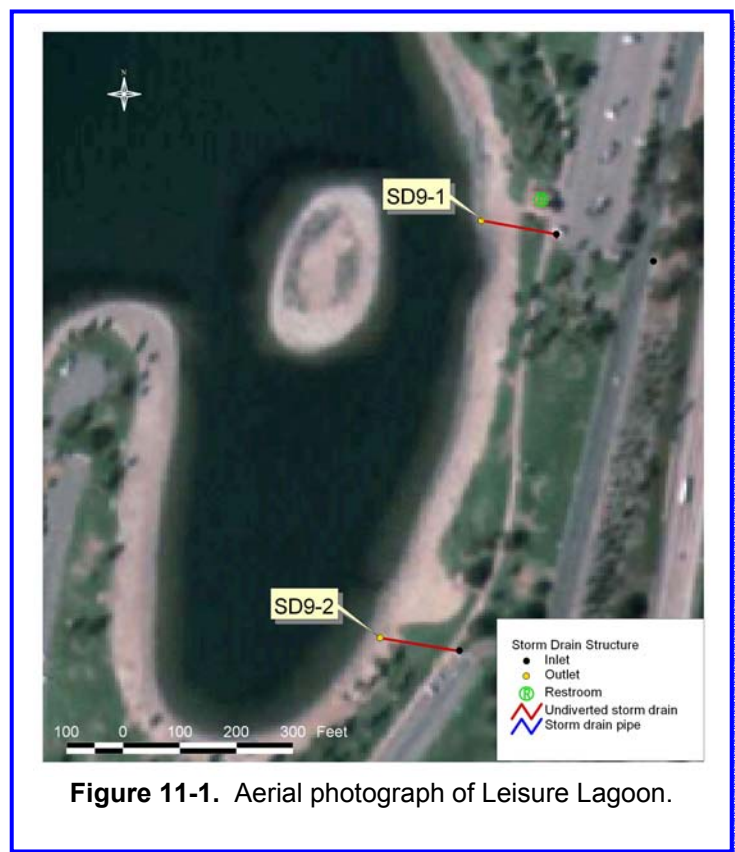
Figure 11-1. Aerial photograph of Leisure Lagoon.

Leisure Lagoon is located on the eastern side of Mission Bay, south of the Visitor's Center. The east side of the Lagoon is bordered by East Mission Bay Drive and the west side is bordered by the open water of North Pacific Passage (Figure 11-1). The beach at Leisure Lagoon is surrounded by a grass buffer strip, parking lots, and a small playground. This site is heavily used by park visitors. During summer holidays, there are typically more swimmers at this site than any other area in Mission Bay. The lagoon itself is fairly small (approximately 500 feet wide by 1,200 feet long) and water circulation is constricted by an island at the lagoon entrance. There are two comfort stations at the site, one located on the northeastern end and one located at the far southern end. There are no major creek drainages in this area, but there are two storm drains that discharge to the Lagoon: SD9-1 and SD9-2. They both drain fairly small drainages within Mission Bay Park and neither of them are part of the MBSIS. The Leisure Lagoon AB411 monitoring site is located directly in front of storm drain SD9-2.

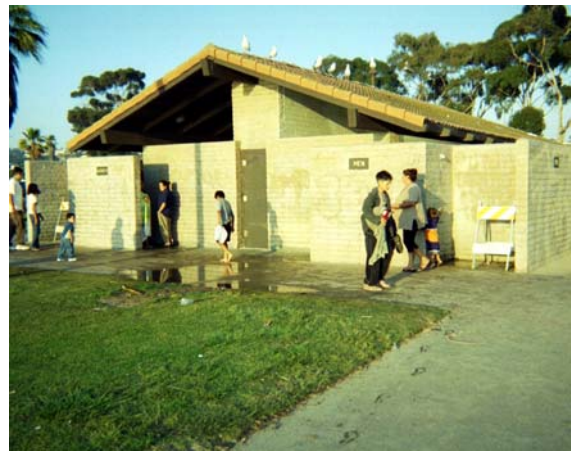
There are two comfort stations that serve Leisure Lagoon. Comfort Station 1092 is located at the northeast end of Leisure Lagoon and Comfort Station 1093 is located on the southern end. During the Visual Observations Task, numerous observations documented that washdown runoff from the comfort stations was being swept out of the facility towards the bay. A total of eight samples were collected from the runoff generated during washdown procedures of both comfort stations. All of the samples exceeded AB411 criteria for at least one indicator and some had extremely high densities. The results are summarized in Table 11-1.

Comfort Station 1092 at Leisure Lagoon

The structural integrity of the comfort stations' lateral lines at Leisure Lagoon was inspected by closed circuit television as part of Task 1. These inspections were conducted on October 24, 2002. The results of the inspections showed that the lateral lines were in good condition and were an unlikely source of bacterial contamination to the receiving waters at this site. Appendix B provides a detailed description of these inspections.

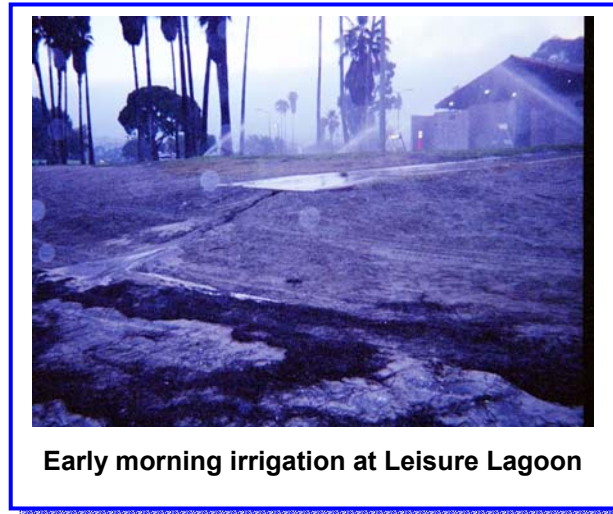
During the Visual Observations Task, excessive irrigation was observed to be a common problem at this site, particularly at the southern end of the site. Surface runoff from the grass to the receiving waters at Leisure Lagoon occurred regularly and there was also evidence of erosion associated with the runoff from irrigation practices. Steep slopes in this area likely contributed to the increased runoff. Similar to the Wildlife Refuge site, water collected from the sprinkler head at Leisure Lagoon had non detectable levels of all three indicator bacteria. However, bacterial densities in all of the samples taken from the grass and parking lot areas of the site exceeded AB411 criteria. Table 11-2 summarizes the results of samples collected from ponded water as a result of excessive irrigation. Compared to other sites around Mission Bay, irrigation runoff at Leisure Lagoon (either through sheet flow or through the park storm drains) may be a more important pathway for the conveyance of bacteria from the park to the bay.

Early morning irrigation at Leisure Lagoon

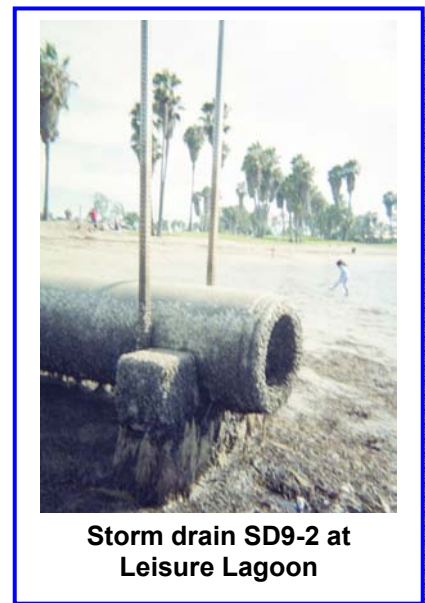
Storm drains were identified as a potential source of bacteria to Leisure Lagoon and an important mechanism for the transport of excess irrigation to the receiving waters. Two storm drains discharge directly to Leisure Lagoon: storm drain SD9-1 on the northeastern end of the site and storm drain SD9-2 on the eastern shore (Figure 11-1). A third storm drain discharges into North Pacific Passage approximately 700 feet south of the entrance to Leisure Lagoon, draining the western parking lot of the site. Inspections of these storm drains and their drainage areas were conducted in the spring of 2003. All three of the storm drains are un-diverted (i.e., they are not part of the MBSIS) and they drain small areas within the park. Five samples of dry weather discharge were collected from storm drain SD9-1 during the Visual Observations Task. The source of the discharge was excess

Storm drain SD9-2 at Leisure Lagoon

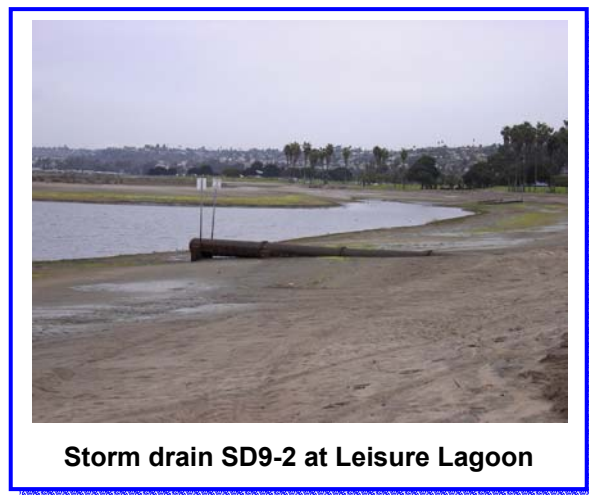
Storm drain SD9-2 at Leisure Lagoon

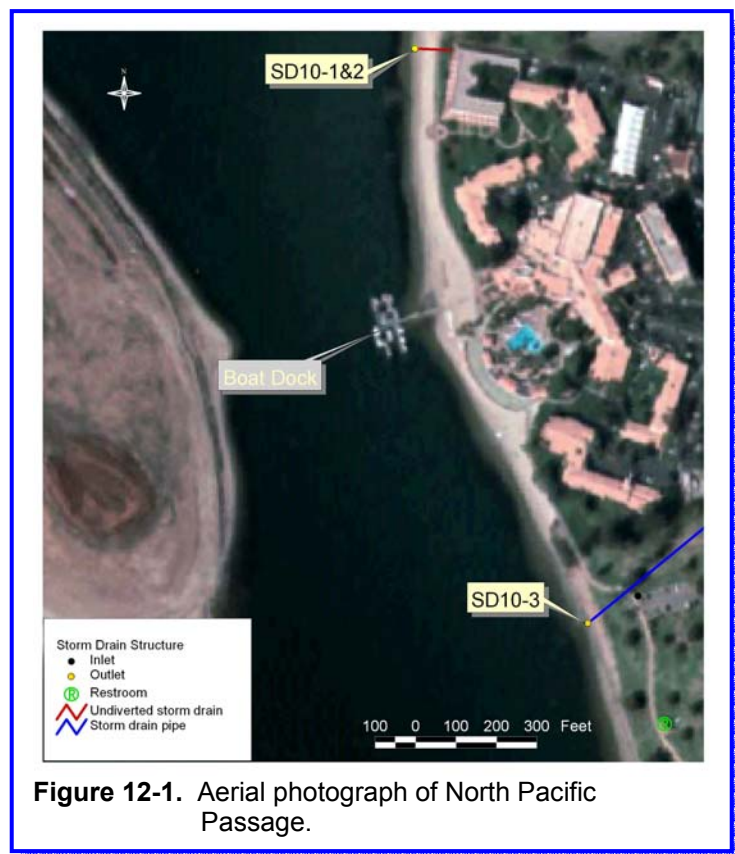
Figure 12-1. Aerial photograph of North Pacific Passage.

North Pacific Passage is located on the eastern side of Mission Bay directly west of the Hilton Hotel property. The sampling site is located on a small stretch of very well-maintained beach north of the Hilton Hotel boat dock (Figure 12-1). Many park visitors use the boardwalk bordering the beach, but in general, beach usage (i.e., swimming and sunbathing) is relatively low at this site throughout the year. There is no irrigation conducted at this site, and no major creek drainages that discharge to the immediate area. However, there are three storm drains that discharge to the beach at North Pacific Passage. Storm drains SD10-1 and SD10-2 drain small areas within the Hilton Hotel complex. The AB411 monitoring site is located directly in front of these storm drains. Storm drain SD10-3 is located just south of the Hilton Hotel and is part of the MBSIS. In addition, there is one comfort station at this site located south of storm drain SD10-3.

Three storm drains discharge to the North Pacific Passage site (Figure 12-1). Storm drains SD10-1 and SD10-2 have a small drainage within the Hilton Hotel property and both samples collected during the Visual Observations Task exceeded AB411 criteria. Storm drain SD10-3, located south of the hotel property, was only sampled once and had bacterial densities that were one to two orders of magnitude greater than those measured at SD10-1 and S10-2 (130,000 MPN/100 ml for total coliform, 35,000 MPN/100 ml for fecal coliform, and 14,390 MPN/100 ml for enterococcus). Although the bacterial densities were high, flow from all three storm drains at the time of sampling was very low, suggesting that the magnitude of the bacterial load was small.

The majority of the samples collected as part of the Visual Observations Task at this site were from four 6-inch PVC pipes that discharged under the Hilton Hotel boat dock (Figure 12-1). Nearly 70% of the samples collected from these drains exceeded the AB411 criteria for at least one indicator bacteria. Table 12-2 summarizes the results.

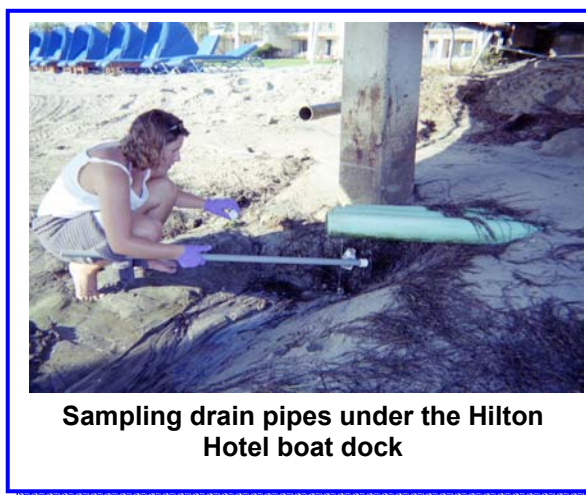
A follow-up study was conducted on October 31, 2002 to investigate the source(s) of bacteria discharging from these pipes. Working with the Hilton Hotel's Director of Property Operations, the probable source of the high bacterial counts was traced to a koi pond located near the Hotel's swimming pool. An inspection found that water in the pond had not been properly aerated and sediment and debris had accumulated on the bottom. Pond water was flowing continually from the pond through an overflow drain to a drain box and then directly to the bay receiving waters. The complete results from the follow-up study are presented in Appendix K.

As part of the follow-up study, water samples were collected from the koi pond, drain box, and discharge point for bacterial analyses. The results indicated that levels of all three indicator bacteria were very low in the sample taken from the surface of the koi pond near the drain pipe (Table 12-3). However, very high levels of total coliform (1,300,000 MPN/100 ml) and enterococcus (143,000 MPN/100 ml) were measured in the sample taken from the koi pond drain box, which contained a large amount of debris and organic matter. In addition, the pipe leading from the koi pond to the box was flowing at the time the sample was taken and it was covered with a heavy biofilm. These results reflected the resiliency of the indicator bacteria, particularly enterococcus, to survive in biofilms and drainage systems that are kept continually moist. Similar results were found at a drain pipe at Campland used for boat and vehicle cleaning and in other studies investigating environmental sources of bacteria to recreational waters (Jiang et al. 2001, Solo-Gabriele et al. 2000).

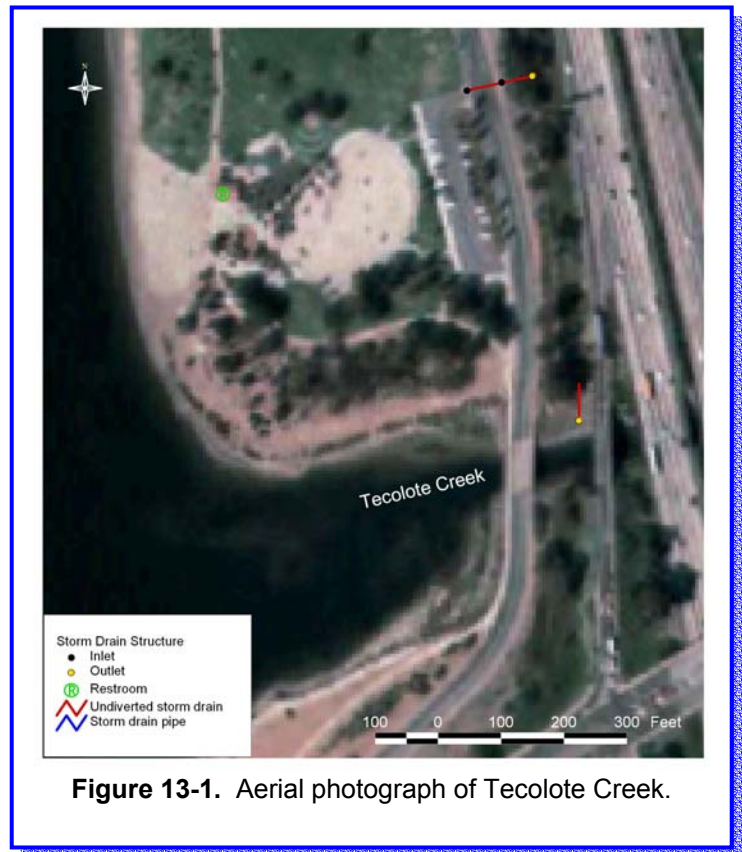
Figure 13-1. Aerial photograph of Tecolote Creek.

There are two AB411 monitoring sites at Tecolote Creek. One is located at the mouth near the East Mission Bay Drive bridge (called Tecolote Creek) and the other is located on the beach directly in front of the comfort station (called Tecolote Playground). The site at the mouth of the Tecolote Creek was monitored by the County and for this study during Phase I. However, in the spring of 2003 the County discontinued this monitoring site and began monitoring the Tecolote Playground site because a greater number of swimmers use this area.

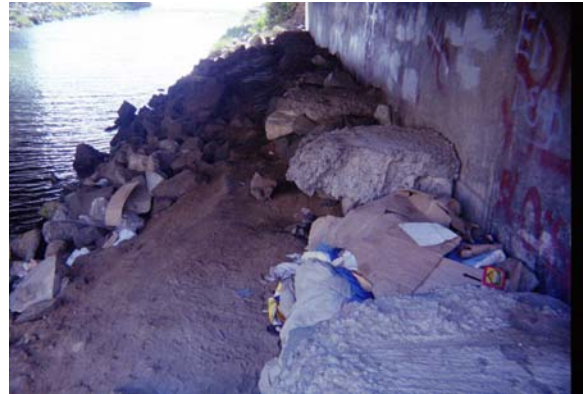
Homeless encampment on Tecolote Creek approximately 20 feet from the Tecolote Creek monitoring site

During the Visual Observations Task, homeless people were frequently observed under the Interstate 5 bridge, adjacent to and immediately east of the mouth of Tecolote Creek. Because the AB411 monitoring site was located just downstream of that area during the study, fecal contamination from the homeless population was thought to be more likely here than at other sites. However, samples collected from the delta sediments and receiving water at the mouth of Tecolote Creek during the Sediment Investigation Task of Phase II indicate that there is virtually no bacteria in this area from human origin. The results are discussed in detail in Appendix G and summarized below.

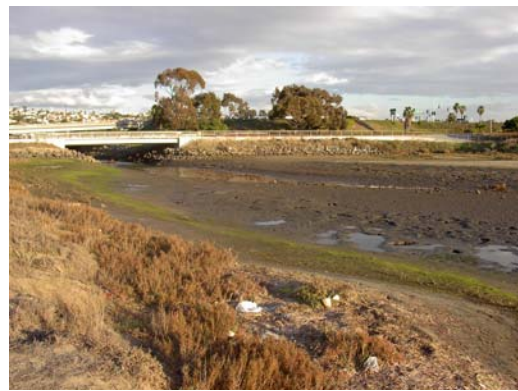
Birds and sediment at the mouth of Tecolote Creek

The sediment investigation conducted in Phase II provided the most valuable information in identifying sources of the bacteria at Tecolote Creek. The results of the study suggested that, during the dry season, the delta sediments at the mouth of Tecolote Creek are an unlikely source of bacteria to the receiving waters. During the wet season, a large majority of the bacteria in the receiving waters (84%) and the sediment (55%) at this site originate from birds. In addition, the delta sediments act as a reservoir of indicator bacteria during the wet season. The vast majority of time at this site, tidally-induced current velocities are insufficient to entrain sediment-sorbed bacteria from the delta and transport them to the receiving waters. However, during the largest ebbing tides, bacteria contained in the delta sediments can act as a source to the receiving waters.

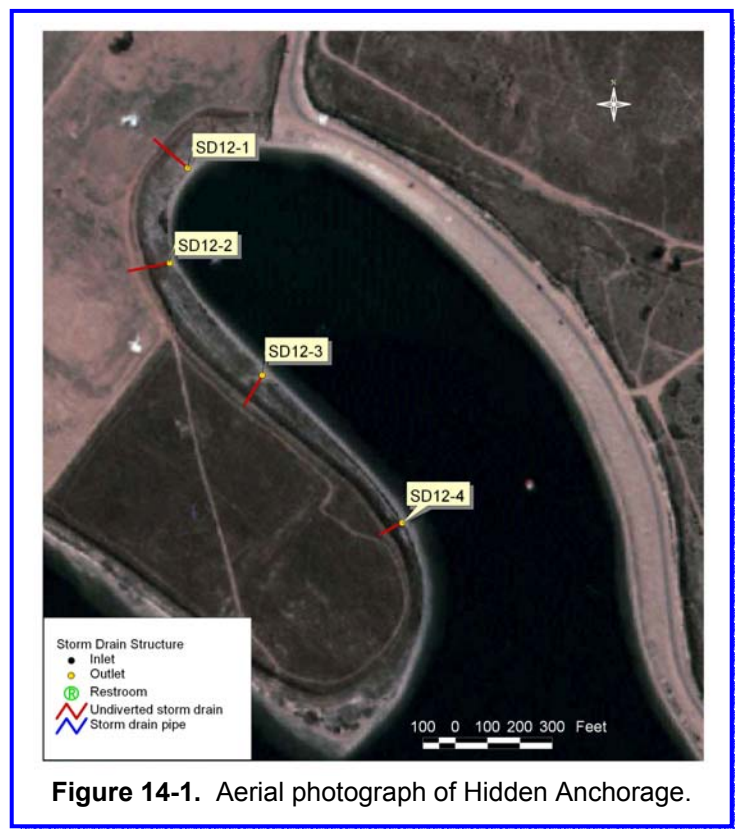
Figure 14-1. Aerial photograph of Hidden Anchorage.

Four storm drains discharge to the receiving waters at Hidden Anchorage (Figure 14-1). During the Visual Observations Task and subsequent weekly monitoring activities, none of these storm drains were flowing, therefore, no samples were collected. The inlets to the storm drains are imbedded in the soil (as opposed to impervious surfaces typical of other storm drains in the park). This, combined with the lack of irrigation at this site, effectively eliminate dry weather flows to the receiving waters.

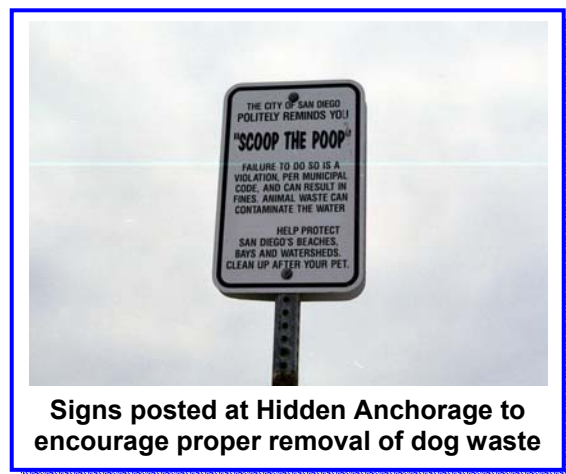
Signs posted at Hidden Anchorage to encourage proper removal of dog waste

Based on the presumed connection between tidal height, dog waste on the beach, and elevated bacterial levels in the water column, BMPs were initiated to reduce the dog waste on the beach at Hidden Anchorage. As a result, additional trash cans, baggie dispensers, and signs were placed around the Hidden Anchorage beach during the first and third weeks of December, 2002. Park rangers from the City Park and Recreation Department implemented additional enforcement activities to further ensure proper disposal of dog fecal matter by park goers.

Observations made during the weekly monitoring efforts showed that the amount of dog waste on the beach decreased after the management actions were taken. Of the 21 days of observation between November 2002 and March 2003, pet waste was observed on the beach only twice. Since the management actions were initiated, there have been only three exceedances of AB411 criteria at Hidden Anchorage. All three were attributed to extremely turbid water at the time of sampling, apparently due to recreational boating activities. Thus, the management actions are thought to have been effective in reducing bacterial levels at Hidden Anchorage.

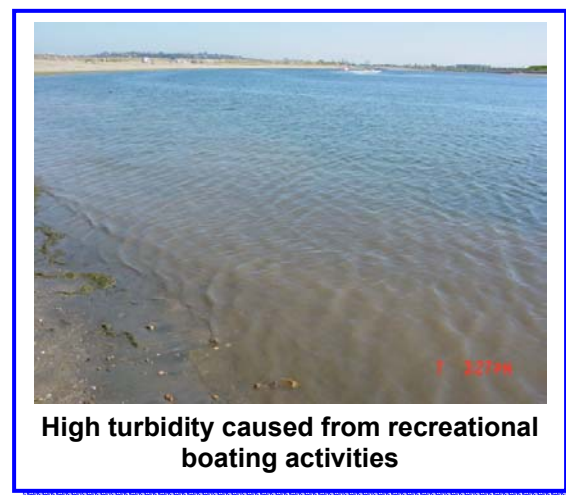
High turbidity caused from recreational boating activities
