# Storm Drain Insert Pilot Study

FINAL REPORT

DOC ID# CSD-RT-12-URS43-03

PREPARED BY URS CORPORATION

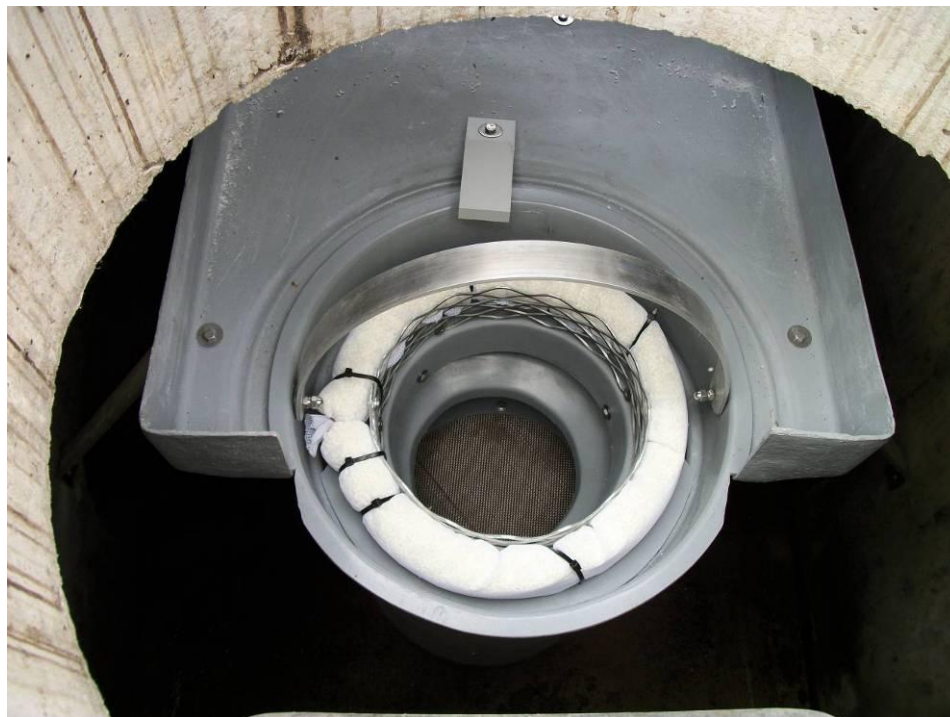
The Round Curb Inlet Basket product installed at the BEY-TS location is a curb inlet insert that is mounted with the basket located directly beneath the manhole. A shelf system diverts low flows entering the catch basin to the basket for treatment. High flows are bypassed over the shelf system. The frame of the Round Curb Inlet Basket is constructed of marine-grade fiberglass, with stainless steel screens. The top rim of the basket accommodates a hydrocarbon-absorbent boom. The design employs a graduated series of screens with decreasing mesh size towards the bottom of the basket. The Round Curb Inlet Basket installed at this location incorporated a multi-layer media filter. Figure 2-3 shows the Round Curb Inlet Basket and shelf system installed, as viewed from the manhole opening. Figure 2-4 shows the basket removed from the manhole.

**Figure 2-3. Bio Clean Round Curb Inlet Basket and Shelf System Installed at BEY-TS.**

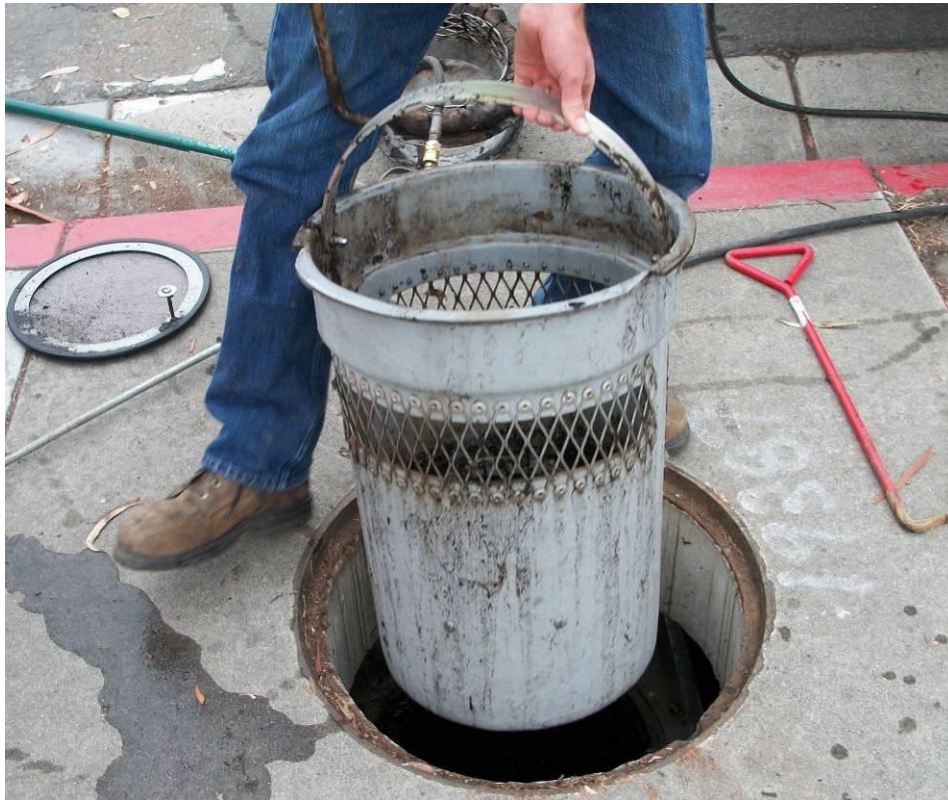
**Figure 2-4. Bio Clean Round Curb Inlet Basket Removed from Manhole**

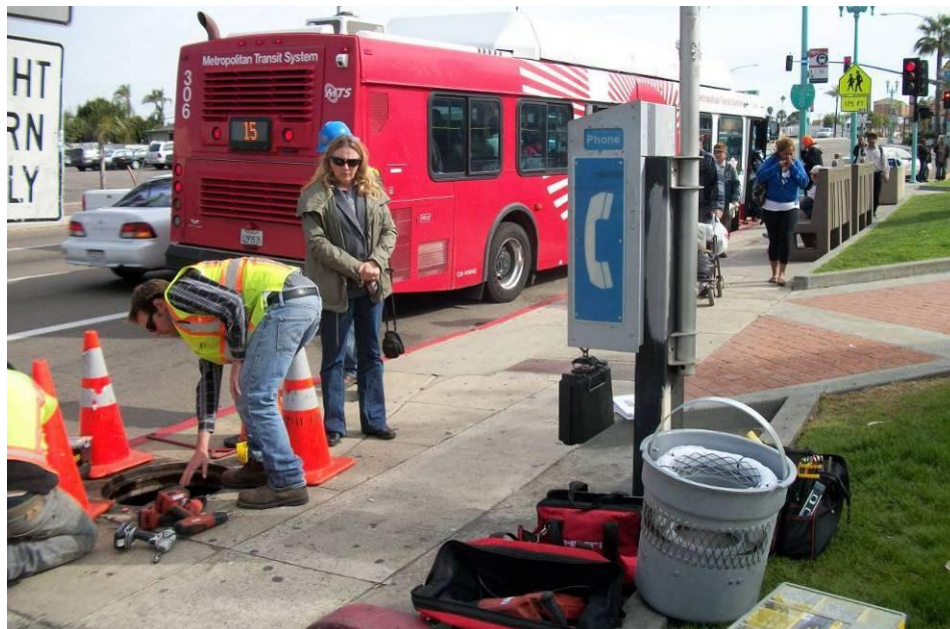
The same Round Curb Inlet Basket product installed at the BEY-TS location was installed at the ECB-54 site. The product incorporated a multi-layer media filter and hydrocarbon boom. Figure 2-6 shows the Round Curb Inlet Basket and shelf system being installed at the ECB-54 site.

**Figure 2-6. Installation of Bio Clean Round Curb Inlet Basket at ECB-54 Pilot Site**

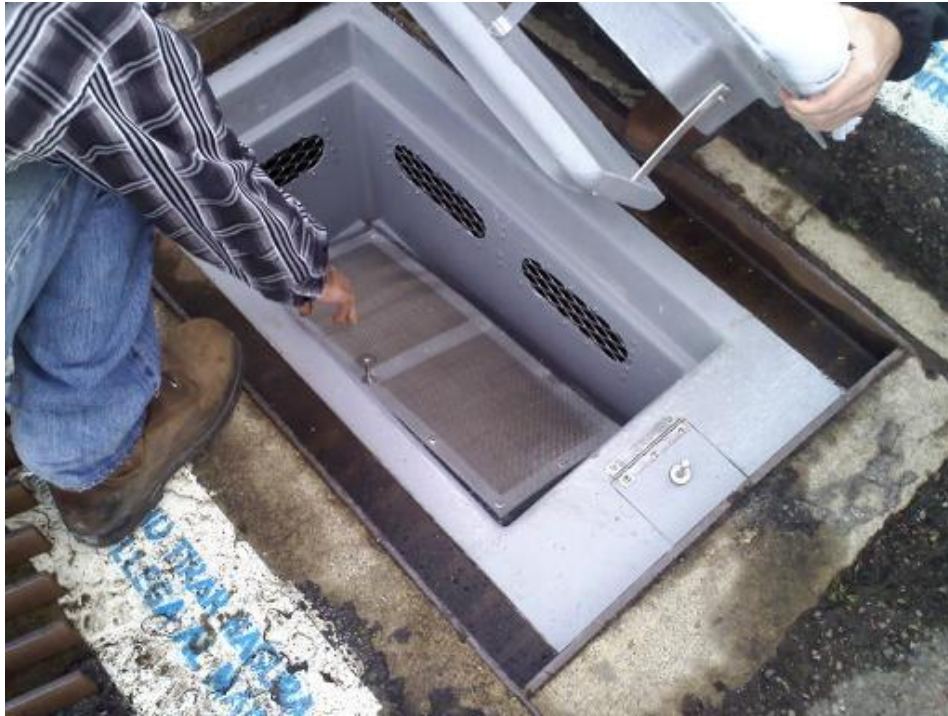
**Figure 2-9. Bio Clean Grate Inlet Skimmer Box at QUAL Site with Skimmer Removed (Media Filter Shown)**

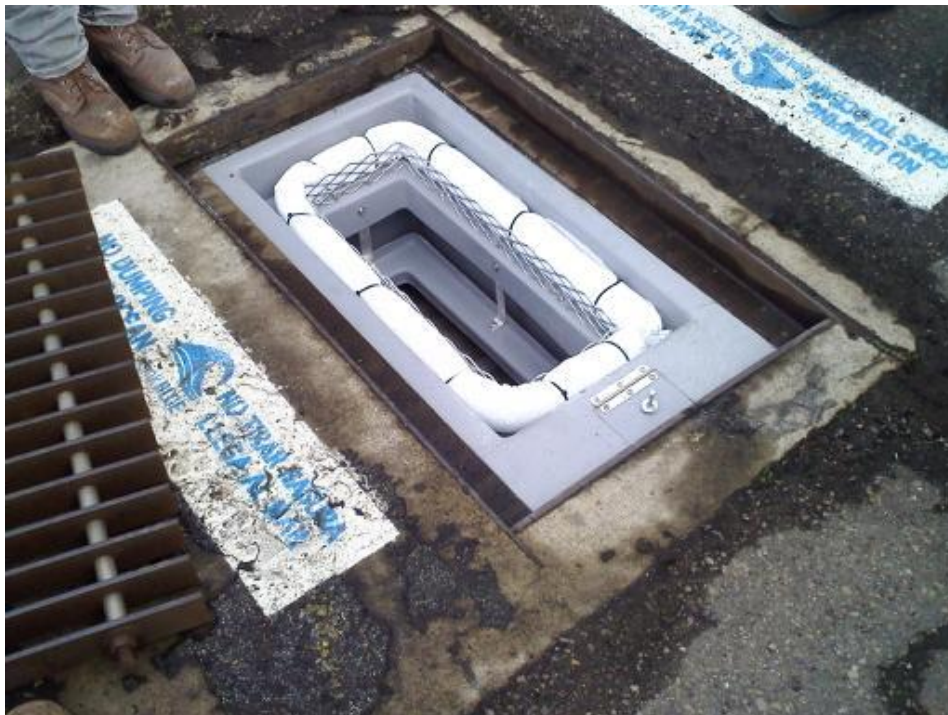
**Figure 2-10. Bio Clean Grate Inlet Skimmer Box at QUAL Site with Skimmer**

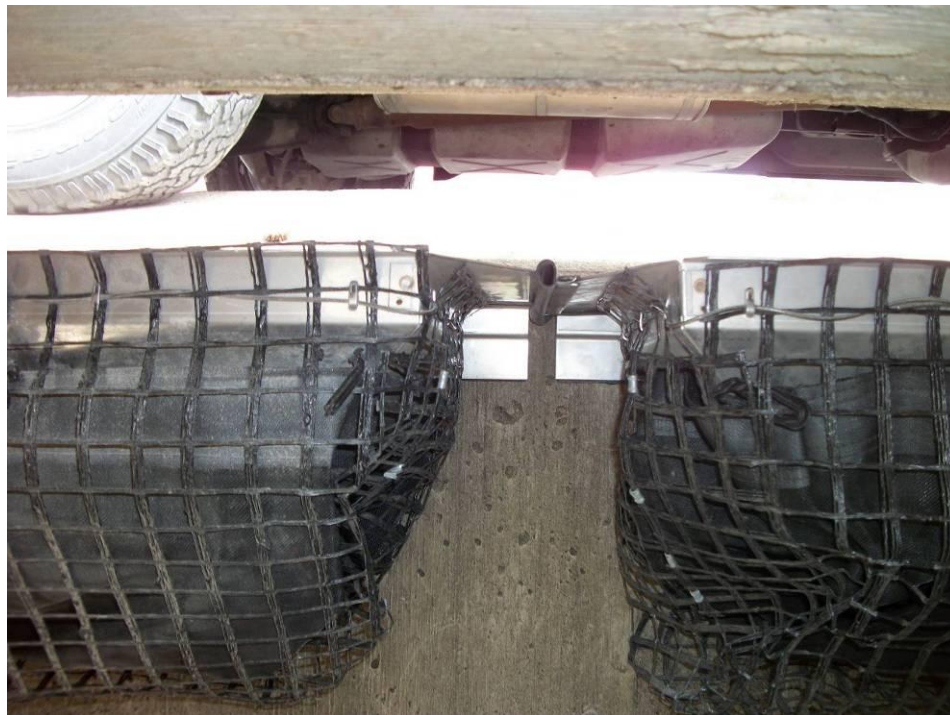
Figure 2-14. Downstream Services FloGard Plus Curb Inlet Filter Installed at BEY-1 Site (View from Catch Basin)

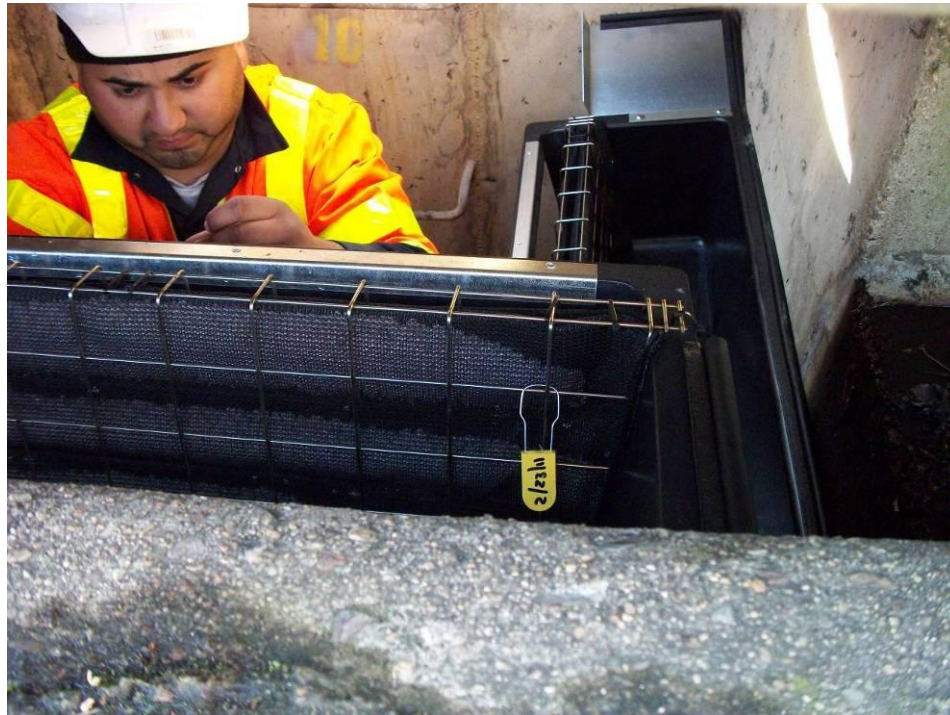
The Triton Curb Inlet Filter Insert is a curb inlet basket-type insert, mounted below the curb inlet opening. The insert housing is constructed of high impact polystyrene plastic. The insert is fitted with a geotextile polypropylene-fabric media filter pack. Towards the top of the housing, a series of orifices allow for bypass of higher flows. An optional polypropylene web system (StormWeb) can be installed to assist in retention of large debris. The Storm Web was not initially installed at the BER-PL site, however was added later after the Vendor conducted the initial maintenance visit. Due to the particular configuration of the curb inlet and catch basin at the site, two inserts were installed overlapping at a 90-degree angle to provide full coverage of the inlet opening. A concrete shelf or “wing” adjacent to the curb inlet opening is present for a portion of the length of the curb inlet. One of the inserts was attached along the wall of the catch basin below the end of the wing, to capture material flowing off the wing and into the catch basin. Another insert was placed at the far end of the curb inlet, beyond the point where the wing is present. Figure 2-17 displays the configuration of the two inserts at the BER-PL site, during product installation. The edge of the wing can be seen on the right-hand side of the photo. The bottom of the photo shows the insert mounted below the remaining length of the curb inlet opening.

**Figure 2-17. Configuration of the REM Triton Curb Inlet Filter Inserts at BER-PL Site**

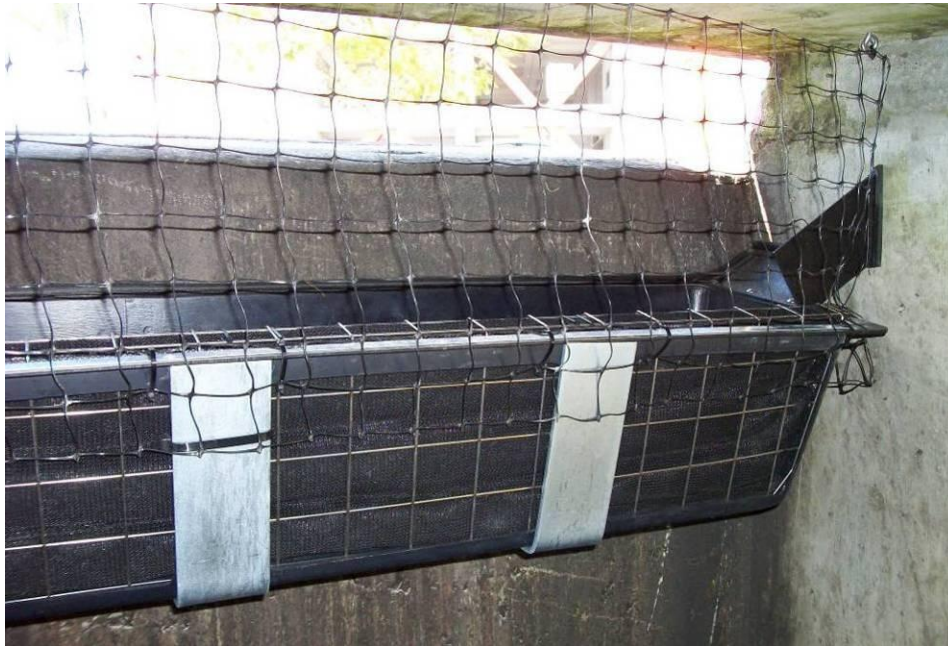
The same product, the Triton Curb Inlet Filter Insert, was installed at the PET site. Unlike the BER-PL location, the catch basin configuration at the PET site allowed installation of a single insert to cover the curb inlet opening. The optional Storm Web polypropylene system was also utilized at the PET site. Figure 2-19 shows the Triton Curb Inlet Filter Insert installed at the PET site.

**Figure 2-19. REM Triton Curb Inlet Filter Insert Installed at PET Site**

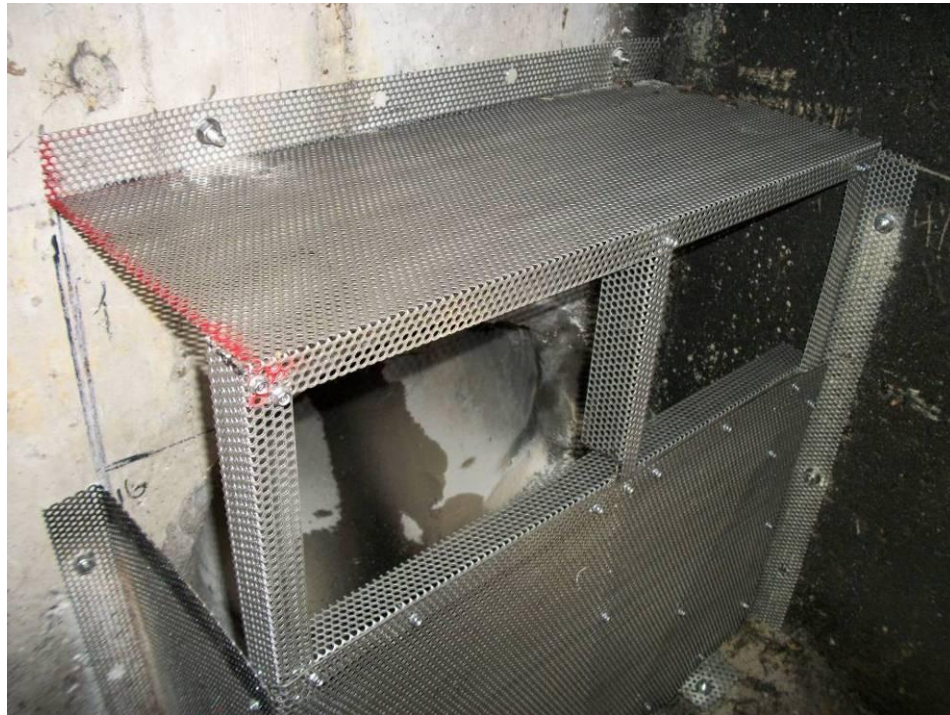
Typically, the CPS and/or the Drain Pac Curb Inlet Basket are installed as a component of the ARS system. Originally, it was anticipated that all three components would be installed at the BER-TC site, however it was determined by the Vendor that the depth of the catch basin was insufficient to accommodate the three components together. Ultimately, the Vendor recommended installation of both the CPS and Drain Pac Curb Inlet Basket at the site. Figure 2-21 shows the CPS installed at the BER-TC site.

**Figure 2-21. United Storm Water Connector Pipe Screen (CPS) Installed at BER-TC Site**

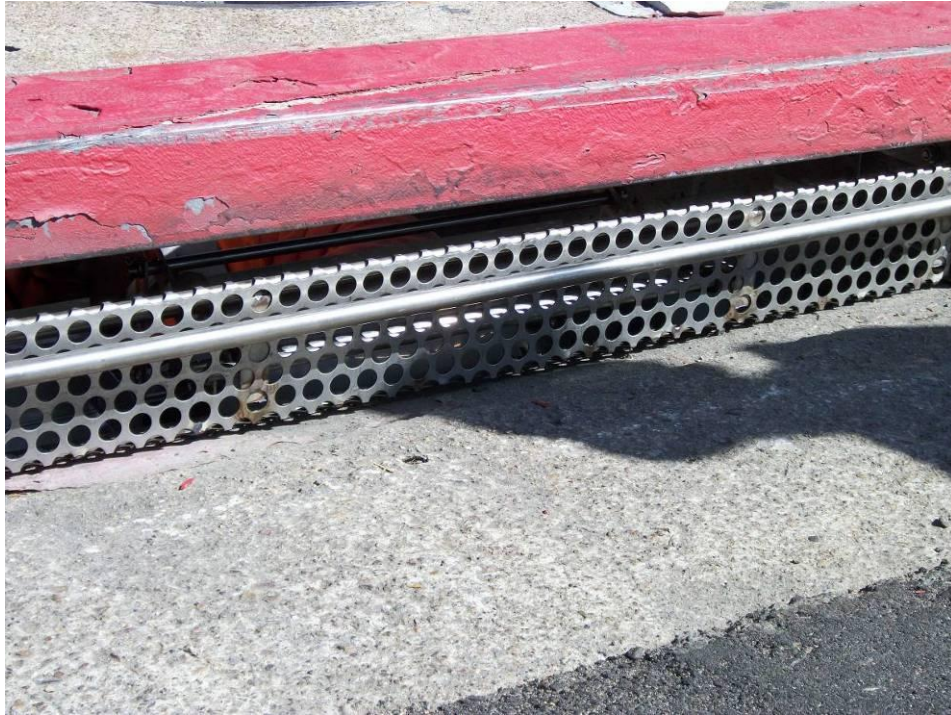
The ECB-F site was installed with three system components: the ARS, CPS and Drain Pac Curb Inlet Basket. The ARS unit consists of a stainless screen that covers the curb inlet opening, and is actuated and opens in response to runoff flows. When the force of the water is sufficient to activate the actuator, the actuator pulls the rotating linkage attached to the screen and holds the screen in an open position of approximately 45 to 55 degrees. This allows water to flow into the catch basin unimpeded by the screen. The screen cannot be opened from outside of the catch basin without a special rod.

**Figure 2-24. United Storm Water Automatic Retractable Screen Installed at ECB-F Site**

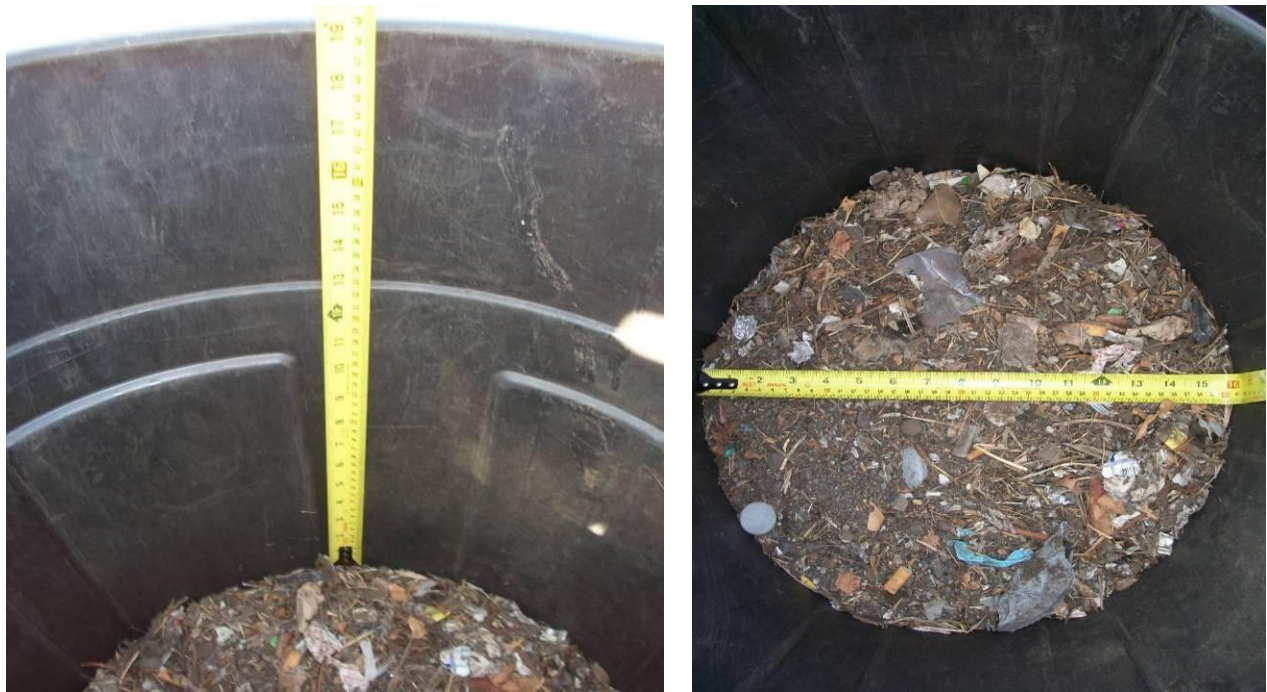
- **Gross Solids Volume-** The plastic trash bags containing the gross solids were transferred to a container of known volume [i.e., standard 20-gallon (2.81 cu. Ft) trash can]. The top of the trash bag was opened to expose the surface of the collected gross solids. The material in the bag was made as level as possible across the entire surface area of the container. The depth of freeboard (i.e., height from the top of the container to the surface of the gross solids), and container diameter at the surface of gross solids were measured with a tape measure (Figure 3-3). The measured depth of freeboard and surface area diameter were used to calculate the volume of freeboard (i.e., frustrum volume) by using the following equation:

$$V = \Pi * (h/3) * (R^2 + r^2 + (R*r)); \text{ where}$$

**Figure 3-3. Measurement of Freeboard Depth and Diameter for Gross Solids Volume Calculation**

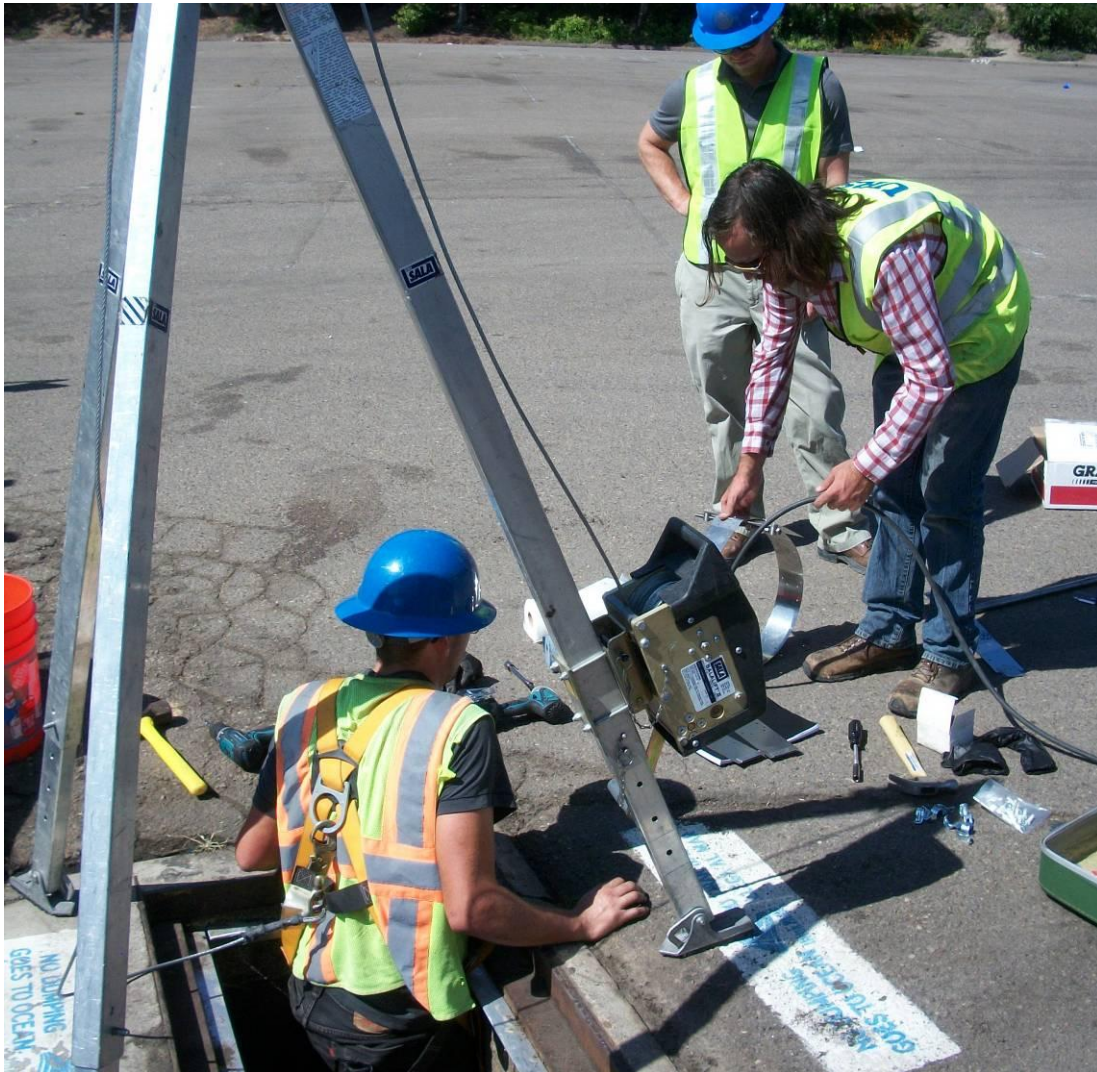
**Figure 3-5. Installation of Flow Meter at Bio Clean QUAL Pilot Site**

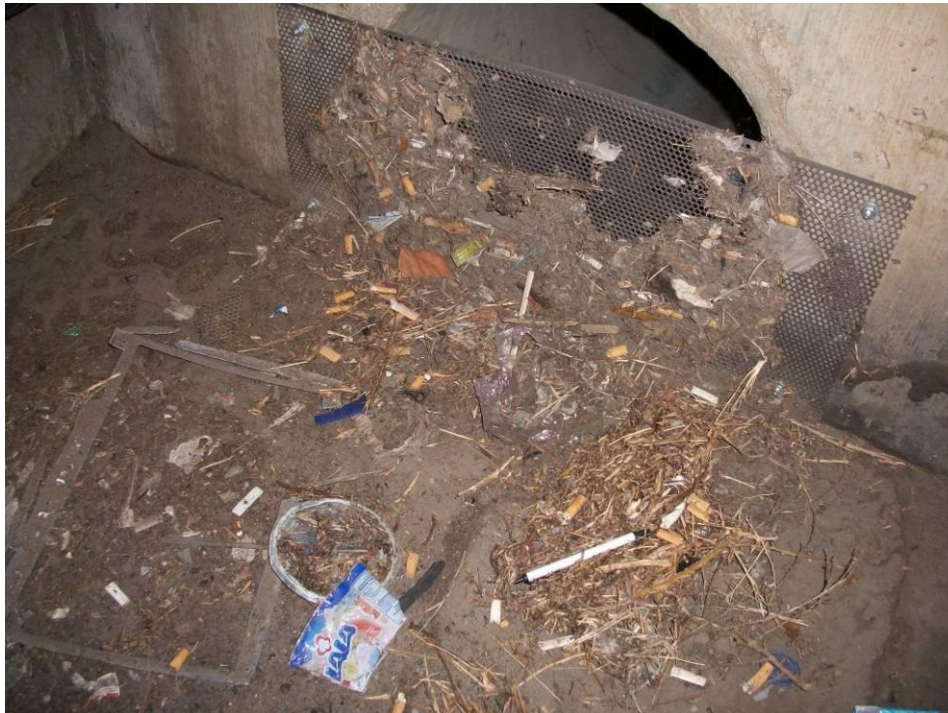
Outlet pipe screens were installed at all sites without a CPS (i.e., sites Bio Clean BEY-TS, Bio Clean ECB-54, Bio Clean QUAL, Downstream Services BEY-1, REM BER-PL, and REM PET), to help retain and facilitate observations of gross solids in the catch basin that have bypassed the insert product. The outlet pipe screens were installed so that approximately  $\frac{3}{4}$  of the outlet pipe opening was covered. An opening at the top of the outlet pipe was provided to allow bypass, in the case that collection of gross solids on the screen had potential to cause hydraulic impacts during storm events. The CPS also has an opening near the top of screen to provide bypass capability.

**Figure 3-6. Outlet Pipe Screen Installed at Downstream Services BEY-1**

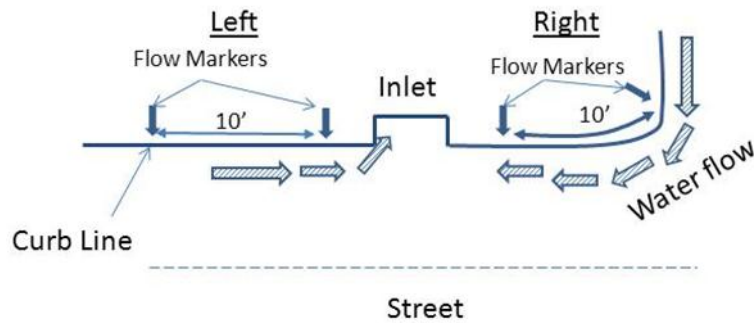
**Figure 3-7. Schematic of Flow Measurement Path**

To calculate the flow rate entering the curb inlet using the measurements recorded above, travel times were averaged for each 15-minute period to determine the average flow velocity (in ft./sec.) in the gutter. The geometry of the curb and gutter was determined and multiplied by the measured width of flow to calculate the cross-sectional area. Flow rates for each 15-minute interval were calculated by multiplying the cross-sectional area by the flow velocity. The direction of flow was also noted on field forms (i.e., into or away from the curb inlet). In one case (at site United Storm Water ECB-F), conditions observed in the field during the monitored storm event indicated a partial backwater/flow-reversal condition, and flow rates were adjusted based on review of documented conditions (video and photos) and using best professional judgment.

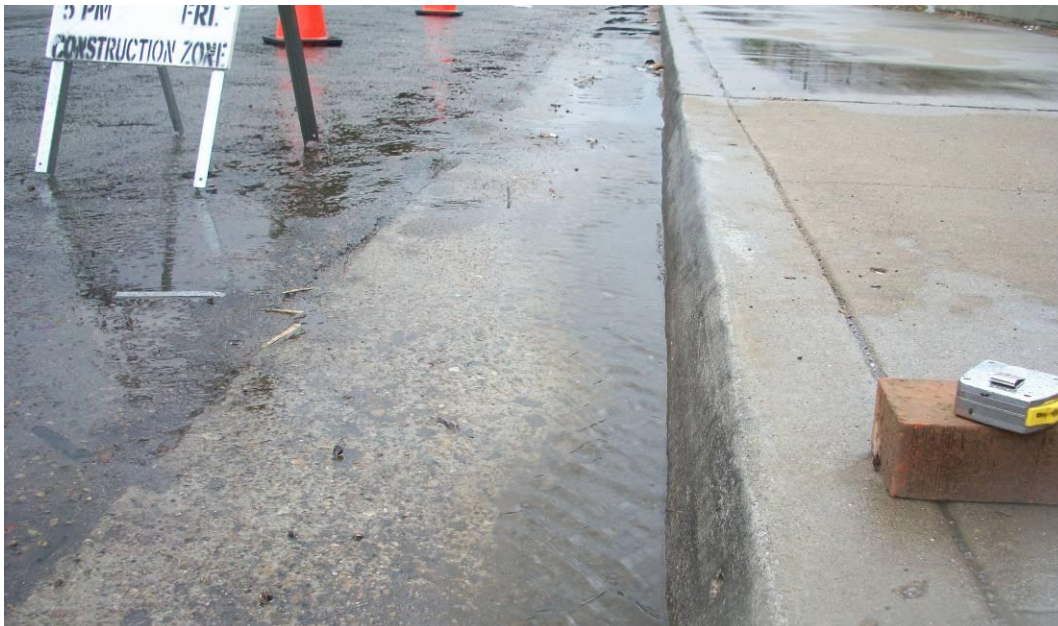
**Figure 3-8. Flow Measurement Path at Downstream Services Site BEY-1**

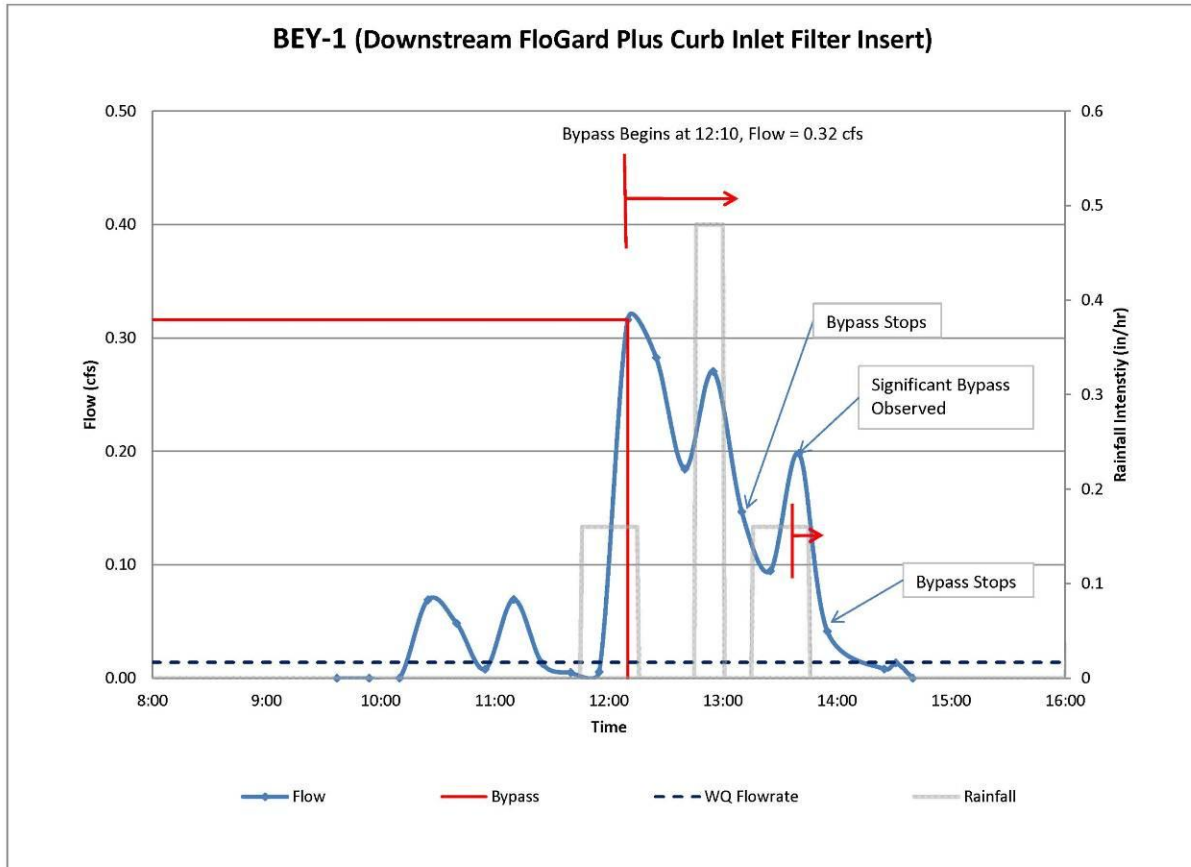
**Figure 4-7. Event Hydrograph for Downstream Services BEY-1**

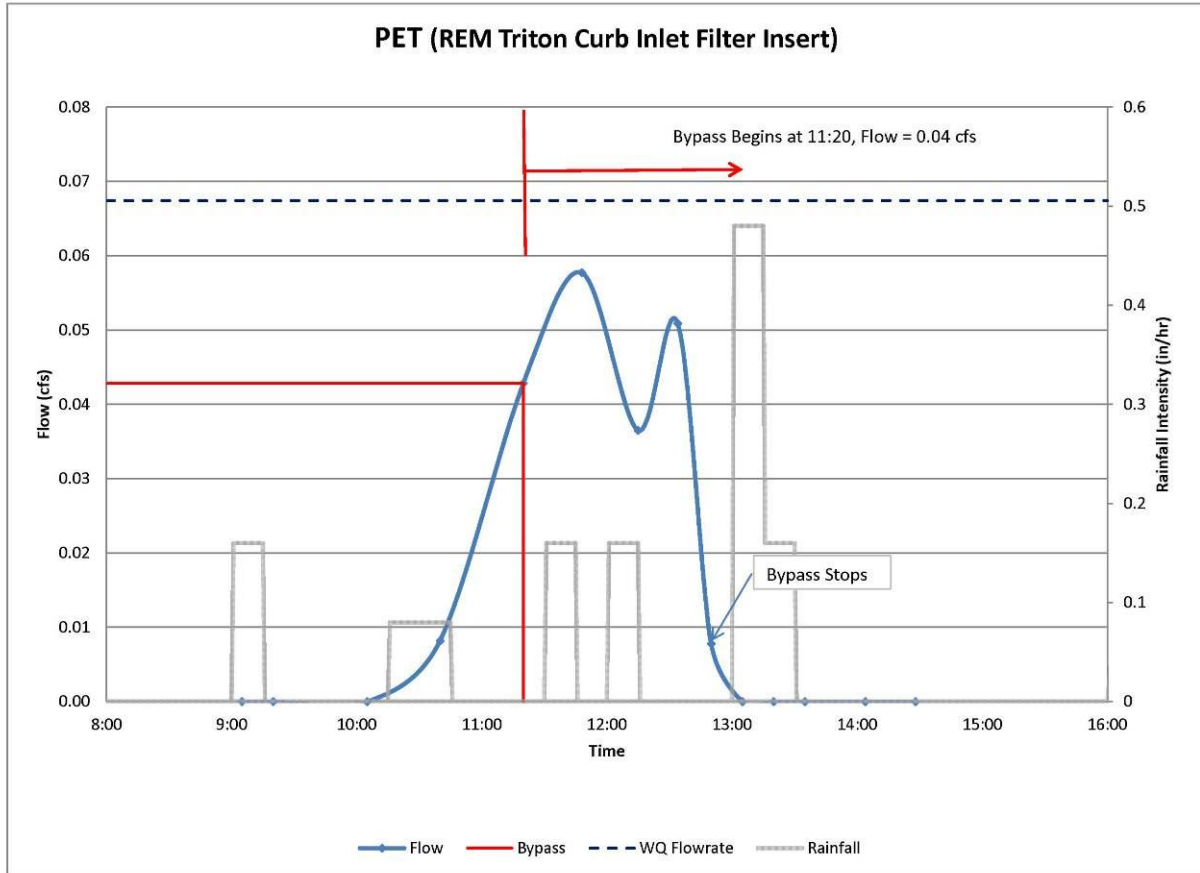
Figure 4-11. Event Hydrograph for REM PET

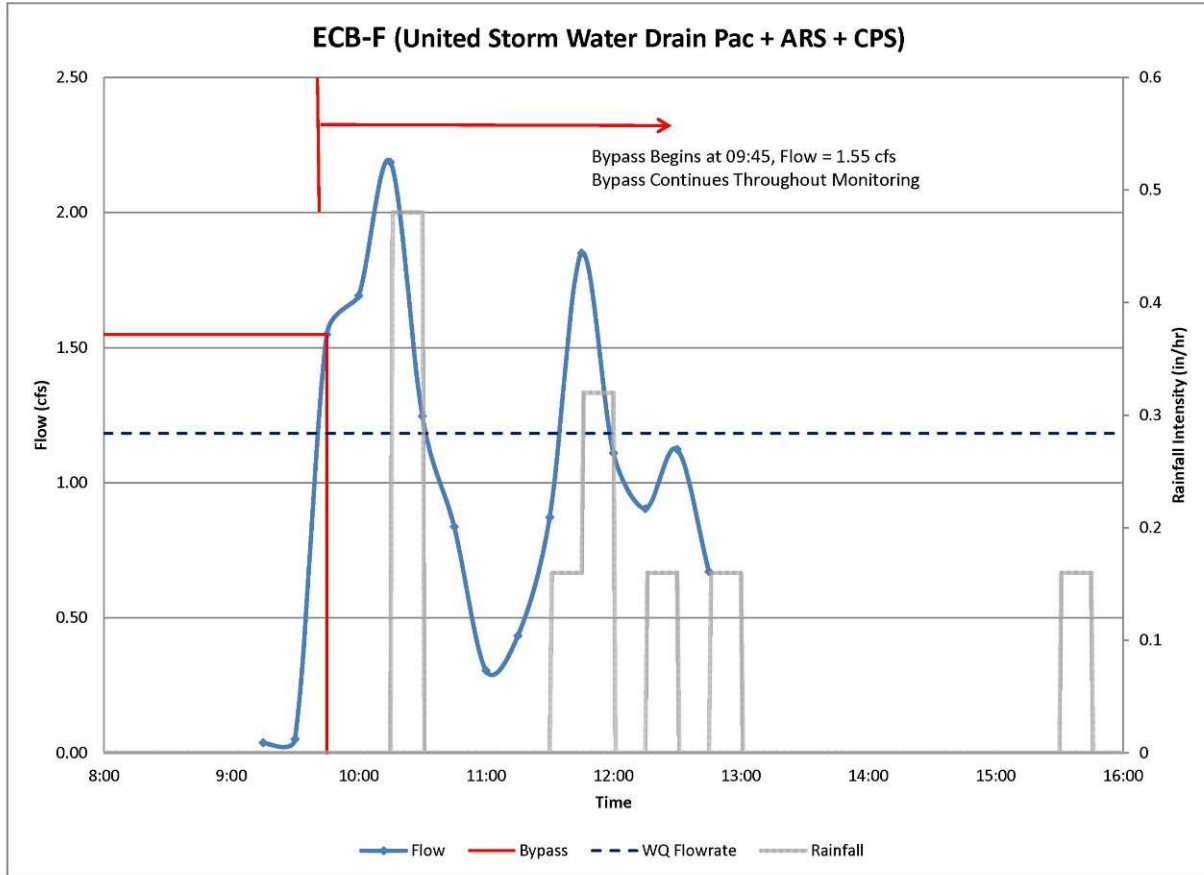
**Figure 4-15. Event Hydrograph for United Storm Water ECB-F**

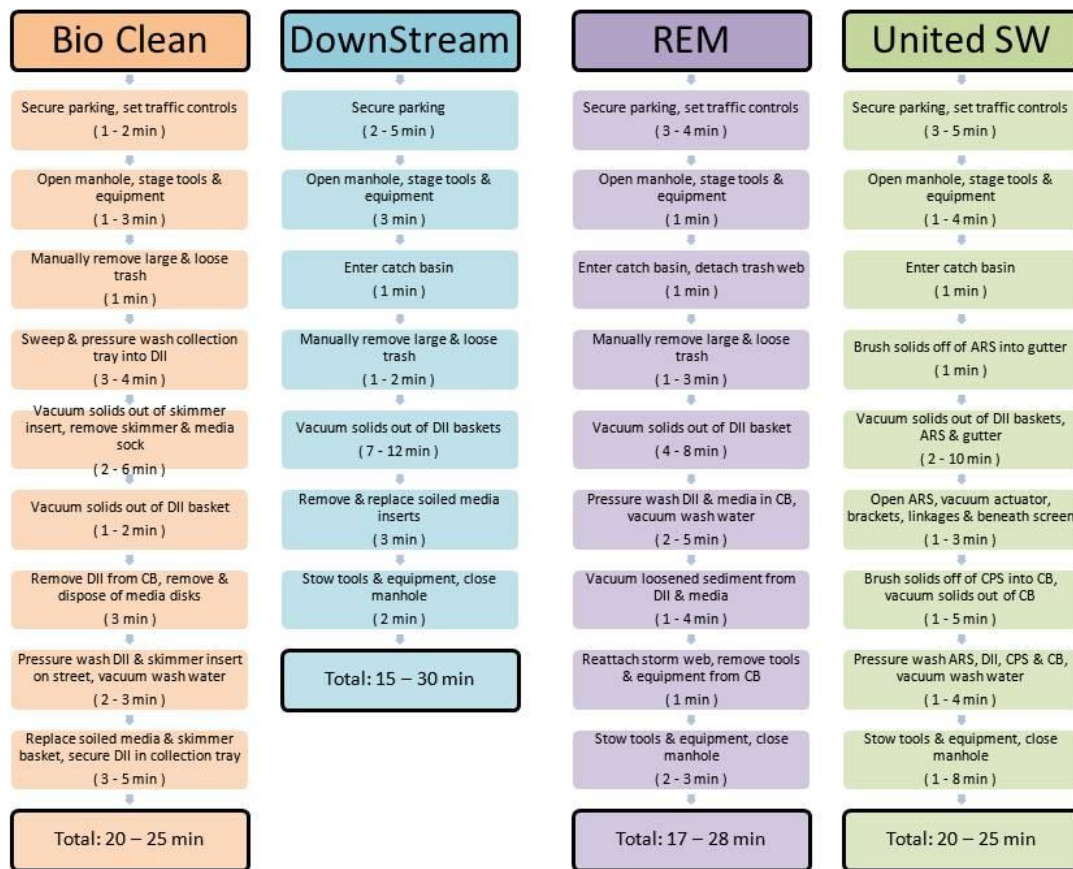
**Figure 4-17. General Maintenance Steps and Range of Maintenance Level of Effort by Vendor**

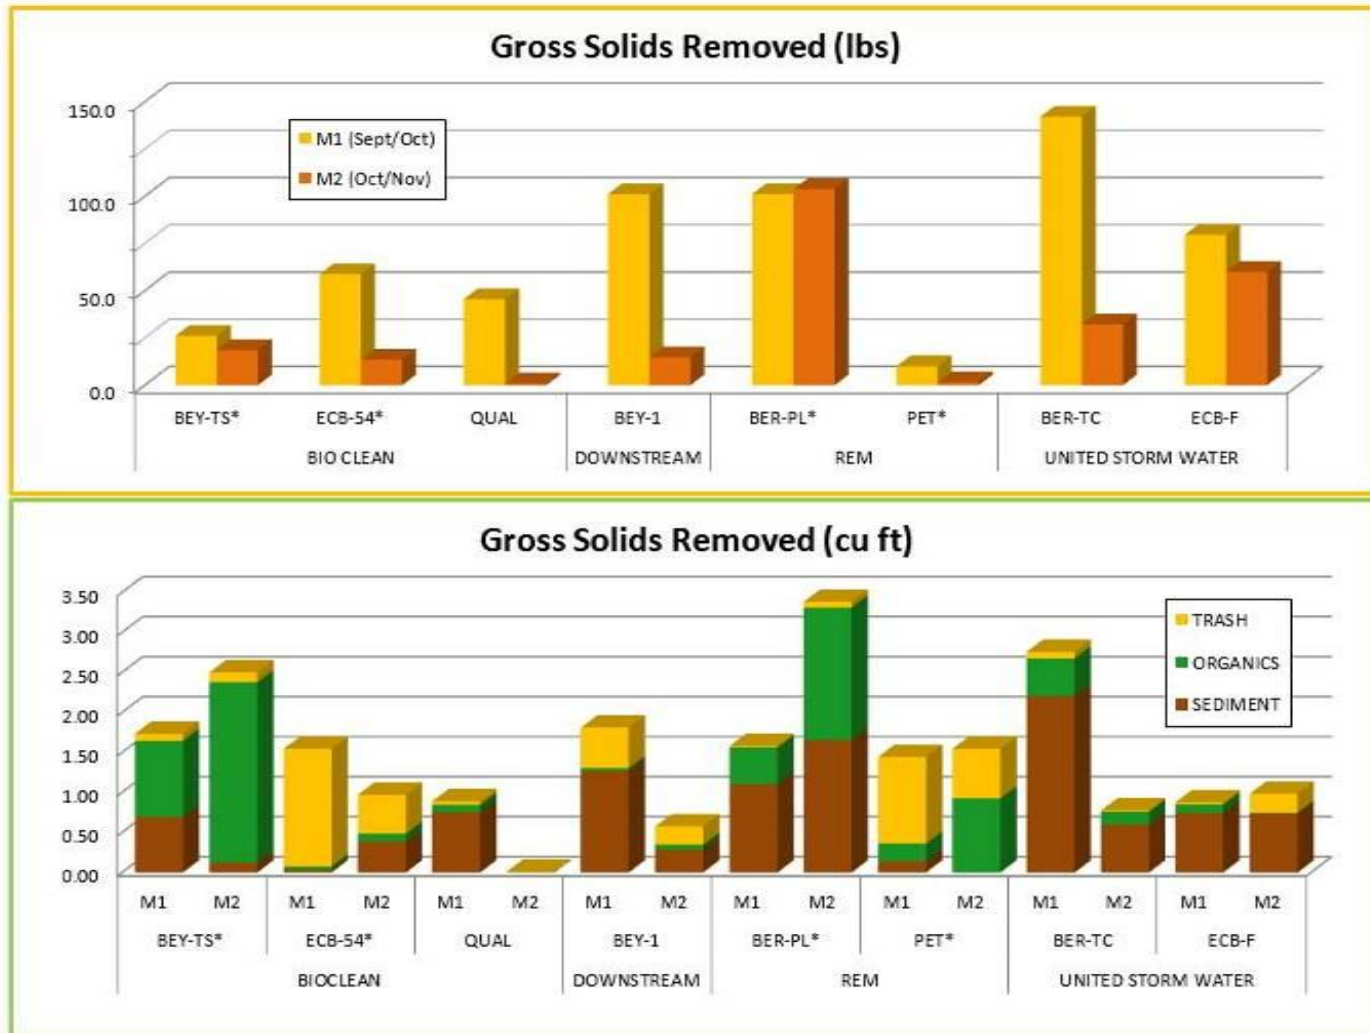
Figure 4-18. Gross Solids Removed by Weight (Lbs) and Volume (cu ft)
