Implementation of Advanced Water Purification Facility Extended Testing

Project Report

Prepared for the City of San Diego

Trussell Technologies, Inc.

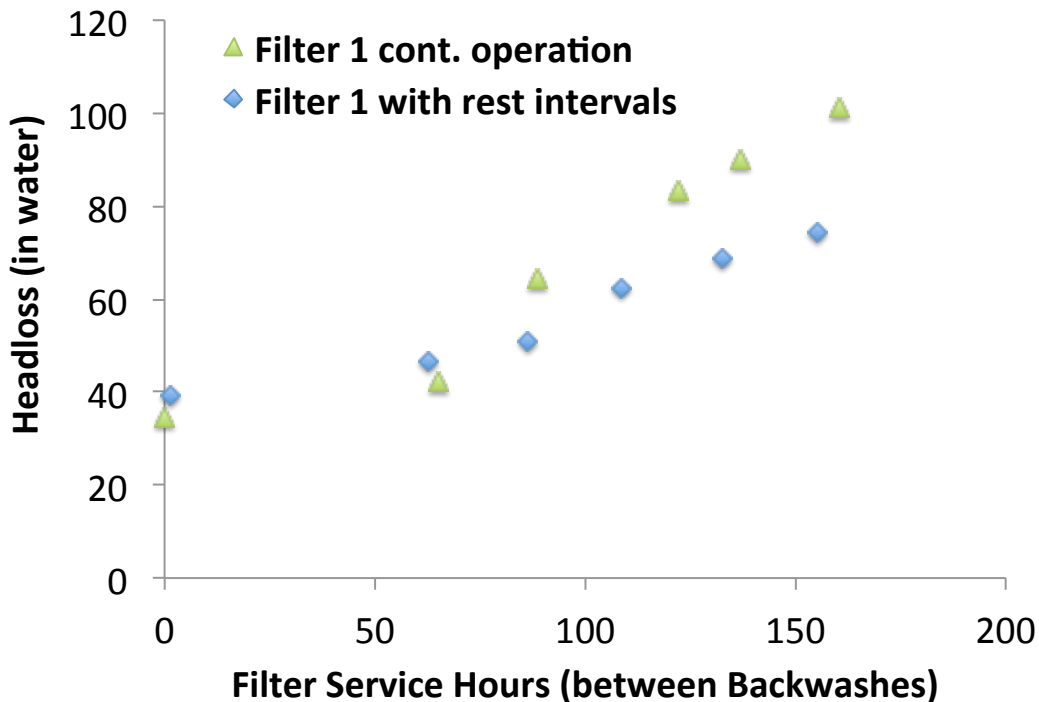
During initial start-up the head loss were found to be caused by air binding, as ozonated feed water is saturated with dissolved oxygen. To achieve the weekly backwash interval, air binding was addressed by short periodic pauses in filter production. This was achieved by closing the effluent valve. Logic was added to filters' controller, so that filter 1 and 2 were programmed to rotate every hour. This allows each filter to rest every two hours briefly. A short rest period of 90 seconds, allowed trapped gas to evolve, while also keeping production with the spare filter. Figure 4-1 presents the headloss accumulation in the BAC filter over the one-week operating period with and without the "filter rest intervals", illustrating that less than 40 inches of water headloss accumulates over a week of operation.

Figure 4-1 Typical Headloss Accumulation Through the BAC Filters

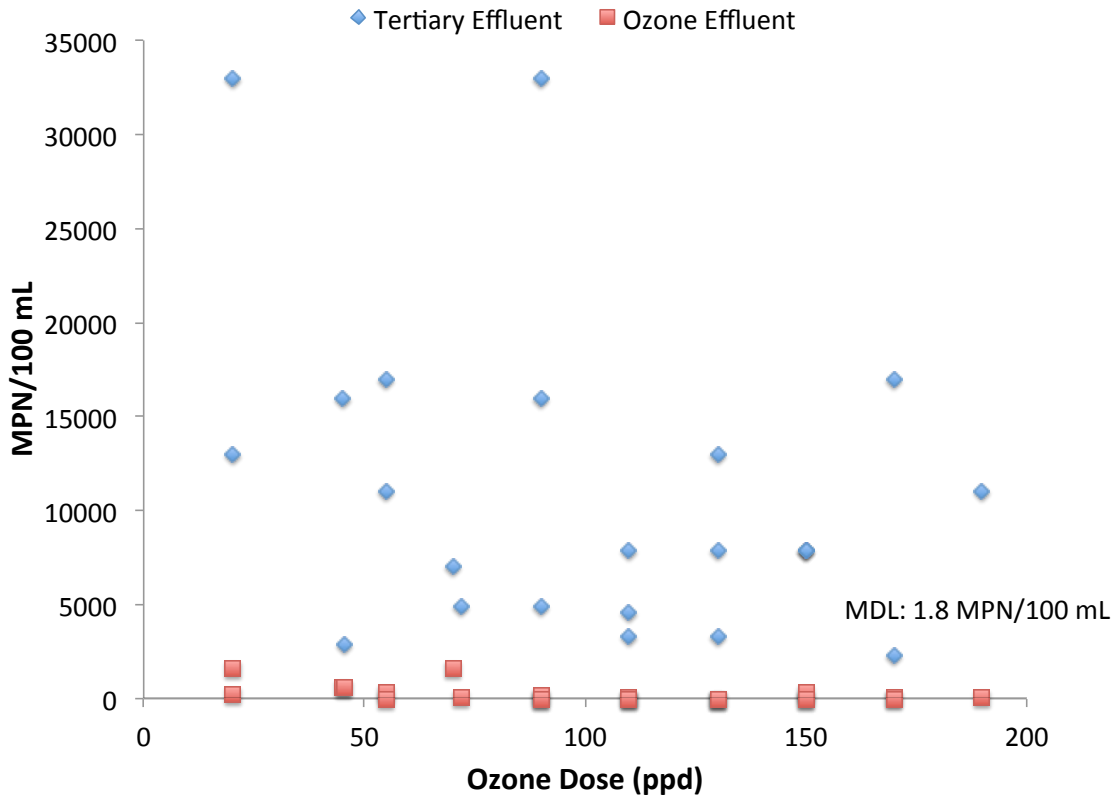
Biological surrogates commonly used in water reclamation were monitored to quantify removals through the ozone disinfection process. Total coliform, fecal coliform and somatic as well as male specific coliphage were monitored at sample locations through out the treatment train. Figure 4-5 presents the dependence of the applied ozone dose on the effluent total coliform concentrations from the ozone contactor. Although the general trend observed is that more effective total coliform activation occurs with increased ozone dose, it was common to have detections in the ozone effluent. Table 4.5 presents the total coliform concentrations through the entire pretreatment process, including membrane filtration. The total coliform concentration is reduced by 37% through the full-scale tertiary filters, but was significantly reduced (99.6%) through the ozone disinfection process. This translates to 2.5 log removal of total coliform on average through the ozone process. The total coliform increased 14 times through the BAC filter, which demonstrates the biological activity occurring the in the filter bed. Both membrane filtrates, MF and UF, produced effluents that were consistently non-detect for total coliform.

Figure 4-6 Effect of Ozone Dose on Total Coliform Concentrations (n=24)

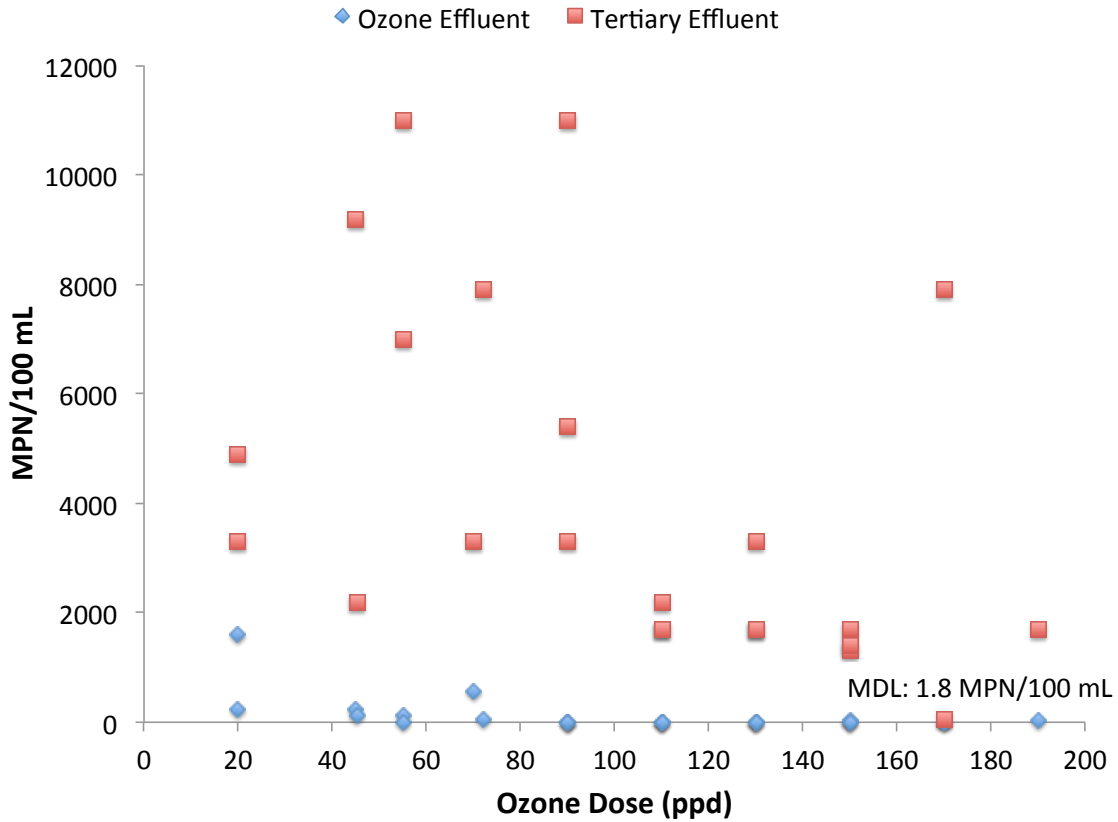
Fecal coliform results are presented in Figure 4-6 and Table 4-6. The results indicate a similar trend to that observed for the total coliform with fewer coliform at the higher ozone dose. Fecal coliform was 67% through the tertiary filters and 99.9% removal through the ozone disinfection process, which translates to 3-log removal on average. Fecal coliform concentrations increased 7 times through the BAC, but it is unclear how much weekly BAC backwashes with non-disinfected

Figure 4-7 Effect of Ozone Dose on Fecal Coliform (n=24)

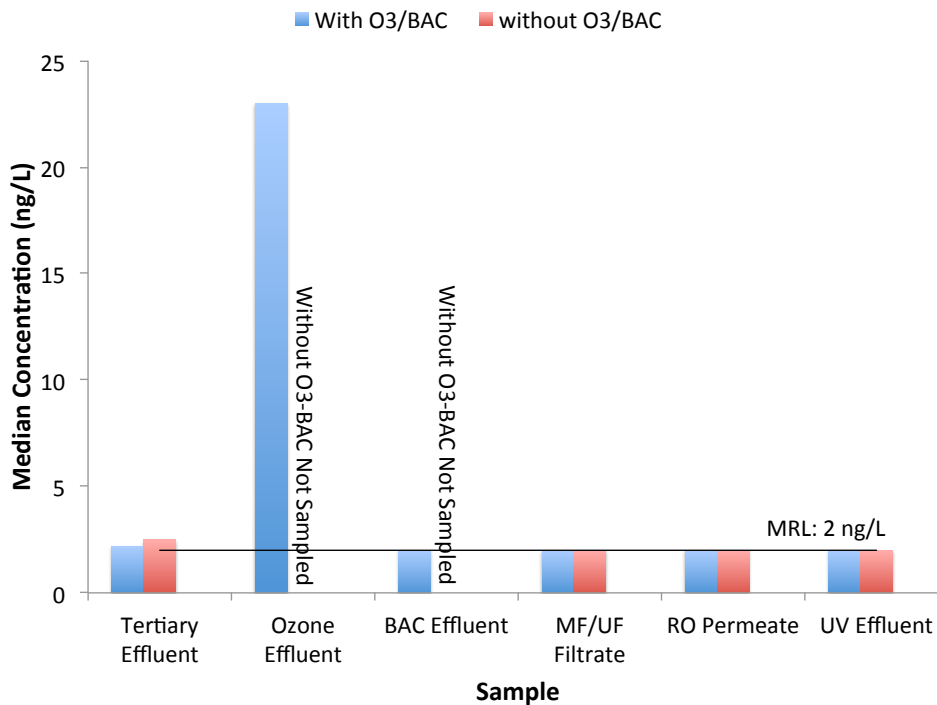
A modern disinfection byproduct that can be formed through reactions with chloramines and ozone is N-nitrosodimethylamine (NDMA). Although there is no federal regulation for NDMA, California Division of Drinking Water (DDW) has a public notification limit of 10 ng/L. Figure 5-3 presents the median concentrations from the treatment train profile sampling that was performed. Although NDMA is formed through the ozonation process, it is well removed by the BAC process and restored the NDMA concentrations to non-detect concentrations.

Figure 5-3 Effect of Ozone-BAC Pretreatment on NDMA in Treatment Train (n=3 for sampling without ozone/BAC, n=5 for sampling with ozone/BAC)

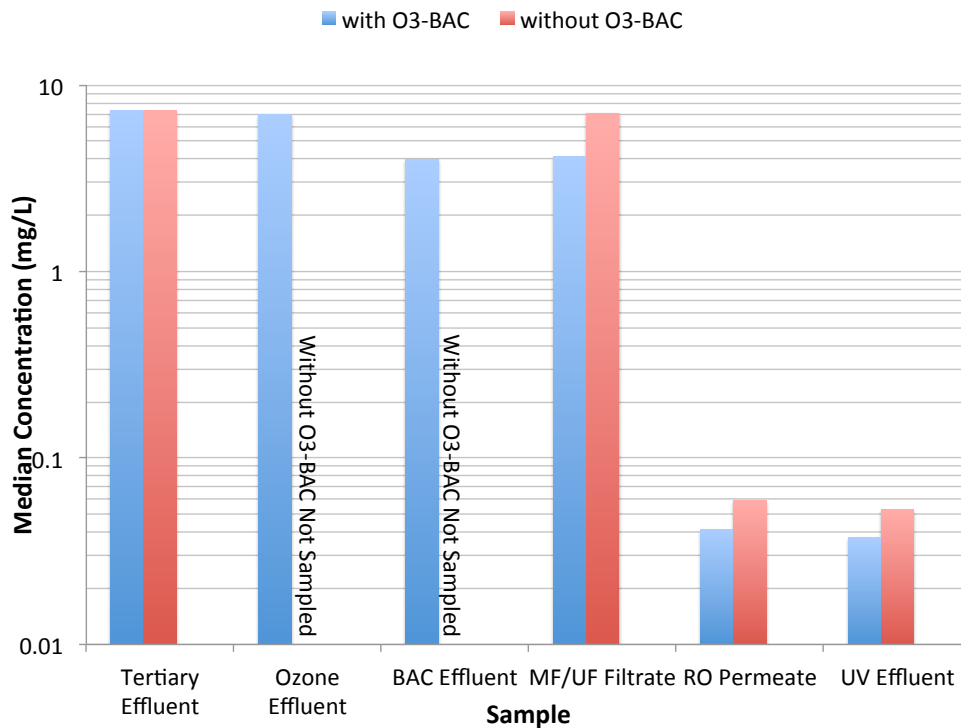
Figure 5-5 presents the TOC concentrations through the treatment train. The TOC concentration is relatively unchanged following the ozonation process, but the organics have been transformed such that they are more readily removed biologically. On average, we observed 40% TOC removal through the BAC filtration process, which can be observed on Figure 5-5. The TOC of the MF/UF filtrate is relatively unchanged in contrast to the feedwater, but the RO permeate is significantly lower for both treatment trains. The RO permeate was reduced to 0.06 mg/L on average while the RO permeate with pretreatment was reduced to 0.04 mg/L. The UV effluent produced a similar number to the RO permeate because the AOP is not being operated at levels that would drive mineralization.

Figure 5-5 Effect of Ozone-BAC Pretreatment on TOC in Treatment Train
(n=3 for sampling without ozone/BAC, n=5 for sampling with ozone/BAC)

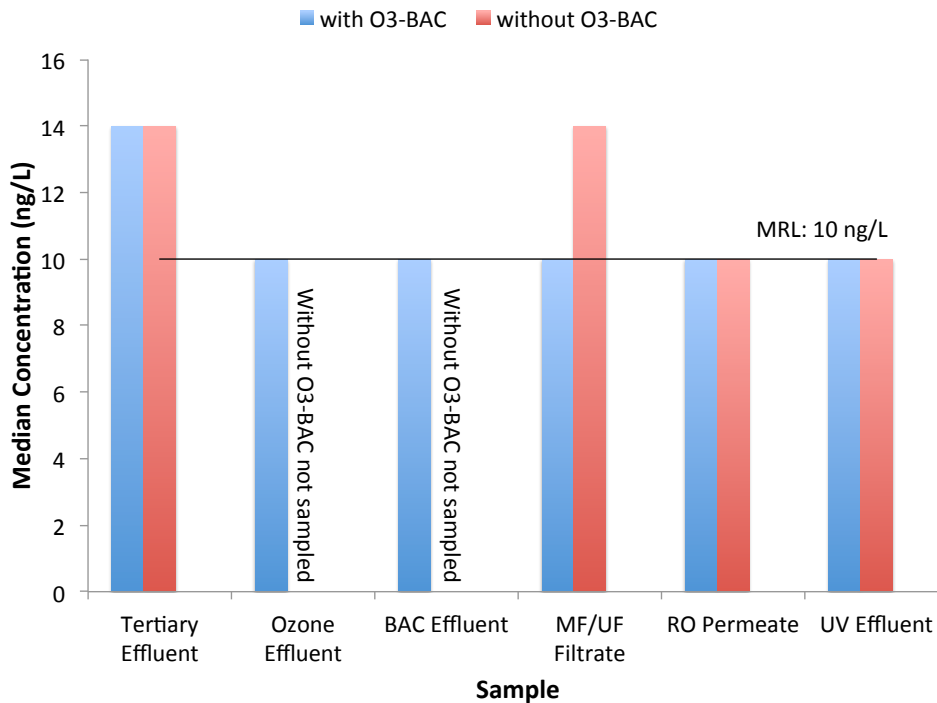
Figure 5-13 presents the concentrations of triclosan, a common antibacterial addition to household soaps. The triclosan was observed at low levels and ozone pretreatment as well as the RO membrane effectively removed this compound.

Figure 5-13 Effect of Ozone/BAC Pretreatment on Triclosan (n=3 for sampling without ozone/BAC, n=5 for sampling with ozone/BAC)

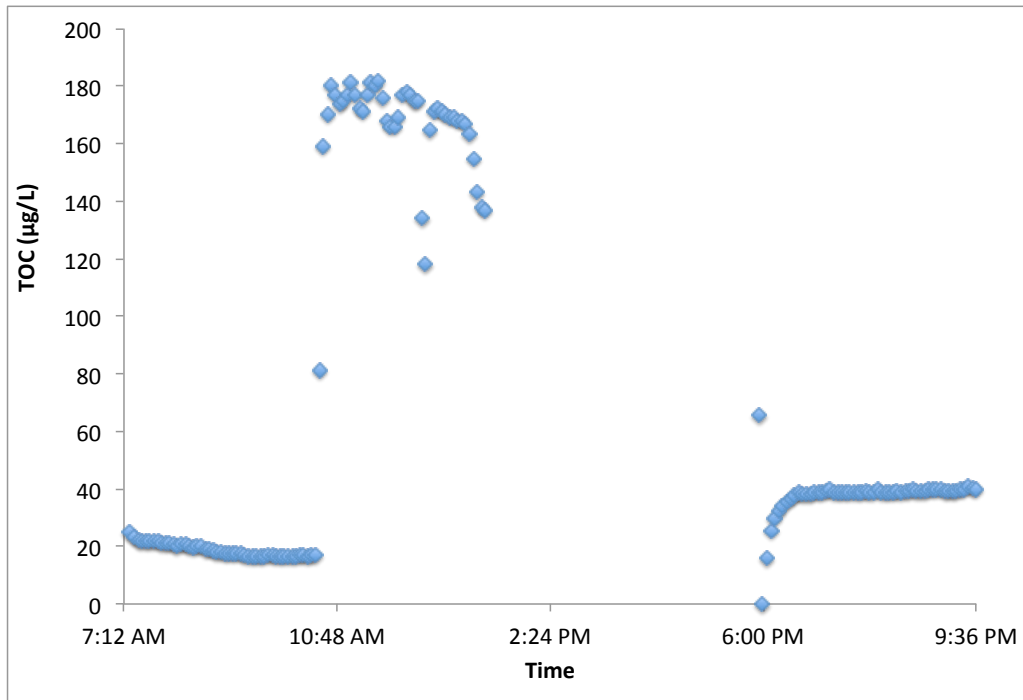
The results from laboratory and field analysis for grab samples of the feed (before UV) water are shown by Table 6-2. Based on observed levels of the total nitrogen, the RO permeate water quality was consistent during the duration of the test. Changes in TOC of RO permeate are shown in Figure 6-3. During 1,4-dioxane dosing, TOC increased to approximately 170 µg/L.

Figure 6-3 RO Permeate TOC (µg/L) during 1,4-Dioxane Spike Experiment

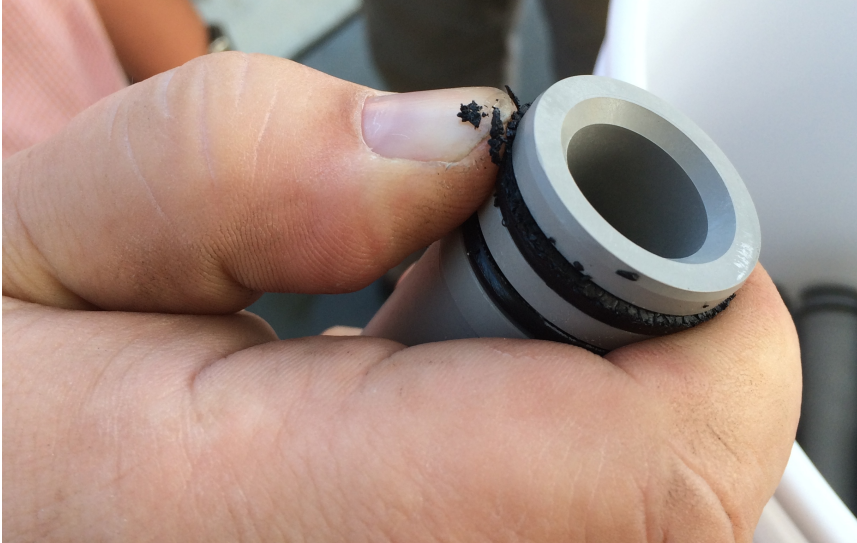
The type of damage illustrated by Figure 7-14 is a result of long-term exposure to chloramines of lower grade of EPDM materials (such as sulfur-cured EPDM) commonly used by the industry. Several studies identified that peroxide-cured EPDM material offers significantly higher resistance to chloramines and is commercially available. After changing to new seals, a marked improvement in vessel conductivities was observed in both Trains as shown in Figure 7-12 and Figure 7-13.

Figure 7-14 Permeate Interconnector O-ring

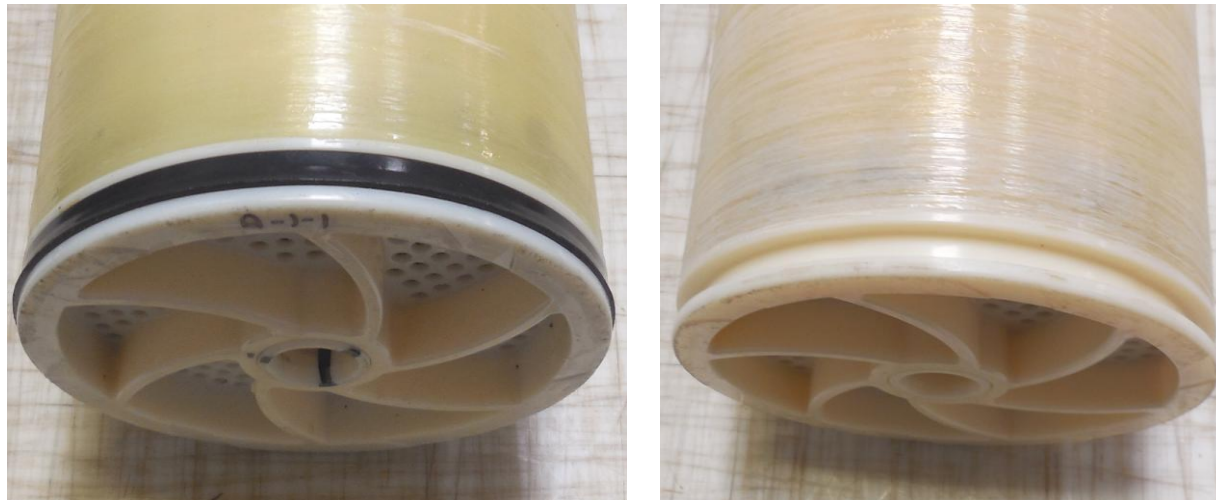
The feed and concentrate anti-telescoping devices (ATDs) were in good condition and free from physical damage.

Image of feed ATD (left) and concentrate ATD (right) for SN# SOY35615

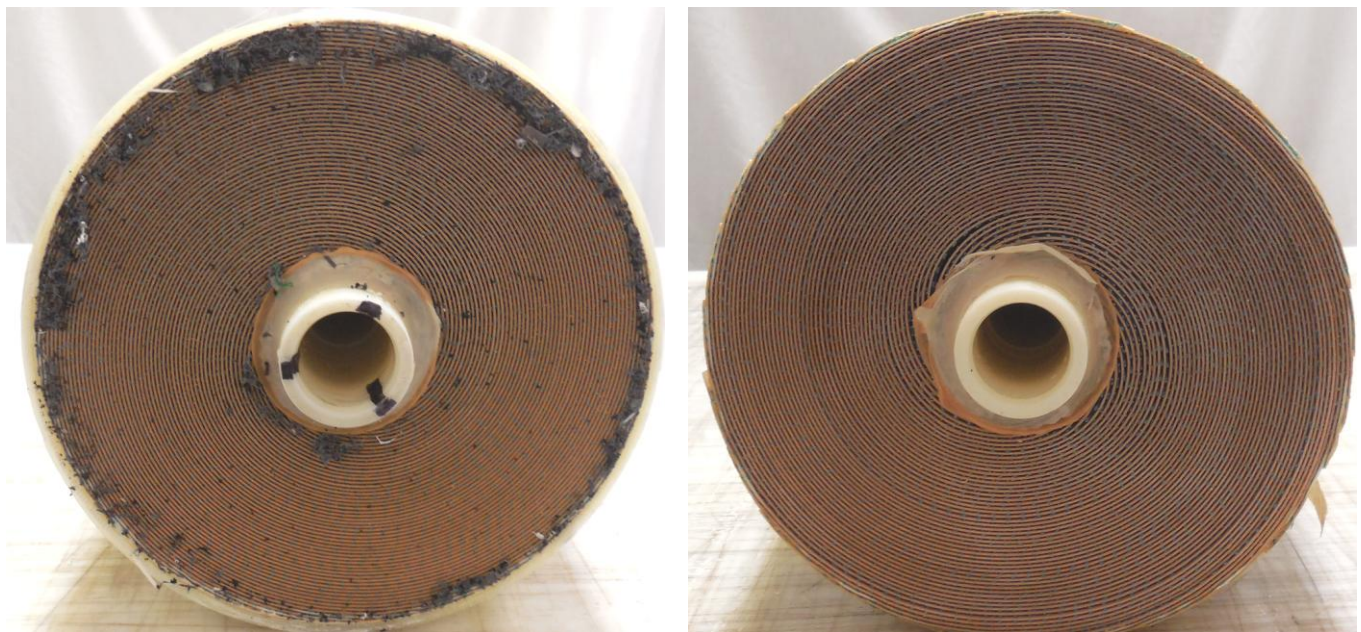
Large foulant debris (black shavings, white orange brown flakes, metal mesh) was visible on the feed scroll end, especially concentrated on the outer radius. The concentrate scroll end was virtually free of visible foulant. Slight telescoping was also observed during the scroll end examination.

Image of feed scroll end (left) and concentrate scroll end (right) for SN# SOY35615

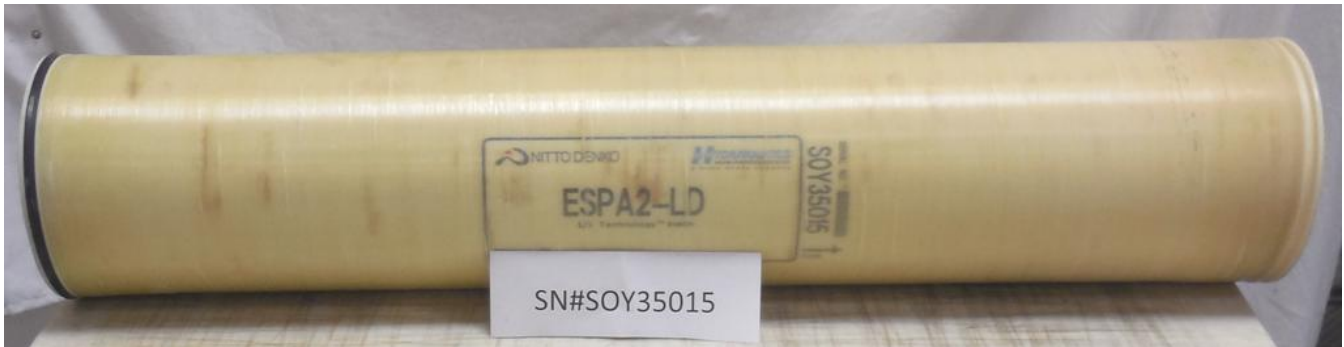
The fiberglass casing of the element was in good mechanical condition, although brown foulant was observed on the casing.

Fiberglass Casing for SN# SOY35015

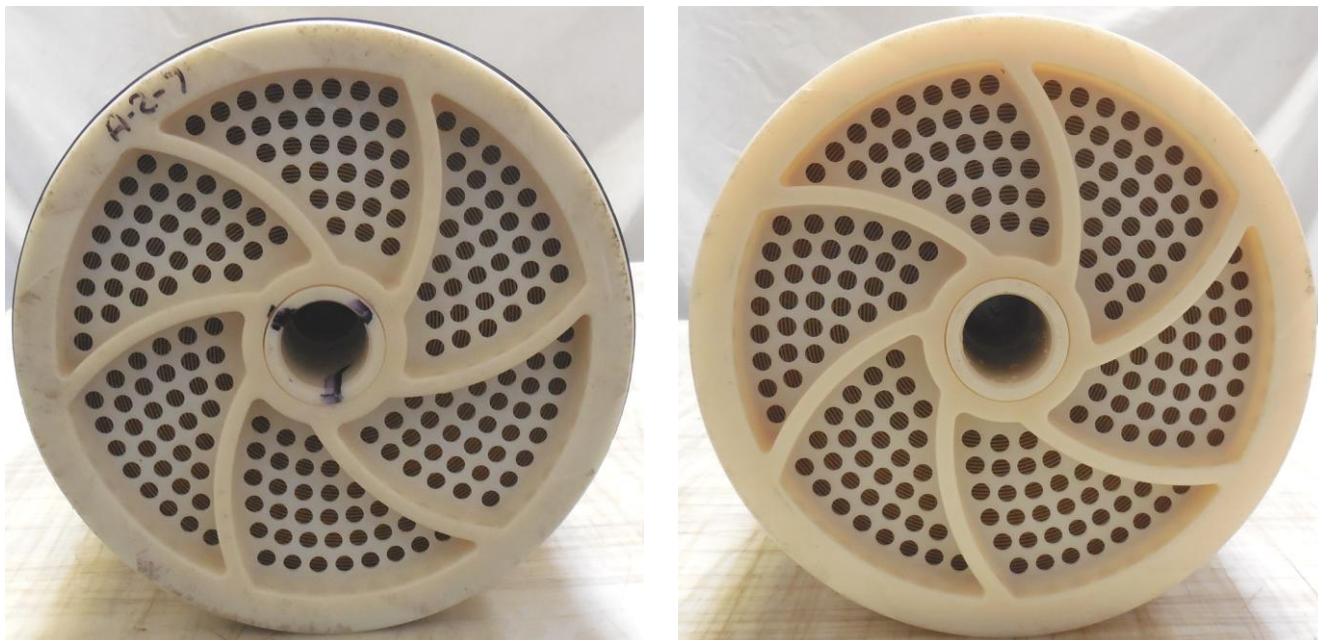
Both anti-telescoping devices (ATDs) were in good condition.

Image of feed ATD (left) and concentrate ATD (right) for SN# SOY35015
