Mission Bay is an enclosed, recreational water body in San Diego, California that is used by twelve million people each year. Numerous recreational activities take place in Mission Bay, including swimming, diving, boating, fishing, kayaking, and water skiing. Water quality in the Bay has been monitored since the mid-1960s and exceedances of bacterial standards have been recorded from surface waters of the Bay since the early 1970s. Poor tidal flushing, contamination from storm drains, and periodic overflows from the City of San Diego sewage system were thought to be the primary causes of most of the bacterial problems in the Bay.

Figure 3. Map of Mission Bay showing infrastructure investigation sites.

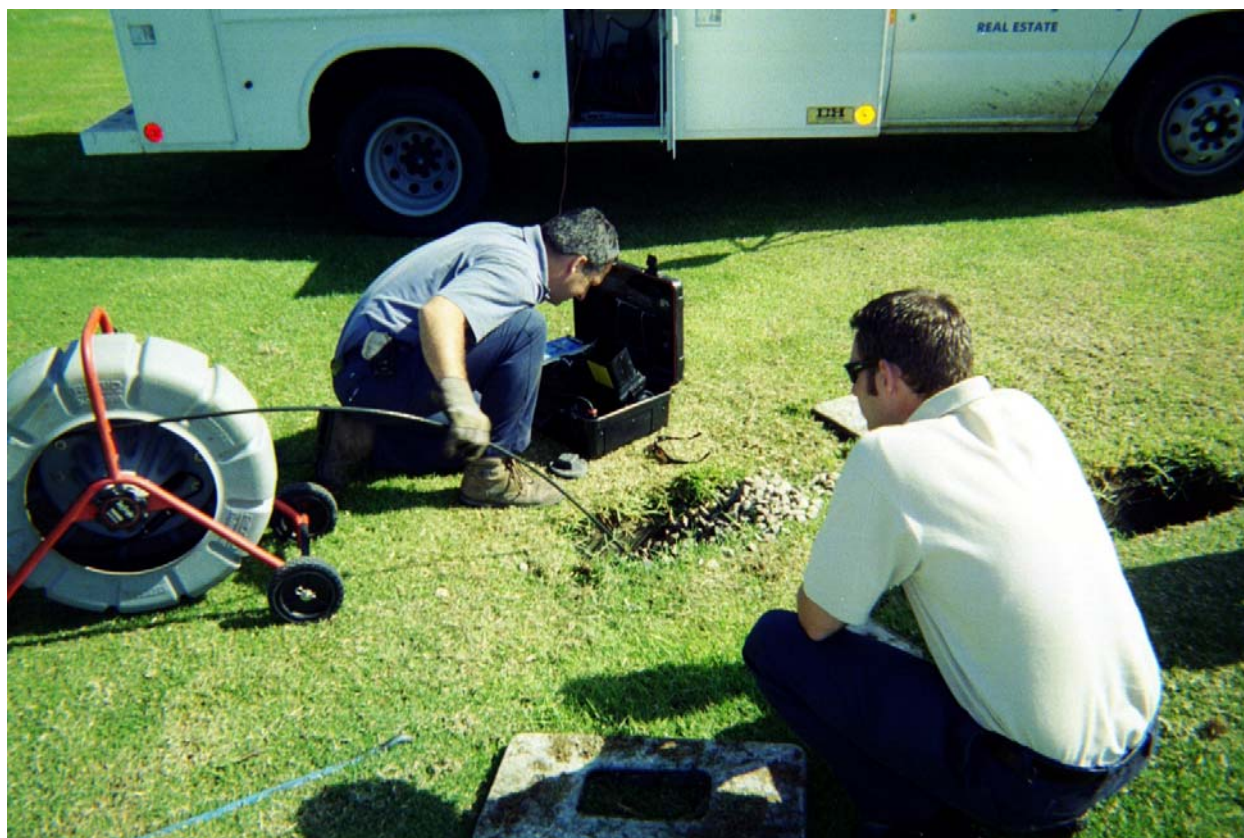
The lateral lines of each of the restroom facilities were investigated using close circuit television (CCTV) to look for cracks, tree roots, sedimentation, and other evidence of integrity problems. The system consists of a push camera connected via a 250-foot long cable to a video monitor and VCR. The camera was inserted down the sump or line to be investigated and pushed the length of the pipe (up to 250 feet). A typical investigation started inside the restroom facility, but lines were also accessed from clean outs located outside the facility along the pipe's length (Figure 4). The camera image was viewed on the monitor and recorded by the VCR. The locations of any pipe transitions or potential problem areas were identified on the tape as was the audio recording of the technician's observations.

**Figure 4.** Photograph of typical CCTV investigation in Mission Bay Park.

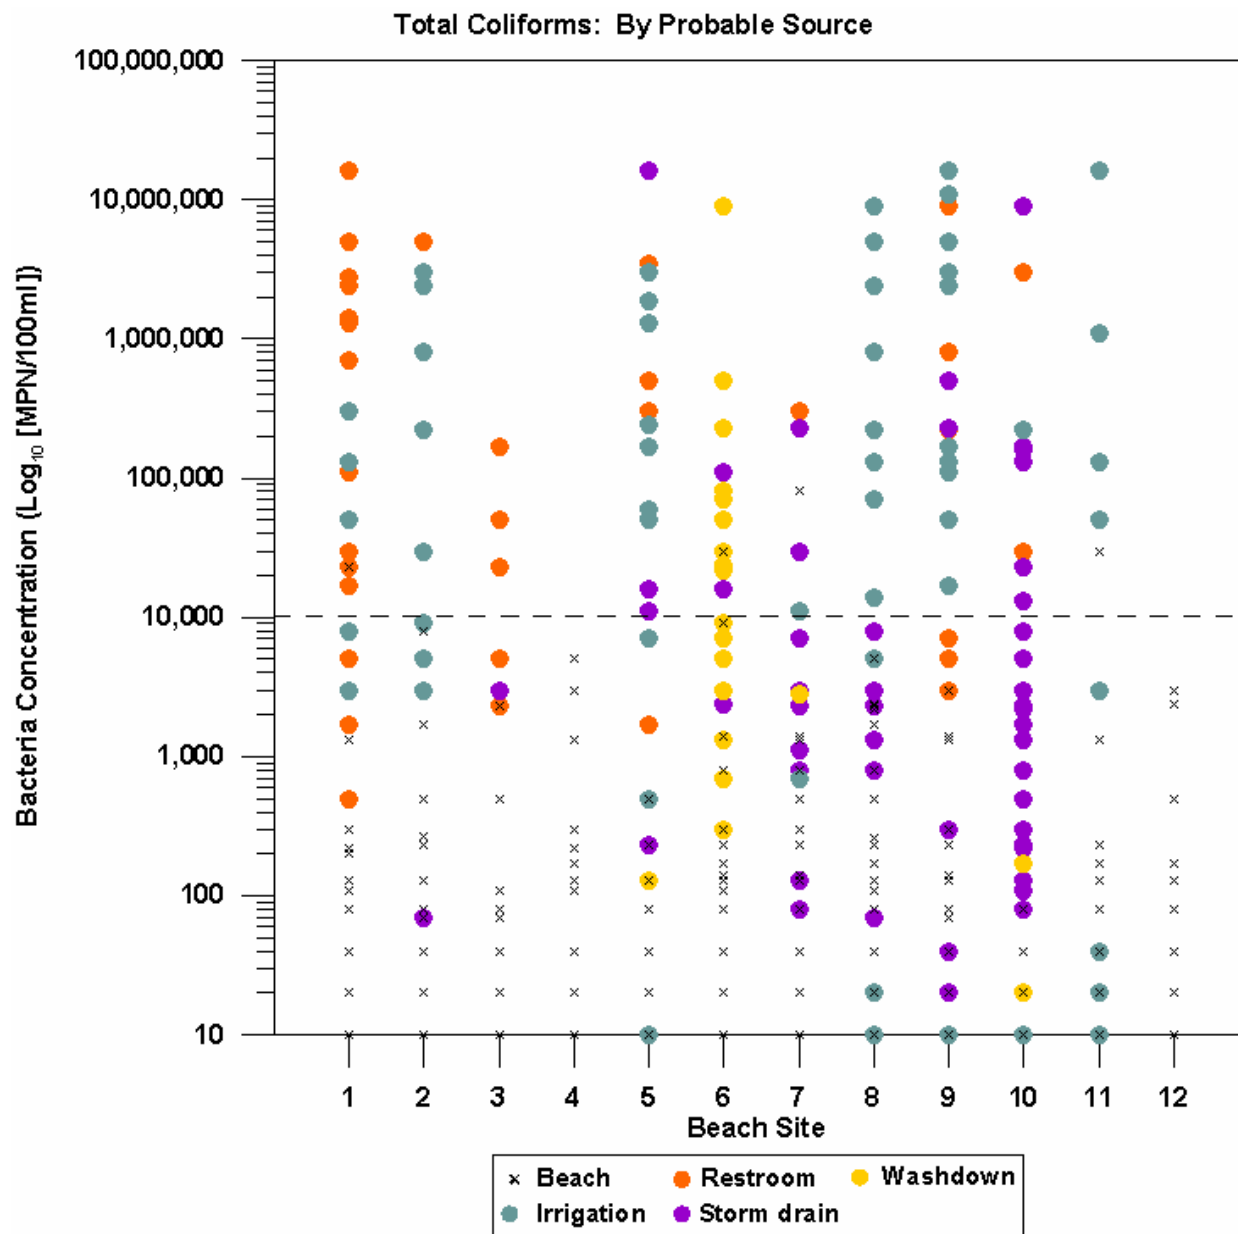
**Figure 4.** Plot of total coliform concentration by site and probable source. The dashed line represents the AB411 single sample criteria of 10,000 MPN/100 ml.

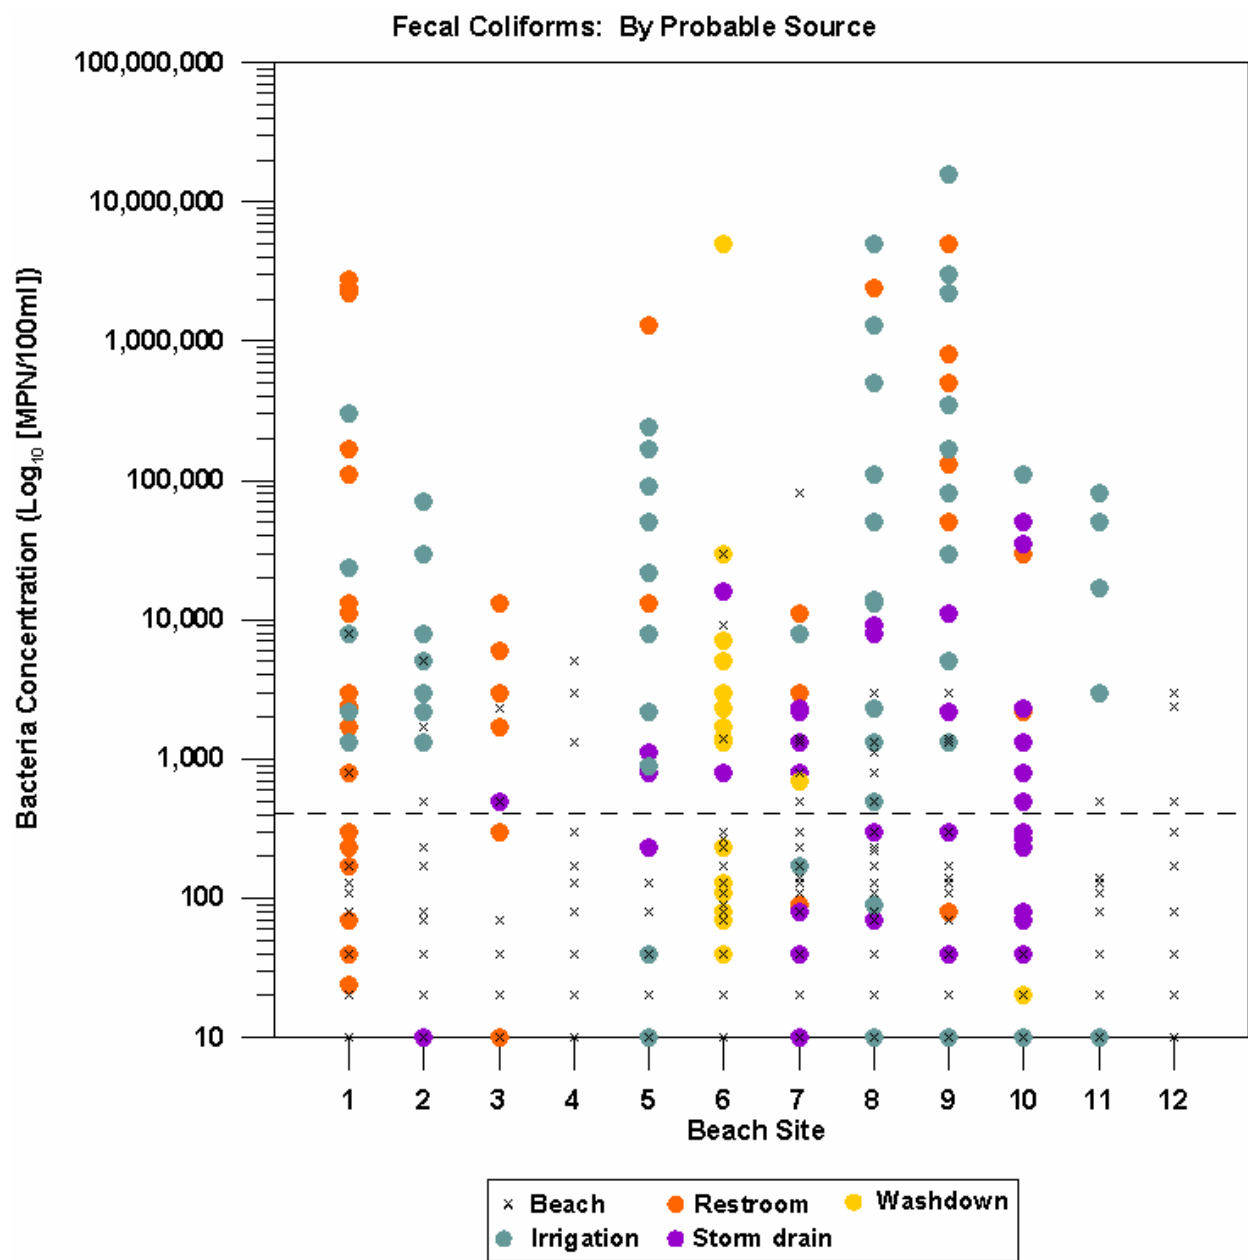
**Figure 5.** Plot of fecal coliform concentration by site and probable source. The dashed line represents the AB411 single sample criteria of 400 MPN/100 ml.

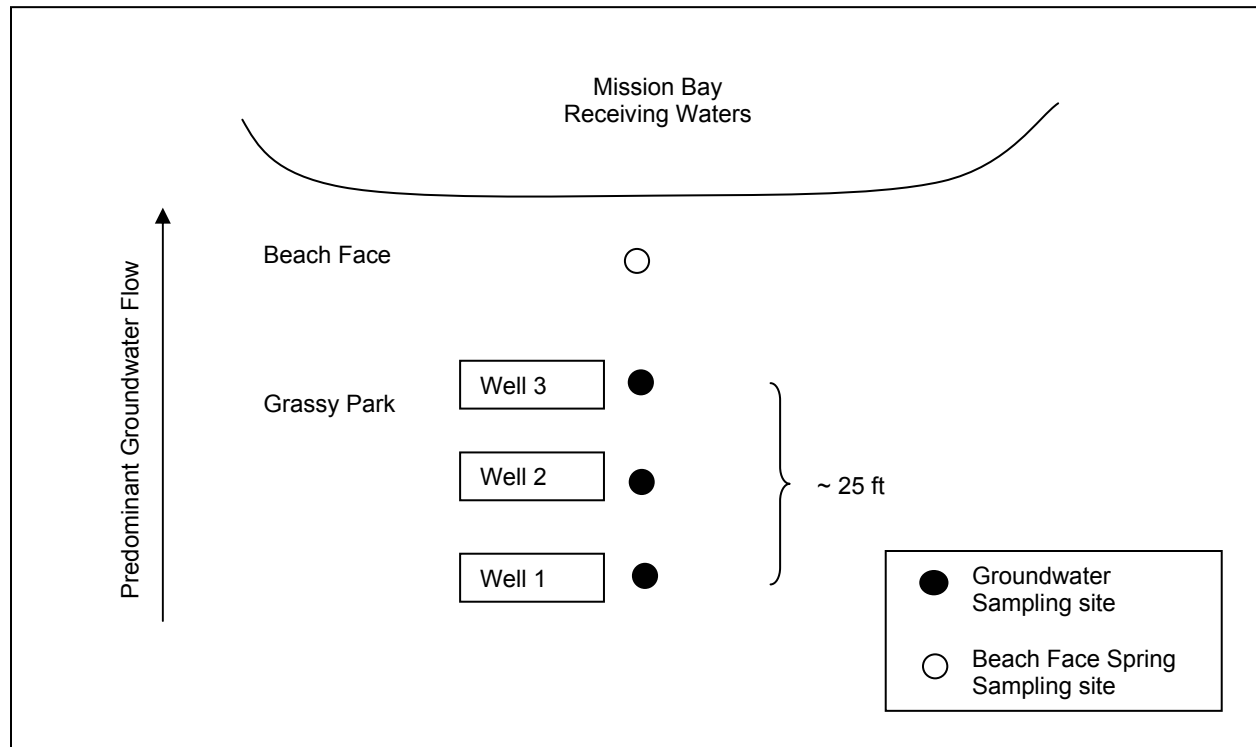
**Figure 2.** Plan view schematic showing fate and transport sampling array.

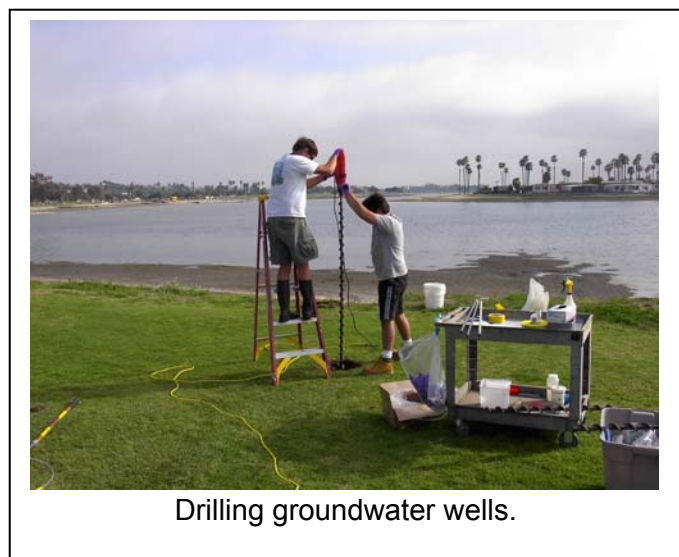
The wells were drilled using a 3-inch auger and a hammer drill powered by a portable generator. Each well was drilled to a depth of ten feet. Once the desired depth was reached, the auger was removed and a small, sterile, approximately one inch long, stainless steel, screened probe (AMS, American Falls, ID, part #211.00) was inserted into the soil an additional two feet using a push rod and slide hammer. The upper end of the probe was attached to a length of 3/16 inch sterile plastic tubing, which was inserted inside the push rod and protruded above the surface of the ground. The lower end of the push rod covered the

Drilling groundwater wells.

screened portion of the probe as it was being inserted into the soil. Once the probe had reached the final depth of 12 feet, the push rod was removed, leaving the probe at a depth of 12 feet connected to sterile tubing that extended up to the surface of the ground. After the first probe was inserted, approximately six inches of fine-grained sand was poured on top of it, followed by six inches of bentonite clay, followed again by an additional six feet of sand. The bentonite forms a hydraulic seal, which prevents water from entering the probe from above. Two additional probes were inserted similarly in the same hole at depths of 7 and 4 feet below the surface of the ground. In this way, groundwater probes were set at three discrete depths in each of three wells at each site (Figure 3). The tubing from each probe that protruded above the surface of the ground was marked with the appropriate depth.

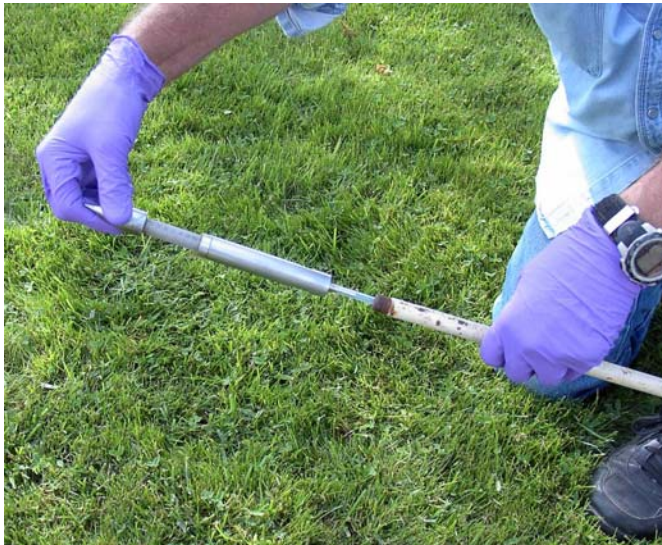
Beach spring groundwater sampler showing screened, retractable sampling port

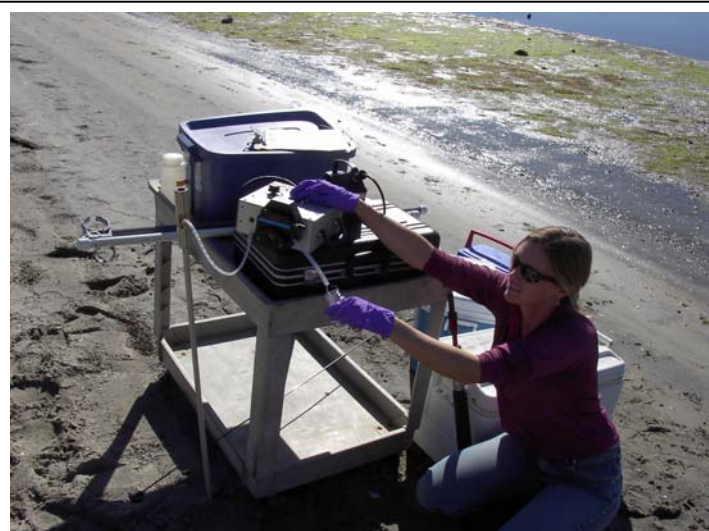
To take a groundwater sample, the probe was inserted to the appropriate depth with a slide hammer. Then, the rod was pulled up approximately two inches, exposing the screened sampling port. The tubing from the top of the sampling rod was inserted inside a short length (approximately 12 inches) of sterile, flexible tubing and samples were collected with a peristaltic pump as described above.

Groundwater sampling from beach face spring

ten feet above the top edge of the spring, measured along the beach face, at a depth of 12 to 24 inches below the surface of the beach face. Samples were taken using a four-foot long, 0.5 inch diameter sampling rod connected to a six inch long, sterilized probe (AMS, Inc., American Falls, ID, part # 210.01). At the bottom of the probe is a 1.5-inch long pointed, conical tip for insertion into the ground. The probe encases a retractable sampling port surrounded by a stainless steel screen. The top of the sampling port is connected to an eight foot length of 3/16 inch sterile tubing that was inserted inside the sampling rod and out the top.

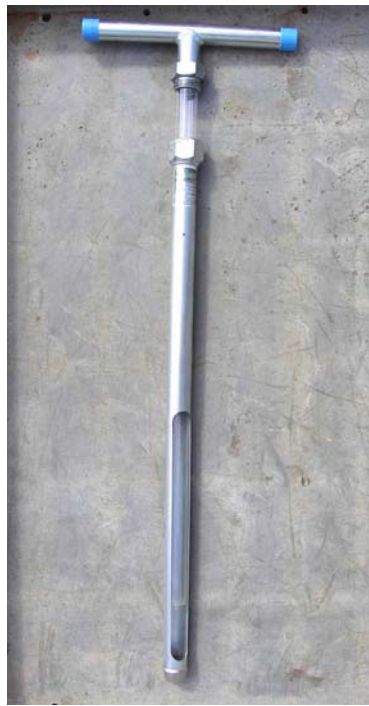
Push core soil probe with sterile butyrate liner

In addition to the groundwater monitoring wells, two soil cores were also taken at each site adjacent to Wells 1 and 3. The cores were taken with a 24-inch long chrome plated push core soil probe (AMS, Inc., American Falls, ID, part # 424.23) fitted with a cross handle and sterile butyrate liner. The sampler was pushed manually through the turf and into the soil to a depth of approximately eight inches. A slide hammer was then used to pound the sampler to a depth of approximately 22 inches below the ground surface. The sampler was then extracted from the soil and the liner containing the soil core was removed using sterile technique, capped on both ends, and labeled with the appropriate site information. After extraction, the cores were kept on ice in a cooler for transport to the laboratory.

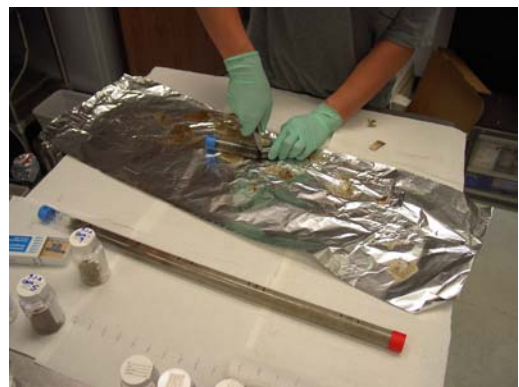
The soil cores were also processed at the MEC Microbiology Laboratory. In the laboratory, the cores were visually inspected for distinct soil strata. The strata were delineated with a marker, numbered, photographed, and catalogued with a visual description of the color, consistency, and depth from surface of each stratum in the core. Four to five strata were identified in all the cores. A sterilized utility knife was then used to cut the cores at each of the identified strata so that representative soil samples from each stratum could be removed for three separate analyses: bacterial indicators, moisture content, and soil grain size. The soil extracted for bacteria and moisture content analyses (typically 30 – 60 grams each) were placed into separate, sterile, pre-weighed, 100-mL

Processing cores in the laboratory

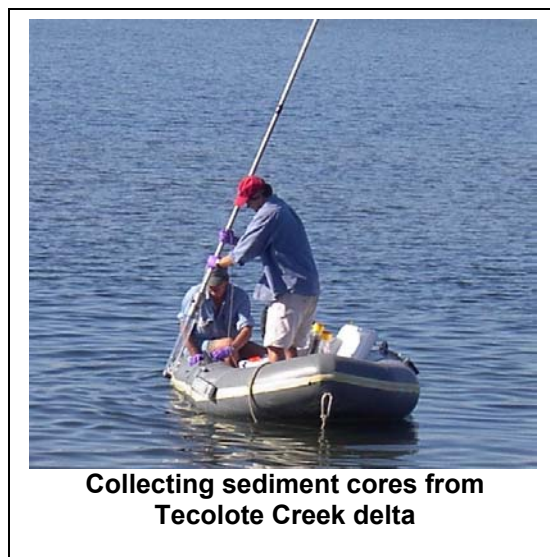
**Sediment Cores.** Sediment cores were taken from an inflatable raft (Zodiac) equipped with an 8 horse outboard motor. The coordinates of each of the sampling locations were located in the field using a hand-held GPS. Once in position, the inflatable was anchored on site. Sediment cores were taken with a hand core that consisted of 10-foot long aluminum push rod attached to an aluminum block. The block consisted of a six cubic inch head connected to a six inch long, 3 inch diameter cylinder. At the bottom of the cylinder was a rubber stopper that was held in place with a line that passed through the aluminum block and out of a port near the top of the push rod. The stopper was secured inside the bottom of a 3-inch diameter, sterile, plastic tube approximately 20 inches long. The sterile tube was then attached to the outside of the aluminum cylinder with hose clamps.

Collecting sediment cores from Tecolote Creek delta

To remove a sediment core, the plastic tube was inserted into the sediment from the inflatable boat and pushed into the sediment using the push rod. A slide hammer was then used to pound the tube into the sediment until refusal. The stopper, located at the sediment water interface, was pushed up the plastic tube as the tube was inserted into the sediment. When the appropriate depth was reached, the whole apparatus was removed from the sediment with the sediment core in tact within the plastic tube. The stopper creates suction within the tube that holds the sediment core in place. As the core was lifted to the surface of the water, a sterile

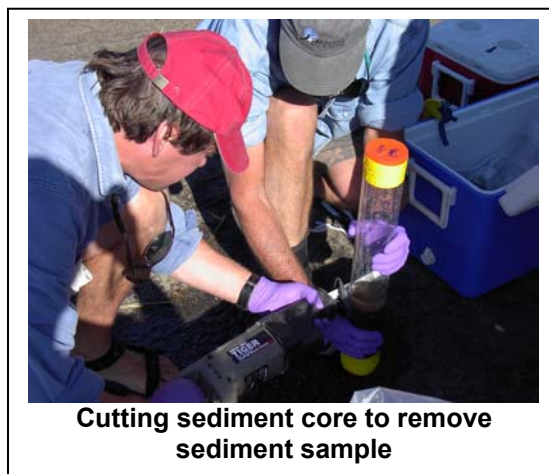
**Sediment Core Processing.** After the cores had been removed and capped, they were stored in the dark on ice, then transferred to shore for processing. The top cap was removed and any excess water on top of the sediment (typically less than 1 cm) was removed with a sterile pipette. The tube was then cut with a reciprocating saw equipped with a sterilized blade, approximately 2 cm above the top of the sediment layer. The top 1 cm of the sediment core was then removed with a sterile spoon and placed into a sterile 100-ml plastic bottle and capped. Surficial sediments from

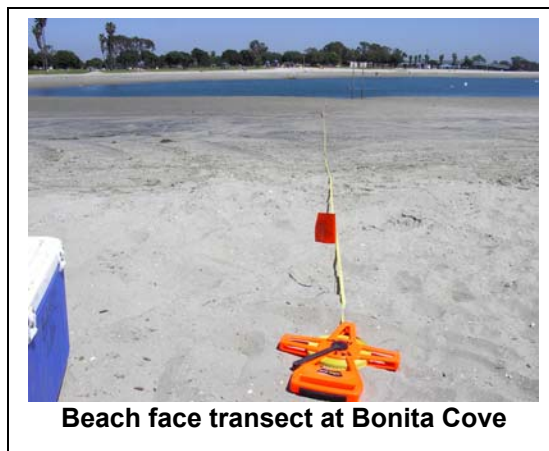
**Beach Face Transects.** Bacterial densities were measured along beach face transects at Bonita Cove and Leisure Lagoon (De Anza Cove was not included in this assessment). At each of the three sites, five transects were positioned along the beach face. At Bonita Cove and Leisure Lagoon, the transects were centered around the AB411 receiving water monitoring site (Figures 2 and 3). Each transect, which consisted of a measuring tape secured at either end with a metal pin, ran perpendicular to the Bay from a tidal height of 0 to +6 feet above Mean Lower Low Water (MLLW). The transects were put in place during a low tide (below 0 MLLW). The position of the tidal height on the beach face was determined using tide charts and the measuring tape. Along each transect, six stations representing tidal height positions from 0 to +6 feet above MLLW were identified with survey flags. The transect stations were: 0, +1, +2, +4, +5, and +6 feet above MLLW. At each of the transect points, one surficial (approximately 1 cm deep) sediment sample consisting of approximately 50 g of sediment was taken using a sterile 100-ml plastic bottle. At each of the two sites assessed, a total of 30 sediment samples were taken (5 transects x 6 stations).

**Beach face transect at Bonita Cove**

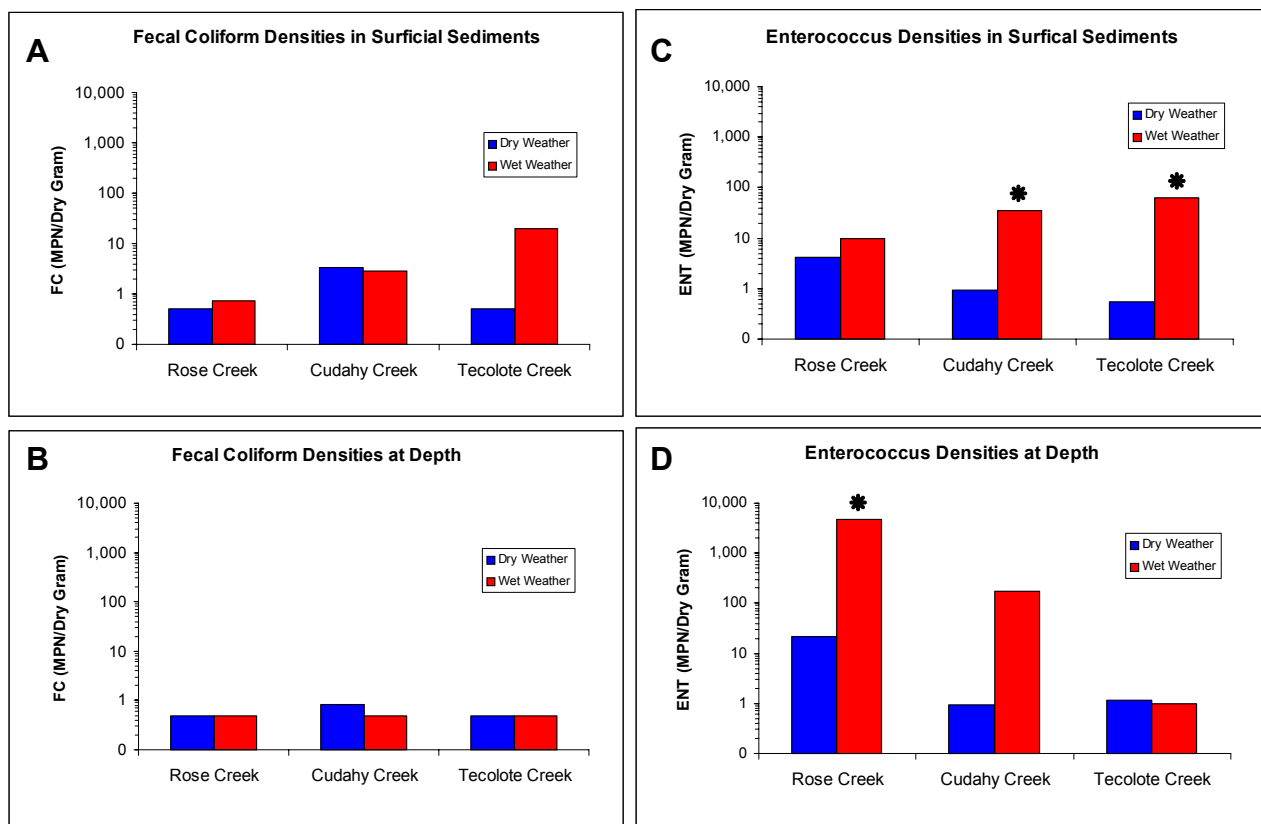
**Figure 6.** Graphs of fecal coliform and enterococcus densities in surficial sediments (top 1 cm) and at a depth of four inches from deltas at Rose Creek, Cudahy Creek, and Tecolote Creek. Bars represent the geometric means of bacterial densities collected during the dry and wet weather surveys (\* represents statistical significance between survey means).

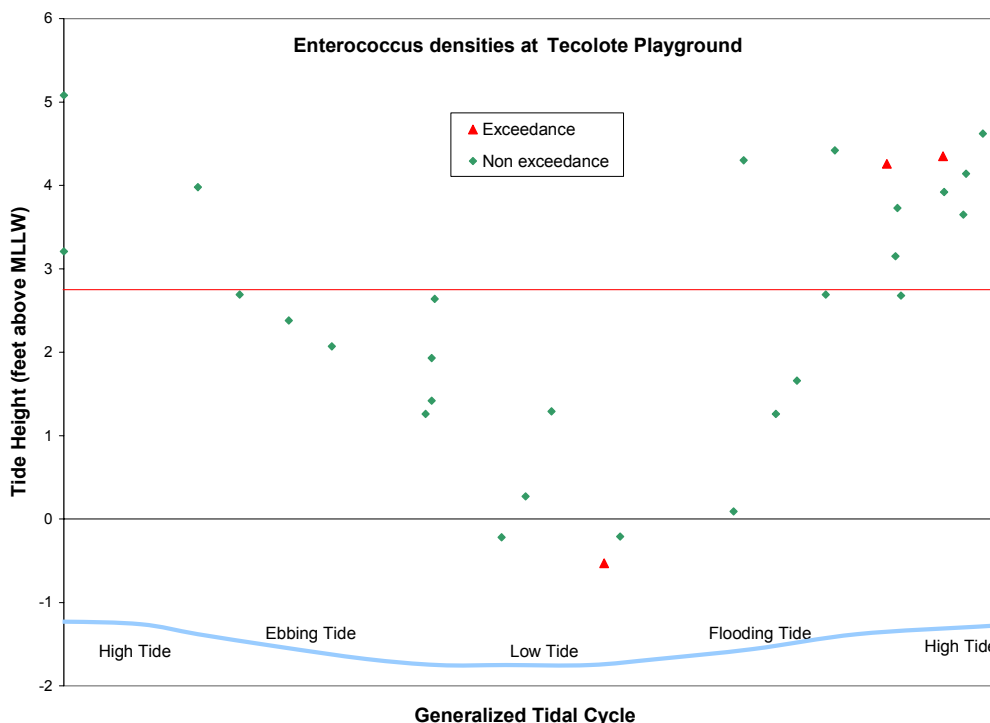
**Figure 21.** Enterococcus densities versus tidal height at Tecolote Playground from 2001 through 2003. Samples shown in red exceeded the AB411 criteria for enterococcus of 104 MPN/100 ml. The red line separates samples taken in the upper intertidal from the lower intertidal zones.

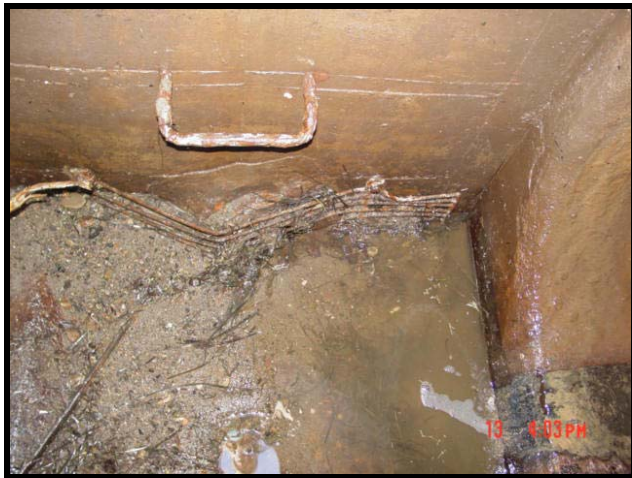
The diversion pipe is typically a six-inch line that is covered in the diversion vault with a metal grate to prevent debris from entering the sewer system. A typical diversion structure is shown in Figure I-1. Those storm drains that are influenced by tide water are fitted with a metal flap valve (Figure I-2), a tide flex valve (Figure I-3), or a manually operated tide gate. These structures are designed to protect the system from salt water intrusion at high tides. The valves are typically located at the base (Bay side) of the diversion box.

**Figure I-1.** Photograph of water entering a storm drain diversion vault (on the right side of the photograph), the diversion berm (on the left side of the photograph), and grate. The vault shown here is filled with sediment that had washed up from the Bay.

Storm drain diversion structures, when present, should be cleaned and maintained on a regular basis to prevent storm drain effluent from inoculating beach sediments. In addition, we recommend that the City consider placing flap valves at the ends of storm drains, where appropriate, to prevent seawater intrusion.

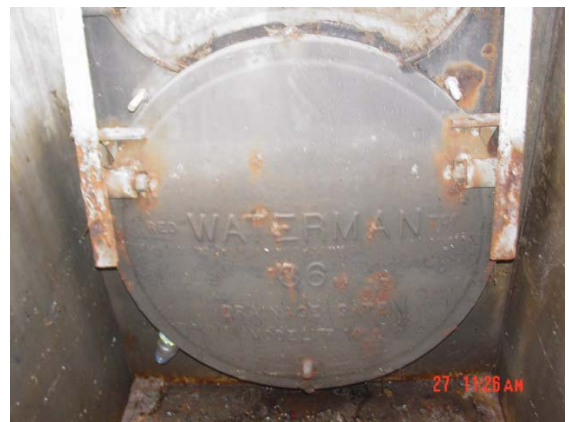
**Figure I-2.** Photograph of a typical flap valve used to prevent salt water intrusion of the diversion system.

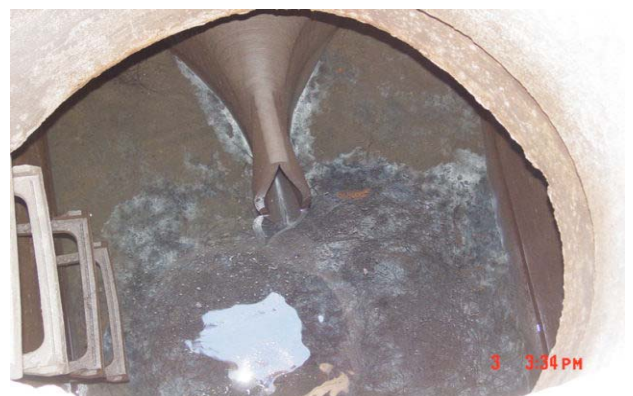
**Figure I-3.** Photograph of a typical tide flex valve used to prevent salt water intrusion of the diversion system. This tide flex has been bowed open and is ineffective in preventing tidal backflow.

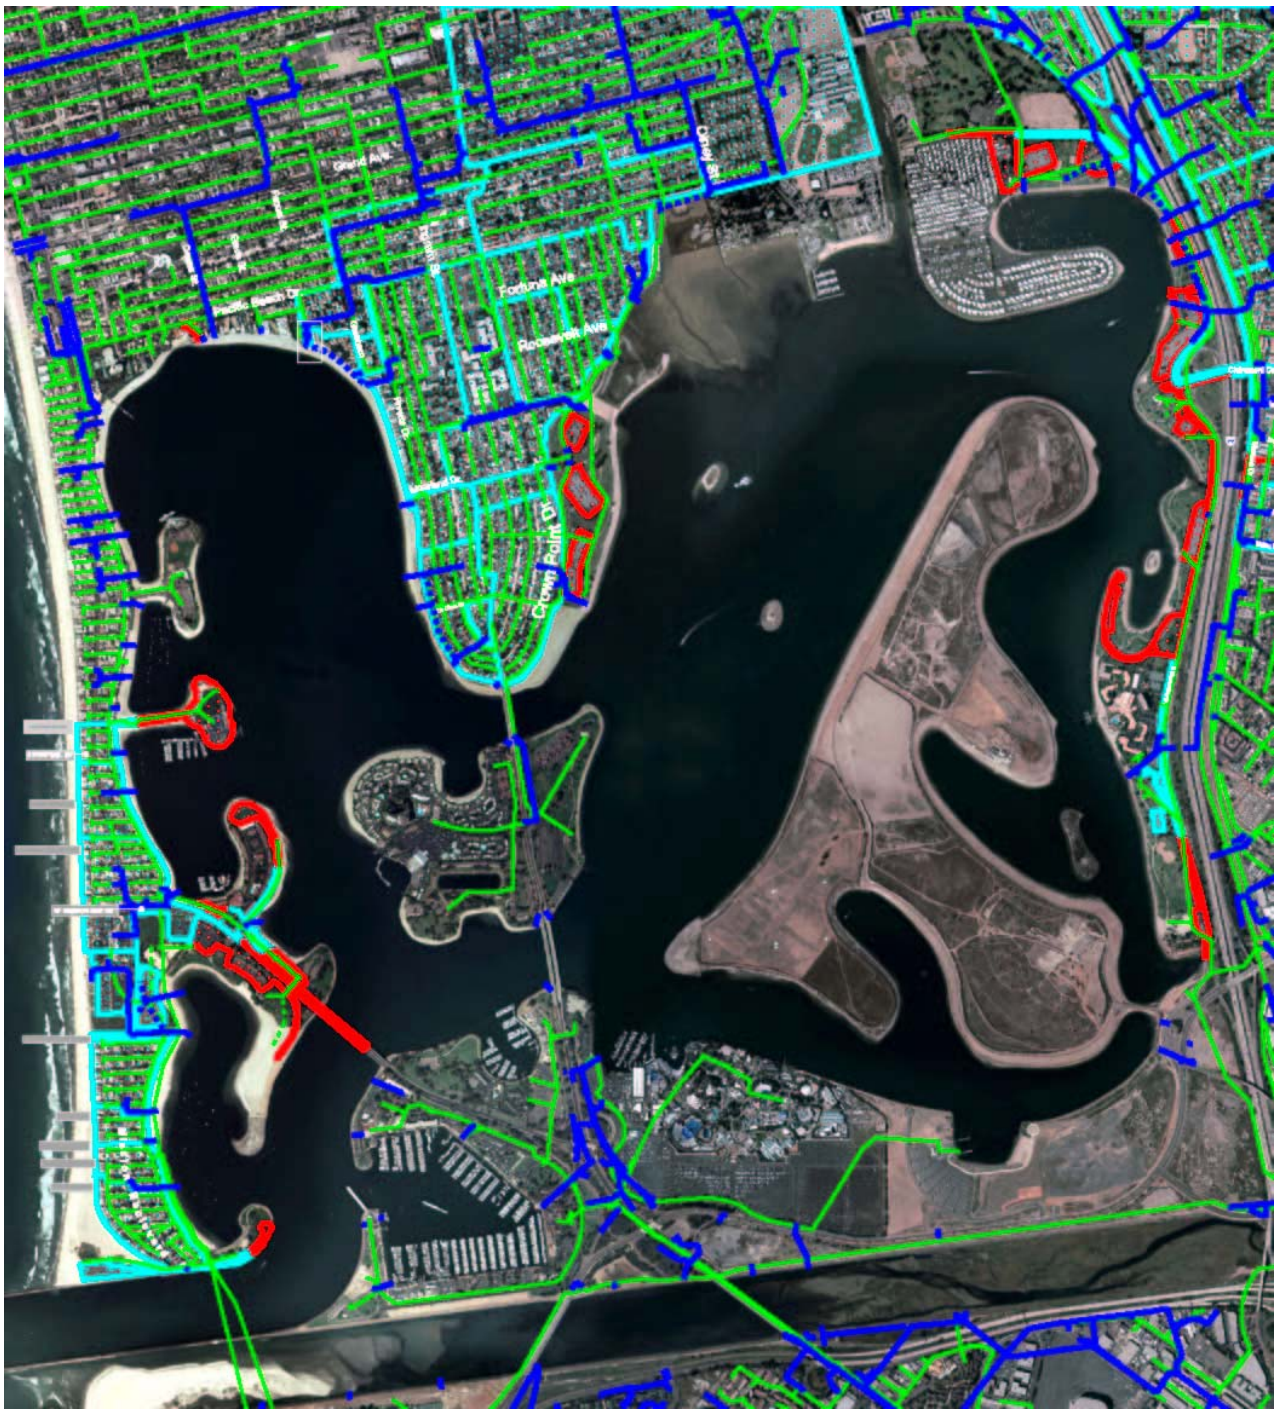
**Figure I-4.** Map of Mission Bay storm drain diversion system showing diverted areas in blue and un-diverted areas in red.

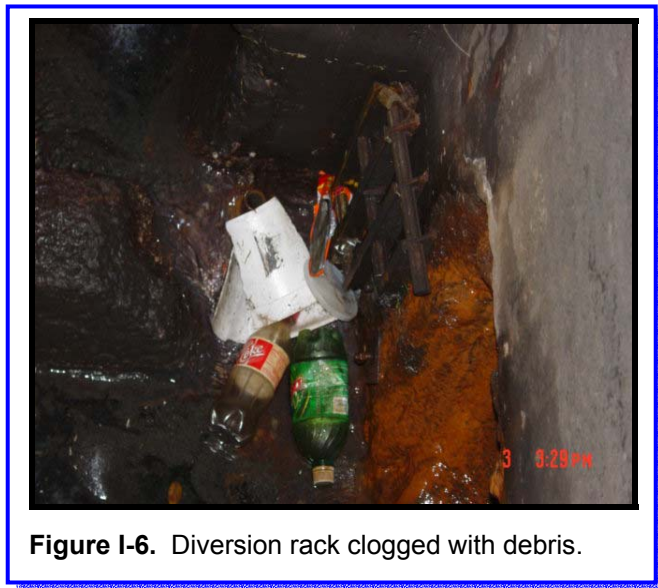
The majority of the peninsula on the west side of Bonita Cove is drained to the Cove by storm drain diversion boxes and motorized plug valves located at Balboa Court (V-30), Cohasset Court (V-32), and Deal Court (V-33). The storm drain at Balboa Court (V-30) was completely clogged with debris and sediment during the inspection (Figure I-6). There were no flows at the time of the inspection, but the clogged diversion rack suggested that dry weather flows are not properly diverted at this site. Diversion structures at Balboa Court and Cohasset Court appeared to be functioning properly. Tide gates are in place at the Balboa Court and Deal Court storm drains. Both appeared to be in good condition and functioning properly. The storm drain at Cohasset Court has a tide flex that apparently is submerged and could not be inspected.

Figure I-6. Diversion rack clogged with debris.

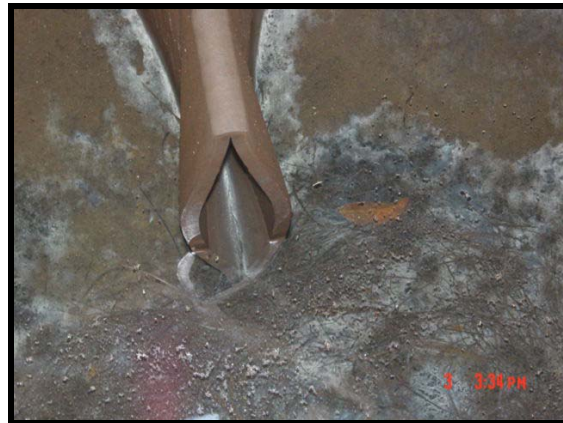
**Figure I-8.** Broken Bonita Cove tide flex valve stuck open.

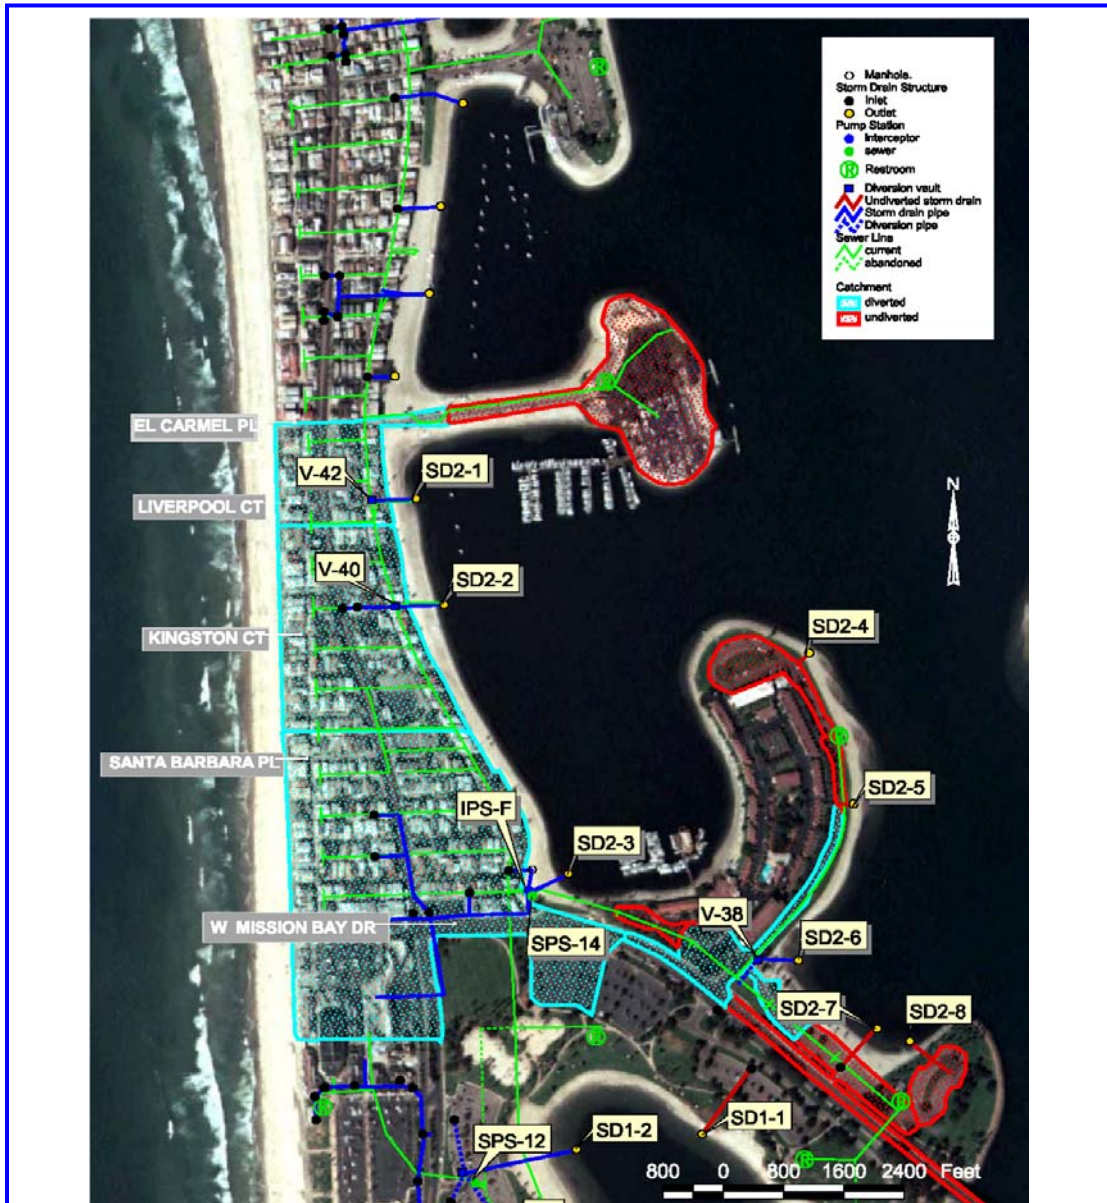
**Figure I-9.** Map of storm drain system at Bahia Point showing diverted (in blue) and un-diverted areas (in red).

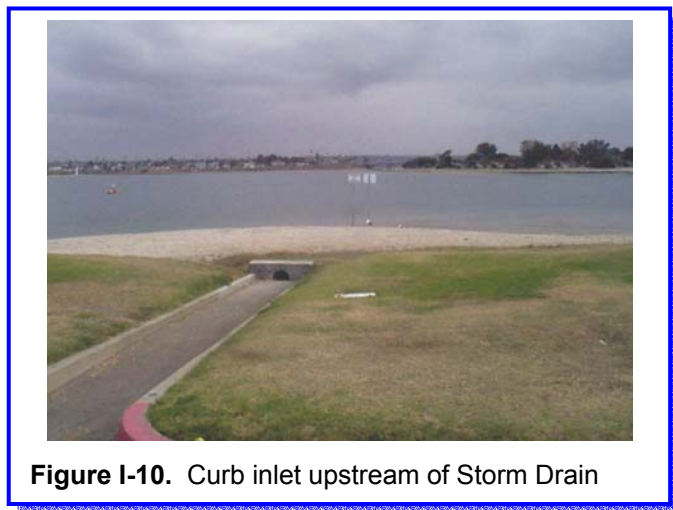
There are two storm drains that drain the northern half of the Bahia Point Peninsula (SD2-4 and SD2-5). Both are undiverted and drain surface runoff to Ventura Cove on the east side of the Peninsula. During the Visual Observations Task of this study, elevated bacterial levels were measured from the discharge of both storm drains and from water samples taken before the water entered these storm drains. Weekly monitoring was conducted in the receiving water adjacent to SD2-4 (Figure I-10).

**Figure I-10.** Curb inlet upstream of Storm Drain

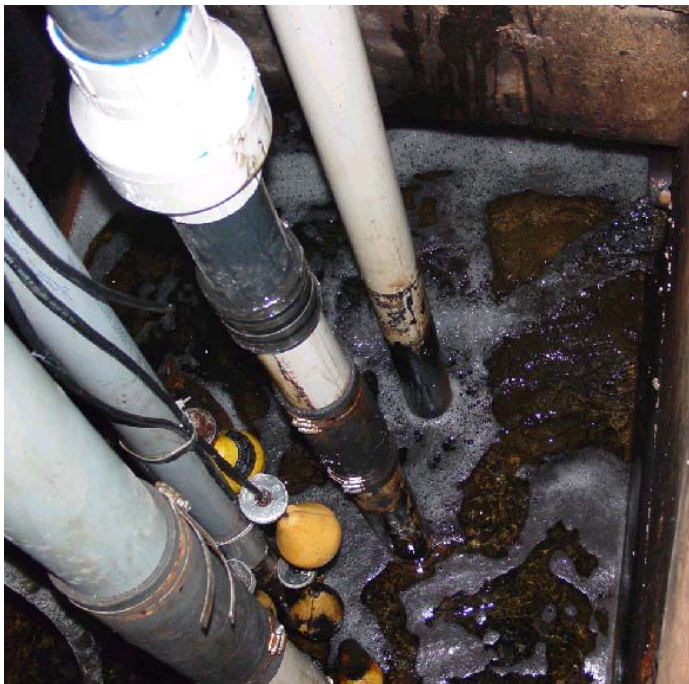
In addition to the problems mentioned above, there are other concerns associated with the Fanuel Park storm drain system. There are two pipes that connect to the storm drain downstream of the diversion system. Both are thought to carry water from de-watering activities and sumps associated with the condominiums and apartment buildings in the area (Figure I-12). The results of an investigation that was recently conducted to assess bacterial levels from these sources is discussed below.

**Figure I-12.** De-watering sump pump located at Fanuel Park.

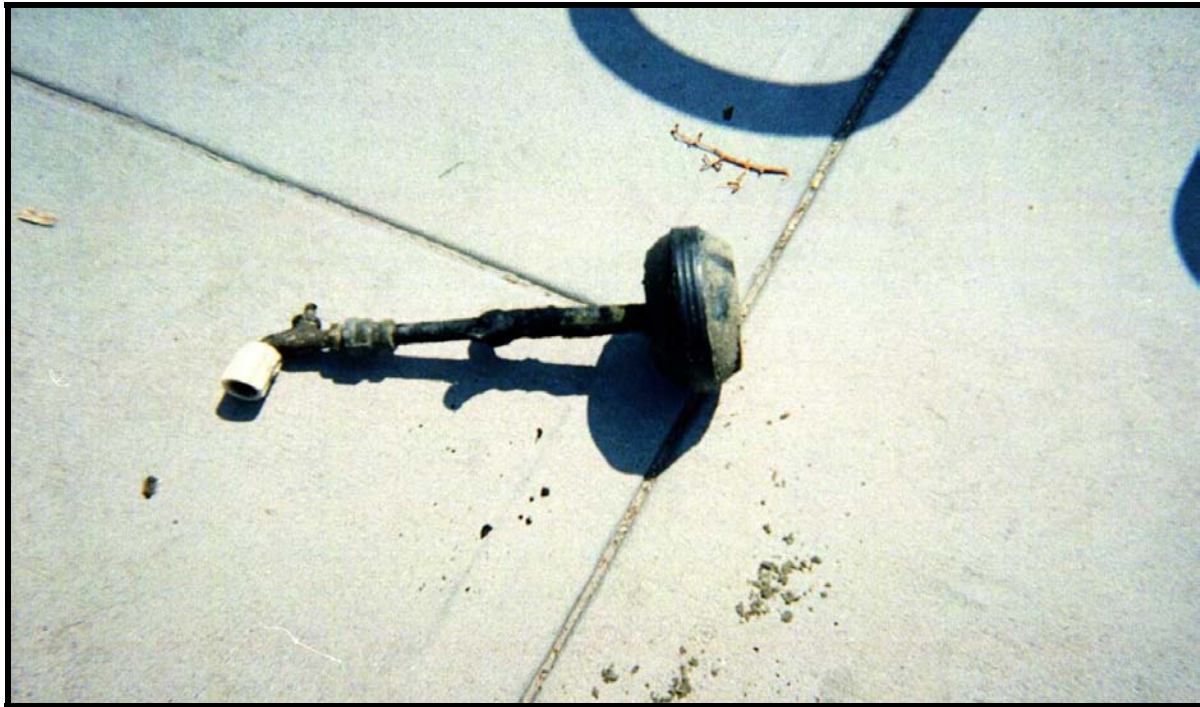
**Figure I-13.** Plug found after vacor truck cleaning of storm drain system.

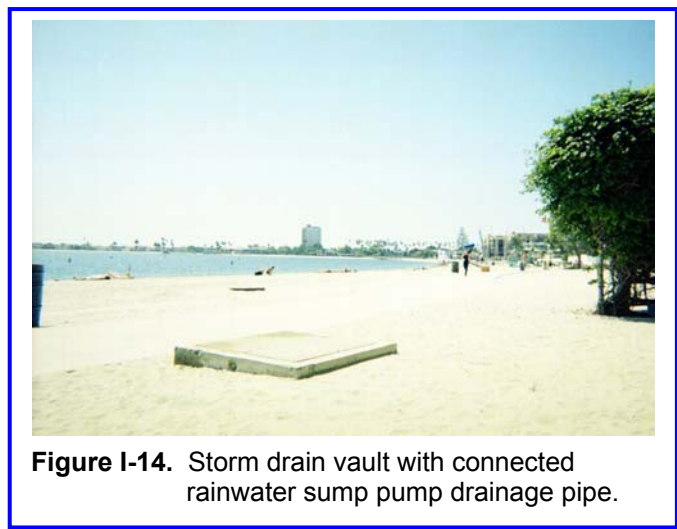
**Figure I-14.** Storm drain vault with connected rainwater sump pump drainage pipe.

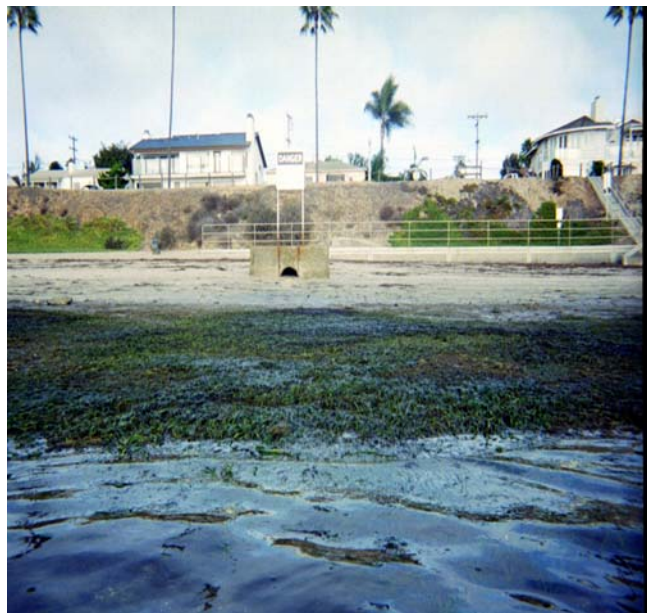
drains at Riviera Shores are located at the ends of the following streets: La Mancha Drive (SD4-1), La Cima Drive (SD4-2), and Edge Cliff Drive (SD4-3) (Figure I-16). Dry weather flow from all three of the storm drains is diverted to the sewer via Interceptor Pump Station I-14 located at the western end of La Cima Drive. All of the storm drains drain small, residential neighborhoods and the diversion system appeared to be diverting storm drain system flows to

**Figure I-16.** La Cima Drive storm drain (SD4-2) and sampling site location.

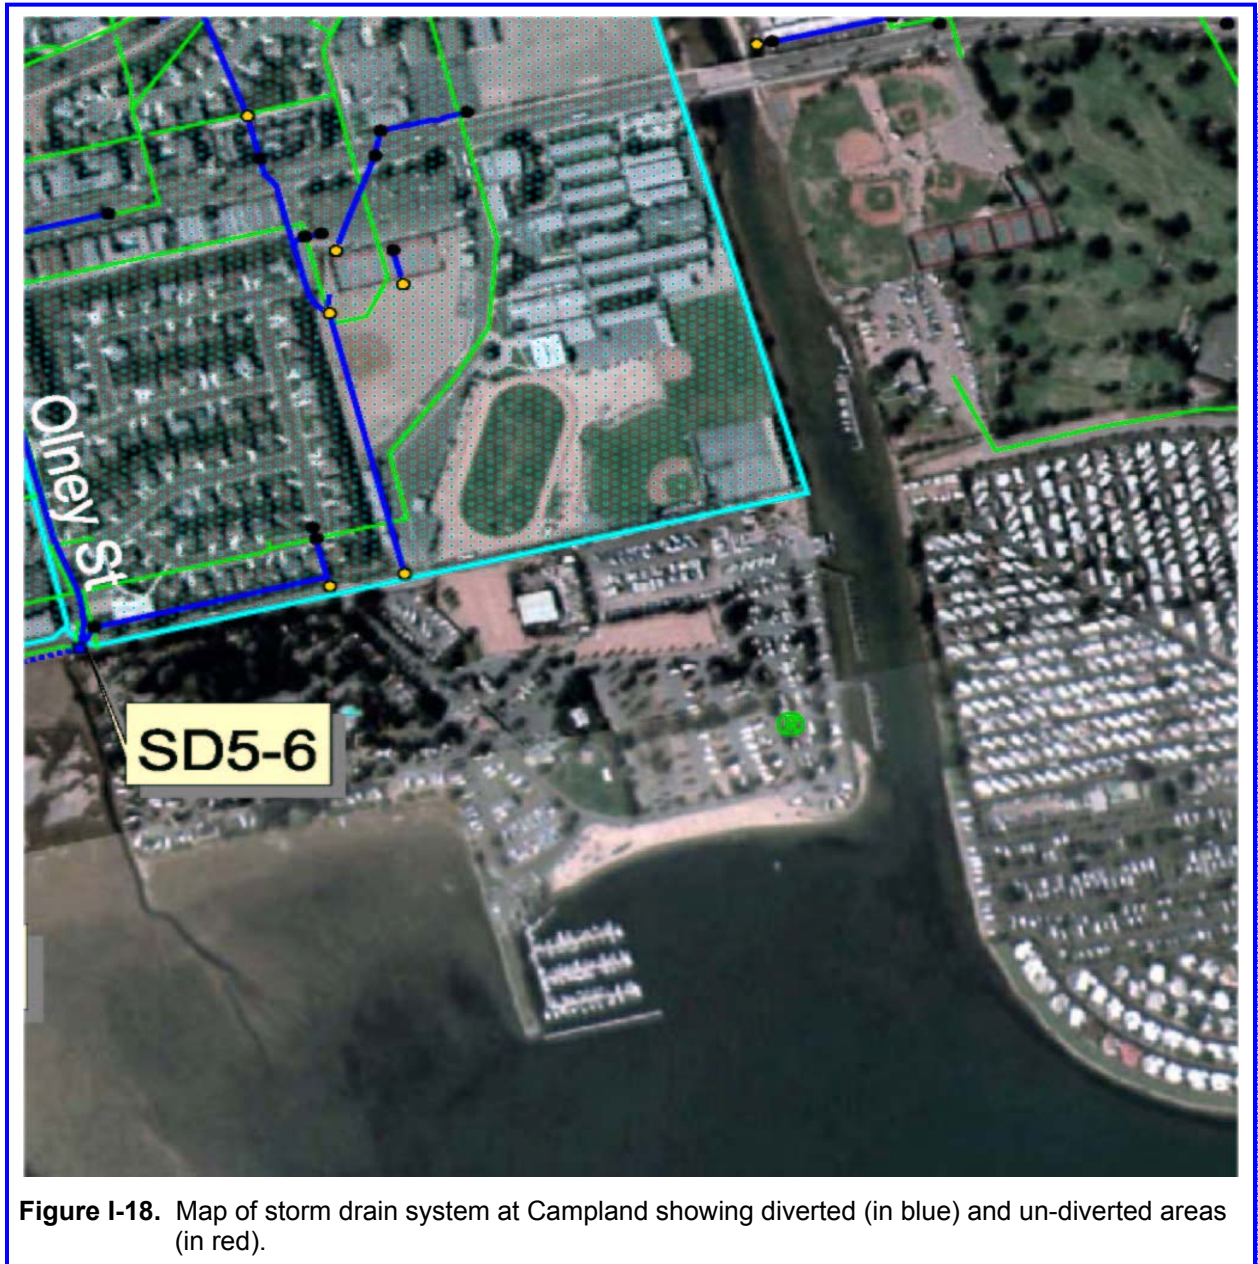
**Figure I-18.** Map of storm drain system at Campland showing diverted (in blue) and un-diverted areas (in red).

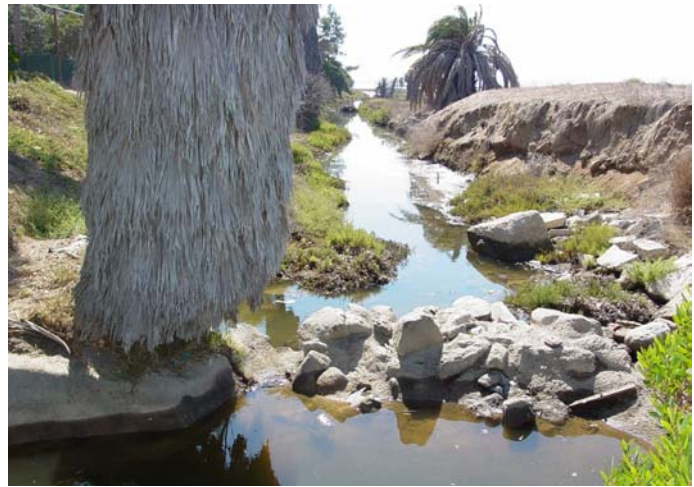
The first is located just west of the Campland property at the intersection of Olney Street and Pacific Beach Drive (SD5-6 in Figure I-19). It consists of two large culverts that discharge to a storm drain diversion box. Each culvert is supposed to contain a tide flex valve, however one of the storm drains is missing a tide flex and has been since at least November 11, 2002. It was recommended to the Streets Division that a tide flex be replaced at this site. Bacterial levels that exceeded AB411 criteria have been measured in the storm drain diversion box and from areas downstream. Dry weather flow from these storm drains is diverted to Interceptor Pump Station I-8, located

**Figure I-19.** Facing south of the storm drain outlet located at Olney Street and Pacific Beach Drive.

west of the storm drain at Pacific Beach Drive and Noyes Street. There are two manholes in the line that connects the storm drain with the diversion box. Both were completely flooded with stagnant water during the inspection, suggesting that the diversion system was not working properly. A second investigation was conducted on May 1, 2003. During this inspection it appeared that the clogged line had been cleared and that the storm drain conveyance system for I-8 was functioning properly.
