Mission Bay is an enclosed, recreational water body in San Diego, California that is used by twelve million people each year. Numerous recreational activities take place in Mission Bay, including swimming, diving, boating, fishing, kayaking, and water skiing. Water quality in the Bay has been monitored since the mid-1960s and exceedances of bacterial standards have been recorded from surface waters of the Bay since the early 1970s. Poor tidal flushing, contamination from storm drains, and periodic overflows from the City of San Diego sewage system were thought to be the primary causes of most of the bacterial problems in the Bay.

Figure 3. Map of Mission Bay showing infrastructure investigation sites.

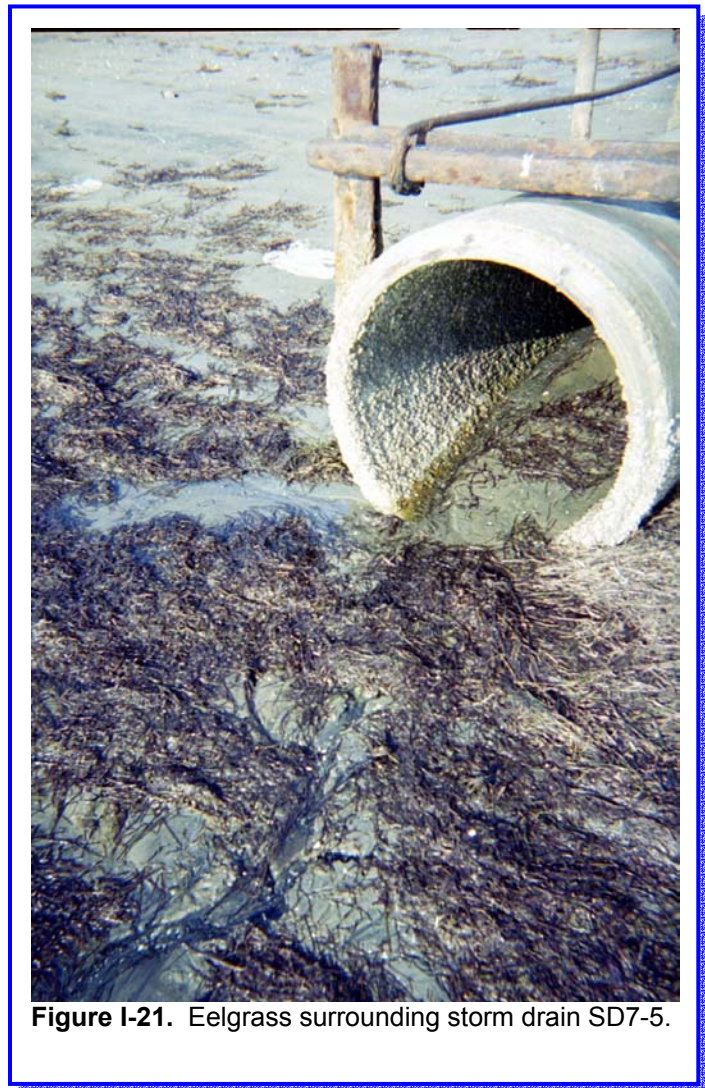
Figure I-21. Eelgrass surrounding storm drain SD7-5.

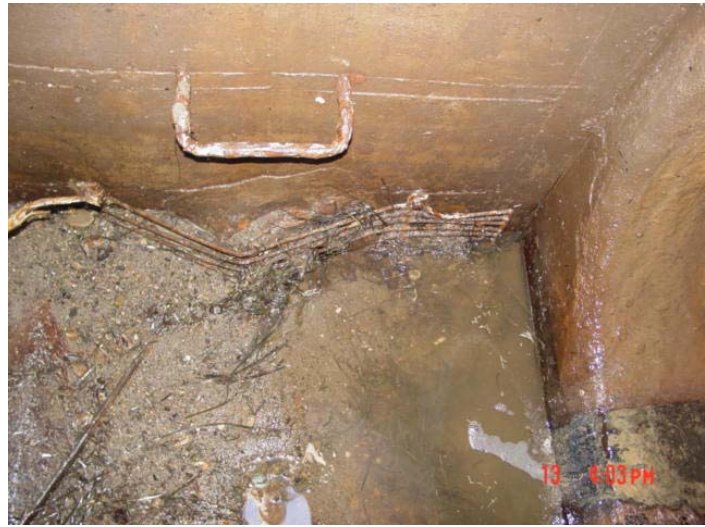
The diversion system at storm drains SD7-6 and SD7-8 also consist of a diversion box, a motorized plug valve, and a check valve. Diverted flow from these storm drains flows into Interceptor Pump Station I-5, which is located approximately half way in between the two storm drains on the west side of East Mission Bay Drive. The diversion boxes of both SD7-6 and SD7-8 were filled with sediment during the inspection and the check valves were propped open with debris (Figure I-22). It was apparent that during high tides a large volume of seawater was flowing up the storm drains, through the diversion boxes, and into Interceptor Pump Station I-5. Dry weather flows in these storm drains flow directly to the Bay when the diversion structure is filled with debris.

**Figure I-22.** Sediment and debris clogging the diversion rack at storm drain SD7-6.

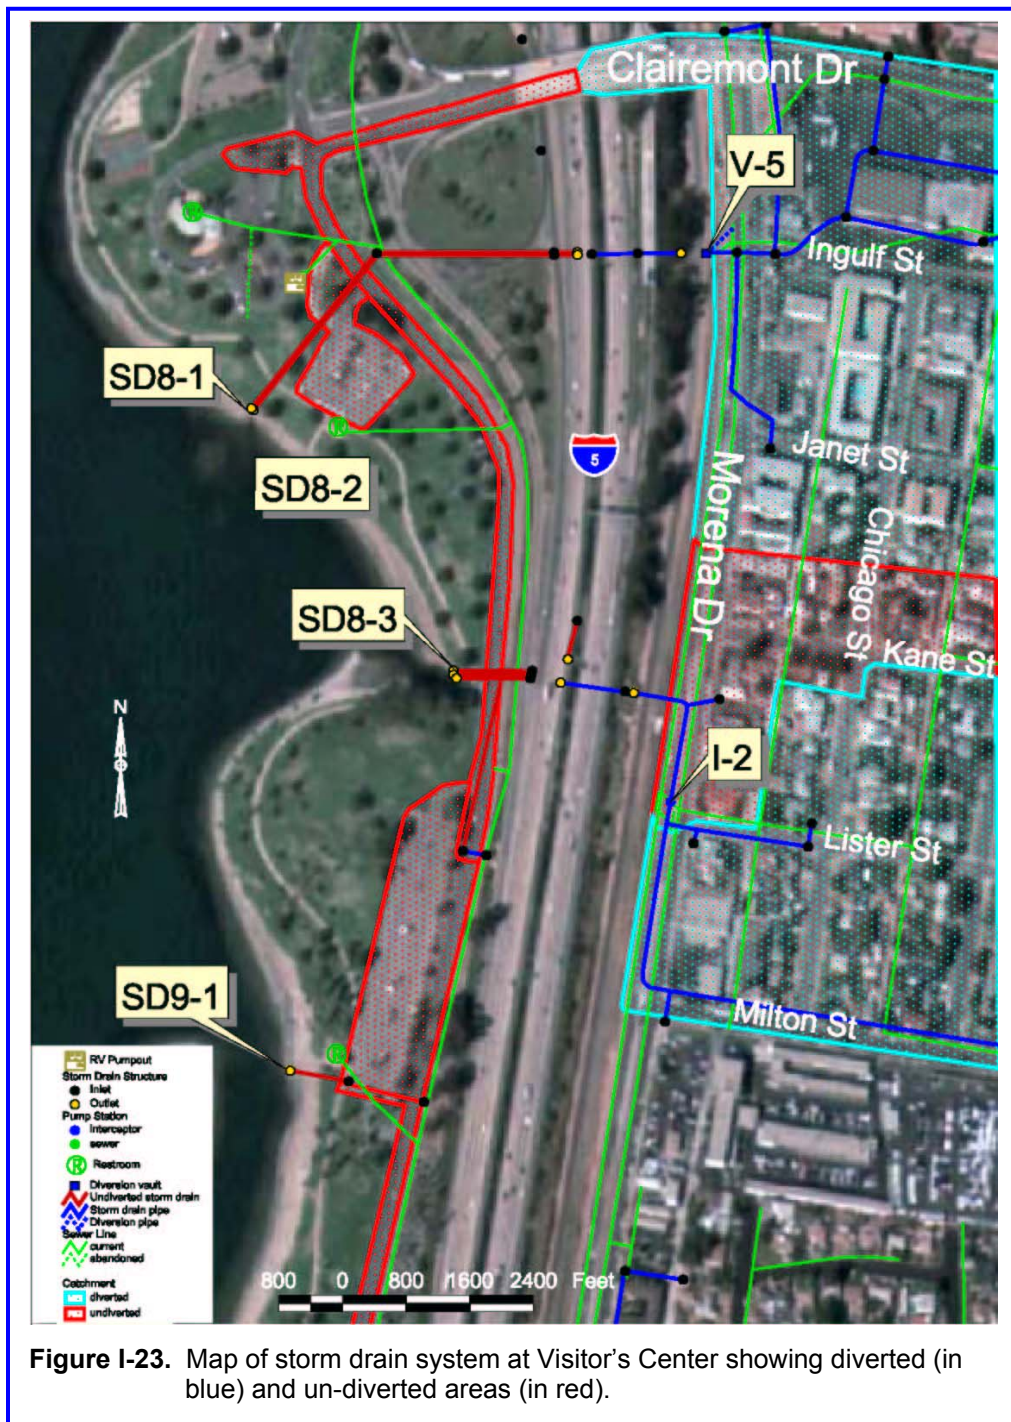
The first two storm drains (SD8-1 and SD8-2) are located just south of the Visitor's Center building (Figure I-24). SD8-1 is a 60-inch diameter reinforced concrete pipe (RCP). Although there are no maps currently available for the storm drains at Visitor's Center, SD8-1 is thought to originate on the east side of Interstate 5, west of the railroad tracks at Ingulf Street. East of the railroad tracks at Ingulf Street is Diversion Box V-2. The diversion box consists of an approximately 12-inch tall concrete berm that directs upstream flow to the sewer line by gravity. Above the diversion box, this storm drain conveys runoff from a large residential and commercial area on the east side of Interstate 5 north of Ingulf Street. All dry weather flow from this area should be diverted at diversion box V-2. Although the diversion box is not tidally influenced, directly downstream of the diversion and just east of the Interstate 5 off ramp at Clairemont Drive is a groundwater spring. There is perennial vegetation at this location and evidence of one homeless person encampment. During a site reconnaissance performed on January 16, 2003, the salinity of this water was measured at 3.6 parts per thousand (ppt), which is typical of freshwater. From here, the groundwater flows under Interstate 5 towards Mission Bay. It is not known if runoff from the Interstate enters storm drain SD8-1.

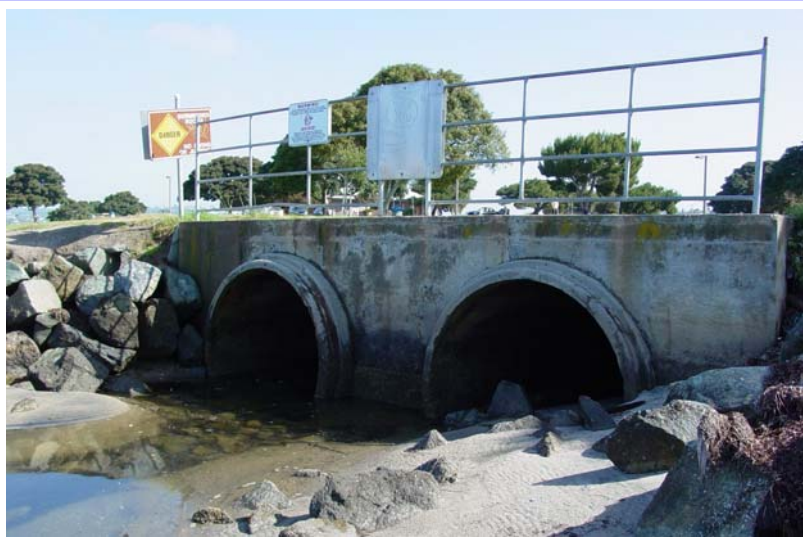
**Figure I-24.** Storm drains 8-1 (on left) and 8-2 (on right), located just south of the Visitor's Center building.

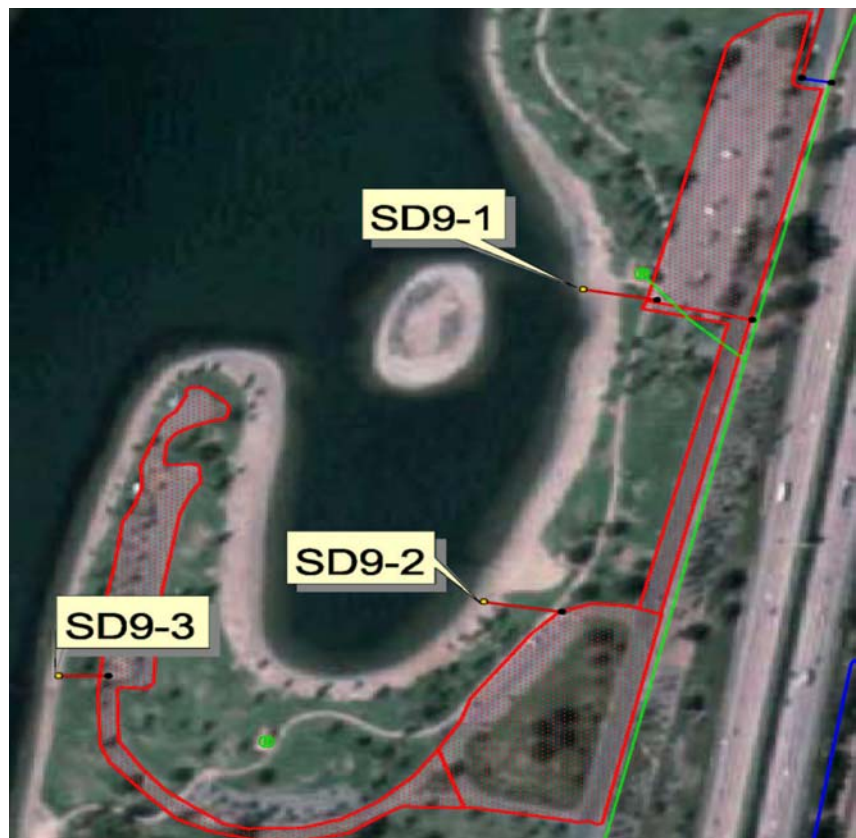
**Figure I-26.** Map of storm drain system at Leisure Lagoon showing diverted (in blue) and un-diverted areas (in red).

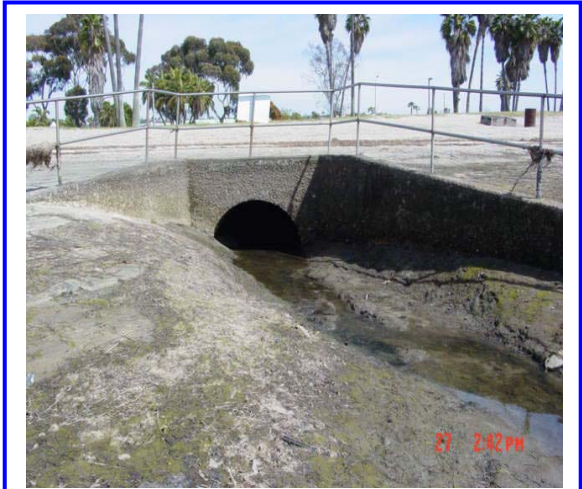
**Figure I-27.** Photograph of storm drain SD9-1 on the northeast side of Leisure Lagoon.

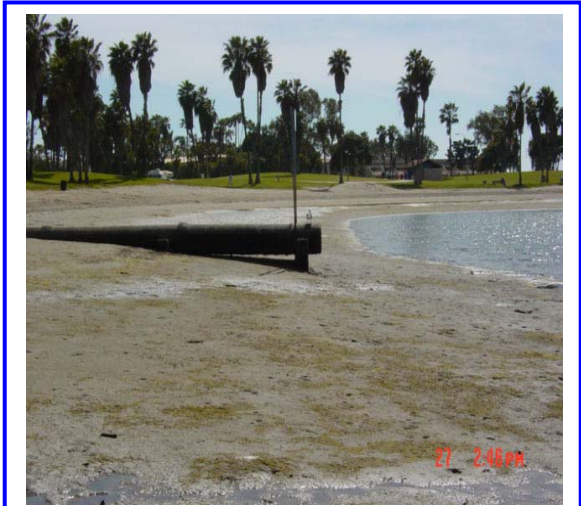
The County AB411 monitoring site is located directly in front of the southern-most storm drain, SD9-2 (Figure I-28). The drainage area of storm drain SD9-2 is small, encompassing a parking lot and grassy areas of the Park. It is not part of the MBSIS and directs runoff directly to the Bay. Enterococcus levels in samples taken from this storm drain during the Visual Observations Task were extremely variable, but ranged as high as 68,000 MPN/100 ml. The most likely source of the high concentrations is runoff from the grassy areas of the Park during irrigation. Only two samples were taken from the northern storm drain (SD9-1). Both had very low levels of all three bacterial indicators.

**Figure I-28.** Photograph of storm drain SD9-2 on the east side of Leisure Lagoon.

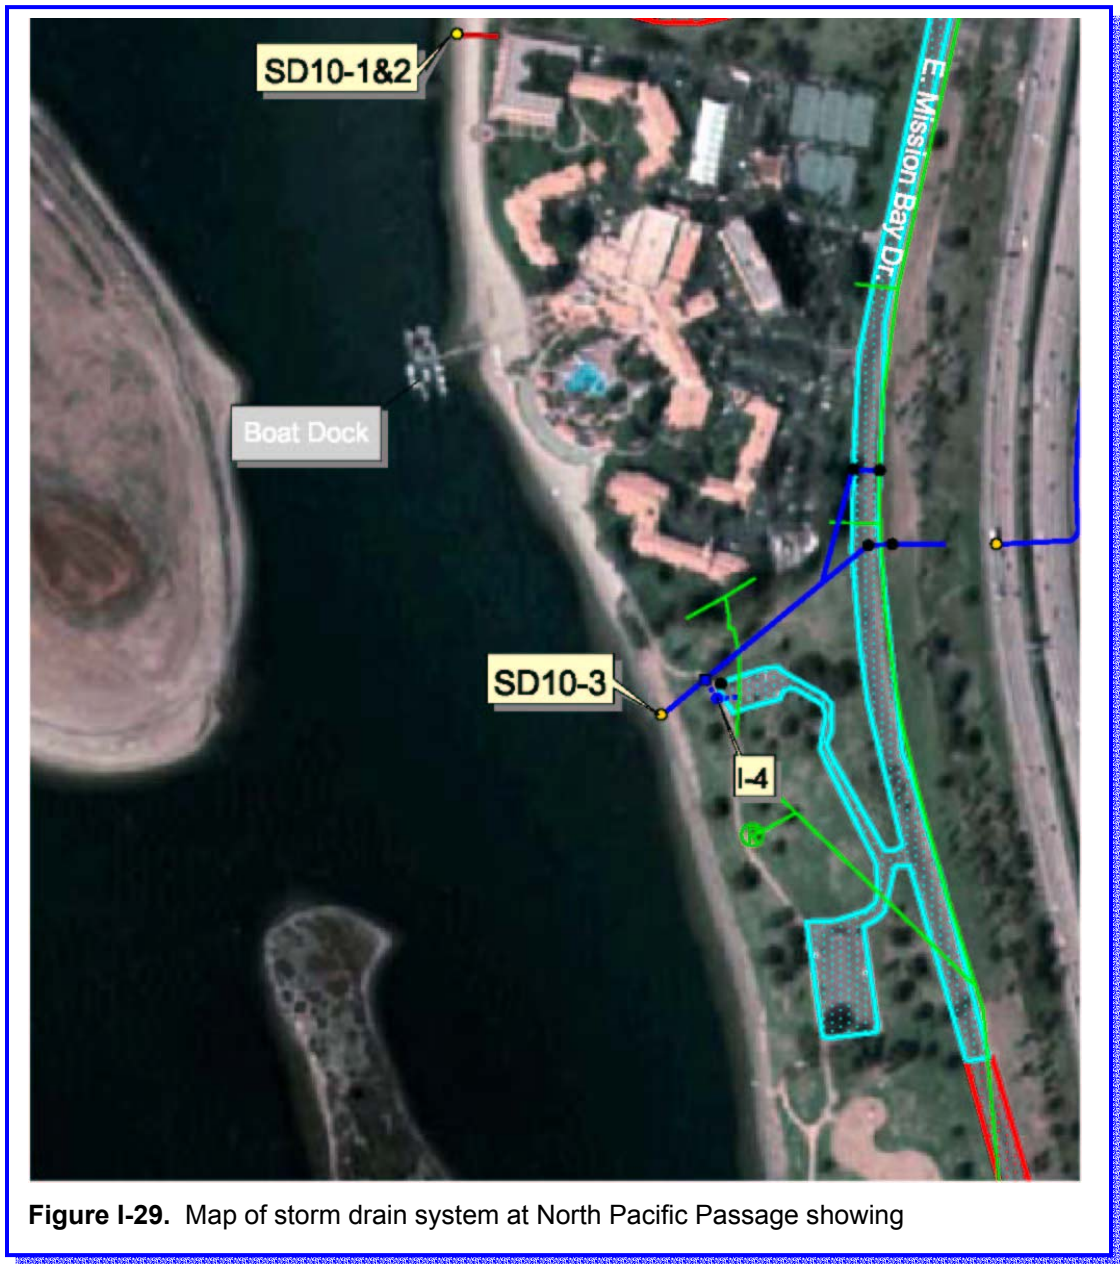
Figure I-29. Map of storm drain system at North Pacific Passage showing

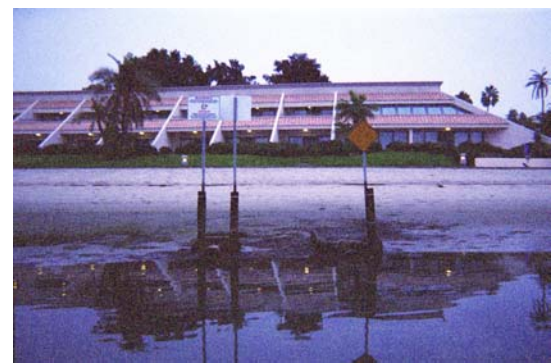
**Figure I-30.** Storm drain SD10-1 and SD10-2 at North Pacific Passage.

Storm drains SD10-1 and SD10-2 are located directly in front of the Hilton Hotel to the north of the Hilton boat ramp (Figure I-30). The County Department of Environmental Health AB411 sampling site is located directly in front of the discharge of these storm drains. The drainage area for both storm drains is small and is limited to portions of the Hilton Hotel property. Neither storm drain is part of the MBSIS. Elevated levels of enterococcus were recorded from samples taken from this storm drain during the Visual Observations Task. However, flow was always very limited.

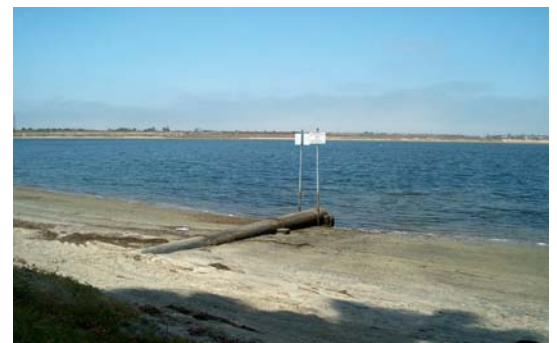
**Figure I-31.** Storm drains SD10-3 at North Pacific Passage.

The third storm drain at this site (SD10-3) is located just south of the Hilton Hotel west of East Mission Bay Drive (Figure I-31). The drainage area of the storm drain consists of portions of East Mission Bay Drive and two parking lots at the south end of Tecolote Shores. The diversion system consists of a diversion box, a check valve, and an Interceptor Pump Station. The system was assessed in March 2003. The diversion box was obviously tidally influenced, but at the time of the inspection it was free from debris. However, the check valve was propped open by a water bottle, allowing tidal water to enter the diversion system at high tide and dry weather flow to enter the Bay (Figure I-32). During the Visual Observations Task, a single sample was taken from this storm drain. The sample had an enterococcus concentration of over 14,000 MPN/100 ml. At the storm drain terminus, the beach had been eroded away.

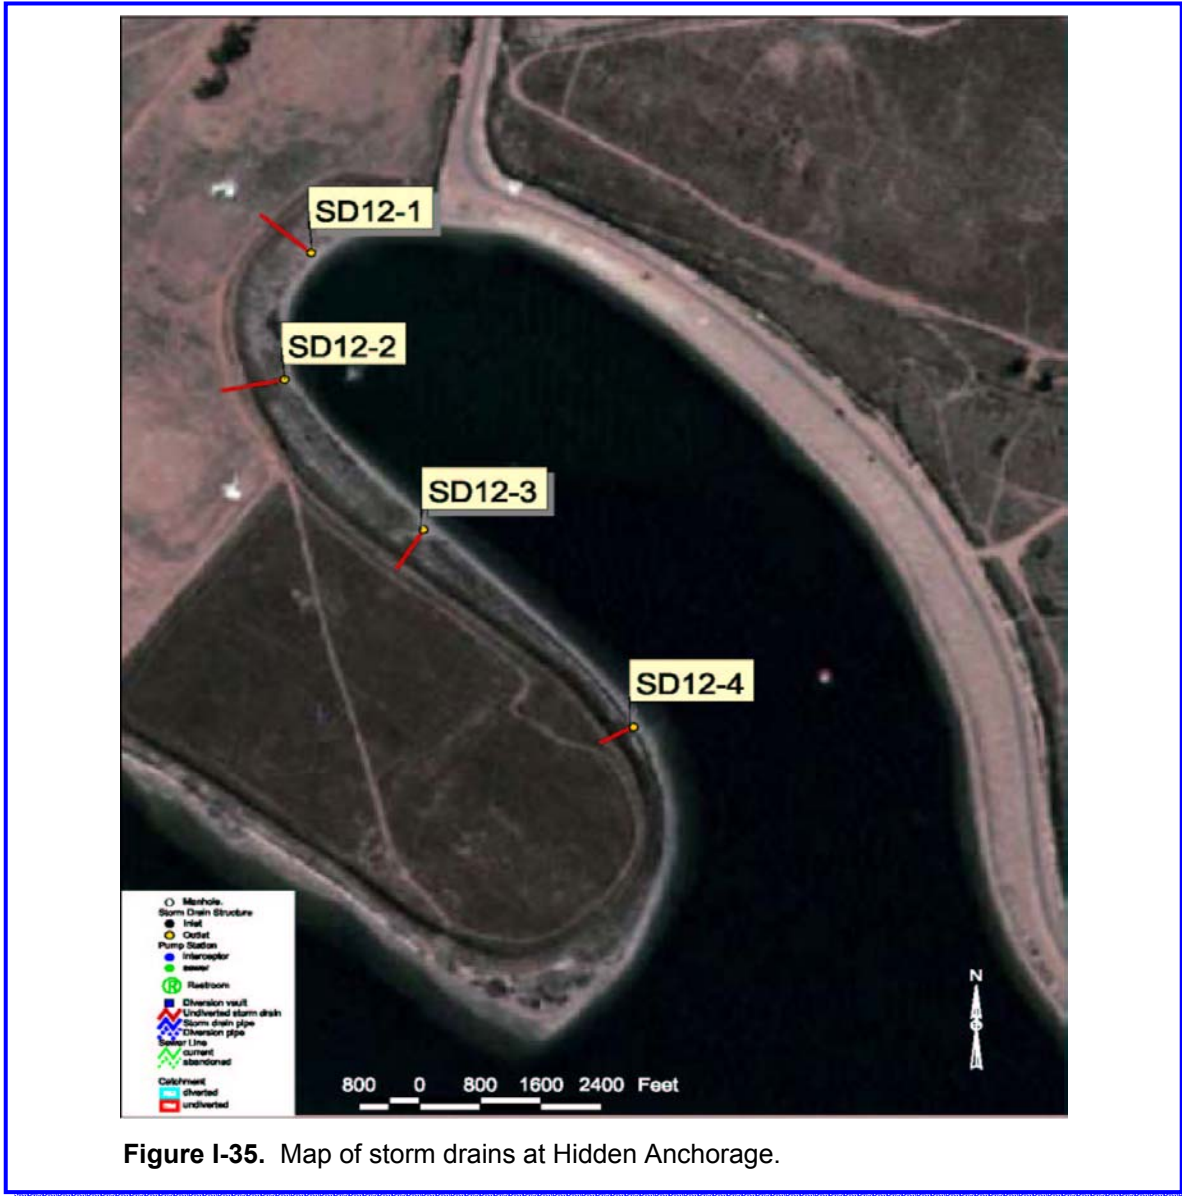
Figure I-35. Map of storm drains at Hidden Anchorage.

There are four storm drains that discharge to the Hidden Anchorage area (Figure I-35). All of them drain a large basin on the opposite side of a berm that surrounds the north and west sides of the site. None of the storm drains are diverted and none of them were flowing during the Visual Observations Task or the weekly monitoring. During rain events, these storm drains have the potential for impacting bacterial standards at Hidden Anchorage by delivering dog fecal matter from the basin to the receiving waters.

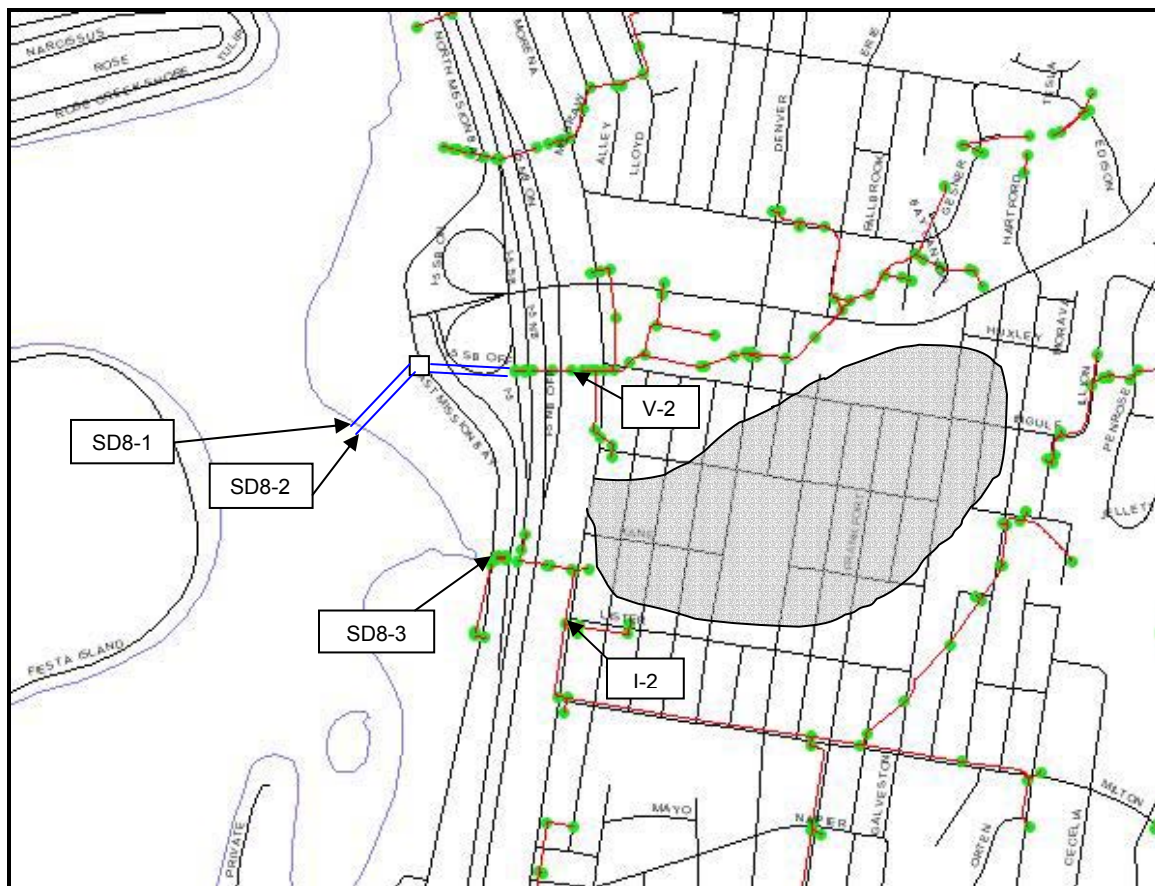
**Figure 1.** Map of the Visitor's Center Storm Drain System.

Green dots = storm drain inlets/manholes/junctions  
 Red lines = storm drain conveyance system  
 Blue lines = suspected storm drain conveyance system  
 Shaded area = undiverted area of watershed  
 V-2 = Diversion Box, Morena Blvd. and Ingulf Street  
 I-2 = Interceptor Pump Station, Morena Blvd. and Lister Street

Number	Latitude	Longitude	Terminus Diameter	Diversion Status <sup>1</sup>	Diversion Type	Drainage Description
SD8-1	32°47.312	117°12.574	60"	D; V-2	Berm in Diversion Box, gravity feed to sewer	large residential and commercial area on the east side of Interstate 5 north of Ingulf Street
SD8-2	32°47.313	117°12.571	60"	D; V-2	Berm in Diversion Box, gravity feed to sewer	unknown
SD8-3	32°47.219	117°12.485	48" x 72" triple box culvert	D; I-2	Berm in Diversion Box, pumped to sewer	Upstream: diverted dry weather flows from a large residential area south of Lister Street and east of Denver Street; also a small area between Morena Boulevard and Denver Street and between Jellet Street and Lister Street Downstream: undiverted surface flow from street drains along both sides of East Mission Bay Dr.; also undiverted flow from Interstate 5
