LOS PEÑASQUITOS LAGOON TMDL – WATERSHED PHASE I SEDIMENT SOURCE IDENTIFICATION STUDY

Final Report
June 2, 2009

Prepared For:
Storm Water Pollution Prevention Program
Storm Water Department
City of San Diego

**Weston Solutions, Inc.
2433 Impala Drive
Carlsbad, California 92010**

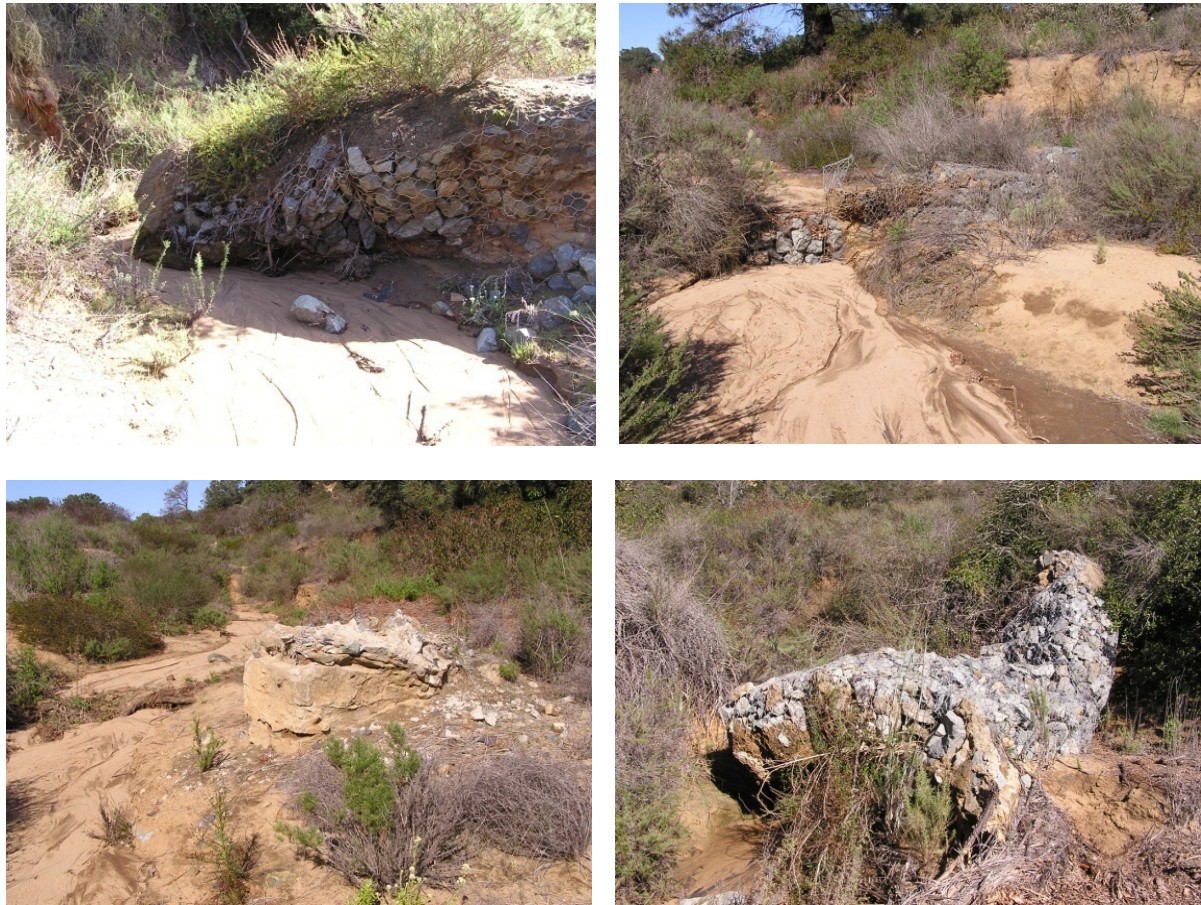
Figure 4-12. Failed Gabions within the Torrey Pines Reserve Extension

Approximately 15 gabion structures were constructed within the main gully in the late 1970s by State Parks to decrease storm runoff velocities and sediment transport. However, these structures have been only moderately successful in reducing peak flows due to the highly erosive nature of the soil types found in the Reserve Extension. In many cases, the structures have been bypassed as peak flows erode the banks of the gully, effectively circumventing the structures (Figure 4-12). Recent site inspections and surveys by State Parks staff and engineering consultants have led to the consideration of an alternative that would remove the gabions and replace them with native vegetation and an energy dissipater at the bottom of the gully. However, this alternative has not been developed to the conceptual level. Additional photos of this site are presented in Appendix C.

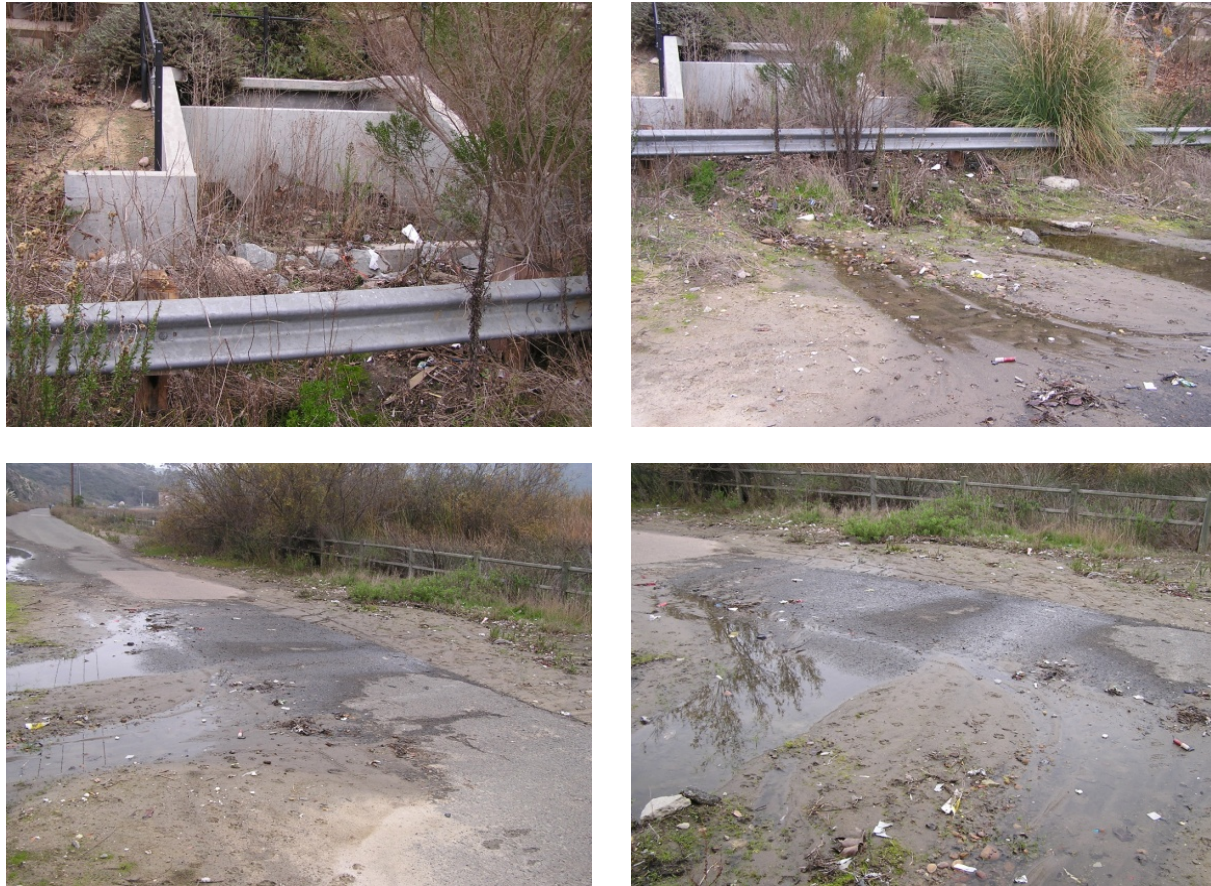
Figure 4-14. Caltrans Detention Device from I-5, Sorrento Valley Road

These structures are all within the Caltrans easement along Sorrento Valley Road and capture storm runoff from I-5 and consist primarily of small detention basins with energy dissipaters (Figure 4-13). Discussions with State Parks staff that work at the Torrey Pines State Reserve indicate that these structures are seldom if ever maintained by Caltrans. One such structure, shown in Figure 4-14, has been a chronic problem with regard to storm water discharges, sediment deposition, and trash commonly found along freeways.

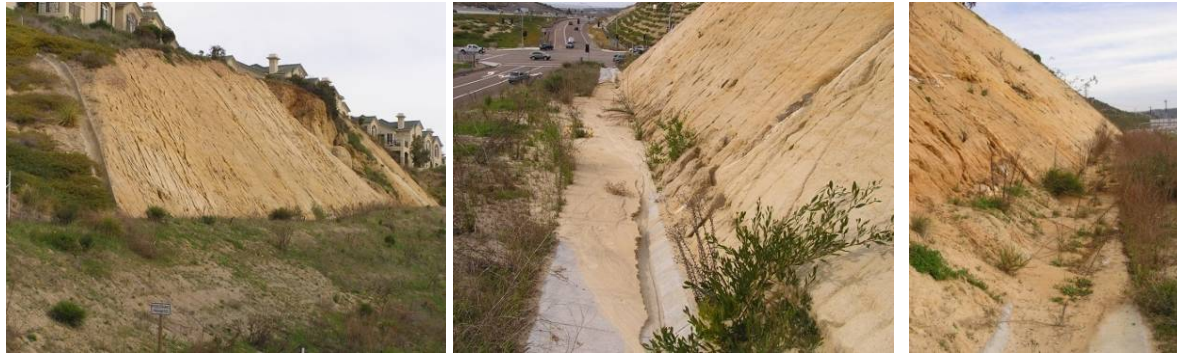
Figure 4-16. Erosion and Deposition below Torrey Villas Resort Apartments

Located along the eastern side of I-5, just south of Black Mountain Road, this area is located within a City-owned parcel (APN 3100402600) and consists of three steep, unvegetated areas just below the Torrey Villas Resort Apartments that reside on parcels owned by the Irvine Co. LLC (Figure 4-15). Field investigation of this location revealed that the northern exposures have been eroded by runoff potentially associated with storm runoff and/or irrigation of landscapes above the exposures. Inspection of the brow ditches, culverts, and detention basins revealed considerable sediment deposition (Figure 4-16), though not to the magnitude of other potential sources within the watershed. However, the highly visible nature of this location and proximity to Carroll Canyon Creek might make this effort appealing to the City with regard to its sediment abatement efforts.

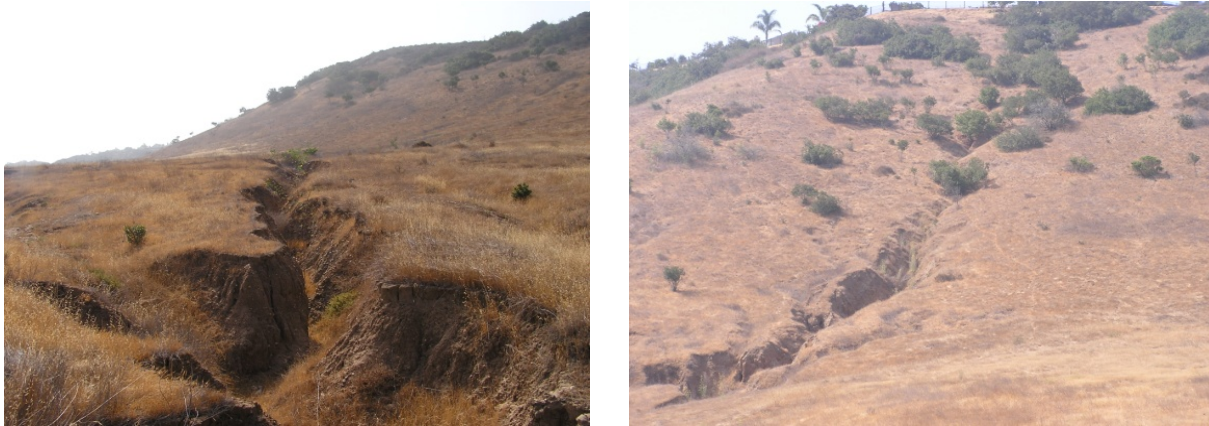
Figure 4-18. Examples of Erosion (i.e., gullies) within Los Peñasquitos Subwatershed

Prior to the implementation of El Cuervo Norte in 2005, the LPLF conducted visual surveys of Los Peñasquitos subwatershed that included both Los Peñasquitos Canyon and Lopez Canyon (Hastings, 2004). These surveys were conducted to find potential sources of sediment within this subwatershed to facilitate future restoration efforts designed to control sediment at its source. Figure 4-18 provides some examples of erosion within the Los Peñasquitos subwatershed and Figure 4-19 provides a summary of these efforts with additional photos provided in Appendix D.

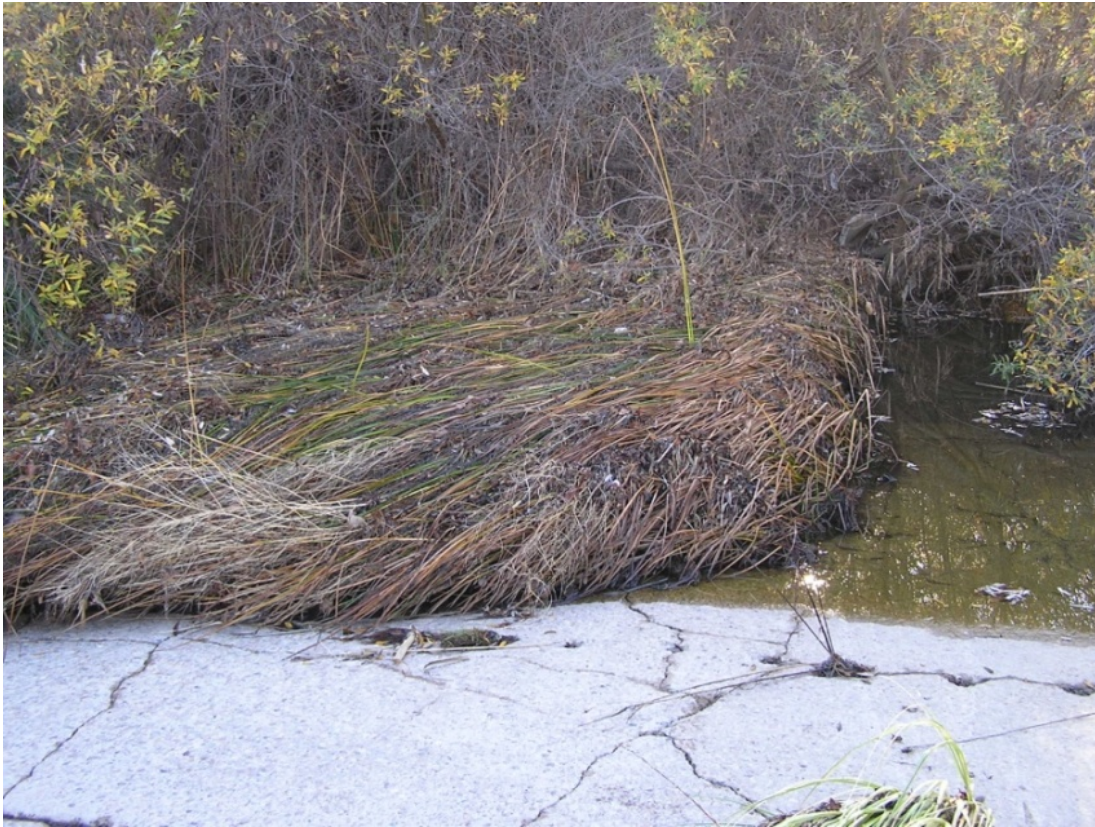
Figure 4-22. East of Site A

Carroll Canyon Creek is the main tributary within the Carroll Canyon subwatershed. As it enters the lower portion of Carroll Canyon, it transforms from an earthen channel with vegetation in the creek bed to a cement channel designed for flood control. The cement section runs for about 0.5 mile and then reverts to an earthen channel just before the confluence with Los Peñasquitos Creek (Figure 4-21). This short section of cement channel appears to increase the sediment transport capacity within the creek based upon sediment deposition characteristics observed on-site during field investigations. As the channel transitions to cement, vegetation bends in the direction of the creek's flow and the cement channel is clearly visible, indicating that flow velocity at this location has increased to prevent sediment deposition (Figure 4-22).

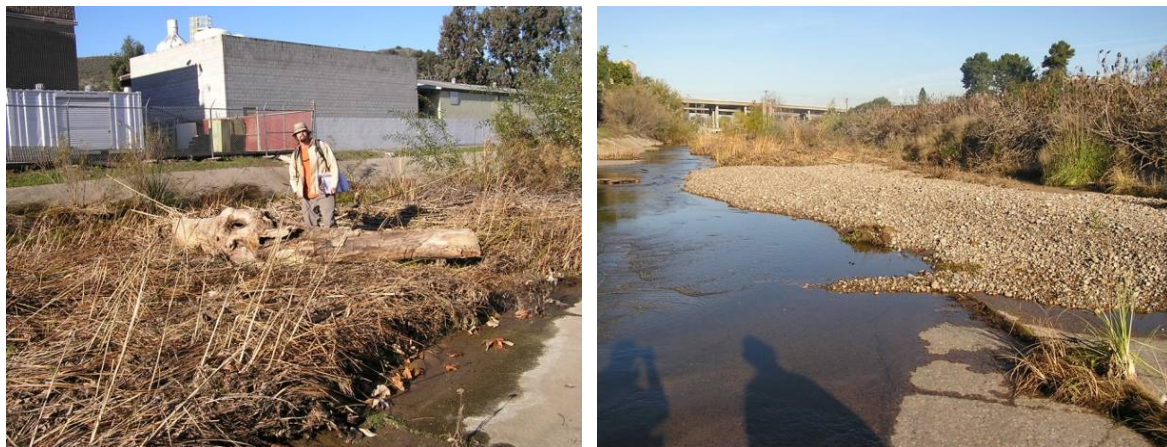
Figure 4-23. Site B

Just downstream of this location, islands of vegetation, large cobbles, and debris were present, indicating that flow velocity had decreased somewhat to allow for some deposition, but flows still had enough velocity to strip the channel down to its cement foundation (Figure 4-23).

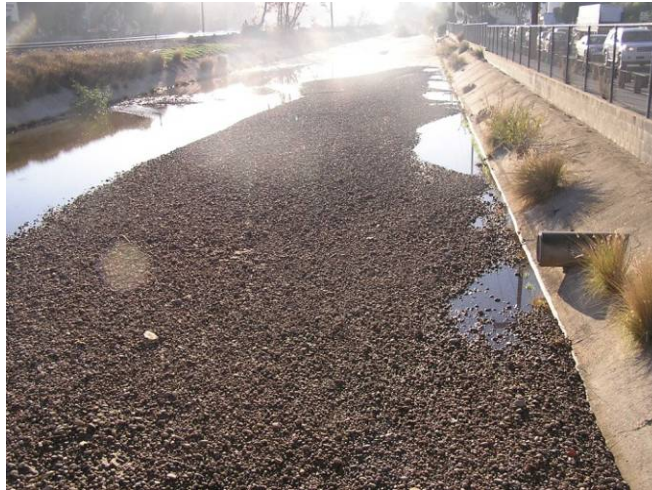
Figure 4-24. Site C

Moving farther downstream, the cement channel is barely visible due to the deposition of smaller sized cobbles, indicating that flow velocities are still decreasing slightly, but not enough for the finer sediments that are being carried downstream toward LPL (Figure 4-24 photos from C).

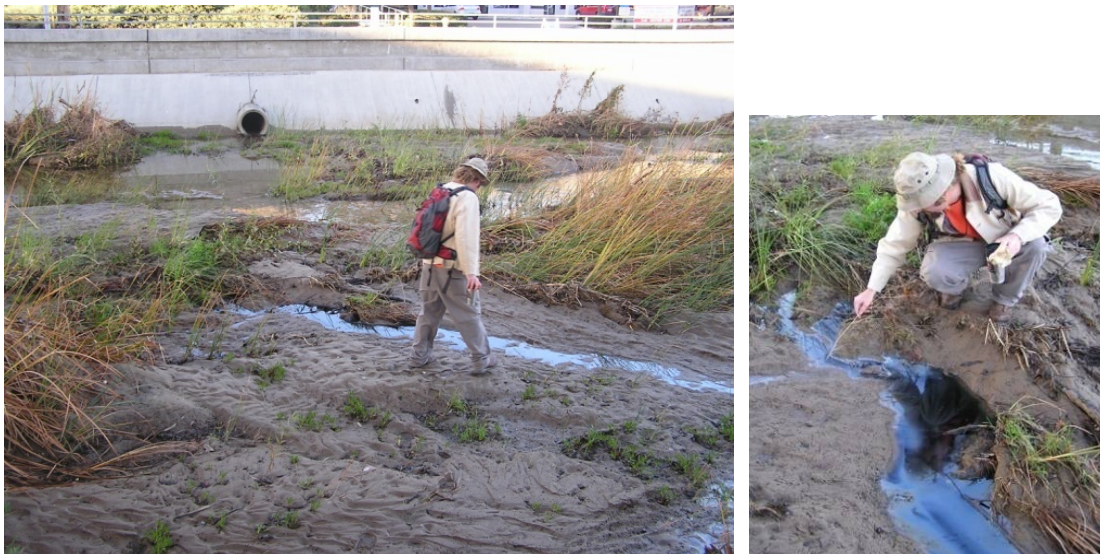
Figure 4-25. Site D

As the cement channel crosses under I-5, sediment deposition of finer grains and light vegetation establishment was evident (Figure 4-25), indicating that flow velocity has decreased, quite possibly due to the end of the cement channel and the transition back to a vegetated channel downstream.

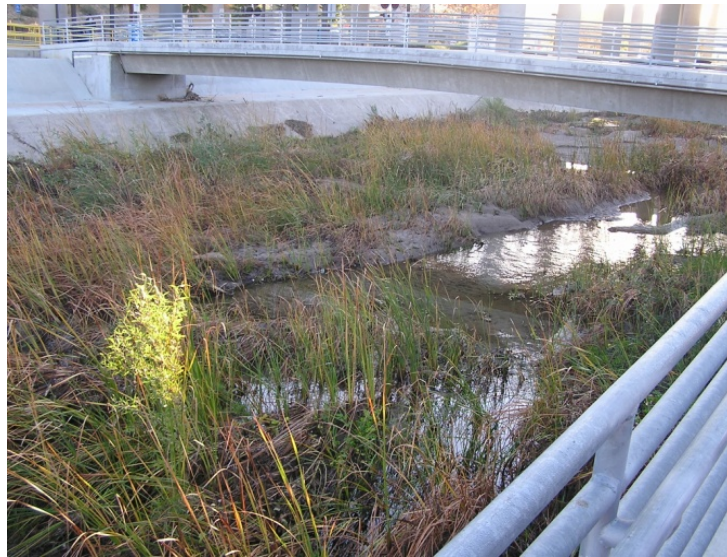
Figure 4-26. Site E

Just downstream of this site and near the Sorrento Valley Coaster Railway Station, vegetation becomes reestablished within the creek bed (Figure 4-26). While this indicates a further decrease in flow velocity within the creek, evidence of wrack washed up on an access ramp (Figure 4-27) shows that flow velocity is still prominent before it leaves the cement channel and enters the lagoon approximately 0.4 mile downstream.

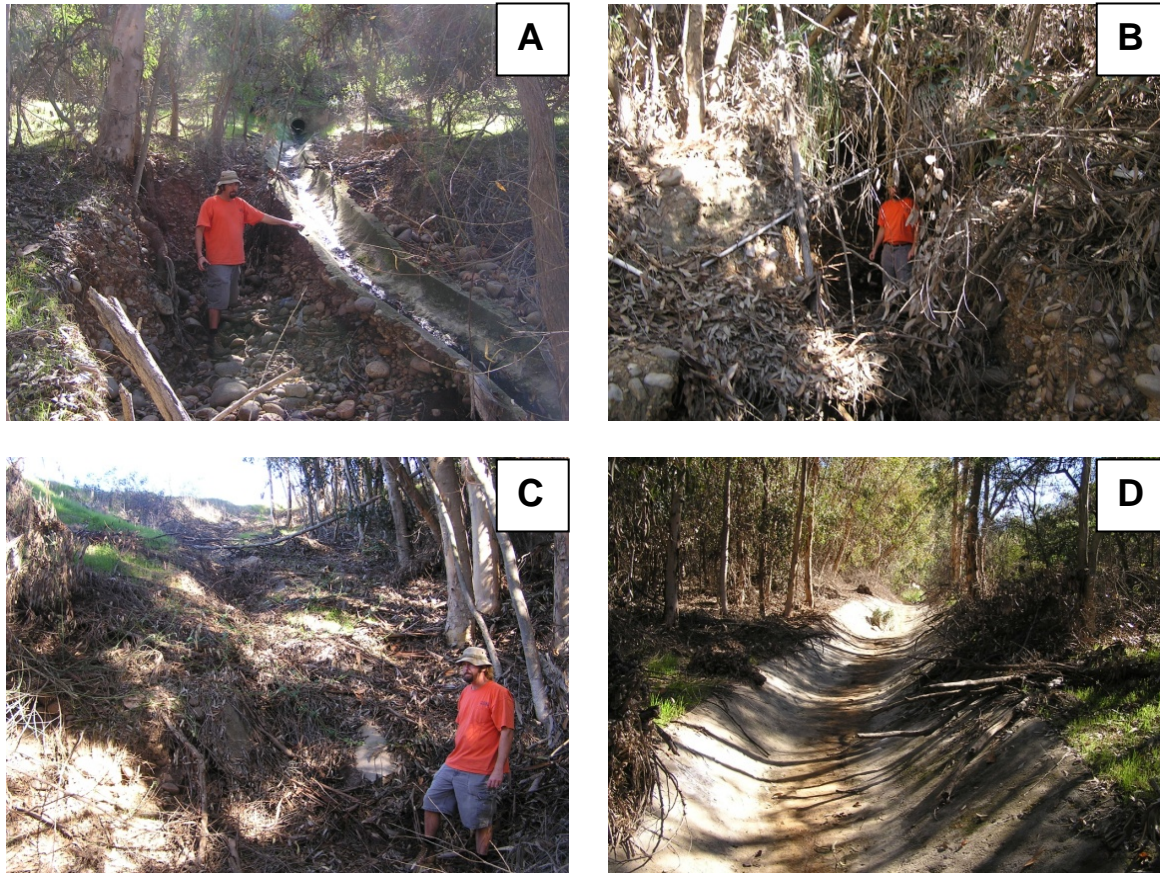
Figure 4-29. Photos of Brow Ditches in Trade Canyon

- Evidence of Multiple Pollutants. Investigation of this site revealed both the presence and potential for multiple pollutants. Trash, oil, and nutrient loading were observed immediately below the outfall. Bacteria and vector (mosquito larvae) should also be considered because the main outfall contained deep impoundments of water, which were also present downstream of the outfall. Furthermore, an illicit discharge down one of the cement brow ditches, potentially from one of the Trepte Industrial Properties, was observed during the site inspection (Figure 4-29 A).

- X factor. This site scored high under this criterion in order to account for the degraded structural integrity of the brow ditches leading to this drainage, creating the potential to offset deferred maintenance costs. Furthermore, 11 businesses within the drainage area of this MS4 are defined as potentially high- and medium-priority threats to water quality due to sediment under JURMP and WURMP inspection programs (Figure 4-31).

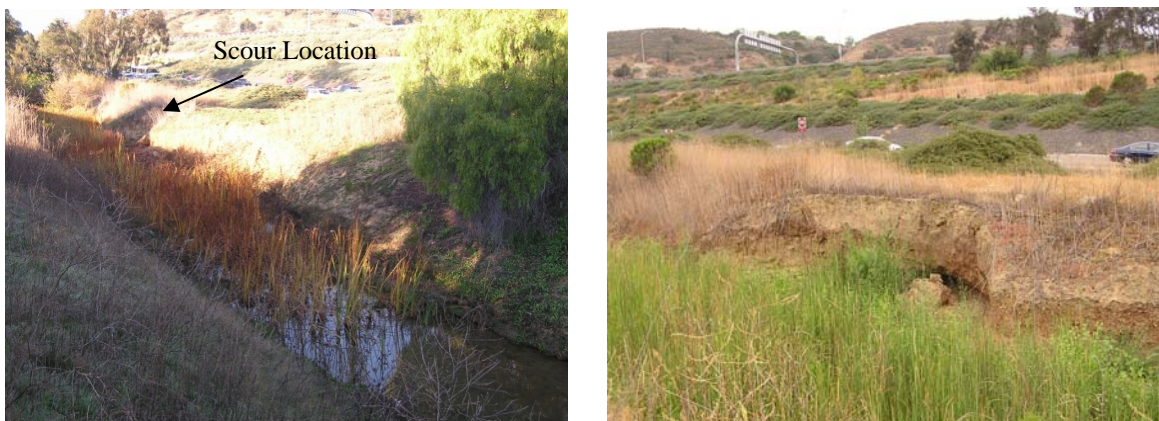
Figure 4-36. Photos of Drainage and Scour in the Lower Drainage

- Evidence of Scouring. Slumping of the channel bank in the lower portion of the drainage was observed approximately 165 ft from the outfall located at Carroll Canyon Creek. Access to higher portions of the drainage was not possible due to thick vegetation and constrained access along a heavily used road (I-5 off ramp) (Figure 4-36).

Before further development of the structural BMP for this location is pursued, three important issues that face this site may need to be explored: landownership, correcting the MS4 map provided by SanGIS, and the potential for multiple pollutants.

Currently, the lower portion of the drainage that is suitable for a structural BMP for this site is within the Caltrans right of way as it borders I-5 and an off-ramp from I-5 to Roselle Street (Figure 4-37 and Figure 4-38). Coordination and/or negotiation with Caltrans may be necessary if a BMP is to be implemented at this location to determine whether easements could be expanded for construction and maintenance needs and the potential for increased vulnerability of the nearby roadways, which includes a freeway off-ramp, to flooding and/or undercutting.

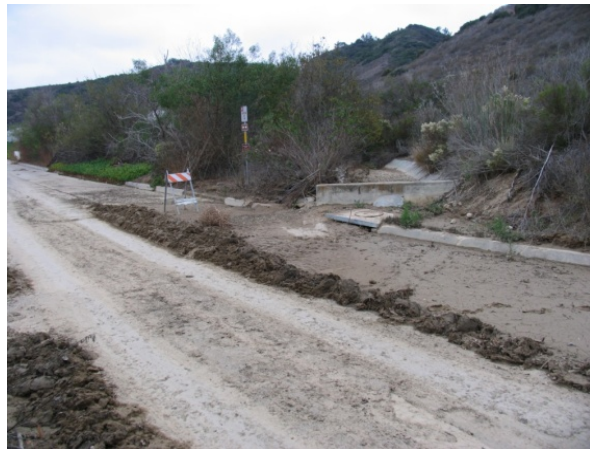
Figure 4-41. Photos of Deposition on Flintkote Avenue

- *X-factor.* This site ranked high under this criterion for the following reasons: 1) Its proximity to LPL; 2) it drains an area with five businesses identified by JURMP and WURMP inspection programs as potentially high threats to water quality for sediment; and 3) it presents a safety and access issue because the road is blocked even during minor rain events.

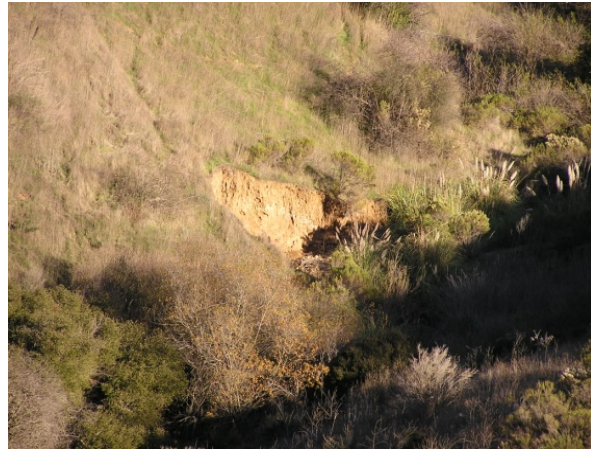
Figure 4-44. Evidence of Scour in the Drainage below the Autoport Mall Outfall

- ***Evidence of Scouring.*** While the area around the outfall was heavily vegetated and exhibited indications of high-energy flows (e.g., bent vegetation, trash deposited in upper tree branches), there did not exist evidence of heavy scouring immediately below this outfall (Figure 4-44). However, there were signs of large areas of cutting in the lower portion of the drainage, which could be the result of high-energy flows caused by water moving down the steep grade of this drainage.

- X-factor. While there was not a great deal of scour evident near the outfall (note, this area was choked with vegetation), signs of large slumping of the drainage banks (see photos) were evident downstream. Since soil types are not highly erosive in this drainage (K-factor of .02-0.1), the evidence of scour indicates that this drainage experiences high-energy flows during storm events and/or erosion within the drainage is a function of the steep grade as shown in Figure 4-43.

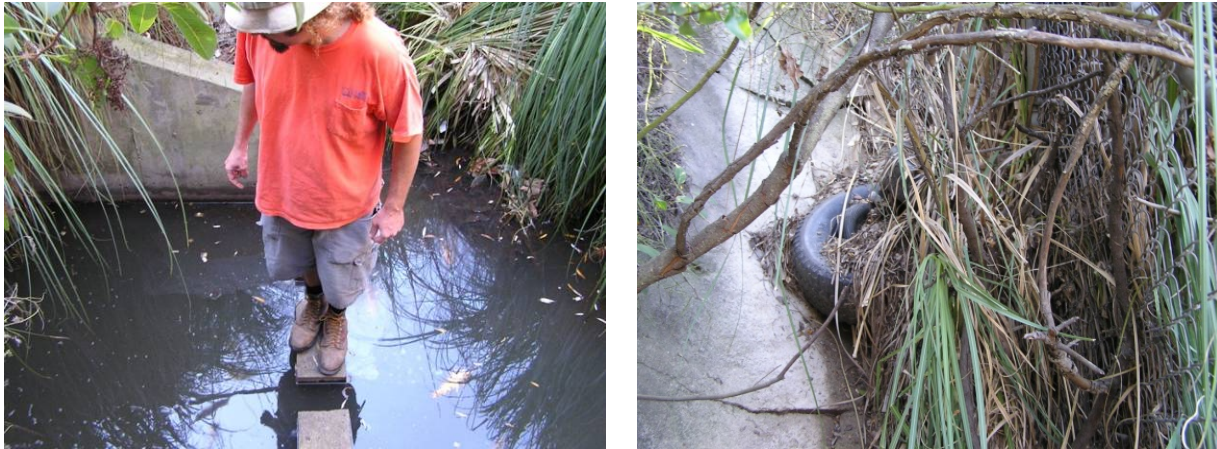
Figure 4-47. Photos of Potential Multiple Pollutants and Trash at the Outfall

- Evidence of Multiple Pollutants. Brow ditches choked with cobble, broken concrete, and assorted trash (appears to be a minor dump site). This outfall is also located below several automotive shops, which could contribute to polluted runoff to this drainage (Figure 4-46 and Figure 4-47). Furthermore, this outfall has been identified during dry-weather sampling programs as a location with high levels of turbidity, bacteria and other pollutants.

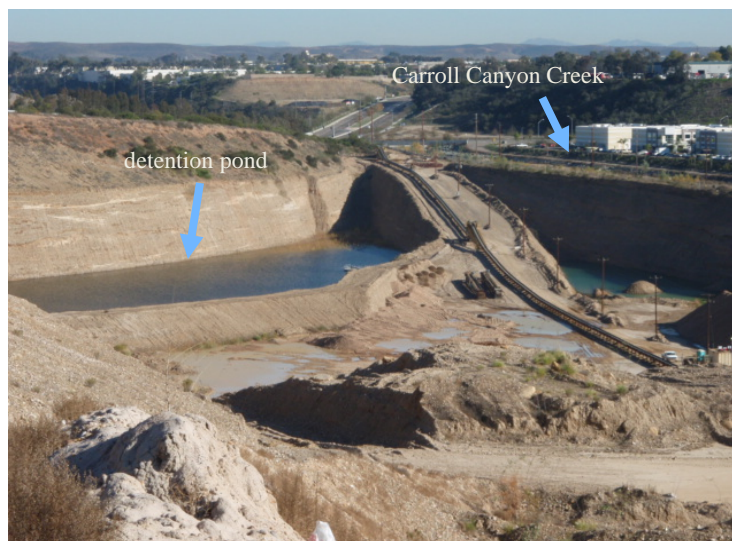
Figure 4-58. Mining Operations at Vulcan's Carroll Canyon Facility

Inspection of the Vulcan Facility revealed that this site would probably not contribute significantly to sediment loading into Carroll Canyon Creek. Structural BMPs designed to reduce runoff to Carroll Canyon Creek and control dust (e.g., rumble strips) appeared intact and well maintained. Furthermore, it appears that the facility's mining operations and detention ponds occur in areas that are below the creek bed, which would prevent runoff from these sites from entering Carroll Canyon Creek (Figure 4-58).

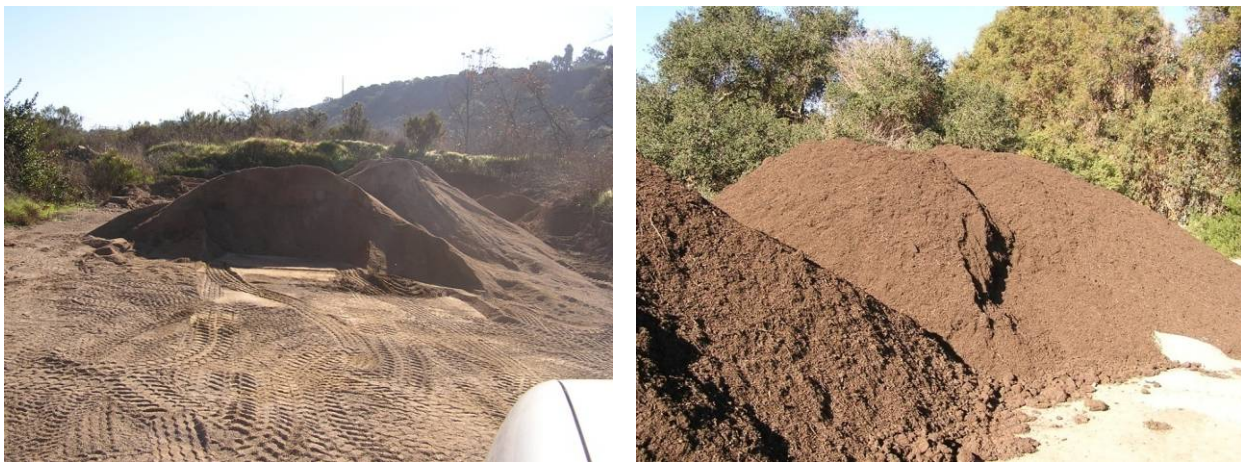
Figure 4-59. Sediment Stockpiles near Carroll Canyon Creek

Located off of Carroll Road, the El Camino Memorial Cemetery was identified as a potentially high threat to water quality by the City under its JURMP and WURMP. Overall, this land use activity did not appear to present threats to Carroll Canyon Creek with regard to sediment. The property appeared to be well vegetated in that there were no visible areas of exposed sediment other than from grave excavation and sediment stockpiles. While the sediment stockpiles, used for fill material at the cemetery, located near Carroll Canyon Creek lacked silt fencing or other temporary devices used to contain runoff during storm events at the time of inspection, an earthen berm located between the sediment piles and the creek seemed to be providing adequate water quality protection (Figure 4-59).

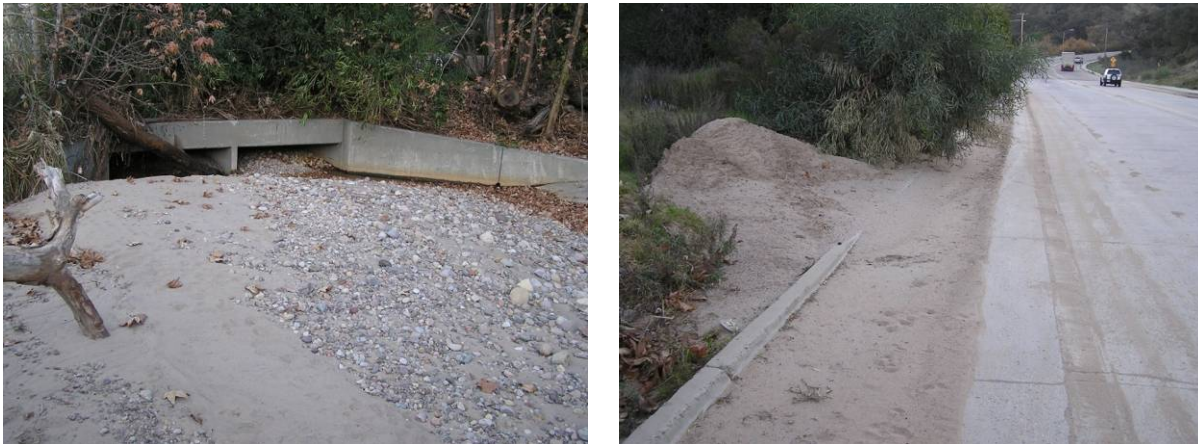
Figure 4-63. Sediment Deposition within the Culvert and along Carroll Road

The Carroll Road Culvert (Figure 4-61) presents an opportunity to remove loads of sediment at a relatively low cost while protecting infrastructure from flooding and sediment deposition. Should the City need to meet TMDL load reductions in the future, this site could provide quantifiable reductions of sediment loads. As shown in Figure 4-63 and Figure 4-64, this location is susceptible to flooding, most likely attributed to the heavy deposition of sediment, including cobble and debris. The investigation of this site revealed that the culvert was almost entirely blocked by sediment and debris, as well as sediment deposition on Carroll Road.
