## AIRPORTS DIVISION

### MONTGOMERY FIELD AIRPORT

### RUNWAY SAFETY PROGRAM

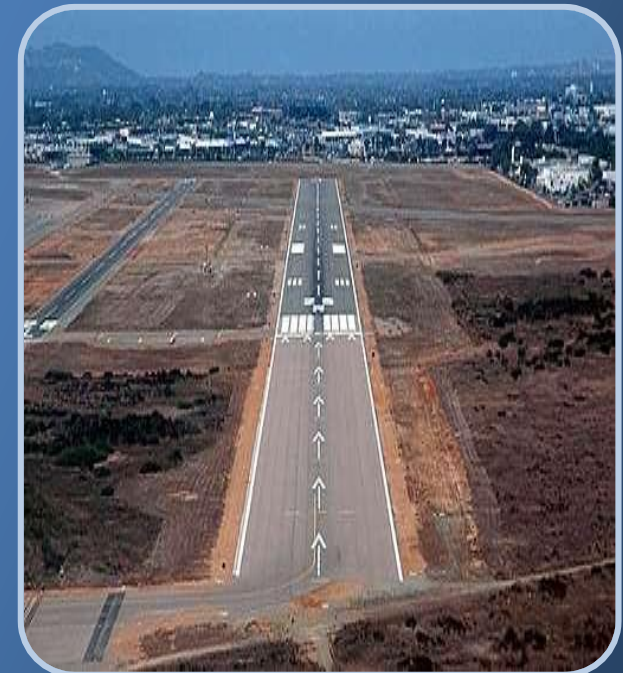
## Airport Markings

**HOLDING POSITION:**  
Hold Short of Intersecting Rwy  
Also Land and Hold Short Marking

**ILS CRITICAL AREA:**  
Hold Short During IMC  
Conditions

**TAXIWAY/TAXIWAY HOLDING POSITION:** Hold Short of Intersecting Taxiway When Directed by ATC

**MOVEMENT AREA BOUNDARY:** Defines Boundary of Movement Area and Non-Movement Area

**TAXIWAY EDGE:** Defines Edge of Usable Full Strength Taxiway Pavement. Adjoining Pavement NOT Usable

**DASHED TAXIWAY EDGE:** Defines Edge Taxiway Where Adjoining Pavement or Apron IS Available for Taxi

**SURFACE PAINTED HOLDING POSITION:** Hold Short of Intersecting Runway on Twy

**SURFACE PAINTED TAXIWAY DIRECTION:** Direction & Designation of Intersecting Twy

**SURFACE PAINTED TAXIWAY LOCATION:** Identifies Twy on Which Aircraft is Located
