## **Appendix B** **U.S. Secretary of the Interior's Standards**

# Standards for Rehabilitation & Guidelines for Rehabilitating Historic Buildings

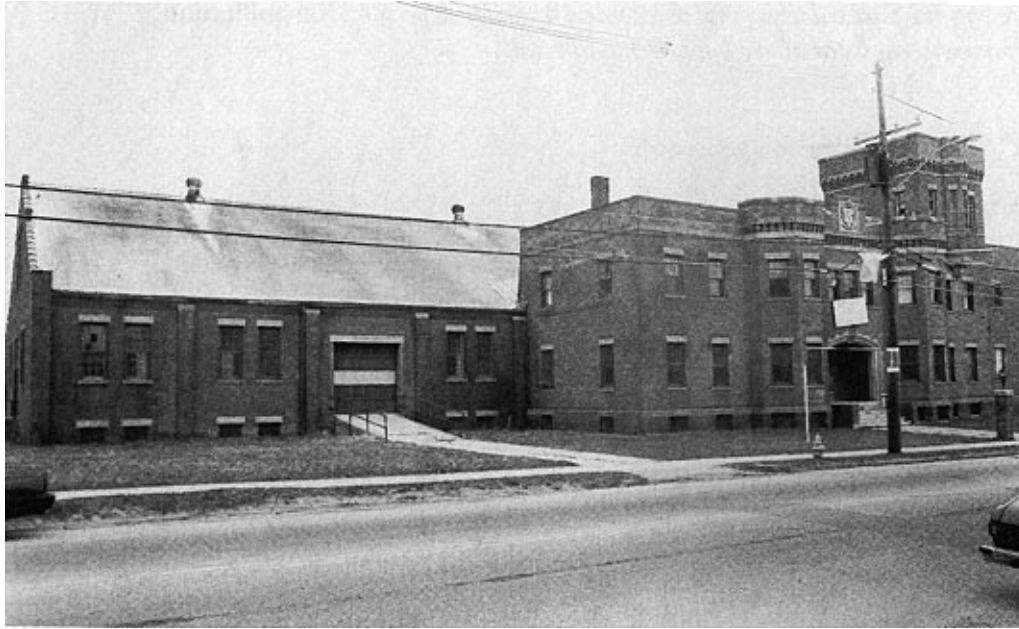
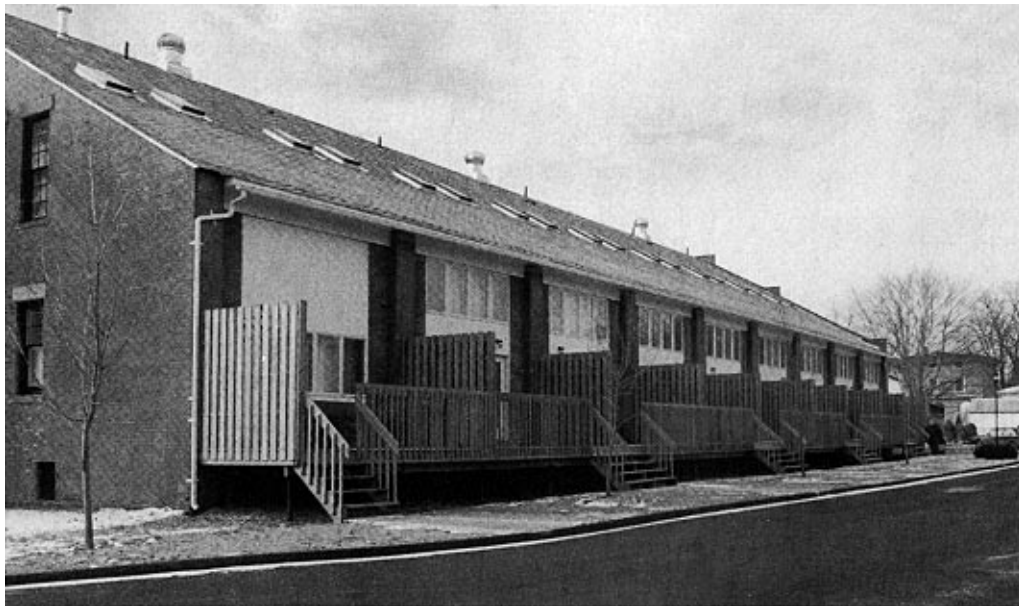
*(a) An armory complex was rehabilitated for rental housing. (b) This view of the rear elevation shows the paired, nine-over-nine wood sash windows and high sills that characterized the building. (c) After inappropriate rehabilitation work, the same rear elevation is shown with new skylights added to the roof, prefabricated panels filling the former brick areas, and new wood decks and privacy fences. Because the work changed the historic character, the project did not meet the Standards.*

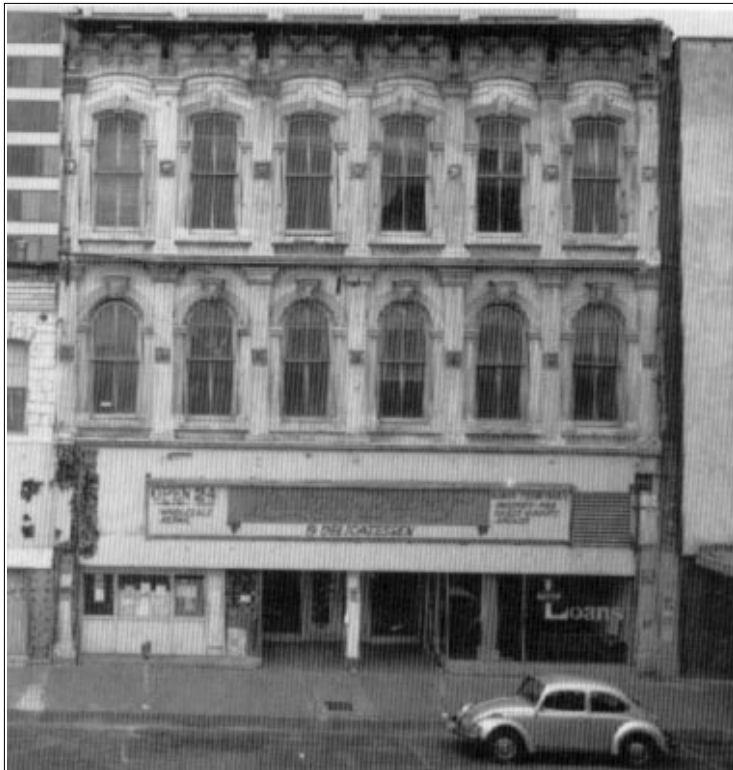
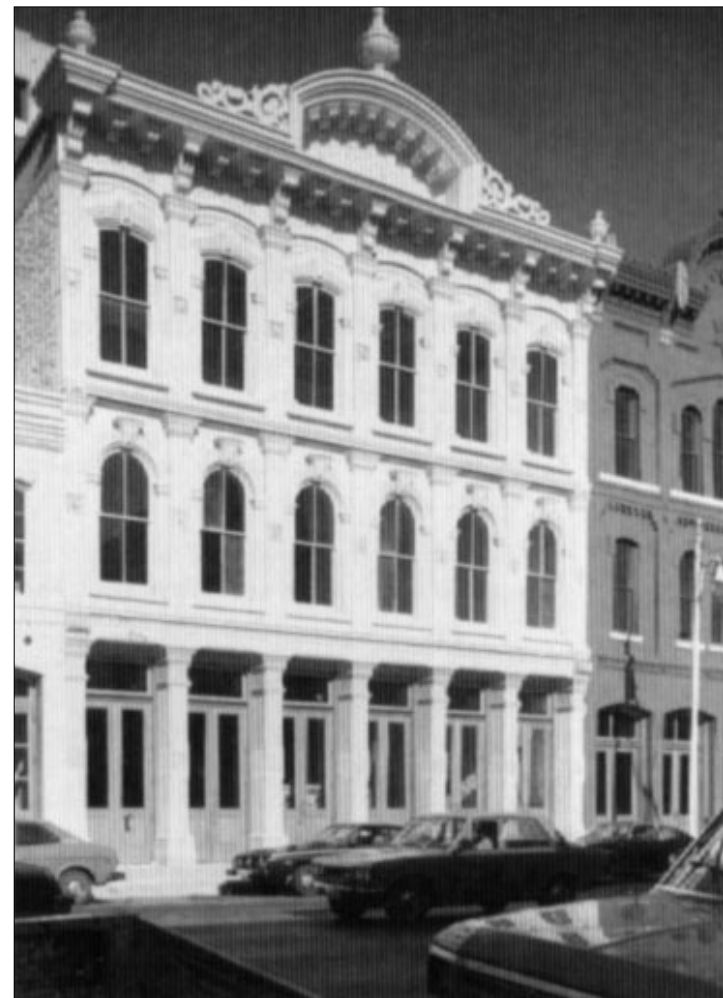
*In the treatment, Rehabilitation, one option for replacing missing historic features is to use pictorial documentation and/or physical evidence to re-create the historic feature. (a) In this example, the ornamental cornice of an 1866 limestone building was missing; and the ground level storefront had been extensively altered. (b) and (c) Based on the availability of photographic and other documentation, the owners were able to accurately restore the cornice and storefront to their historic configuration. A substitute material, fiberglass, was used to fabricate the missing pressed metal cornice, an acceptable alternative in this project. All work met the Standards.*

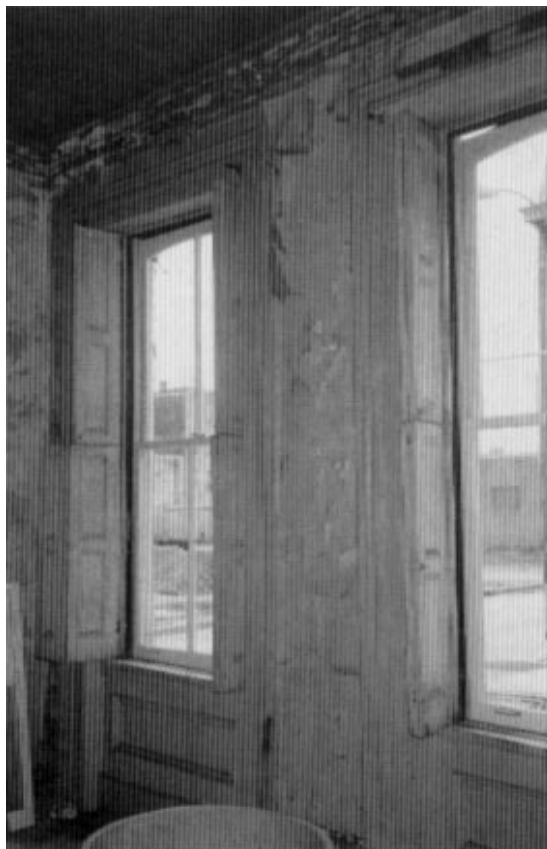
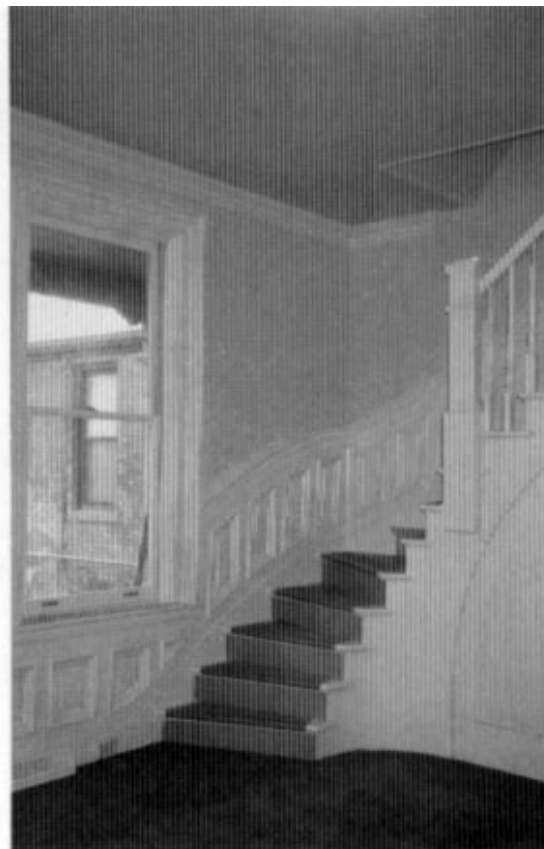
Rehabilitating historic dwelling units often includes some level of lead-paint hazard abatement. Whenever lead-base paint begins to peel, chip, craze, or otherwise comes loose (*a*), it should be removed in a manner that protects the worker as well as the immediate environment. In this example (*b*), the deteriorating lead-paint was removed throughout the apartment building and a compatible primer and finish paint applied.
