College Area Pedestrian Plan

Pedestrian Master Plan – Phase 4

College Area Pedestrian Master Plan

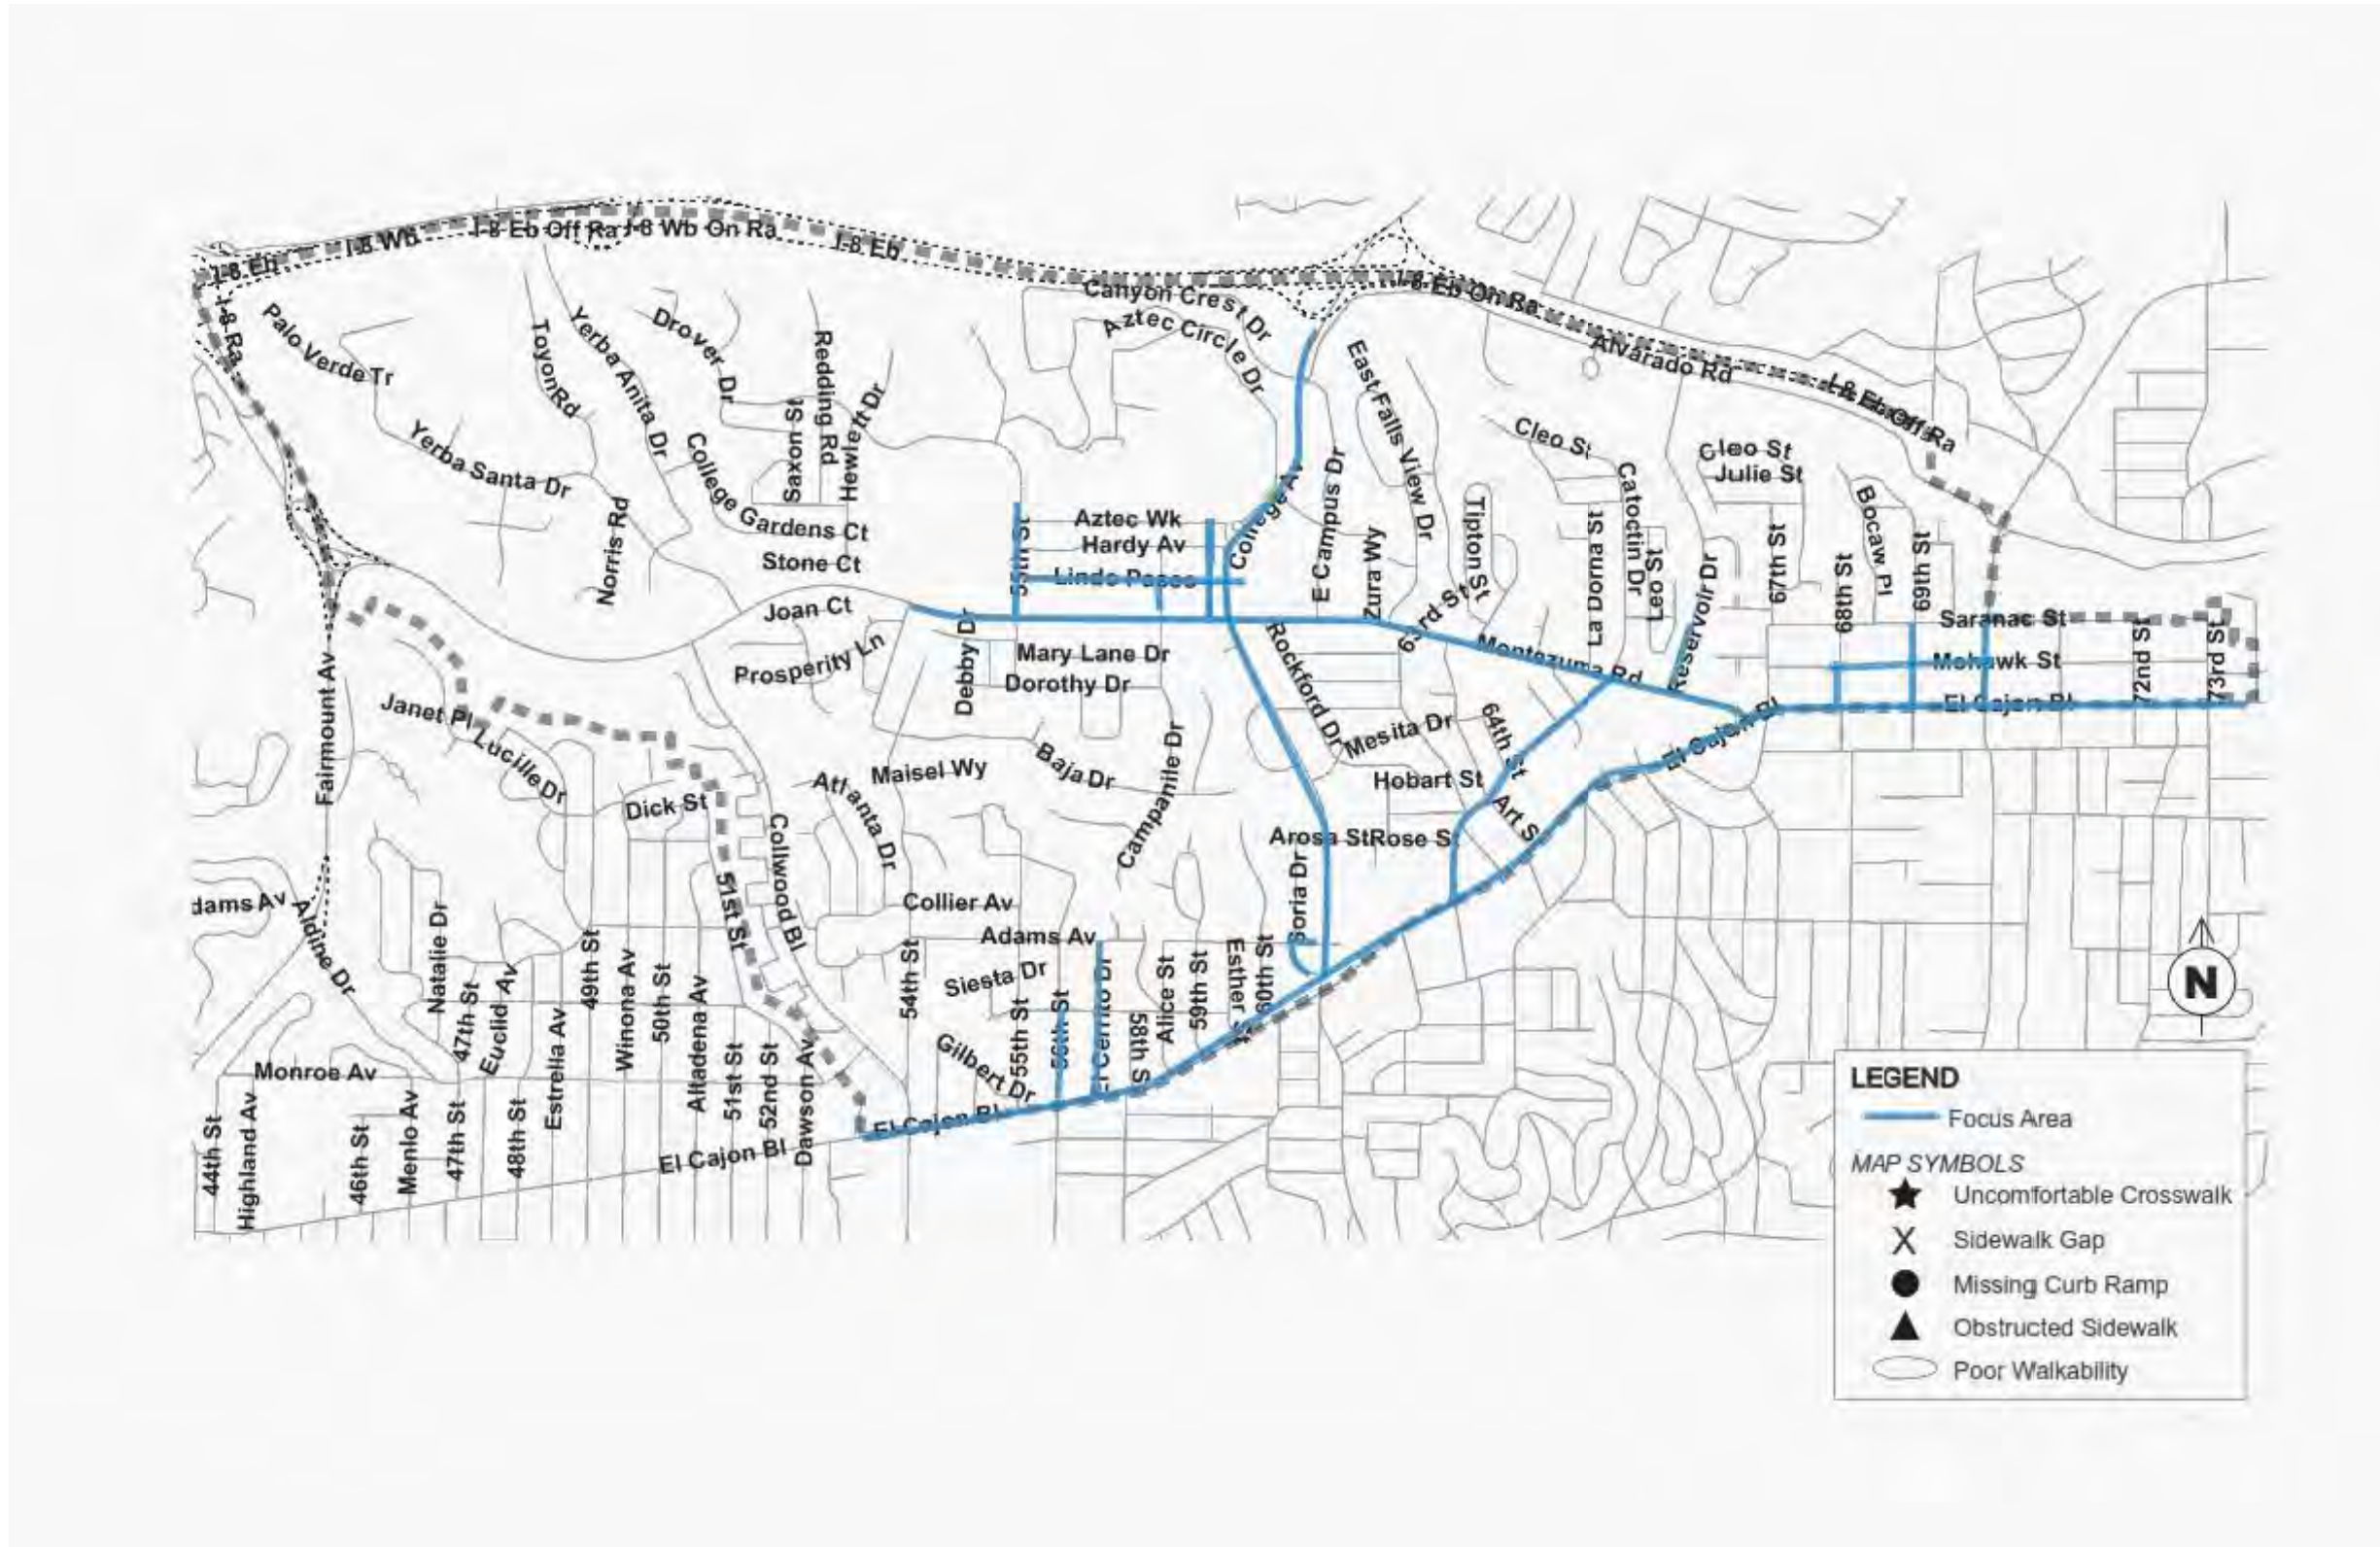
Exhibit C-3: Focus Area

result of the existing conditions needs assessment and input from the community. **Exhibit C-3** illustrates the College Area Focus Area routes.

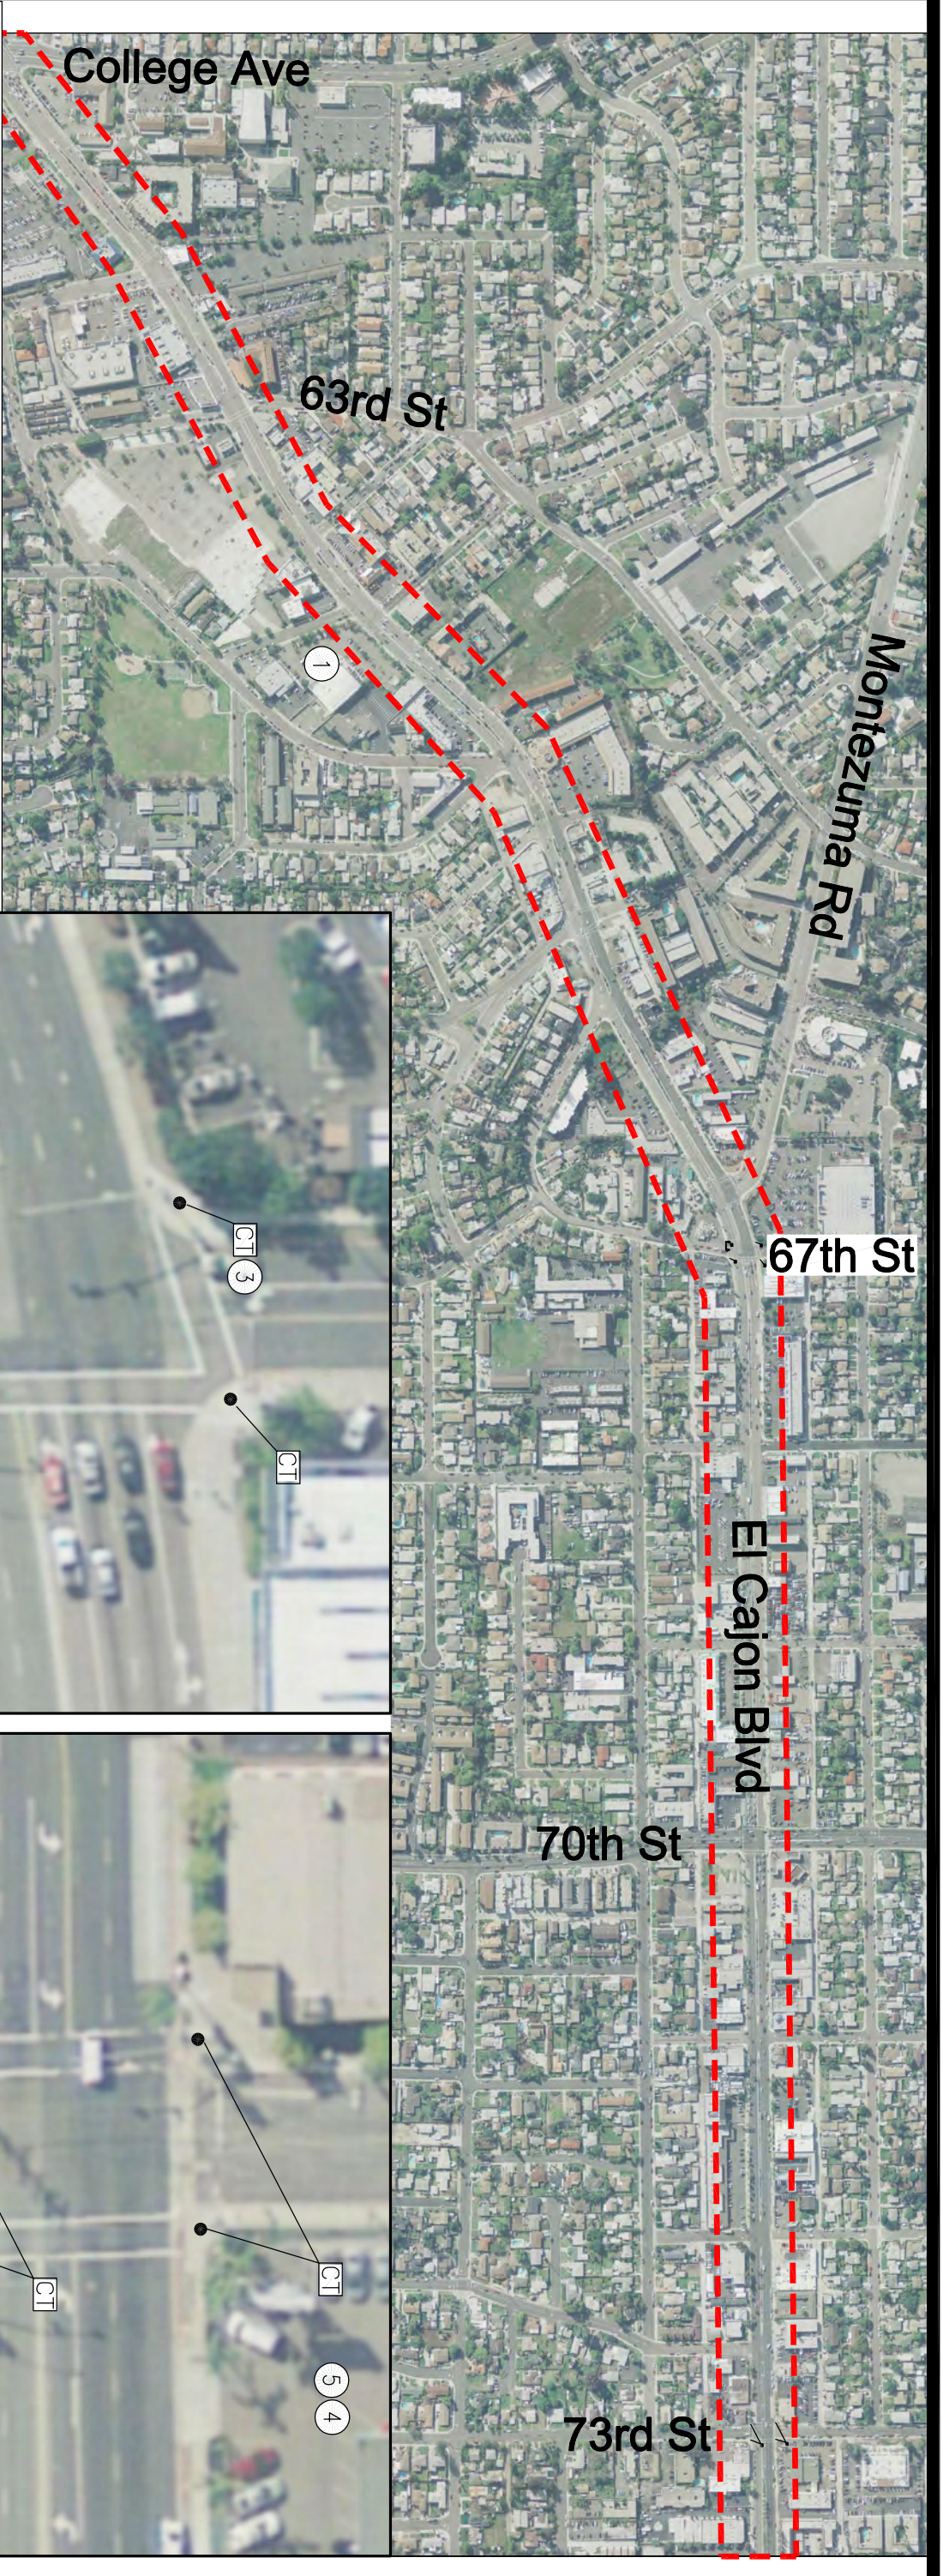
IMPROVEMENT AREA C-2

Recommendations: Prepare a comprehensive Corridor Mobility Study that addresses pedestrian walkability, access to transit, bicycle facilities and vehicular circulation. Implement short term intersection improvements to address existing pedestrian issues.

- ① Conduct a Corridor Mobility Study to evaluate multimodal improvements
 - ② Install "Turning Vehicles Yield to Pedestrians" sign at 67th St on southbound approach
 - ③ Replace all pedestrian heads with pedestrian countdown timers (CT) at 67th St
 - ④ Modify signal timing to add lead pedestrian interval at 73rd St
 - ⑤ Replace all pedestrian heads with pedestrian countdown timers (CT) at 73rd St
- (See Table C-2 for more detailed descriptions)

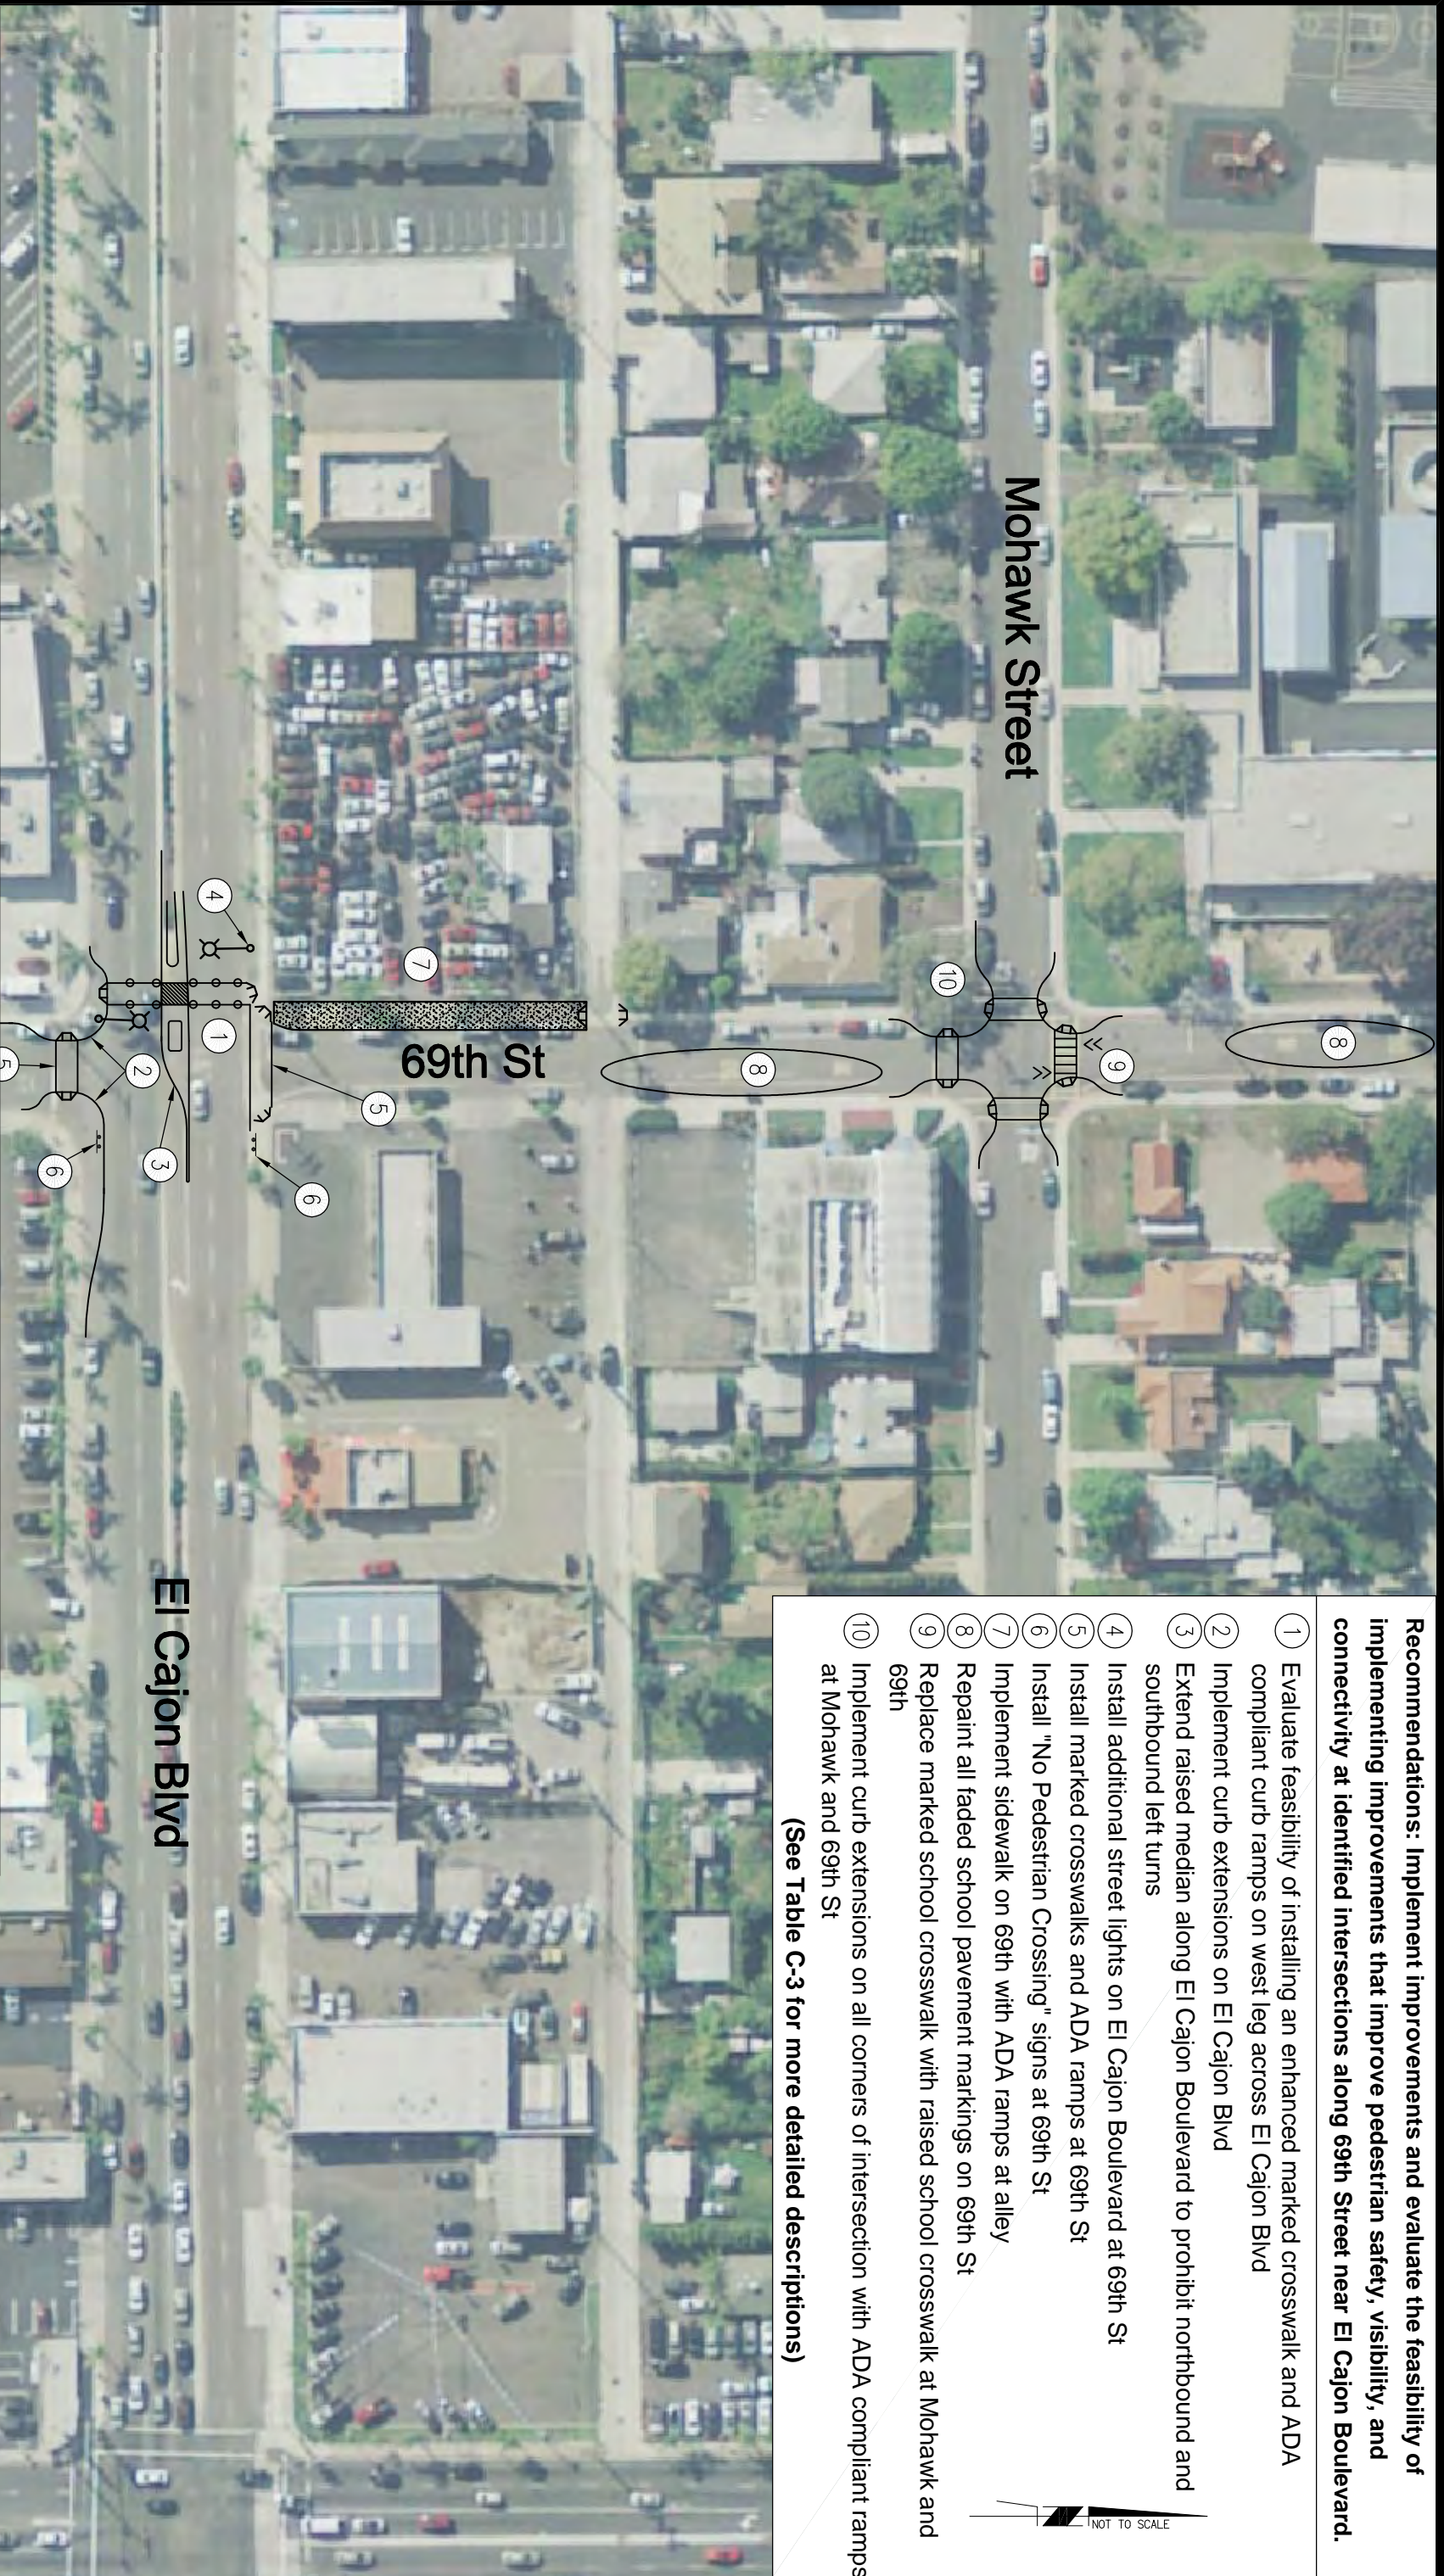
IMPROVEMENT AREA C-3
69th Street Corridor Improvements
Pedestrian Master Plan - Phase 4

Recommendations: Implement improvements and evaluate the feasibility of implementing improvements that improve pedestrian safety, visibility, and connectivity at identified intersections along 69th Street near El Cajon Boulevard.

- ① Evaluate feasibility of installing an enhanced marked crosswalk and ADA compliant curb ramps on west leg across El Cajon Blvd
 - ② Implement curb extensions on El Cajon Blvd
 - ③ Extend raised median along El Cajon Boulevard to prohibit northbound and southbound left turns
 - ④ Install additional street lights on El Cajon Boulevard at 69th St
 - ⑤ Install marked crosswalks and ADA ramps at 69th St
 - ⑥ Install "No Pedestrian Crossing" signs at 69th St
 - ⑦ Implement sidewalk on 69th with ADA ramps at alley
 - ⑧ Repaint all faded school pavement markings on 69th St
 - ⑨ Replace marked school crosswalk with raised school crosswalk at Mohawk and 69th
 - ⑩ Implement curb extensions on all corners of intersection with ADA compliant ramps at Mohawk and 69th St
- (See Table C-3 for more detailed descriptions)**

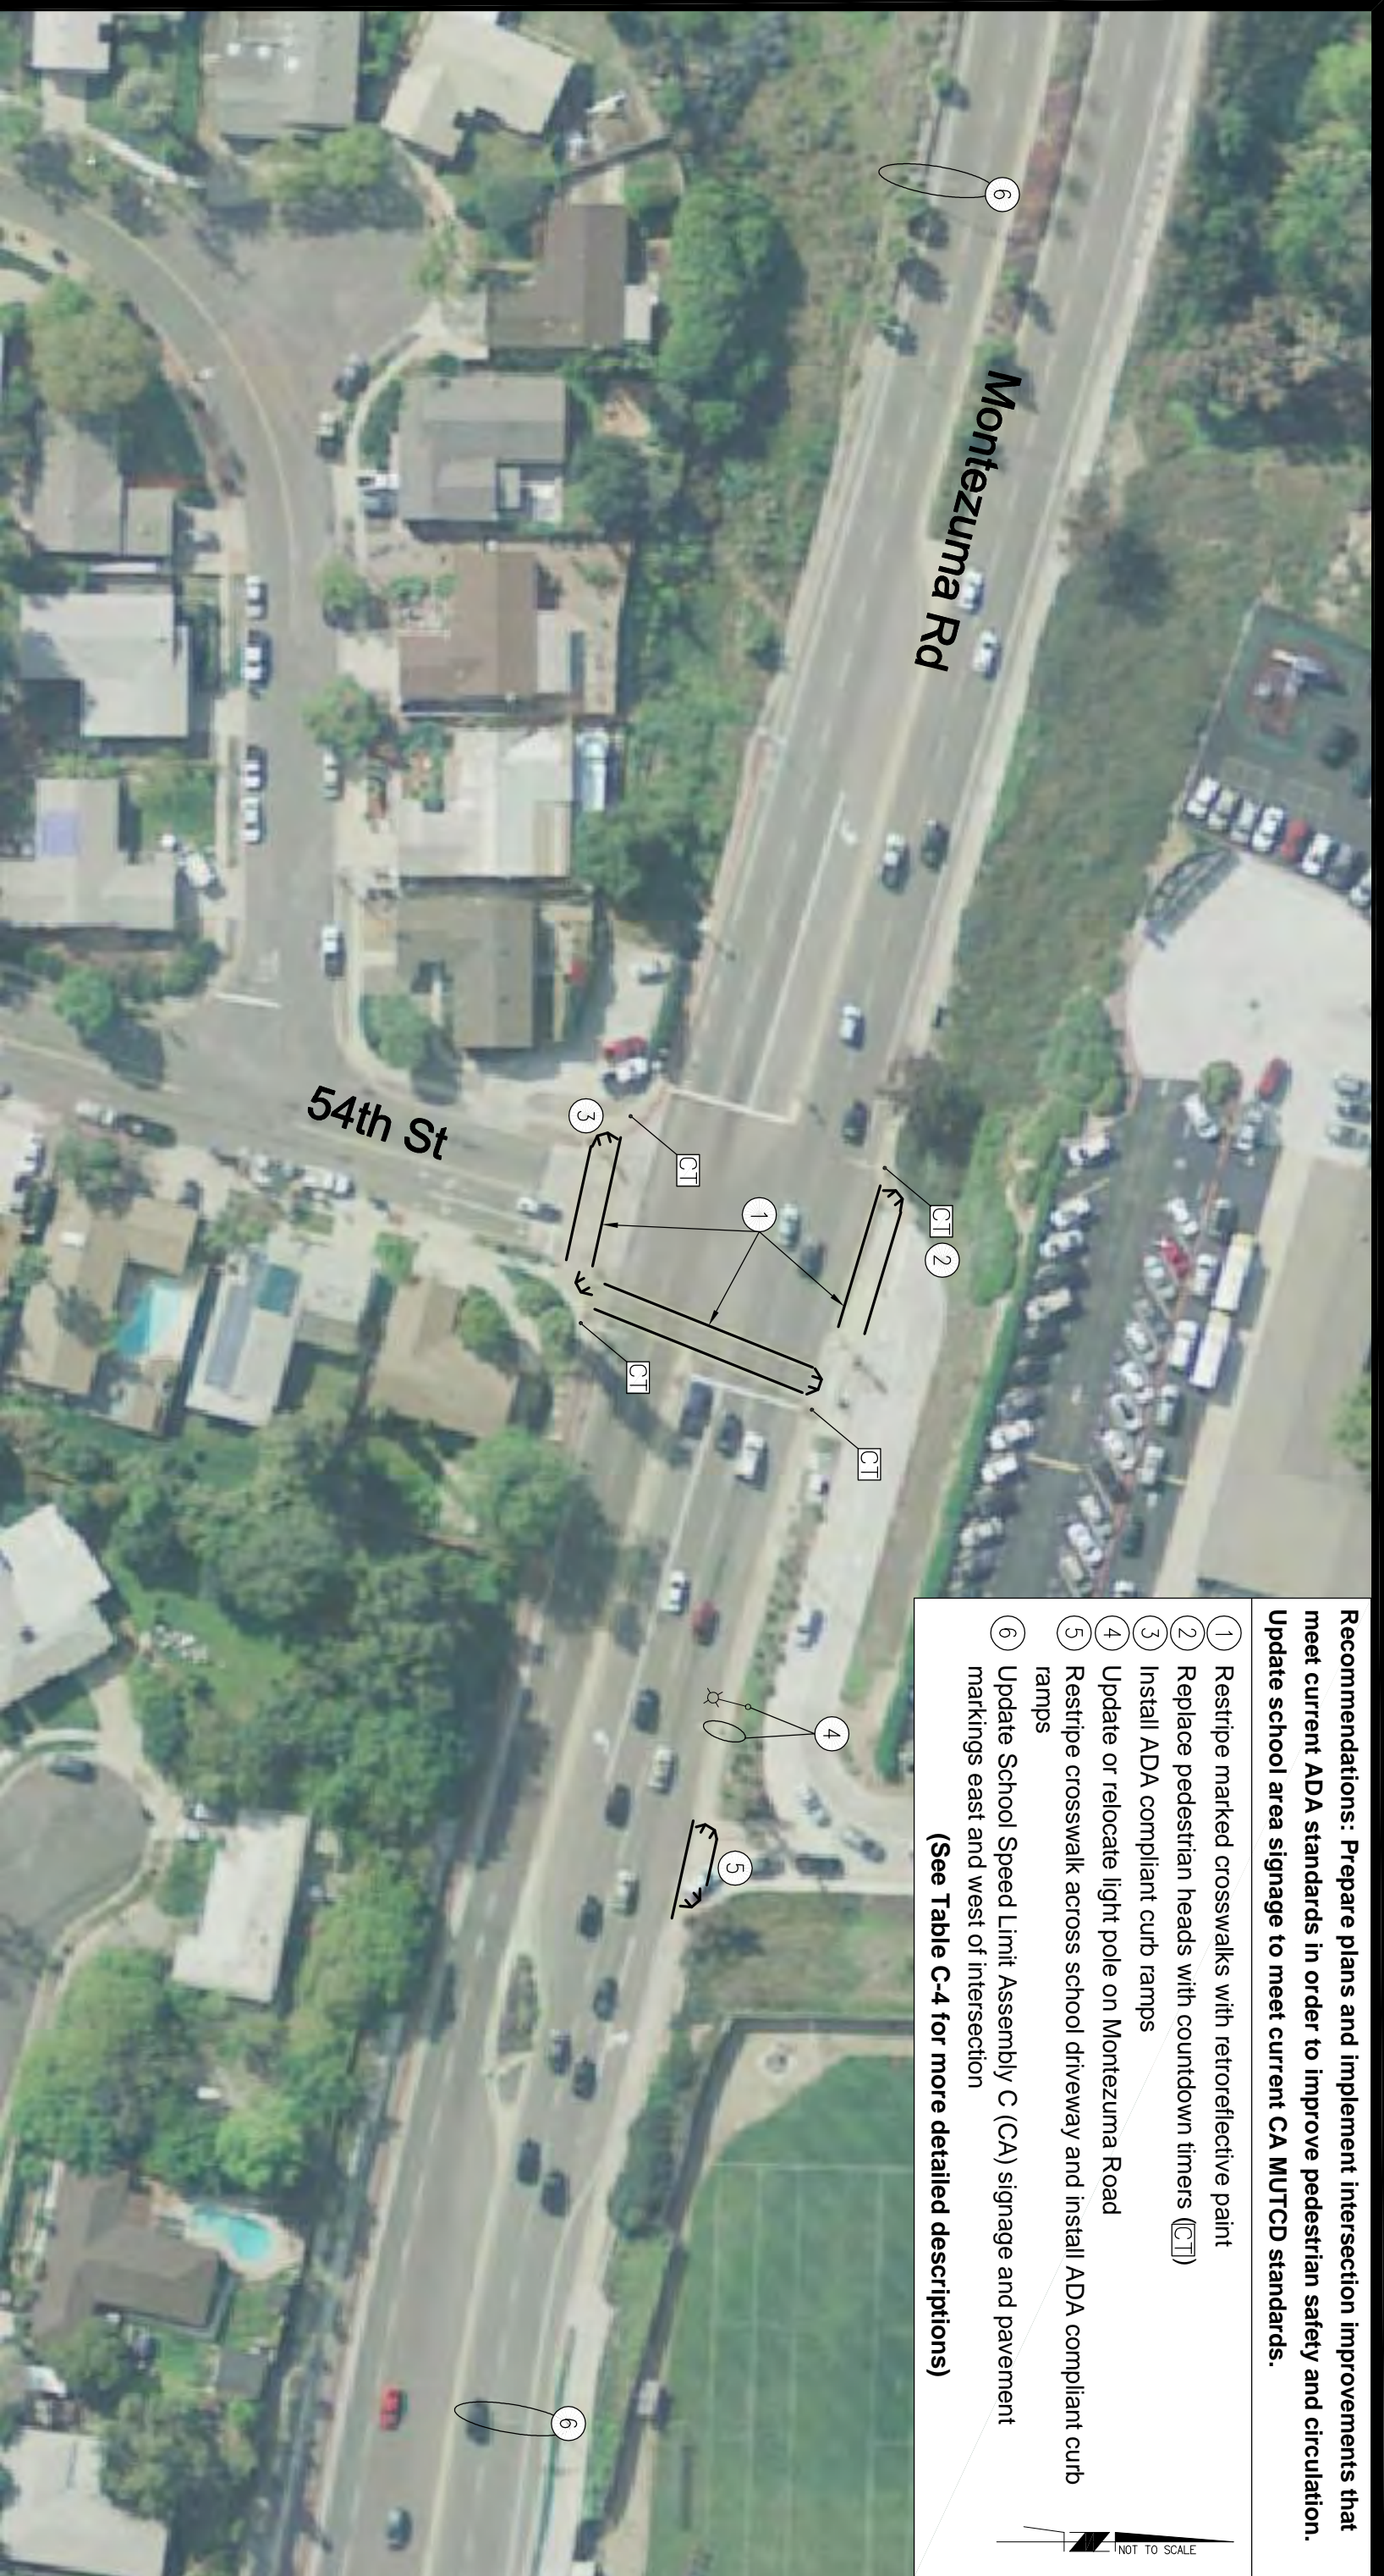
IMPROVEMENT AREA C-4

Recommendations: Prepare plans and implement intersection improvements that meet current ADA standards in order to improve pedestrian safety and circulation. Update school area signage to meet current CA MUTCD standards.

- ① Restripe marked crosswalks with retroreflective paint
- ② Replace pedestrian heads with countdown timers (CT)
- ③ Install ADA compliant curb ramps
- ④ Update or relocate light pole on Montezuma Road
- ⑤ Restripe crosswalk across school driveway and install ADA compliant curb ramps
- ⑥ Update School Speed Limit Assembly C (CA) signage and pavement markings east and west of intersection

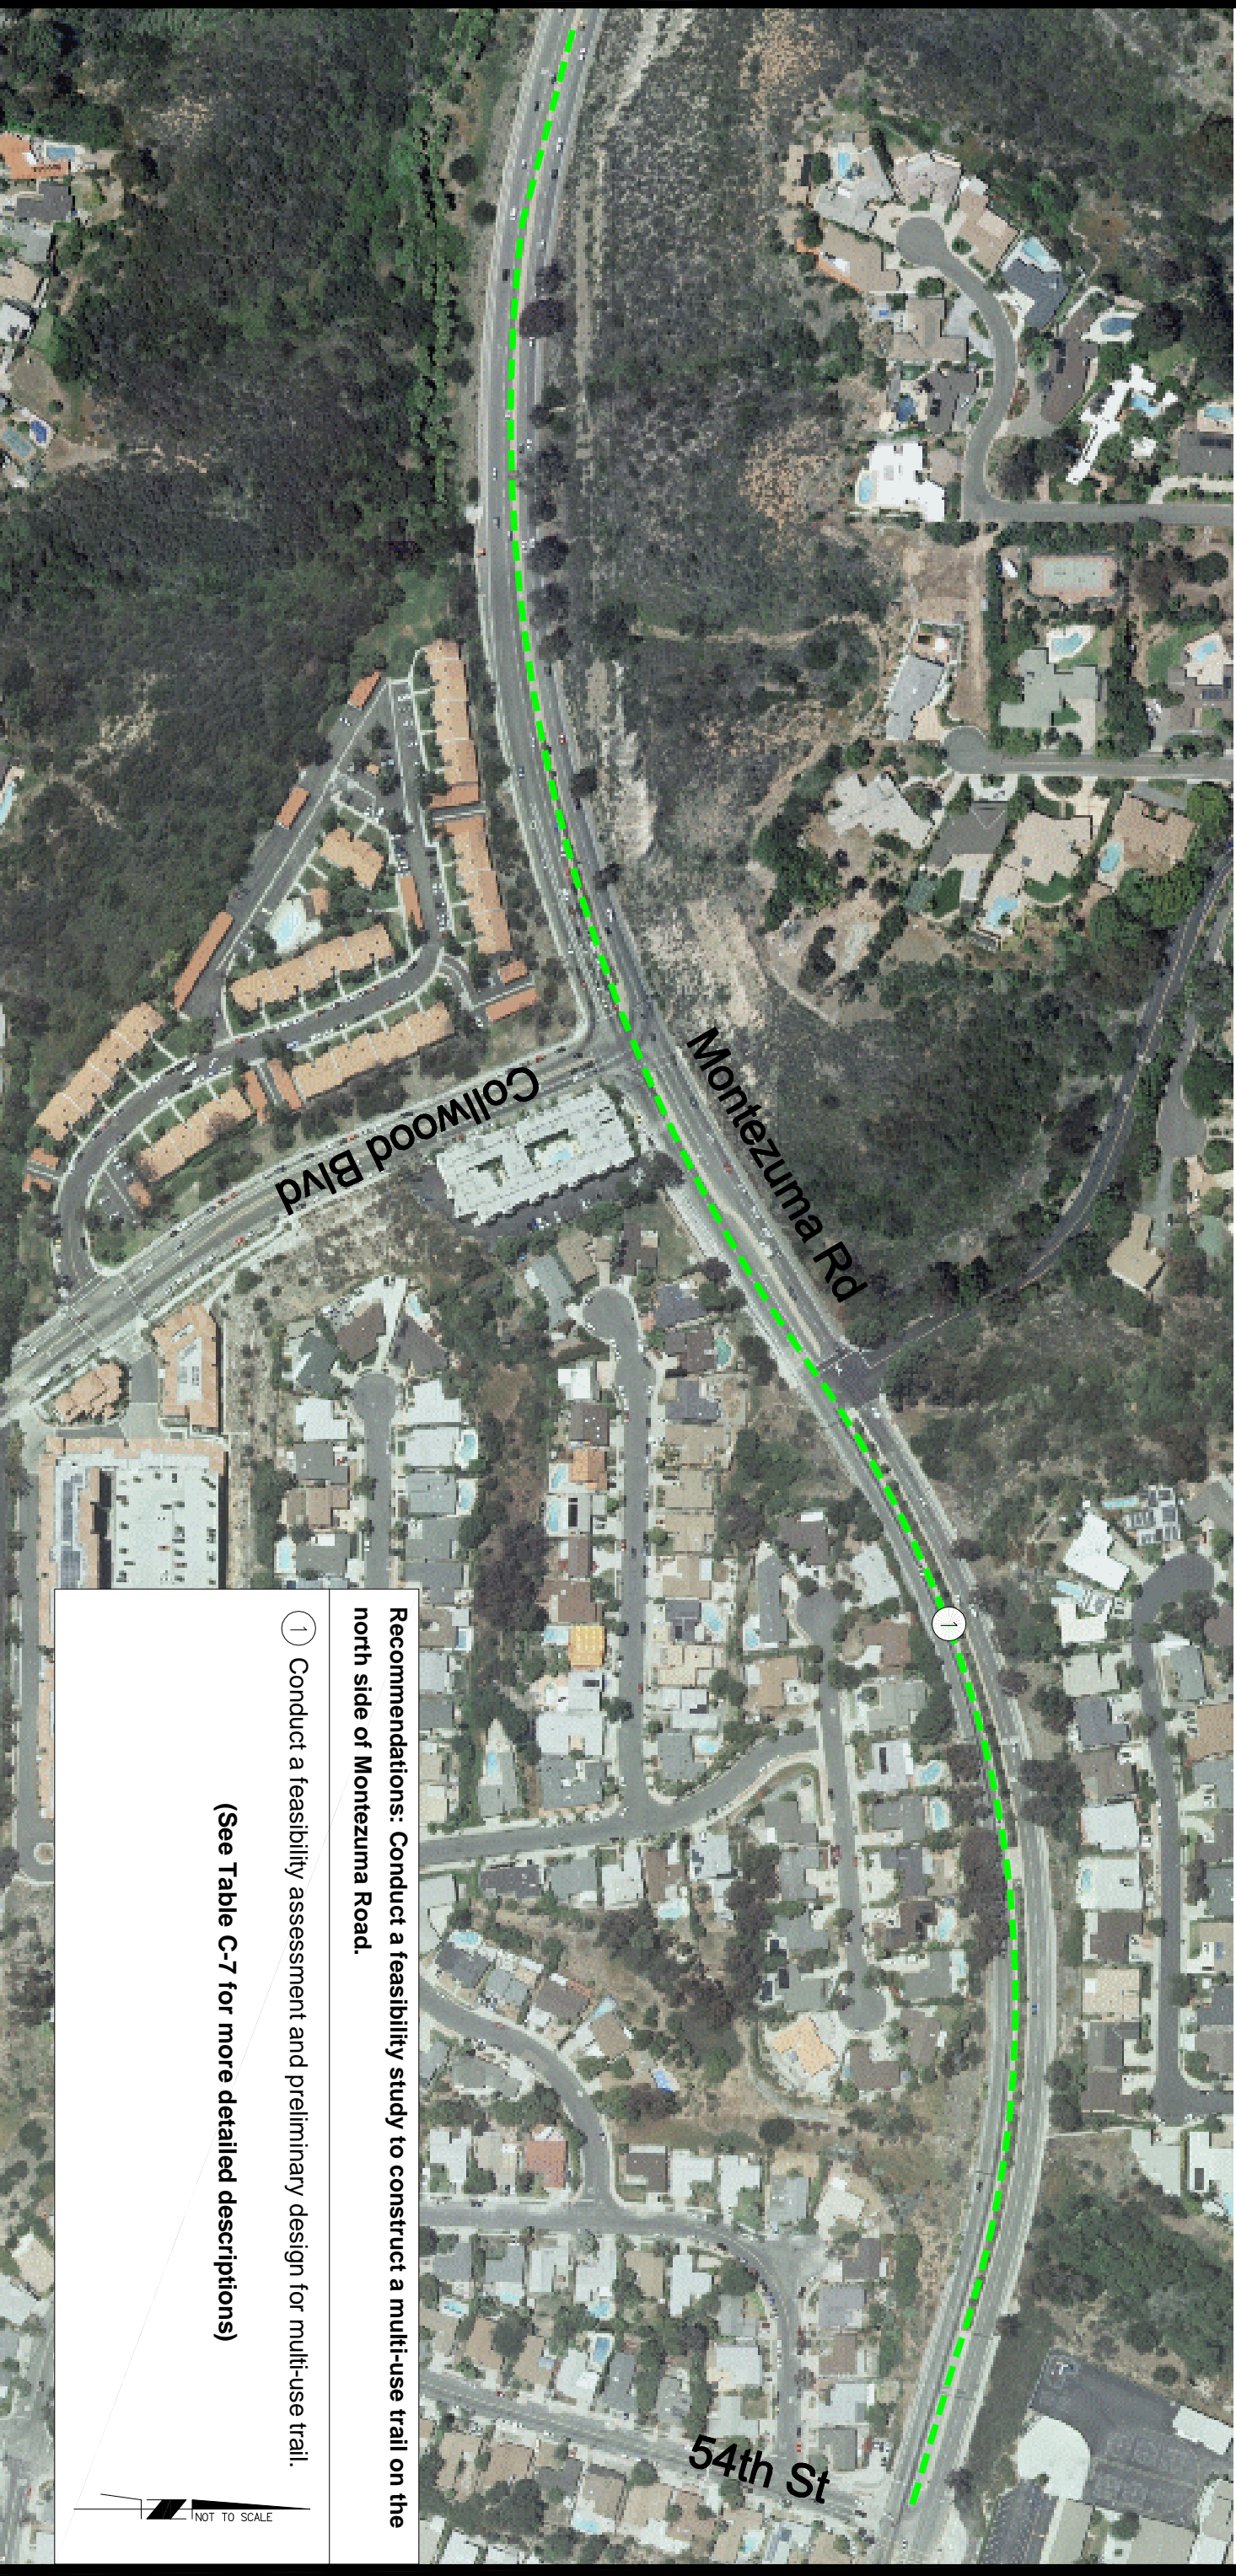
IMPROVEMENT AREA C-7

Recommendations: Conduct a feasibility study to construct a multi-use trail on the north side of Montezuma Road.

- ① Conduct a feasibility assessment and preliminary design for multi-use trail.

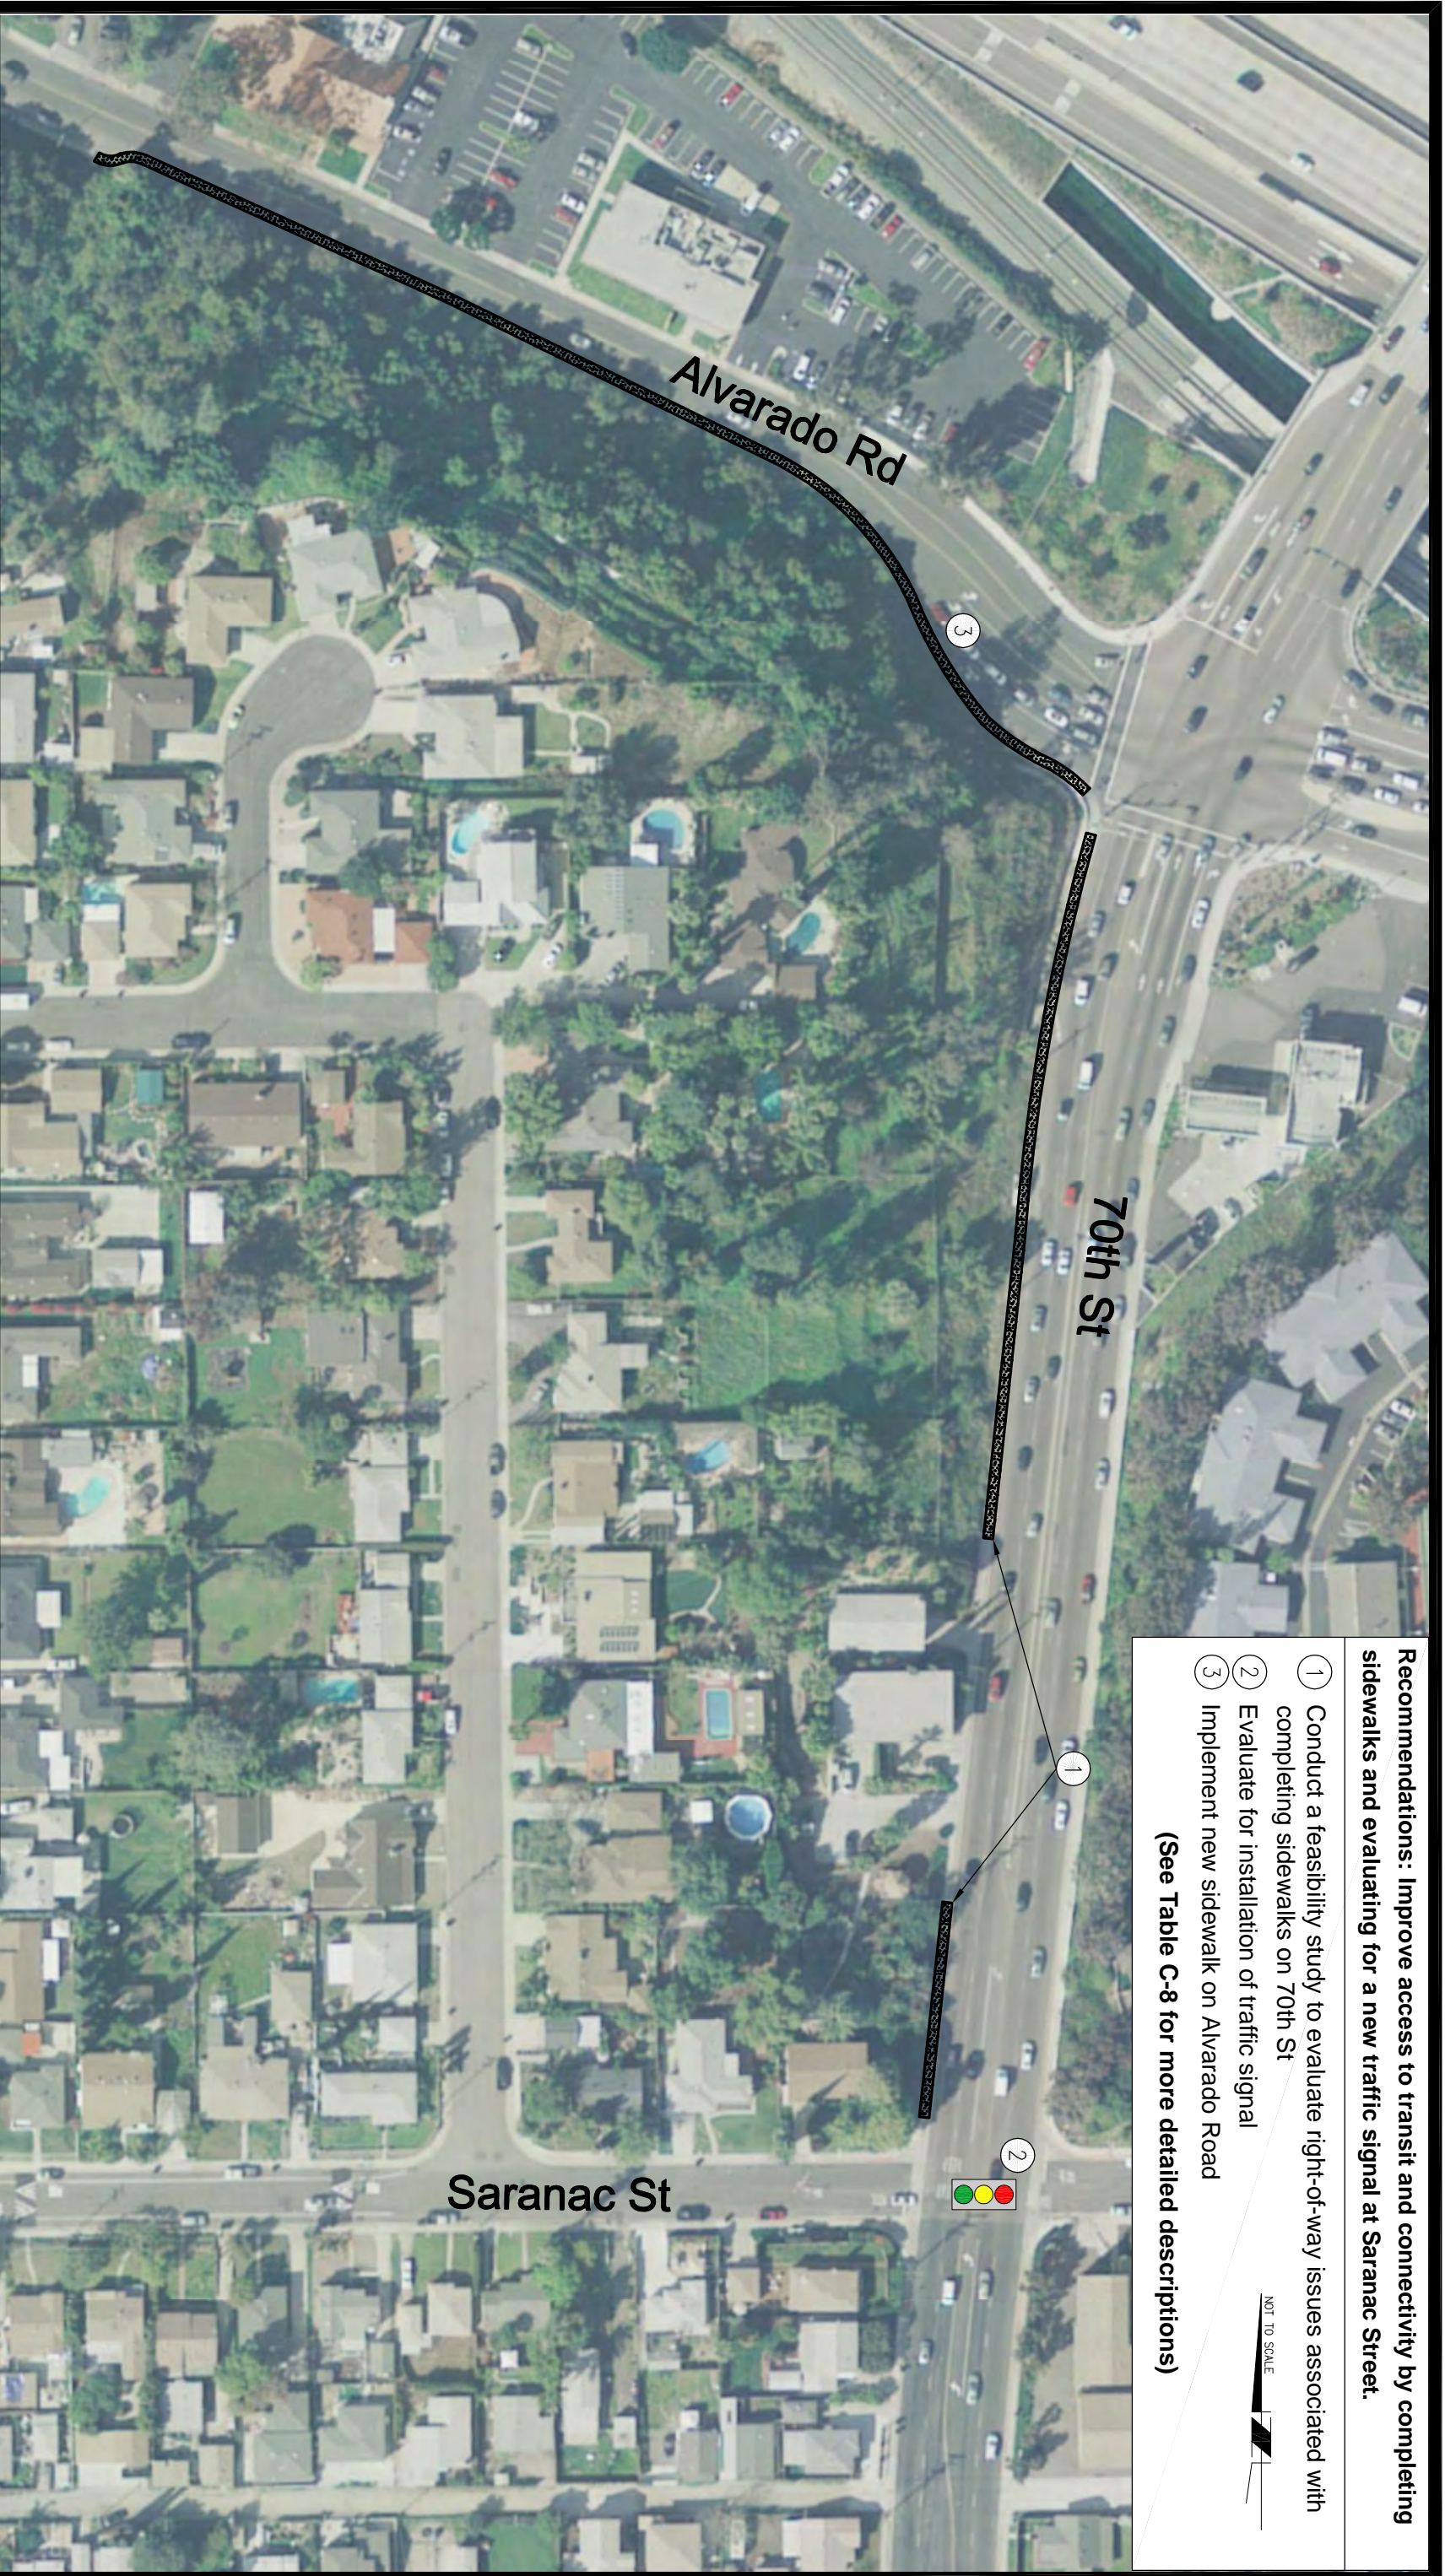
IMPROVEMENT AREA C-8

Recommendations: Improve access to transit and connectivity by completing sidewalks and evaluating for a new traffic signal at Saranac Street.

- ① Conduct a feasibility study to evaluate right-of-way issues associated with completing sidewalks on 70th St
- ② Evaluate for installation of traffic signal
- ③ Implement new sidewalk on Alvarado Road

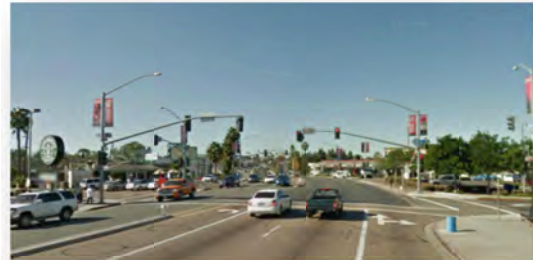
El Cajon Blvd / 67th Street

The eastern corridor study for El Cajon Boulevard includes an area that is less dense than the western corridor, with longer street blocks and closer proximity to the SDSU campus. Activity centers along the corridor include The College Center Shopping Center, College Heights Library, various auto repair shops and car dealerships, and various strip malls. The posted speed limit through this area is 35 mph with average daily traffic ranging from 20,000 to 28,000 vehicles per day. Sidewalks are provided but walkability is still uninviting with long street blocks, no marked crosswalks outside of signalized intersections and a lack of a clear path of travel around SDSU. MTS Route 1 serves this corridor with 15 minute headways on the weekdays and 30 minute headways on the weekends. MTS Route 14 serves this corridor with one hour headways on the weekdays only. Both land use and transit activity support the need for pedestrian enhancement. A five year accident history shows that a total of 11 pedestrian-involved accidents have been reported along this corridor. Key pedestrian issues include frequency of marked crossings and vehicle-pedestrian conflicts at intersections. A Corridor Mobility Study is recommended to address corridor-wide improvements for all modes. However, intersection improvements at 67th Street and 73rd Street would address immediate safety concerns where multiple pedestrian-involved accidents have been reported in the past 5 years.

3) Replace all pedestrian heads with pedestrian countdown timers.	S, A	Reduce potential for pedestrians to cross at end of phase	\$21,000
El Cajon Blvd / 73 rd Street	4) Modify signal timing to add lead pedestrian interval.	S	Allow pedestrians to cross before vehicle indication turns green to minimize pedestrian-vehicle conflicts	\$1,000

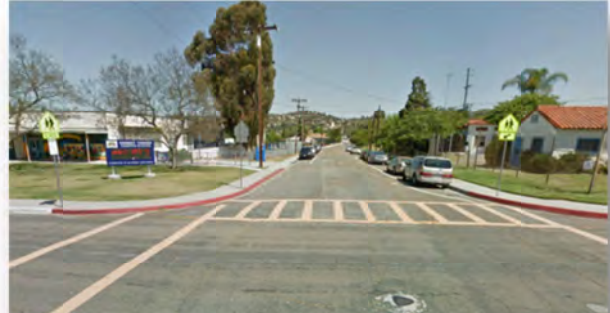
Mohawk Street / 69th Street – school crossing

69th Street runs north-south and provides access to Harriet Tubman Village Charter School, residential neighborhoods, and commercial centers on El Cajon Boulevard. One block south of the school 69th Street intersects with El Cajon Blvd, a four-lane high-volume road with on-street parking on both sides, no marked crosswalks and poor visibility. There is no sidewalk provided on the west side of 69th Street just north of El Cajon Boulevard, and several curb ramps are missing or non-compliant along the corridor. This project would improve pedestrian safety, improve visibility and connectivity at the intersections.

8) Repaint all faded school crossing pavement markings along 69 th Street.	S	Improve driver awareness in school zone	\$1,000
69 th Street / Mohawk Street	9) Replace existing marked school crosswalk on north side of intersection with a raised school crosswalk.	A	Reduce speeds and improve driver awareness in school zone	\$18,000

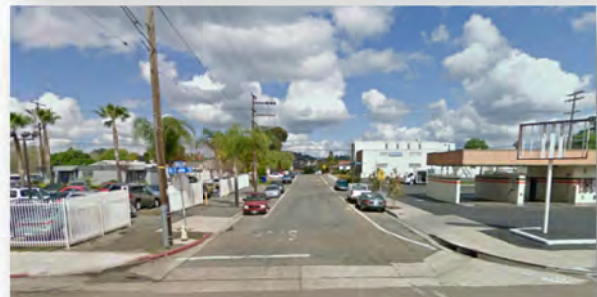
69th St north of El Cajon Blvd – no sidewalk on west side

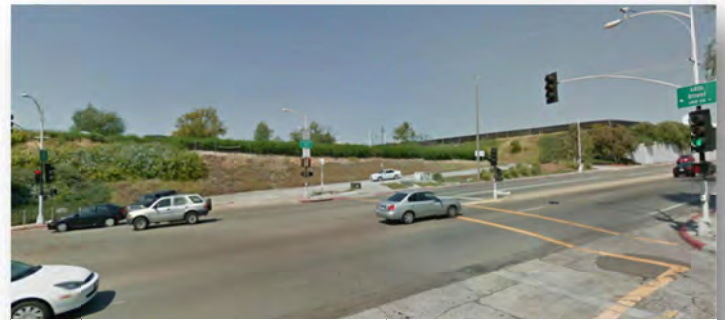
Montezuma / 54th Street – entrance to school

Montezuma Road at 54th Street, a busy intersection with high traffic speeds, serves as the main entrance to Hardy Elementary School. Although there are crosswalks provided on three legs, there are no curb ramps on the north leg and non-compliant ramps on the east and south legs. The crosswalk paint is faded and the unprotected left turn for the southbound vehicles creates potential pedestrian-vehicle conflicts in the western crosswalk. The sidewalk along the north side of Montezuma Road is obstructed by a light pole with an above ground foundation with little clearance for pedestrians. This project would update signage, curb ramps, and crosswalks to improve pedestrian safety in the area. Sidewalk widening and intersection improvements are also suggested to improve pedestrian circulation.

2) Replace all pedestrian heads with countdown timers.	S	Prevent pedestrians from crossing at end of phase	\$18,000
	3) Install ADA compliant curb ramps at crosswalks.	A	Provide access at curb for all users	\$12,000
Montezuma Road	4) Update light pole to underground foundation or relocate to back of sidewalk.	A, W	Eliminate obstruction on sidewalk	\$6,000
