College Area Pedestrian Plan

Pedestrian Master Plan – Phase 4

College Area Pedestrian Master Plan

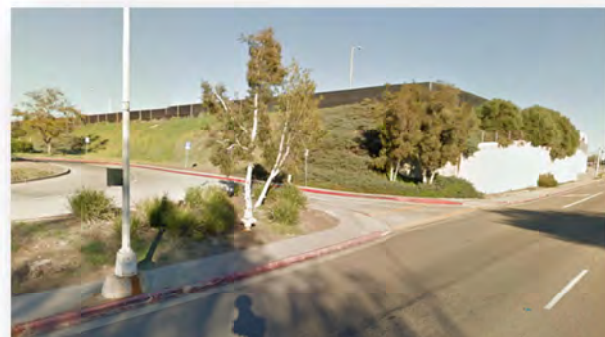
Obstructed sidewalk and lack of proper curb ramps

2) Replace all pedestrian heads with countdown timers.	S	Prevent pedestrians from crossing at end of phase	\$18,000
	3) Install ADA compliant curb ramps at crosswalks.	A	Provide access at curb for all users	\$12,000
Montezuma Road	4) Update light pole to underground foundation or relocate to back of sidewalk.	A, W	Eliminate obstruction on sidewalk	\$6,000

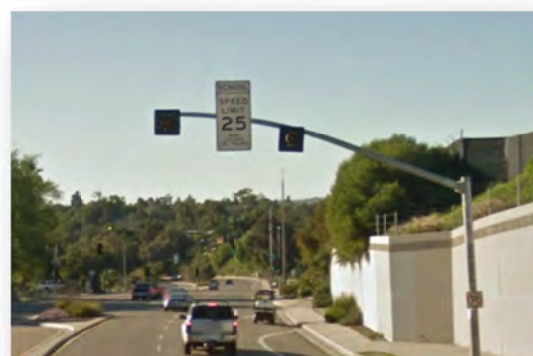
Advance school signage – not compliant with 2010 MUTCD

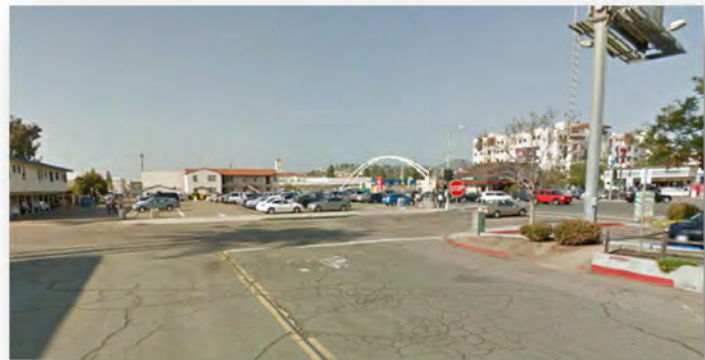
Montezuma Place / Lindo Paseo – wide intersection

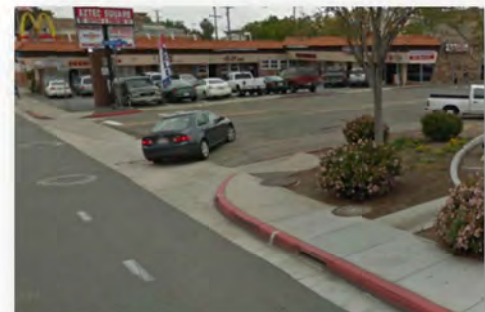
Montezuma Rd / Montezuma Place
vehicles do not yield to pedestrians

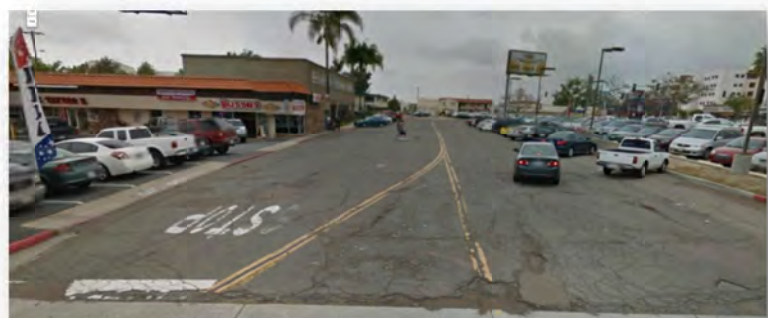
Montezuma Place – no clear path for pedestrians

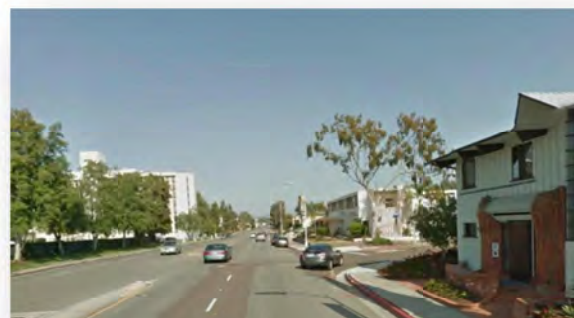
Montezuma Rd at Rockford Dr

Montezuma Road is a wide, high-volume street that hosts an abundance of student life including Greek housing, the Chabad House (part of the Jewish Student Life of San Diego), residence halls, and apartment complexes. Many of these housing units are on opposing sides of the street and results in jaywalking. One pedestrian fatality was recorded in the past five years on this corridor to the east of Rockford Drive on Montezuma Road. Pedestrian trips are also frequent to and from the Aztec Student Union on the SDSU campus, which is located a few blocks north of Montezuma Road on College Avenue. The intersection of Montezuma Road / College Avenue and Montezuma Road / Rockford Drive is a hub for pedestrian activity and provides access to the college campus as well as many eateries. This project proposes recommendations to improve pedestrian safety at the intersections.

- ① Replace existing pedestrian heads with countdown timers (CT) at College Ave
- ② Extend raised median on Montezuma Road
- ③ Install "No Pedestrian Crossing" signs on median
- ④ Reimplement corner at Rockford Dr and install ADA compliant curb ramps

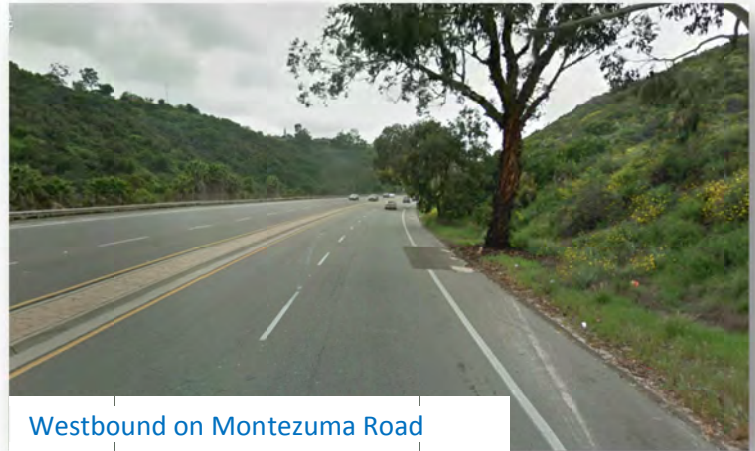
Westbound on Montezuma Road

This segment of Montezuma Road connects the College Area community to the communities of Kensington and Talmadge as well as Grantville. The community has initiated a plan to add a multi-use path along the north side of Montezuma Road to improve pedestrian and bicycle connectivity. The segment currently has sidewalk on the south side and bicycle lanes on both sides. This project would assess the feasibility of installing a multi-use trail on the north side of the street.

Pedestrian and bicycle connectivity would be improved by implementing a multi-use path along Montezuma Road. Feasibility assessment is recommended to evaluate the potential impacts, costs, and constraints associated with the proposed plan of installing a multi-use trail.

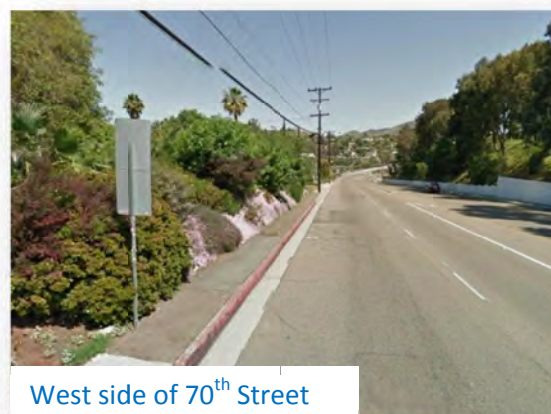
West side of 70th Street

70th Street connects the College Area neighborhoods to the Trolley station located west of 70th Street on Alvarado Road. There are missing or incomplete sidewalks along 70th Street between El Cajon Boulevard and Alvarado Road. Crossing 70th Street is challenging due to speed of traffic, lack of gaps, and topography. This project would assess the feasibility of completing the sidewalks and improving the visibility of pedestrians at the intersection of 70th Street / Saranac Street. Improved street lights, curb extensions, and other pedestrian features are needed to improve overall walkability.

Location	Description	Goal ⁽¹⁾	Objective	Est. Cost
70 th Street	1) Conduct a feasibility study to evaluate ROW issue associated with completing missing sidewalks.	A, C	Improve connectivity and access to transit	\$50,000
70 th Street / Saranac Street	2) Evaluate for the installation of a traffic signal.	A, S	Improve circulation of pedestrians crossing to transit stop with a pedestrian phase at signal	\$5,000
Alvarado Road	3) Implement new sidewalk on Alvarado Road west of 70 th Street.	C, W	Provide connected pedestrian path of travel	\$630,000
TOTAL ESTIMATED COST				\$685,000
