**Baseline Effectiveness Assessment Monitoring –
43rd Street & Logan Avenue**

Final Report

Prepared by:
Weston Solutions, Inc.
2433 Impala Drive
Carlsbad, California 92010

June 30, 2009

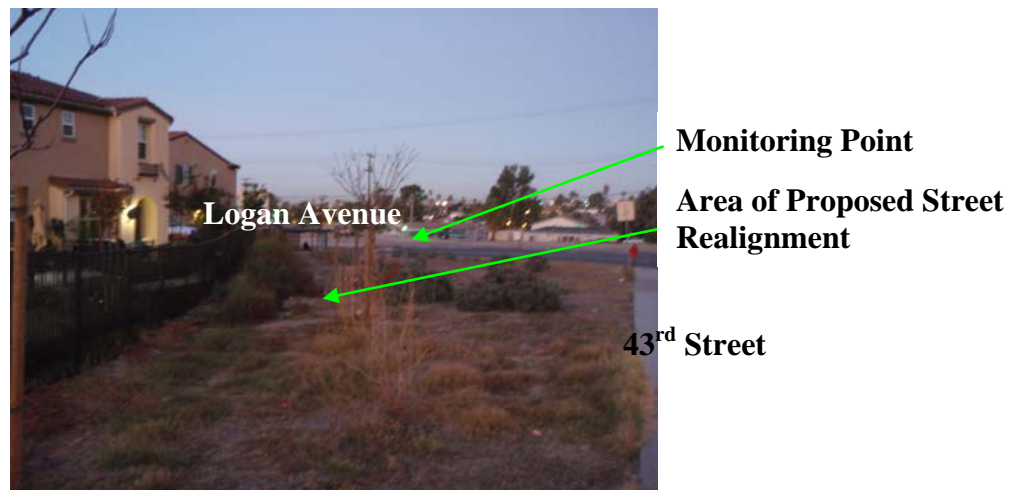
Figure 7. 43rd Street and Logan Avenue Realignment,

The monitoring site is located approximately 150 ft south of the existing corner of 43rd Street and Logan Avenue. The flow catchment area of the site is predominantly residential since the public park located across the street resides below the grades of 43rd Street. The proposed street realignment project will take place at the intersection of 43rd Street and Logan Avenue, and the Green Street BMPs will be installed on the south and east corners of the intersection. The biofiltration basin area will be located along the northeast corner of the intersection, after the street alignment (Figure 1). For both events, sampling took place at a location slightly north of the existing catch basin that is situated along 43rd Street. This point was chosen in lieu of sampling from the catch basin because of the risk of personnel injury and equipment damage from the combination of several factors, such as intermittent but heavy roadway traffic, poor visibility (from rainfall) and inadequate lighting around the catch basin. Based on the similar type of land use (residential) and similar topography, the drainage area monitored is assumed to also represent the portion of the catch basin drainage area (approximately 2.2 acres) located south of the existing catch basin. Figure 7 and Figure 8 show the monitoring location during dry weather. Table 3 provides the globe positioning system coordinates of the monitoring location.

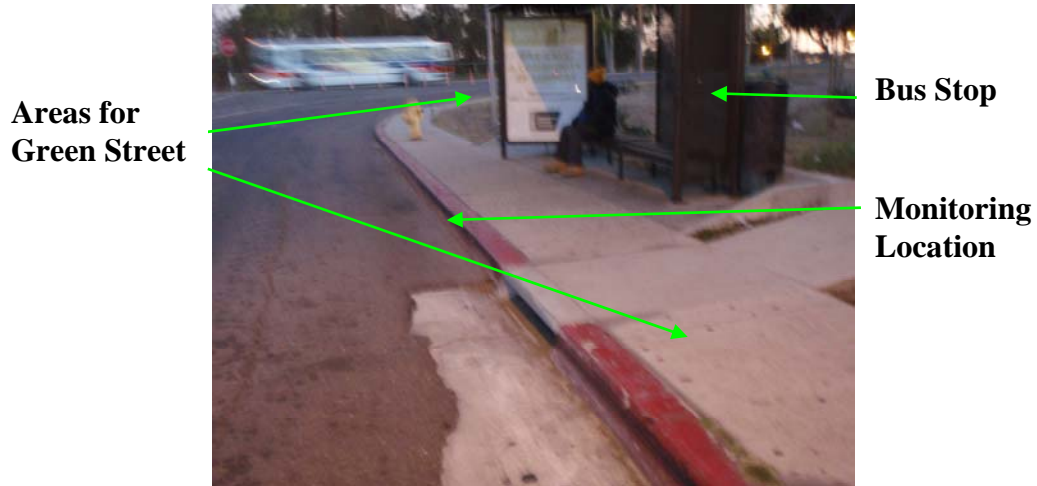
Figure 8. Bus Stop at 43rd Street and Logan Avenue

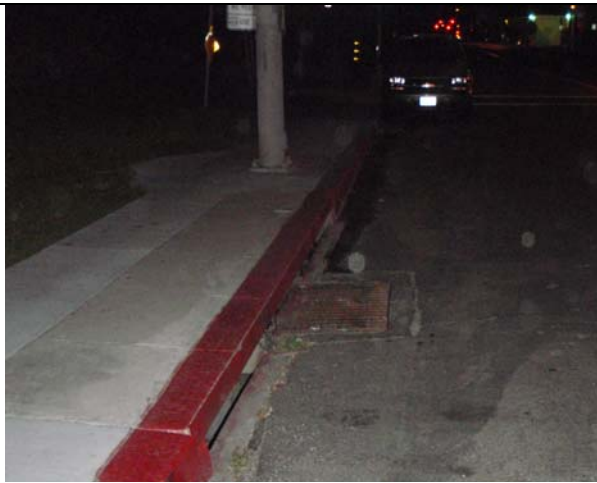
Figure 9. Storm Drain Inlet along East Side of 43rd Street, South of Logan Avenue

WESTON field scientists conducted the early morning reconnaissance of the monitoring location at South 43rd Street and Logan Avenue between 05:00 and 07:00 on November 14, 2008. At the time, the storm drain inlet was dry and there was no moisture or other indication of recent runoff (Figure 9). Neither the curb nor the inlet had staining or calcification to indicate any chronic runoff in this area. There did appear to be a small amount of coarse-grained sediment built up directly in front of the storm drain.

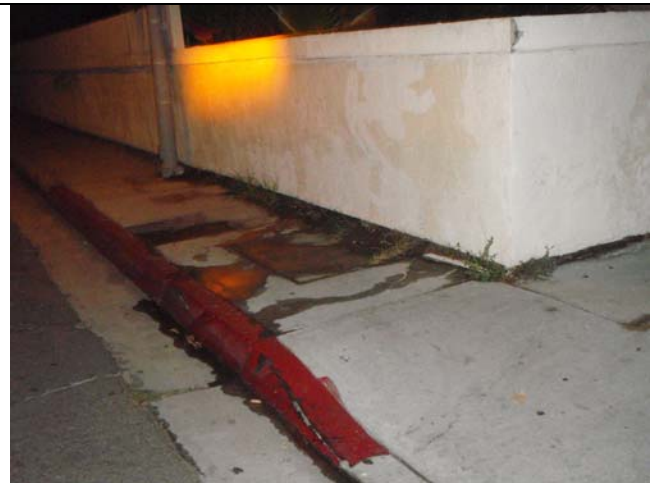
To the north of the 43rd Street and Logan Avenue monitoring location, the street curb bent around to the east and turns into Logan Avenue where it proceeded uphill. Only leaf debris and trash were observed up to Elizabeth Street. A small amount of flow was observed from sprinklers at an apartment complex on the southeastern corner of Elizabeth Street and Logan Avenue (Figure 10). The flow traveled approximately 50 ft west on Logan Avenue before becoming ponded and terminating. There was also a wetted area on the southeastern corner of South 45th Street and Logan Avenue that had no observed flow and had a small ponded area. The runoff appeared to be from sprinklers at the apartment complex and also from the nearby Willie Henderson Sports Complex.

Figure 10. Sprinkler Runoff at Elizabeth Street and Logan Avenue

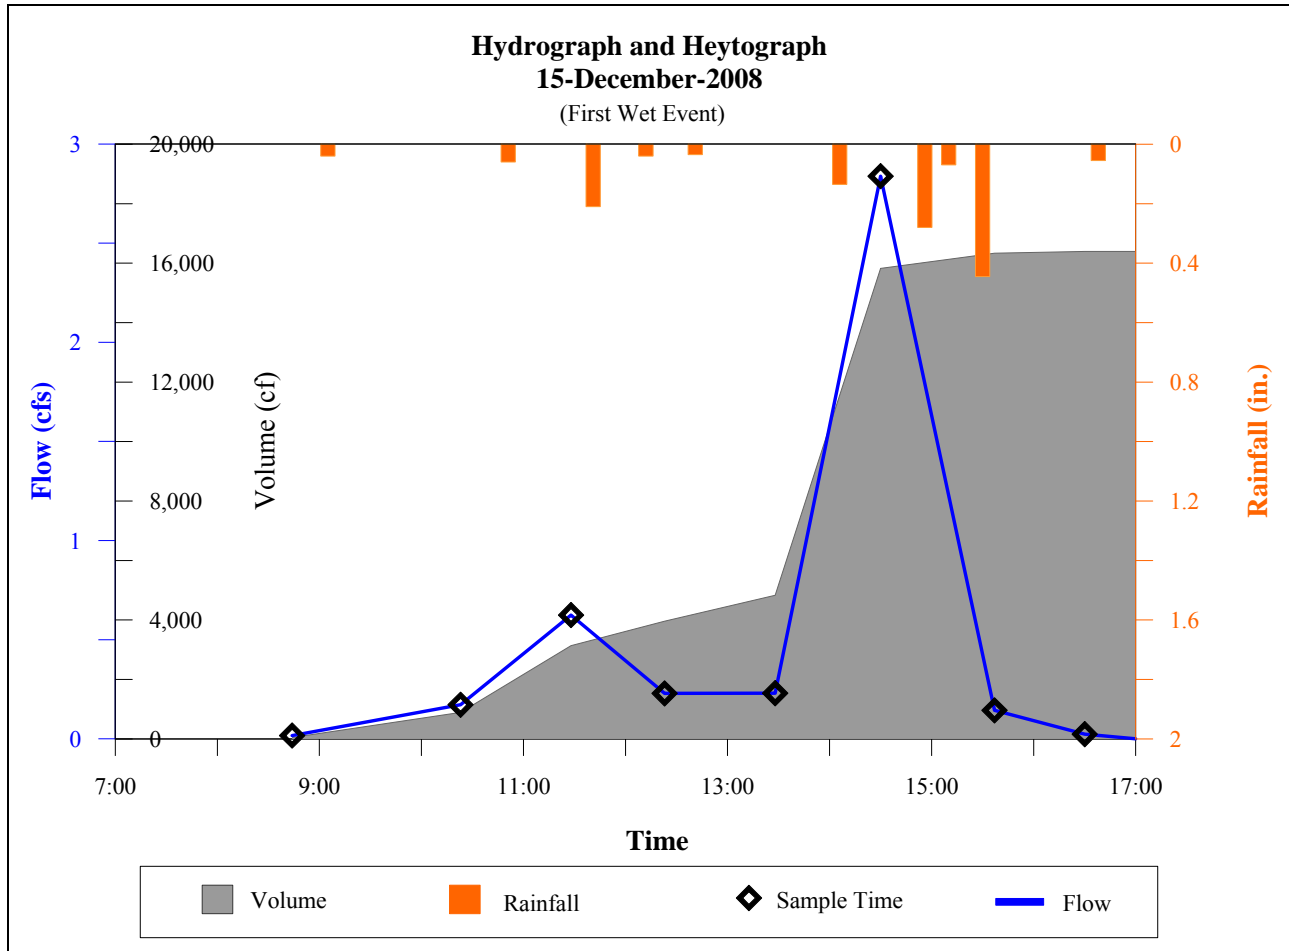
Figure 11. Storm 1 Hydrograph – December 15, 2008

The first monitoring event at this location was on December 15, 2008. The total storm duration was approximately eight hours. The field team was deployed onsite at 08:00. Samples were collected at hourly intervals, with some exceptions based on rainfall patterns. At each sample collection time, flow was estimated by measuring width, depth, and velocity of the runoff into the storm drain. Figure 11 displays the storm hydrograph, sample collections times, rainfall over the course of the storm, and runoff volume.

In general, the samples collected were opaque, white, or brown in color, and contained fine particulates and/or sediment. As can be seen in the hydrograph on Figure 11, flow corresponds closely to rainfall amounts, with the highest peak occurring shortly before the greatest rainfall intensity recorded. This is most likely a result of the measuring device not accurately reporting when the peak occurred, which happens if the needle on the device gets stuck, and then become unstuck. This discrepancy does not affect the accuracy of the total rainfall measured. The cumulative volume for this storm event was estimated to be approximately 16,500 cubic feet (cf) from a total of 1.37 inches of rainfall.

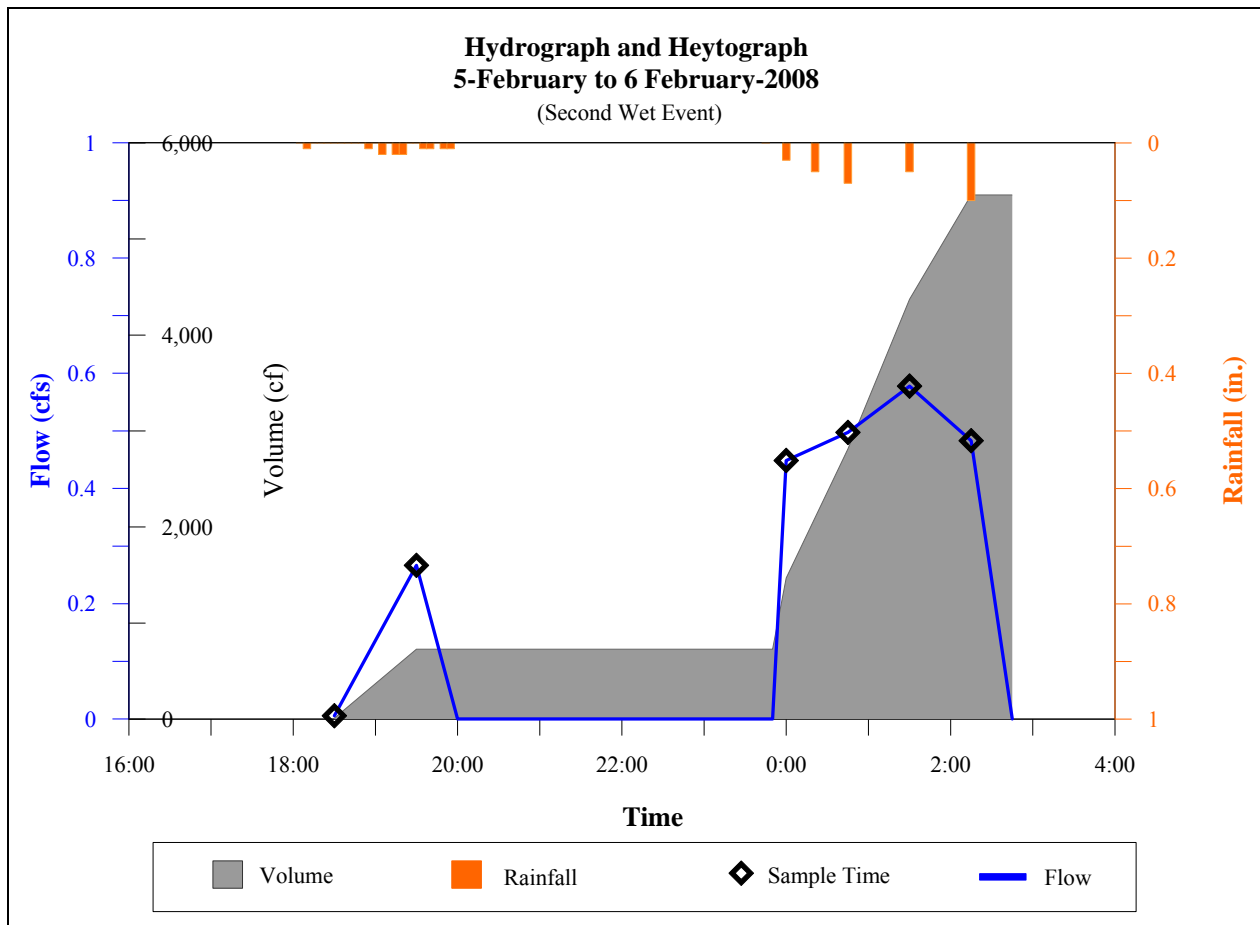
Figure 12. Storm 2 Hydrograph – February 6, 2009

The second storm monitoring event at this location was on evening of February 5, 2009 and continued through to the early morning of February 6, 2009. The total storm duration was approximately eight hours. The field team was deployed onsite at 18:00. Samples were collected on hourly intervals, with some exceptions based on rainfall patterns. At each sample collection time, flow was also estimated by measuring width, depth, and velocity of the runoff into the storm drain. Figure 12 displays the storm hydrograph, sample collections times, rainfall over the course of the storm, and runoff volume.

In general, the samples collected were slightly cloudy and brown in color, and foam was observed. This storm had approximately one third of the rainfall of the first event, with a total of 0.42 inch of rainfall. Correspondingly, the maximum flow observed during this storm event and the total volume of runoff estimated were approximately one third of the first storm event. The cumulative volume 5,500 cf was estimated for this storm event.

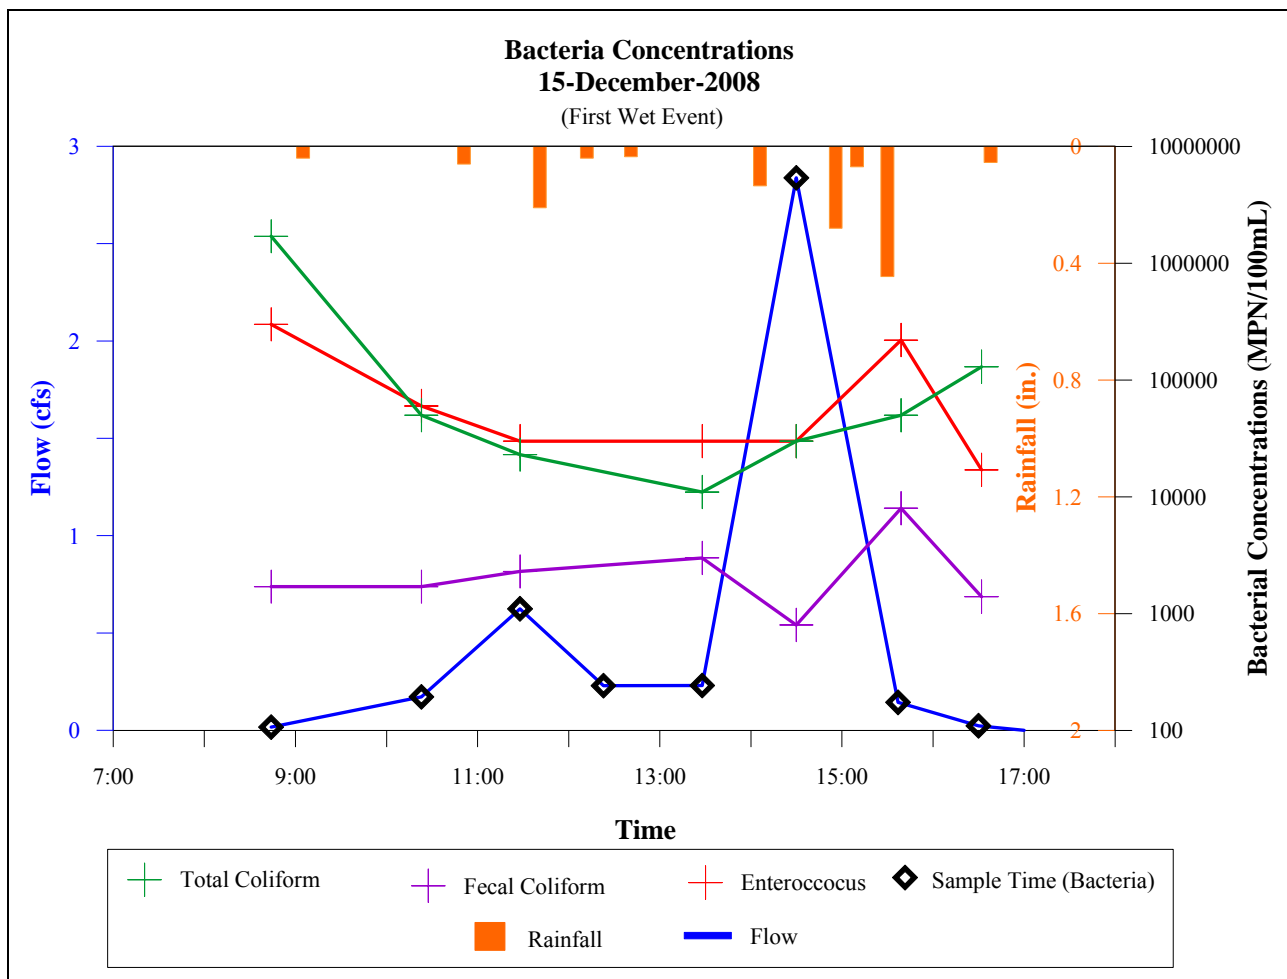
Figure 13. Hydrograph and Sample Concentrations during First Storm Event – December 15, 2008

- **Bacteria** – During the December storm, bacteria concentrations started high, decreased when flow was relatively small and steady, and rose again during the peak flow event (Figure 13). During the February storm bacterial concentrations rose across the peak flow of the storm event (Figure 14).
