CHAPTER 3: EXISTING CONDITIONS ASSESSMENT

This chapter of the University Avenue Mobility Study will focus on an assessment of the existing state of mobility for all modes of transportation and identify areas where short term improvements should be considered. To complete this assessment, the corridor was evaluated to determine the existing traffic operating conditions, the availability of transit, the pedestrian facilities and accessibility, and the bicycle access and circulation. A review of the on-street parking was also conducted to determine the location of the existing parking along the corridor.

UNIVERSITY AVENUE MOBILITY STUDY

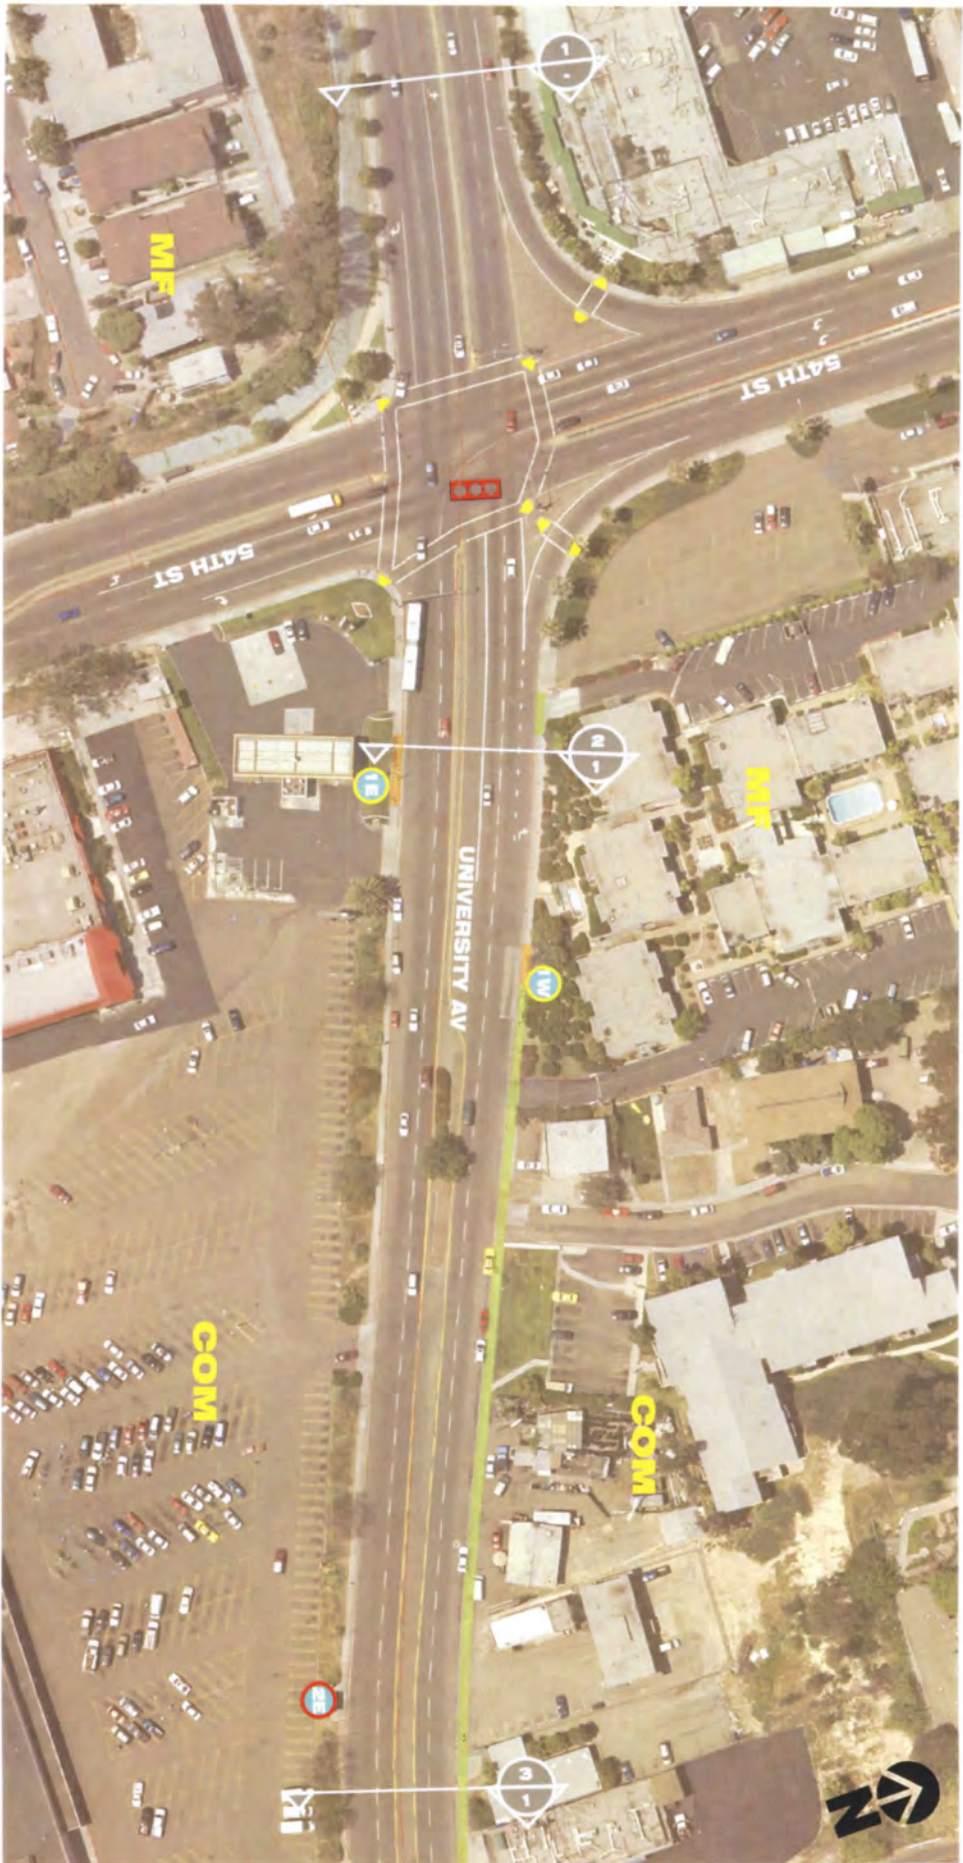
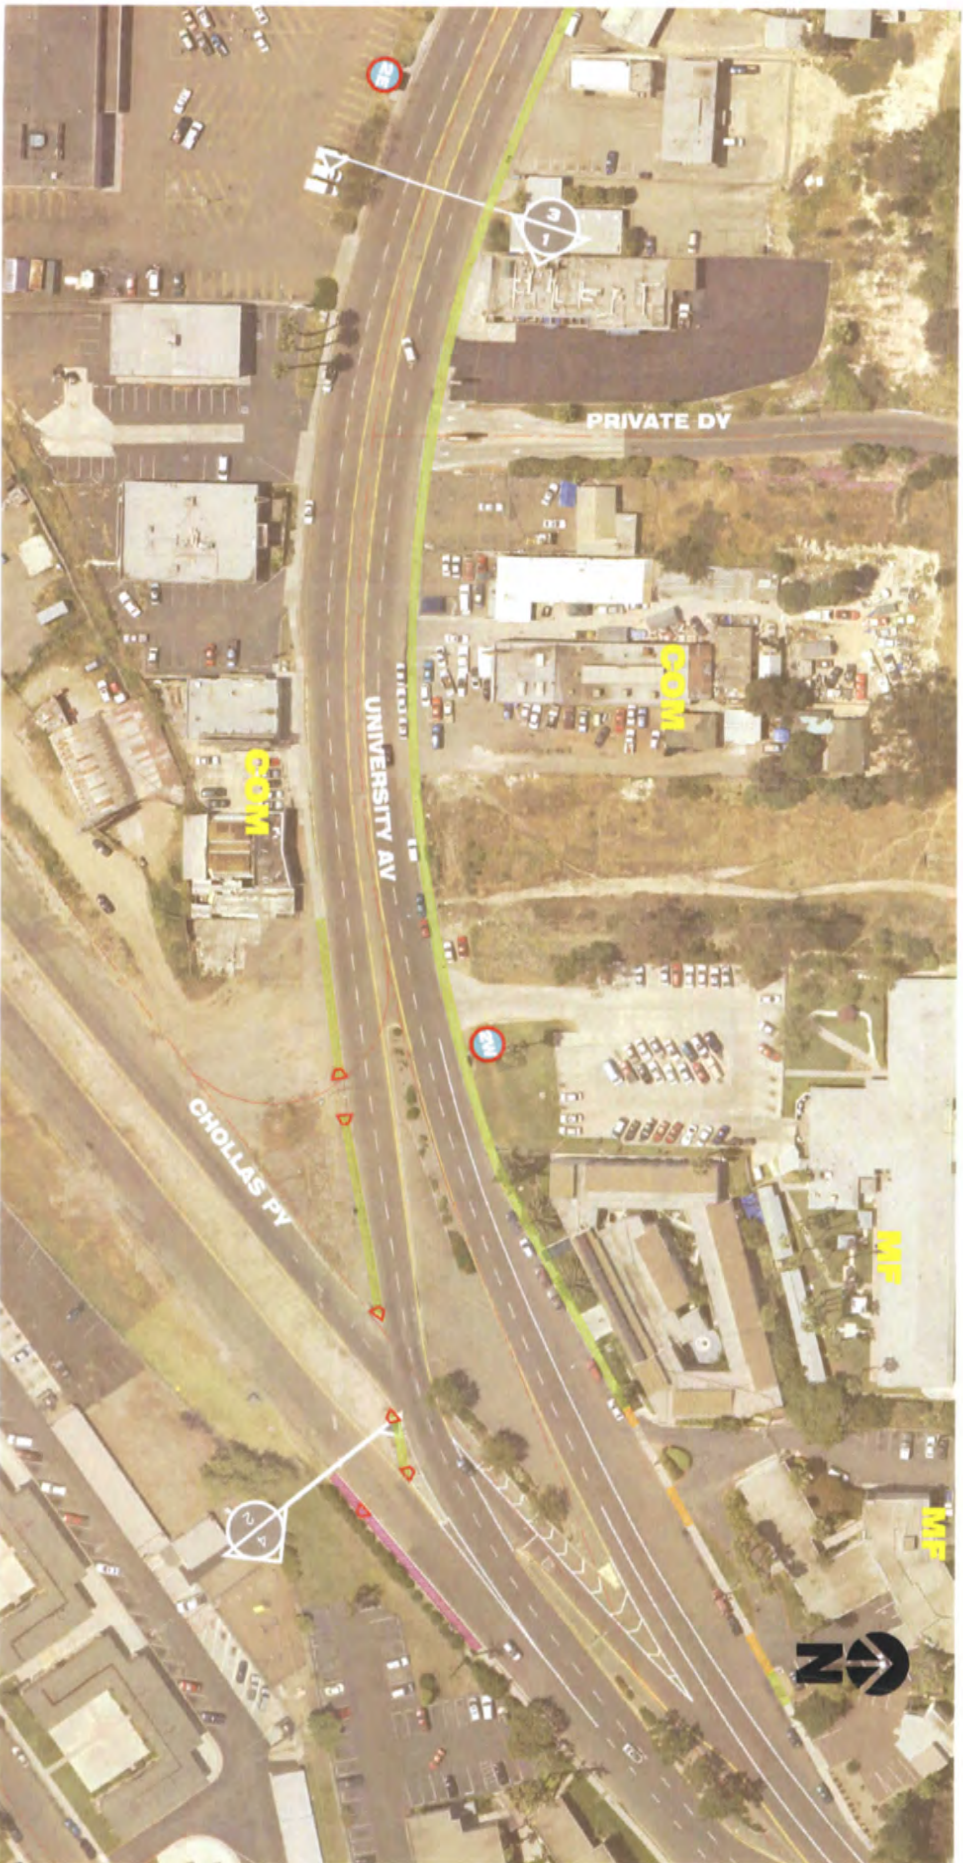
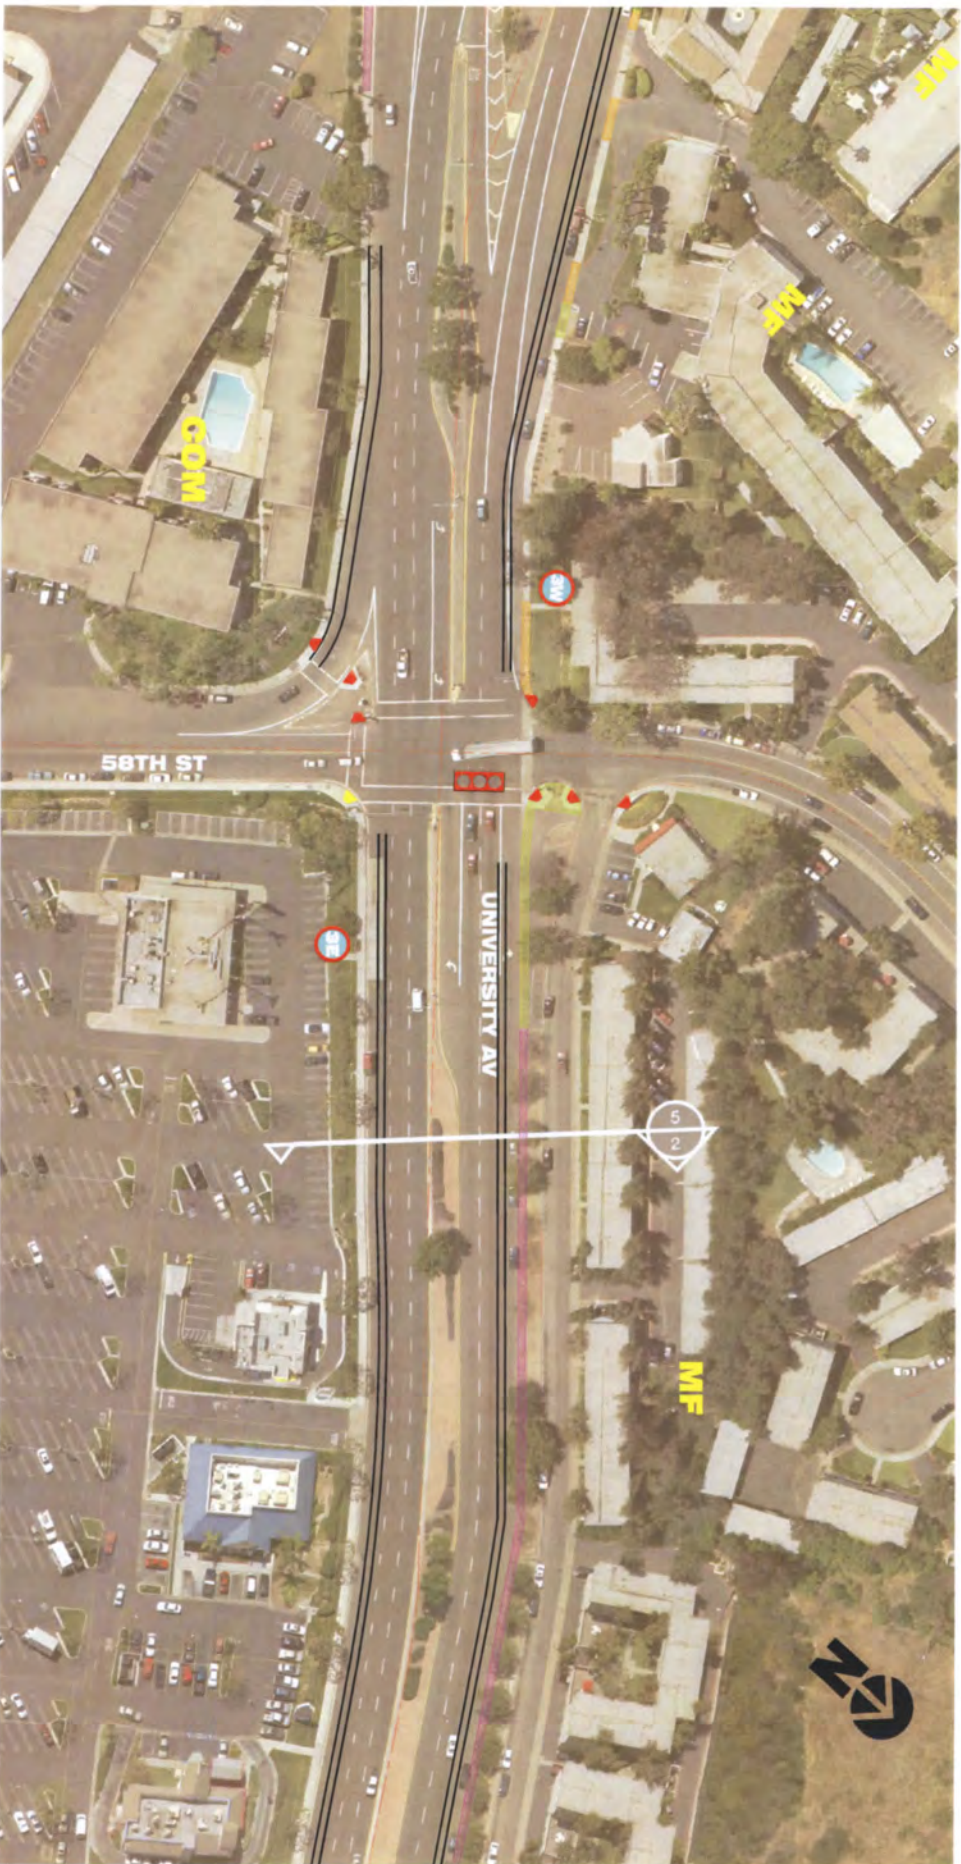
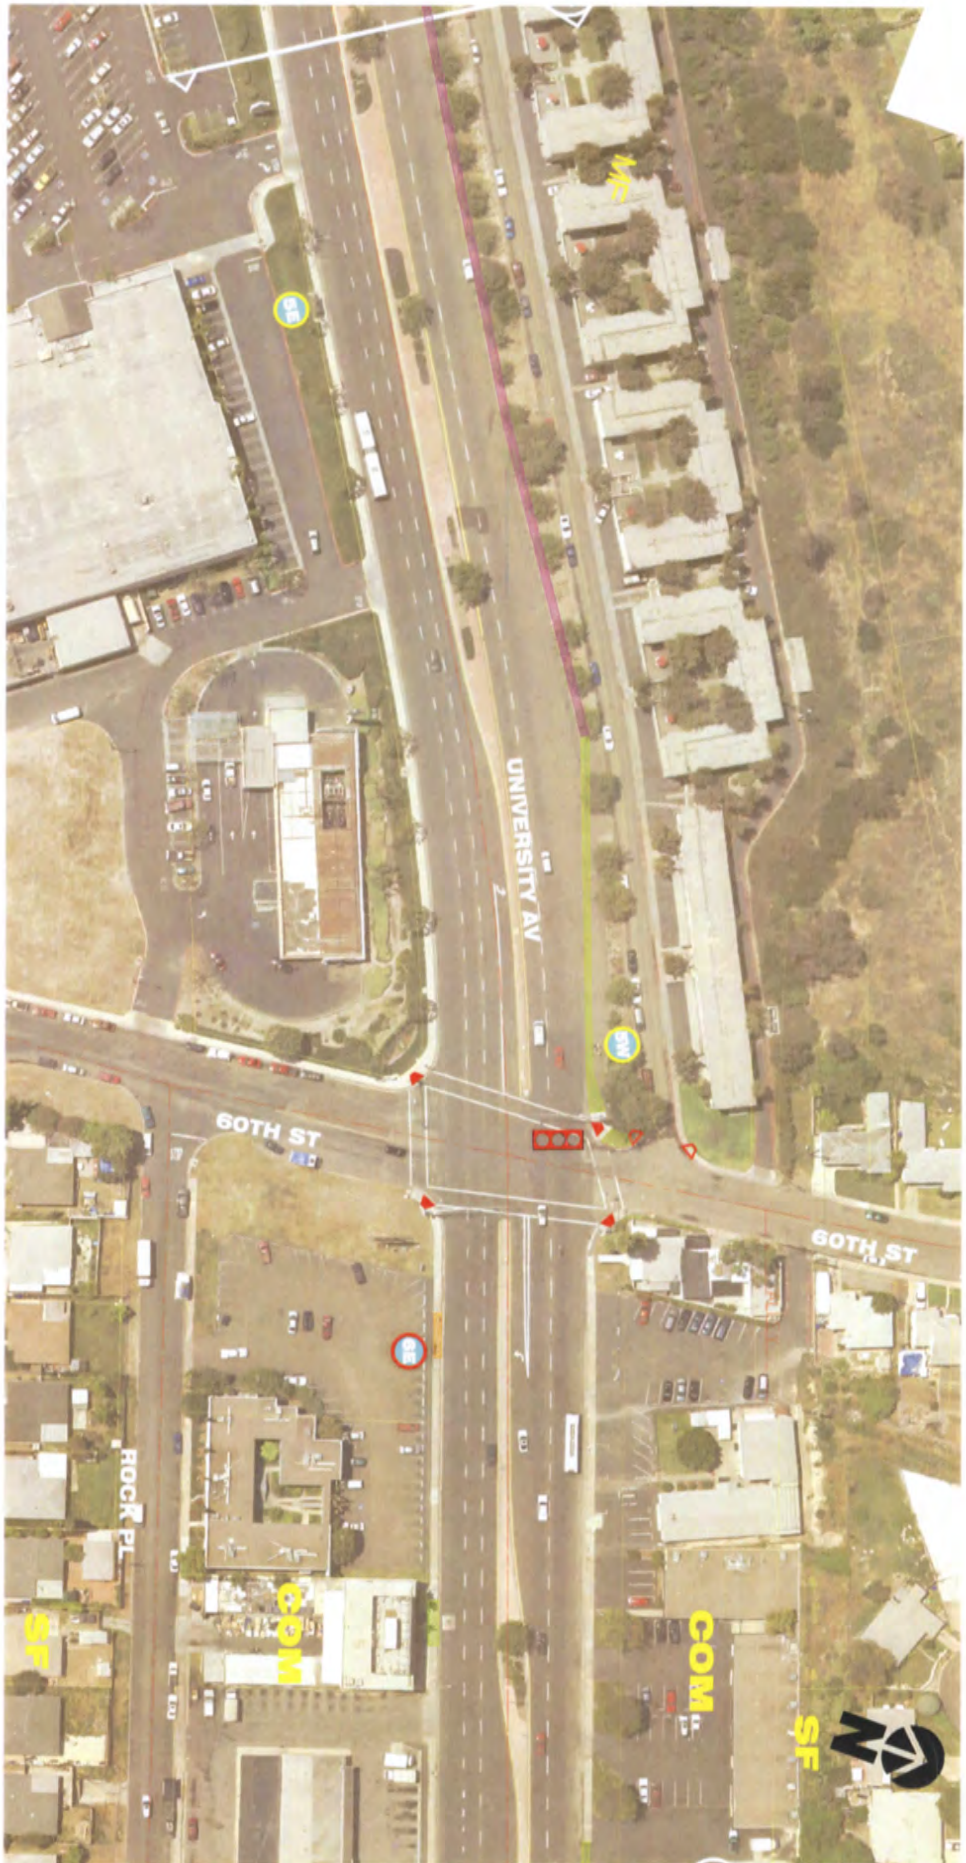
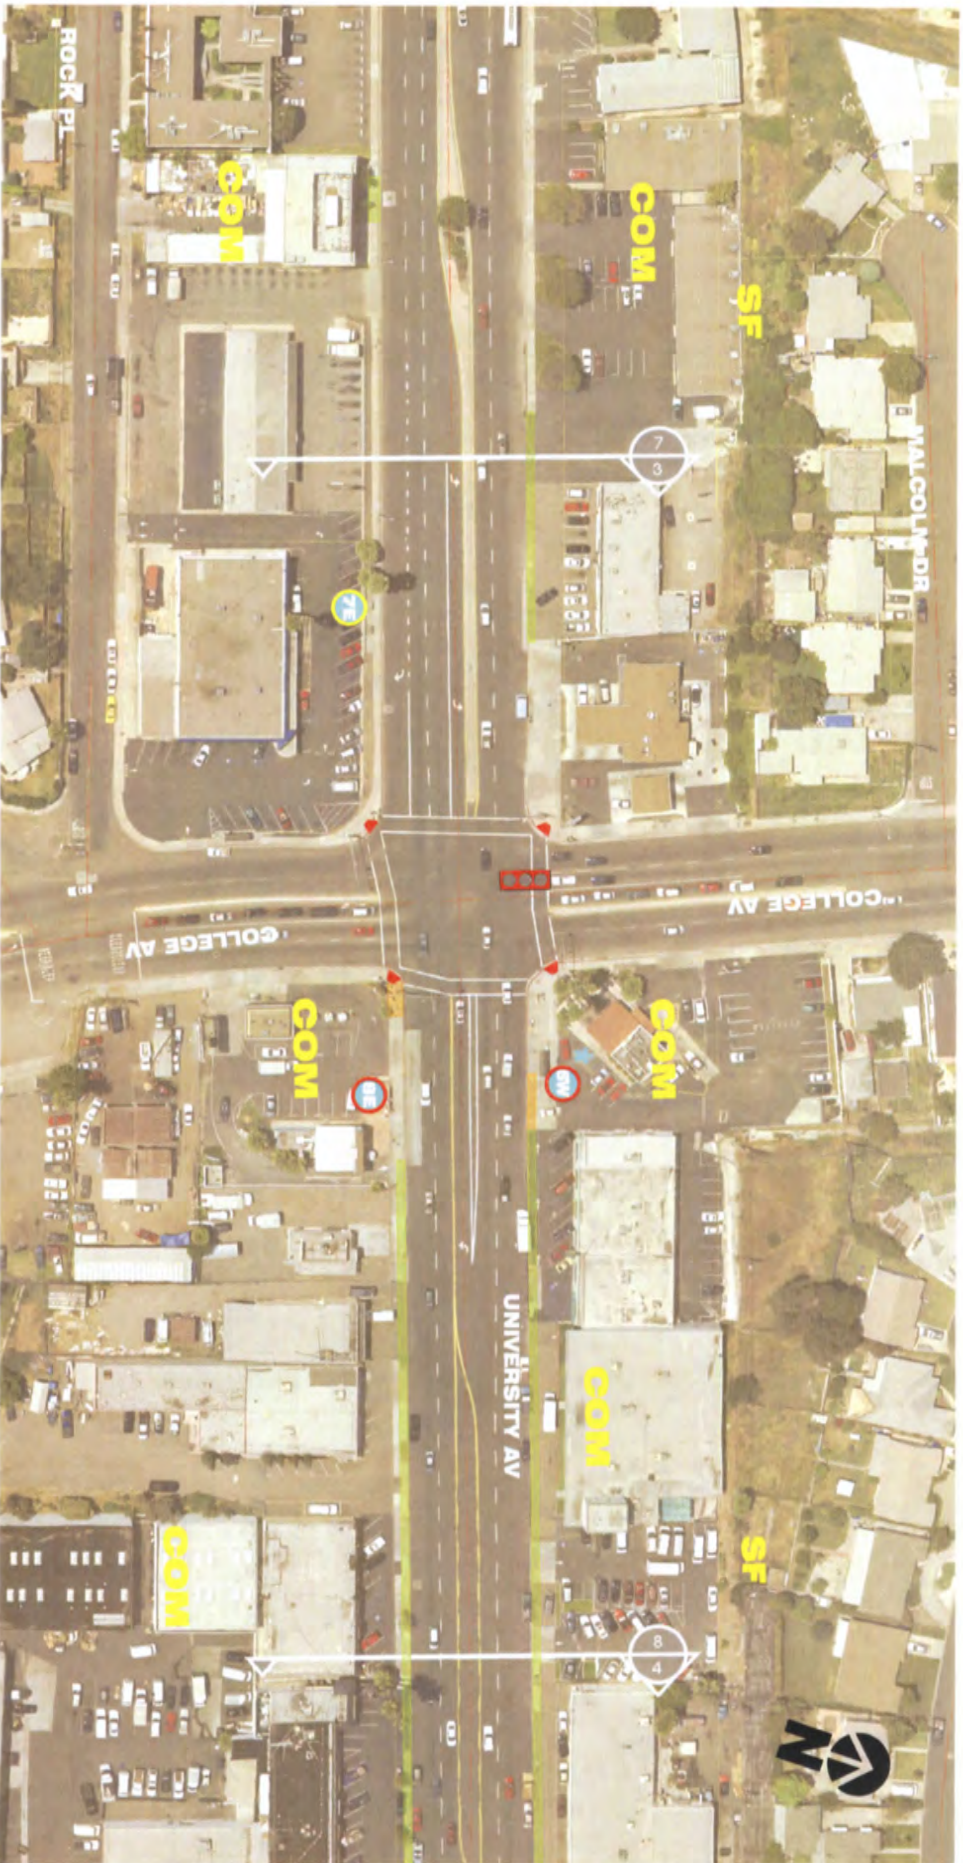
All intersections along the University Avenue Corridor were inventoried for the presence and types of crosswalks. Figures 3-11 through 3-21 display the distribution of crosswalks along the corridor, along with missing infrastructure and sidewalk obstructions. Table 3-9 summarizes the quantity and types of crosswalks found along the corridor by intersection. As shown, there are a total of 27 crosswalks in the corridor. All of the crosswalks within the study corridor are standard white traverse crosswalks. The intersections along the corridor that have no crosswalks are stop-controlled intersections and placing crosswalks across a major street of a stop-controlled intersection is not normally recommended.

Figures 3-11 through 3-21 also displays the locations of missing sidewalks along the University Avenue Corridor. As shown in Figures 3-11 through 3-21, there are either missing or poor sidewalk conditions along most of the University Avenue Mobility Study area with the majority of the problems occurring between College Avenue and Aragon Drive.

- **Pedestrian Walkability and Accessibility:** Based on a review of the existing conditions along the University Avenue Corridor there are several locations where there are missing sidewalks or sidewalks that are obstructed. In addition, there are several missing curb ramps and ramps that are not currently in compliance with the ADA of 1990 and 2010 standards or the California’s Title 24 requirements. Consideration will be given to improving the sidewalks and making sure all curb ramps are ADA compatible.

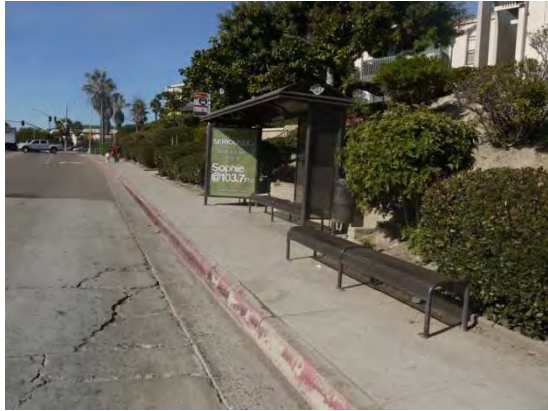
Figure 3-24 - Bus Stop 1W, on the Near Side of the University Ave./54th St. Int.

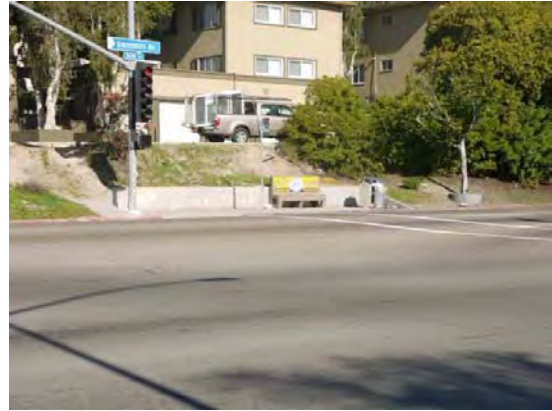
University Square is the only one of these highly utilized stops that does not have shelter and does not have pedestrian access. The College station has adequate area for passengers, but the pavement is in poor condition. The corridor in general is in an older development with narrow sidewalks and intermittent obstructions in the walkways.

Figure 3-25 - Bus Stop 4W, at the Near Side of the University Ave./University Sq. Int.

- **Transit Accessibility/Amenities:** A review of the existing transit stops indicates that there may be a need to relocate some stops to provide better accessibility. Consideration will also be given to providing priority to transit vehicles such that their operating performance will not degrade in the future as traffic volumes increase.

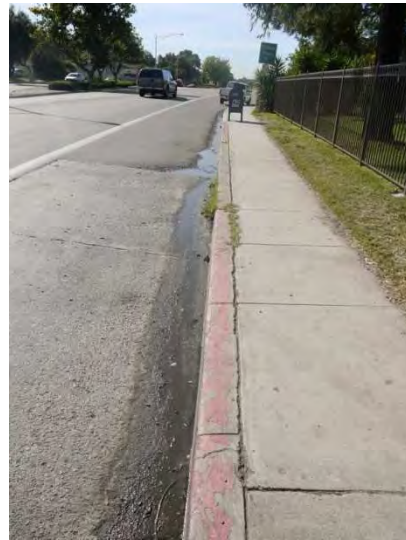
Figure 3-27 - Bus Stop 3W, on the Far Side of the University Ave./58th St. Int.

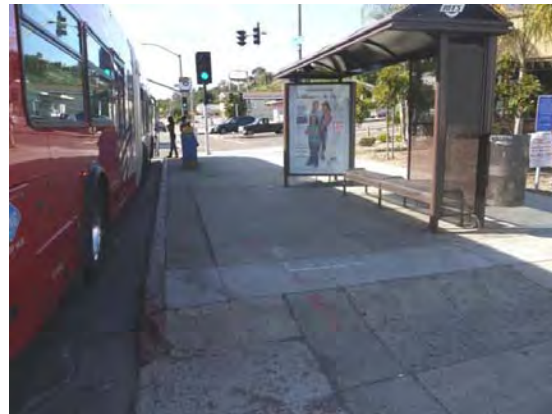
Figure 3-29 - Bus Stop 6W, on the Near Side of the University Ave./College Ave. Int.
