May 8, 2017

Subject: *Master Storm Water System Maintenance Program- Tijuana River Valley Channel Maintenance Project Individual Water Quality Assessment*

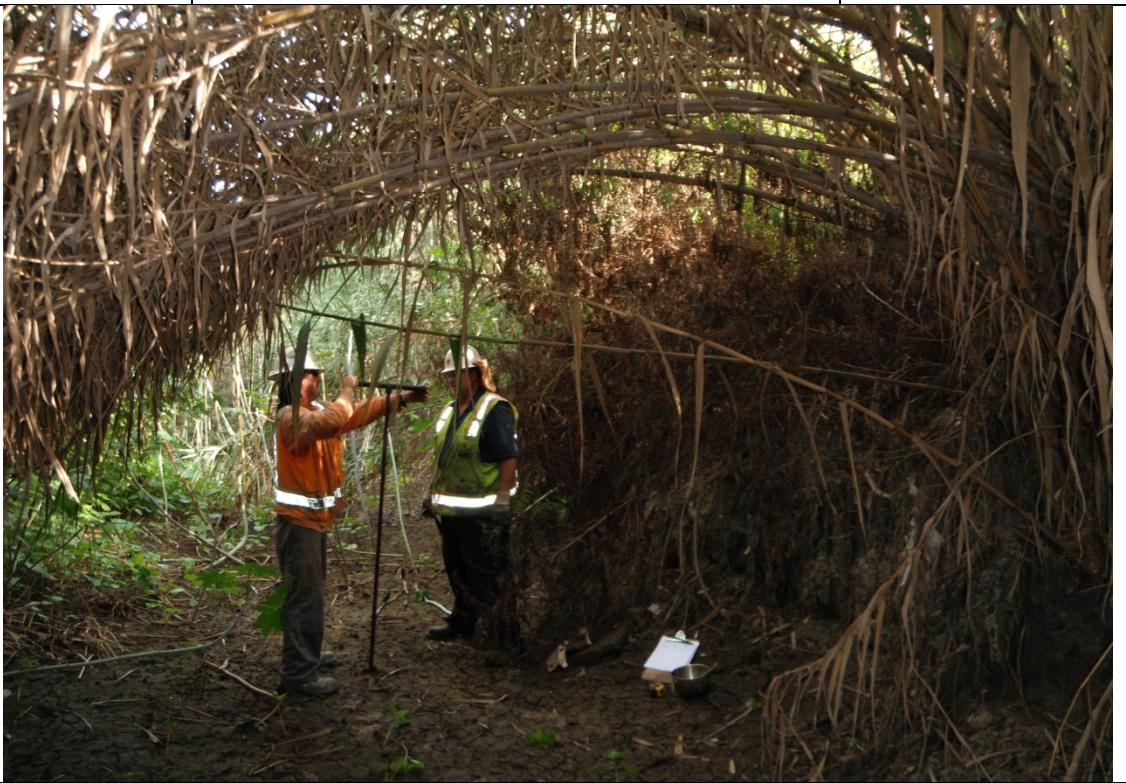
Photo No. 6	Date: 11/14/12
-----------------------	--------------------------

TJ-3 hand auger sample. West of the confluence.

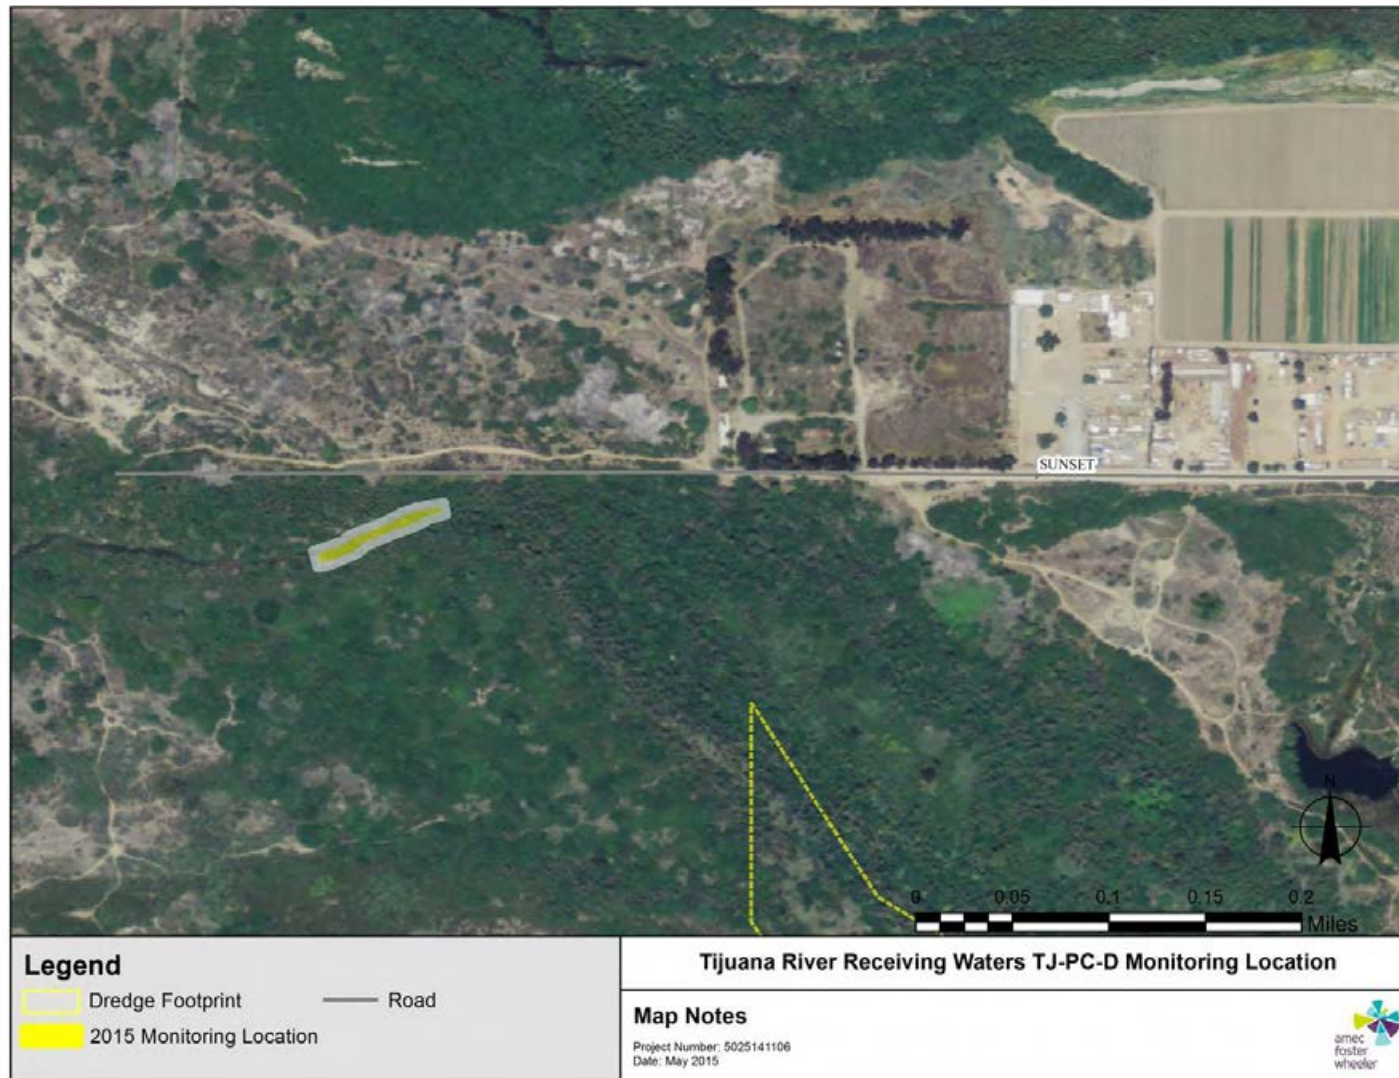
Figure 2-3. TJ-PC-D Monitoring Station
Water quality samples, benthic biological samples, and CRAM data were collected at this location.

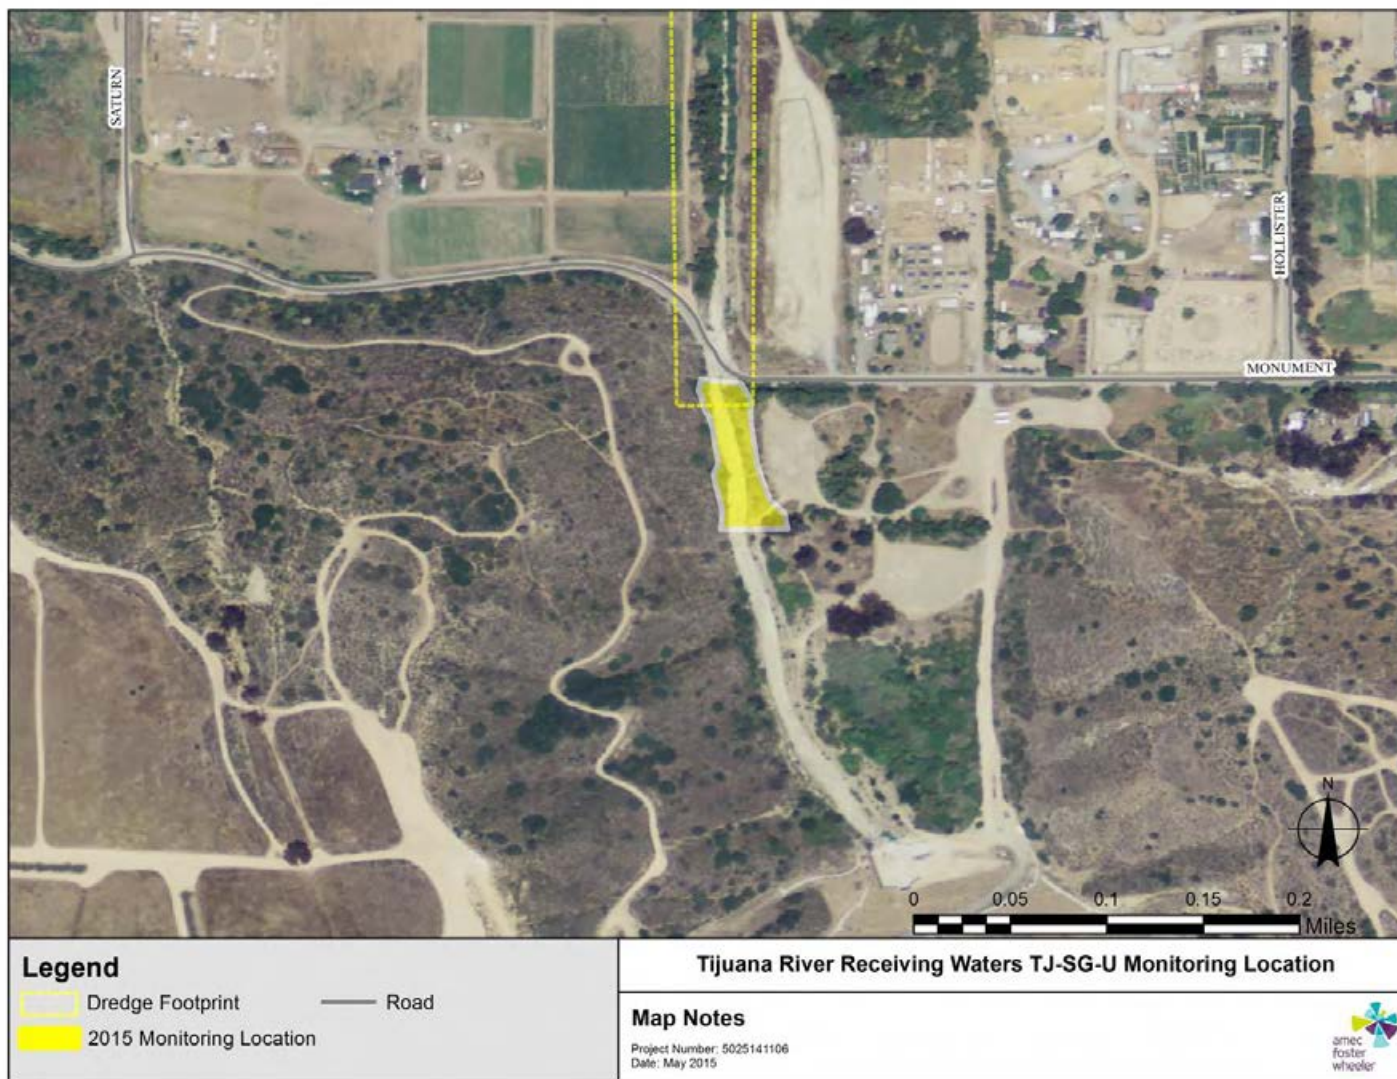
Figure 2-4. TJ-SG-U Monitoring Station
Only CRAM data were collected at this location
