***Subject: 2017 Condition Verification for the Tijuana River Emergency Channel
Maintenance Wetland Mitigation Project, San Diego County, California***

2017 Tijuana River Wetland Mitigation Project

**FINAL WETLANDS
MITIGATION AND MONITORING PLAN
for the
TIJUANA RIVER VALLEY
CHANNEL MAINTENANCE PROJECT**

Third Annual Mitigation Monitoring Report for the Tijuana River Valley Channel Maintenance Mitigation Project

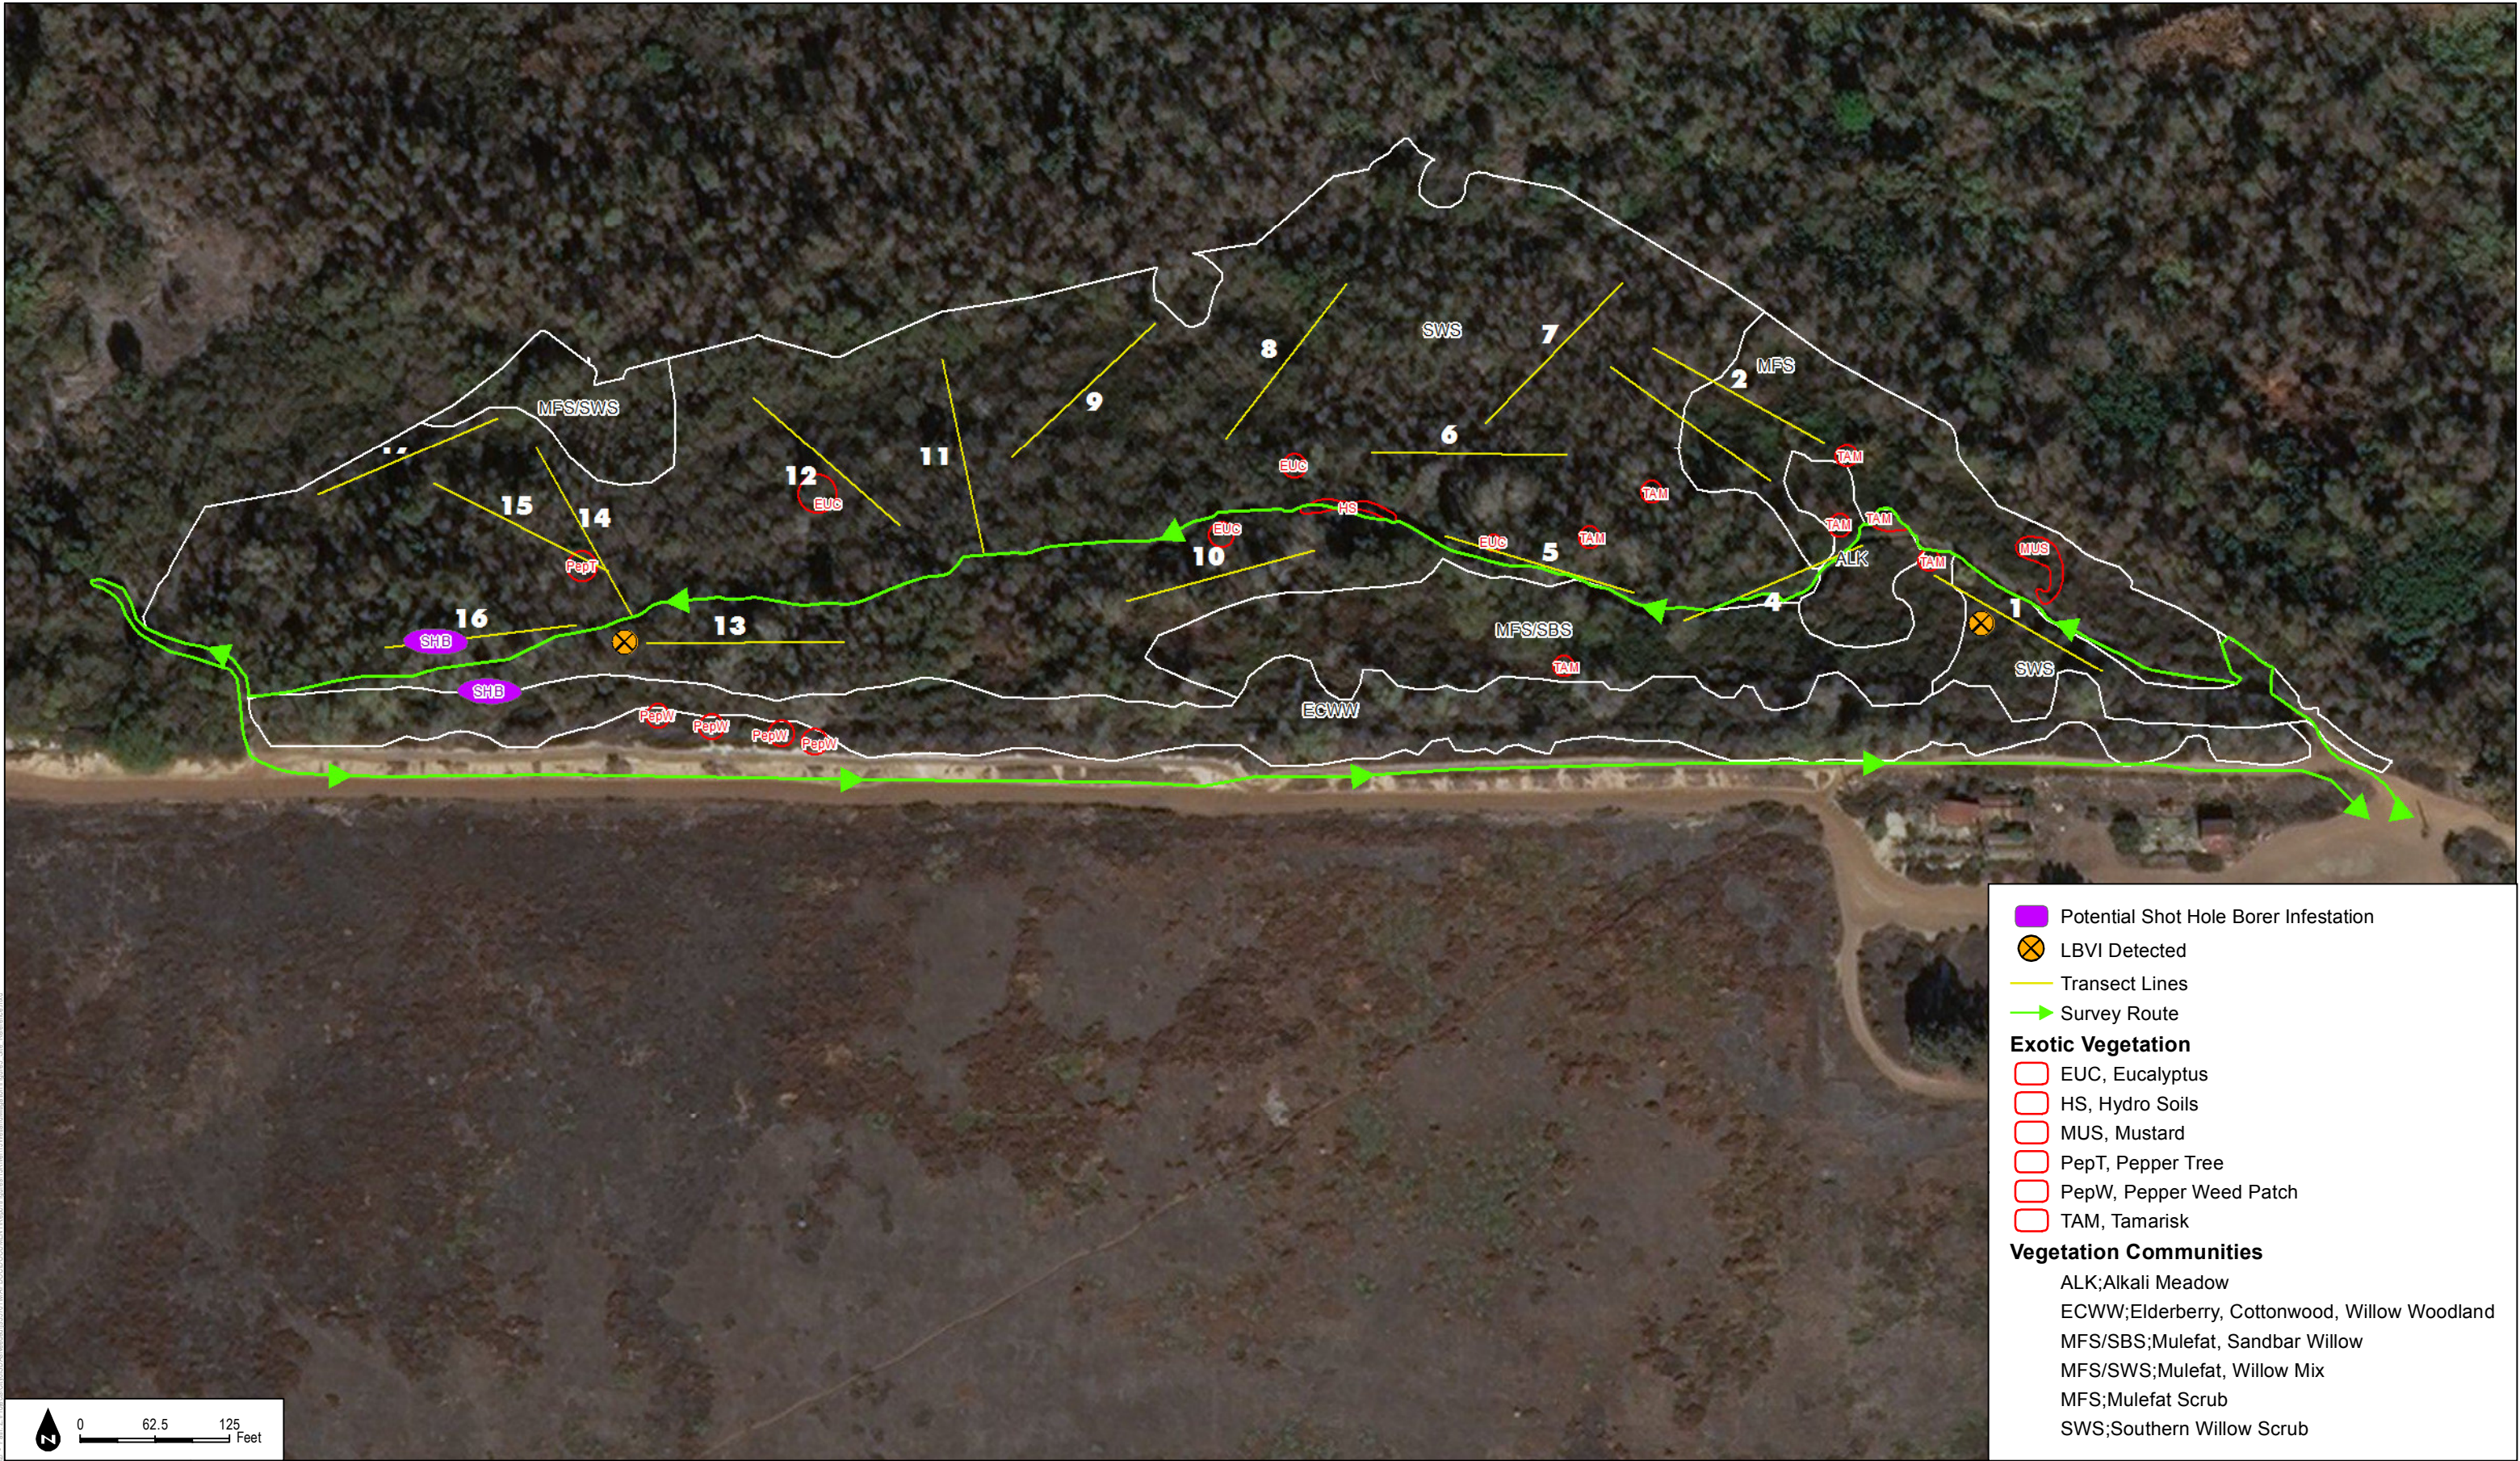
FIGURE 3
Site Reference

In addition to native species, non-native species were noted as well, including salt cedar (*Tamarix ramosissima*), castor bean (*Ricinus communis*), eucalyptus (*Eucalyptus* spp.) and various other non-natives in lesser numbers (Figure 3). These species appear to have increased

At the time of the 2017 mitigation site visit, the majority of the riparian canopy within the mitigation site appeared to be leafed-out and healthy, however towards the western end of the site (Figure 3) there were several stands recently dead willows, some of which were still standing snags, and some of which had fallen, blocking the equestrian trail. Dudek visually examined the trunks, and observed entrance holes and residue consistent with SHB presence. Dudek recommends that tissue samples are collected from these trees and submitted for laboratory analysis to determine if fungi species associated with SHB is present. It is also recommended that regular monitoring of the tree health within the mitigation site be conducted to detect any significant decline in tree health, and/or presence of SHB, so that appropriate management can begin as early as possible if warranted.

During the site walk through, LBVI were detected through vocalization at the eastern end of the site as well as within the western-central portion of the site (Figure 3). Given that the site walk-through was performed during the nesting and breeding season for LBVI, it can be determined that the site is providing suitable functions and services to support forage, nesting and/or breeding. Based on the criteria outlined in Table 2, presence of LBVI constitutes compliance with final performance metrics.

slightly in area/ stature compared to the previous year's site visits, as no focused control has occurred. While they are not yet threatening the overall integrity of the site, it is recommended that a control effort is implemented to prevent continued spread of non-native plant species within the site.

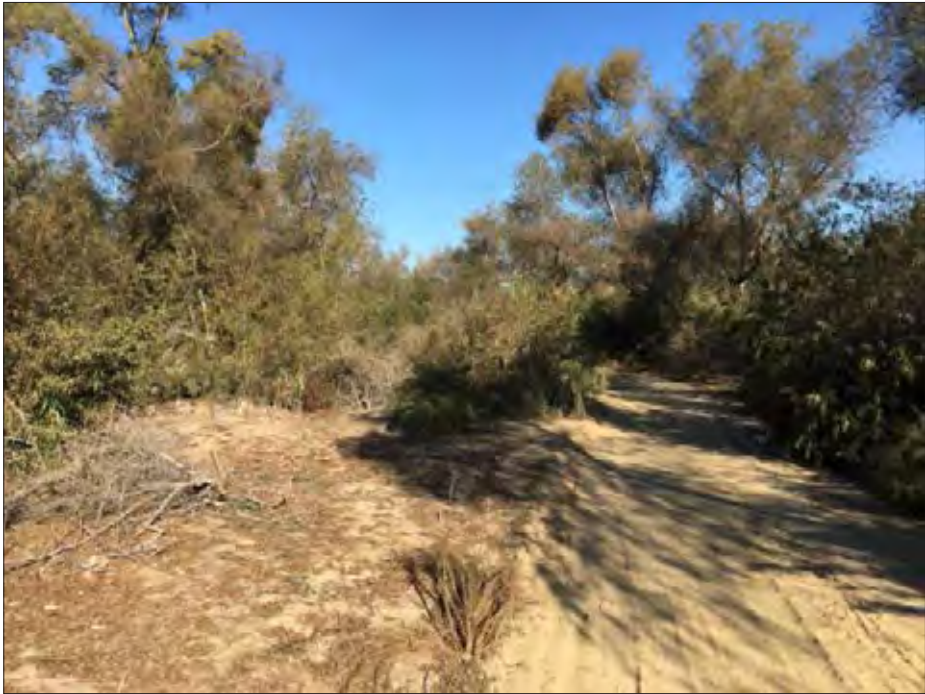
Photo Point 1 (November 2, 2016)

Photo Point #	Date	Time	Coordinates (Lat/Long,)	Direction	Location Description	Notes/Conditions
PP-1	11/2/16	0945	117° 5' 18.73" W 32° 33' 03.70" N	N	View of out-of-channel mitigation area along access road.	Area which received recent invasive non-native removal and control.
PP-2	11/2/16	0956	117° 5' 20.71" W 32° 33' 06.58" N	NW	View of out-of-channel mitigation area along access road at horse trail crossing at northern end of site.	Area which received recent invasive non-native removal and control.
PP-3	11/2/16	0958	117° 5' 20.99" W 32° 33' 06.83" N	W	View of out-of-channel mitigation area along access road at horse trail crossing at northern end of site.	Area which received recent invasive non-native removal and control.
PP-4	11/2/16	0957	117° 5' 21.12" W 32° 33' 06.91" N	W	View of out-of-channel mitigation area looking down the horse trail at cleared area.	Area which received recent invasive non-native removal and control.
