# Municipal Waterways Maintenance Plan

## Annual Report

### Fiscal Year 2024

City of San Diego  
Stormwater Department

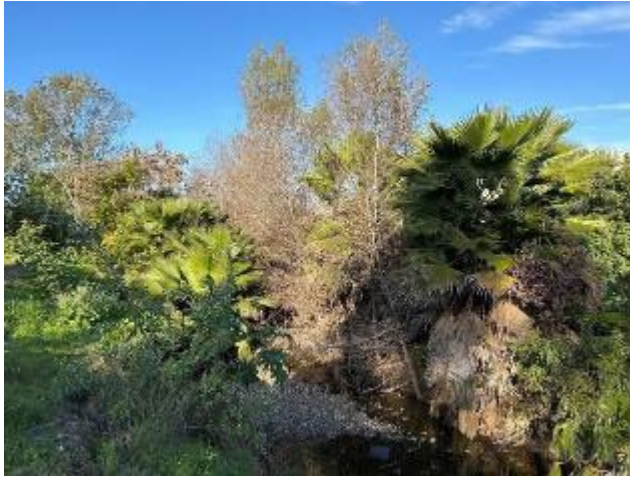
**Rolando 2 Pre-Maintenance- Photo 1**

Rolando 2 channel, pre-maintenance condition. Photo taken from eastern extent of maintenance area, facing west.

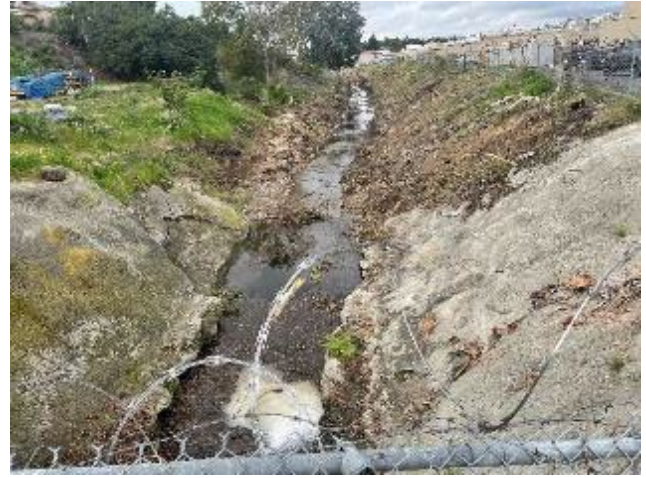
**Rolando 2 Post-Maintenance- Photo 2**

Post-maintenance: Rolando 2 channel, post-maintenance condition.

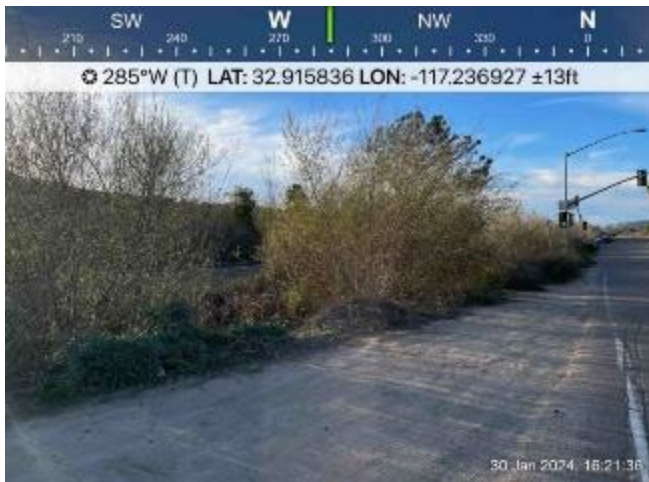
**Industrial 1 Pre-Maintenance- Photo 1**

Pre-maintenance condition of Industrial 1 channel west of Sorrento Valley Road, facing west.

The emergency work at Industrial 1 & 2 was initiated on January 31, 2024, and completed on February 1, 2024. Qualified monitoring biologists were on-site conducting full-time and spot check monitoring visits throughout the duration of emergency maintenance activities to ensure that work was limited to the minimum impacts necessary to alleviate emergency conditions.

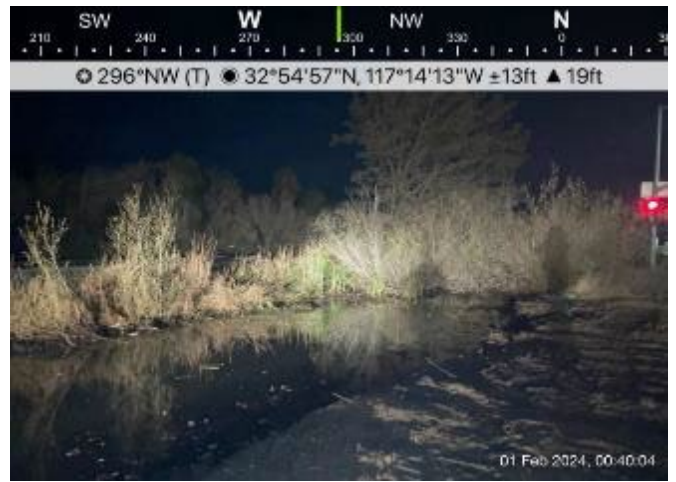
**Industrial 1 Post-Maintenance- Photo 2**

Post maintenance condition of channel showing removal of material.

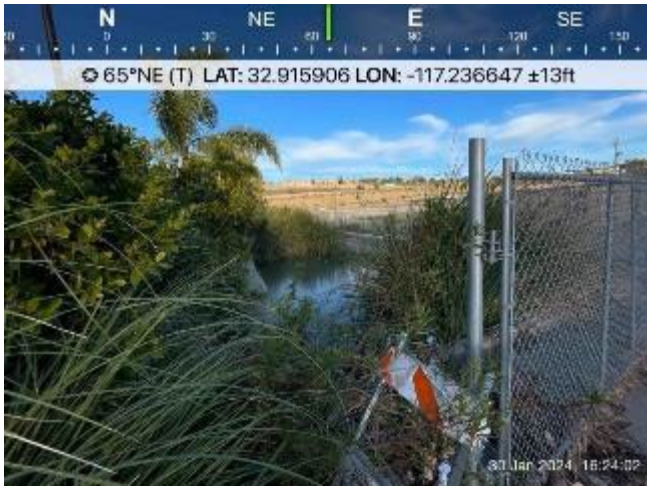
**Industrial 2 Pre-Maintenance- Photo 1**

Pre-maintenance condition of Industrial 2 channel east of Sorrento Valley Road, facing northeast.

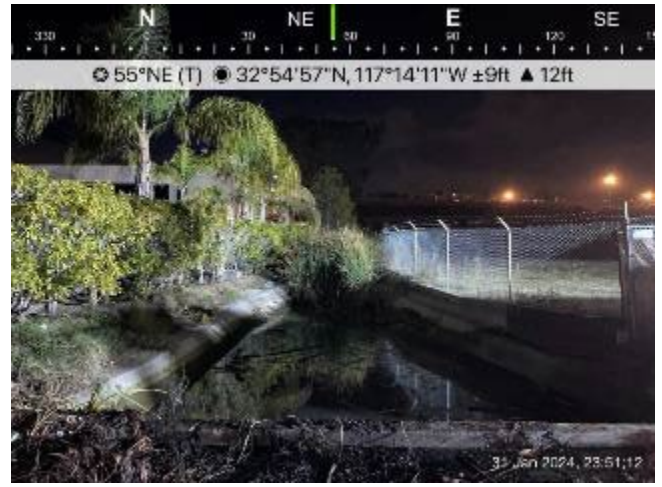
**Industrial 2 Post-Maintenance- Photo 2**

Post maintenance condition of channel showing removal of material.

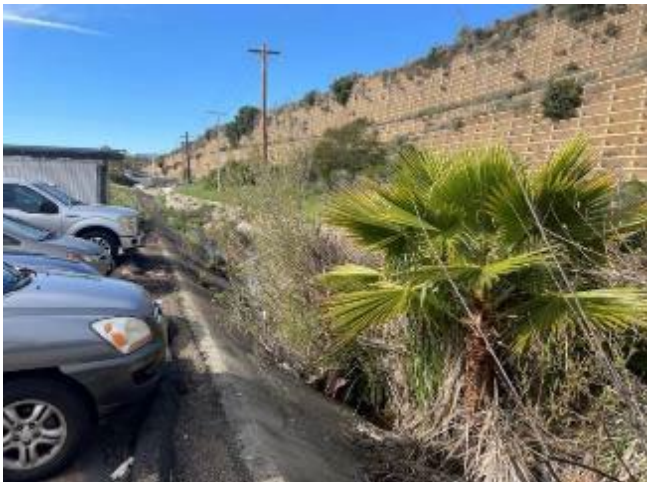
**Tripp 1 Pre-Maintenance- Photo 1**

Pre-maintenance condition of Tripp 1 channel, facing northwest.

The emergency work at Tripp 1 was initiated on March 5, 2024, and completed on March 8, 2024. Qualified monitoring biologists were on-site conducting full-time and spot check monitoring visits throughout the duration of emergency maintenance activities to ensure that work was limited to the minimum impacts necessary to alleviate emergency conditions.

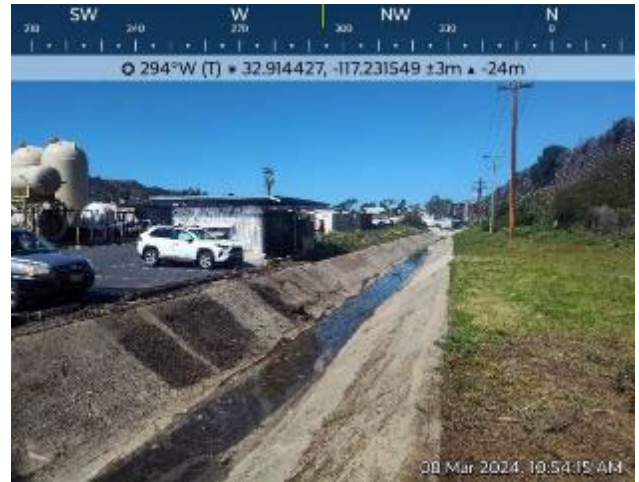
**Tripp 1 Post-Maintenance- Photo 2**

Post maintenance condition of channel showing removal of material, facing west by northwest.

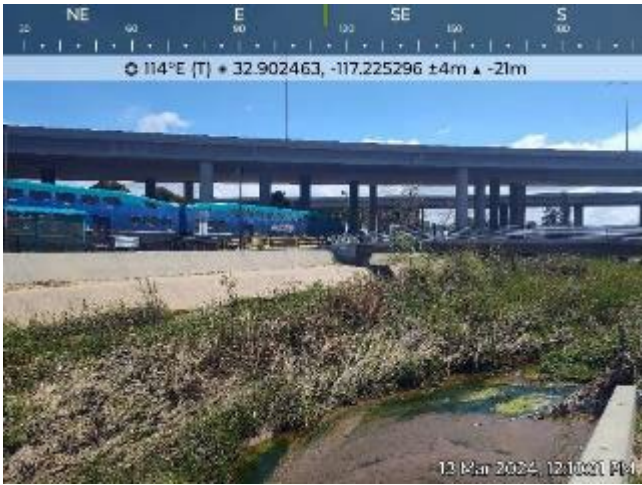
#### **Roselle 2 Pre-Maintenance- Photo 1**

Pre-maintenance condition of Roselle 1 channel, facing east by southeast.

Emergency work at Roselle 2 was initiated on March 14, 2024, and completed on March 26, 2024. Qualified monitoring biologists were on-site conducting full-time and spot check monitoring visits throughout the duration of emergency maintenance activities, to ensure that work was limited to the minimum necessary to alleviate emergency conditions.

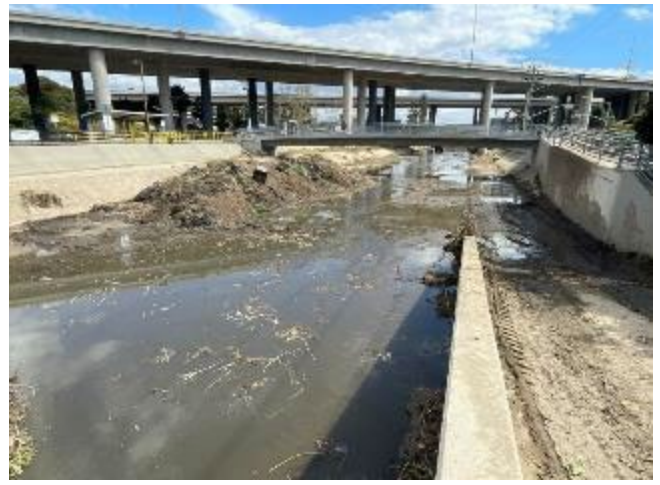
#### **Roselle 2 Post-Maintenance- Photo 2**

Post maintenance condition of channel showing removal of material, facing southeast.

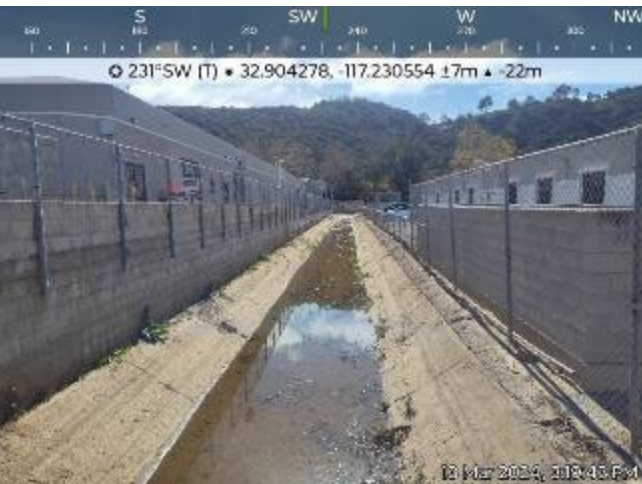
#### **Flintkote 1 Pre-Maintenance- Photo 1**

Post-maintenance condition of Flintkote 1 channel, facing southwest

The emergency work at Flintkote 1 was initiated and completed on March 5, 2024. A qualified monitoring biologist conducted a spot check monitoring visit during emergency maintenance activities, to ensure that work was limited to the minimum necessary to alleviate emergency conditions.

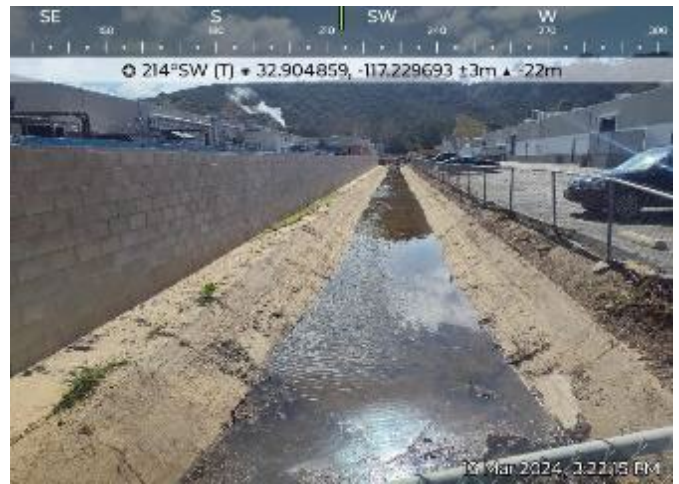
#### **Flintkote 1 Post-Maintenance- Photo 2**

Post-maintenance condition of Flintkote 1 channel, facing southwest.

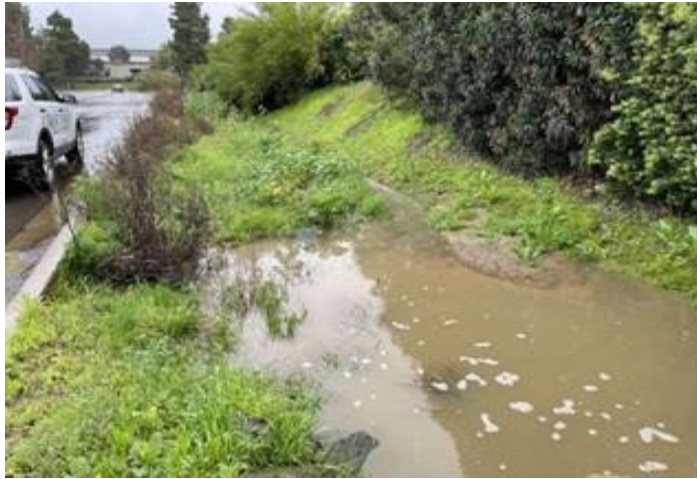
**Dunhill 1 Pre-Maintenance- Photo 1**

Pre-maintenance condition of Dunhill 1 channel, taken from western edge, facing east.

The emergency work at Dunhill 1 was started and completed on March 13, 2024. A qualified monitoring biologist conducted a spot check monitoring visit during emergency maintenance activities to ensure that work was limited to the minimum necessary to alleviate emergency conditions.

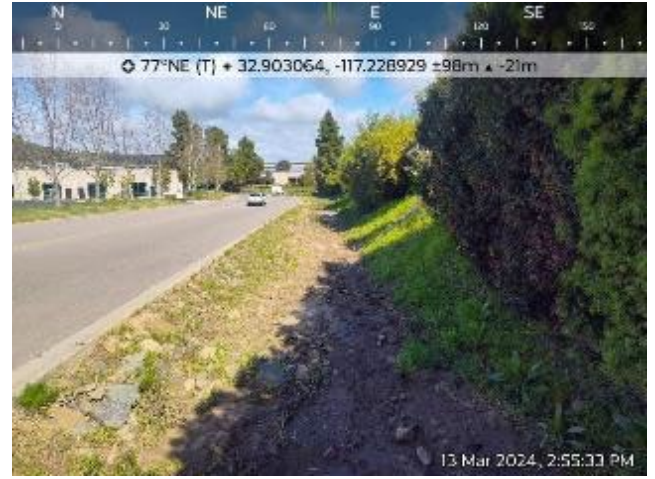
**Dunhill 1 Post-Maintenance- Photo 2**

Post maintenance condition of channel.

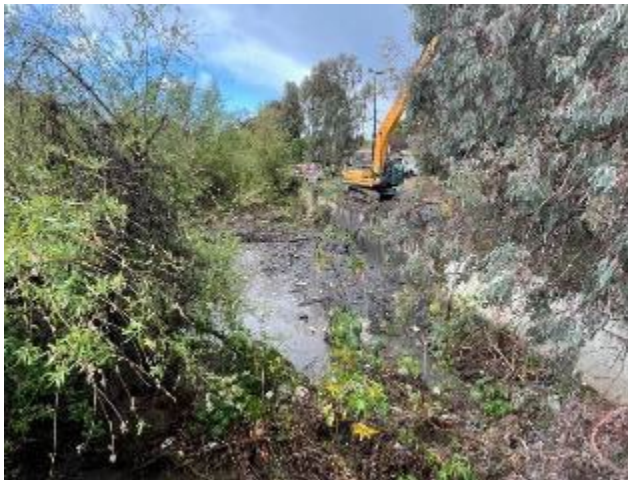
**Garnet 2 Pre-Maintenance- Photo 1**

Pre-maintenance condition of Garnet 2 channel downstream of Mission Bay Drive.

The emergency work at Garnet 2 & Damon 1 was initiated on March 29, 2024, and completed on May 19, 2024. Qualified monitoring biologists were on-site conducting full-time and spot check monitoring visits throughout the duration of emergency maintenance activities to ensure that work was limited to the minimum necessary to alleviate emergency conditions. The monitoring biologist present at the start of maintenance was able to confirm and update, as necessary, the previously mapped vegetation communities and land cover types within the emergency impact area.

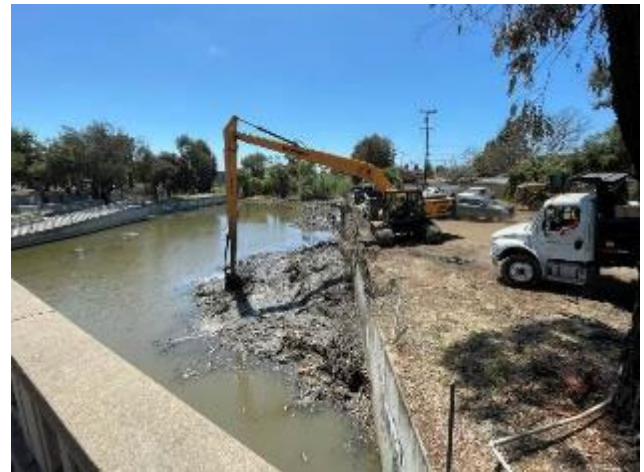
**Garnet 2 Post-Maintenance- Photo 2**

Post maintenance condition of channel showing removal of vegetation.

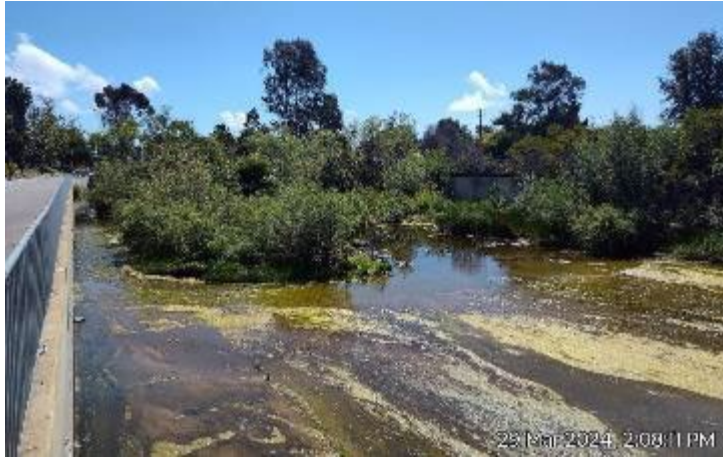
**Damon 1 Pre-Maintenance- Photo 1**

Pre-maintenance condition of Damon 1 channel upstream of Mission Bay Drive.

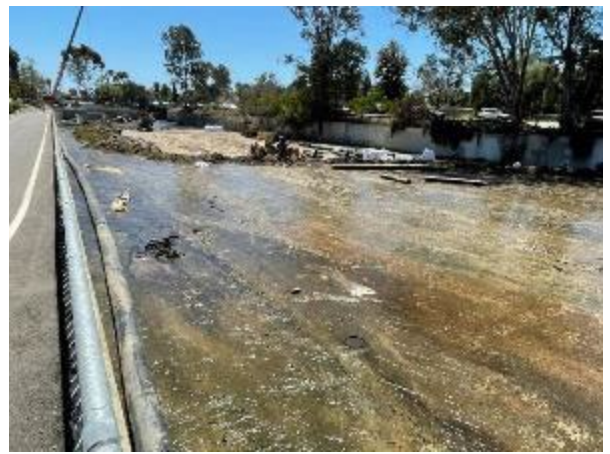
**Damon 1 Post-Maintenance- Photo 2**

Post maintenance condition of channel showing removal of material.

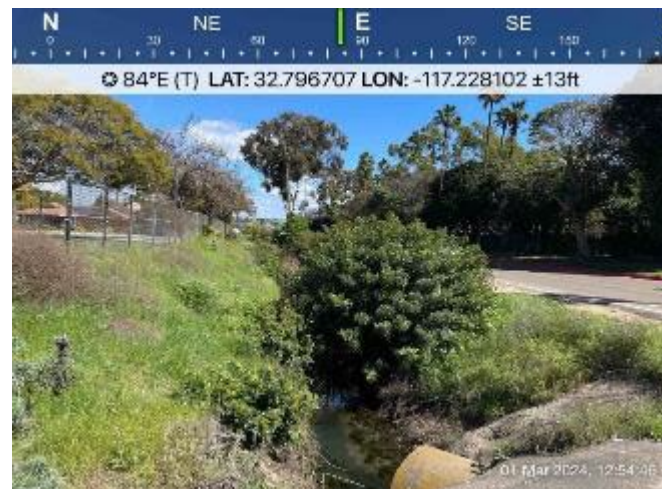
**PB Olney 1 Pre-Maintenance- Photo 1**

Pre-maintenance condition of northeastern end of PB-Olney 1 channel, facing east.

The emergency work at PB Olney 1 & MBHS 1 was initiated on March 11, 2024 and was completed by March 23, 2024. Qualified monitoring biologists were on-site conducting full-time and spot check monitoring visits throughout the duration of emergency maintenance activities to ensure that work was limited to the minimum necessary to alleviate emergency conditions. The monitoring biologist present at the start of maintenance was able to confirm and update, as necessary, the previously mapped vegetation communities and land cover types within the emergency impact area.

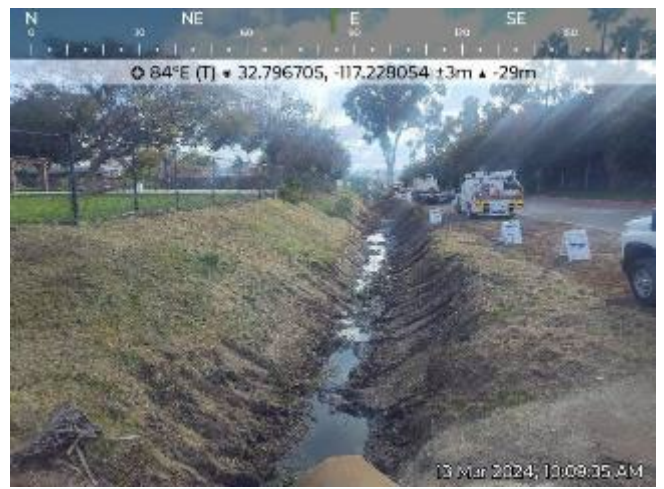
**PB Olney 1 Post-Maintenance- Photo 2**

Post maintenance condition of channel showing removal of vegetation.

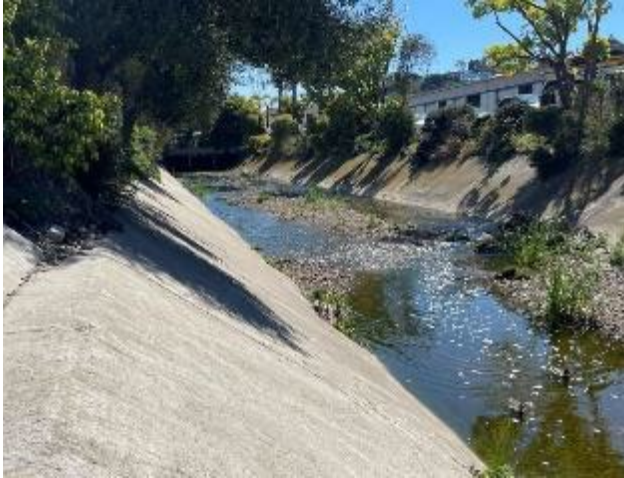
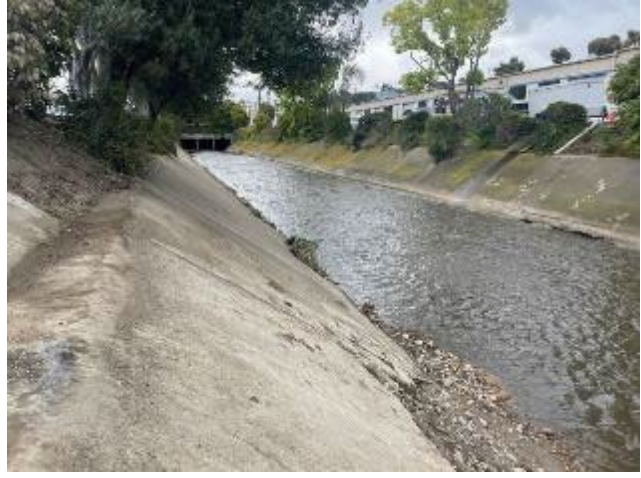
<p><b>Mission Gorge 2 Pre-Maintenance- Photo 1</b></p> <p>Pre-maintenance condition of Mission Gorge 2 channel, facing east.</p> <p>(April 2, 2024)</p>	<p><b>Mission Gorge 2 Post-Maintenance- Photo 2</b></p> <p>Post maintenance condition of channel showing removal of material.</p> <p>(April 5, 2024)</p>

The emergency work at Mission Gorge 2 was initiated on March 28, 2024, and completed on April 15, 2024. Qualified monitoring biologists were on-site conducting full-time and spot check monitoring visits throughout the duration of emergency maintenance activities to ensure that work was limited to the minimum necessary to alleviate emergency conditions.

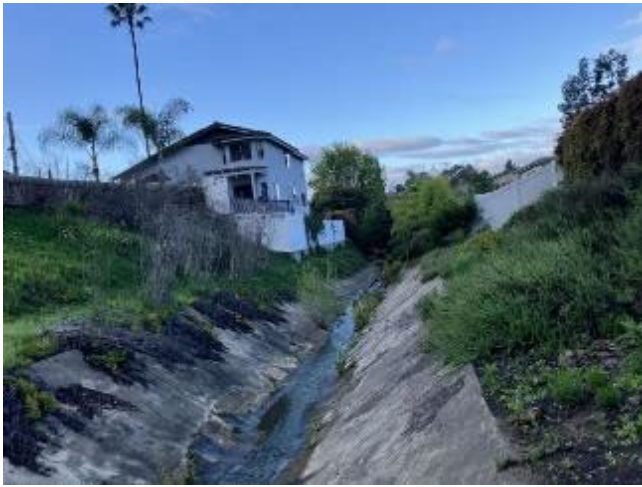
**Cowles Mountain 1 Pre-Maintenance- Photo 1**

Pre-maintenance condition of Cowles Mountain 1 channel north of San Carlos Drive, facing south by southeast.

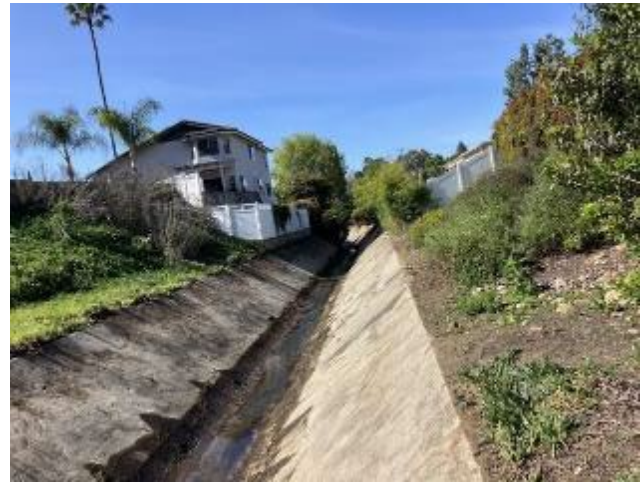
**Cowles Mountain 1 Post-Maintenance- Photo 2**

Post maintenance condition of channel showing removal of material.

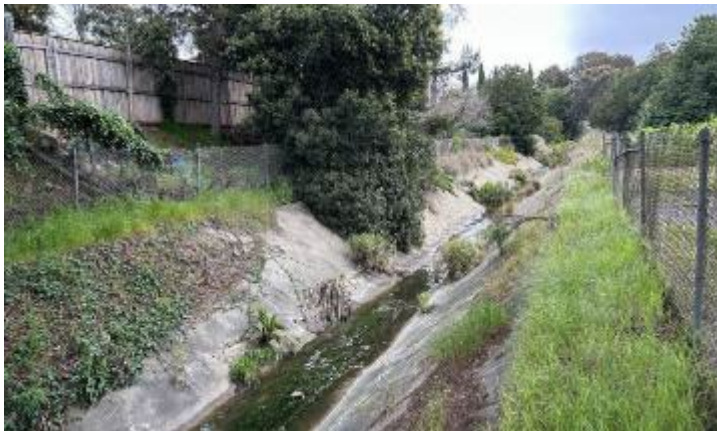
**Cowles Mountain 2 Pre-Maintenance- Photo 1**

Pre-maintenance condition of Cowles Mountain 2 channel east of Lake Badin Drive, facing east by northeast.

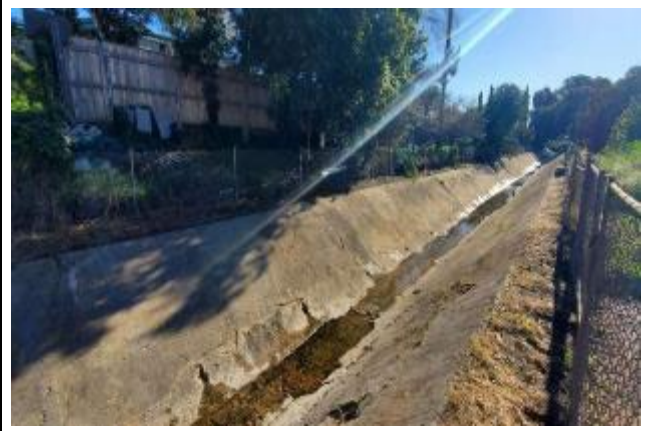
**Cowles Mountain 2 Post-Maintenance- Photo 2**

Post maintenance condition of channel showing removal of material.

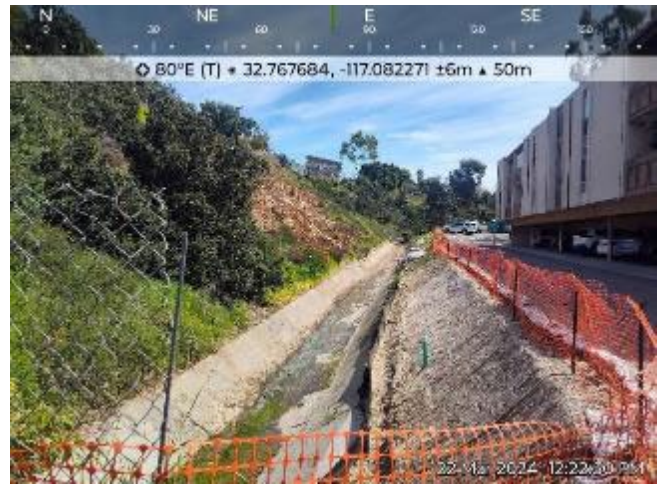
#### **Baja 1 Post-Maintenance- Photo 2**

Post maintenance condition of channel.

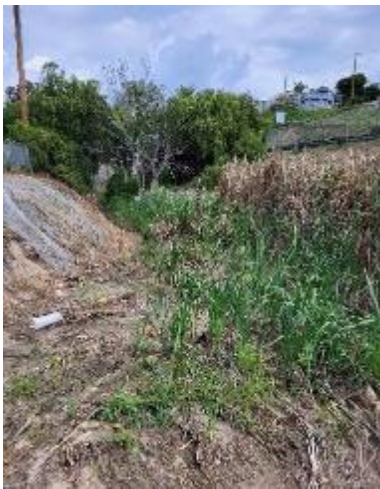
#### **Washington 1 Pre-Maintenance- Photo 1**

Pre-maintenance condition of Washington 1 channel, west of Washington Street, facing north.

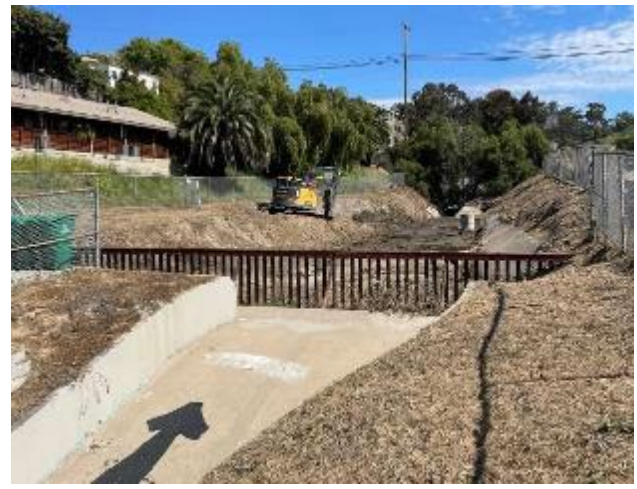
#### **Washington 1 Post-Maintenance- Photo 2**

Post maintenance condition of channel showing removal of material.

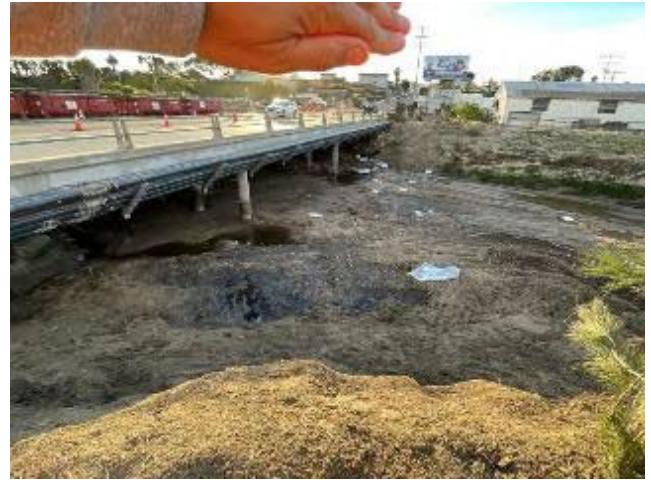
**National 1 Post-Maintenance- Photo 2**

Post maintenance condition of National 1 showing removal of material.

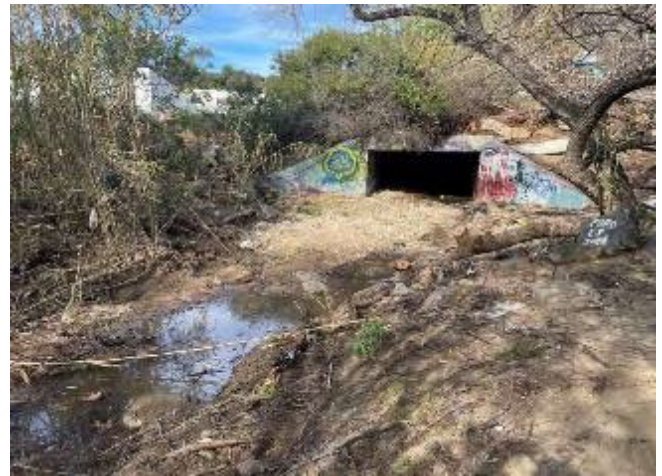
**Home 1 Post-Maintenance- Photo 2**

Post maintenance condition of channel showing removal of debris and vegetation.

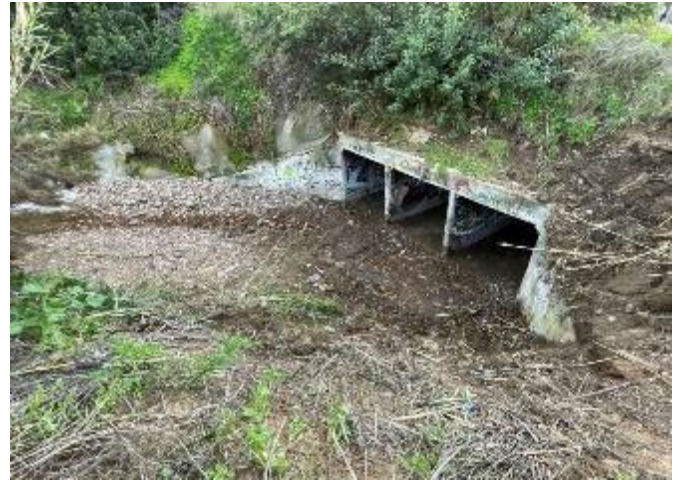
**Home 2 Post-Maintenance- Photo 2**

Post maintenance condition of channel showing removal of material.

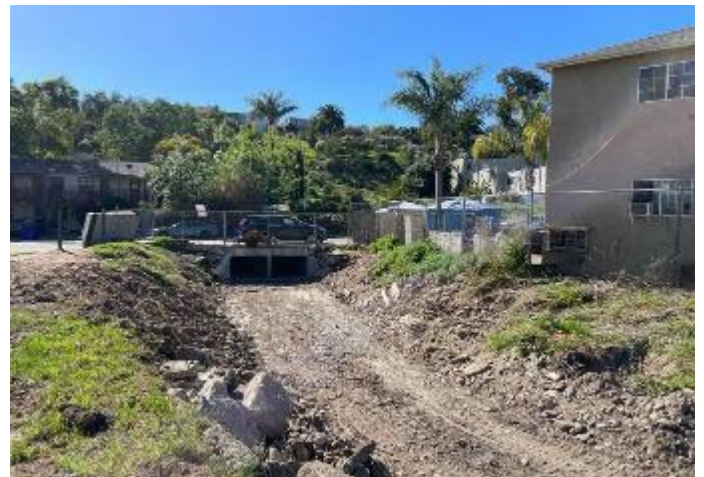
**Ontario 1 Post-Maintenance- Photo 2**

Post maintenance condition of channel showing removal of material

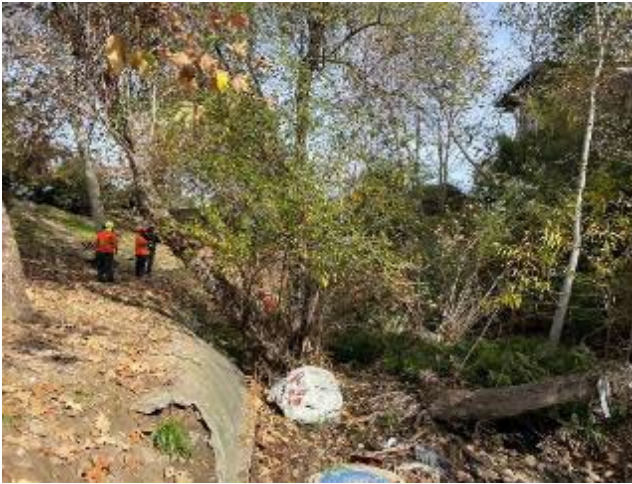
**Wightman 2 Pre-Maintenance- Photo 1**

Pre-maintenance condition of Wightman 2 channel south of University Ave, facing north.

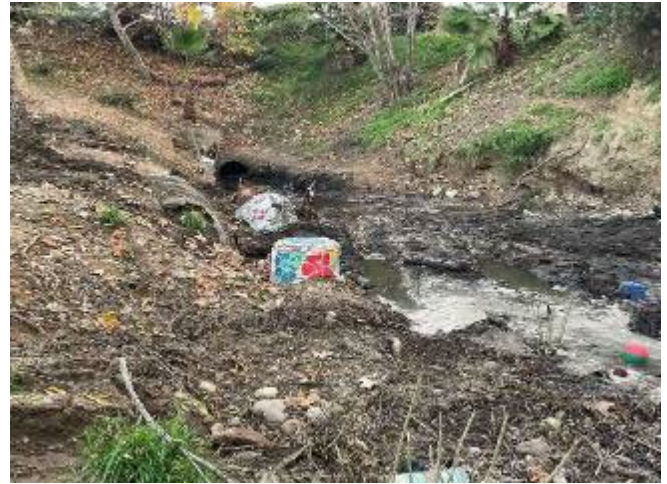
**Wightman 2 Post-Maintenance- Photo 2**

Post maintenance condition of channel at Wightman 2.

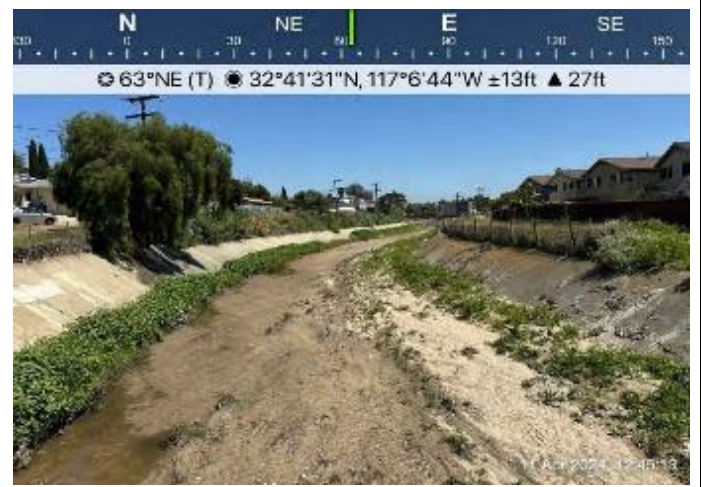
**Alpha 1 Post-Maintenance- Photo 2**

Post maintenance condition of channel showing removal of material

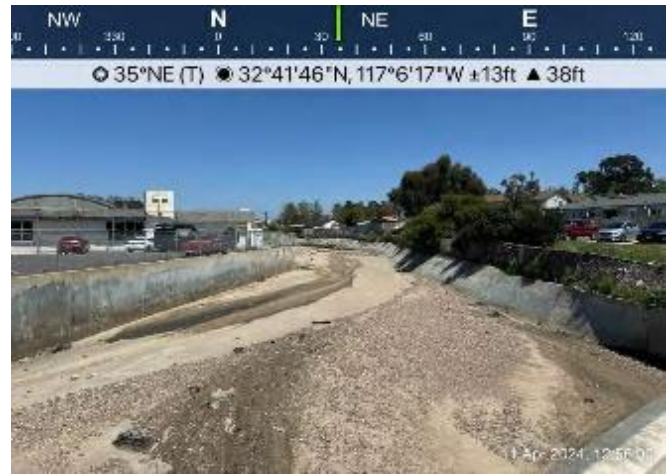
#### **Ocean View 1 Post-Maintenance- Photo 2**

Post maintenance condition of channel showing removal of material.

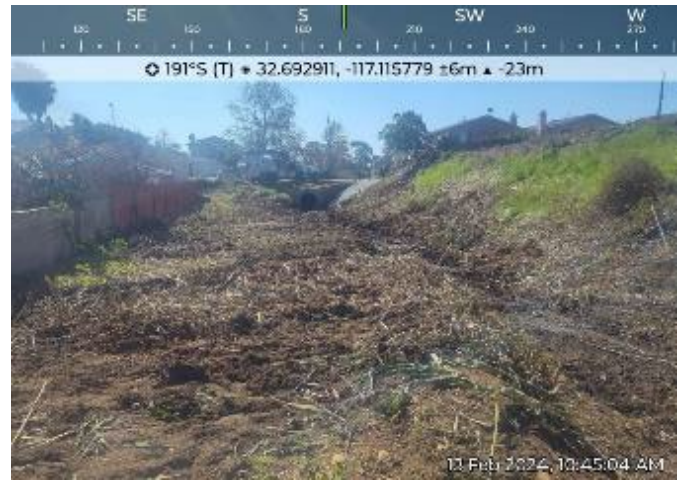
#### **Acacia Grove 2 Post-Maintenance- Photo 2**

Post-maintenance condition of Acacia Grove 2 channel north of Acacia Grove Way, facing south.

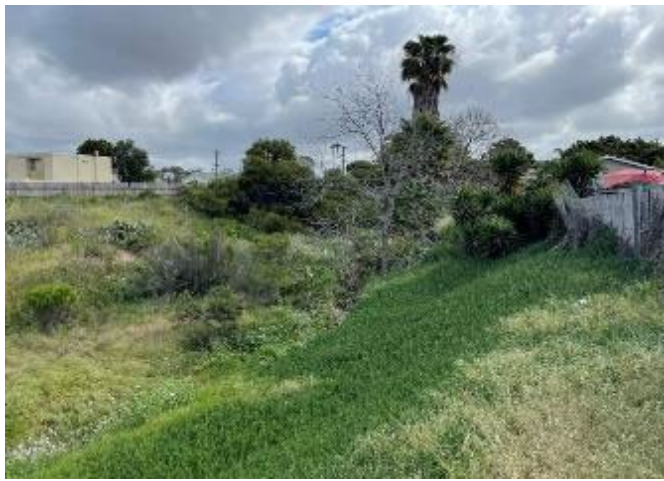
**Castana 1 Pre-Maintenance- Photo 1**

Pre-maintenance condition of Castana 1 channel, facing northeast.

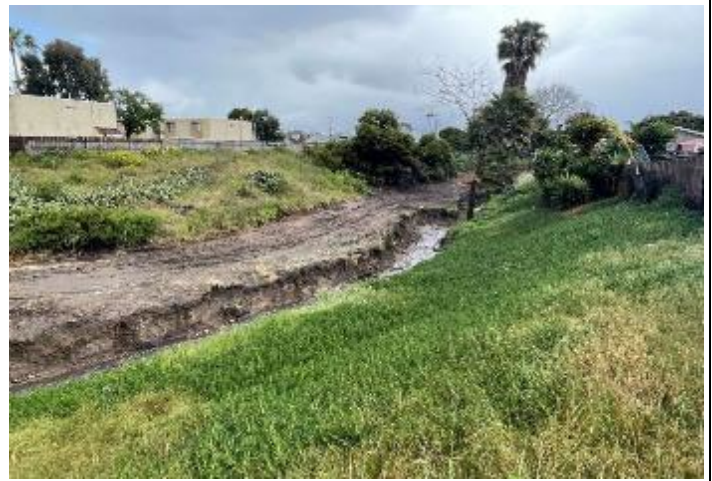
**Castana 1 Post-Maintenance- Photo 2**

Post maintenance condition of channel showing removal of vegetation.

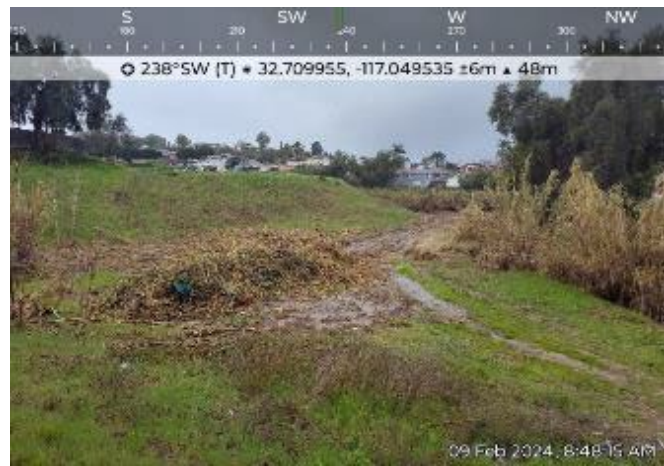
**Jamacha 1 Pre-Maintenance- Photo 1**

Pre-maintenance condition of Jamacha 1 facing southwest.

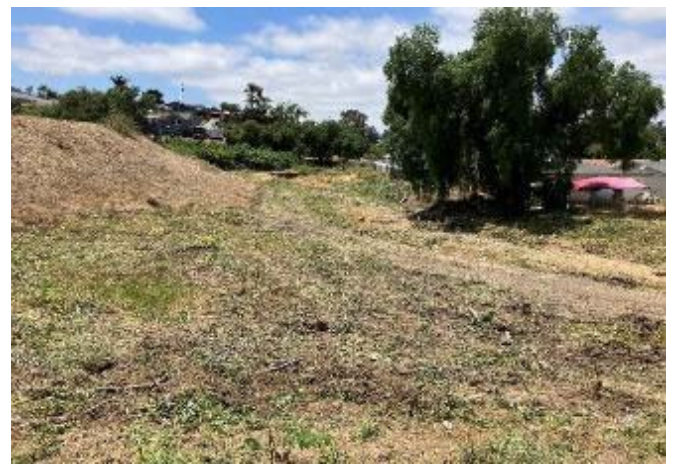
**Jamacha 1 Post-Maintenance- Photo 2**

Post maintenance condition of channel showing removal of material.

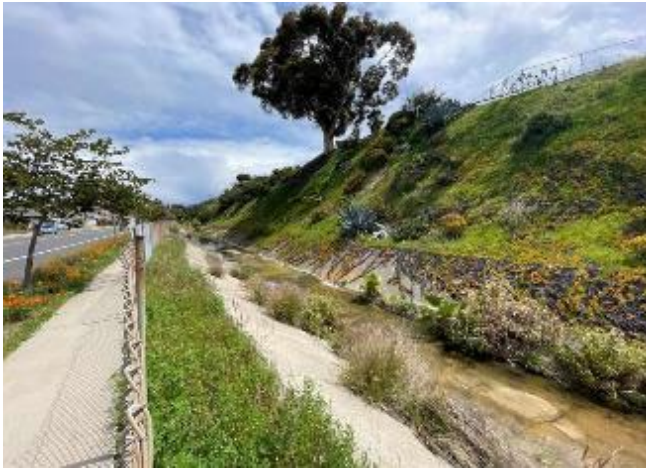
**Parkside 1 Pre-Maintenance- Photo 1**

Pre-maintenance condition of Parkside 1 channel, taken from northern edge, facing east.

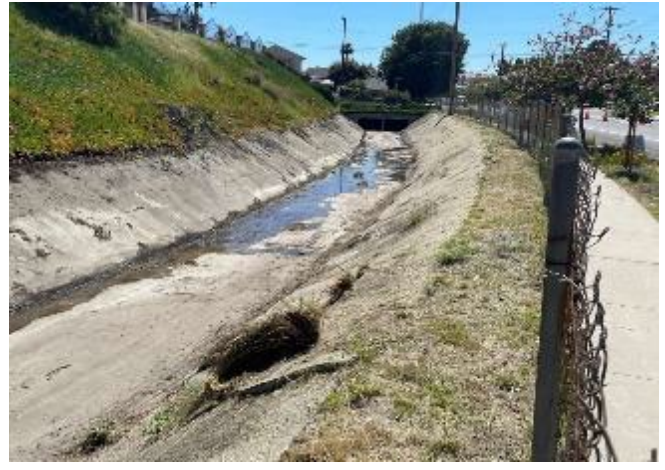
**Parkside 1 Post-Maintenance- Photo 2**

Post maintenance condition of channel.

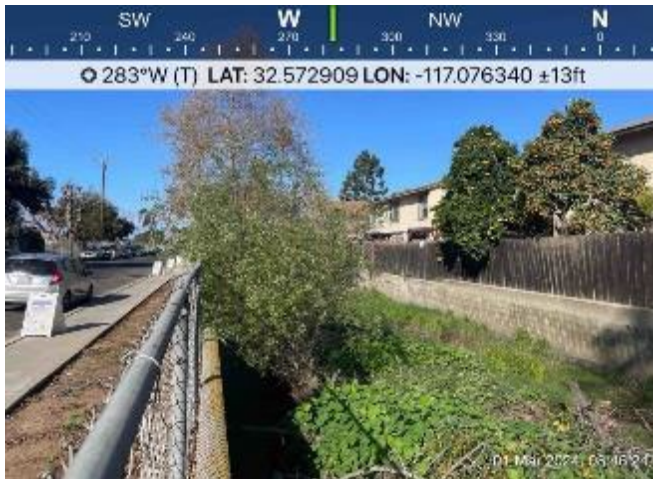
**Grove 1 Pre-Maintenance- Photo 1**

Pre-maintenance condition of Grove 1 channel in eastern portion, facing west.

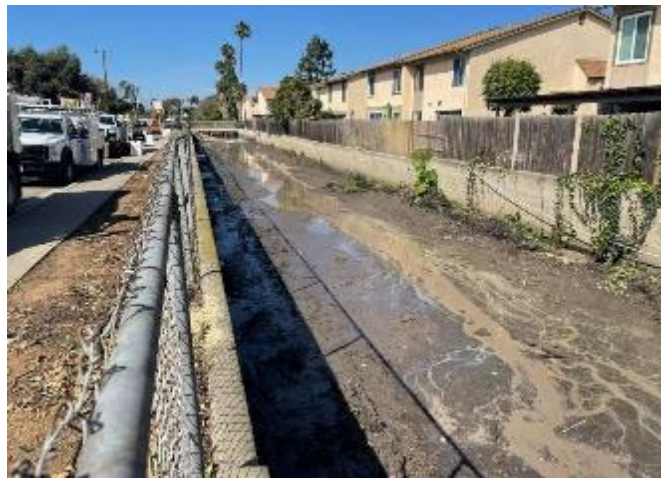
**Grove 1 Post-Maintenance- Photo 2**

Post maintenance condition of channel showing removal of material.

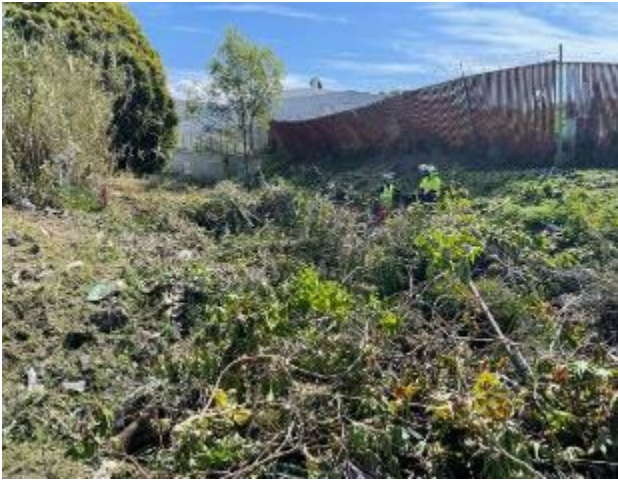
**Cedar 1 Pre-Maintenance- Photo 1**

Pre-maintenance condition of Cedar 1 channel, taken from northern edge, facing east by southeast.

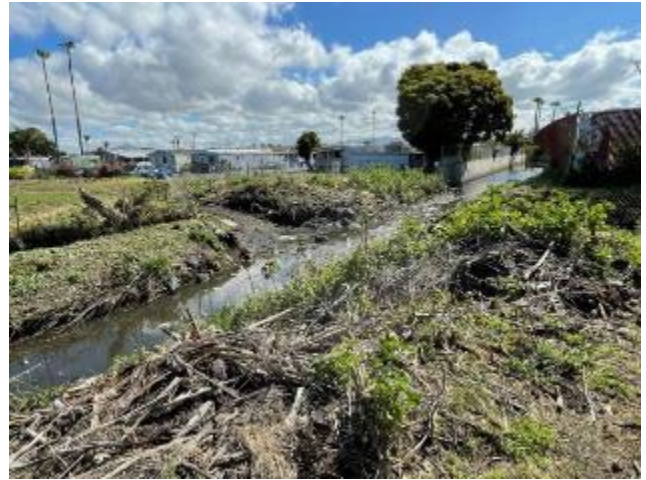
**Cedar 1 Post-Maintenance- Photo 2**

Post maintenance condition of channel, taken from southern edge, facing northwest.

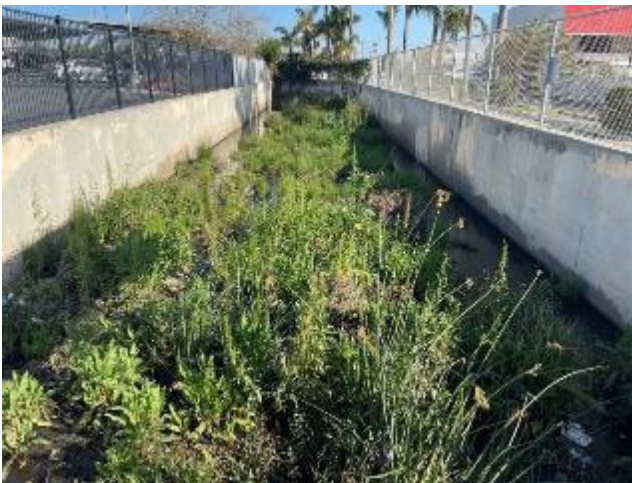
**Cedar 2 Pre-Maintenance- Photo 1**

Pre-maintenance condition of Cedar 2 channel, taken from southern edge, facing north.

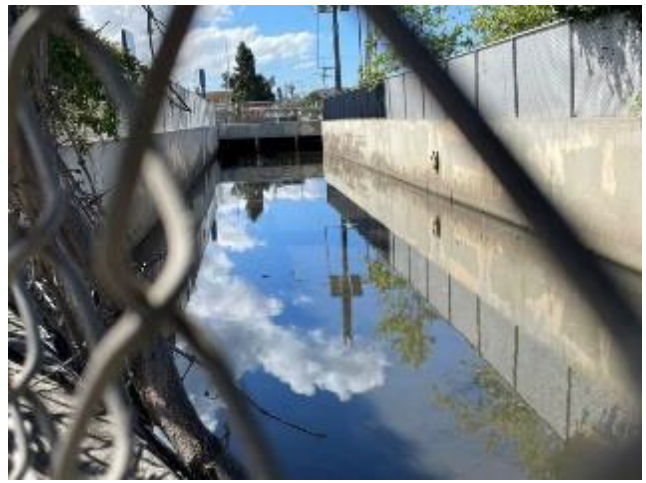
**Cedar 2 Post-Maintenance- Photo 2**

Post maintenance condition of channel showing removal of material, taken from northern edge, facing south.

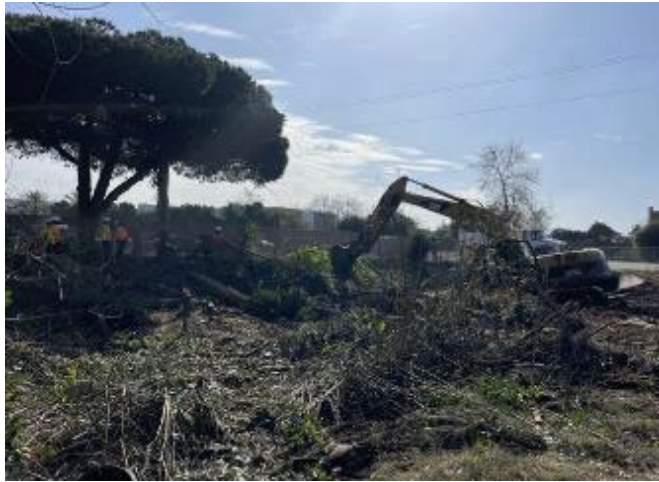
**Cerissa 1 Pre-Maintenance- Photo 1**

Accumulated vegetation debris in Cerissa 1 channel north of Coronado Avenue.

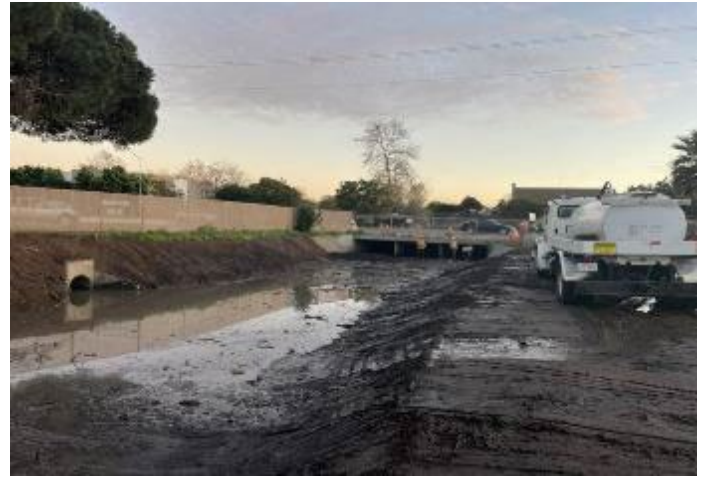
**Cerissa 1 Post-Maintenance- Photo 2**

Post maintenance condition of channel showing removal of material.

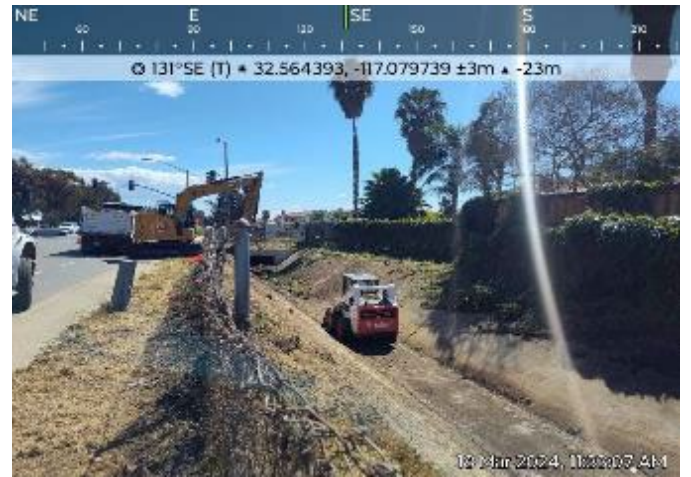
**Tocayo 2 Post-Maintenance- Photo 2**

Post maintenance condition of channel showing removal of material.

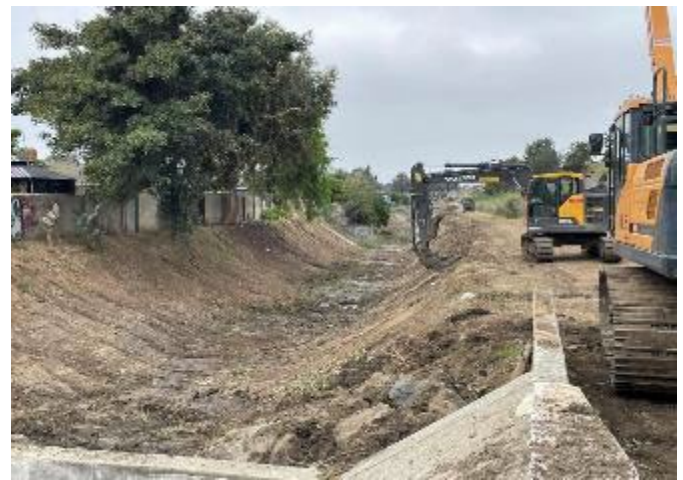
**Smythe 1 Post-Maintenance- Photo 2**

Post maintenance condition of channel showing removal of material at drainage structure.
