**CITY OF SAN DIEGO HISTORICAL RESOURCES BOARD
POLICY SUBCOMMITTEE AGENDA**

This report details the conservation treatment of two large-scale photographic murals located in the interior foyer of the Alvarado Water Filtration Plant Operations Building (5540 Kiowa Drive, La Mesa 91942) and provides recommendations for the continued preservation of the murals.

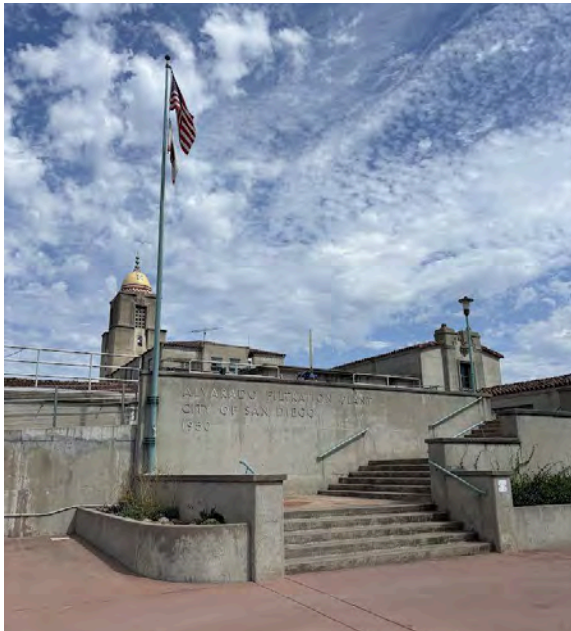
Figure 1: The historic entrance of the Alvarado Water Treatment Plant, with the Operations Building pictured in the back right.

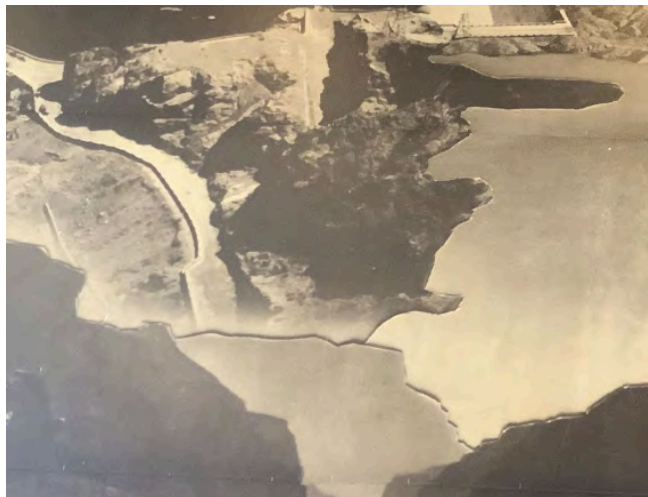
The murals do not appear to be printed directly from the original photographic negatives onto the photographic paper. Each mural was created by assembling pieces of existing photographic prints together like a collage before photographing the composite image and printing this onto the photographic paper we now see. This is clearly visible in the final print where shadows exist along edges of the collaged photographs that were torn, trimmed and layered on top of one another to create the desired visual effect (Figure 3). This method of composition allows for the multiple sites that were significant to the history of water treatment in San Diego to be included in one continuous photograph with multiple focal points.

Figure 3: Each mural is a collage of multiple photographs, as evidenced by torn and overlapping edges shown here. The collages were then photographed to create the two final images used in the murals.

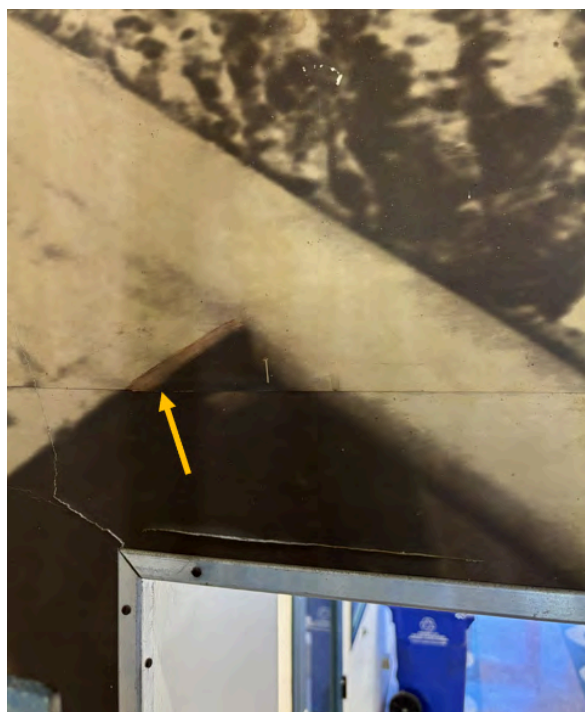
Additional evidence of the photographic process as well as examples of historic retouching were observed across both murals, offering valuable insight into the working methods of the mural makers. Viewers today can observe the location of staples that were used to position the photographic paper during the exposure process, which are now captured in the print. Fibers or other debris on the negatives at the time of printing also result in underexposed areas that are not damages, but artifacts of the printing process (Figure 4). There is also evidence of historic retouching near the edges of the paper strips. Where darker image areas do not align exactly, additional dark pigment was added on top of the original photograph (Figure 5). This added material may have discolored over time at a different rate than the surrounding area, making it more readily distinguishable from the original image areas today than it may have been at the time of application. It is our estimation that this retouching was most likely performed at

the time the murals were installed, to achieve visual continuity across the multiple paper strips that comprise each mural.

Figure 5: Historical retouching evident near seams.

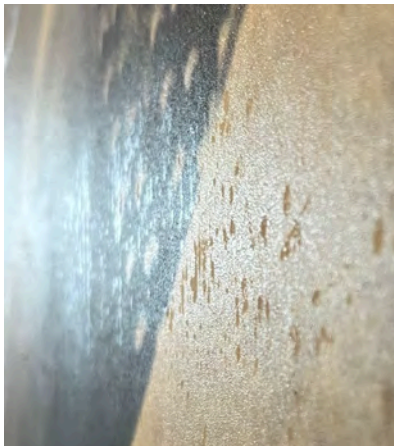
On close inspection with specular and raking illumination, there is some unevenness to the surface sheen and discoloration (Figure 6), suggesting a surface treatment or coating may have been applied at some point in the history of the mural. It is not clear if it would have been done at the time the mural was installed or at a later date. While any coatings may have been intended to protect the surface of the photograph, they have likely contributed to the discoloration and yellowing over time, as coatings tend to both trap dirt and pollutants and also yellow themselves as they degrade. This is also the case with the adhesives and previous repairs where the aging of the materials used has negatively affected the appearance of the mural over time, despite the benefits they may have offered in the short term.

Figure 6: Raking light detail image of surface characteristics of East Mural.

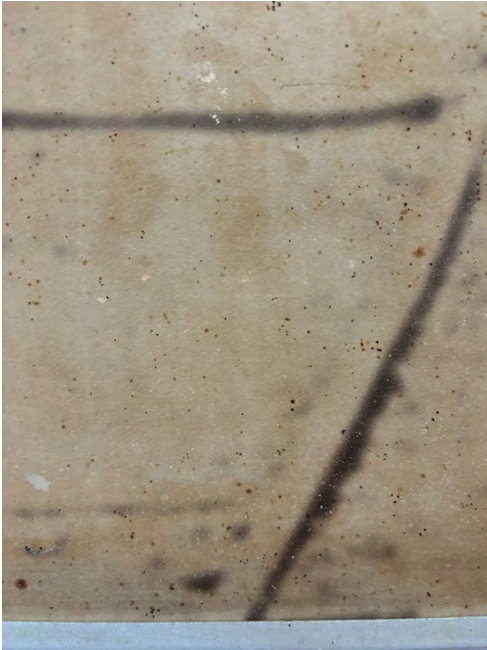
Aging of both the gelatin emulsion (image layer) and the paper support³, combined with the accumulation of a substantial surface grime layer (primarily dust, dirt, and soot), resulted in an overall reduction in image contrast. While the murals were never bright white and true black, there was likely greater contrast between the dark and light image areas at the time of manufacture than what we observe today. On close inspection with specular and raking illumination during treatment, an unevenness of the surface sheen and discoloration was observed in certain areas of the mural. It is possible a protective coating was applied to the mural at some point in its history, but its uneven application or deterioration has resulted in the mottled appearance observed (Figure 6). It is so degraded and/or inconsistent at this point that, without written records, it is difficult to tell whether it was applied intentionally as a protective coating or is the result of unintentional spills or grime accumulation over the years. It is also not clear if this material was applied to the surface of the murals at the time of creation, during installation, or at a later date. The only effect observed is a mottled coloration and surface sheen that is only visible on very close inspection with specific lighting conditions. It does not affect the legibility of the image, and is not easily distinguished at a normal viewing distance for such a large photograph. In addition to overall discoloration, there are physical abrasions, adhesive residues, insect debris (i.e. cobwebs), small stains, accretions (i.e. fly specs) (Figure 7) and paint drips

Figure 7: Fly specs, or stains created by insect excrement, are present throughout.

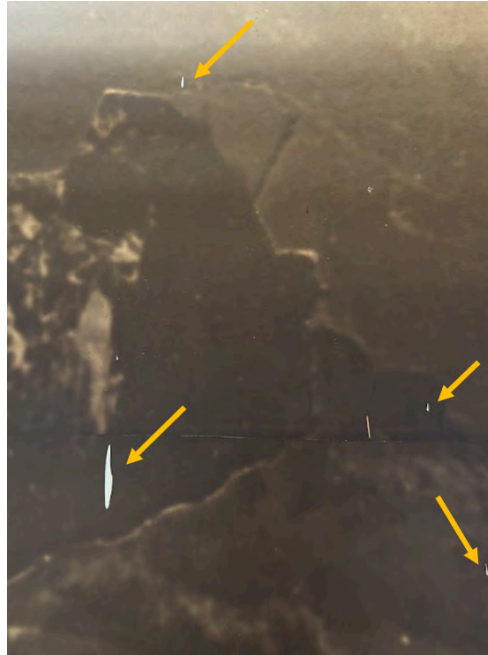
Figure 8: Paint drips on the surface of the murals likely occurred when the ceiling or neighboring walls were painted.

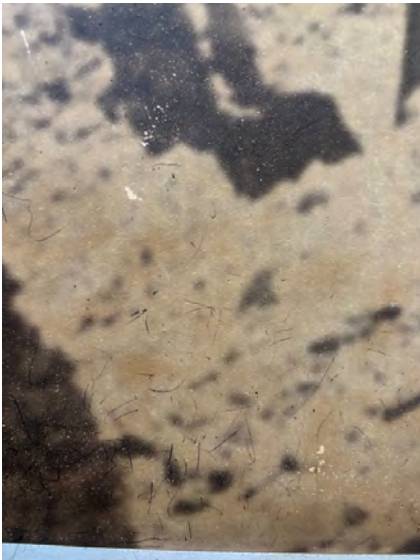
The surface of each mural remains sensitive to physical abrasions as well. Physical abrasions include minor abrasions such as small scratches, scuffs, and pencil marks (Figure 9) and also larger abrasions, such as gouges likely created with a large, heavy object (i.e. maintenance tools or equipment) (Figure 10). The most significant areas of abrasion can be described to be within arms length at standing position. The area to the right of the door frame surrounding the light switch plate was the most heavily damaged. This area will remain vulnerable post-treatment without careful use of the switch. It may be possible to devise a larger switch plate or other covering to hover over the switch area of the mural as a preventive measure, but it is imperative that nothing be adhered or drilled through the photographic mural itself. In addition to the minor and major abrasions noted above, there were also two small pieces of historic pressure-sensitive tape above the entry door (Figure 11). Sticking anything to the murals should be avoided, as it will cause physical damage when removed. If anything is adhered to the surface of the mural in the future, it is recommended that it remain in place and a paper or photograph conservation professional be contacted to perform the removal in an effort to limit damage as much as possible.

Figure 9: Example of small scratches, scuffs, and pencil marks.

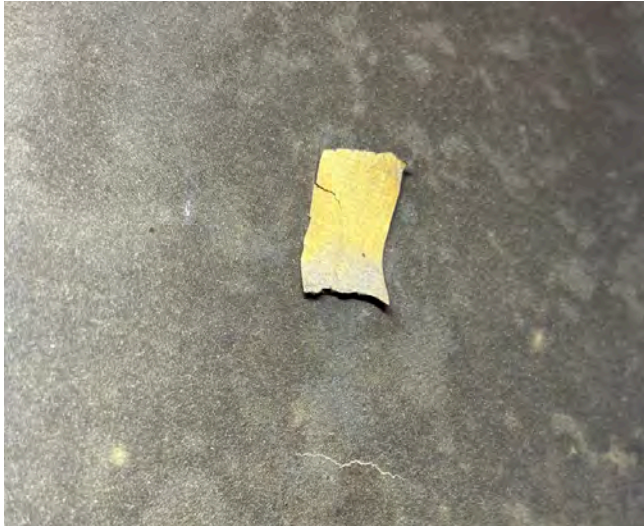
Figure 11: Pressure-sensitive tape was found stuck to the surface of the West Wall mural, above the entry door.

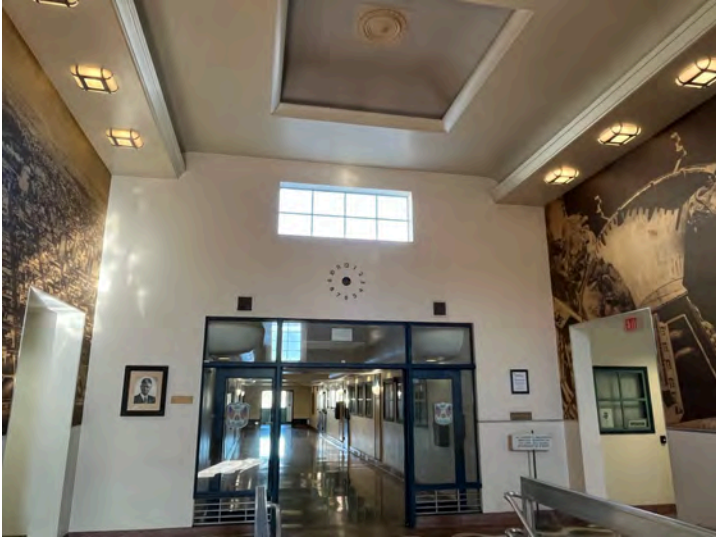
The paper supports are in fair condition due to physical damage and chemical deterioration, but considering their age and environment, the majority of the surface area remains intact and well adhered to each wall. They are a medium weight wove paper that was observed to retain minor flexibility where the paper had already separated from the wall. Since their production over 75 years ago, the photographic paper supports have become brittle and discolored due to natural aging and prolonged exposure to environmental factors including light, heat, moisture and gaseous pollutants. Ultraviolet (UV) light from unfiltered sunlight currently enters through the north and south facing windows on the walls between the two murals (Figure 12). This light is particularly damaging to photographs, as it exacerbates chemical changes that manifest as yellowing, darkening, and embrittlement. The addition of heat (due to the infrared component of sunlight) can speed up deterioration when the photograph is directly exposed for long periods of time.

Figure 12: Direct light on West mural from window.

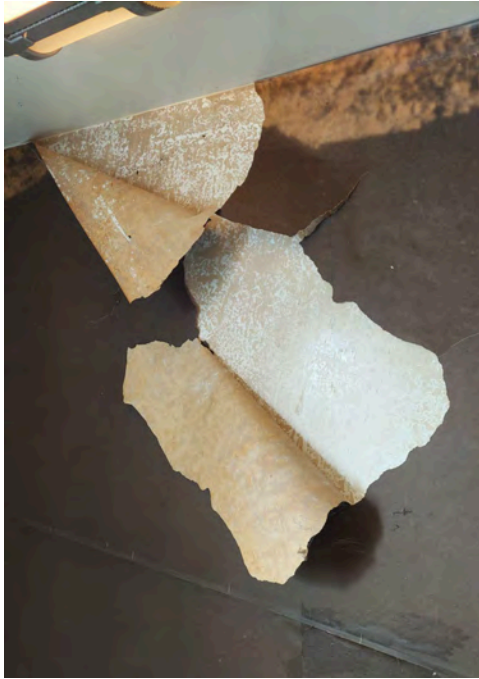
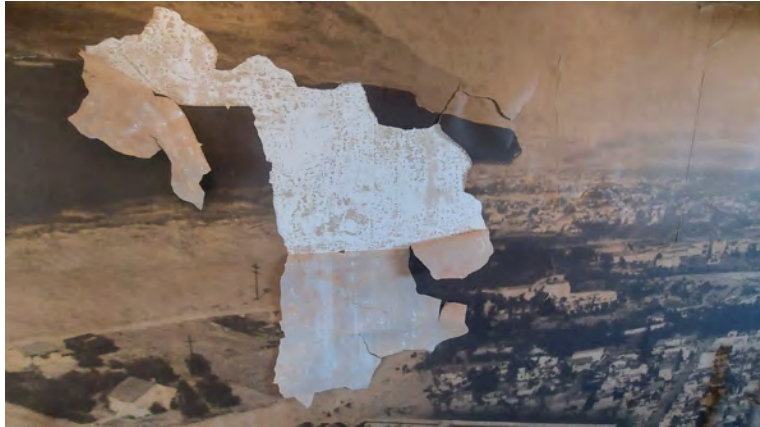
Figures 13 & 14: Detached sections of paper on the West Wall retain enough strength and flexibility to hang down in "flaps."

There were four large areas on the West Mural where the original adhesive failed, resulting in large sections of exposed wall where the paper draped down over itself. In each case, the paper supports suffered only minimal loss at the tear edges and more complex areas where tears overlapped. Naturally, the paper support was most significantly distorted in these areas. Other distortions were present at the wall and ceiling edges where layers of adhesive and interior paints contributed to stiffening and curling at the extreme edges of the photographic paper.

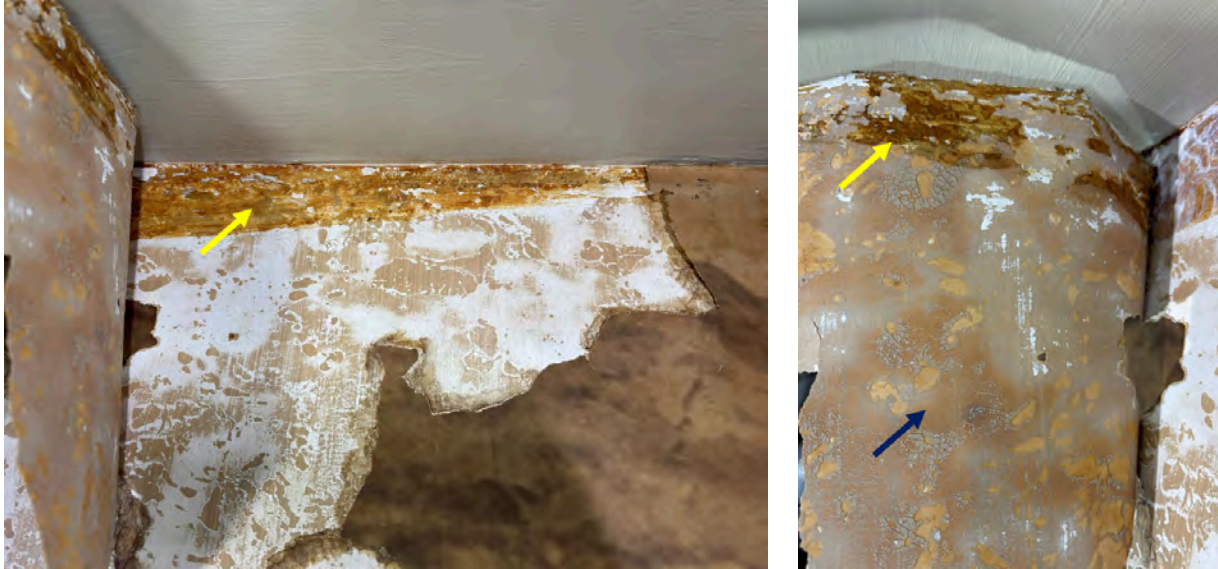
Evidence of prior restoration or repair attempts are apparent on both murals. Sections of torn and lifted paper were re-adhered to the wall and in some cases to the adjacent areas of paper using adhesives that now appear very yellow to orange in color, and are highly brittle (Figures 15 & 16). These adhesives were thickly applied and, in some cases, the photograph was not properly aligned. Misalignment has created distortions that will remain as the adhesive is not reversible and these areas are no longer treatable. During treatment, it was possible in some areas, especially along the seismic joints or behind detached paper flaps, to reduce excess adhesive on the wall behind the murals. However, adhesives applied at the top edge along the ceiling, as pictured below, were not accessible for removal unless the paper was detached, as shown. In these areas, the paper was especially rigid with built up layers of adhesive on the reverse (Figures 15 & 16). In other areas, it appears that a material was brushed or wiped on top

Figures 15 & 16: Adhesive applied during a prior restoration attempt (yellow arrow) is yellow and brittle compared to the original adhesive used to install the murals (blue arrow).

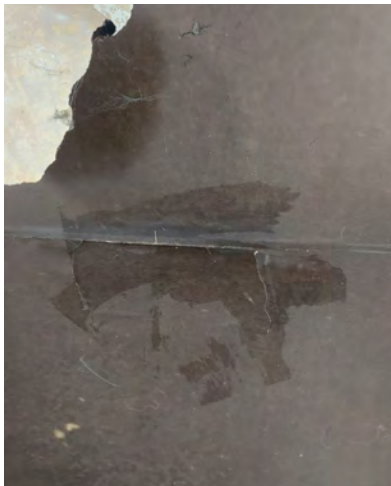
of the image layer, now appearing as a dark stain (Figure 17). Since these dark, swipe stains always align with distortion and tears in the paper support, it is likely that they were also applied during an attempt to re-attach lifted paper. This is another example of how inappropriate and incompatible materials can ultimately cause irreversible damage to historic artifacts.

Figure 17: Dark stains such as associated with torn and previously lifted areas suggest prior restoration attempts were made.

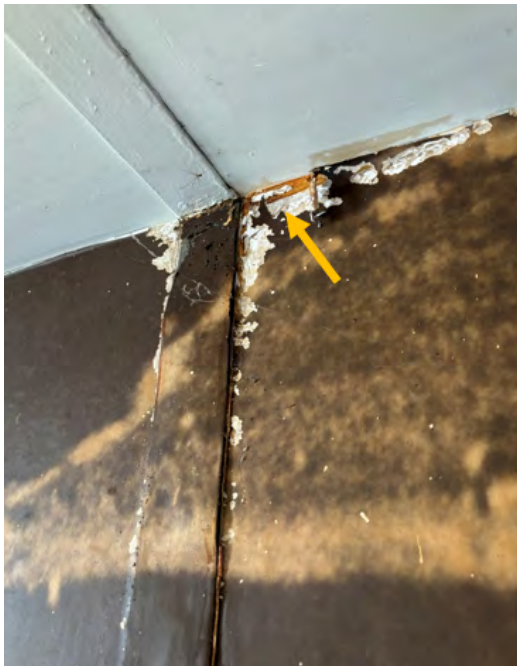
The elevated levels of moisture occurring as a result of airflow at the seismic joint has caused deterioration of the mural, metal joint, and plaster wall surface. This was especially noticeable on the West Wall where the plaster surface of the wall adjacent to the joint was powdery and crumbling in numerous areas. Losses in the wall material created an uneven surface along the joint in addition to pockets of air. The moisture has also caused reddish-brown corrosion on the joint itself which, in the most severe cases, has stained the photographic paper or undermined the adhesion of the paper to the metal surface. The added bulk from the development of the corrosion exerted outward pressure onto the adhesive and photographic paper, which itself expanded and contracted with localized fluctuations in humidity. In many areas on and around the metal joint, the photographic paper was no longer attached or present as a result.

Figure 18: The paper support was severely damaged near the metal joint, as the intrusion of outside air supported pest activity and corrosion (West Wall, before treatment).

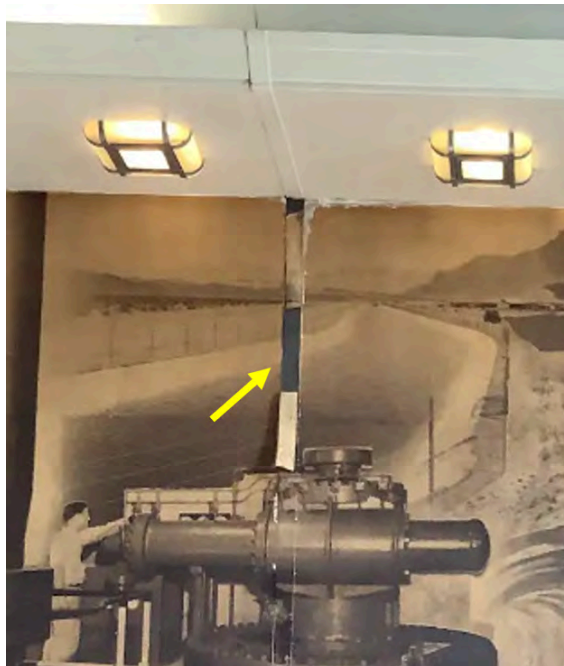
The degree of damage to the photographic paper along the seismic joint on each mural varies. The most severe and noticeable damages on the East Wall include a loss of paper from the joint near the ceiling as well as an adjacent section that had detached and draped down over itself, revealing the bare gray metal joint below (Figure 19). On the West Wall, the edges of the photographic paper along the majority of the metal joint and adjacent wall surface were distorted and partially detached. The yellowed adhesive that was applied to other areas of the murals during a prior restoration attempt was also introduced at the seismic joints, where it has similarly become brittle, bulky and degraded. The glue was applied thickly and has resulted in very rigid and distorted sections along the joint. The rigid or brittle areas are most susceptible to loss, as cracked and lifted sections of paper require very little pressure to detach.

Figure 19: Corrosion of the metal joint led to detached sections of the paper (East Wall)

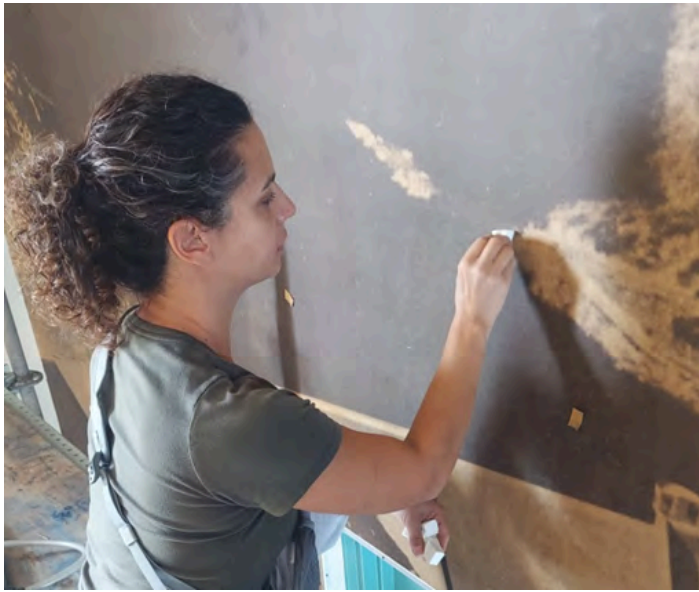
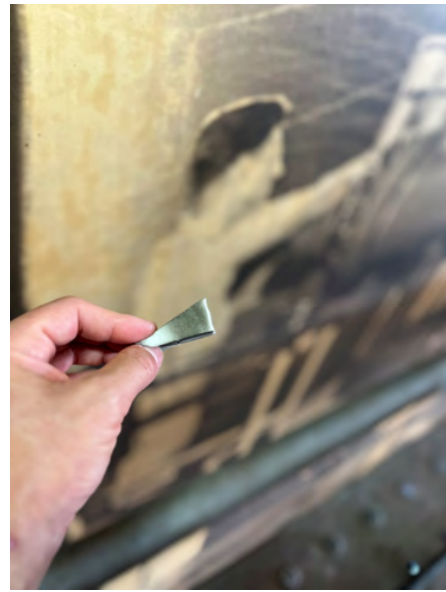
Figures 20 & 21: Surface grime was removed using dry cosmetic sponges.

The goal of cleaning the murals was to reduce harmful dust and debris while improving contrast, and therefore legibility of the image content. Surface cleaning does not reverse yellowing, as the source of this discoloration is not within the grime layer but rather a natural, expected, and irreversible result of the photographic materials and any surface coatings degrading over time. Dry surface cleaning of the murals was carried out in two stages. First, the entire surface of each mural was lightly dusted using soft hake brushes to remove loose particulates, insect debris, and cobwebs. Dust and insect debris was captured using a HEPA-filtered vacuum. Second, lighter areas of the images were selectively cleaned using polyurethane foam cosmetic sponges to gently reduce accumulated grime (Figures 20 & 21).

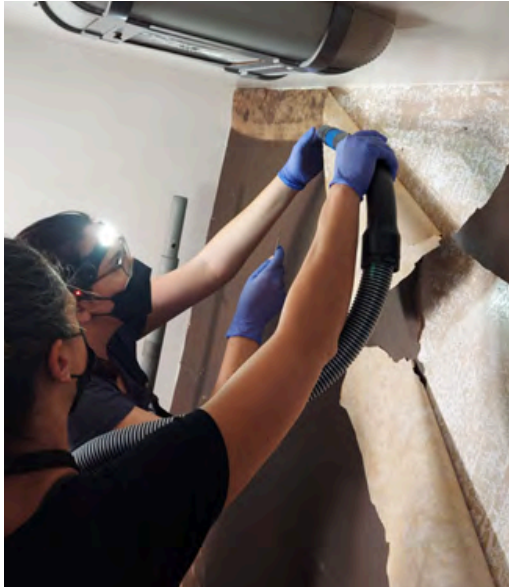
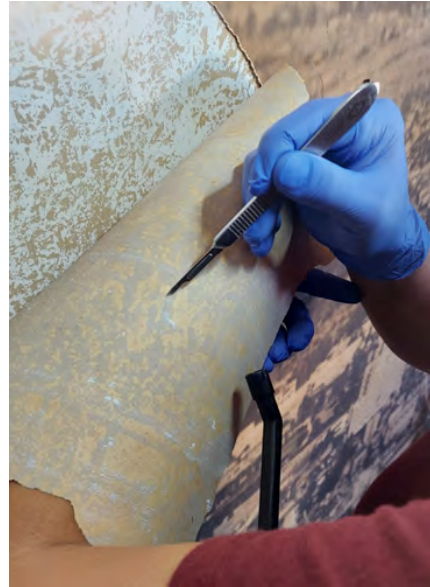
Figures 22 & 23: Debris and old, degraded adhesives were removed mechanically using a HEPA vacuum and scalpel.

These lighter image areas were targeted because surface soiling was more visually apparent and could be reduced safely without visually disrupting the image layer. Additional debris, including old adhesive residues, loose wall material, and corrosion on exposed areas of the seismic expansion joints were mechanically reduced to prepare the surfaces for reattachment. Where accessible, old adhesive residues from previous repair campaigns and powdery white wall material were also mechanically reduced from the back of the photographic paper or the wall surface using hand tools such as scalpels, brushes, microspatulas, air bulbs, and a HEPA vacuum with micro-attachments (Figures 22 & 23). In many areas, old adhesive could not be accessed where the paper remained securely adhered to the wall. The most significant debris removed consisted of loose, powdery wall material trapped between the photographic paper and the wall, which created visible and tactile bulk. This material was carefully removed as much as possible prior to re-adhering the paper to the wall so that the paper could be reattached smoothly and torn edges could meet as close as possible.

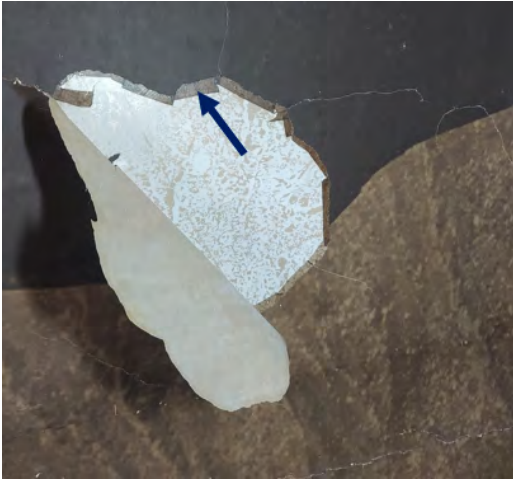
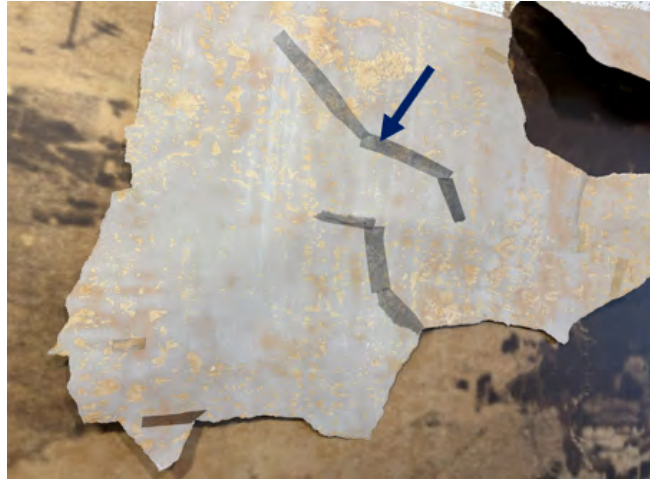
Figures 24 & 25: Tears and edges in the paper support were reinforced with toned mending tissue (blue arrow) when necessary.

The photographic paper retains a substantial amount of strength and integrity considering its age and format. The remaining flexibility in the paper supports allowed the sections of the murals that were detached and torn to hang down over the mural without cracking and fully tearing off, as discussed above. These detached but hanging sections of paper were particularly vulnerable to tearing, as the weight of the flaps put additional strain on the creased paper at the point of attachment. To support these hanging sections of paper in preparation for reattachment, tears and edges were mended with heat-set tissue. These pre-coated mending tissues were prepared in advance using various weights of Japanese paper (koko fiber) coated with a 3:2 mixture of Lascaux 303HV and Lascaux 498HV diluted with deionized water and brush-applied. Some tissues were also toned with acrylic paints to better match the color of the photographic image visible on either side of open tears. The prepared tissues were cut to appropriate sizes and attached to the reverse side of the photographic paper using tacking irons to apply heat and pressure through silicone release paper (Figures 24 & 25). This technique eliminated the need for wet adhesives and was primarily used to stabilize large tears prior to humidification and reattachment of the photographic paper to the wall.

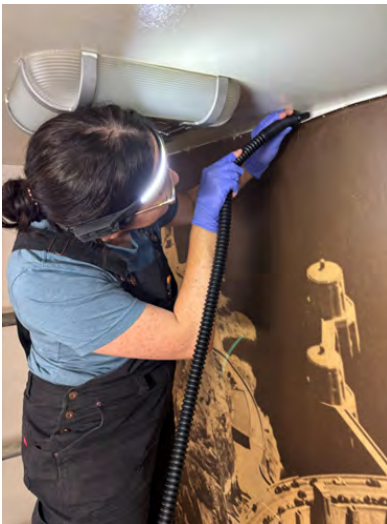
Figure 26: Creased, brittle paper was relaxed with cool humidification in preparation for reattachment.

Where required, rigid, curled, or creased paper edges were lightly humidified using cool deionized water delivered via an ultrasonic humidifier to relax the paper support prior to mending and reattachment to the wall (Figure 26). Initial tests demonstrated that the photographic paper responded well to light humidification which, unlike fully wetting the surface, did not alter surface characteristics or color. Localized humidification was performed mainly along the ceiling so brittle edges could be flattened gently and gradually without tearing. Humidification was also necessary in areas where large sections of paper had separated from the wall and torn, creating distorted flaps.

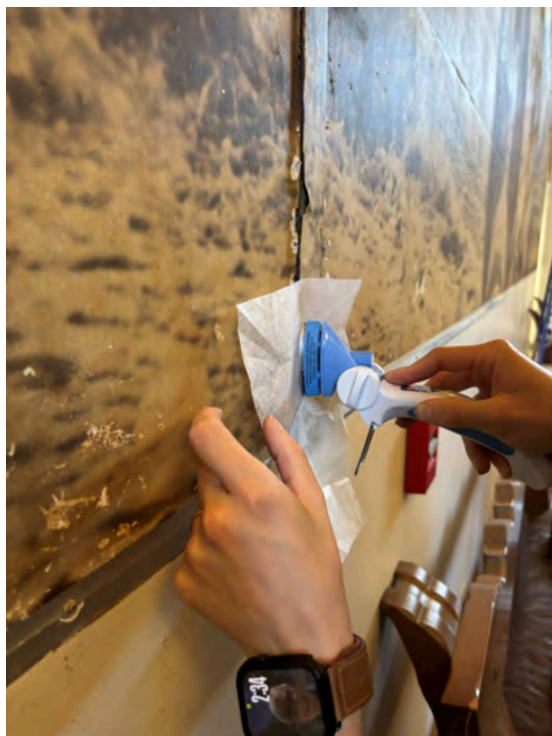
Figure 27: Adhesive was activated using heat from a small tacking iron through silicone release paper.

on the condition of the paper and how much tack was desired. Application methods were selected based on the nature of the damage and aimed to avoid direct application of the adhesive to the photographic paper as much as possible. Whenever possible, a 2:1 mixture of Lascaux 303HV: Lascaux 498HV adhesive diluted in deionized water was applied with a brush directly to the exposed wall surface and allowed to dry. A second layer was applied and allowed to partially dry before pressure was applied to the photographic paper to tack it back into place. Once fully dry, heat and light pressure was applied using a small tacking iron to activate the adhesive between the photograph and the Lascaux-coated wall (Figure 27). In areas where the paper was torn and lifted but the wall was not exposed, syringes of varying sizes were used to introduce the adhesive to the wall beneath the paper (Figure 28). In select cases, small incisions were made using a scalpel to allow syringe access where the paper had separated from the wall and formed bubbles but had not yet torn. This approach was used only when the delamination posed a risk of further damage to the photographic paper in the near future and no alternative treatment was feasible. This step was taken as a preventive measure in an attempt to reduce the timeframe between treatment campaigns.

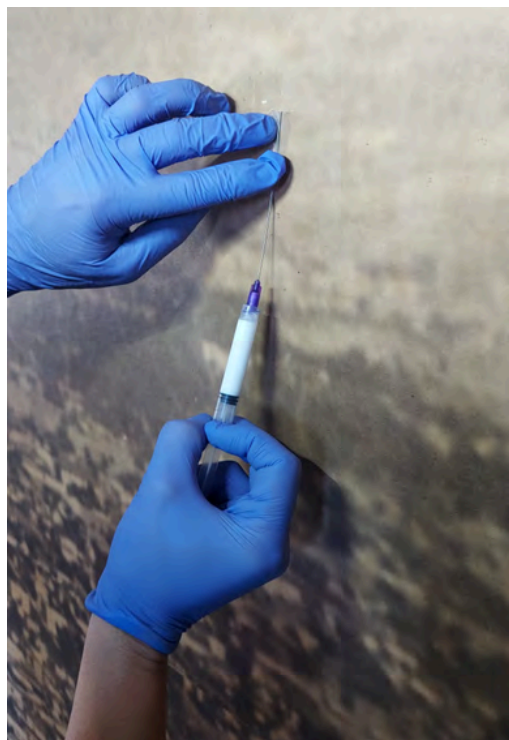
Figure 28: Adhesive was applied using narrow syringes when access was limited.

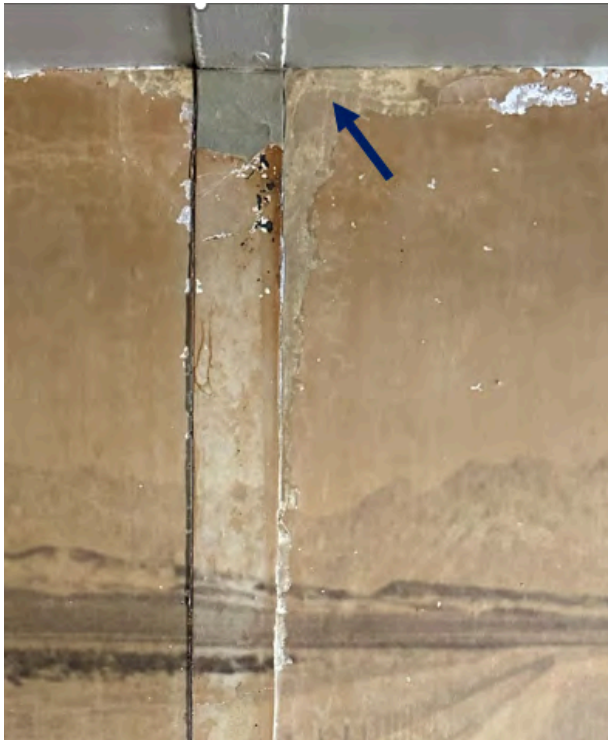
Figure 29: Toned Japanese paper (blue arrow) was used as a fill material to support fragile edges of the paper support and make reattachment more successful (East Wall, during treatment).

Extensive treatment was carried out on the mural along both seismic expansion joints. Due to the severity of physical damage and loss, treatment included fills for missing plaster and in some cases photographic paper as well. Areas where losses resulted in stepped depressions from the surface of the photograph to the wall surface, Modostuc was used to level the area of loss to the same plane as the photograph. In one case along the East Wall seismic joint, the edge of the paper support was especially thin and fragile along an area of loss. To reduce the risk of further lifting, a Japanese paper (koko fiber) fill was adhered to the wall and intentionally overlapped the vulnerable edge of the photograph to reduce the risk of lifting in the future and aid in longer term preservation (Figure 29). This fill was later inpainted to visually integrate it with the surrounding area.

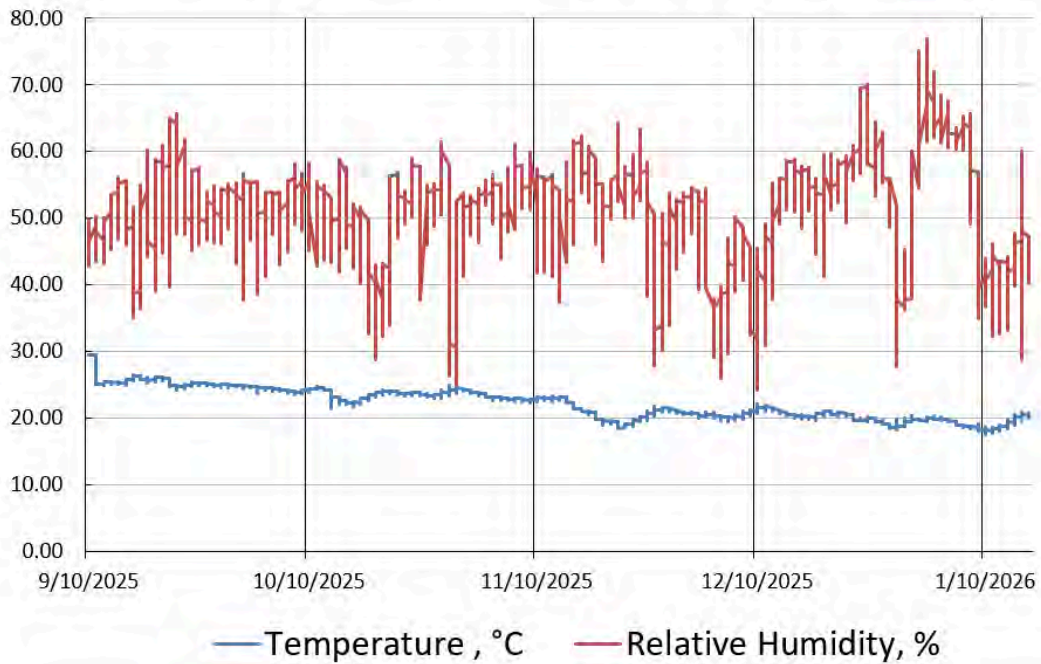
Chart 1: East Mural environmental conditions captured between September 10, 2025 and January 16, 2026.

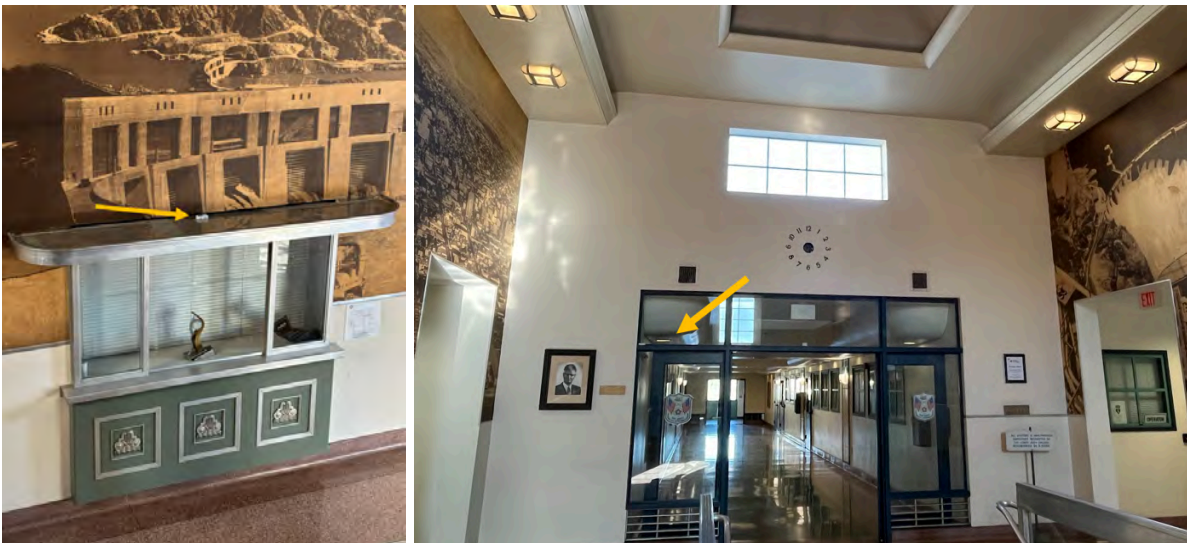
Figures 30 & 31: Placement of datalogger above payment window on East Wall (left) and on the North Wall window framing, near the West Wall (right).

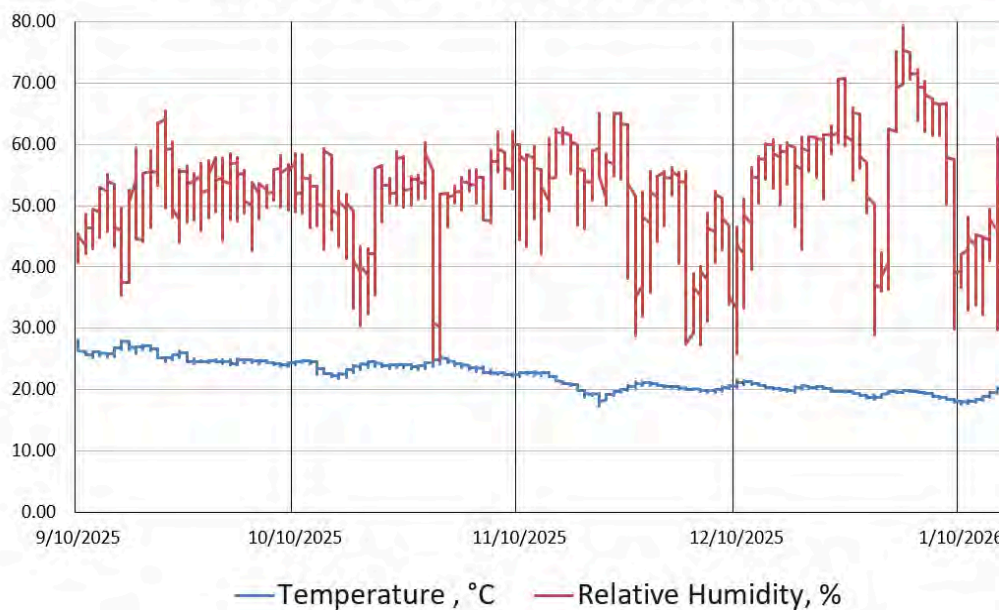
Chart 2: West Mural environmental conditions captured between September 10, 2025 and January 16, 2026.

The effects of repeated mechanical stress, apparently driven by fluctuations in RH, were most pronounced in the upper portion of the West Mural, where the paper support became fully detached from the wall in four locations. Thermal imaging conducted with a FLIR infrared camera helps explain why separation of the paper support from the wall progressed most in these areas (Figures 32, 33, & 34). The upper portion of the West Mural was consistently measured at approximately 1°C warmer than the lower portion of the mural, particularly where the paper support was already lifted and hanging free. While the lower portion of the wall is connected to another section of the building that shields it from direct sunlight, the upper portion of the West Mural receives direct sunlight on the exterior wall behind it. These localized temperature elevations likely amplified the mechanical stress imposed by RH fluctuations, resulting in greater movement of the paper relative to the wall substrate. As the paper repeatedly expanded and contracted in response to rapid RH changes, warmer conditions likely also put strain on the adhesive layers holding the paper in place. Over time, this repeated stress led to weakening of the adhesive bond and progressive separation of the paper from the wall in these areas.

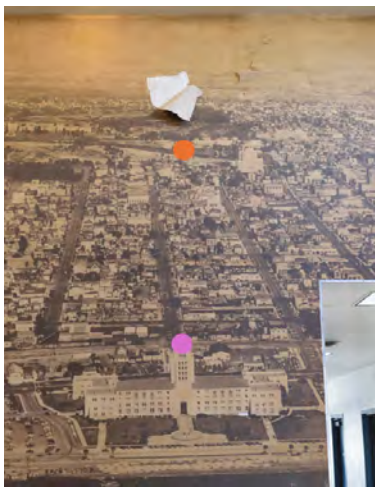
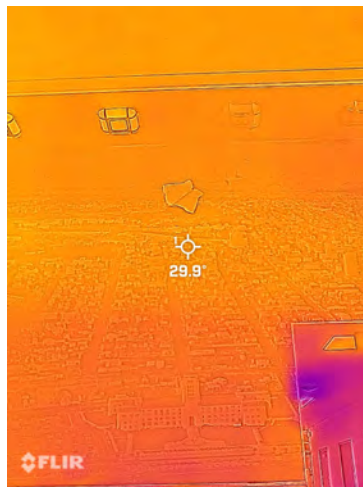
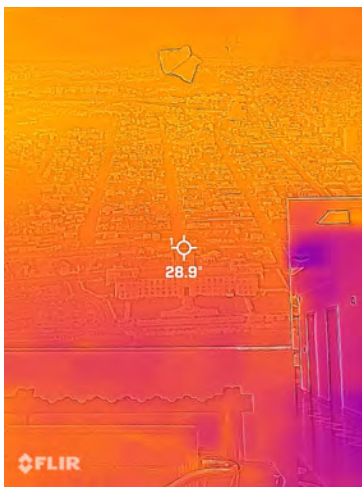
Figures 32, 33, & 34: Thermal images show higher surface heat near the top of the West Mural (above, marked in orange on photo) than on the lower portion of the West mural (left, marked in purple on photo).

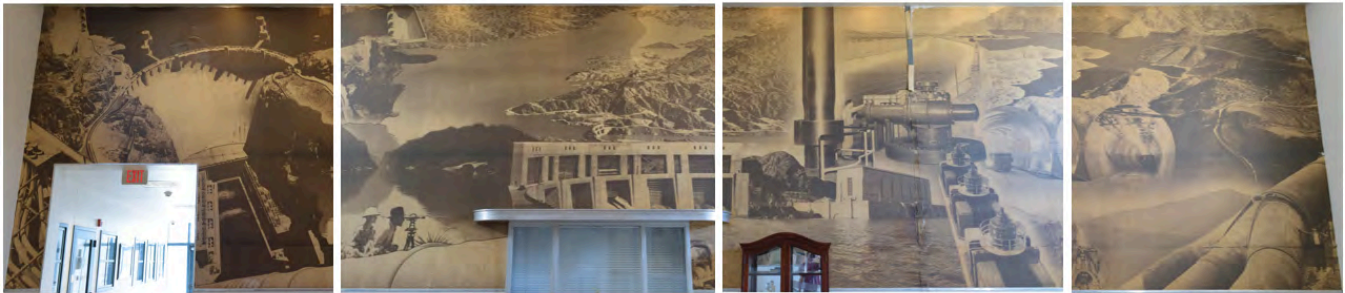
East Wall – Before Treatment

Figures 35 & 36: Before and after photos of both sides of the mural.

Through conservation treatment, the murals were stabilized to the greatest extent possible within the constraints of the building environment and given their age and material condition. Before and after treatment photographs document the significant improvement in overall planar stability, reduction of active lifting of the paper support, and improved visual continuity of the image (Figures 35 through 44). Detached areas of the photographic paper were carefully reattached, surface soiling was reduced, and losses and discoloration were visually integrated through inpainting and retouching. Despite these improvements, the murals remain inherently vulnerable due to ongoing environmental instability, the inherent vice of aging materials, and structural conditions of the building.

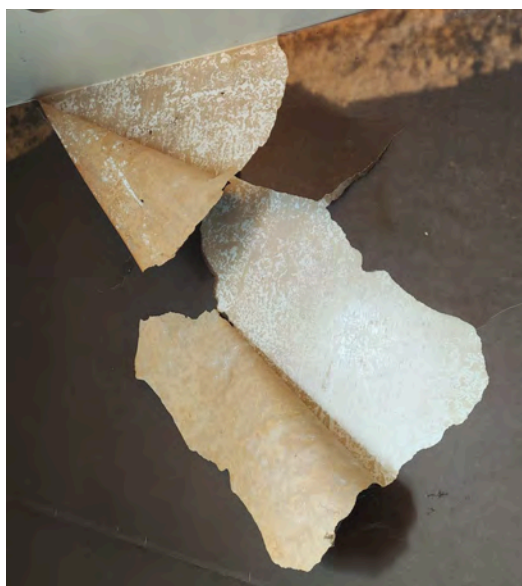
Figure 37: West Wall - Before Treatment (Detail).

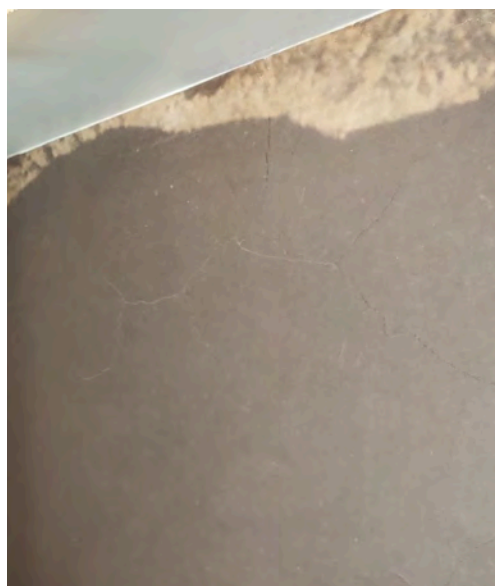
Figure 38: West Wall - After Treatment (Same Area Detail).

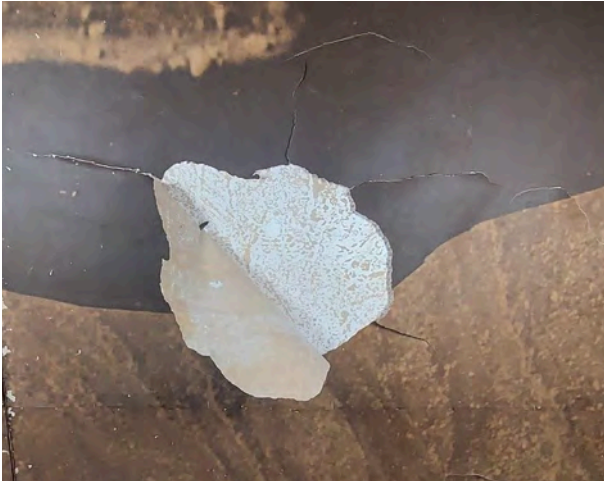
Figure 39: West Wall - Before Treatment (Detail).

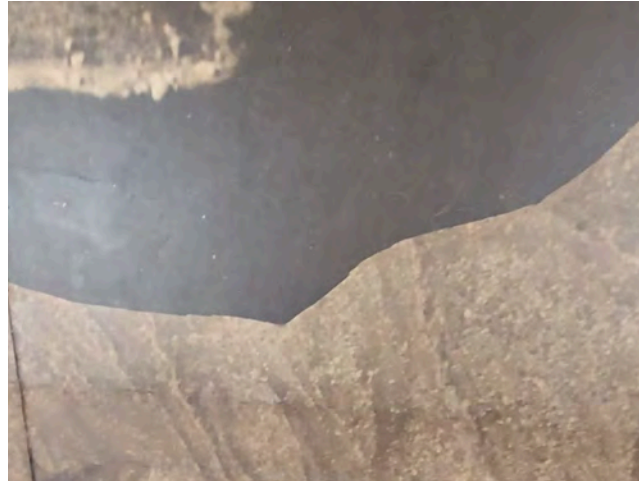
Figure 40: West Wall - After Treatment (Same Area Detail).

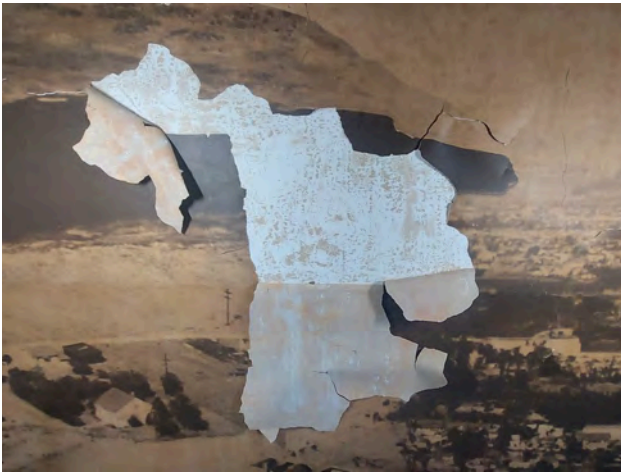
Figure 41: West Wall - Before Treatment (Detail).

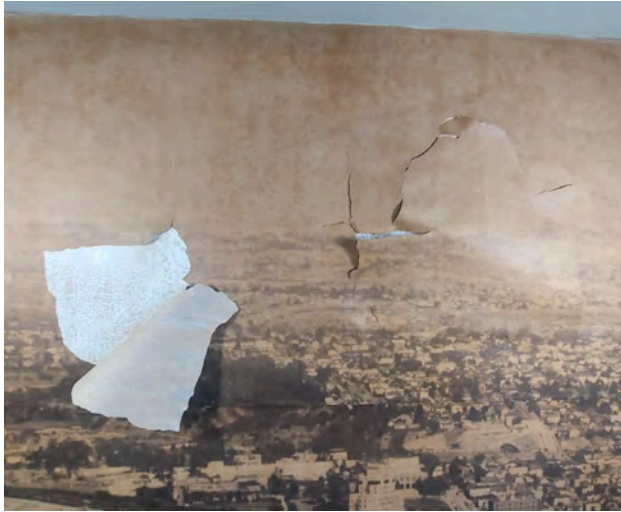
Figure 43: West Wall - Before Treatment (Detail).

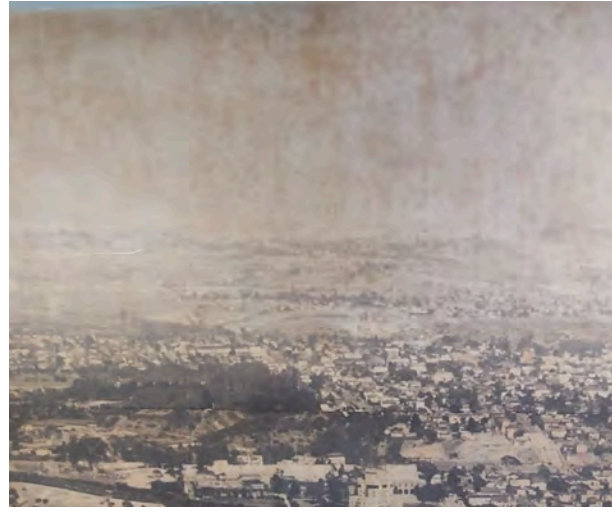
Figure 44: West Wall - After Treatment (Same Area).

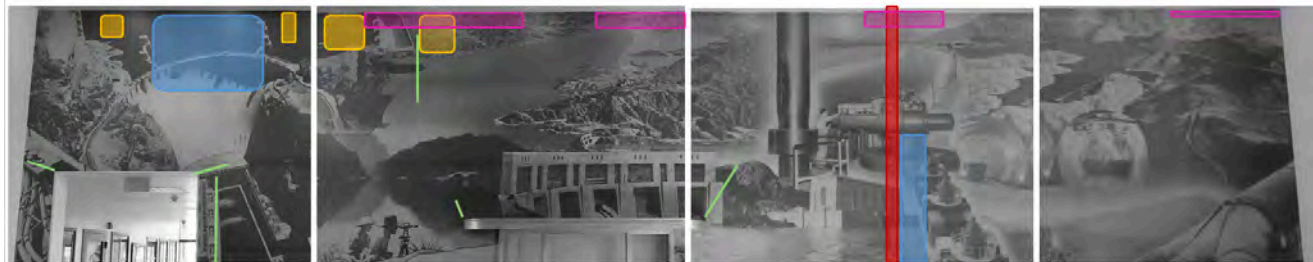
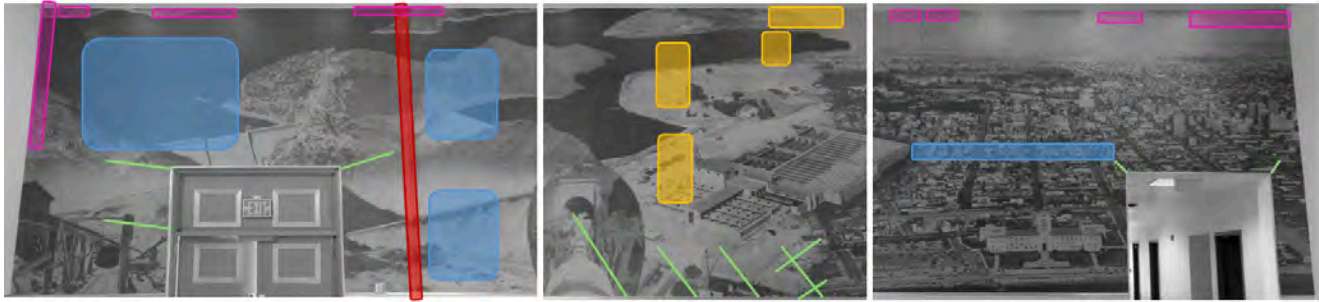
To document residual risks and guide future monitoring, a Preservation Map was created for each mural (Figures 45 & 46). These maps identify areas of known vulnerability and past intervention using color-coded overlays and should be referenced during all future visits, including the post-treatment assessments, as well as any future retreatment campaigns.

Figures 45 & 46: Preservation Map, East Wall (above) and Preservation Map, West Wall (below).

The metal seismic joint, marked in red on the Preservation Maps, remains a significant risk factor. This joint contains a gap that allows air to persistently enter the space on both the East and West sides of the room, contributing to rapid cycles of fluctuating RH in the foyer. As described in the previous section, these RH fluctuations are a primary driver of mechanical stress for the paper support. While the paper on and near the joint was reattached where possible (e.g. when paper pieces remained), these areas remain vulnerable if air intrusion at the metal is not prevented.
