**CITY OF SAN DIEGO HISTORICAL RESOURCES BOARD
POLICY SUBCOMMITTEE AGENDA**

This report details the conservation treatment of two large-scale photographic murals located in the interior foyer of the Alvarado Water Filtration Plant Operations Building (5540 Kiowa Drive, La Mesa 91942) and provides recommendations for the continued preservation of the murals.

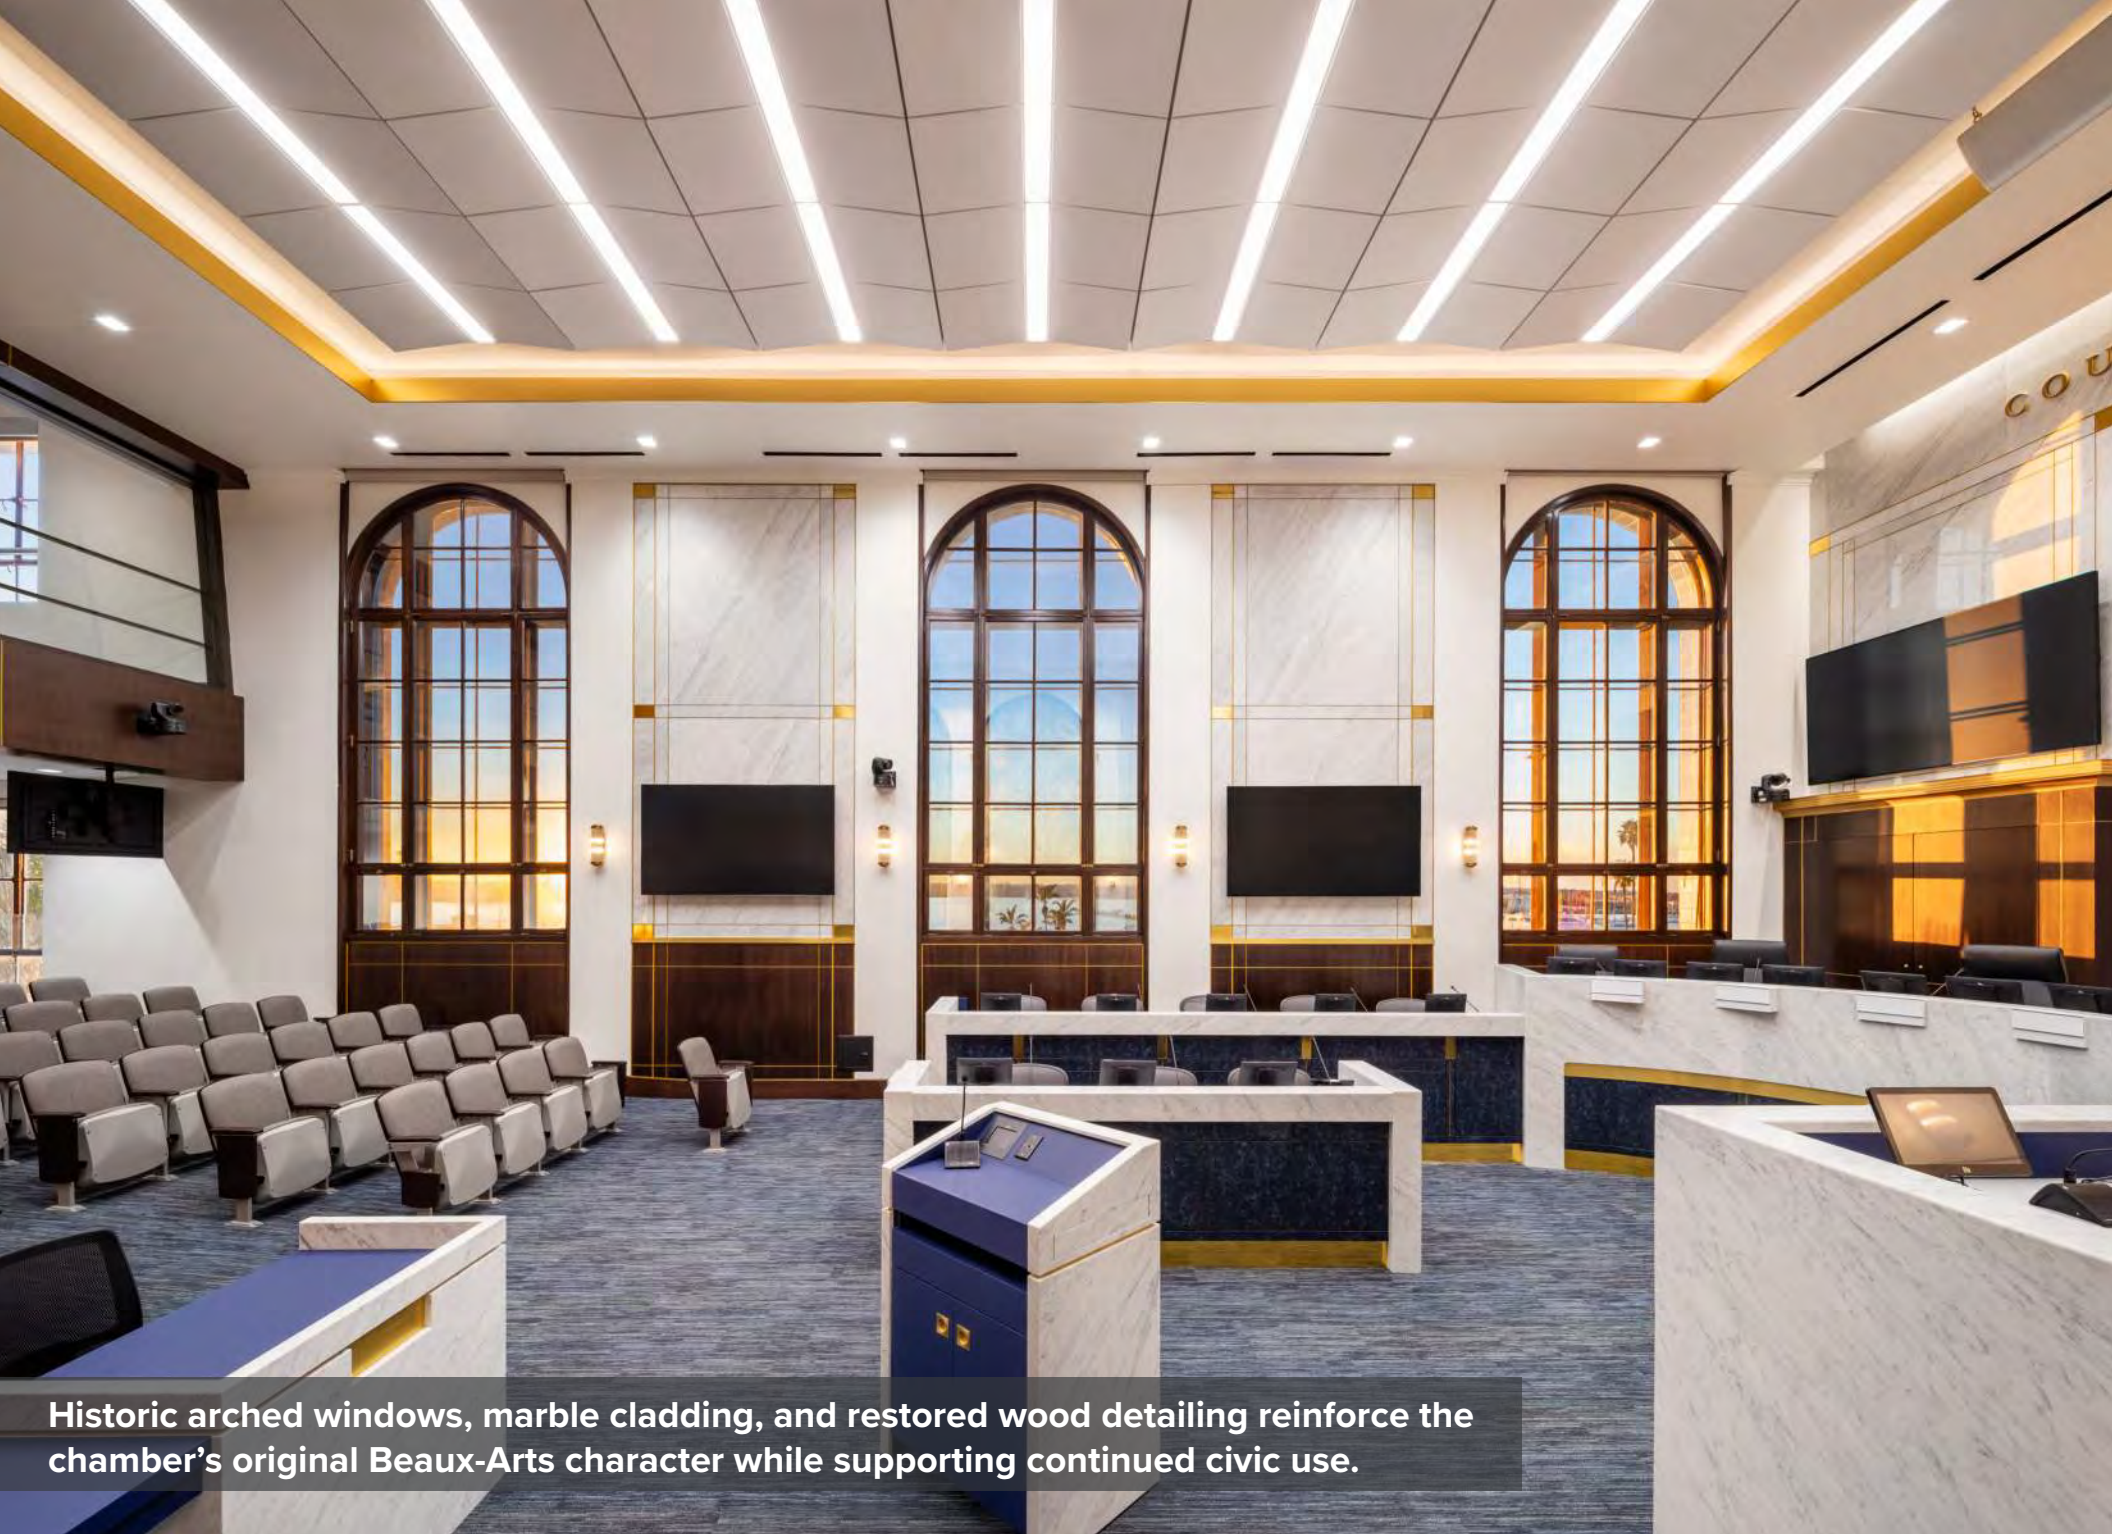
Restoration of the Board Chambers reinstated character-defining finishes and spatial integrity while carefully integrating contemporary life-safety and audiovisual systems.

Historic arched windows, marble cladding, and restored wood detailing reinforce the chamber's original Beaux-Arts character while supporting continued civic use.

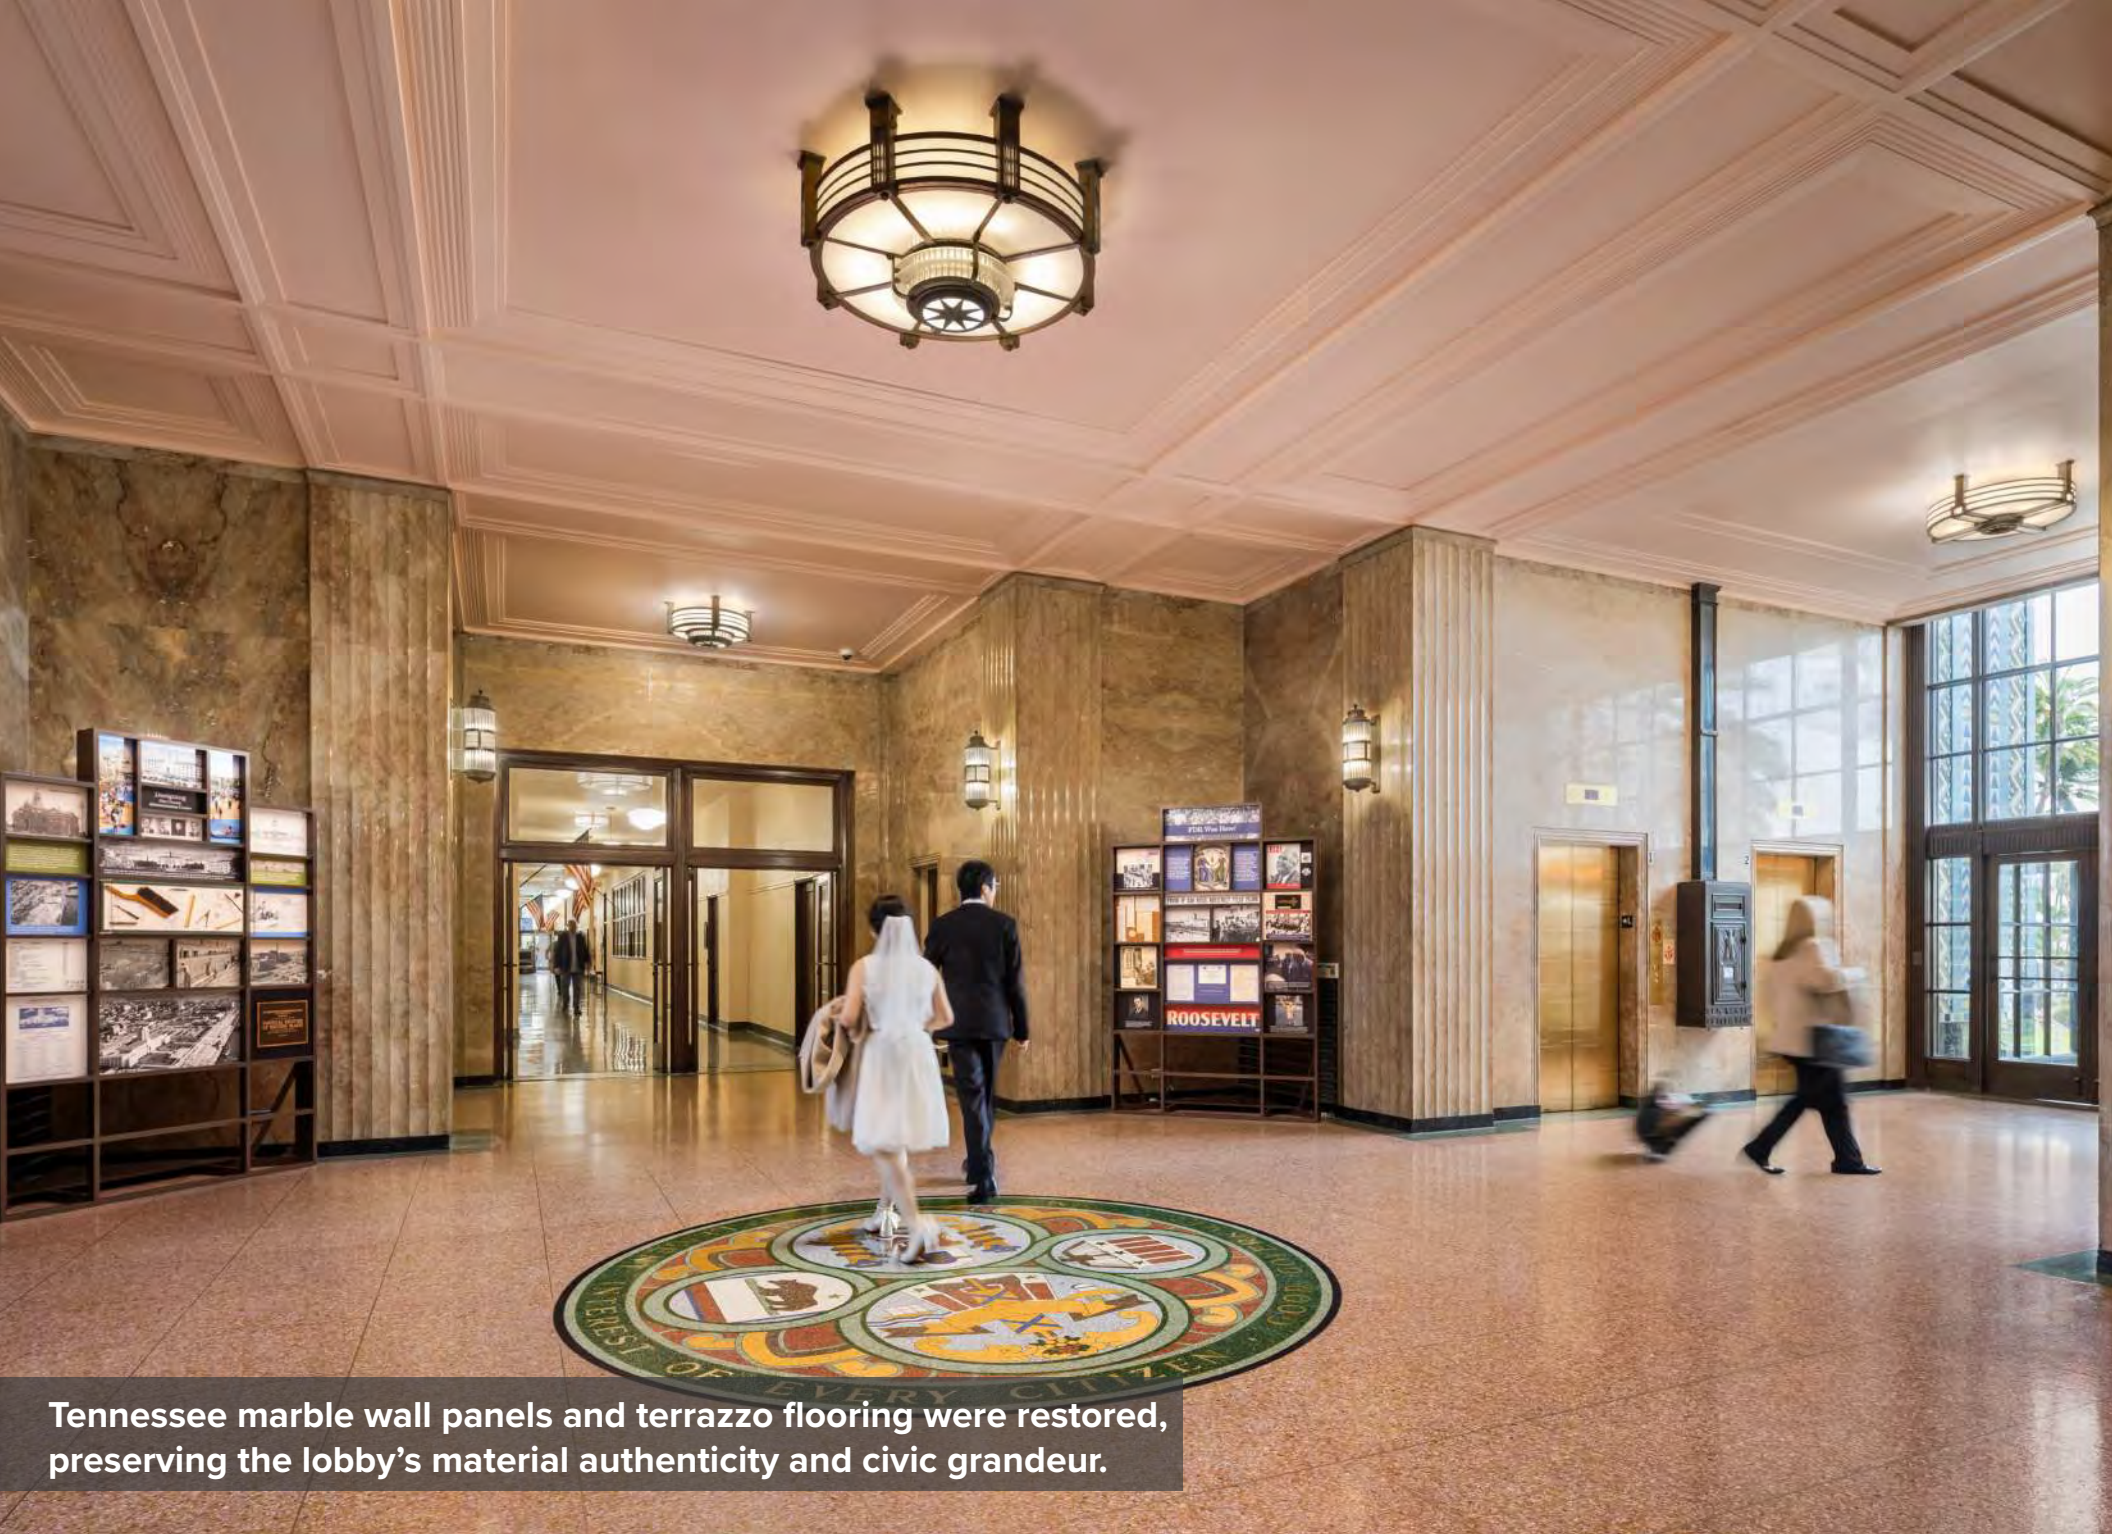
WPA-era murals, hand-painted in egg tempera on muslin over gesso, were conserved in place, safeguarding both their fragile materials and their civic storytelling.

Board Chambers Modern audiovisual and life-safety systems were integrated while protecting **WPA-era murals** under conservator supervision.

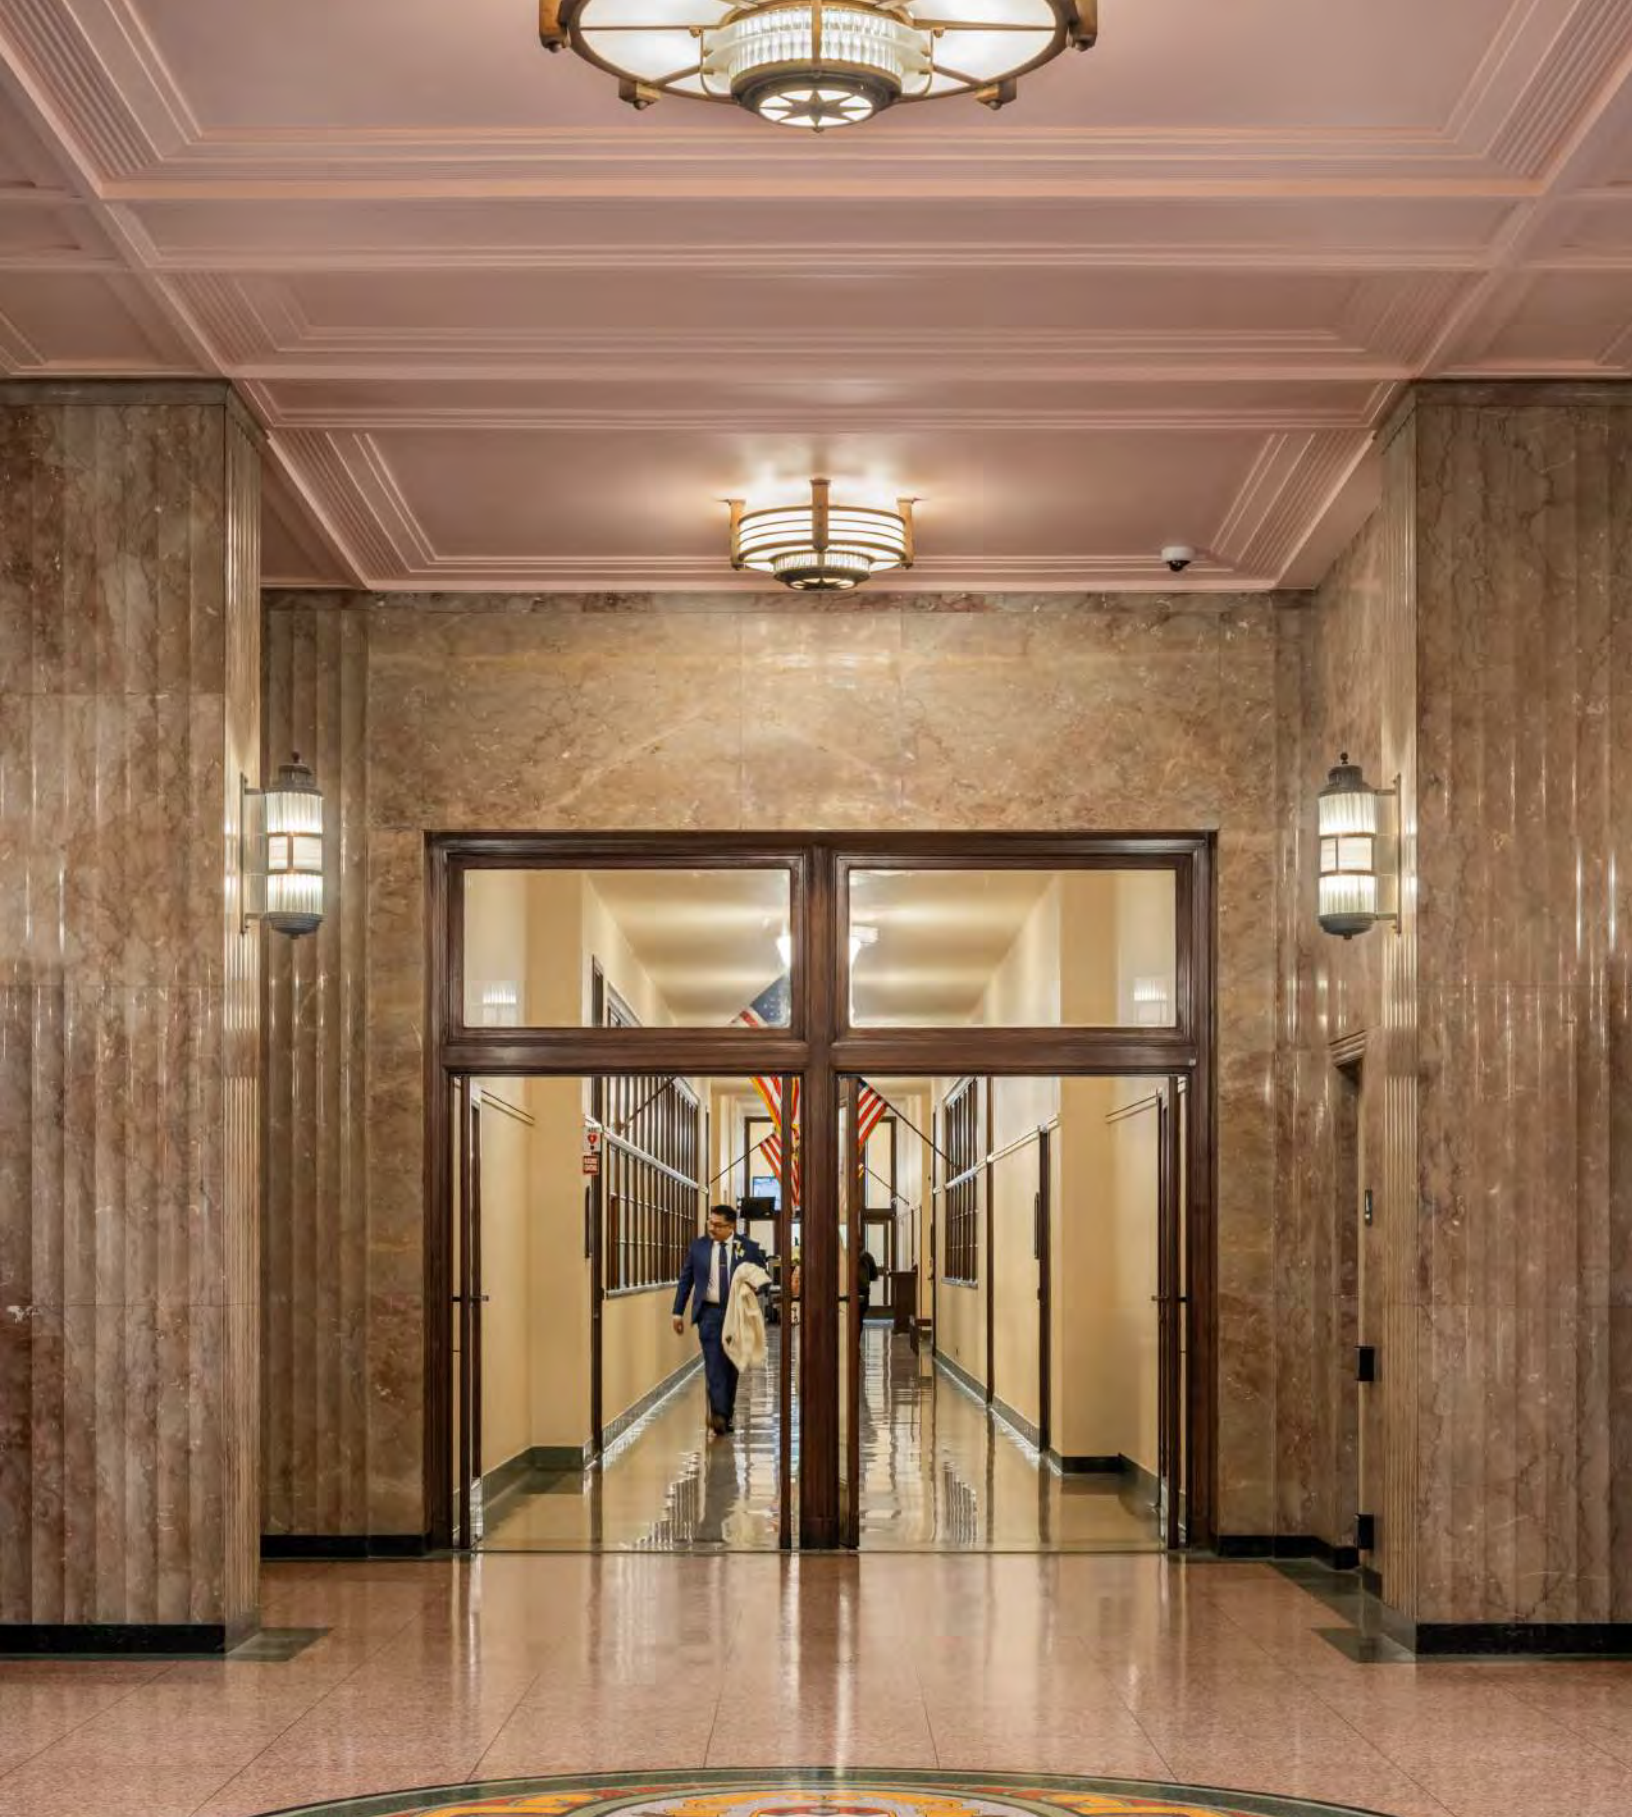
Tennessee marble wall panels and terrazzo flooring were restored, preserving the lobby's material authenticity and civic grandeur.

- Tennessee Rose & Vermont Verde marble restored
- Terrazzo flooring repaired to original composition
- Original wood-and-glass light fixtures restored and retrofitted with concealed LED bulbs
- Mahogany stair railings preserved
- Brass trim revealed and reinstated
- Spatial proportions & Beaux-Arts circulation patterns were maintained.

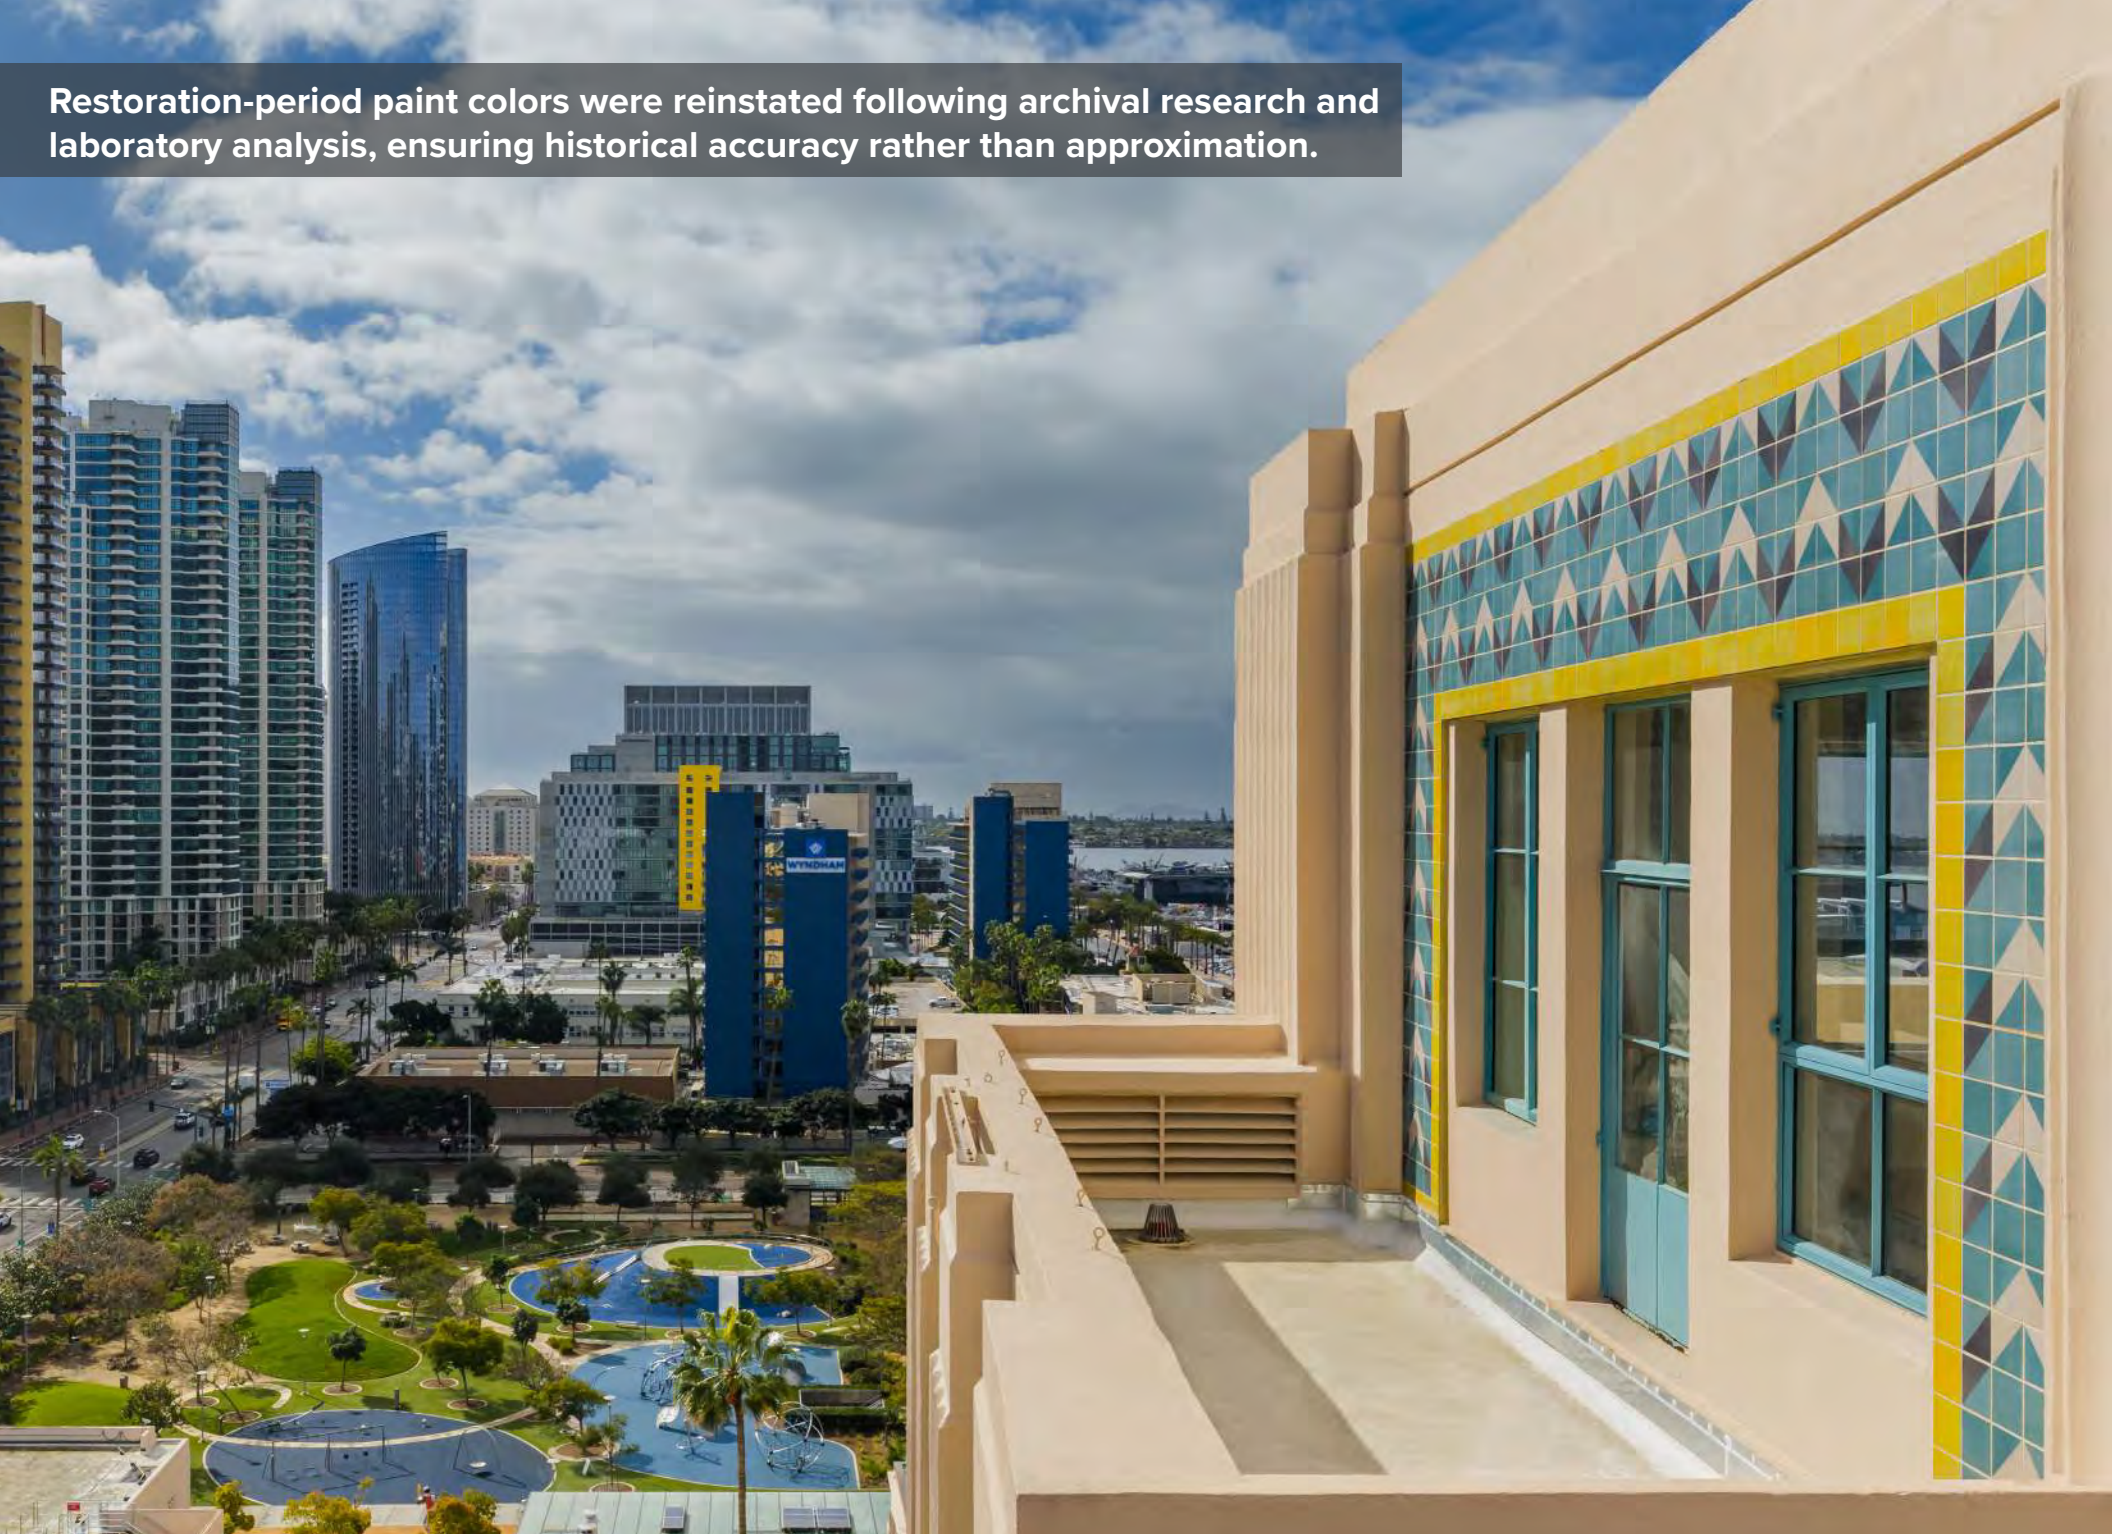
Restoration-period paint colors were reinstated following archival research and laboratory analysis, ensuring historical accuracy rather than approximation.

Determination of Historical Colors & Finishes Laboratory-based paint cross-section analysis established restoration-period colors. Exterior turquoise window finishes and interior brown trim were reinstated based on documentation, not conjecture. **Repainting followed Restoration Standards and Preservation Brief guidance.**

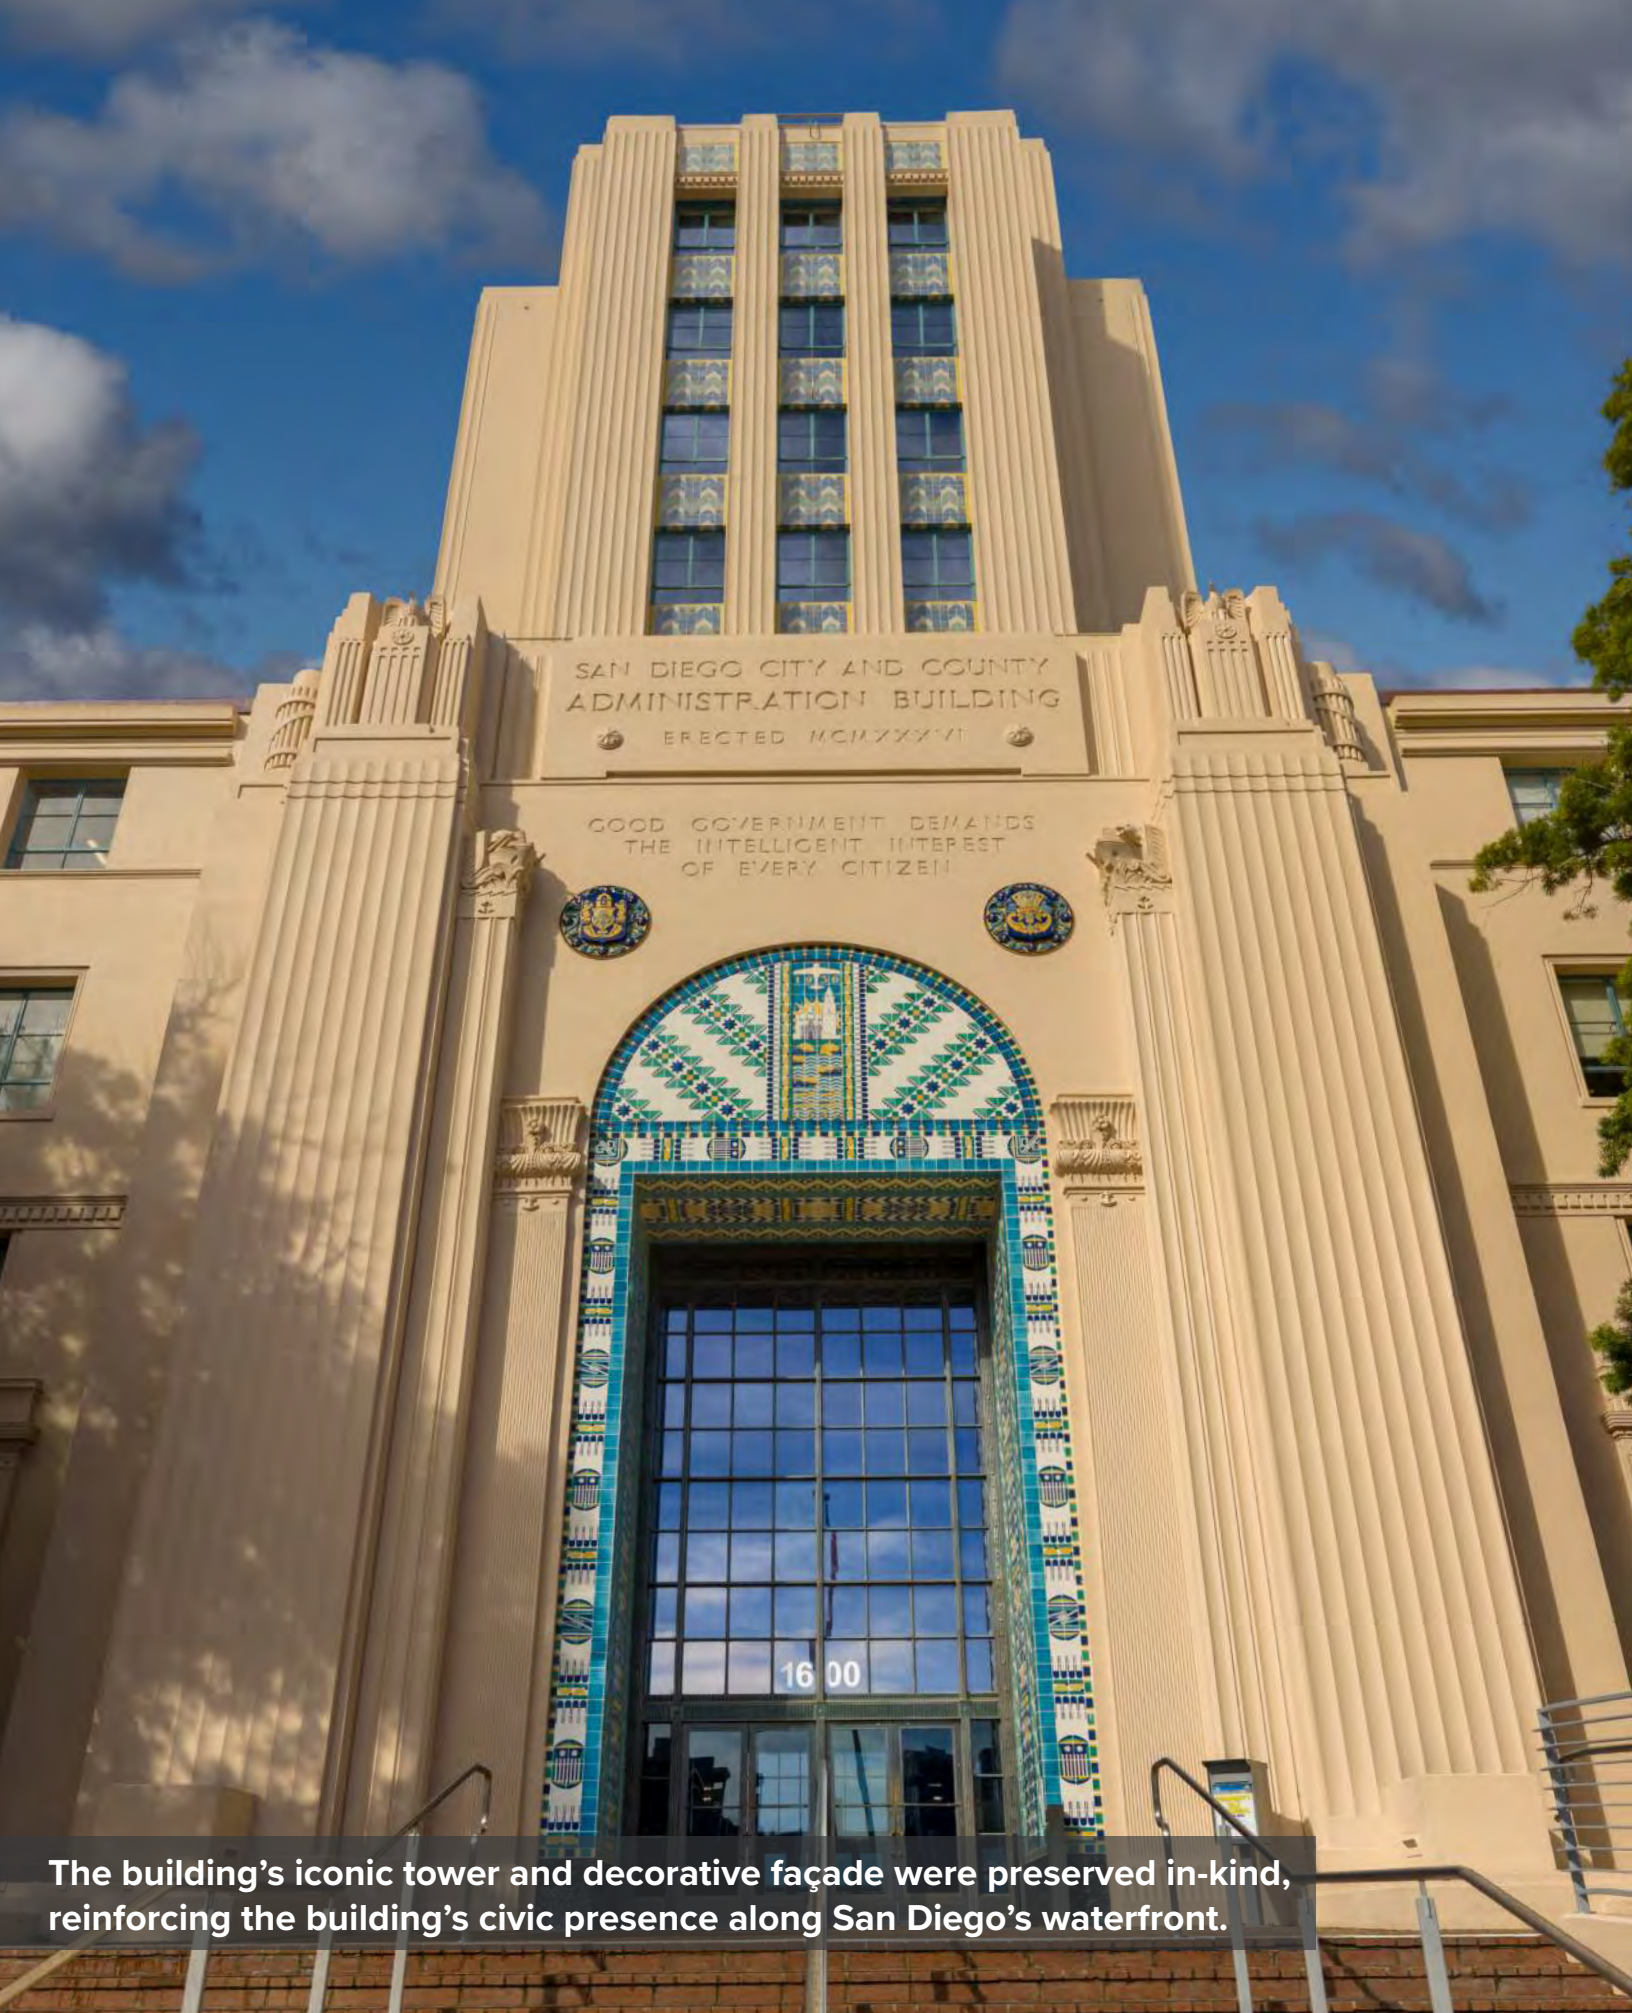
Ceramic mosaic domes were restored by specialized conservators, with mortar composition, color, and profile matched in-kind to maintain historic integrity.

Mosaic Domes Ceramic tile domes were restored by specialized art conservators. Mortar joints were duplicated in strength, composition, color, and profile.

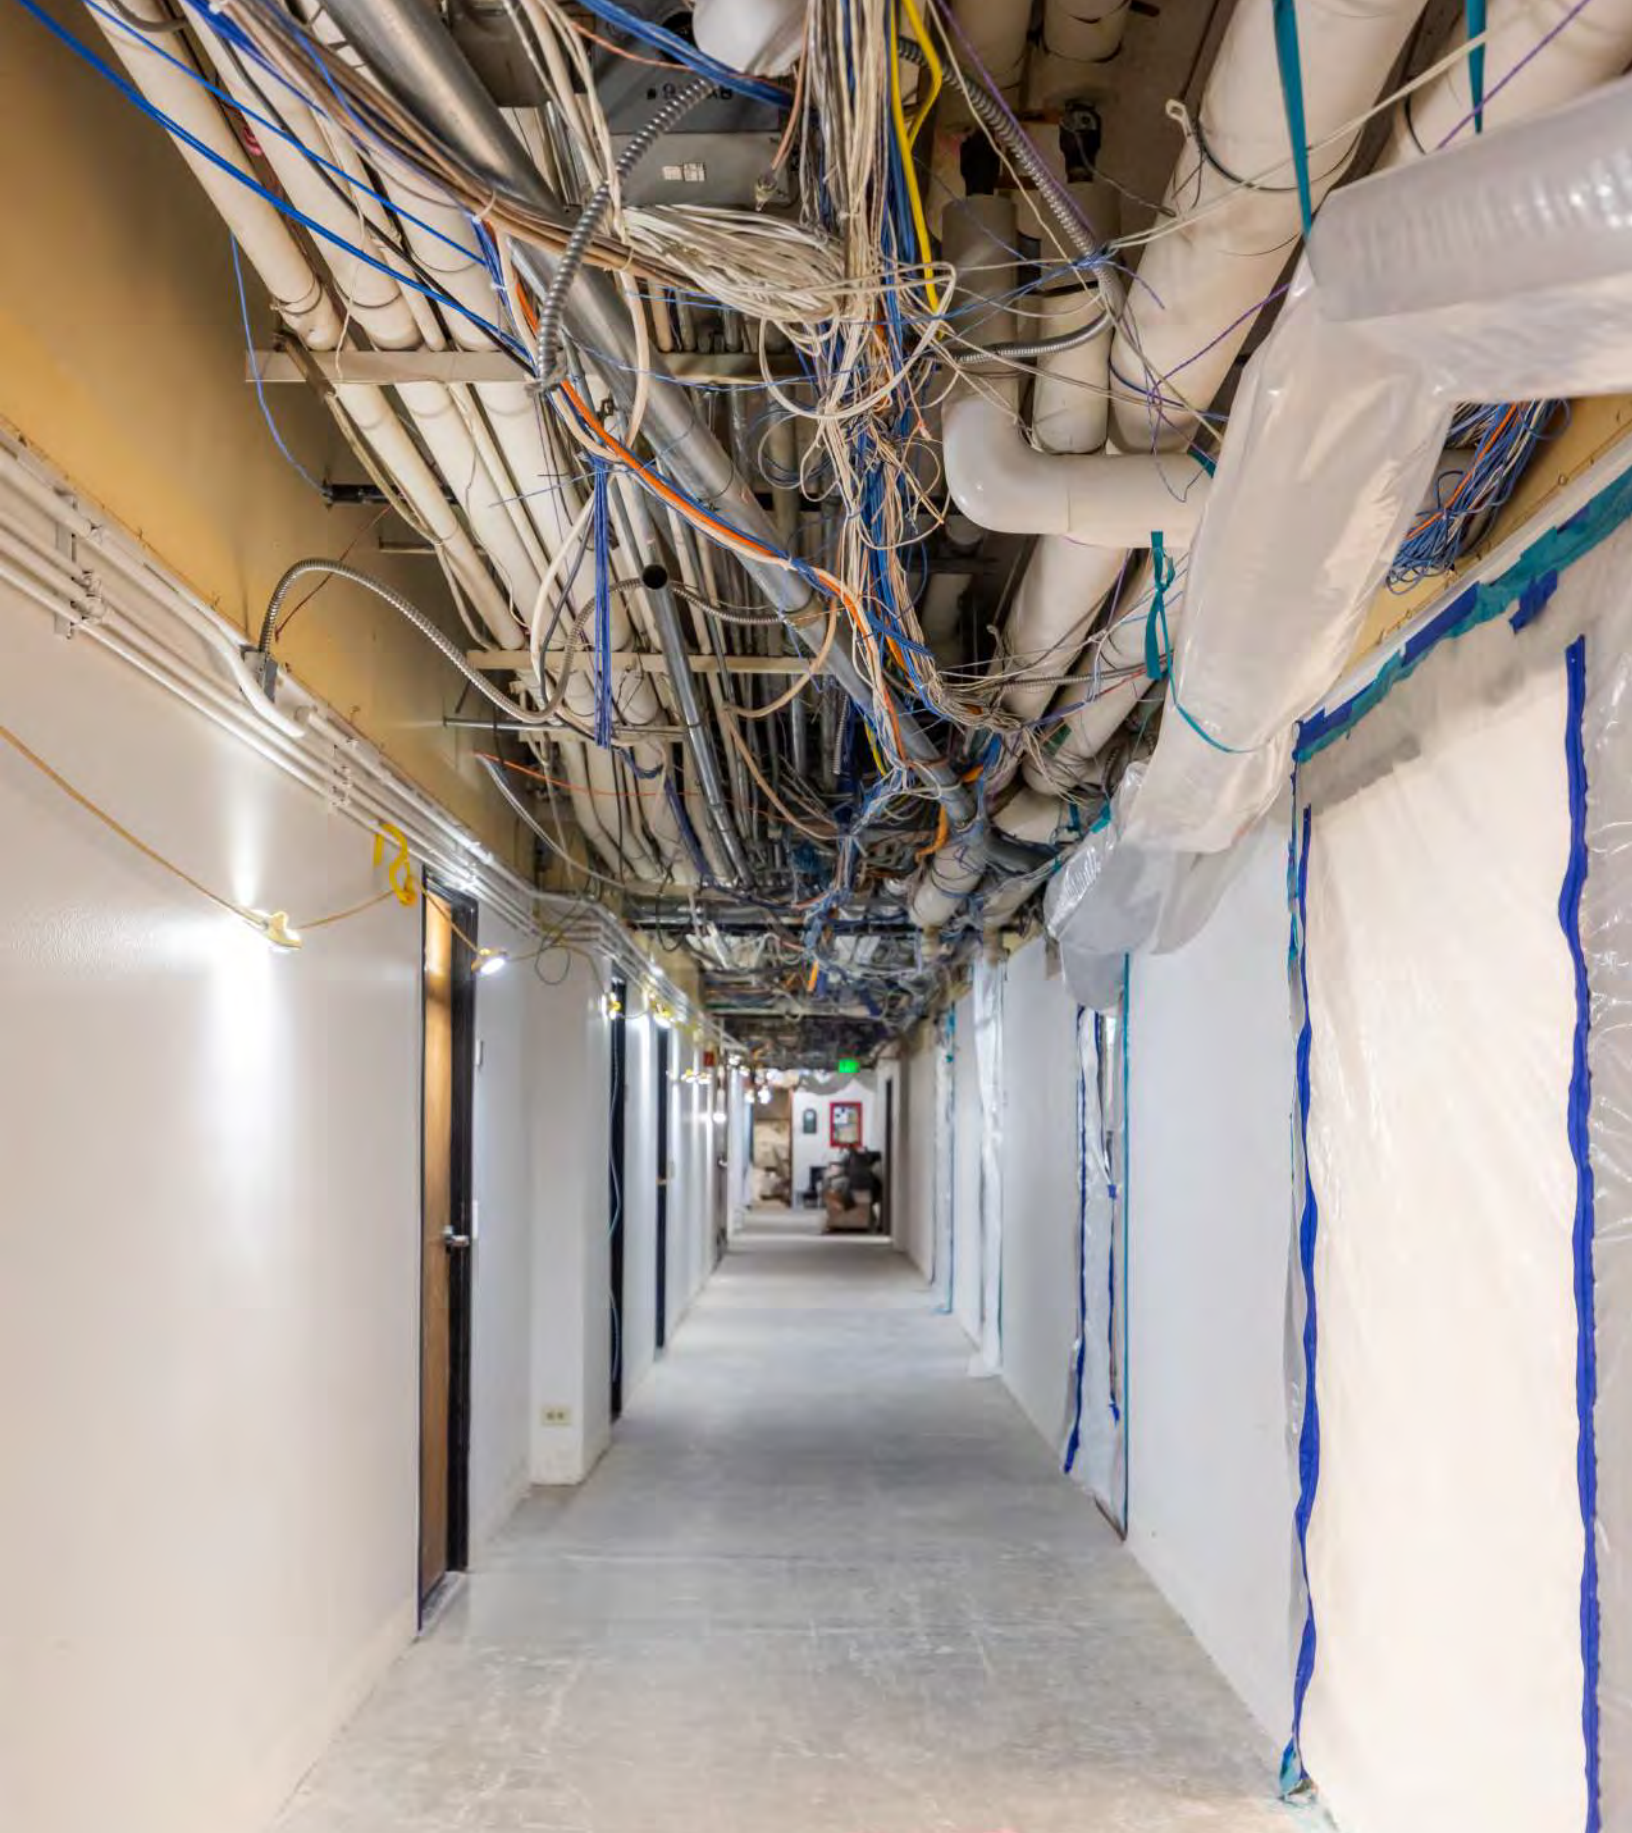
Fiber-reinforced polymer seismic reinforcement strengthens the historic structure discreetly, extending the building's life while retaining original concrete and masonry.

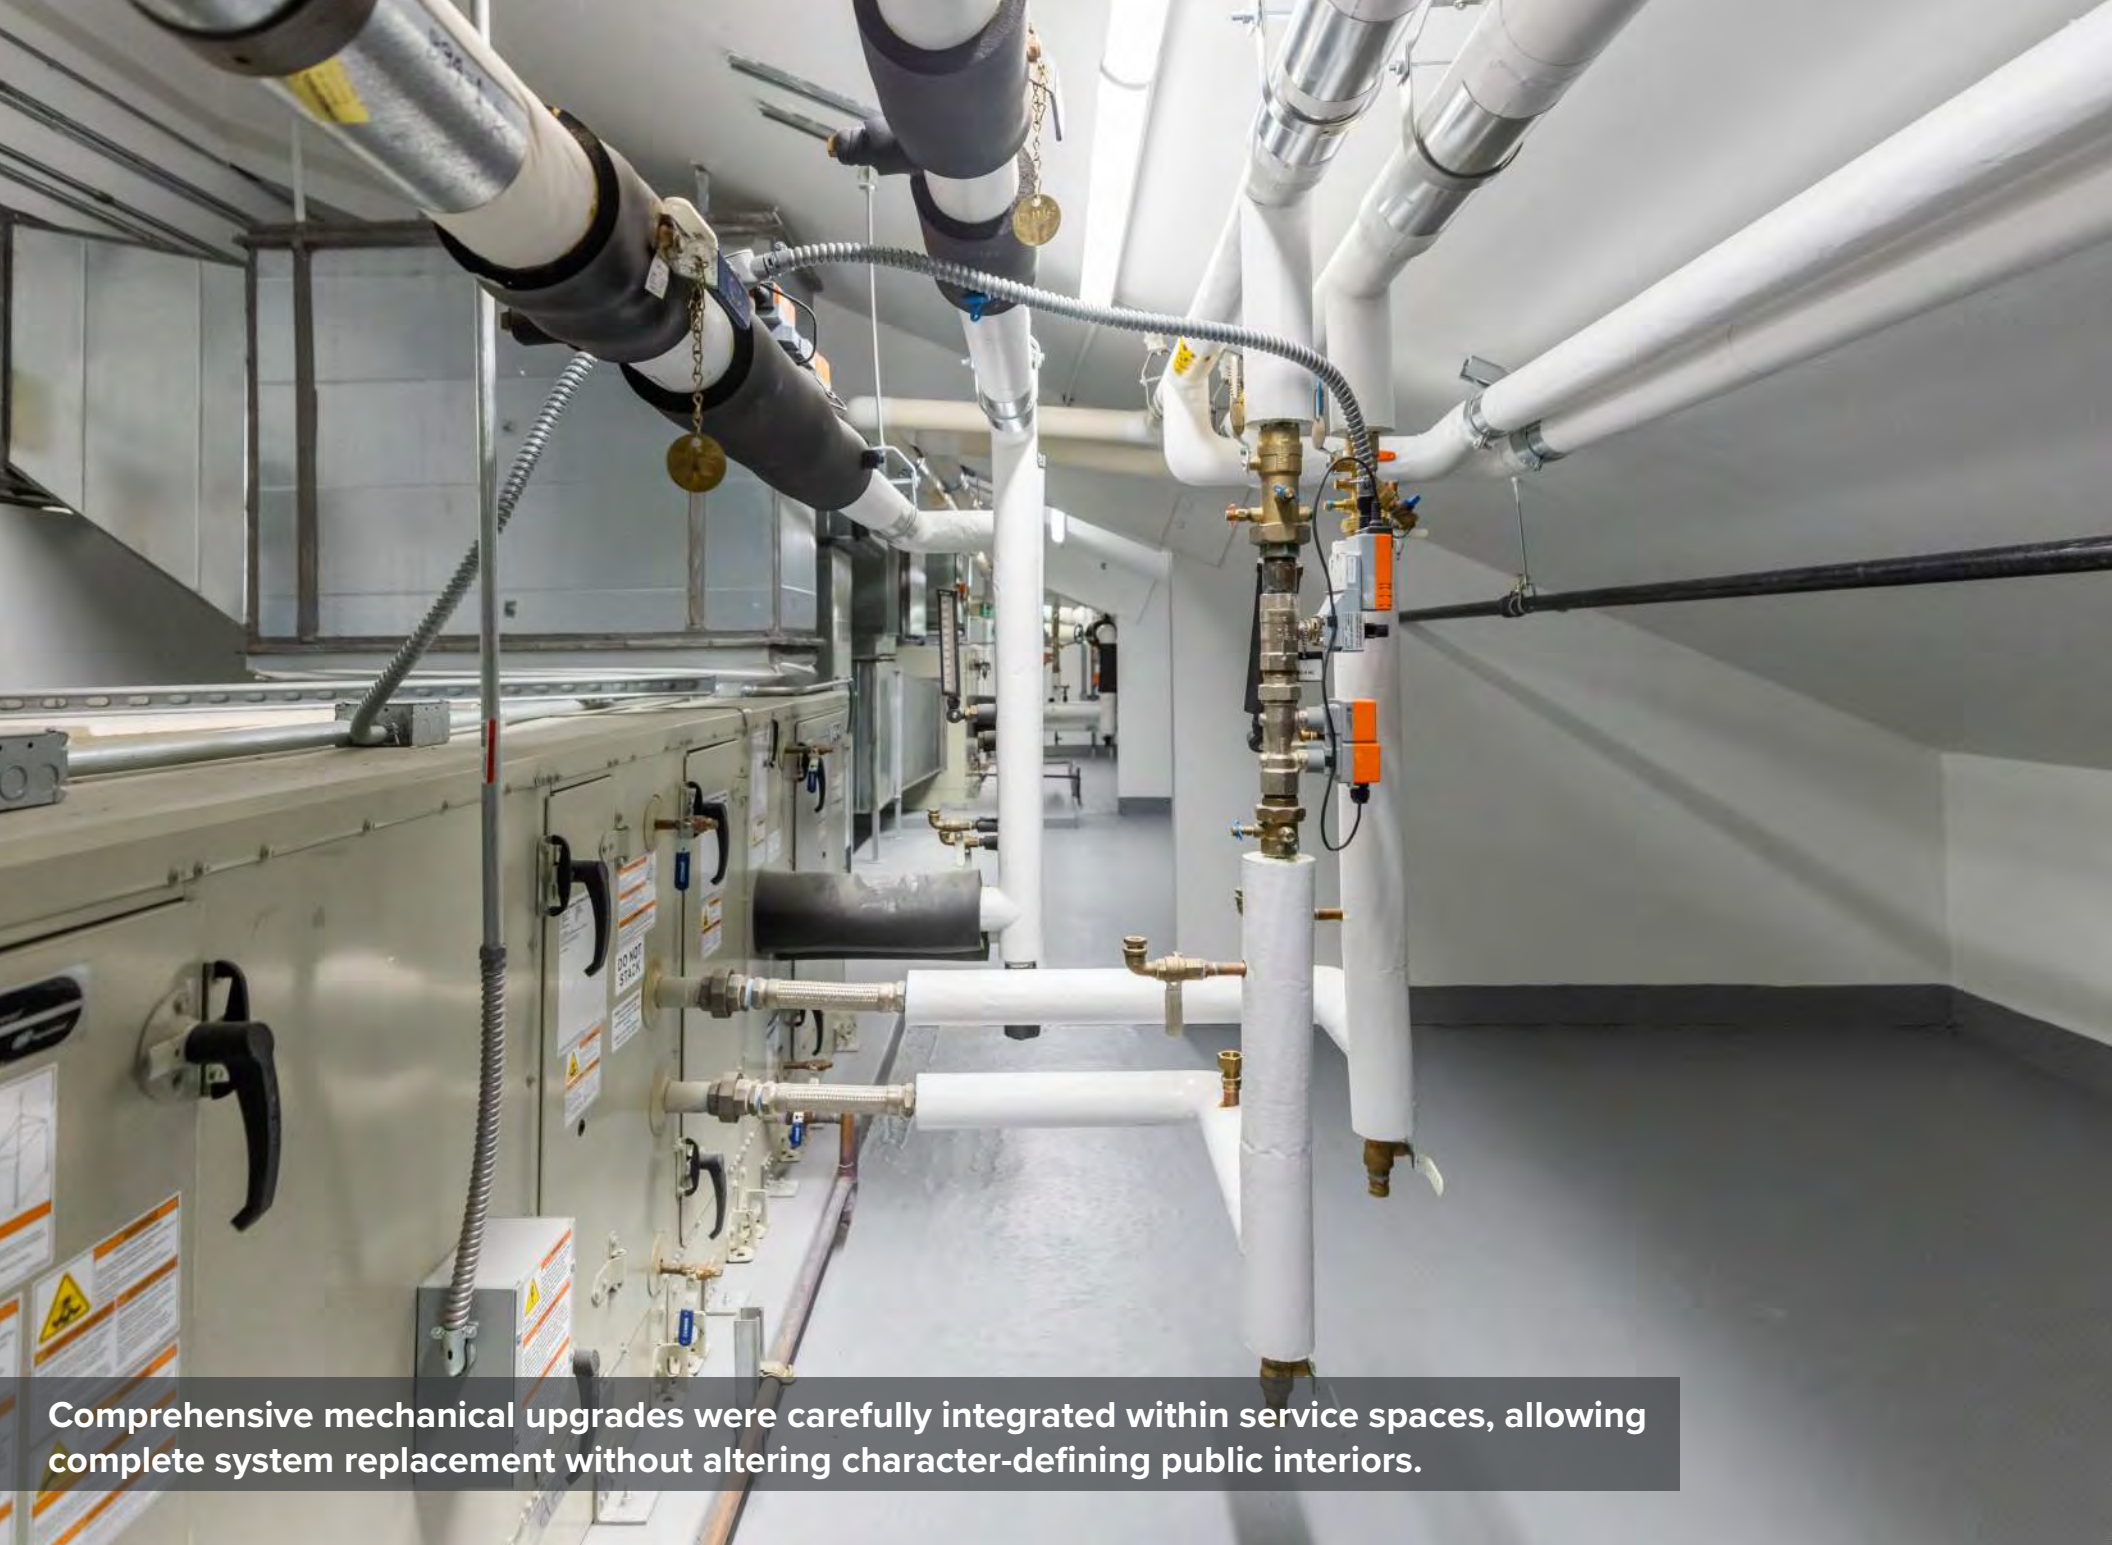
Building automation, fire protection, and life-safety systems were modernized throughout the facility, transforming performance while preserving historic spaces.
