**CITY OF SAN DIEGO HISTORICAL RESOURCES BOARD
POLICY SUBCOMMITTEE AGENDA**

This report details the conservation treatment of two large-scale photographic murals located in the interior foyer of the Alvarado Water Filtration Plant Operations Building (5540 Kiowa Drive, La Mesa 91942) and provides recommendations for the continued preservation of the murals.

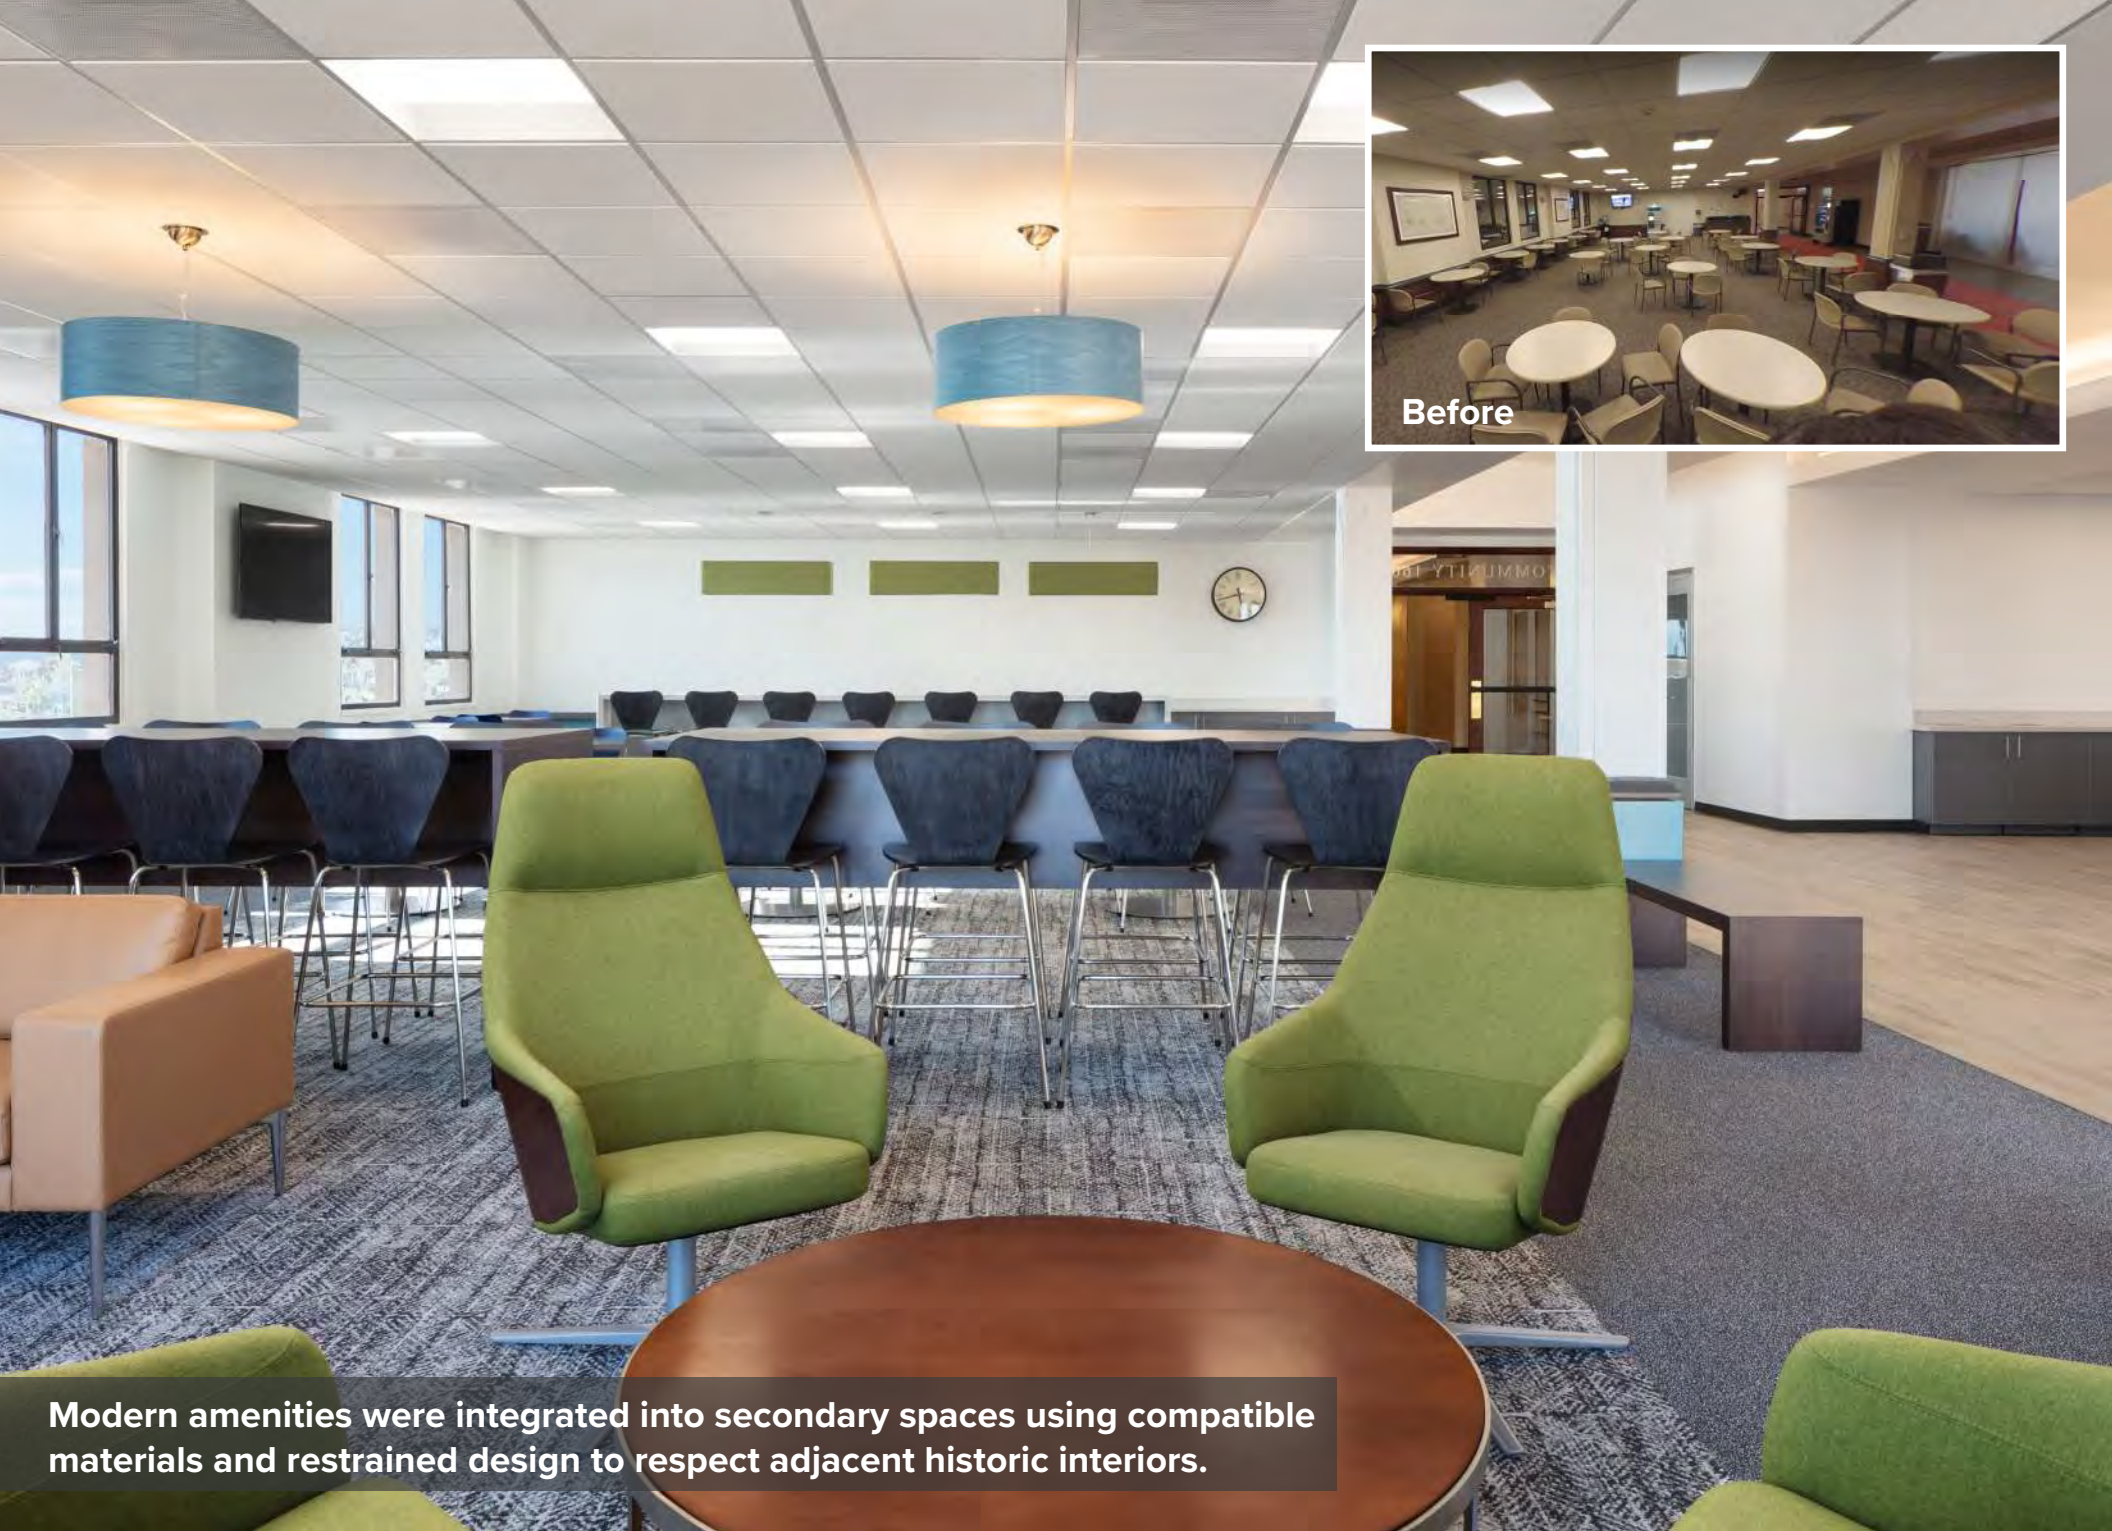
New electrical infrastructure enhances operational reliability and resilience while preserving the historic fabric above and around these service areas.

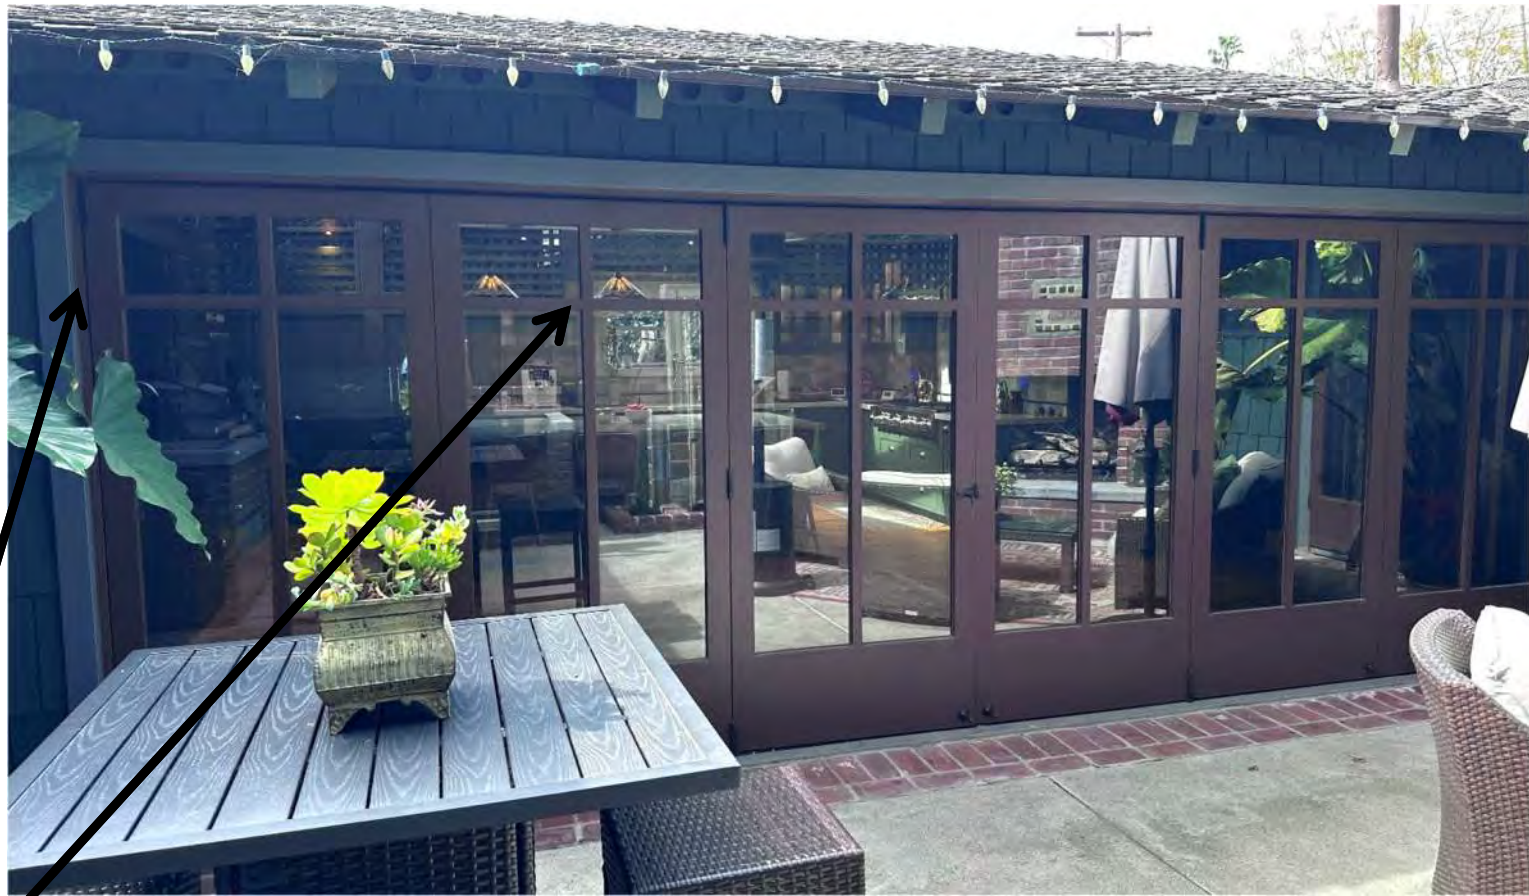
After

Photo of current home: New folding exterior doors to rear courtyard installed within original overall opening of existing three pairs of exterior doors; New door glass break up of two rectangular glass panes over two vertical glass panes below to differentiate from original

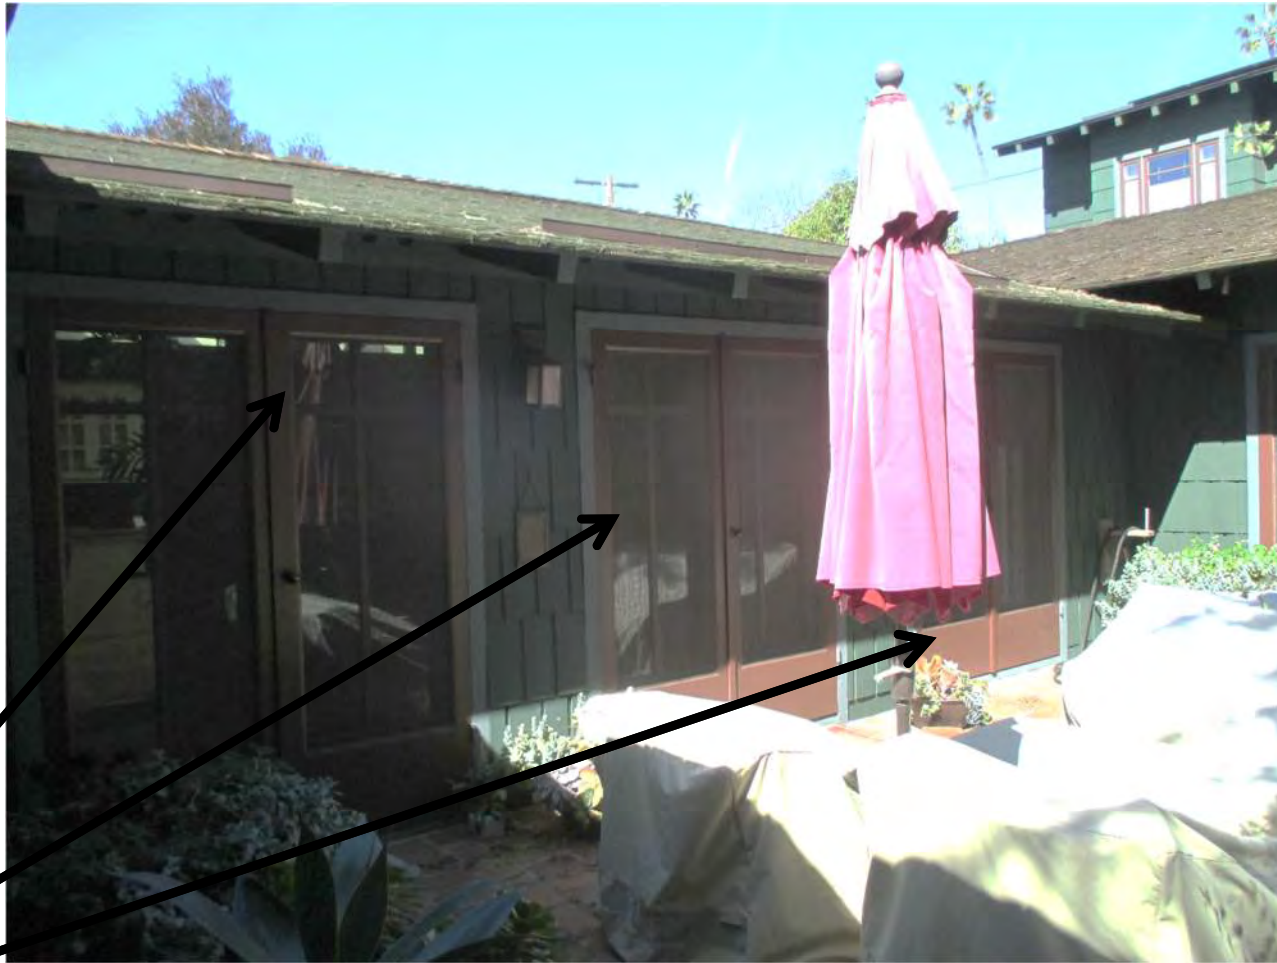
Before

Photo of home prior to construction: Rear courtyard with three pairs of exterior doors; Original door glass break up of two square glass panes over two vertical glass panes below

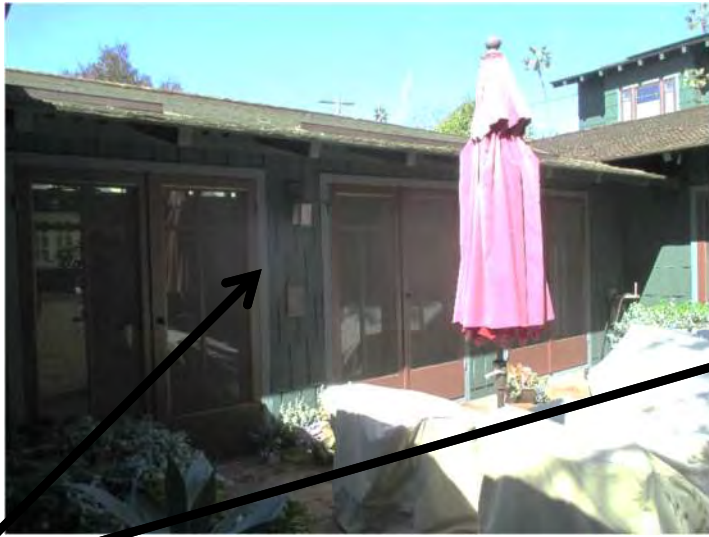
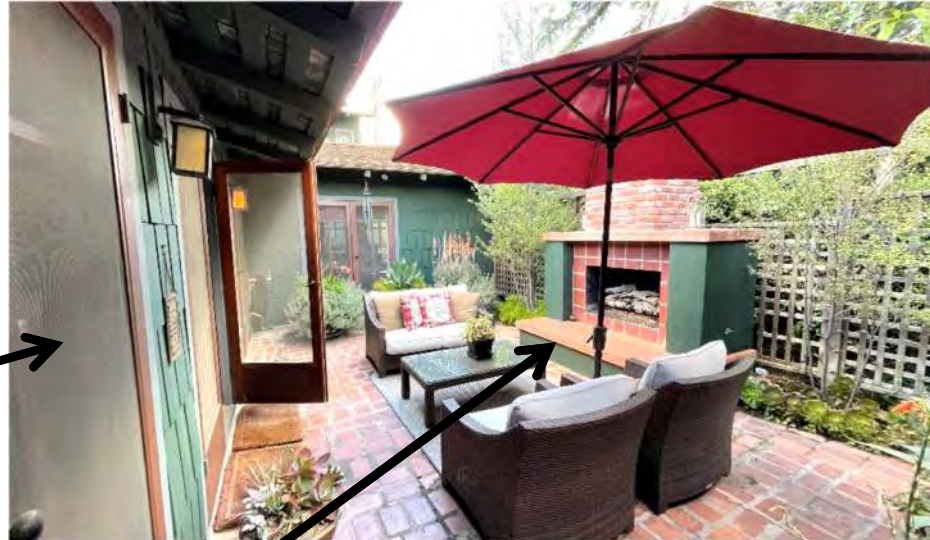
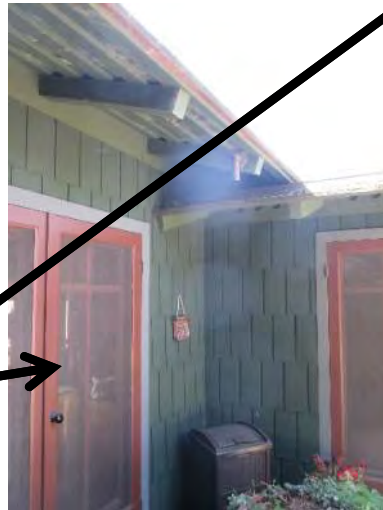
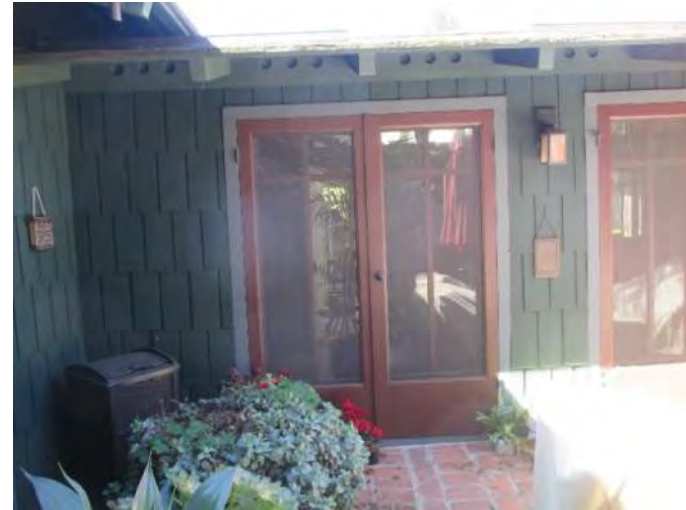
Before Photos of Rear Courtyard

Photos of home prior to construction: Rear courtyard with three pairs of exterior doors; Original door glass break up of two square glass panes over two vertical glass panes below; Non-original fireplace

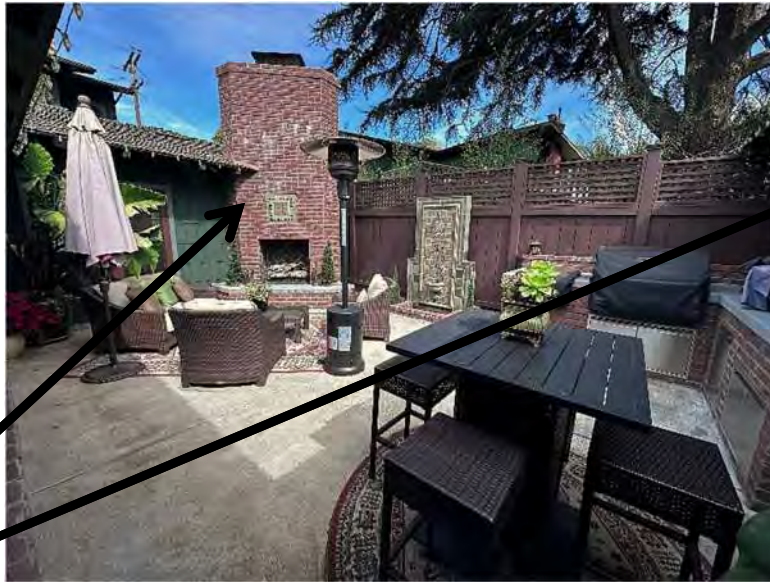
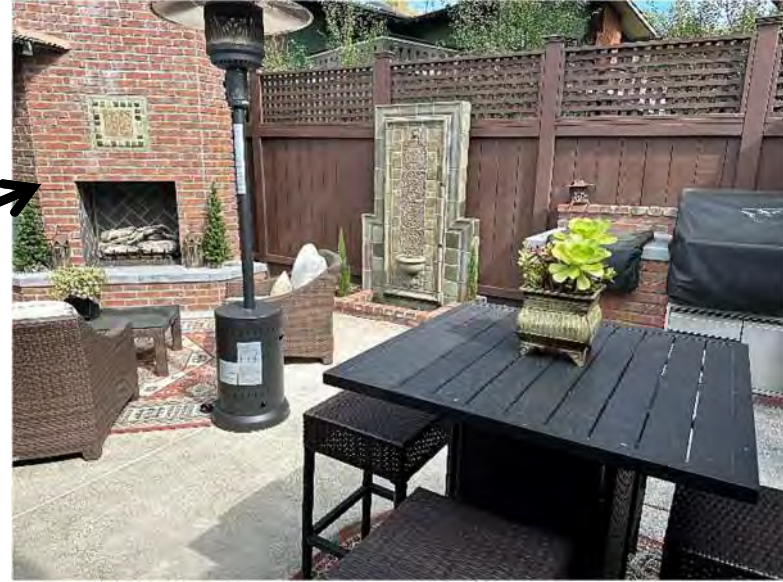
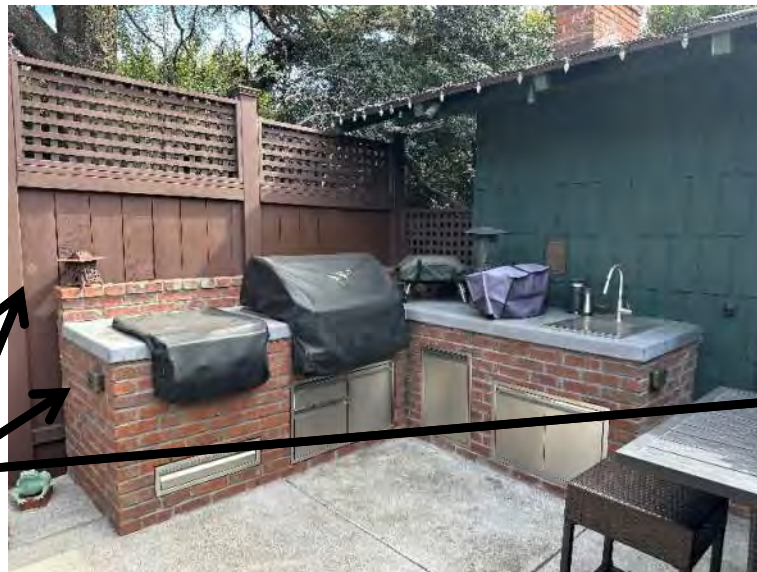
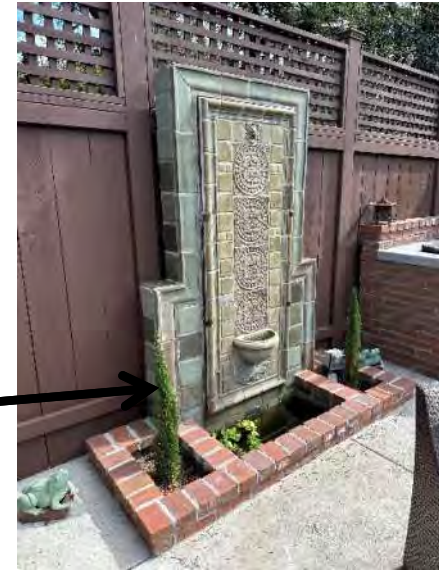
After Photos of Rear Courtyard

Photos of current home:
New outdoor fireplace
with subtle change in
brick pattern to
differentiate from the
original fireplace
chimneys; New wood
fence with open lattice;
New Outdoor Kitchen;
new Water Feature

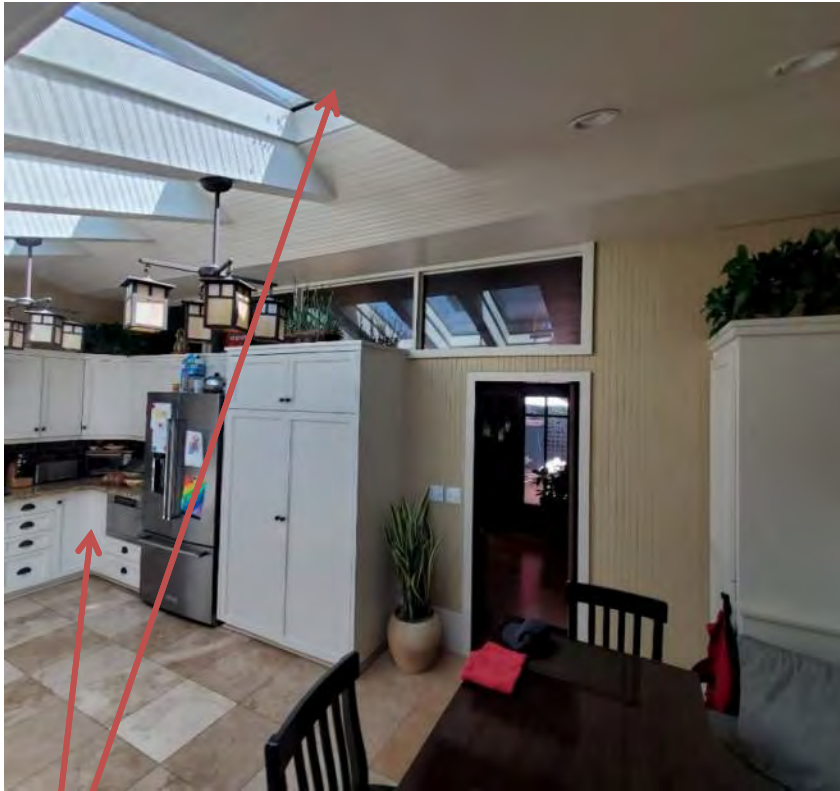
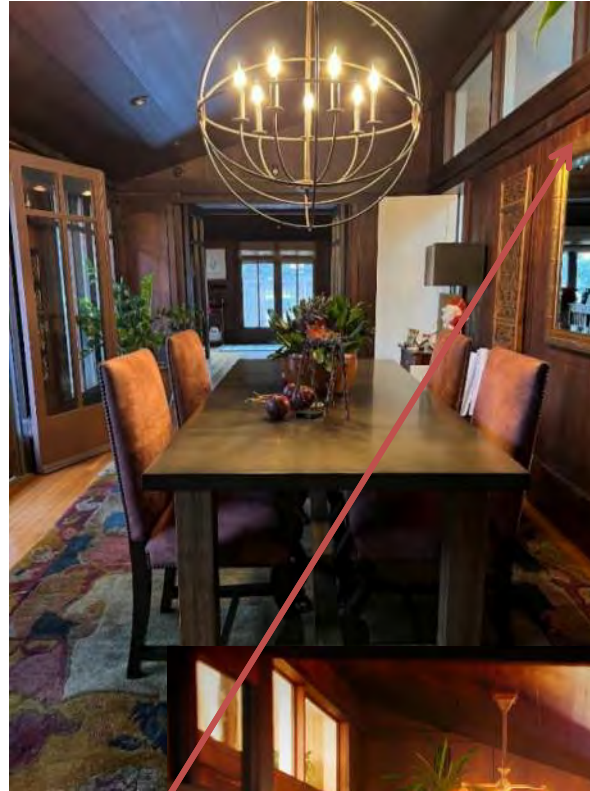
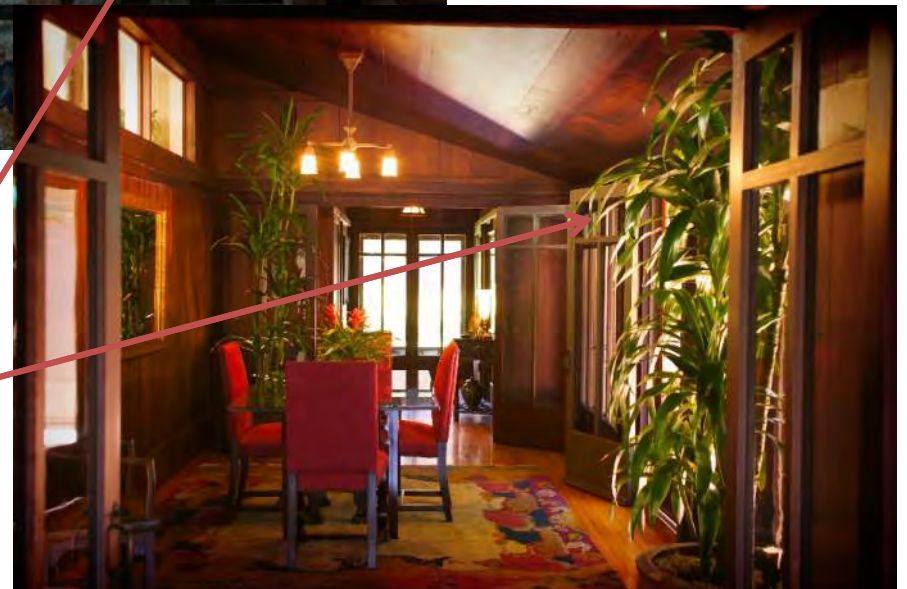
Before Photos of Kitchen and Dining Room

Photos of existing home prior to construction: Separate Kitchen and Dining Room; Existing skylights; Existing doors to Rear Courtyard

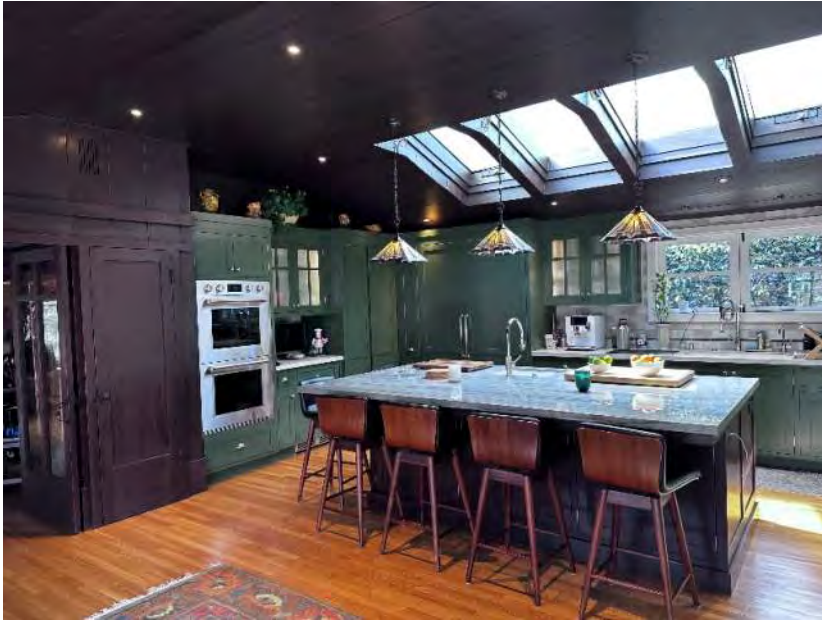
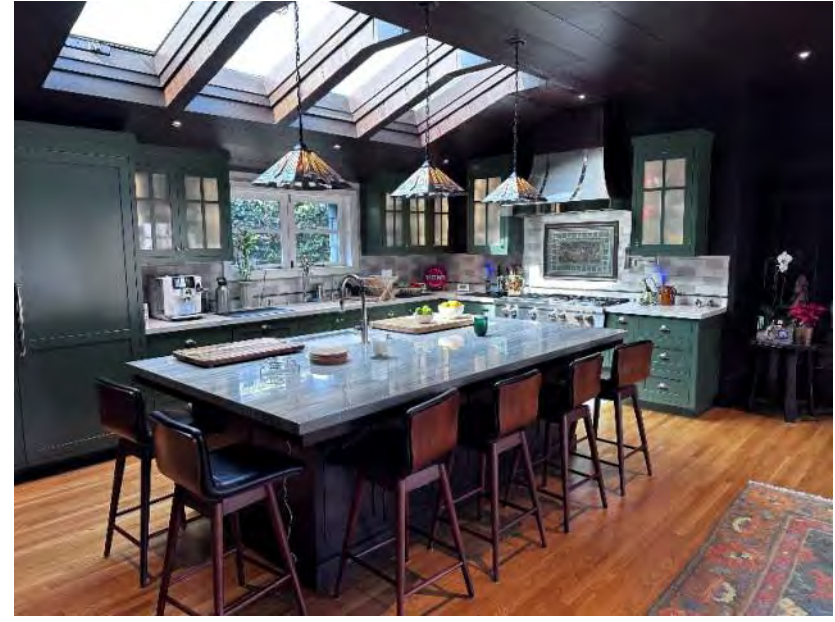
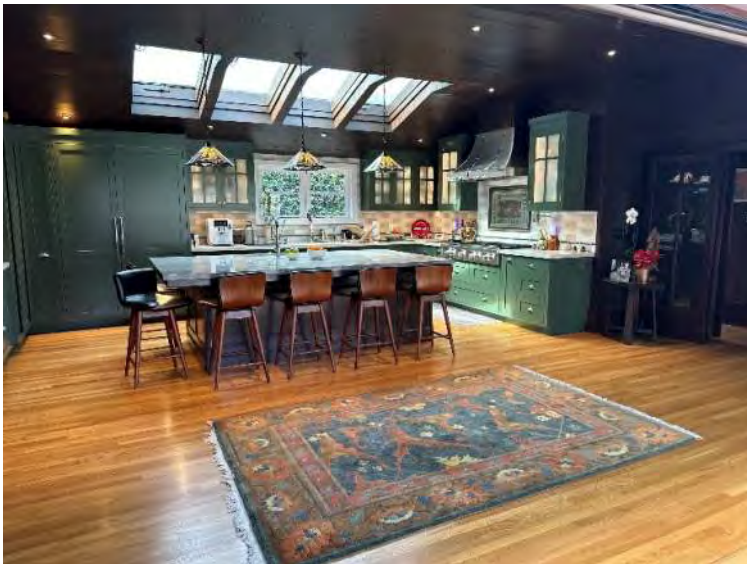
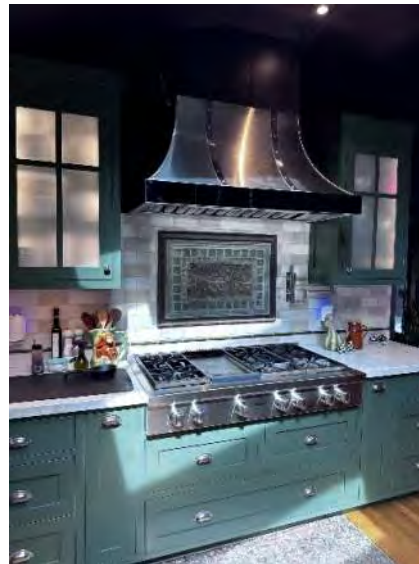
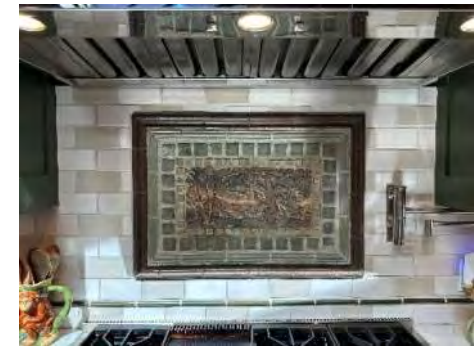
After Photos of Kitchen

Photos of current home:
New open Kitchen/Dining
area; New island, New tile
inlay at range top

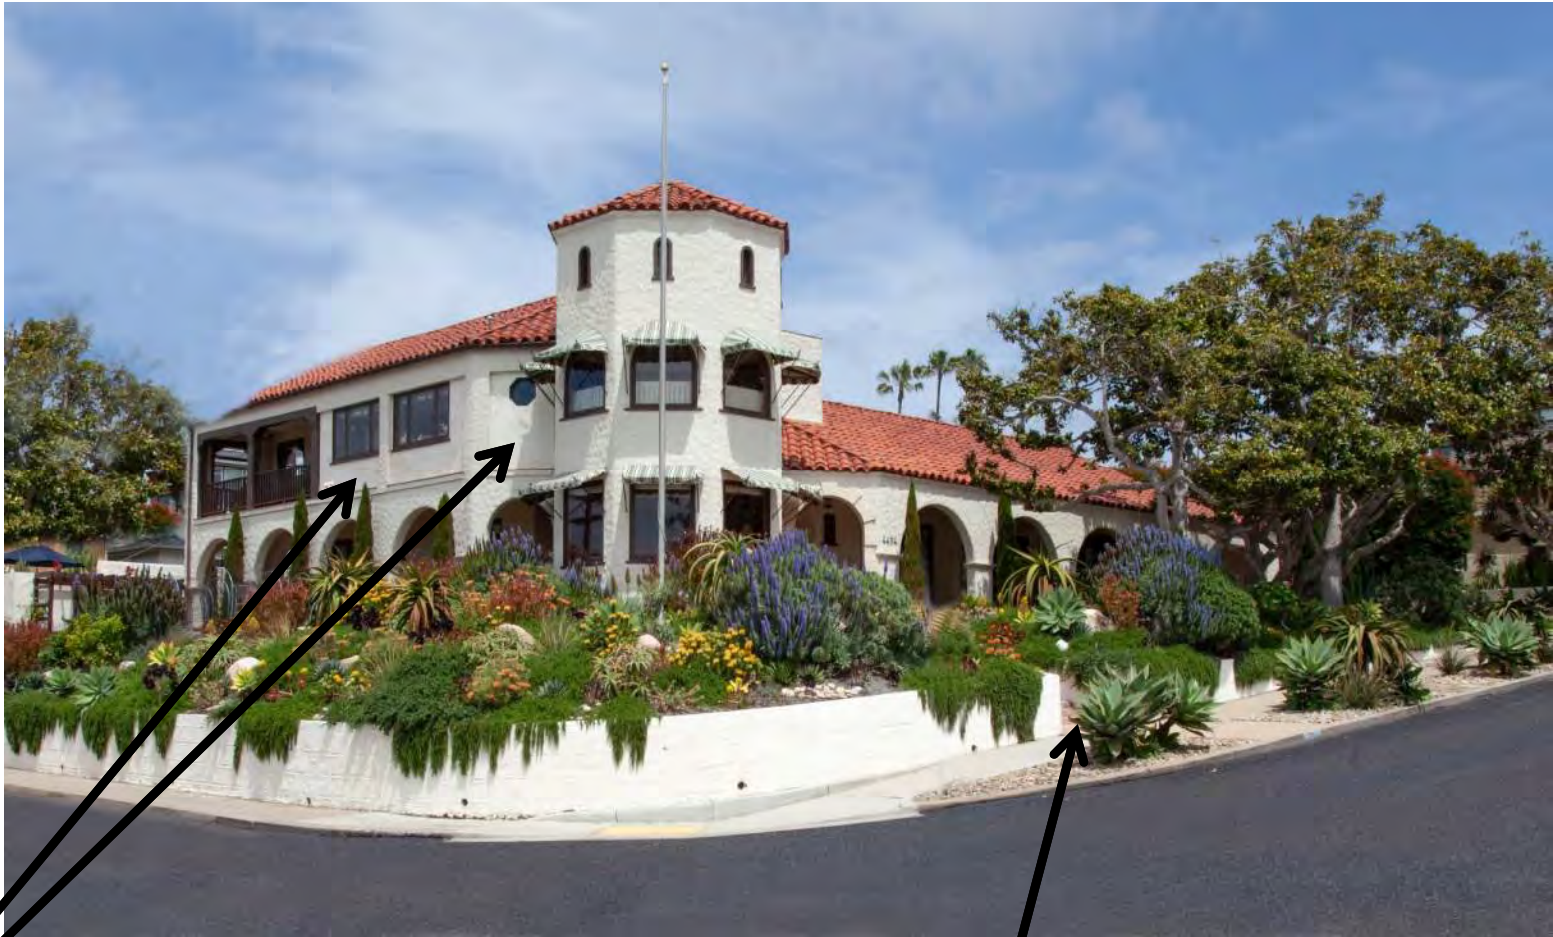
Photo of current home: Stucco texture at previously filled-in balcony changed to smoother texture to differentiate between historic and prior construction

The project met the Standards in that the previous Balcony enclosure was remodeled to differentiate the in-fill stucco from the original stucco texture; the Balcony tile edge detail was added for the extent of the enclosed portion delineating that that portion had originally been an outdoor Balcony; All wood windows were replaced-in-kind as needed where restoration was not possible (custom built); The Kitchen addition was kept in the rear of the house, not visible from public view. The Kitchen addition was differentiated by stepping down the terra cotta roof, use of smoother stucco and a vertical

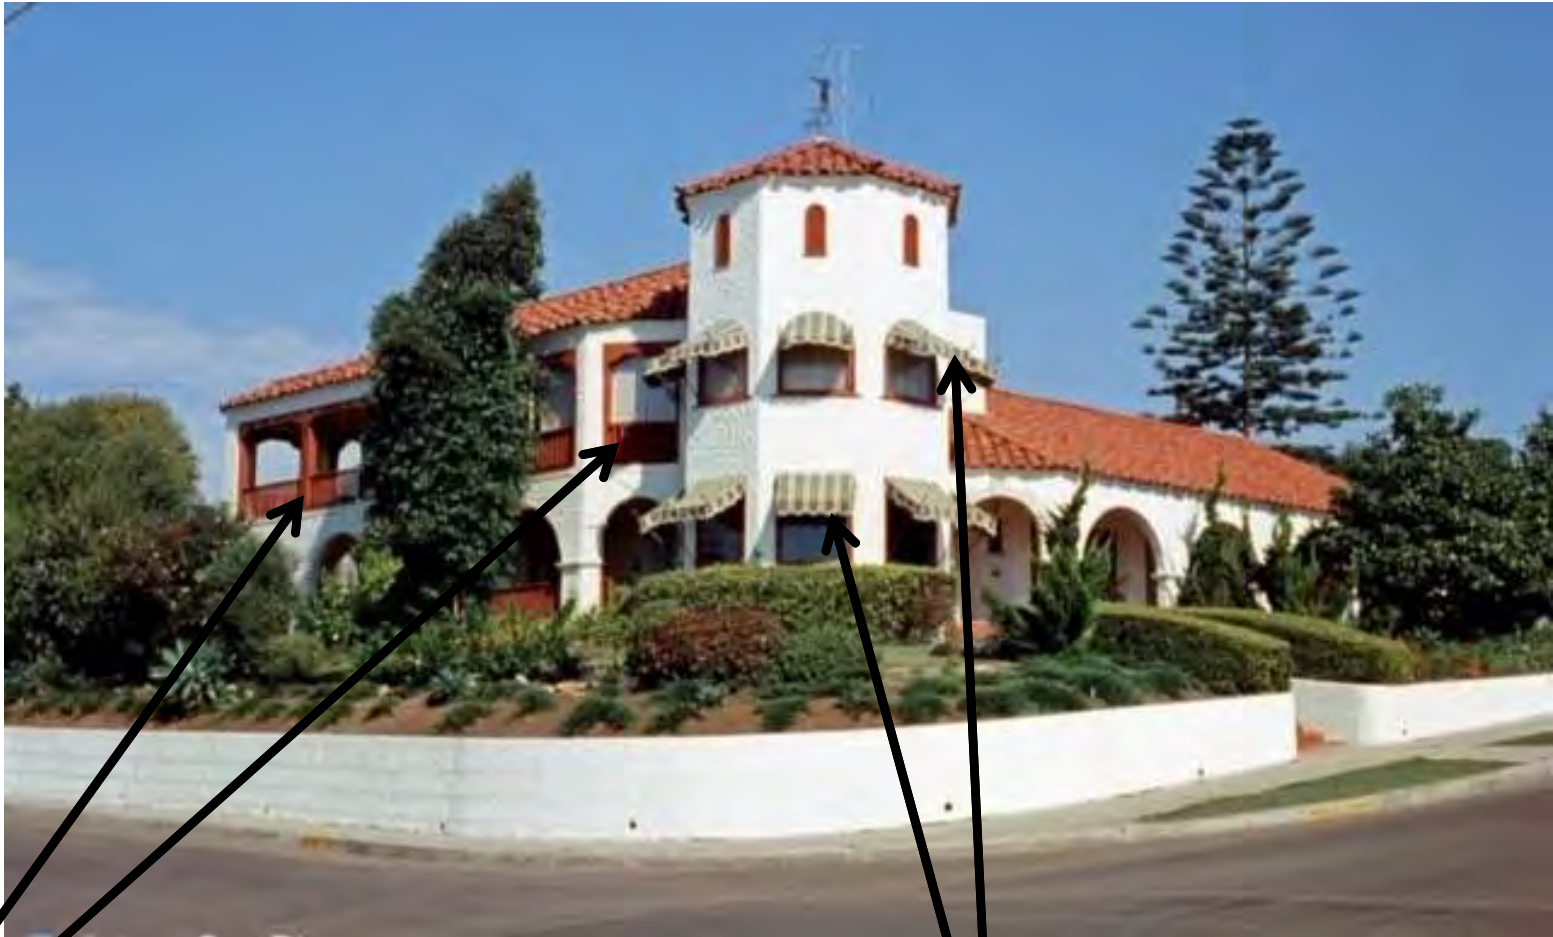
Historic Photo: Showing original open balcony

Historic Photo: Showing original awnings

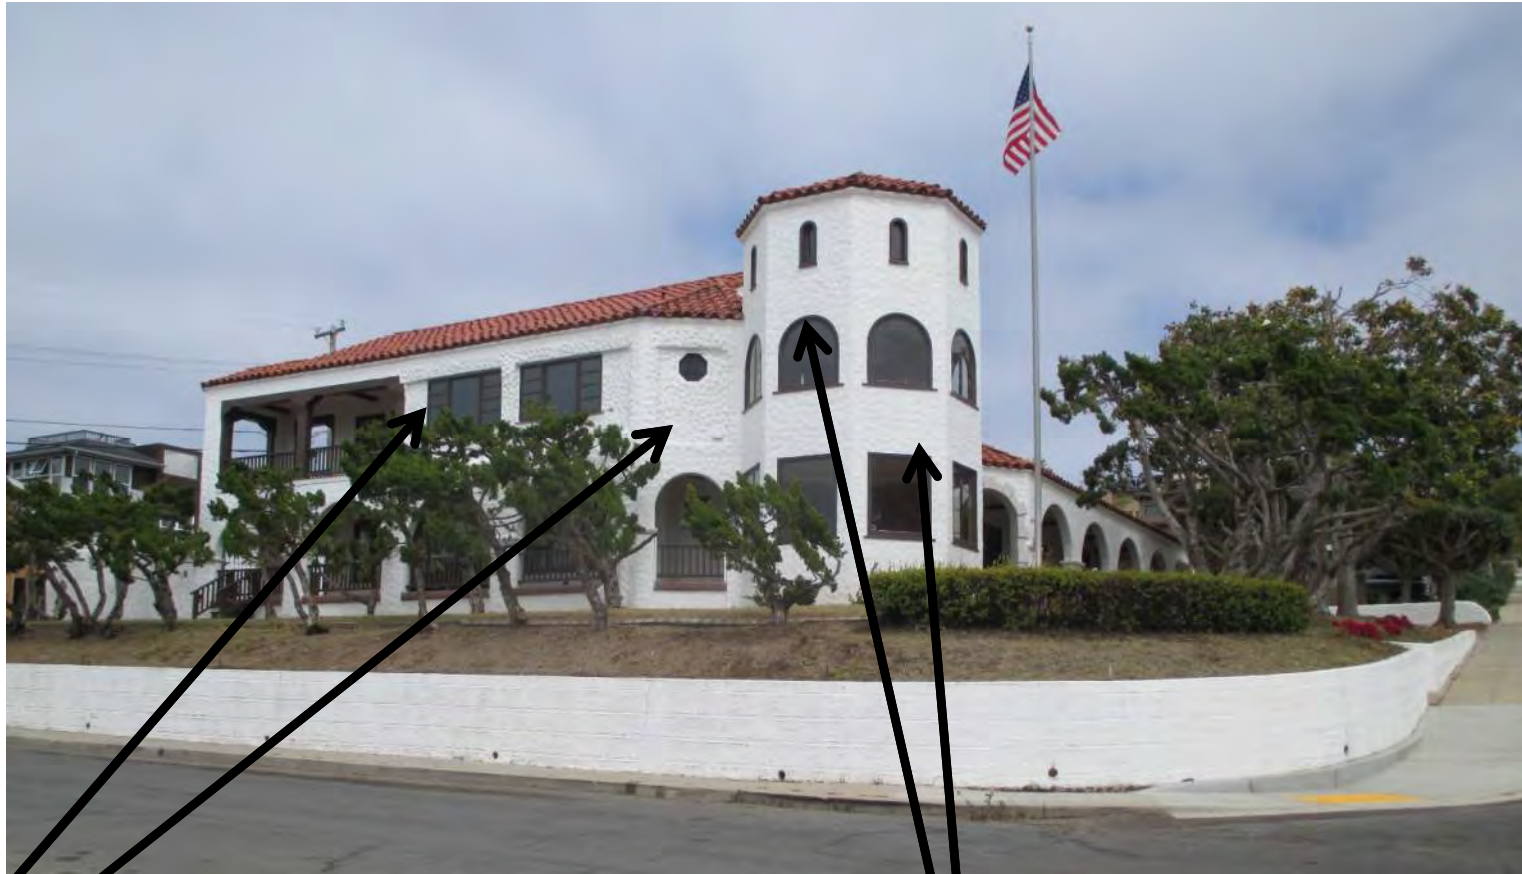
Photo of existing home prior to construction:
Original portion of Second Story open balcony is now
enclosed; Windows added and stucco used closely
matches original

Photo of existing home prior to
construction: Original Awnings
removed

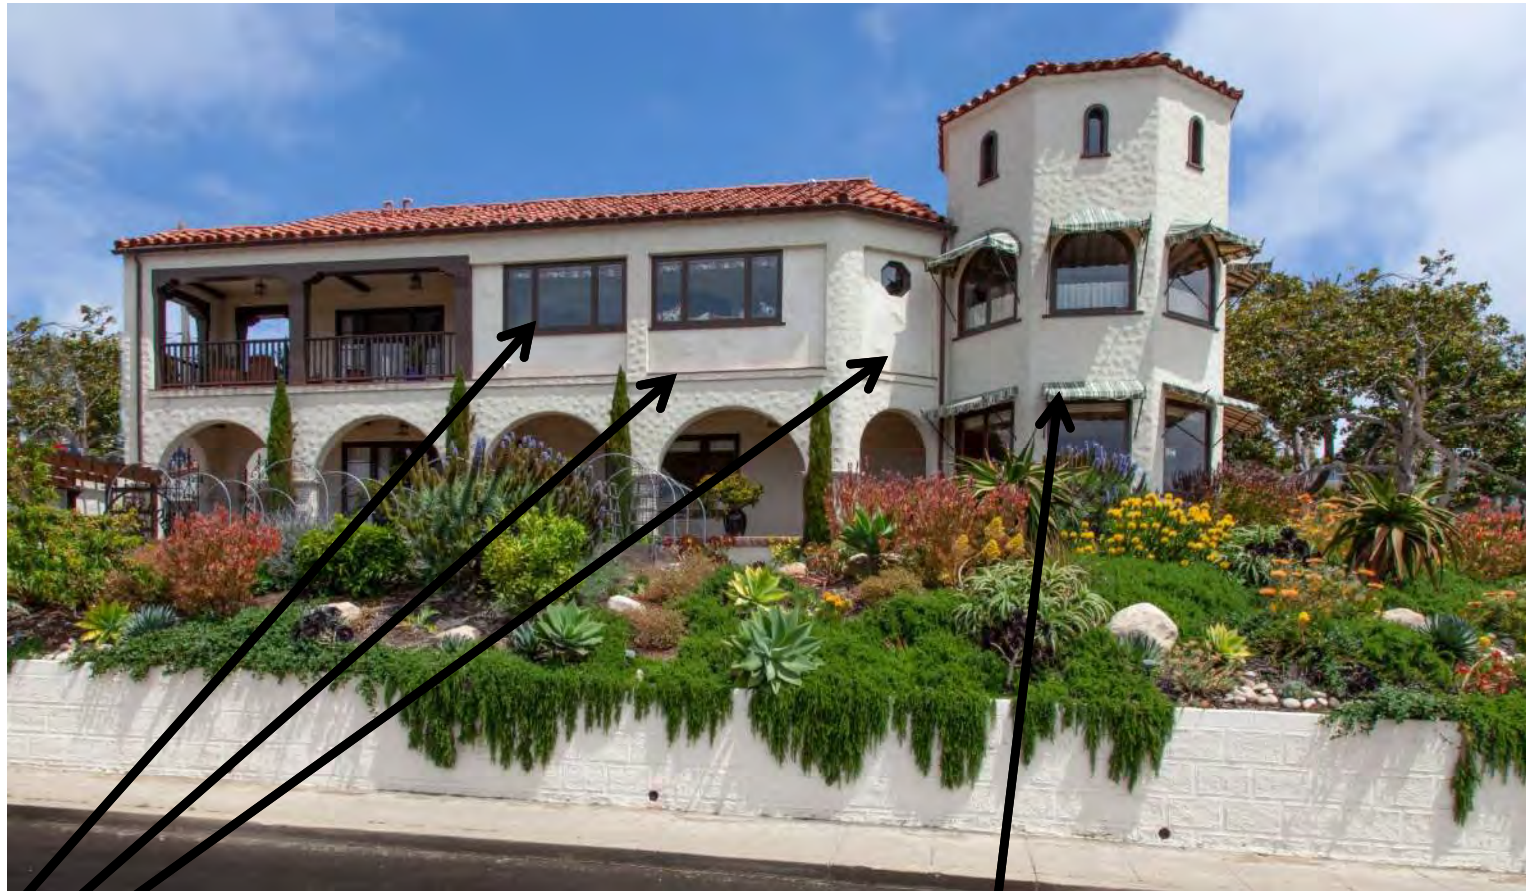
Photo of current home: Stucco texture at previously filled-in balcony changed to smoother texture to differentiate between historic and prior construction; Balcony tile floor extends to create detail below the filled in area; Simplified wood windows installed

Photo of current home: Awnings added

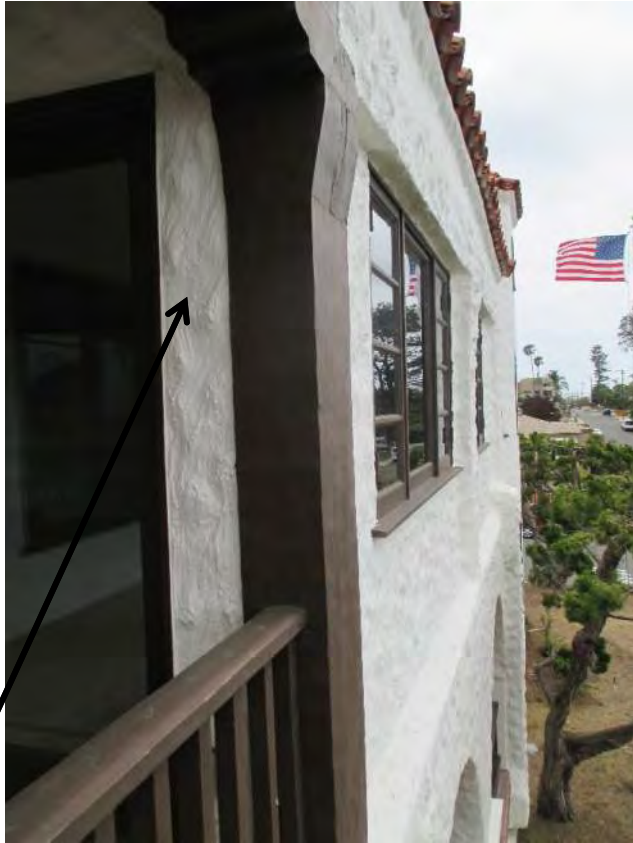
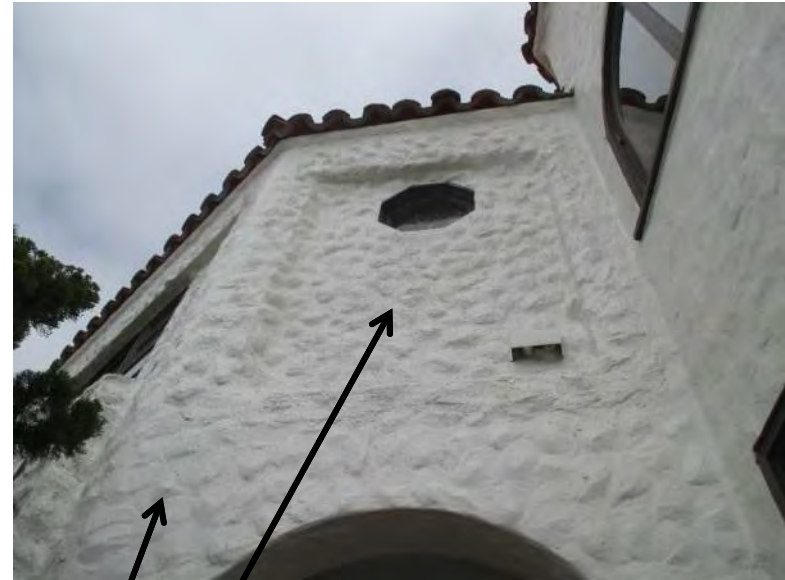
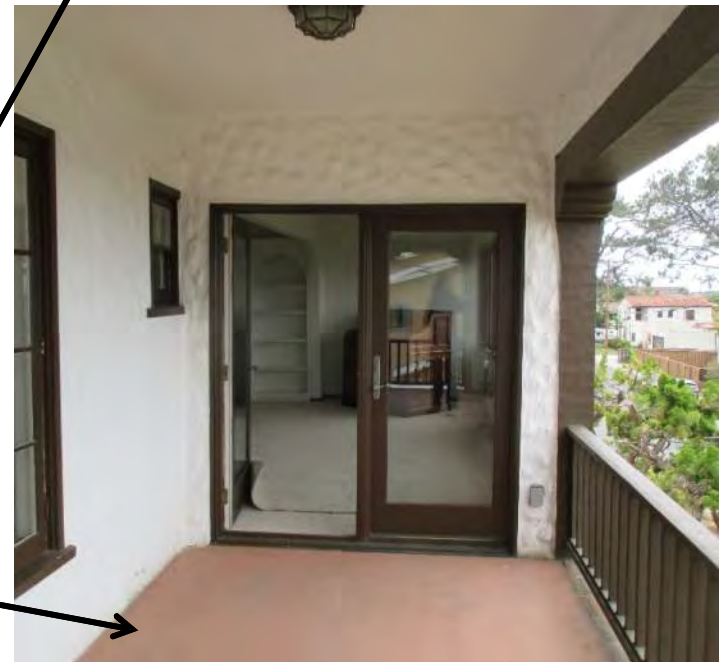
Photos of existing home prior to construction: Previously enclosed portion of original open balcony; Existing stucco too closely matching the original texture at the filled in areas; Non-original concrete balcony flooring

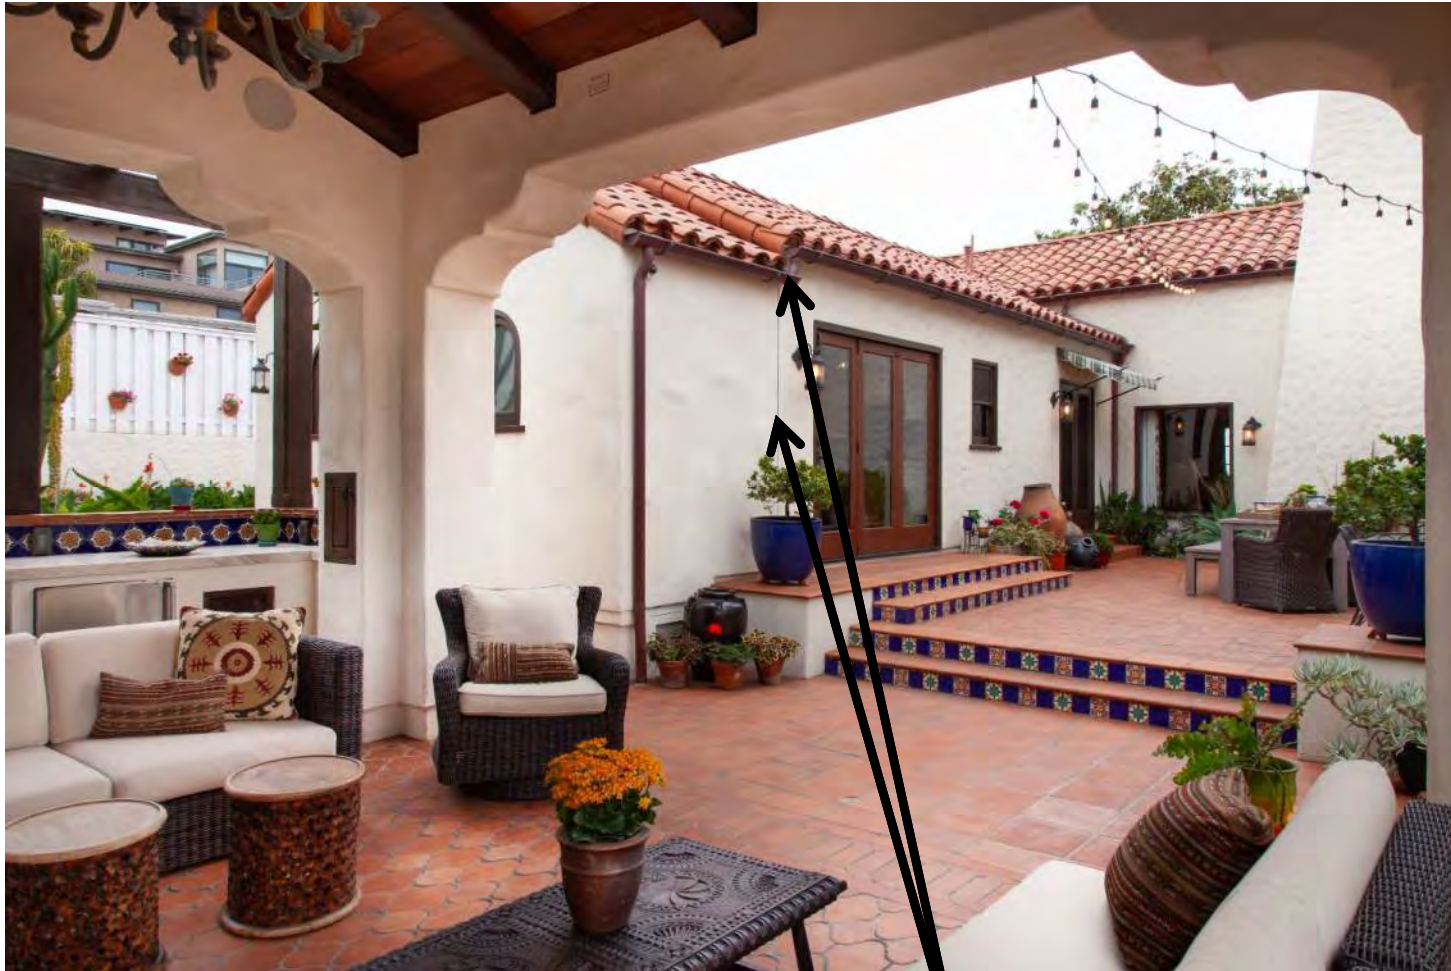
Photo of current home: New kitchen addition with vertical score in stucco and stepped down roof to differentiate from original building

Additions as part of our project included extending the northeast rear wing of the house, adding 101 square feet, towards the backyard and out of public view, to allow for a proper sized Kitchen, Laundry and Powder Room. The exterior work included removing non-original structures in the backyard and creating a covered Terrace area complete with an outdoor fireplace and BBQ. The pool was reshaped to be more traditional and consistent with the Spanish style with the addition of a water feature. The driveway was replaced using matching colored concrete and score pattern from the original design and the addition of a simple iron driveway gate.

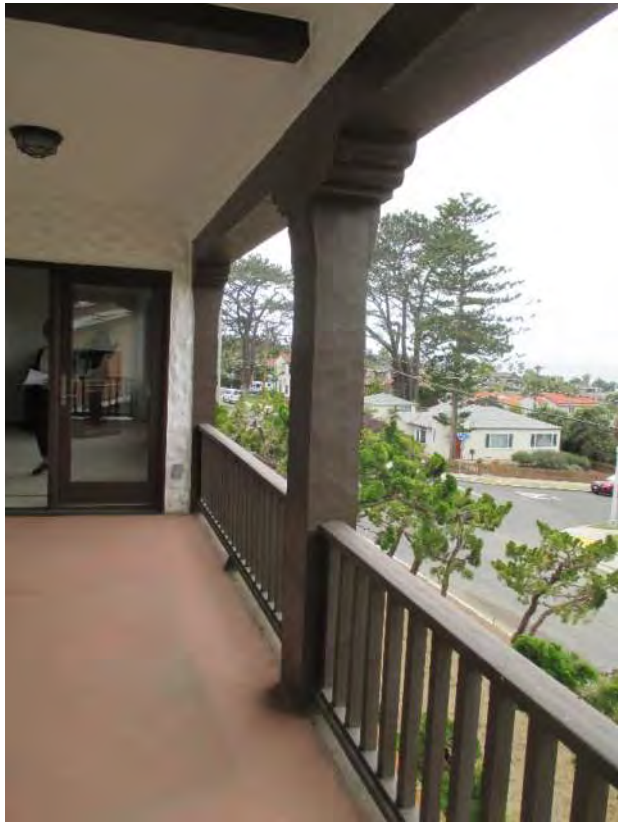
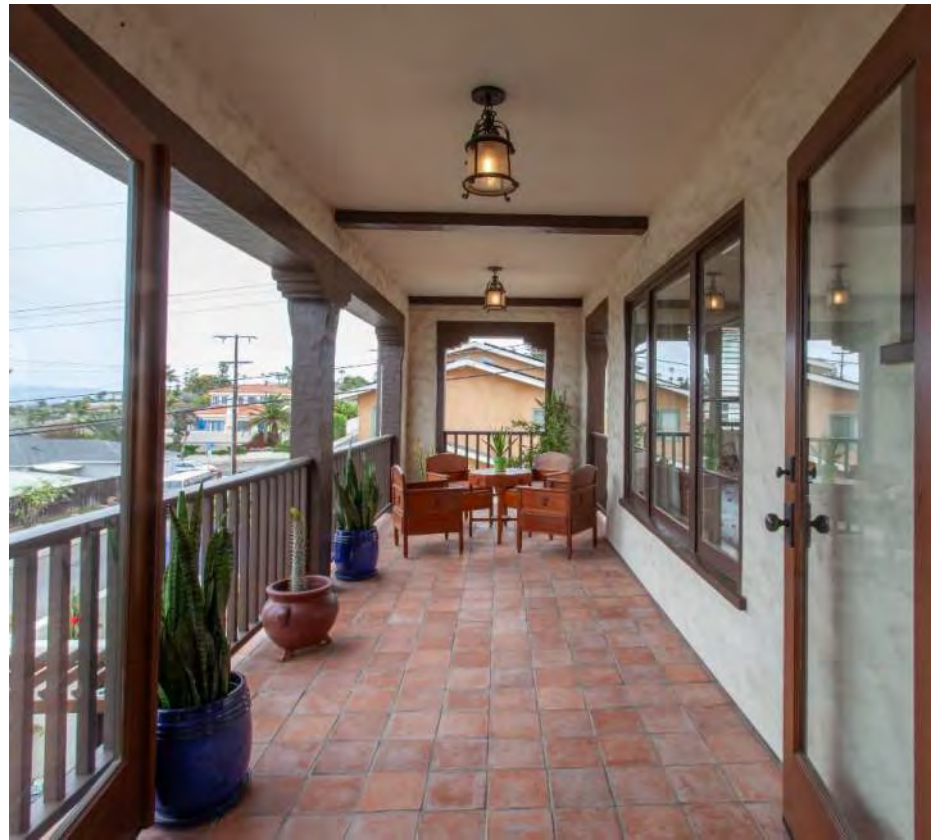
Before and After Photos of Balcony
