**CITY OF SAN DIEGO HISTORICAL RESOURCES BOARD
POLICY SUBCOMMITTEE AGENDA**

This report details the conservation treatment of two large-scale photographic murals located in the interior foyer of the Alvarado Water Filtration Plant Operations Building (5540 Kiowa Drive, La Mesa 91942) and provides recommendations for the continued preservation of the murals.

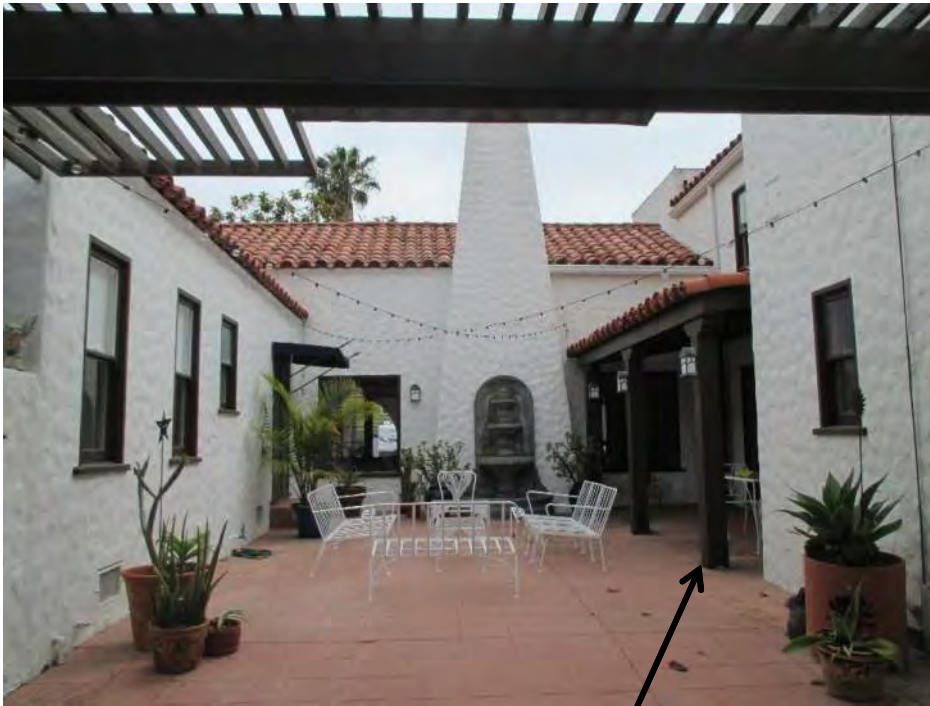
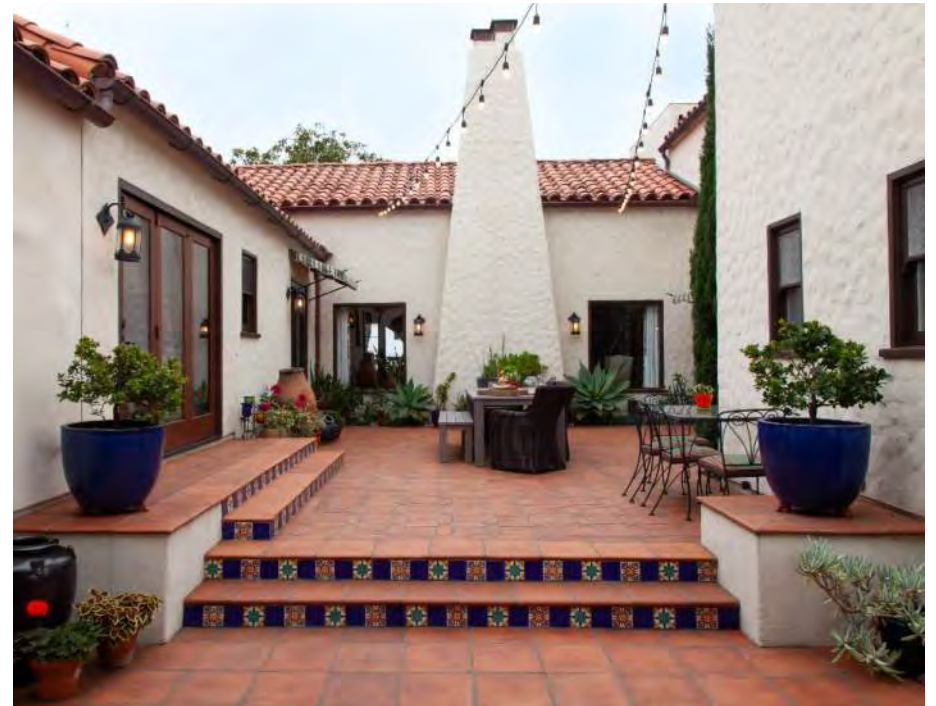
Before
Non-original tiled patio cover

Before and After Photos of Rear Courtyard: Non-original tiled patio cover removed; New folding doors installed within the original opening dimensions; New decorative tile; New lighting

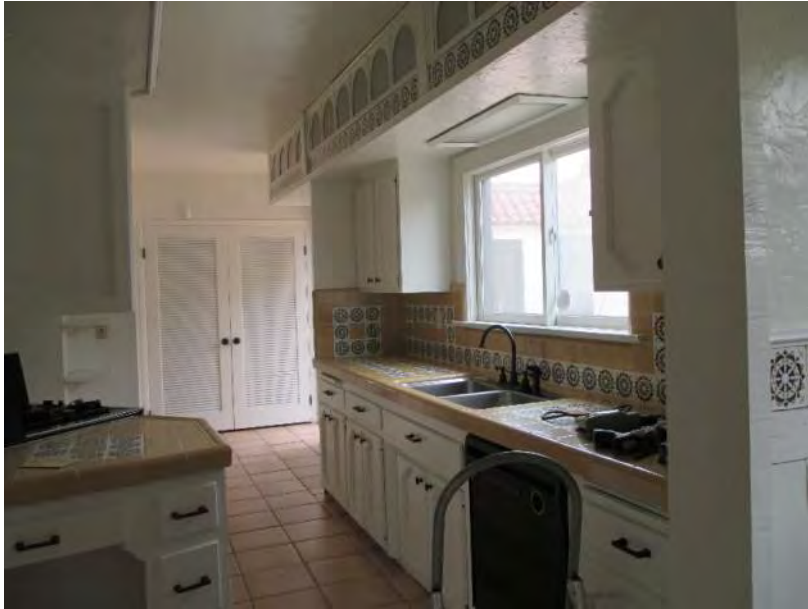
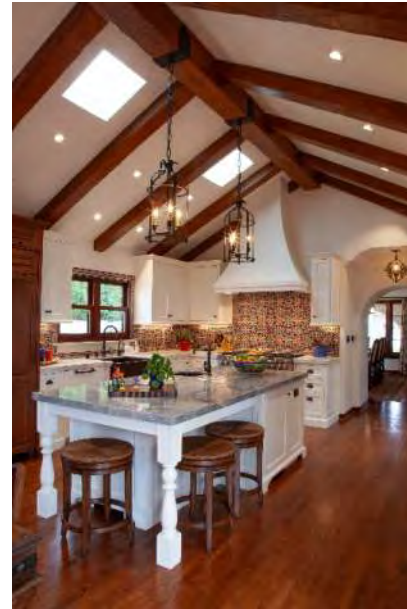
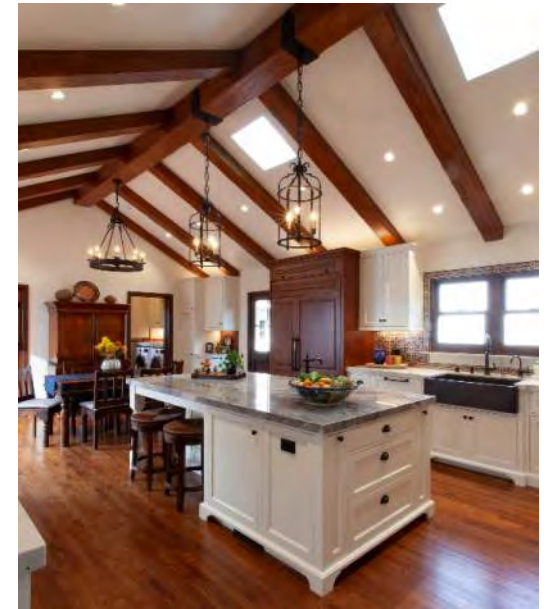
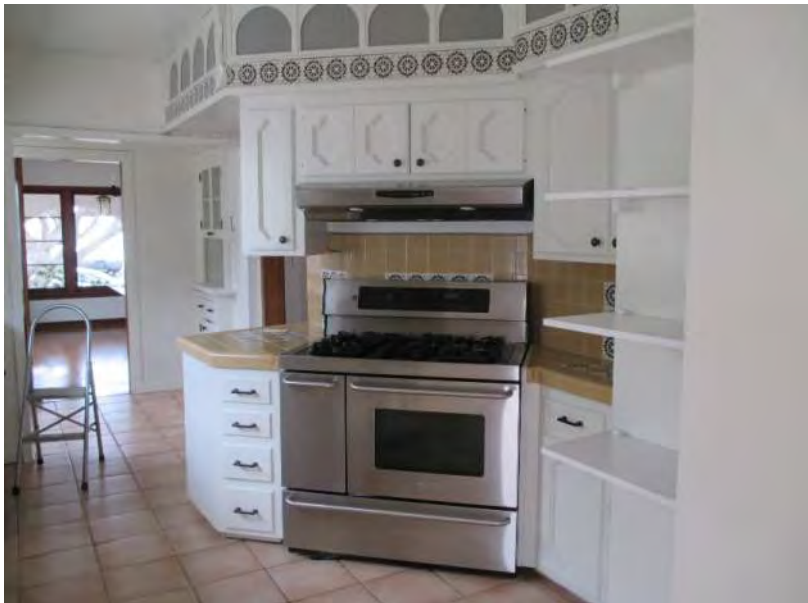
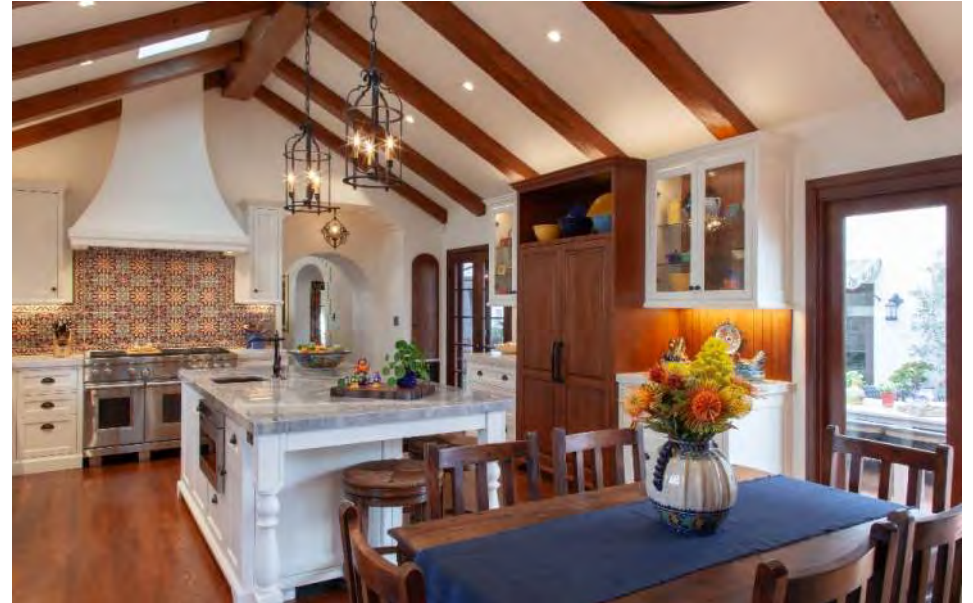
Before and After Photos of Kitchen

This 1912 home underwent a Kitchen Remodel years ago under the direction of the previous owner. That older non-original Kitchen was compartmentalized, bright white, and separated from an outdoor connection. In our project, the Kitchen was remodeled using stained wood on the walls and ceiling more in keeping with the original stained redwood interiors, as well as the use of colors and tile that are more in keeping with the period of the home. The Kitchen was opened to the Dining Room and the Courtyard using large bifold wood doors, using a glass detail respectful of the original French doors but differentiated in scale, filling the width of the original three French door pairs. The entire house was painted and shingles were restored as well as the roof was repaired and replaced as needed.

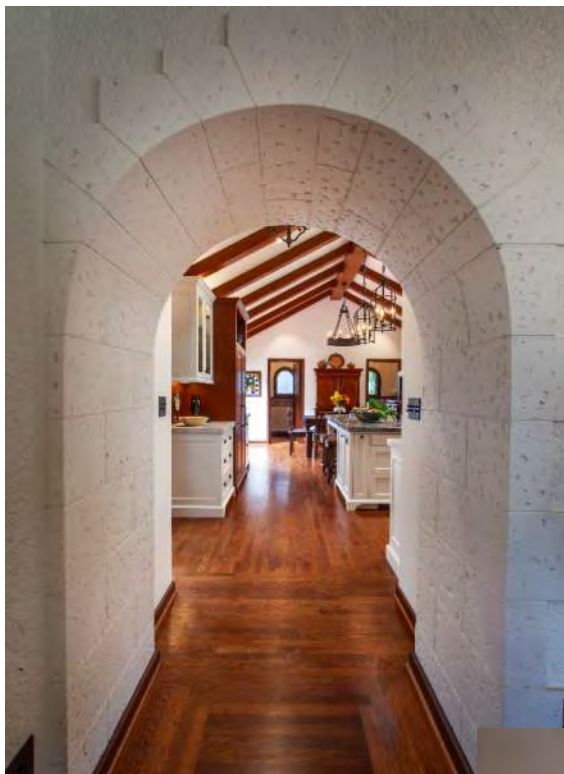
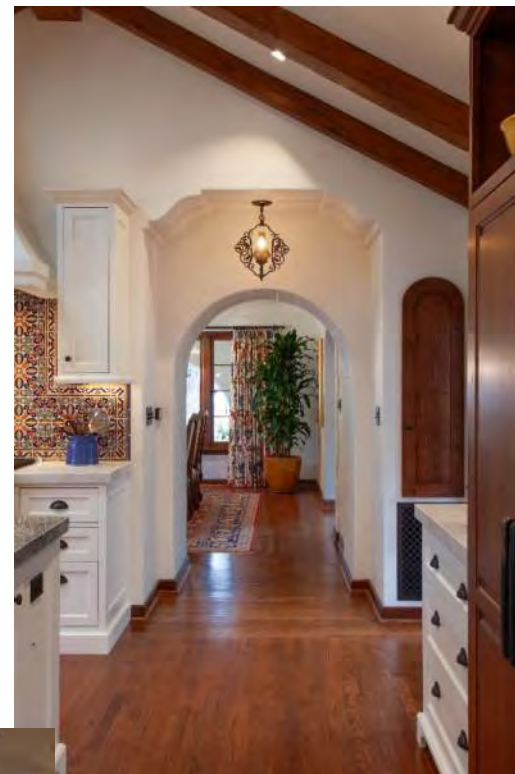
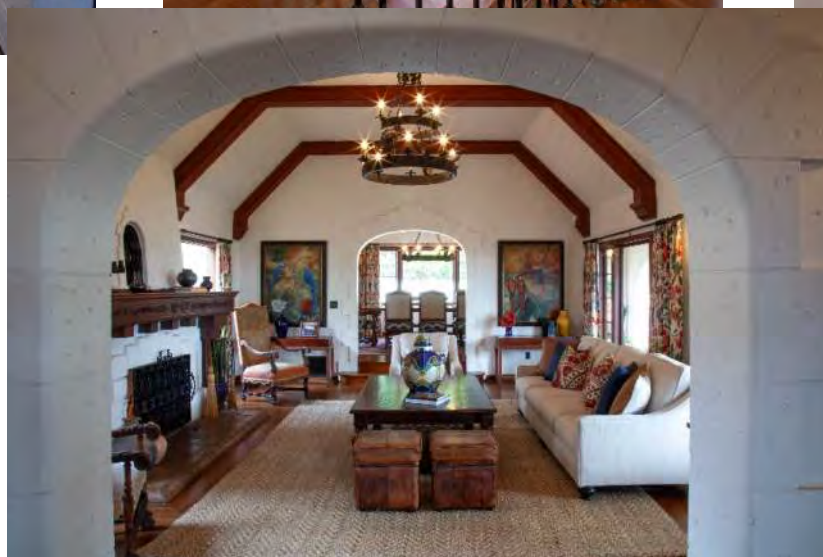
After Photos of Restored Interior: Restored archways and stained-glass skylight

The original faux stone/plaster walls still exist in the Entry and into the Stairwall; The original staircase and railings have been restored; the stained glass/original skylight lens has been restored as the centerpiece of the stairwall; The Living Room maintains the original vaulted and beamed ceiling. Damaged plaster has been repaired. The house has been rewired and replumbed.

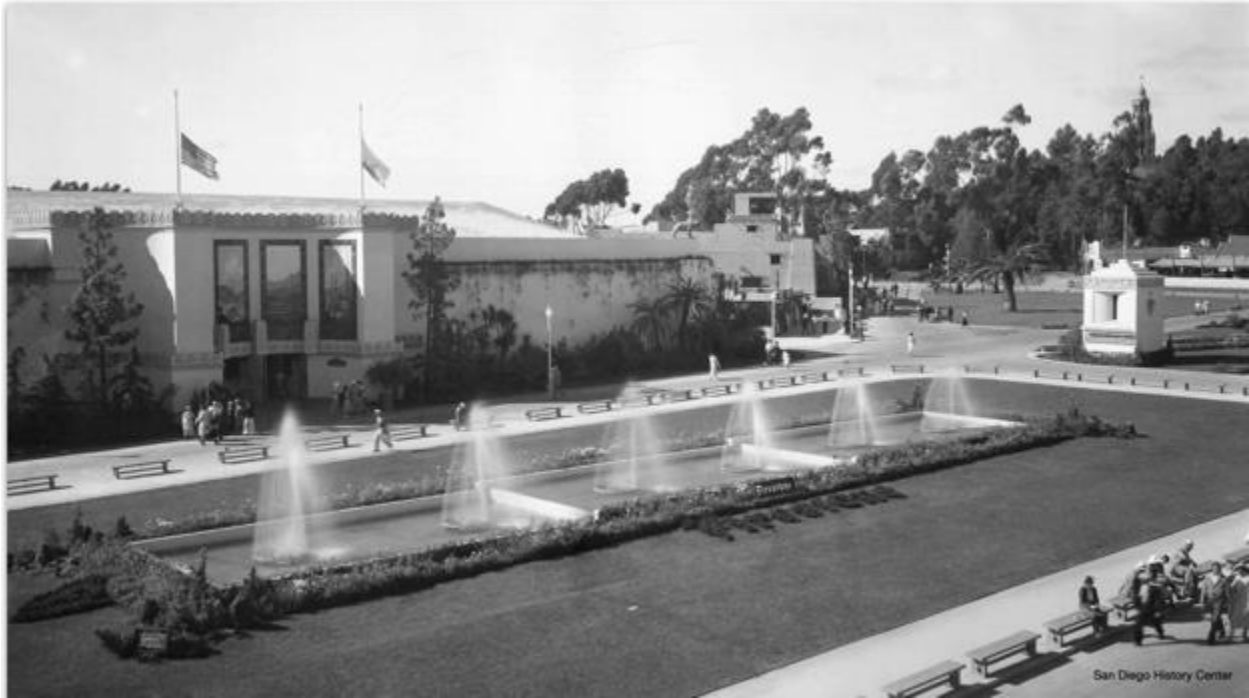
California State Building and fountain in the Palisades, Balboa Park, during the 1935–36 California Pacific International Exposition. Historic view showing the building with monumental façade murals, flagpoles, and bears. San Diego History Center.

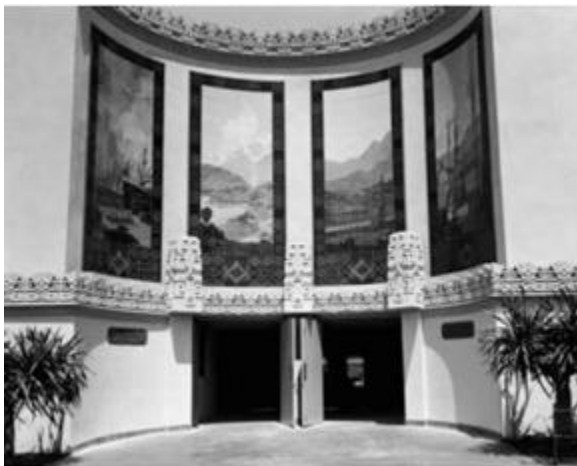
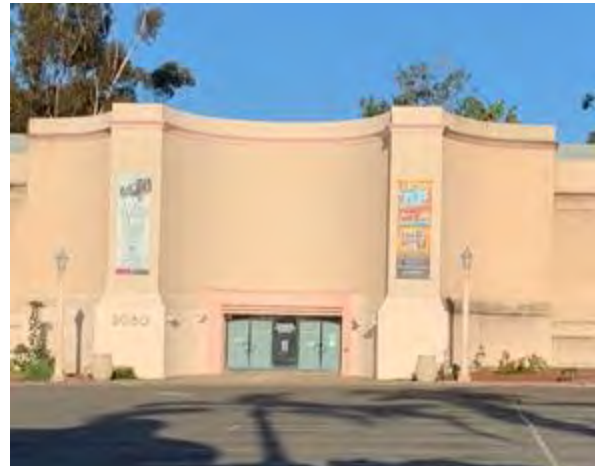
California State Building entrance with original façade murals visible in arched recesses, 1935. Courtesy San Diego History Center.

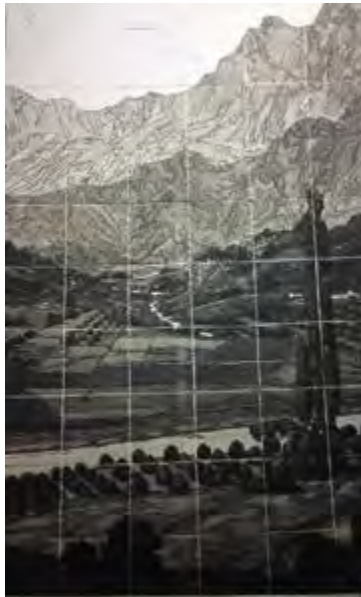
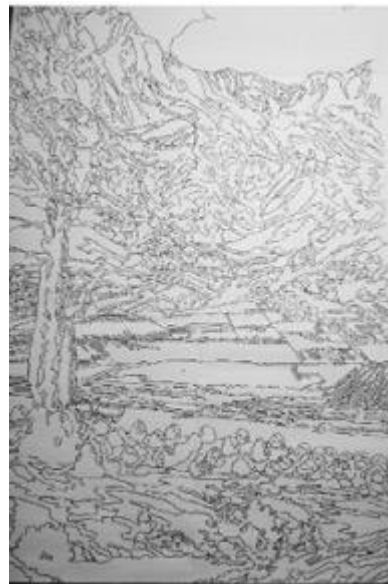
Quarter-scale blow-up of historic mural imagery used for reconstruction (left) and reverse-image line drawing developed using a light table

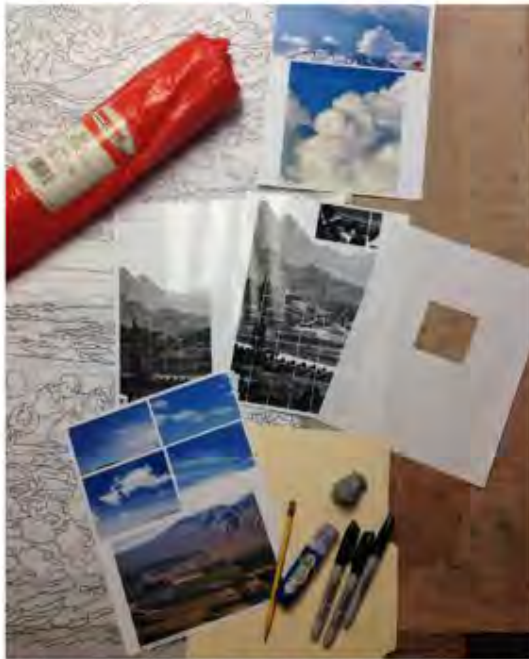
Step #3) Using a see-through vellum type paper on top of reverse image, I can now perfect the lines (camera ready) and create objects out of the unknown with help from google search references. The finished line art is scanned into digital format using a large scale scanner, reversed back to original view and ready to be flood filled on the computer using PaintShopPro. Filters will be applied to create the effects that the ceramic glazes will have in mimicing the original painted mural and lines diminished Transform into banners for hanging/fundraising and Viola!!

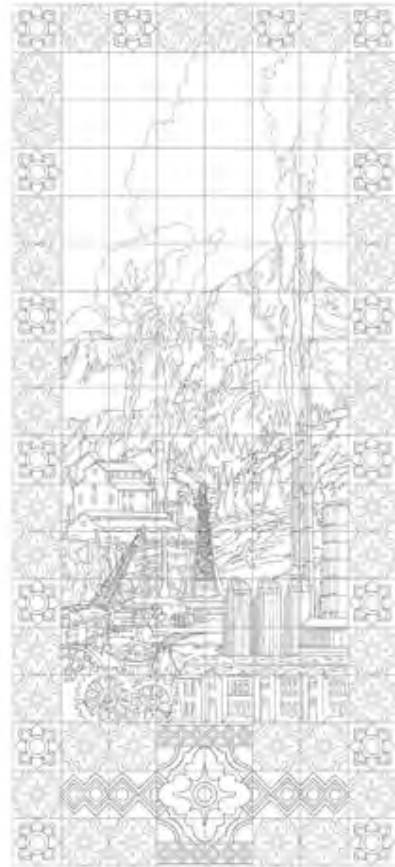
Reconstruction process materials, including archival photo references, line drawings, and digital preparation of mural imagery for ceramic fabrication.

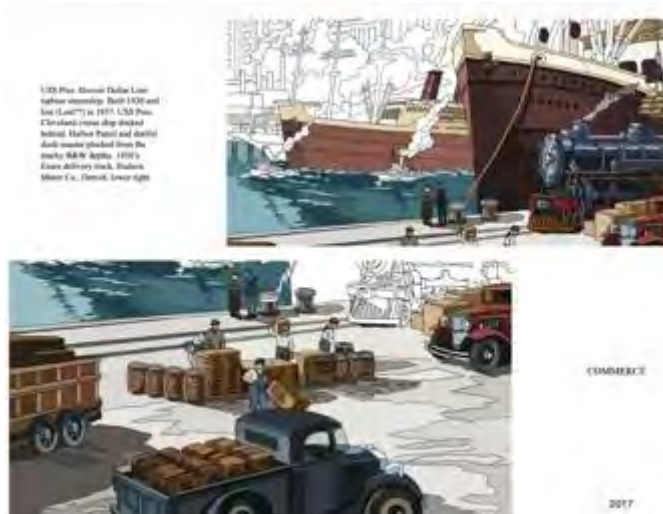
Digital reconstruction drawing of the Commerce mural panel showing harbor, rail, and industrial imagery derived from archival photographs. 2017.

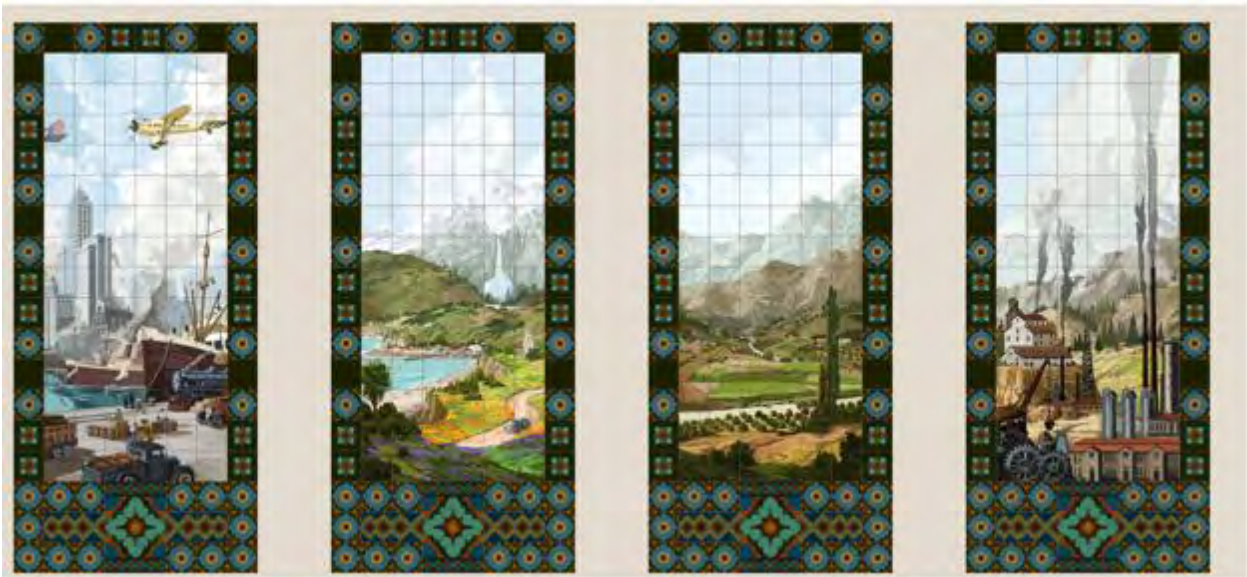
Color prototype for ceramic mural tiles planned for California State Building façade, representing Transportation, Scenic Beauty, Agriculture, and Industry.

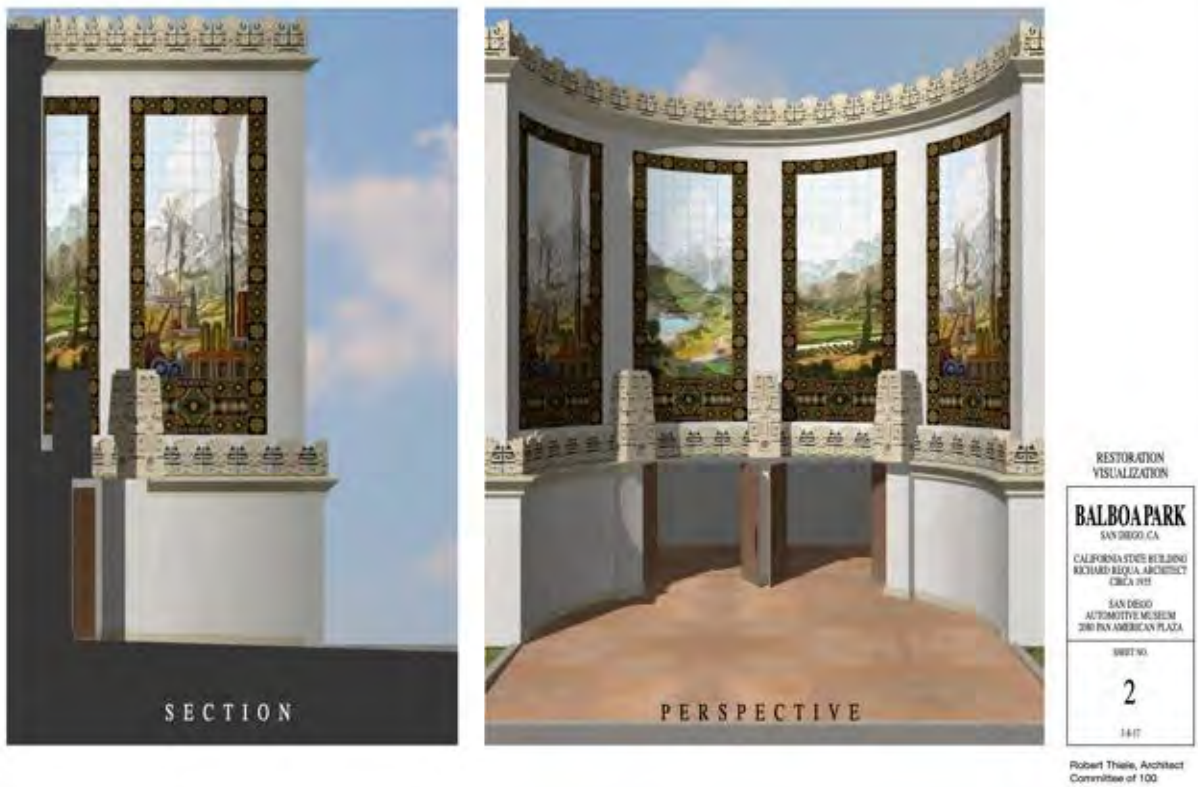
Digital rendering illustrating the reconstructed ceramic mural panels installed within the arched façade bays of the California State Building. Rendering derived from measured documentation and archival photographs to confirm scale, placement, and visual integration prior to fabrication and installation.

Panels were mounted on stainless-steel framing systems engineered to anchor independently of the historic stucco substrate, thereby minimizing intervention into the original fabric while ensuring seismic and environmental stability.

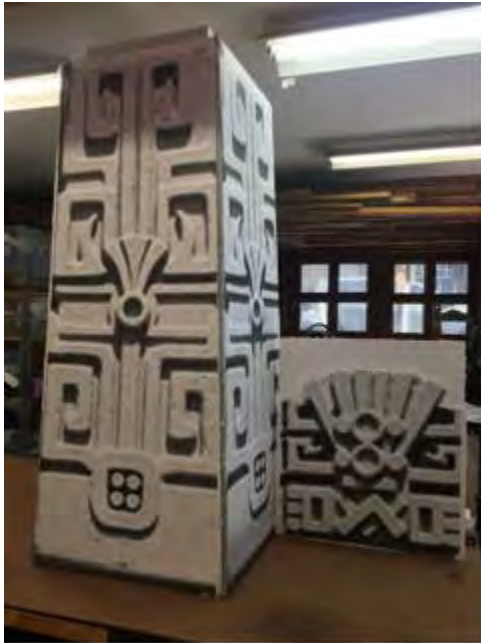
Sculpted study model of reconstructed Maya-inspired relief panel shown with measured drawing documenting dimensions and glyph geometry derived from archival photographs. Used to verify proportion and relief depth prior to GFRC fabrication.

To reconstruct missing sculptural ornamentation, Thiele scaled historic photographs to full size, created three-dimensional foam mockups, and used shadow analysis to determine relief depth before coordinating fabrication with sculptors and precast specialists. He worked closely with sculptor-fabricators to refine the grizzly bear sculptures through multiple maquettes to match the historic bear profile. Thiele also helped resolve design and cost challenges related to installation of the rooftop bears and flagpoles, advocating for historically appropriate solutions that preserved the architectural composition. These projects were identified in Committee of 100 planning documents as key components of the Palisades rehabilitation initiative.

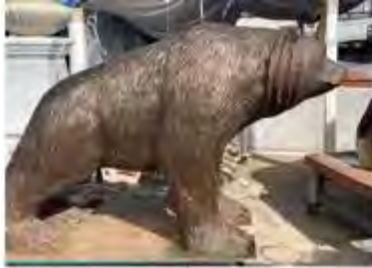
Full-scale armature construction showing sectional rib framework used to create the bear sculptures.

Full-scale modeling refined musculature, fur texture, and stance consistent with historic imagery. Internal stainless-steel armatures were engineered to anchor the sculptures to roof framing while accommodating wind loads and seismic requirements. The final bears were cast in GFRC with a cold-cast bronze finish designed to evoke the intended historic appearance while providing durability appropriate for permanent installation.

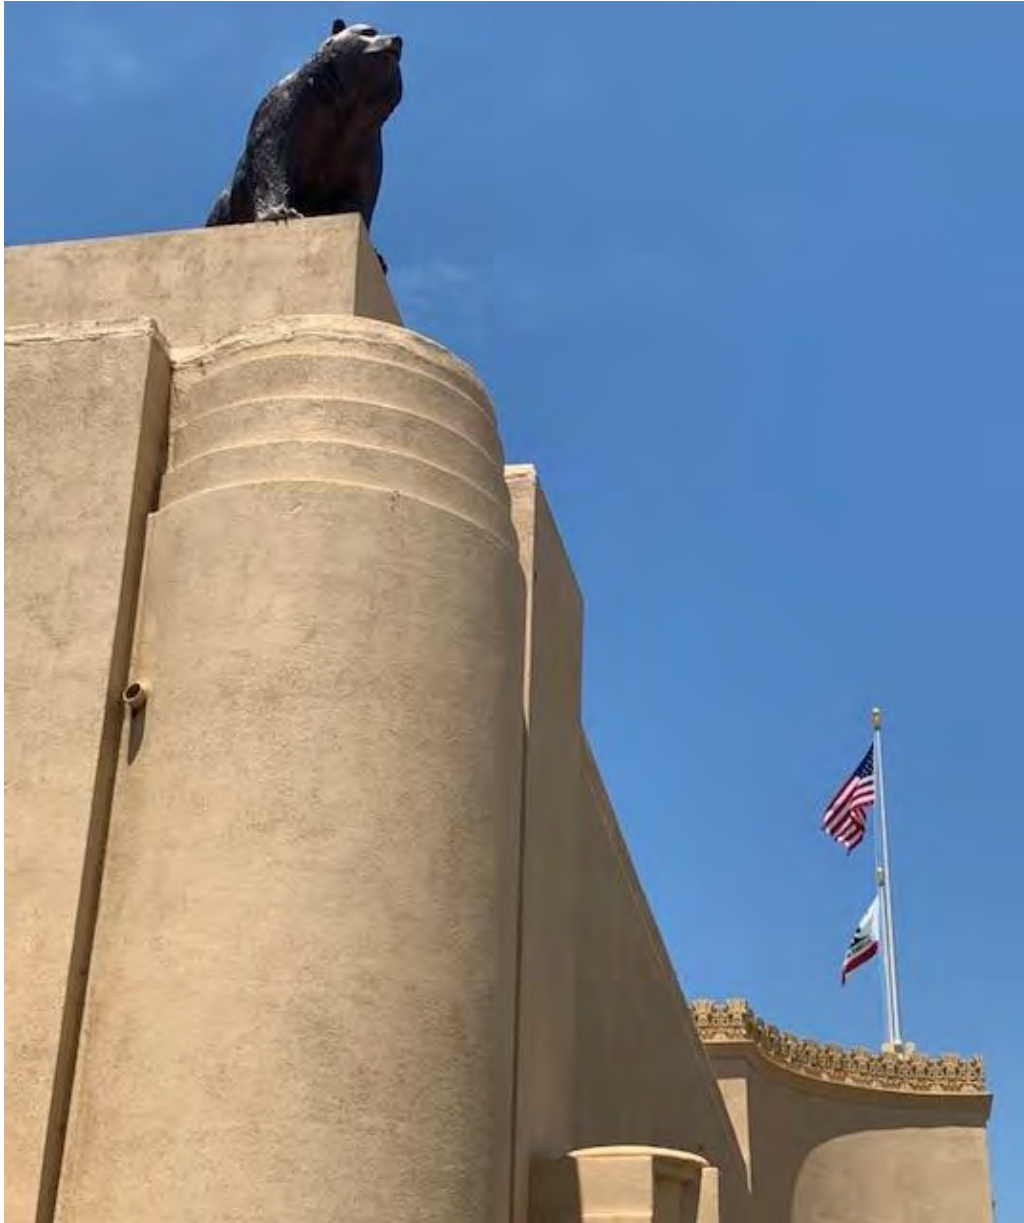
Installed reconstructed California grizzly bear sculpture at roofline corner of the California State Building. The bear's forepaws extend over the curved parapet edge, replicating the original 1935 silhouette and reinforcing the building's vertical sculptural emphasis. Flagpoles are visible in their restored historic locations.

Reconstruction of the bears and flagpoles relied on archival photographs, measured drawings, and digital modeling (Standards 1 and 3). Distinctive architectural features central to the building's identity were reinstated in their original locations (Standard 5). Compatible materials including GFRC and stainless-steel armatures were used to replicate historic appearance while ensuring durability (Standards 6 and 7). Mounting systems minimized impact on historic fabric.

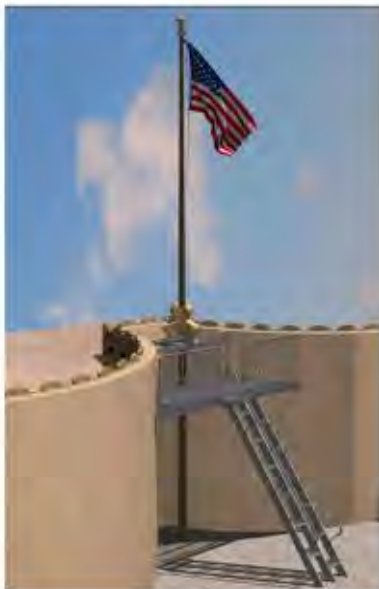
Digital reconstruction model illustrating placement of roof-mounted flagpoles.

EXTRA HEAVY GROUND SET CONE TAPERED ALUMINUM FLAGPOLES EXTERNAL HALYARD

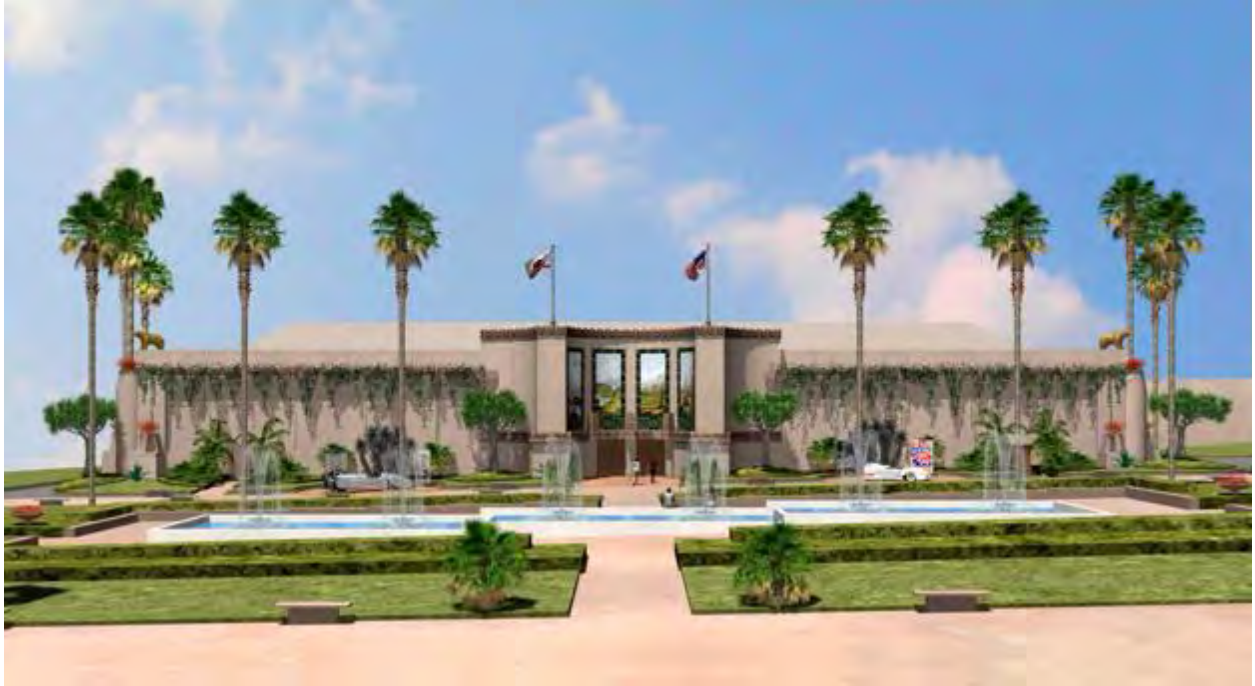
Digital rendering derived from a three-dimensional architectural model of the California State Building, illustrating the proposed reconstruction of the historic bear sculptures and flagpoles based on archival photographs and measured documentation.

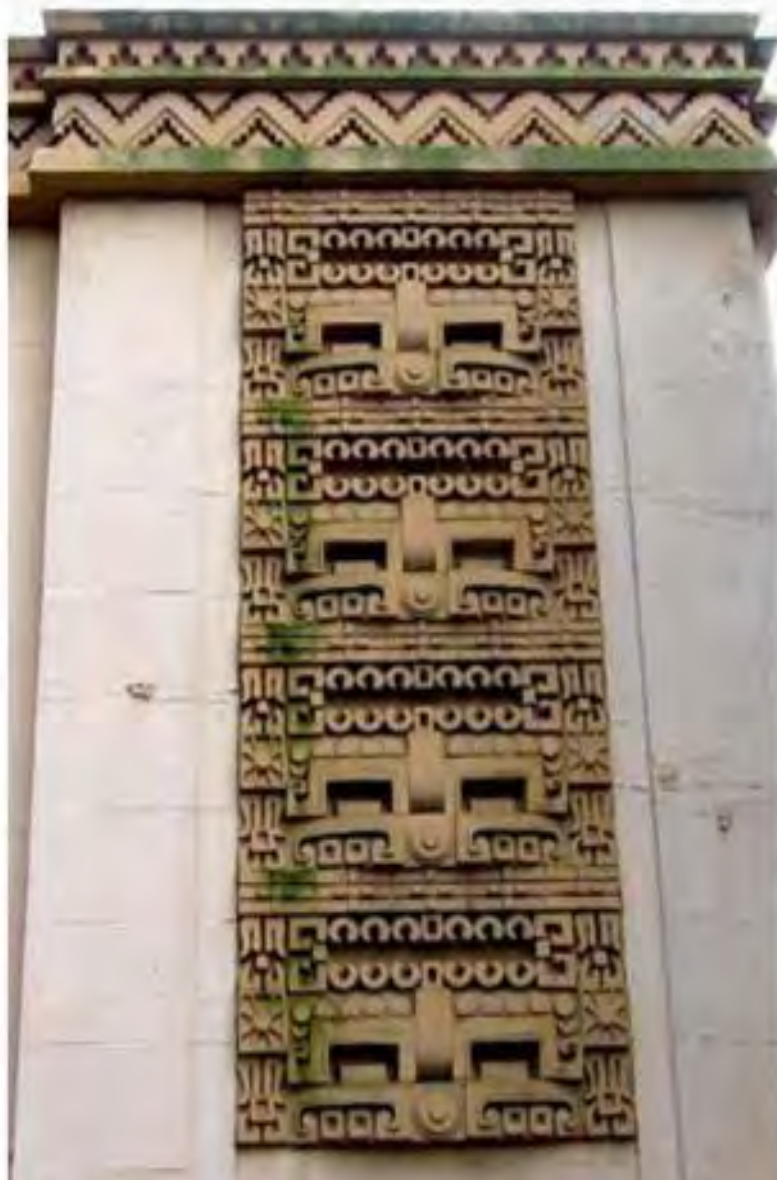
Late 20th-century fiberglass replica ornamentation installed on the northwest corner façade of the Federal Building exhibiting advanced surface deterioration; photograph dated January 23, 2019. Surviving original *Canec* ornament fragments in the San Diego History Center collection derive from the ground-floor cornice band and the vertical panel of four stacked rectangular reliefs.

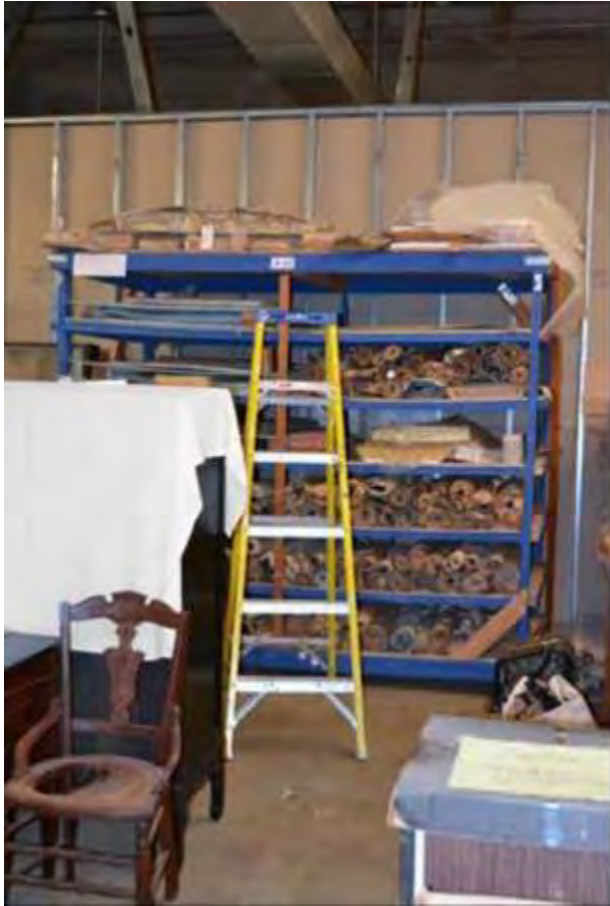
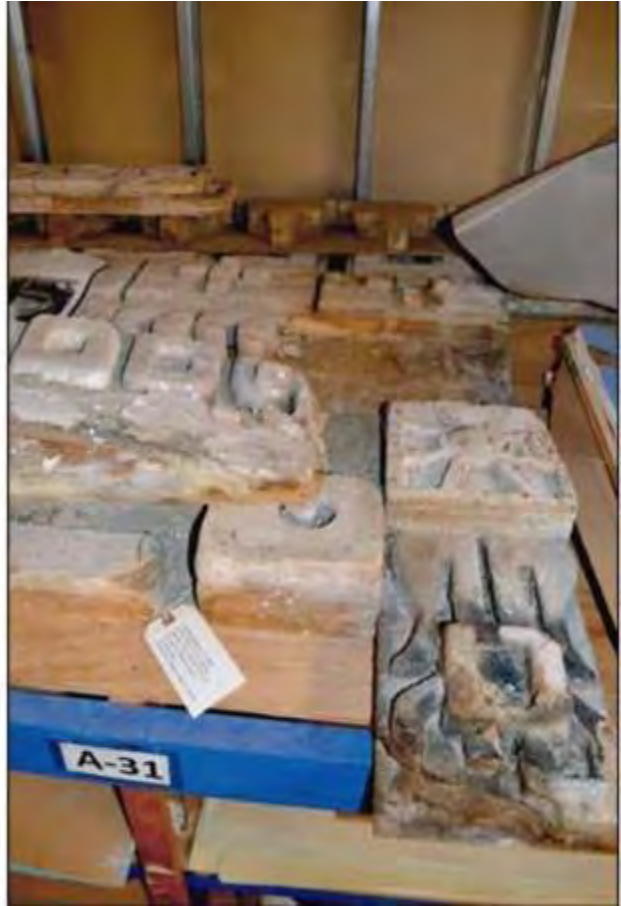
Context photos for color sampling, 1935 Federal Building – Original canec ornamentation fragments as found in San Diego History Center Study Collection, August 2020. William S. Chandler

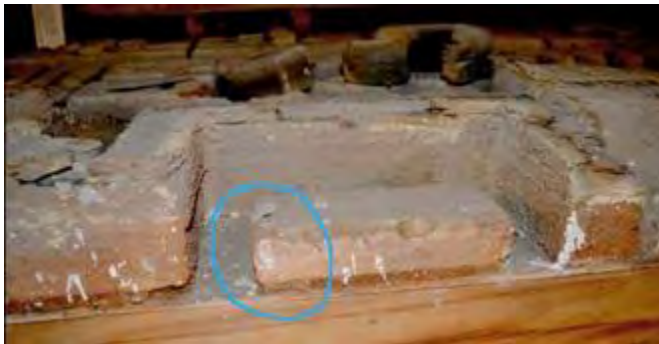
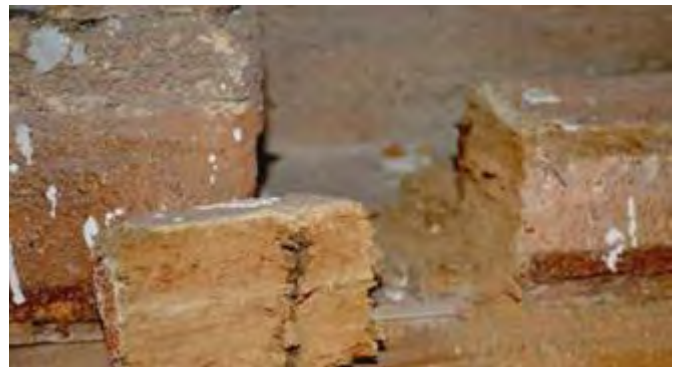
Two-layer sample. Beneath 1950s “Padre Brown” type paint is original paint color. 2020, William S. Chandler.

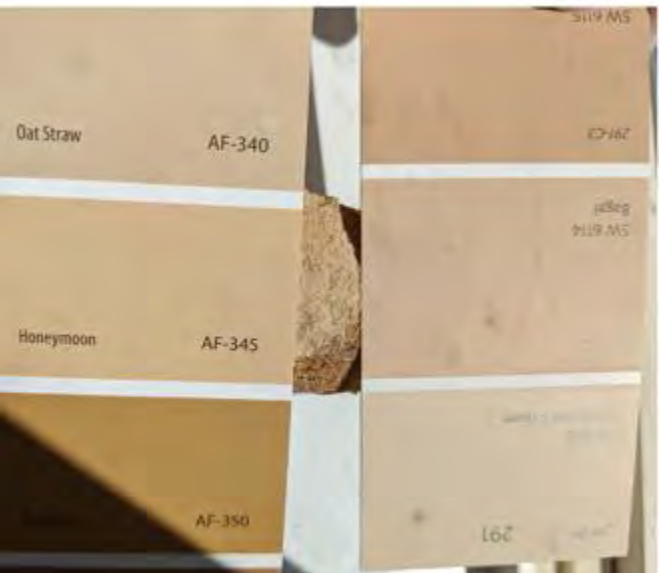
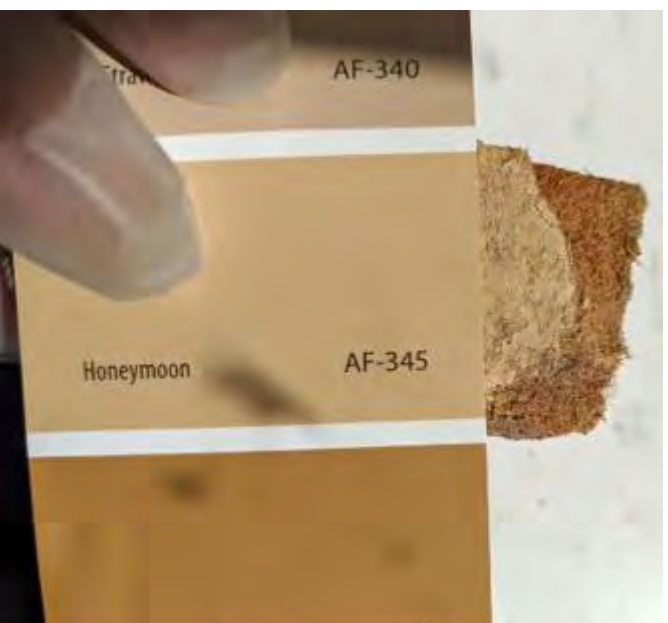
(Left) An area roughly 1 inch wide was scraped down to reveal the original finish. Effort was made to remove as much grime as possible from the surface layer. This material was compared to paint swatches from several commercial paint companies. In natural light, the best match found was Benjamin Moore's AF-345 Honeymoon. (Right) Comparison of another color "Bagel" found in samples from the Gymnasium samples, May 2020. William S. Chandler

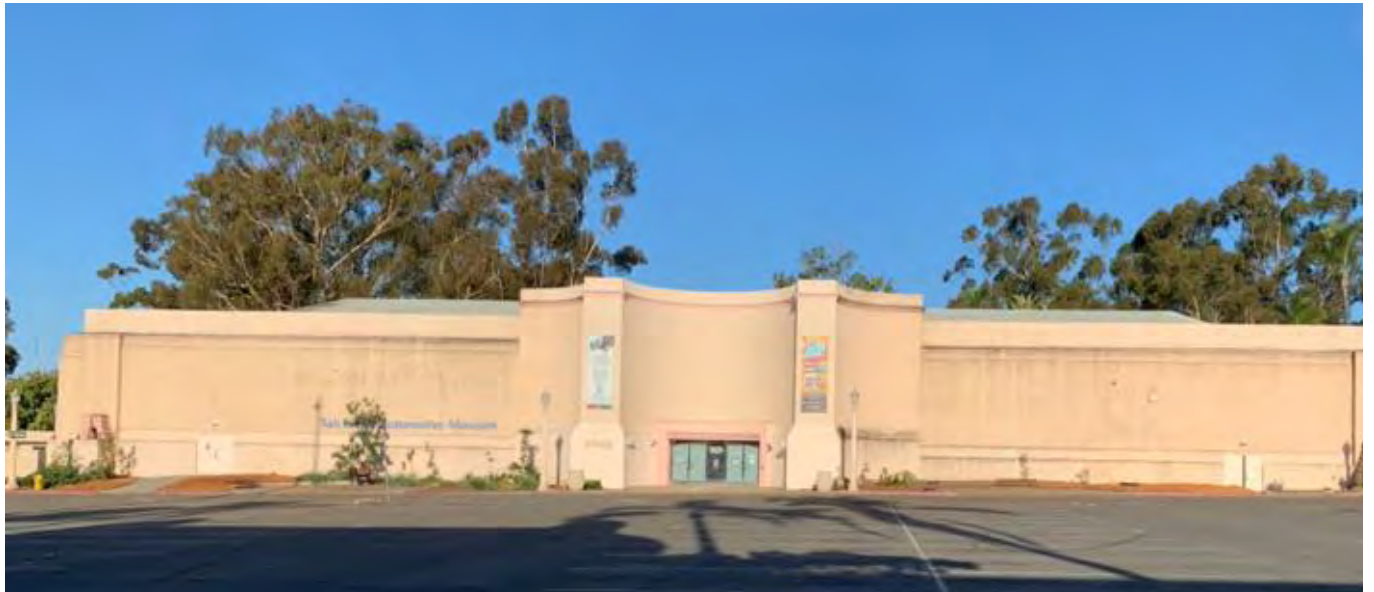
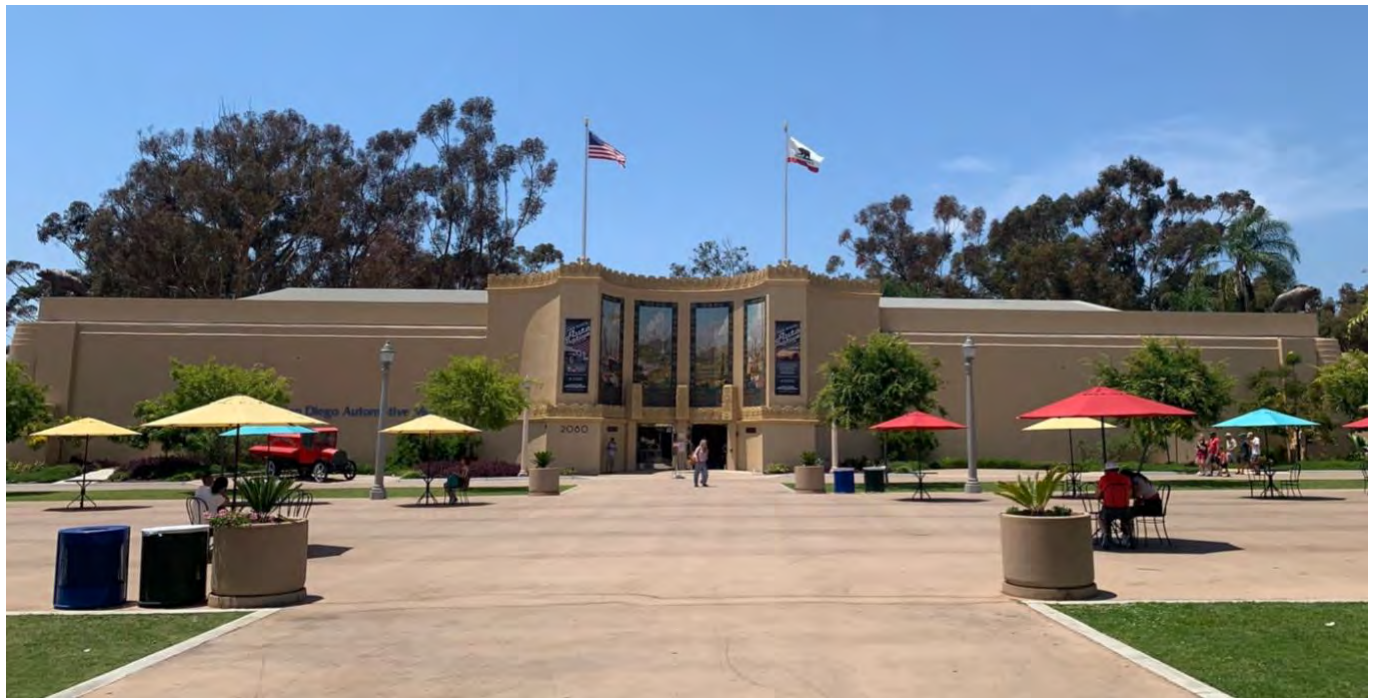
Required Photographs – “Before - 2019” and “After - 2024”

After restoration of murals, relief panels, bears, flagpoles, and reinstated historic color palette.

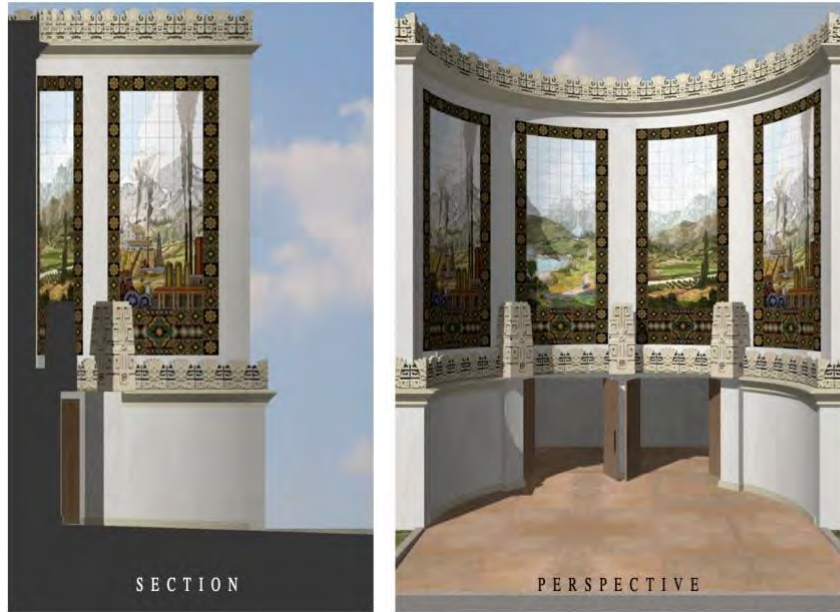
the ceramic tile mural program at the California State Building (San Diego Automotive Museum). Drawings include section, elevation, and panel layout studies based on scaled analysis of historic photographs.

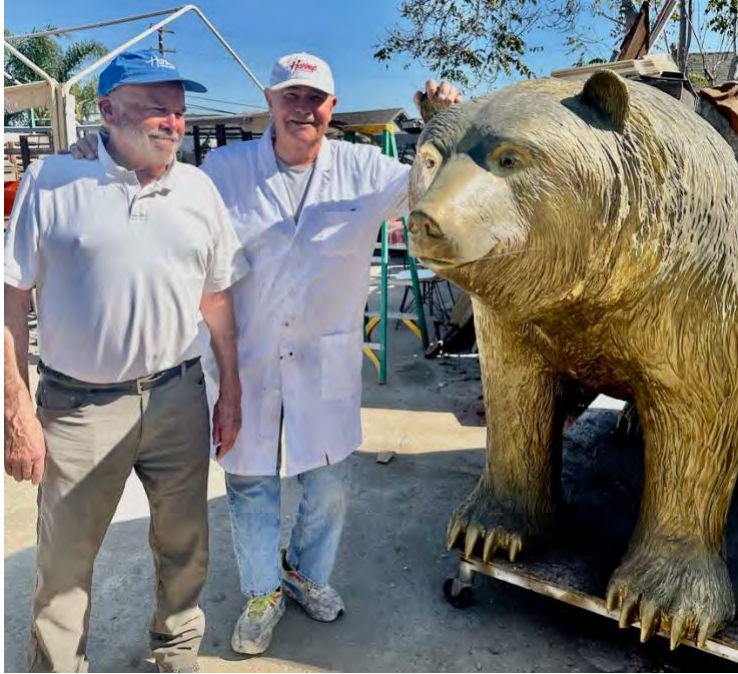
Grizzly Bear Sculpture – Maquette and Section Drawing

Full-scale maquette and section drawing used to determine mounting, structural support, and proportional alignment of

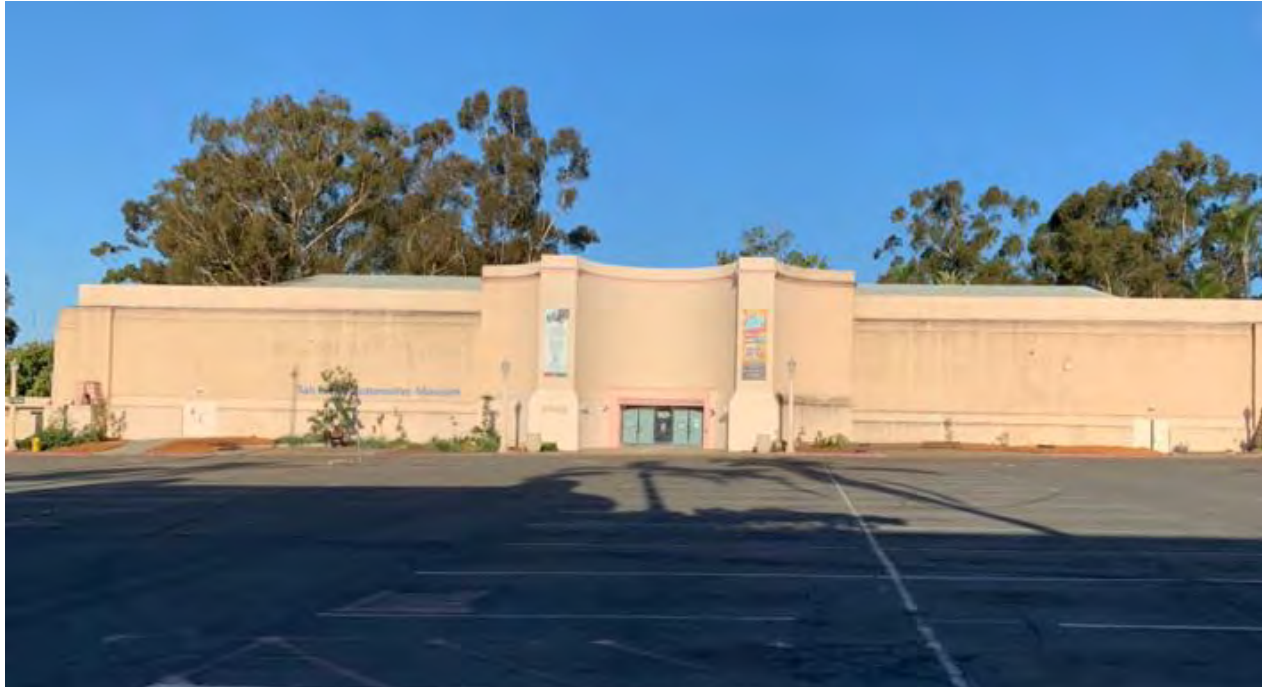
2019

California State Building (Automobile Museum) – “Before” and “After” Committee 100 Project
