THE CITY OF SAN DIEGO

MEMORANDUM

SUBJECT: Summary of Results from General Biological Resources Survey update for Junipero Serra Museum Americans with Disabilities Act Improvements Project, San Diego, California (Update from Biological Letter Report for the Junipero Serra Museum Americans with Disabilities Act Improvements Project, April 23, 2026)

**Junipero Serra Museum:
May 28, 2026 – SITE PHOTOGRAPHS**

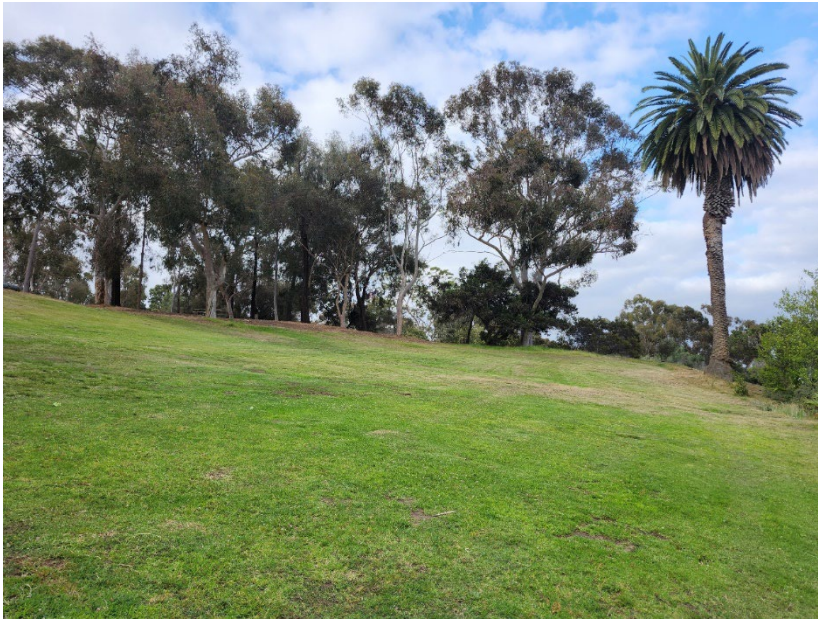
Photo 1. This photo shows the view from northern most end, facing southwest. The area primarily consists of ornamentals.

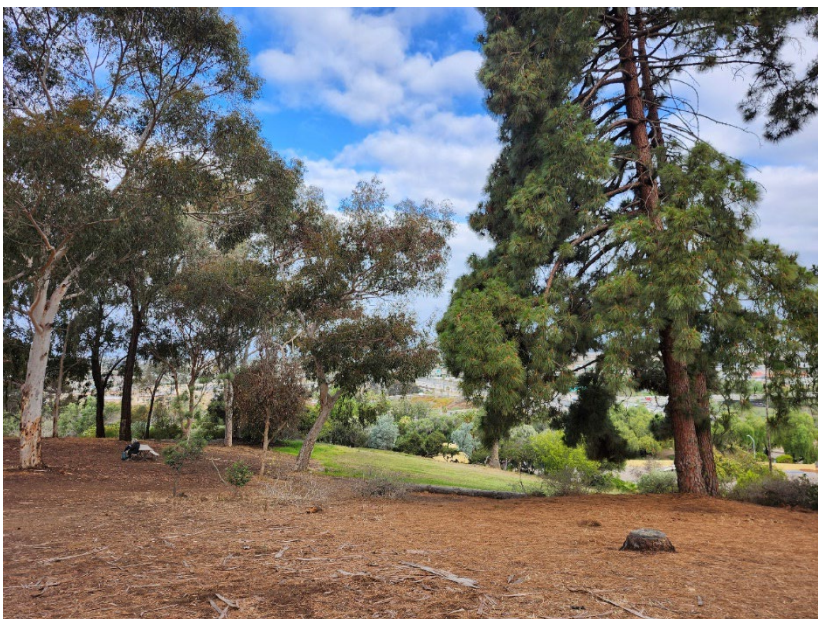
Photo 2. This photo shows the view from the midway point, facing west. The area primarily consists of eucalyptus with planted pines.

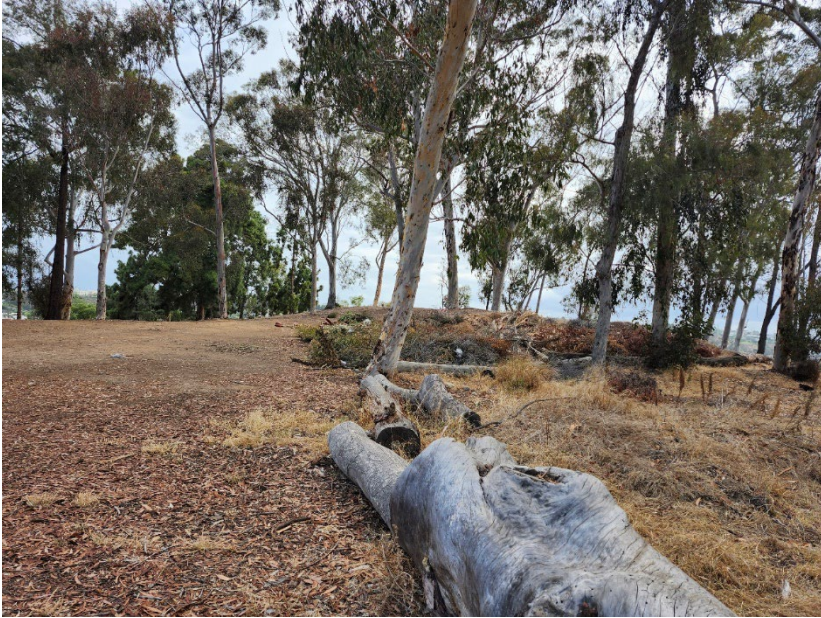
Photo 3. This photo shows the view from the southeastern edge, facing north.

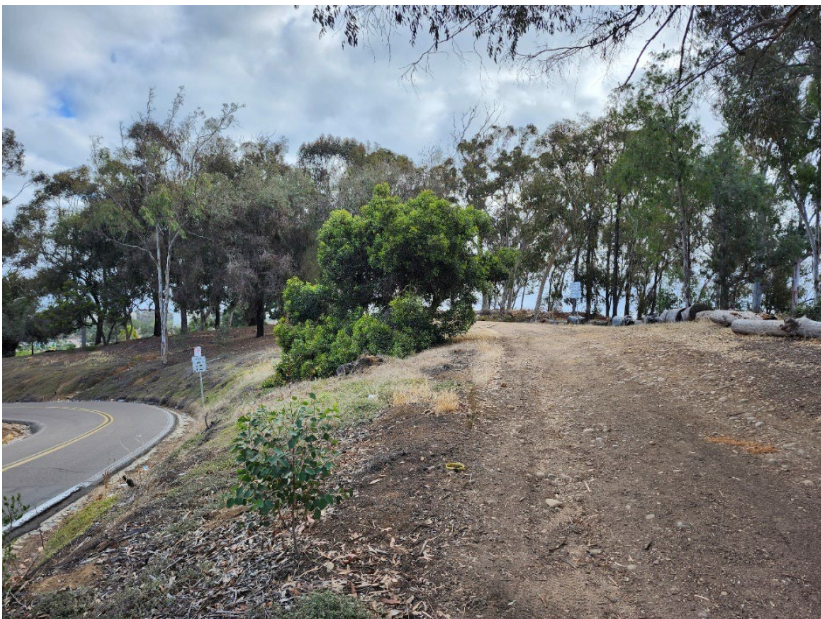
Photo 4. This photo shows the view from the south end, facing north.

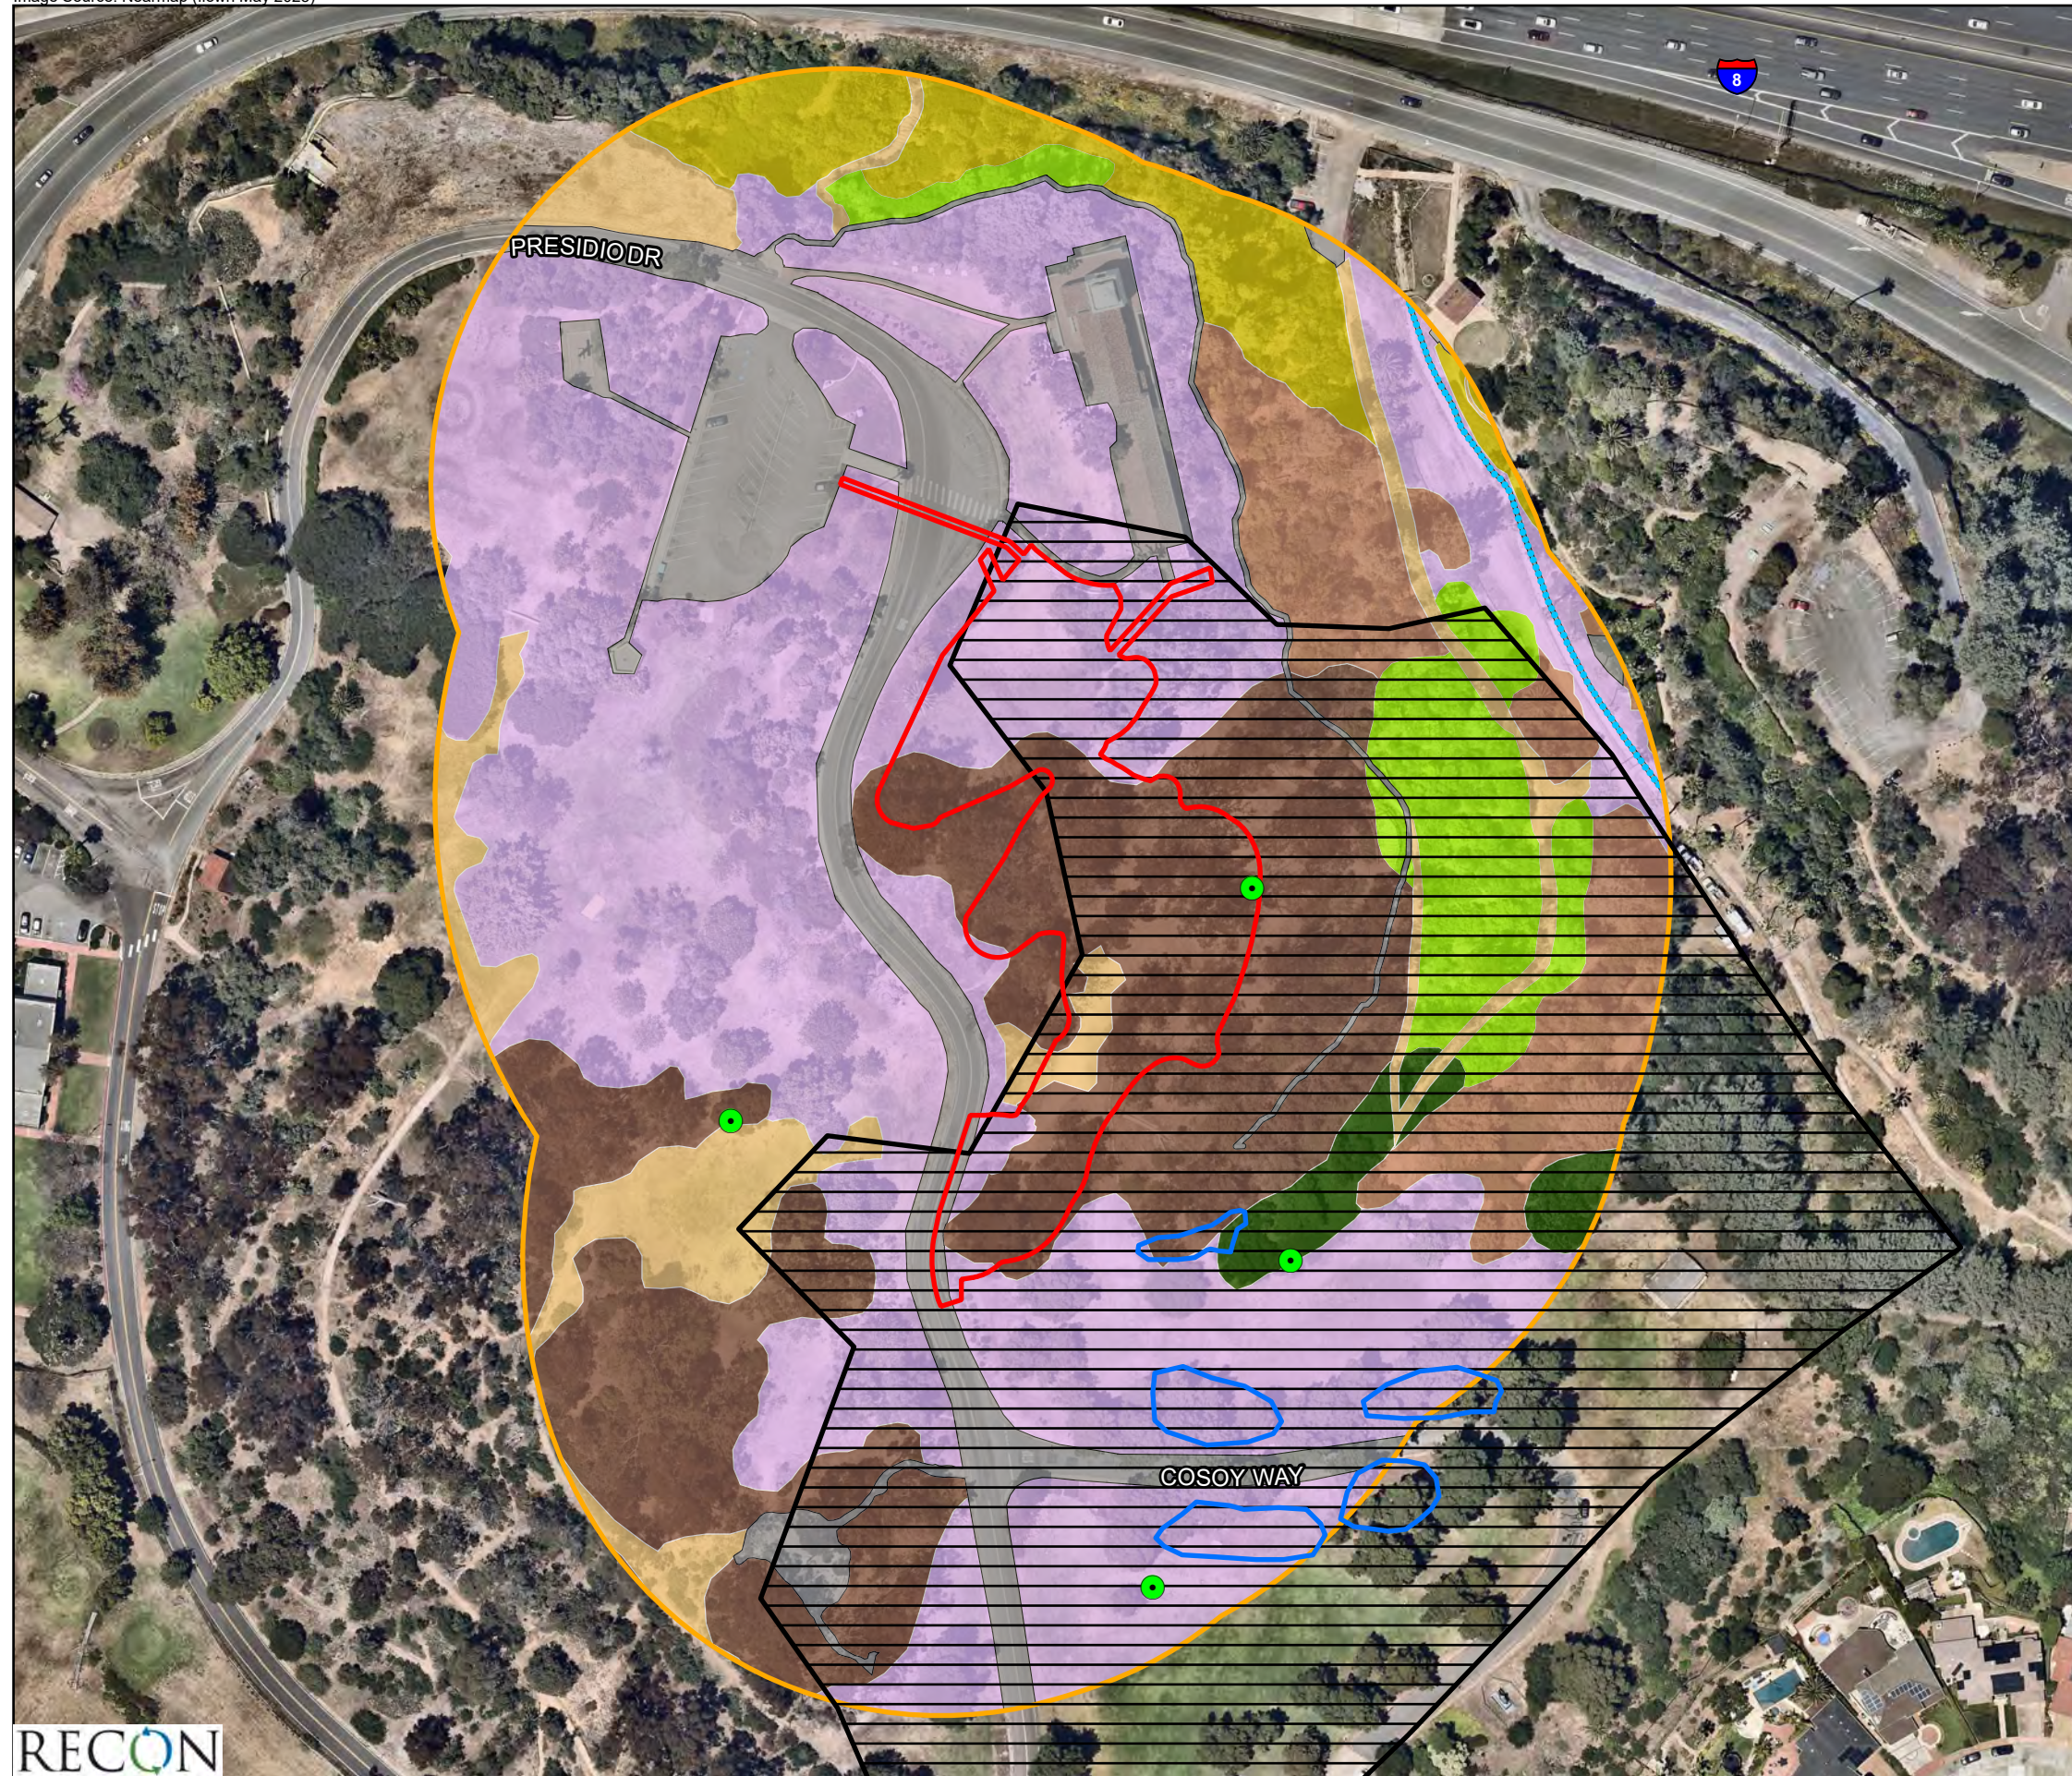
- ▭ Project Area
- ▭ Survey Area
- Monarch Overwintering Site (CDFW 2024a)
- Monarch Roosting Locations (Monarch Program 2019)
- Monarch Butterfly Observation (2024)
- - - - - Channelized Drainage
- Vegetation Communities**
 - ▭ Disturbed Southern Mixed Chaparral
 - ▭ Coast Live Oak Woodland
 - ▭ Non-native Woodland
 - ▭ Non-native Vegetation
 - ▭ Eucalyptus Woodland
 - ▭ Ornamental Plantings
 - ▭ Disturbed Land
 - ▭ Urban/Developed

Presidio Park contains a mapped monarch overwintering site totaling approximately 17.60 acres (Figure 7; CDFW 2024a; Xerces 2024b) and several known stands of roosting trees occur adjacent to Cosoy Way, outside of the project footprint (The Monarch Program 2019). Four monarch butterflies were observed flying in eucalyptus woodland, coast live oak woodland and ornamental plantings within the survey area during the biological survey in 2024, which occurred in late February. According to the tree survey letter report (see Attachment 2), the arborist survey area (project area and an approximate 50-foot buffer) encompasses 93 trees that are considered suitable for monarch roosting. These trees include healthy Canary Island pines and gum trees taller than 15 feet (see Attachment 2).

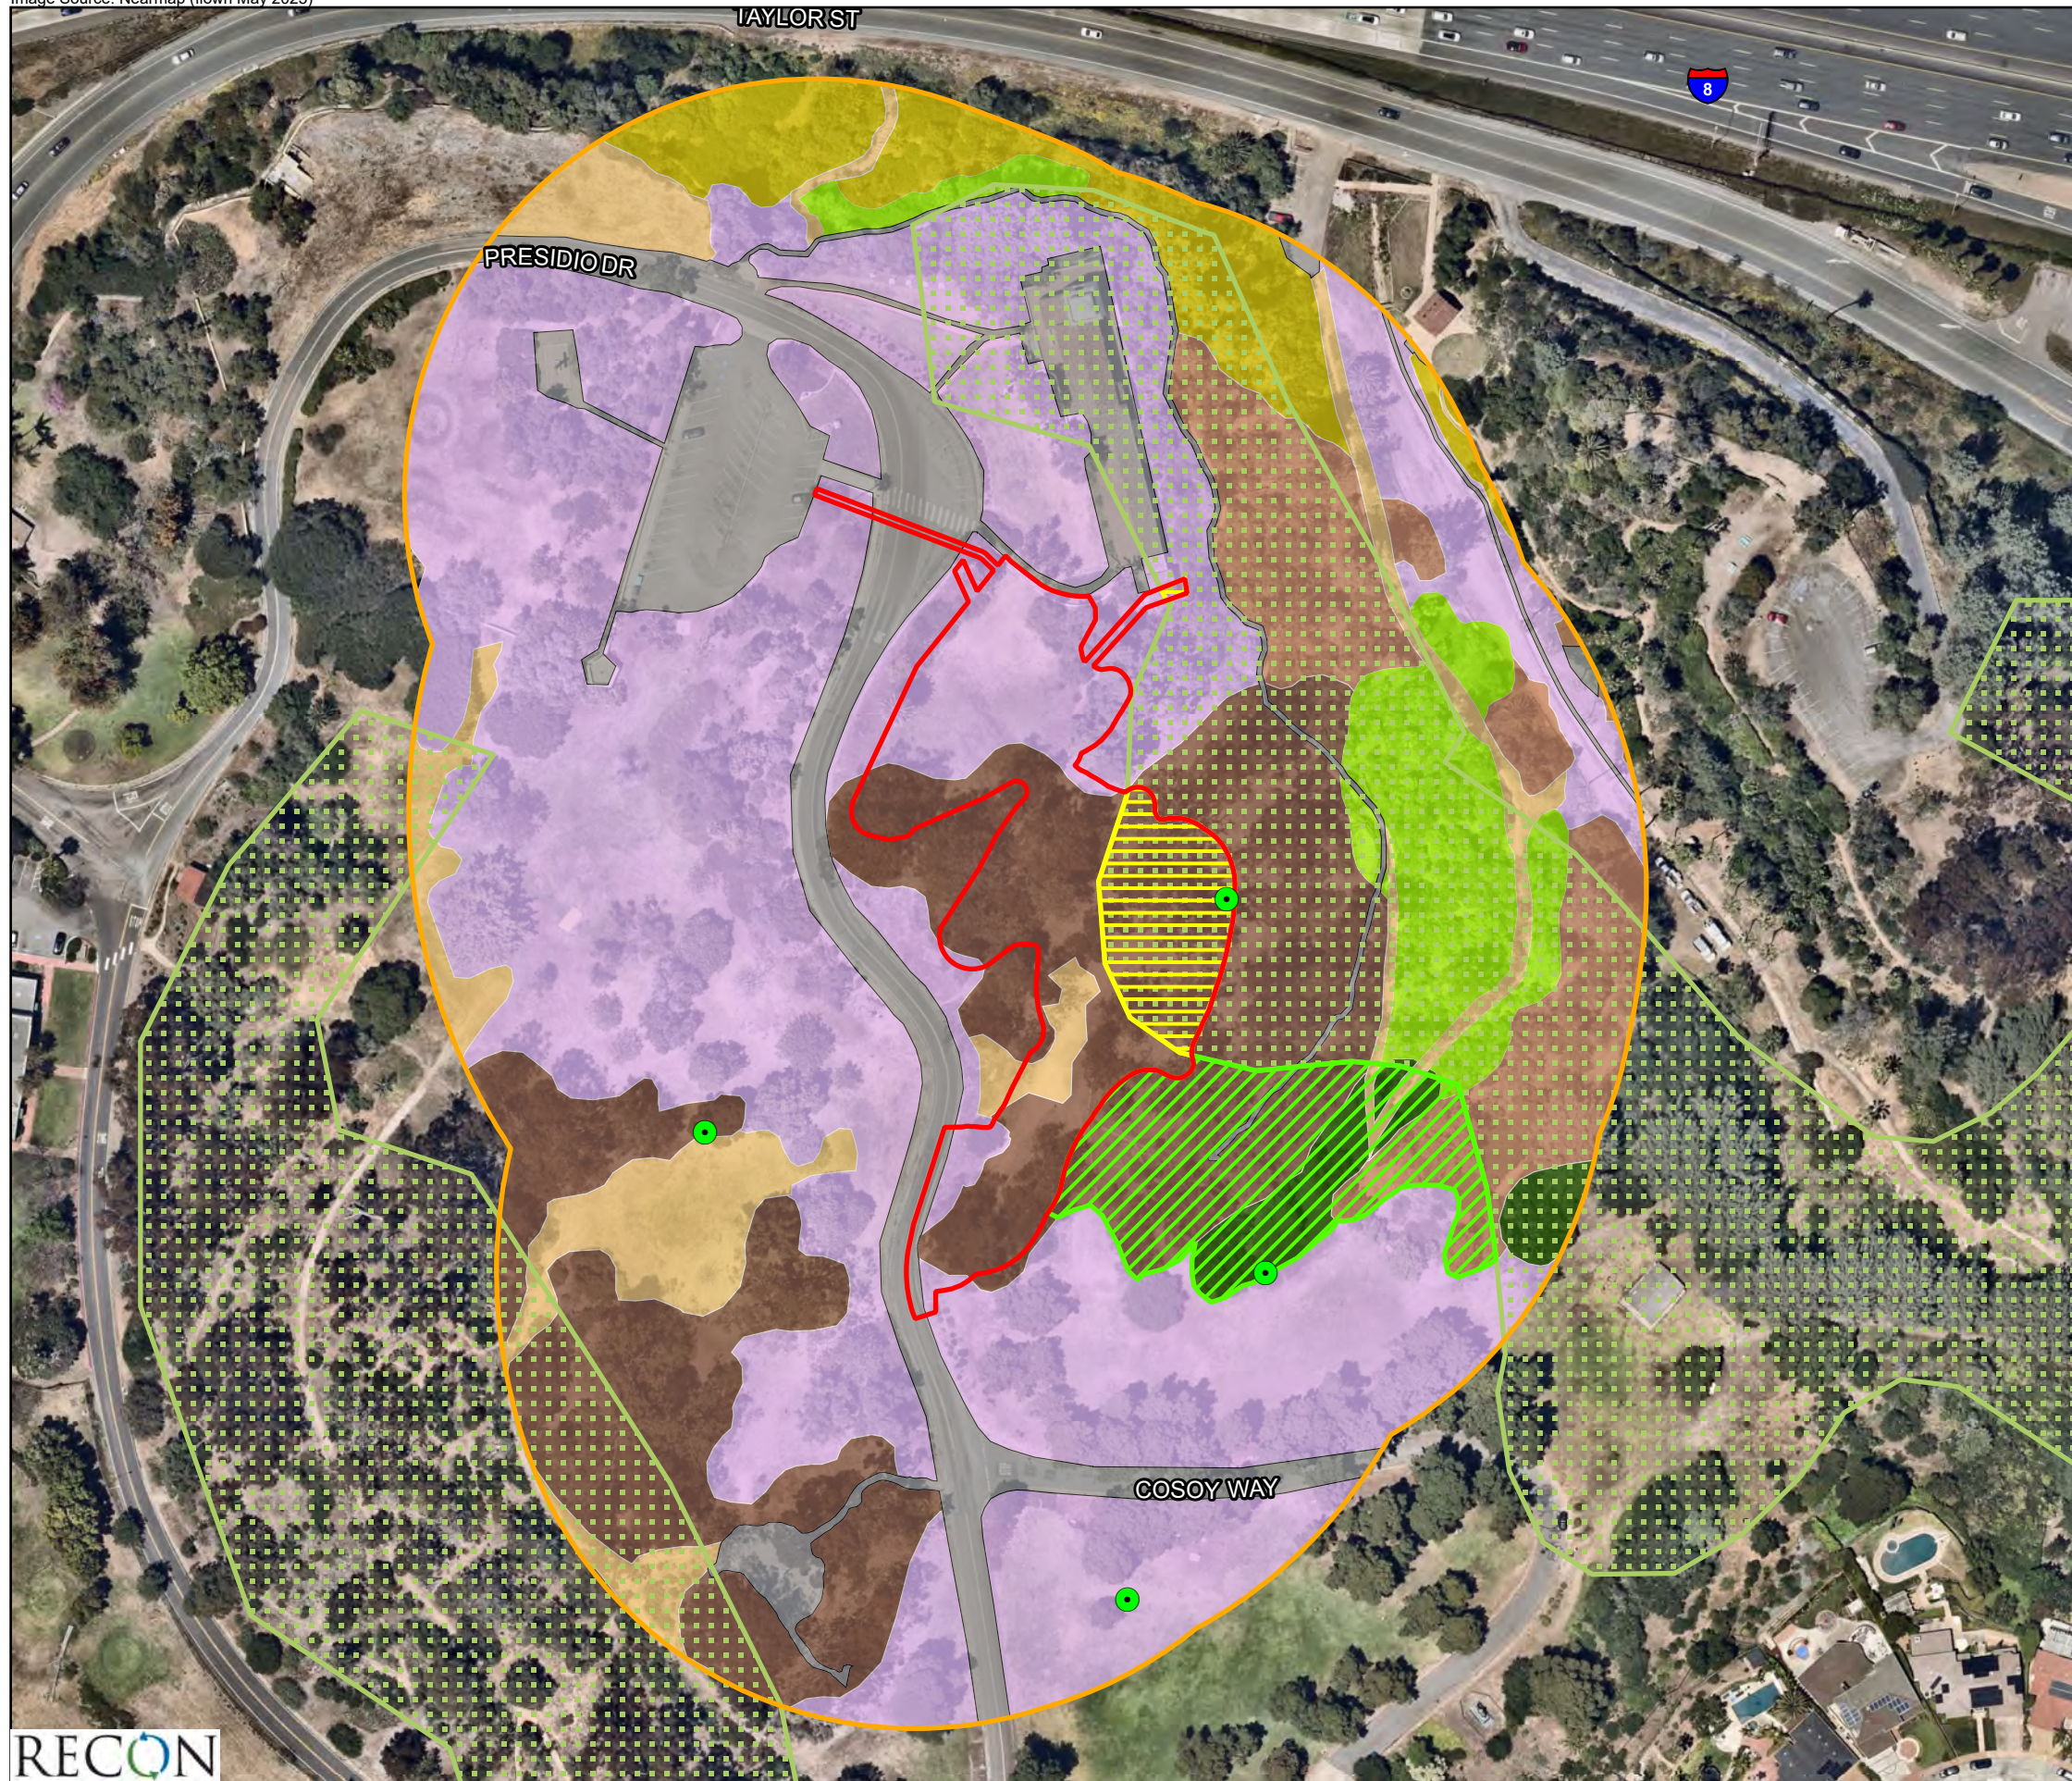
- Project Area
 - Survey Area
 - City of San Diego MHPA
 - MHPA Addition (0.86 ac)
 - MHPA Subtraction (0.31 ac)
 - Monarch Butterfly Observation (2024)
- Vegetation Communities**
- Disturbed Southern Mixed Chaparral
 - Coast Live Oak Woodland
 - Non-native Woodland
 - Non-native Vegetation
 - Eucalyptus Woodland
 - Ornamental Plantings
 - Disturbed Land
 - Urban/Developed

A portion of the project (0.31 acre) occurs inside the existing MHPA boundary and thus would require an MHPA BLA. The BLA would result in the removal of 0.31 acre of eucalyptus woodland and ornamental plantings from the MHPA in an area subject to ongoing park maintenance activity. In exchange, 0.86 acre of coast live oak woodland, disturbed southern mixed chaparral, eucalyptus woodland, non-native woodland, disturbed land and urban/developed would be added to the MHPA, resulting in a net increase of 0.55 acre inside the MHPA. The MHPA encroachment and addition areas for the proposed BLA are shown on Figure 8, and the effect on vegetation community acreages is shown in Table 3.

Vegetation Community	City of San Diego Tier	MHPA Subtraction	MHPA Addition	Net Change
Coast live oak woodland	I	--	+0.21	+0.21
Disturbed southern mixed chaparral	IIIA	--	+<0.01	+<0.01
Eucalyptus woodland	IV	-0.31	+0.47	+0.16
Non-native woodland	IV	--	+0.15	+0.15
Non-native vegetation	IV	--	--	--
Disturbed Land	IV	--	+0.02	+0.02
Ornamental plantings	IV	-<0.01	--	-<0.01
Urban/Developed	None	--	+0.01	+0.01
Total		-0.31	+0.86	+0.55

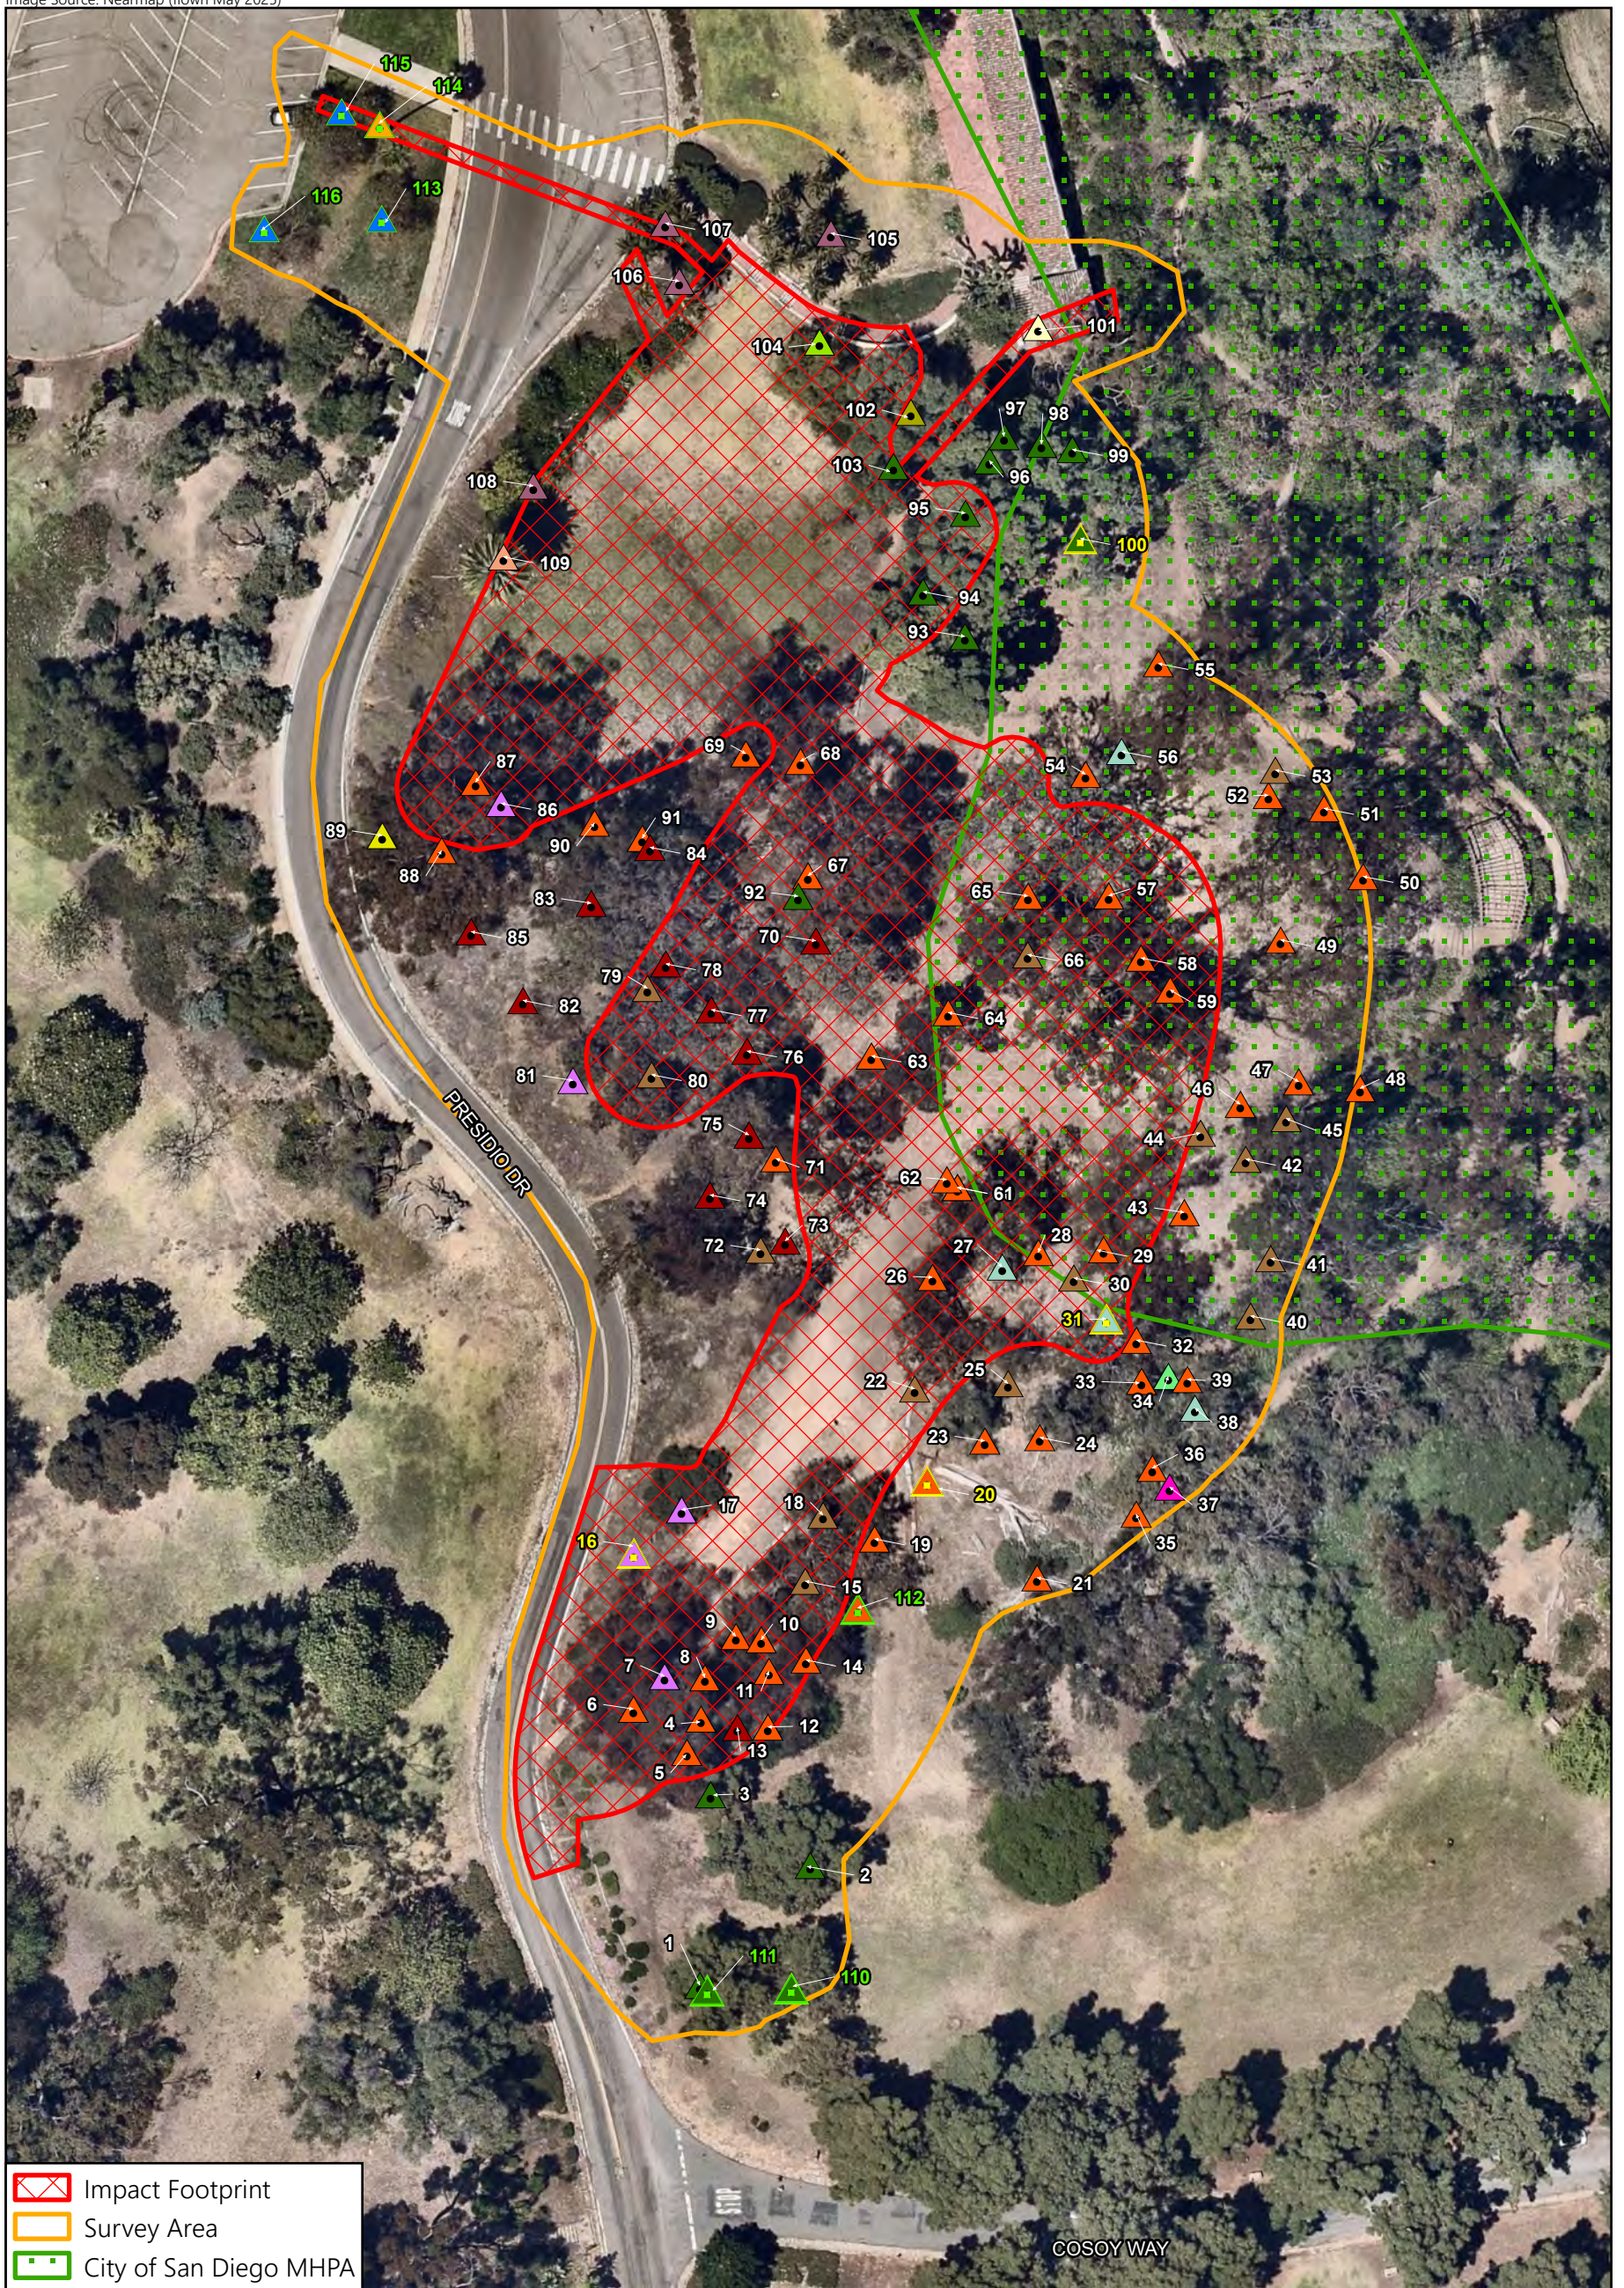
FIGURE 3
Tree Location Map

Impact Footprint
 Survey Area
 City of San Diego MHPA

Tree Species

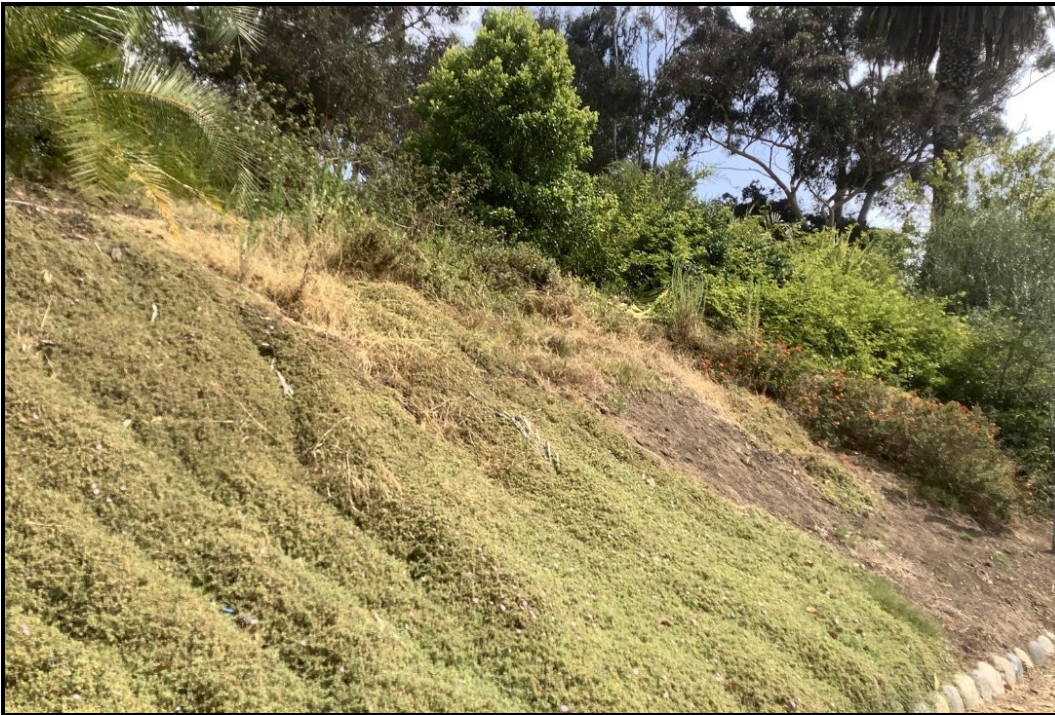
PHOTOGRAPH 1
View of Landscaping on Slopes Along Main Access Road

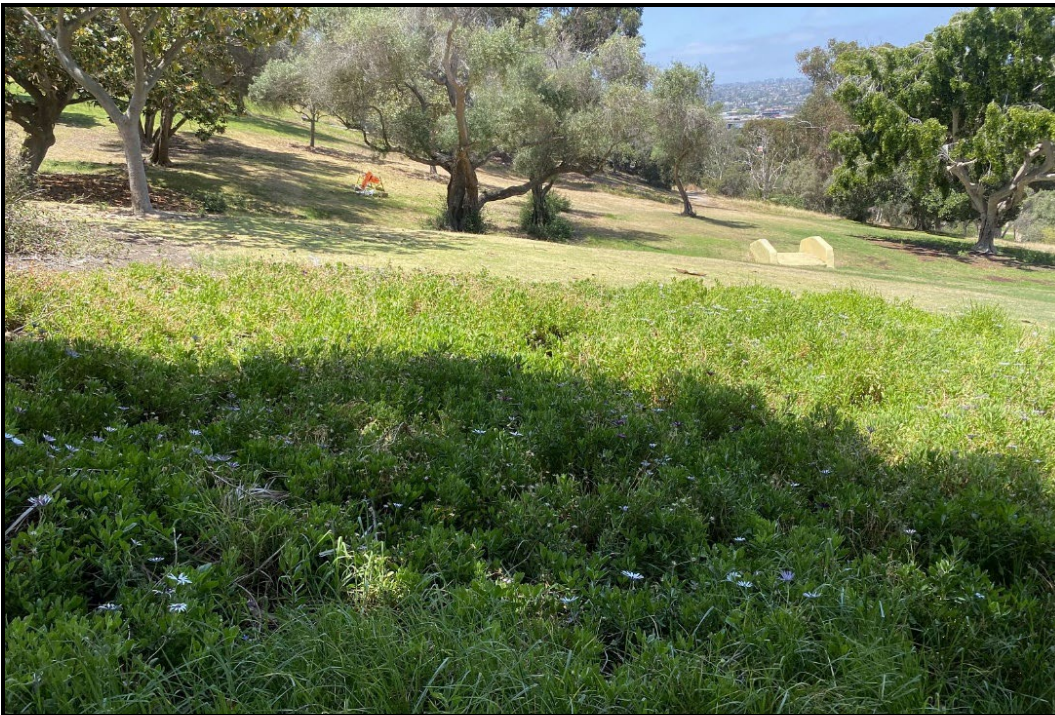
PHOTOGRAPH 2
Example of Lawn and Ornamental Trees and Plants Throughout Park

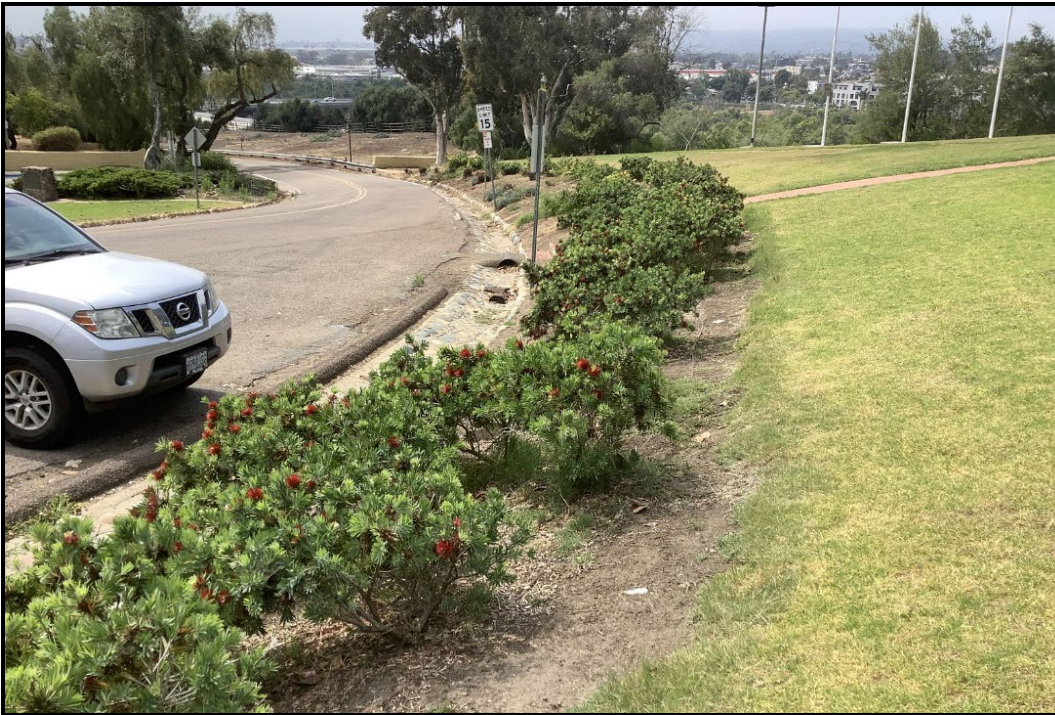
PHOTOGRAPH 3
Lawn and Landscaping Near Museum

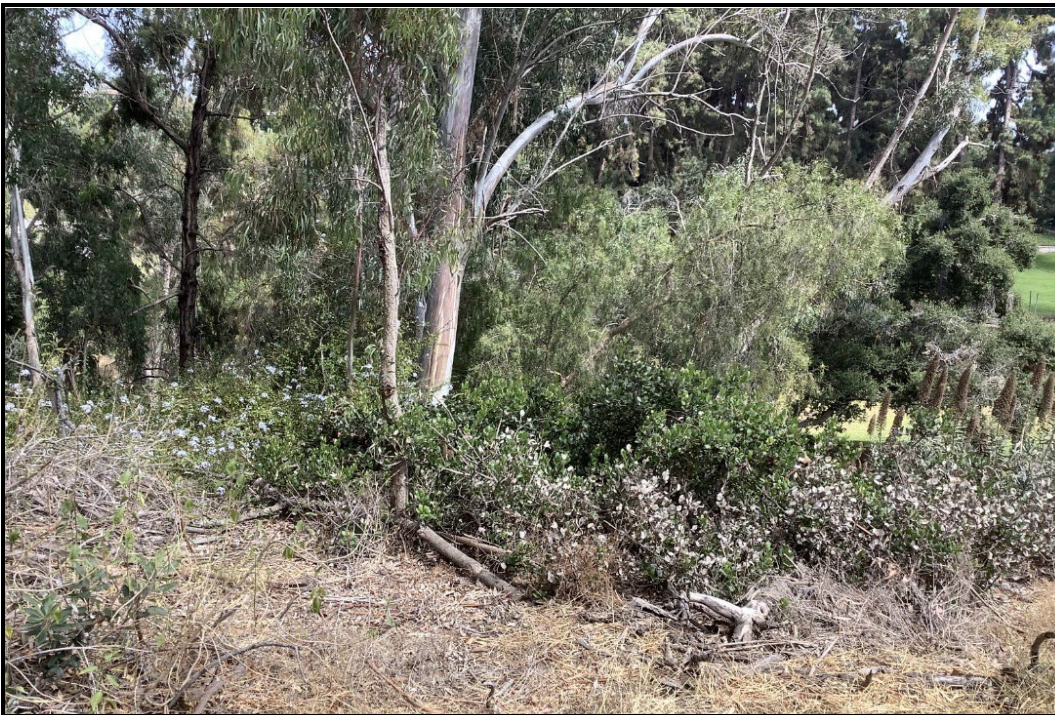
PHOTOGRAPH 4
Mix of Eucalyptus, Landscaping, and Native Plants

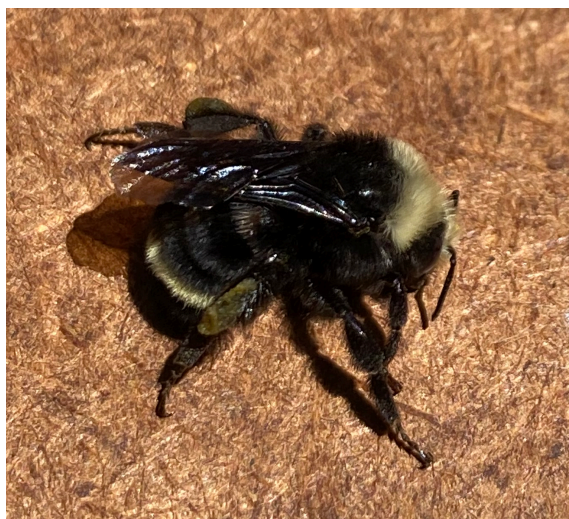
Specimen 1	Image #: RECON9087.1_062024_WEL_a7 (of 11 images) image cropped for detail
Date: 20 June 2024	ID: yellow-faced bumble bee (<i>Bombus vosnesenskii</i>) female.

Based on the set of photos provided and the location, this bee is a yellow-faced bumble bee. Females of this species are distinguished from other similar bumble bee species by having a square cheek (malar space), yellow hair on the face and vertex, yellow hair on the scutum (front of thorax), and mostly black hair on the abdomen except for a yellow strip at the 4 th tergal segment (T4).

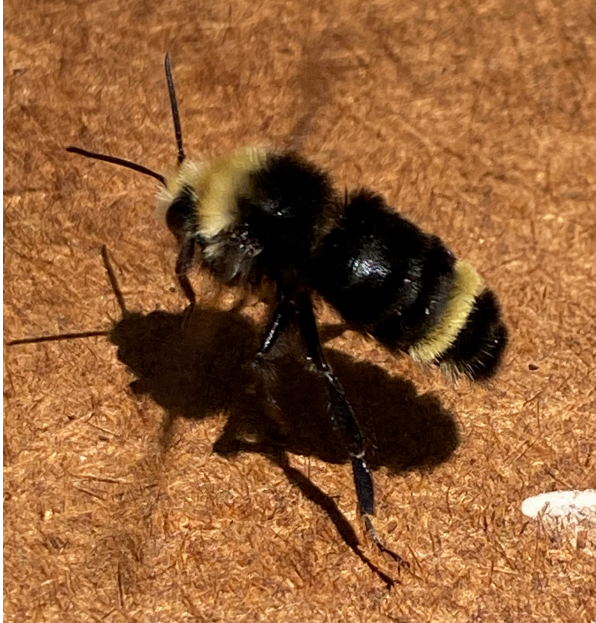
Specimen 2	Image # RECON9087.1_062024_WEL_b8 (of 9 photos), image cropped for detail
Date: 20 June 2024	ID: yellow-faced bumble bee (<i>Bombus vosnesenskii</i>) male.

Based on the set of photos provided and the location, this bee is the common yellow-faced bumble bee. Males of this species are distinguished from other similar bumble bee species by having a square cheek (malar space), yellow hair on the face and vertex, yellow hair on its scutum (front of thorax), and mostly black hair on the abdomen except for a yellow strip at the 4 th tergal segment (T4) and some yellow hair at the side of T5.

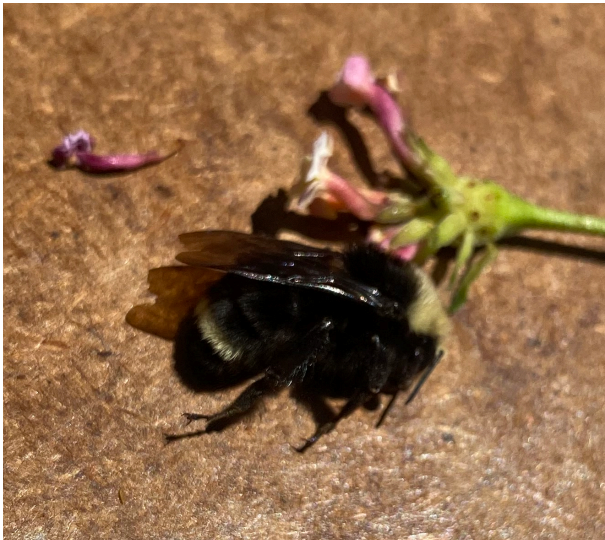
Specimen 3	Image # RECON9087.1_072324_WEL_a14 (of 15 photos), image cropped for detail
Date: 23 July 2024	ID: yellow-faced bumble bee (<i>Bombus vosnesenskii</i>) female.

Based on the set of photos provided and the location, this bee is a yellow-faced bumble bee. Females of this species are distinguished from other similar bumble bee species by having a square cheek (malar space), yellow hair on the face and vertex, yellow hair on the scutum (front of thorax), and mostly black hair on the abdomen except for a yellow strip at the 4 th tergal segment (T4).

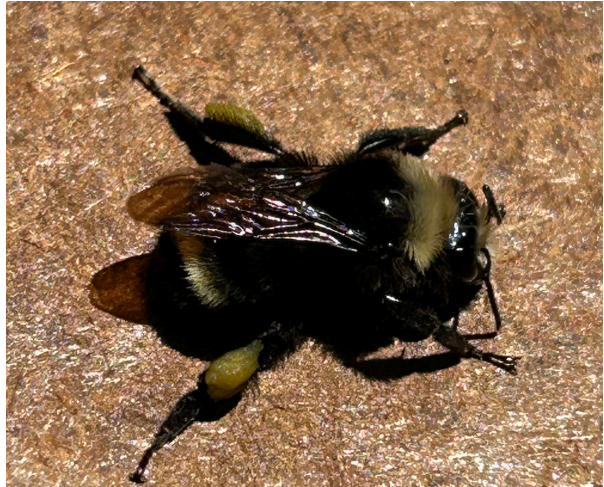
Specimen 4	Image # RECON9087.1_072324_WEL_b4 (of 6 photos)
Date: 23 July 2024	ID: yellow-faced bumble bee (<i>Bombus vosnesenskii</i>) female.

Based on the set of photos provided and the location, this bee is a yellow-faced bumble bee. Females of this species are distinguished from other similar bumble bee species by having a square cheek (malar space), yellow hair on the face and vertex, yellow hair on the scutum (front of thorax), and mostly black hair on the abdomen except for a yellow strip at the 4 th tergal segment (T4).

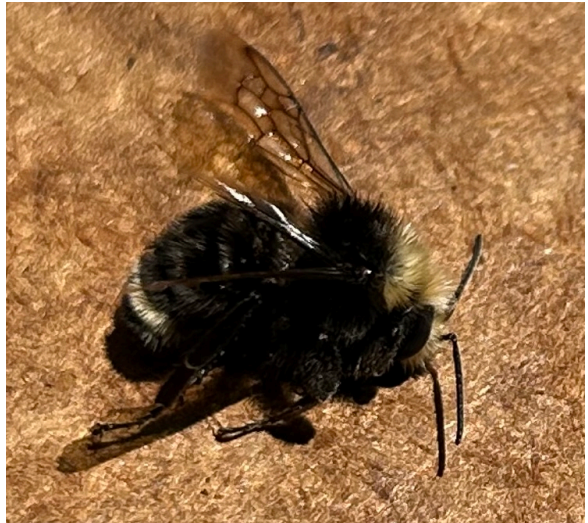
Specimen 5	Image # RECON9087.1_072324_WEL_c3 (of 7 photos)
Date: 23 July 2024	ID: yellow-faced bumble bee (<i>Bombus vosnesenskii</i>) male.

Based on the set of photos provided and the location, this bee is the common yellow-faced bumble bee. Males of this species are distinguished from other similar bumble bee species by having a square cheek (malar space), yellow hair on the face and vertex, yellow hair on its scutum (front of thorax), and mostly black hair on the abdomen except for a yellow strip at the 4 th tergal segment (T4) and some yellow hair at the side of T5.
