Biological Resources Technical Report

# **El Monte Water Transmission Pipeline Rehabilitation Project**

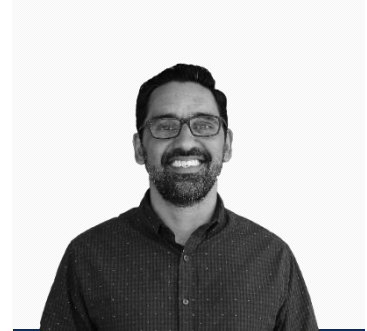
**R Revegetation Monitoring, City of San Diego, California.** Assisted in the collection of data within revegetated wetlands in accordance with monitoring criteria of the City of San Diego and wetlands resource agencies.

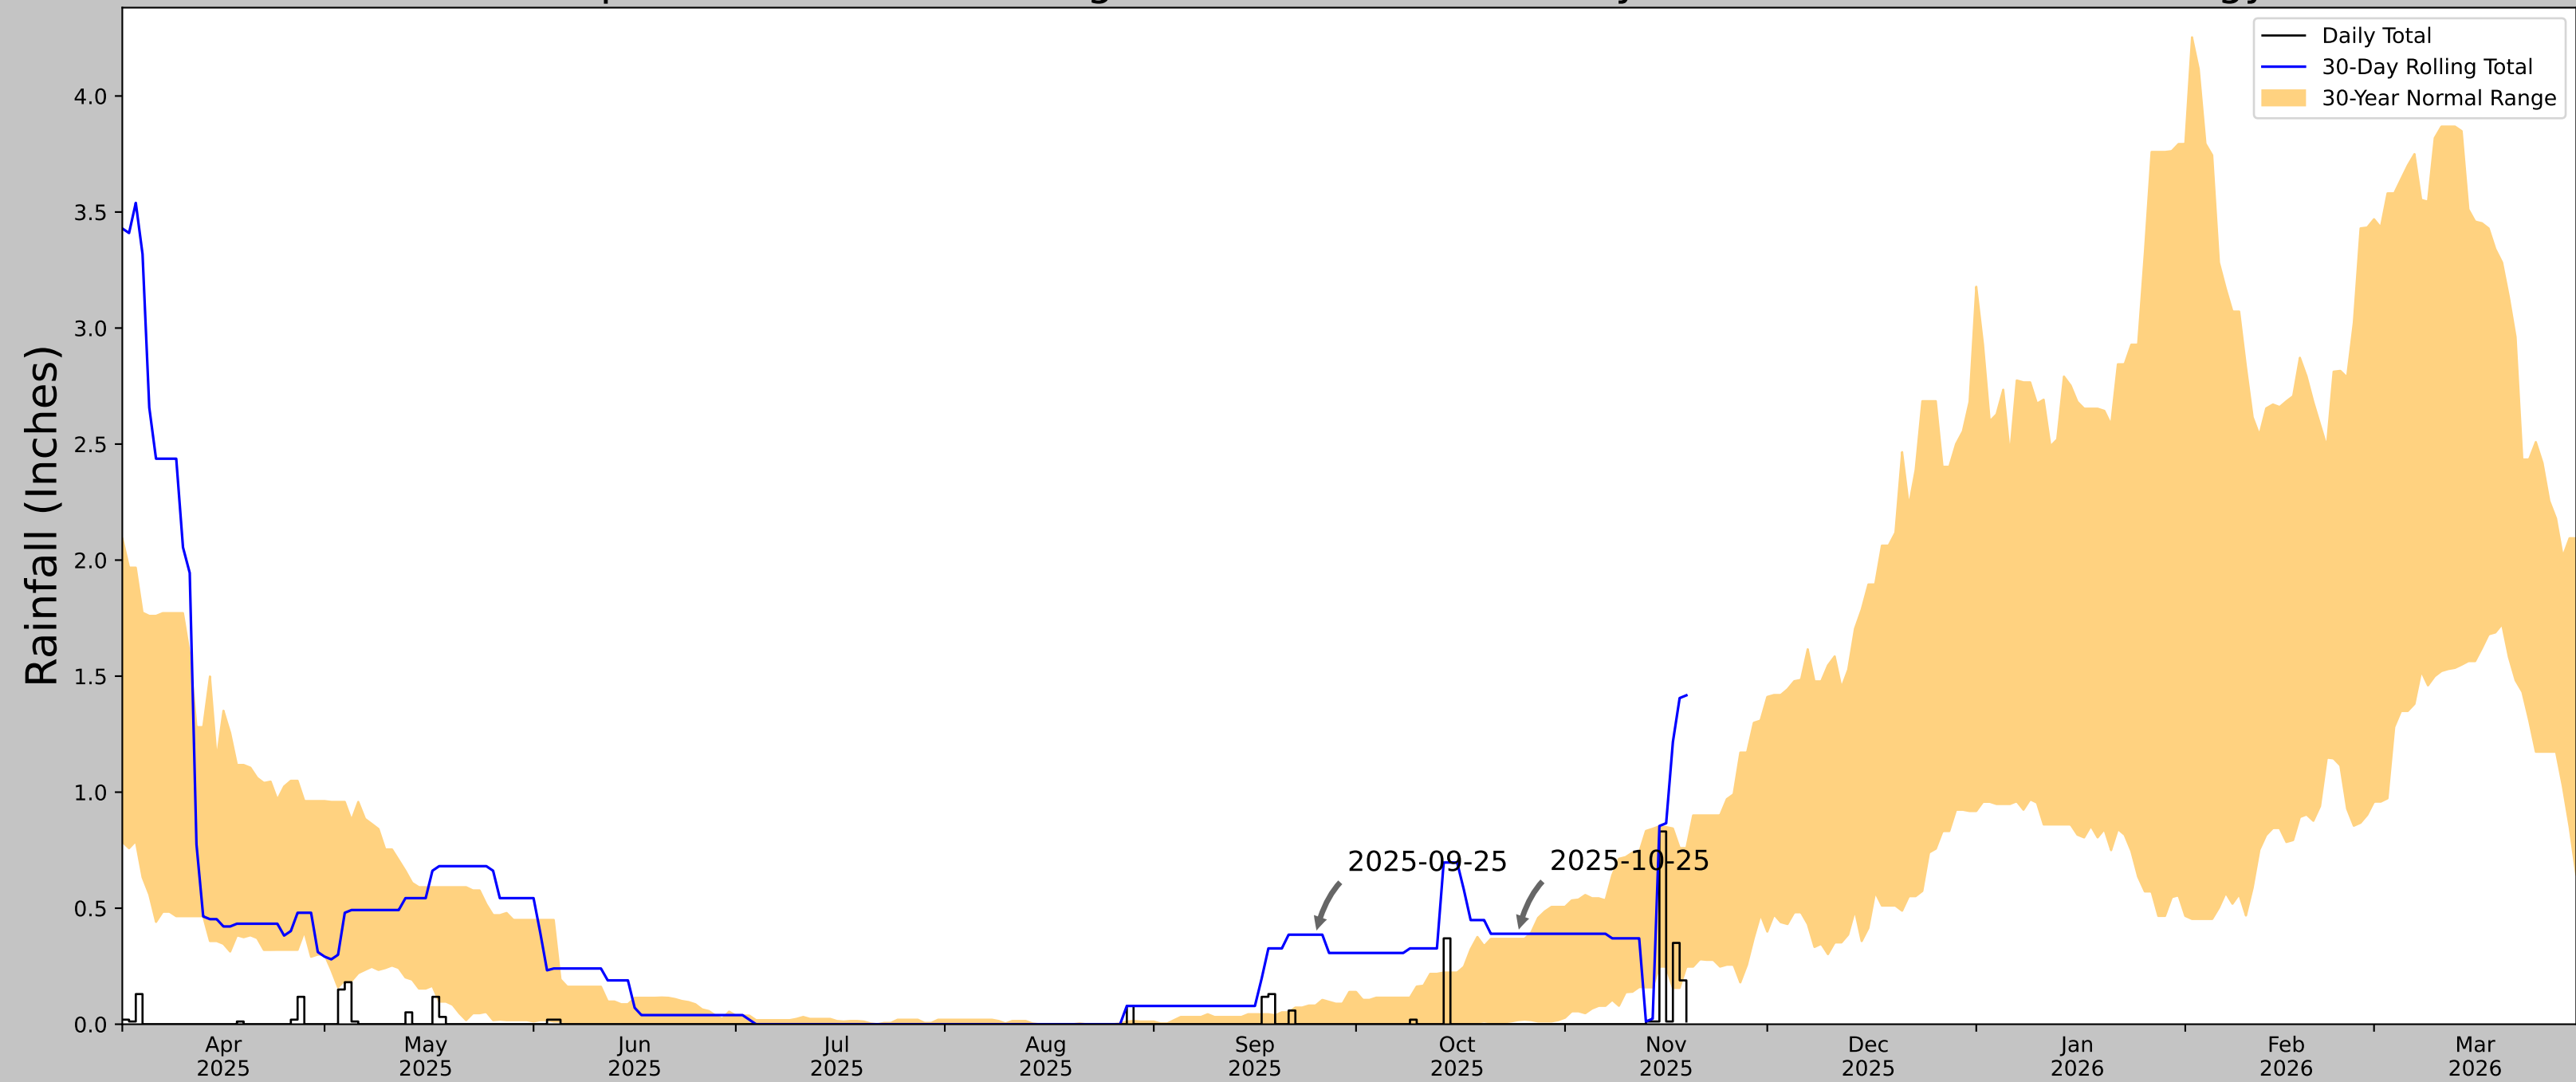
Coordinates	32.79492, -116.98205
Observation Date	2025-10-25
Elevation (ft)	549.805
Drought Index (PDSI)	Moderate drought
WebWIMP H <sub>2</sub> O Balance	Dry Season
