**AQUATIC RESOURCES DELINEATION REPORT FOR
EL MONTE WATER TRANSMISSION PIPELINE
REHABILITATION PROJECT
CITY OF SAN DIEGO, CALIFORNIA**

PROJECT NO.: 20203585.001A

FEBRUARY 2026

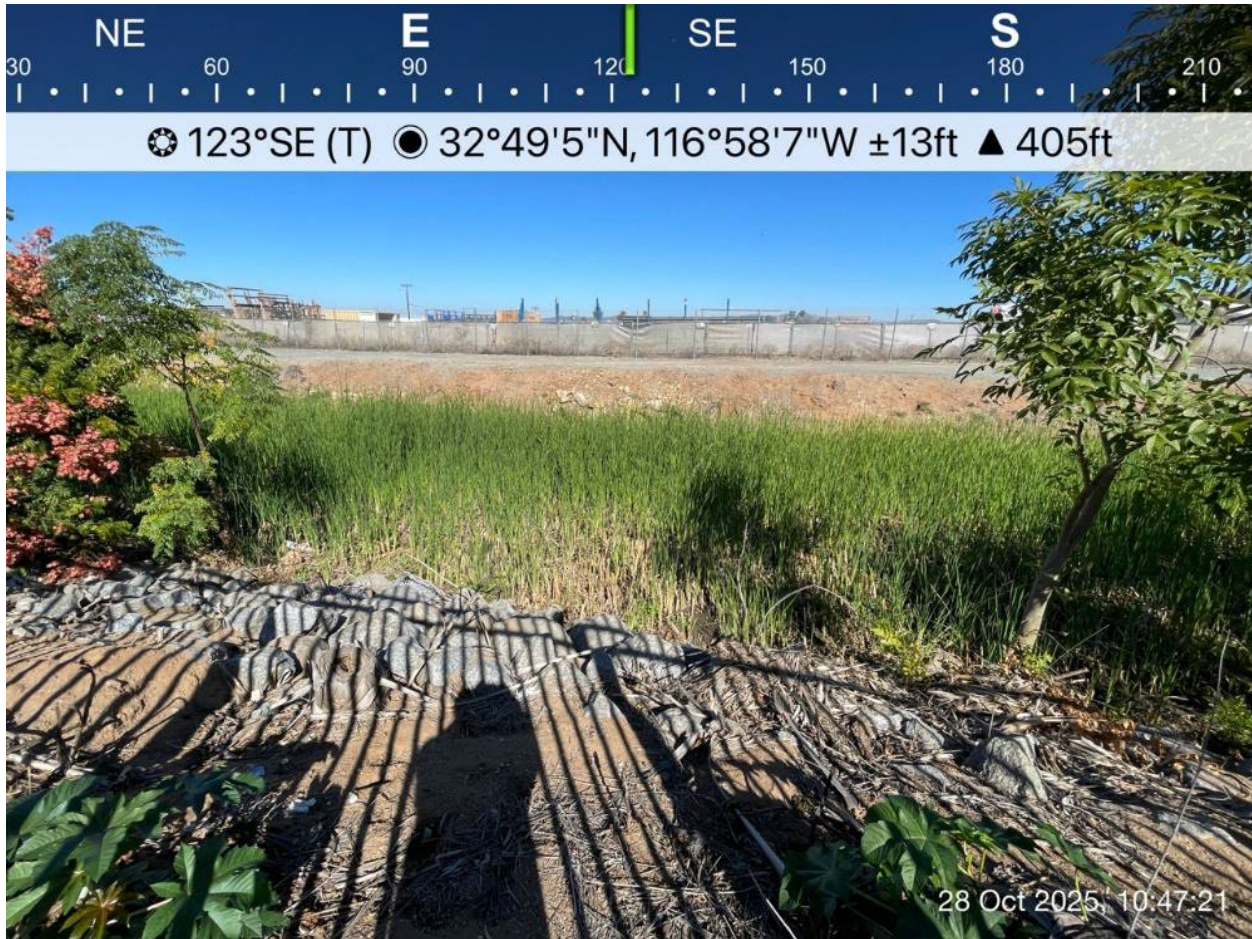
Photo 1. Work Location 345+20 and a view of NWW-ALT-01, a canal constructed between W Bradley Avenue and Floyd Smith Drive; facing southeast. October 28, 2025.

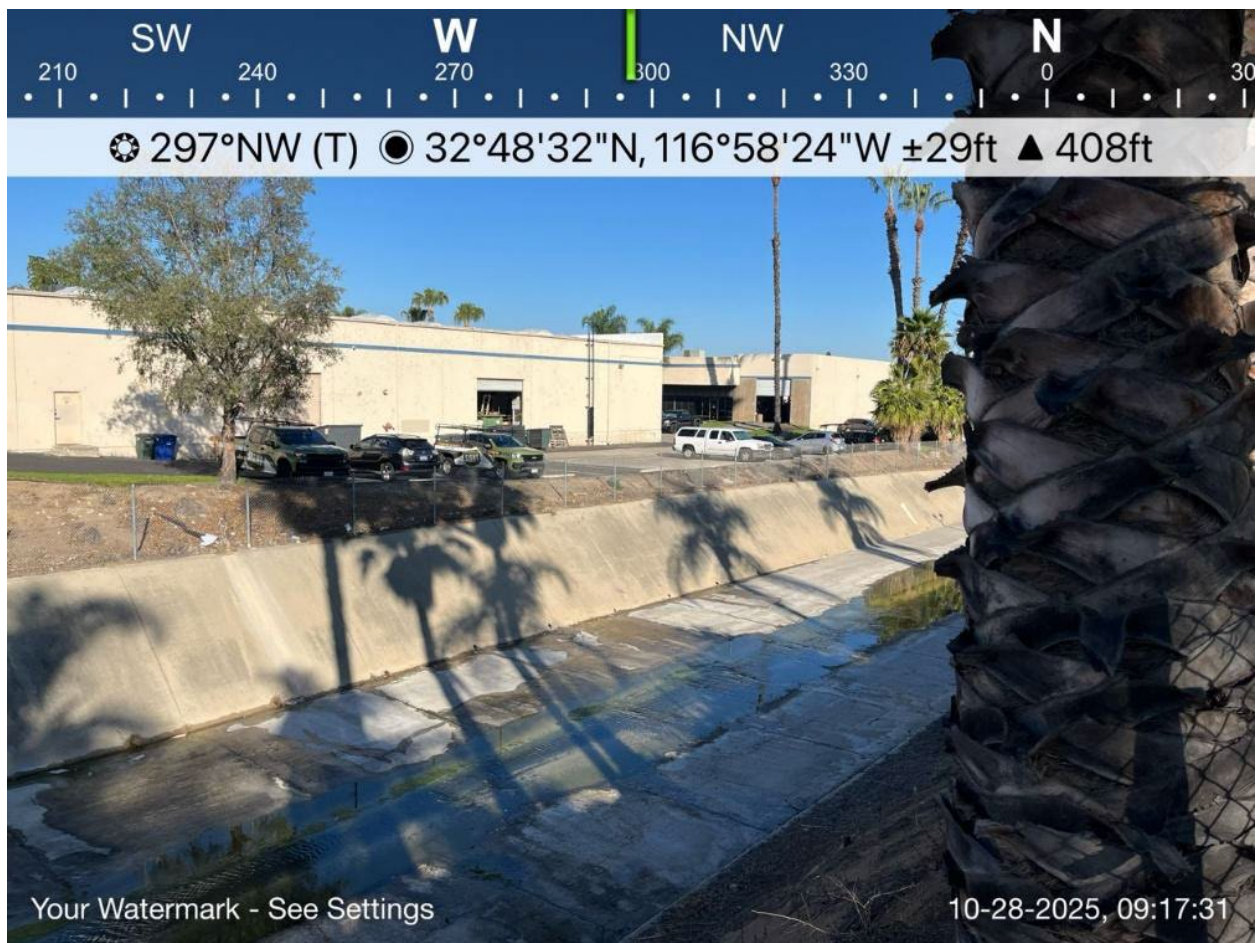
Photo 2. Work Location 380+15 and a view of NWW-ALT-02, a channelized waterway; facing west. October 28, 2025.

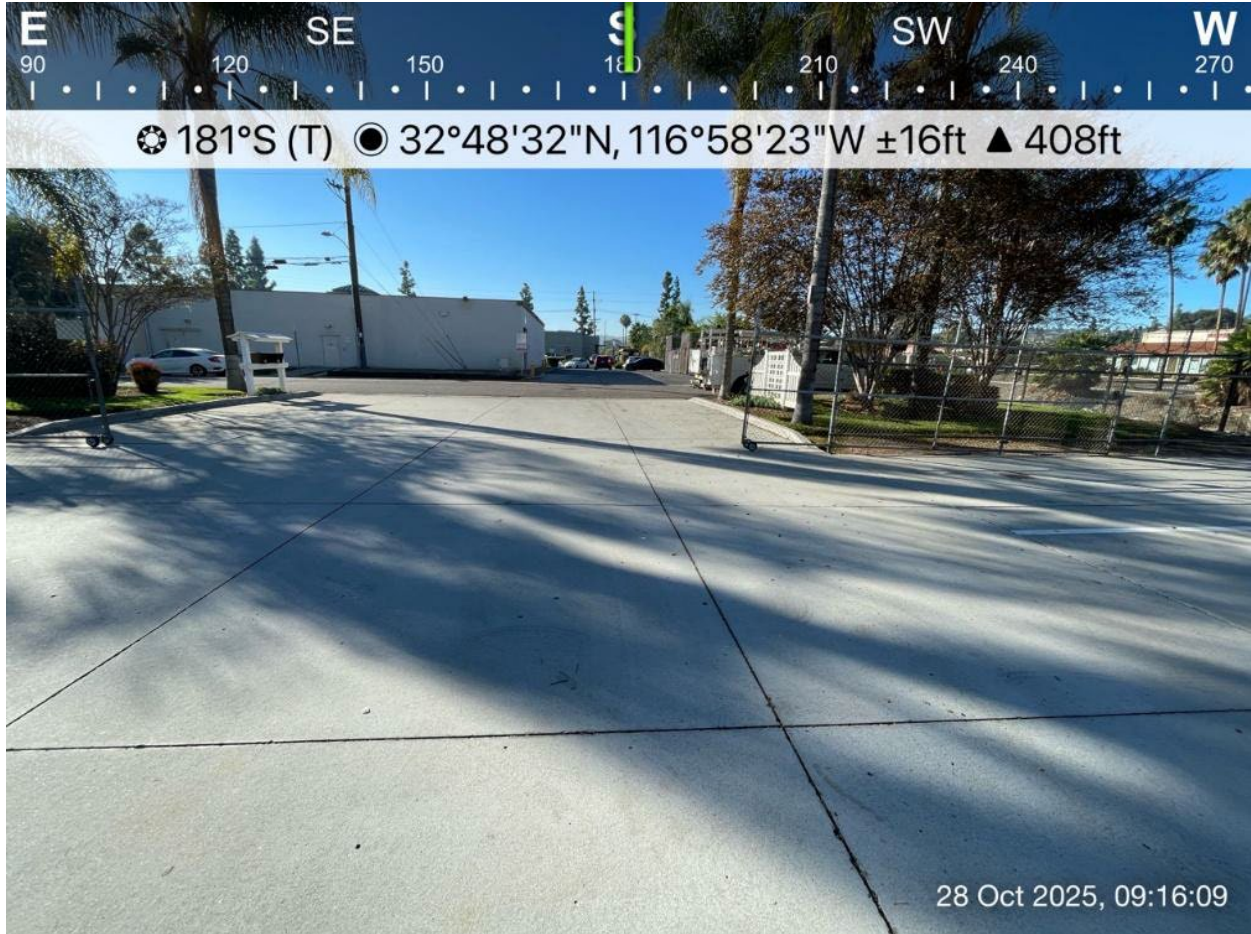
Photo 3. Work Location 380+15, facing south, away from NWW-ALT-02. October 28, 2025.

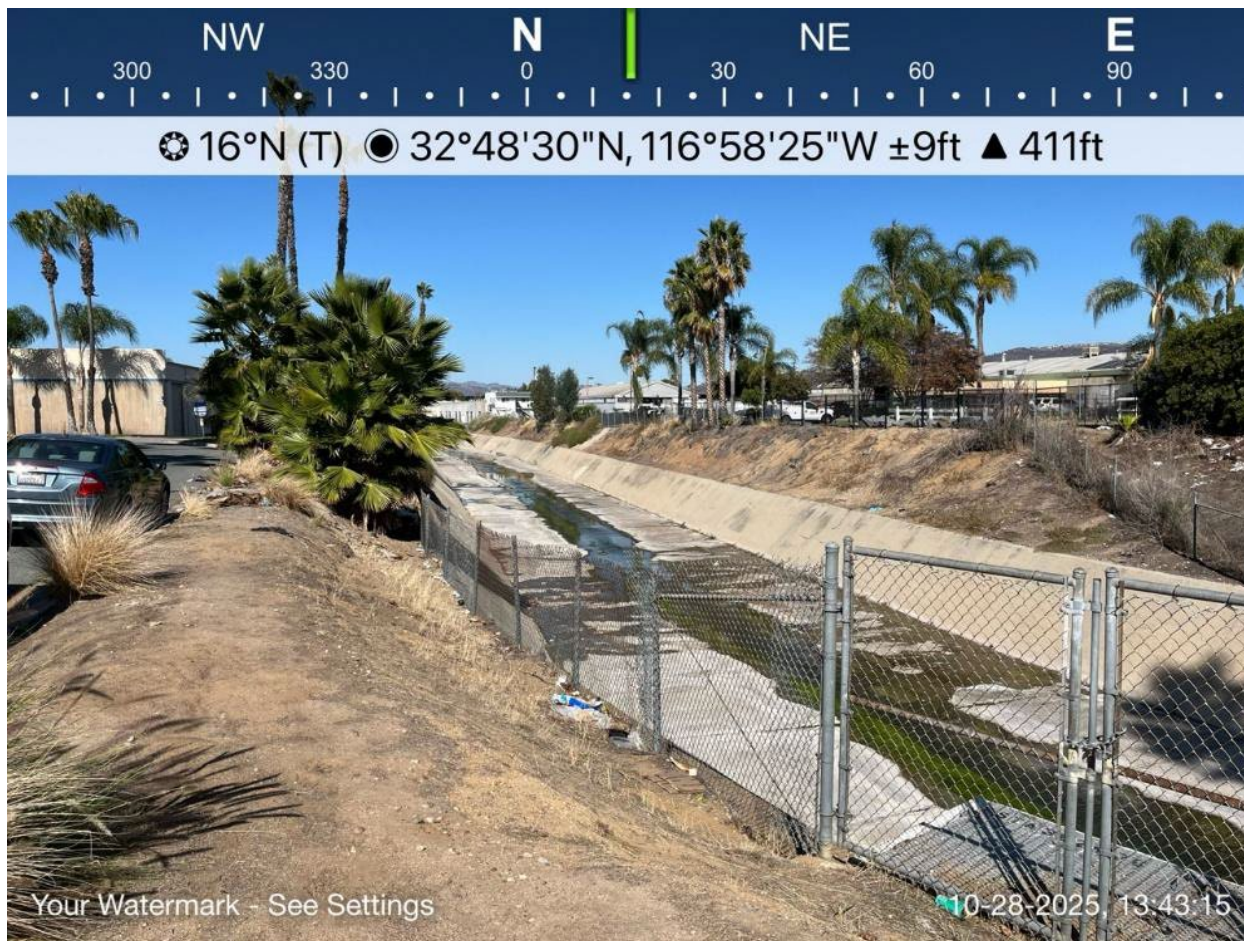
Photo 4. Work Location 382+78 and a view of NWW-ALT-02; facing north. October 28, 2025.

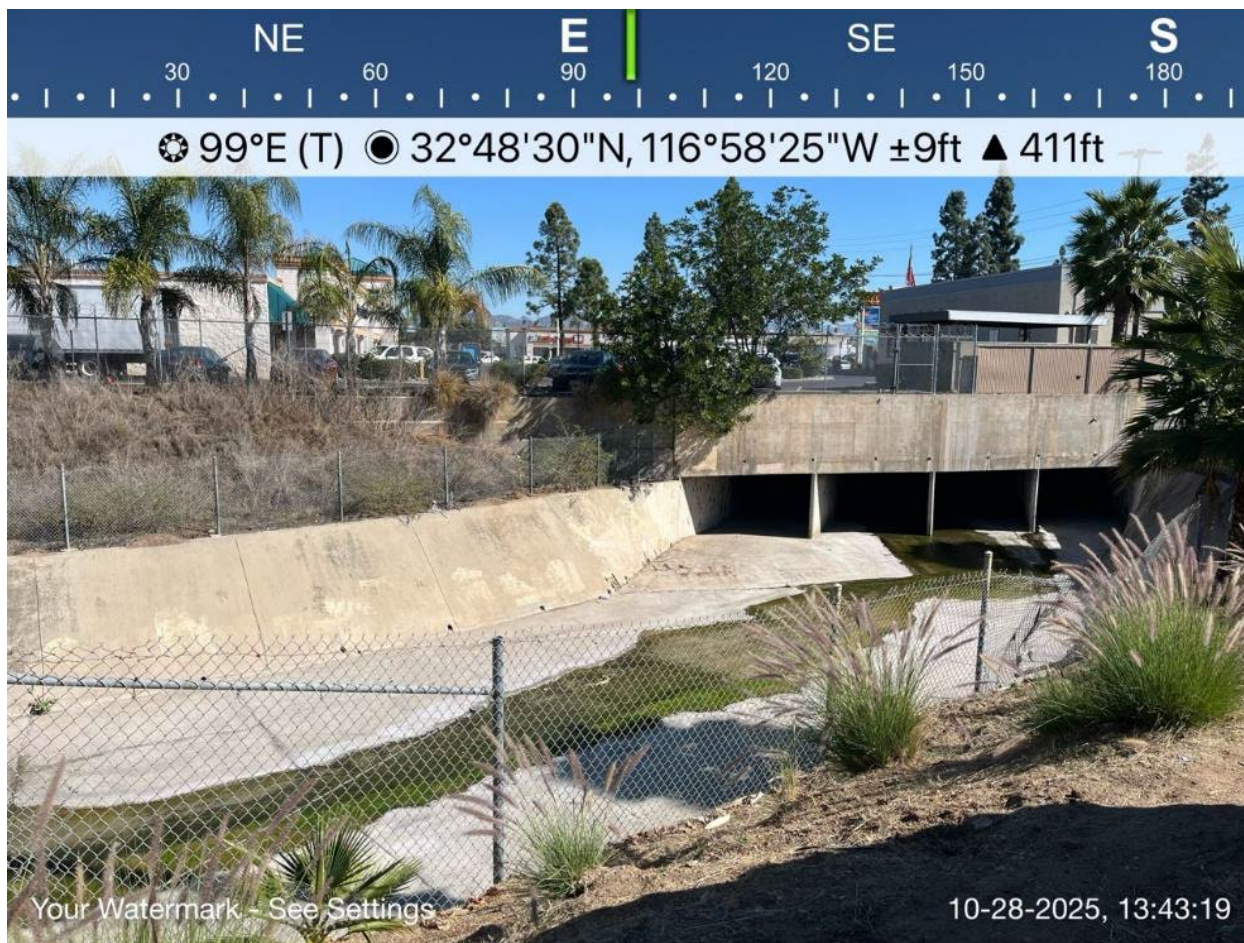
Photo 5. Work Location 382+78 and a view of NWW-ALT-02; facing east. October 28, 2025.

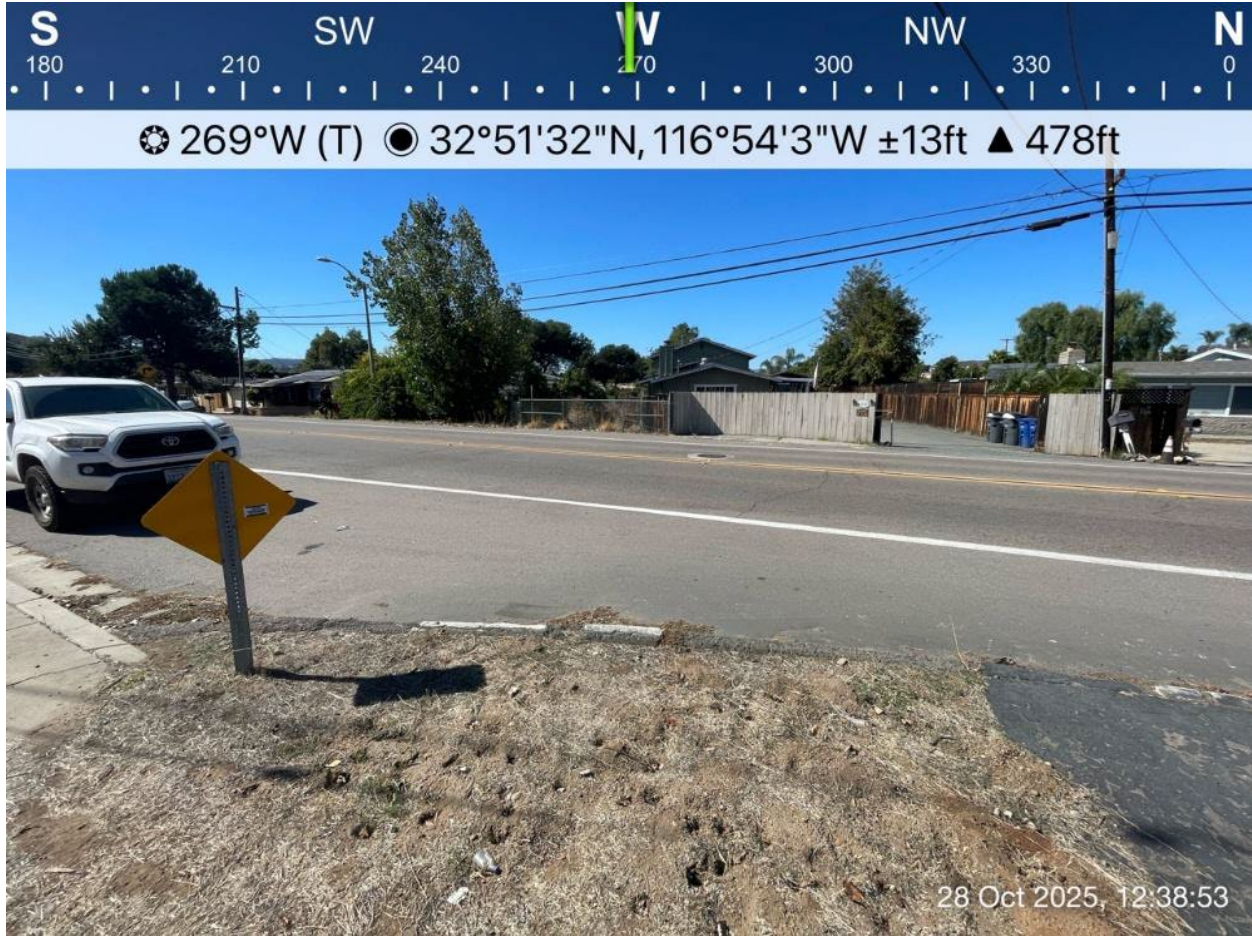
Photo 7. Work Location 40+29, with NWW-ALT-03 behind the photographer. View facing west. October 28, 2025.

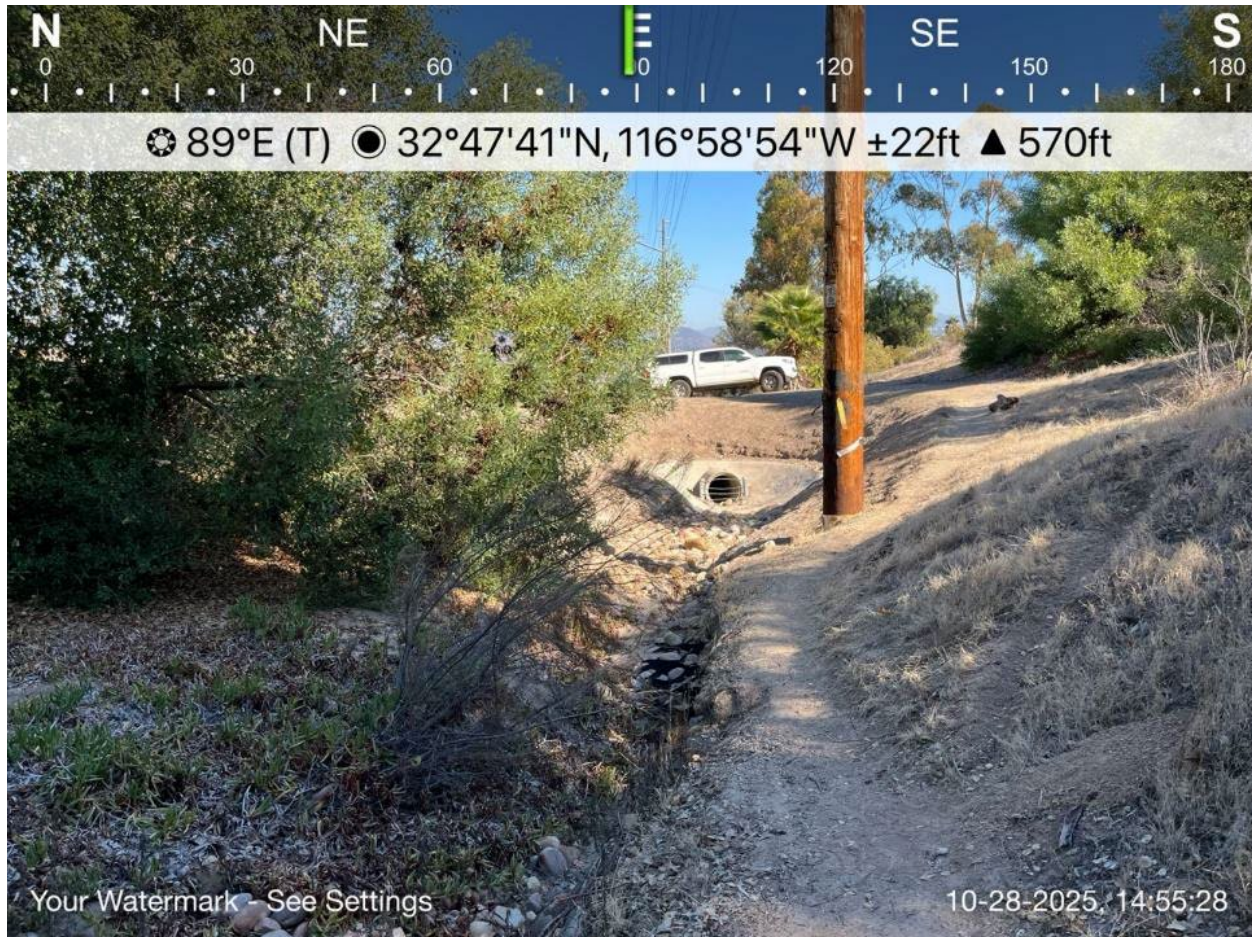
Photo 8. Work Location 439+20, NWW-ALT-04; view of culvert inlet that directs water from both NWW-ALT-04 and -05 into an underground stormwater system of pipes that are assumed to flow 0.75-miles to a channelized reach of Forester Creek; View facing east. October 28, 2025.

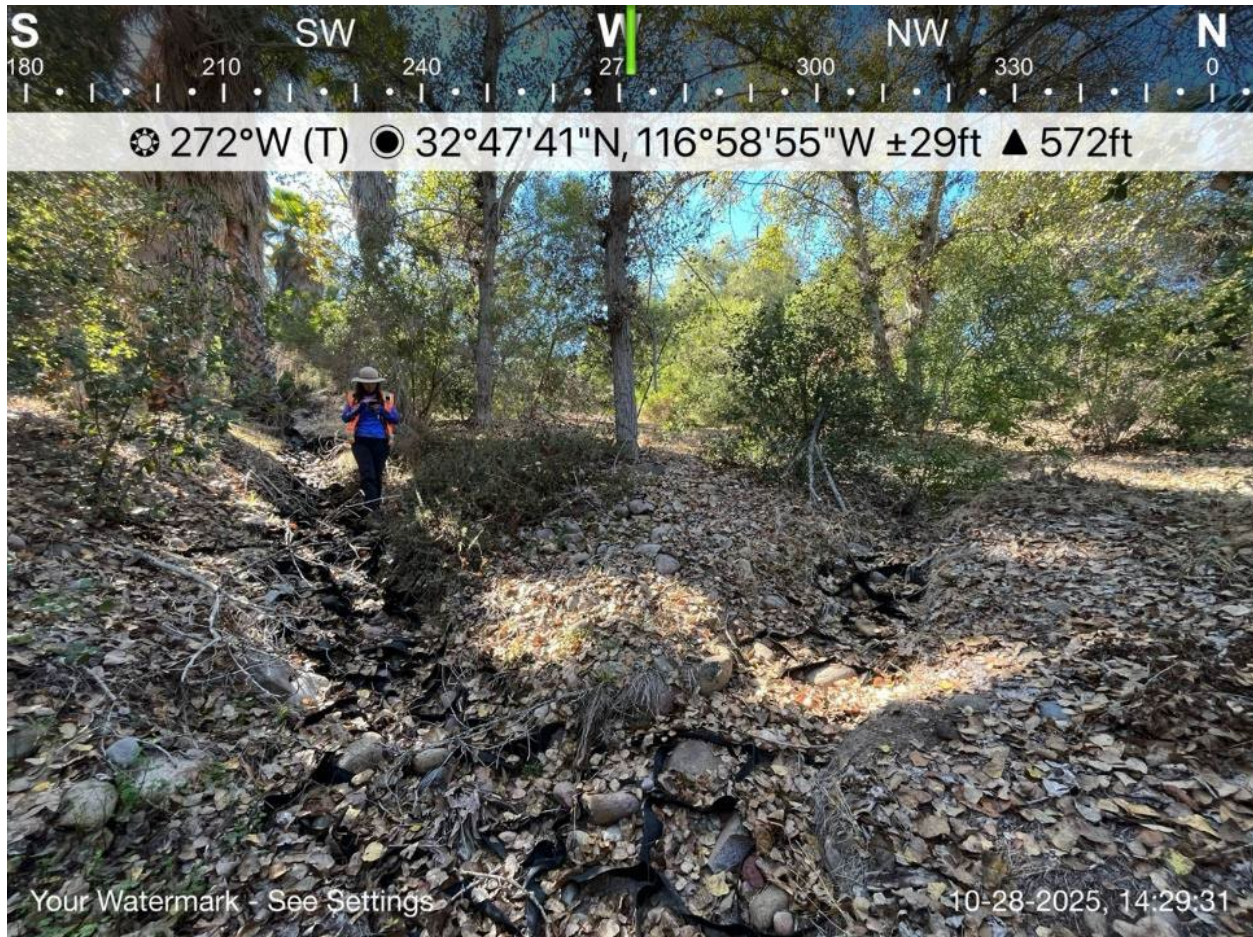
Photo 9. Work Location 439+20. Convergence of intermittent channel NWW-ALT-04 and ephemeral channel NWW-ALT-05; both provide surface flow connections to stormwater culverts. Note existing geogrid and rock installed to reduce erosion. View facing west. October 28, 2025.

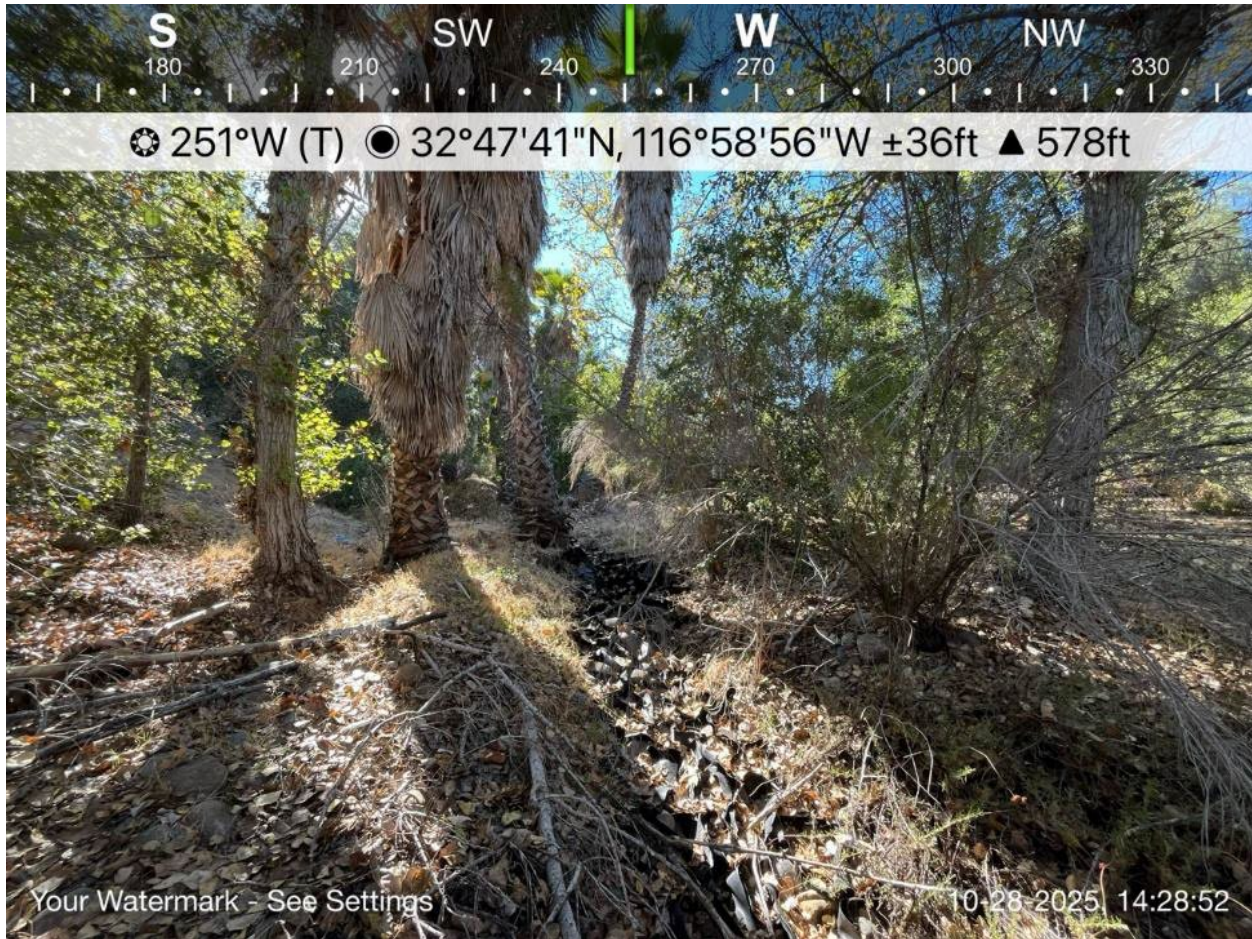
Photo 10. Work Location 439+20. NWW-ALT-04 is an intermittent channel aligned along a hillside between a culvert outfall under West Main Street and another stormwater culvert (Photo 9). View facing west by southwest. October 28, 2025.

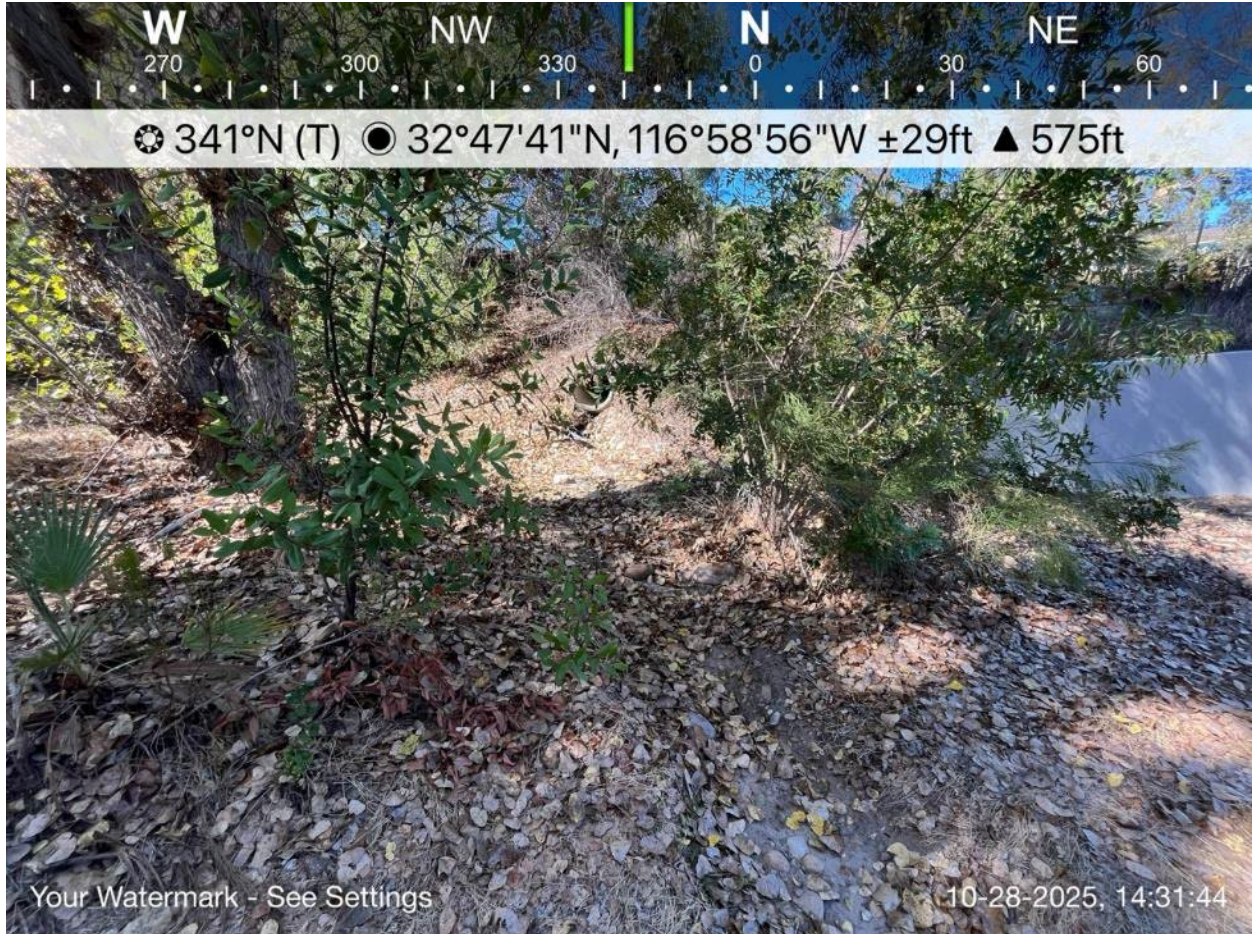
Photo 11. Work Location 439+20, NWW-ALT-05, an ephemeral channel aligned between culvert outfall under West Main Street and flowing toward NWW-ALT-04; facing north. October 28, 2025.

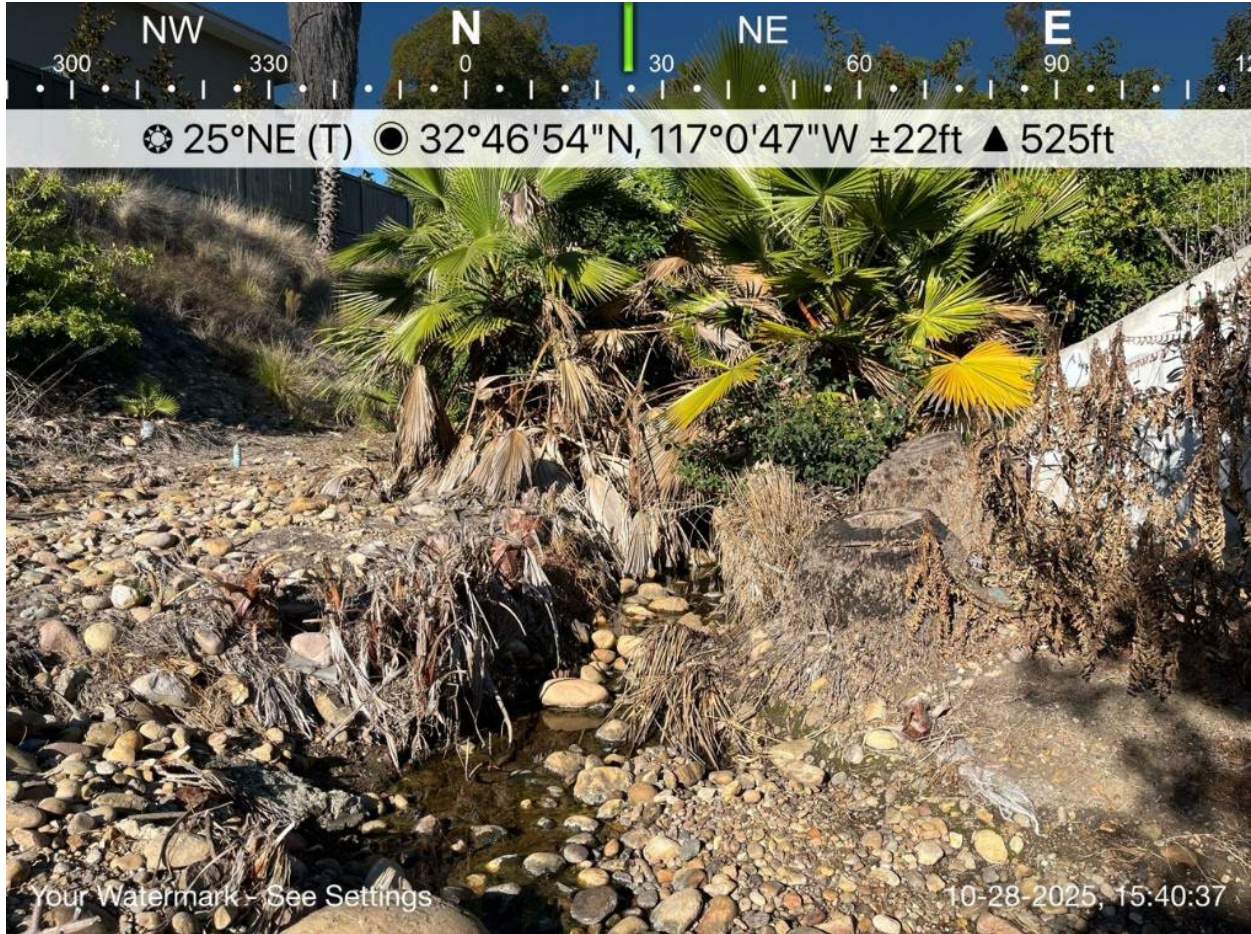
Photo 12. Work Location 555+79 is to the left of the photo of NWW-ALT-06, a channel associated with a culvert under Fletcher Parkway. View facing north. October 28, 2025.

One perennial drainage (NWW-ALT-06) and one tributary intermittent drainage (NWW-ALT-07) were identified at work location 555+79/555+76. The perennial drainage supported a non-native riparian corridor, and both drainages supported emergent wetland vegetation that appeared to have been recently mowed or trimmed. Both drainages had flowing water present at the time of the survey. There was an exposed culvert observed within the intermittent drainage that may have been originally intended to underground the drainage under an unpaved access road. However, the culvert appears to have been washed out and the drainage currently flows aboveground. The perennial drainage originates off site to the northeast and continues off site to the south via a large, concrete culvert under Fletcher Parkway. The intermittent drainage originates at a concrete culvert under Amarillo Avenue and flows southeast into the perennial drainage. Downstream connectivity of these features is unknown, but they are assumed to have relatively permanent, continuous downstream connectivity to a Traditional Navigable Water. Therefore, these features are anticipated to be under the jurisdiction of USACE, RWQCB, and CDFW below OHWM, and under the jurisdiction of CDFW to the TOB or edge of riparian, whichever is greater.

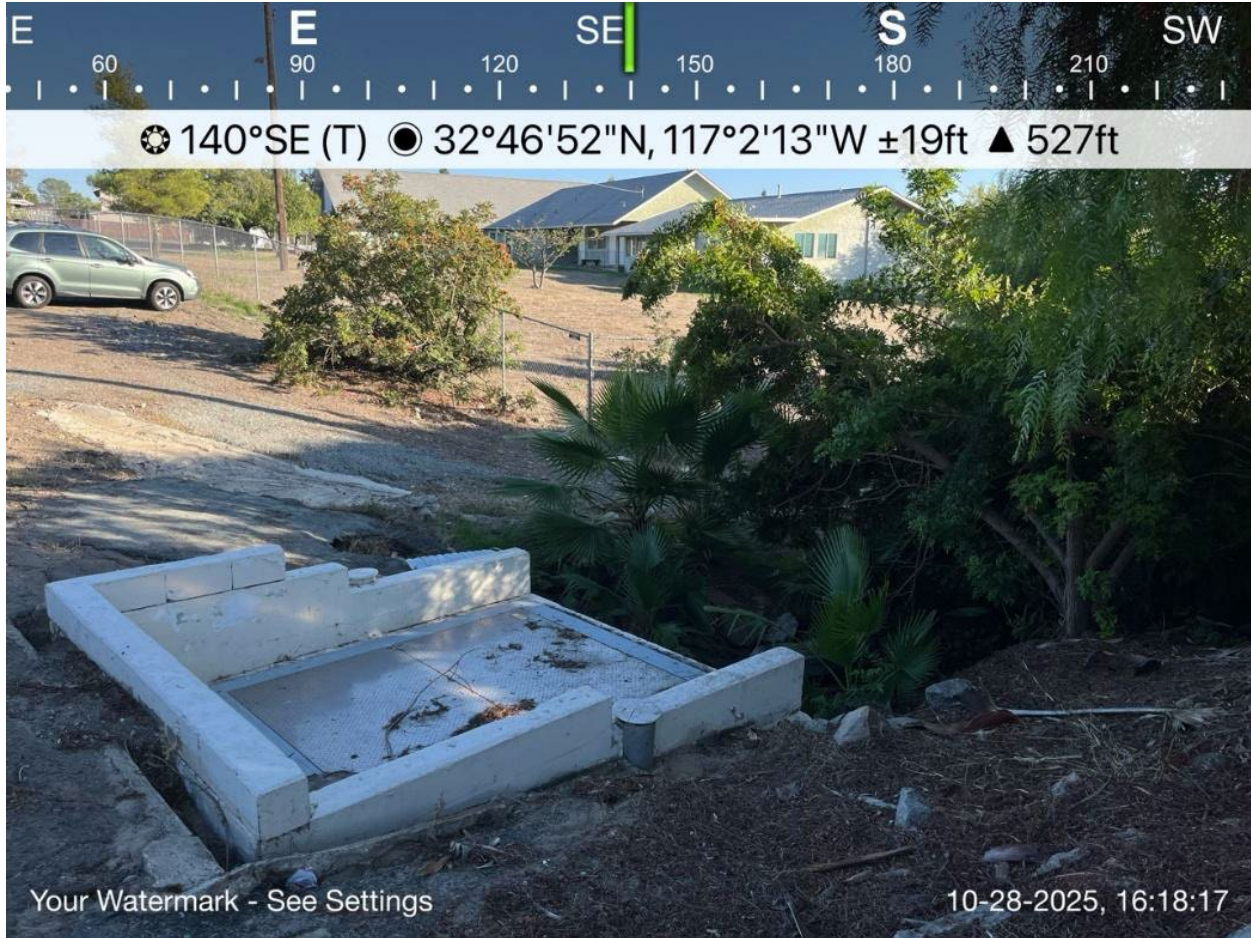
Photo 14. Work Location 644+21 and view of NWW-ALT-08; facing southeast. October 28, 2025.

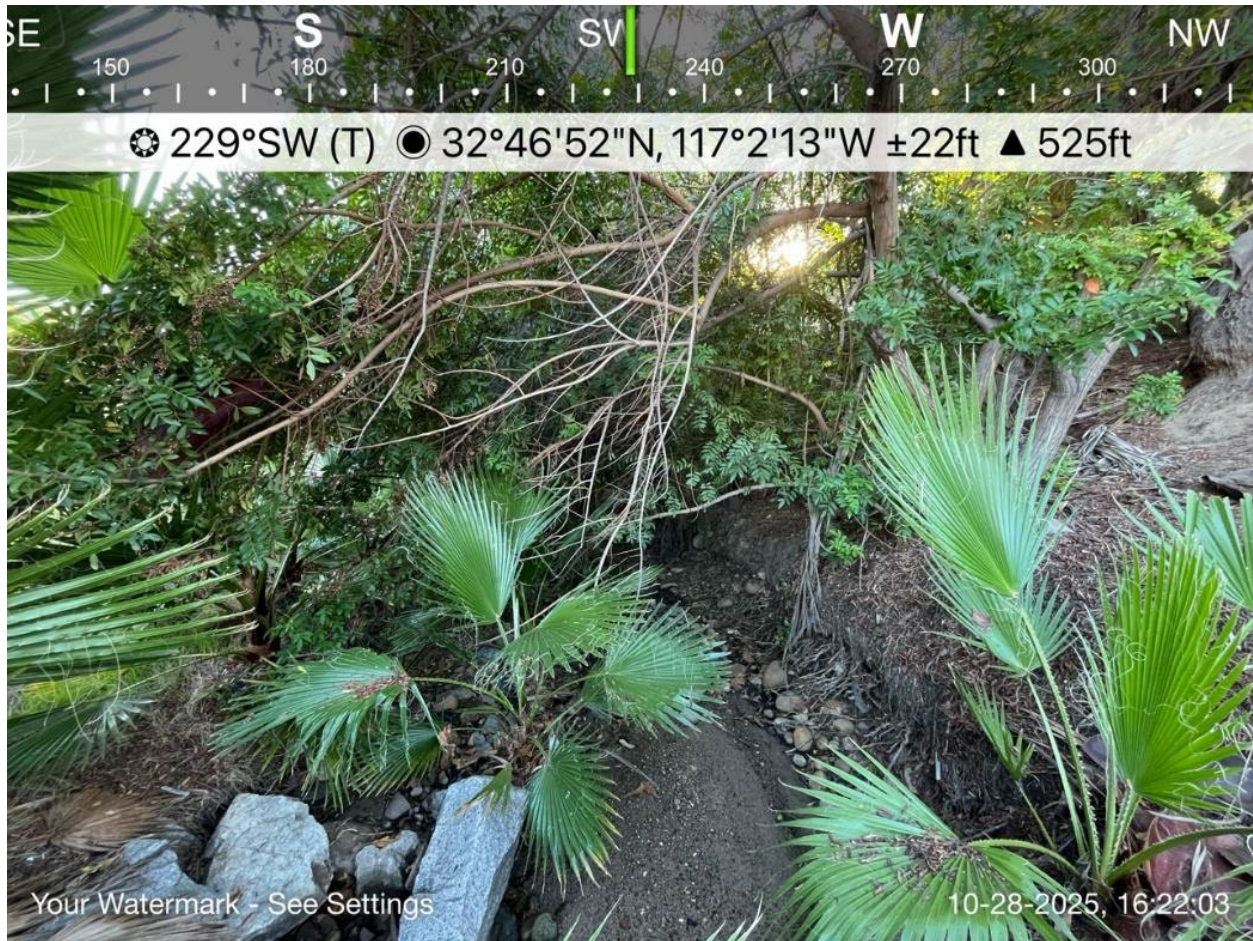
Photo 15. Work Location 644+21 and view downstream of NWW-ALT-08, facing southwest. October 28, 2025.
