AQUATIC RESOURCES DELINEATION REPORT

CITY OF SAN DIEGO – OTAY 2ND PIPELINE PHASE 4 PROJECT
(H207169)

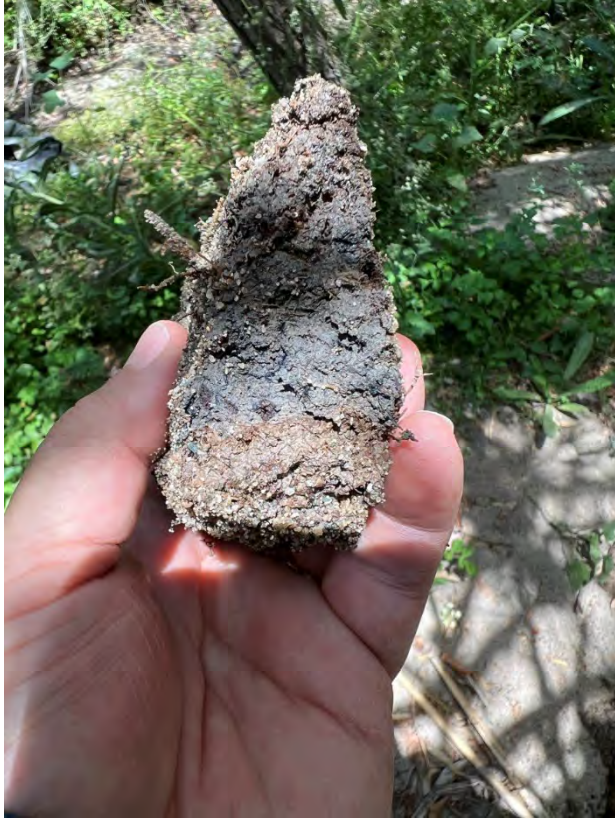
Photo 3: Slice of soil from wetland sample point #3 in the SWS showing moisture and redox indicators of a wetland soil (July 20, 2022).

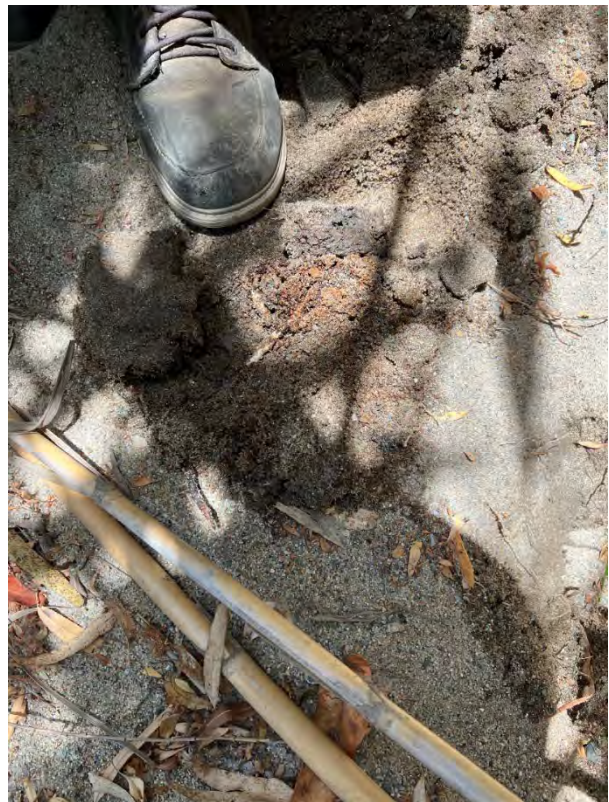
Photo 4: Wetland Sampling pit #3 (July 20, 2022)
