**AQUATIC RESOURCES DELINEATION REPORT FOR  
EL MONTE WATER TRANSMISSION PIPELINE  
REHABILITATION PROJECT  
CITY OF SAN DIEGO, CALIFORNIA**

**PROJECT NO.: 20203585.001A**

**FEBRUARY 2026**

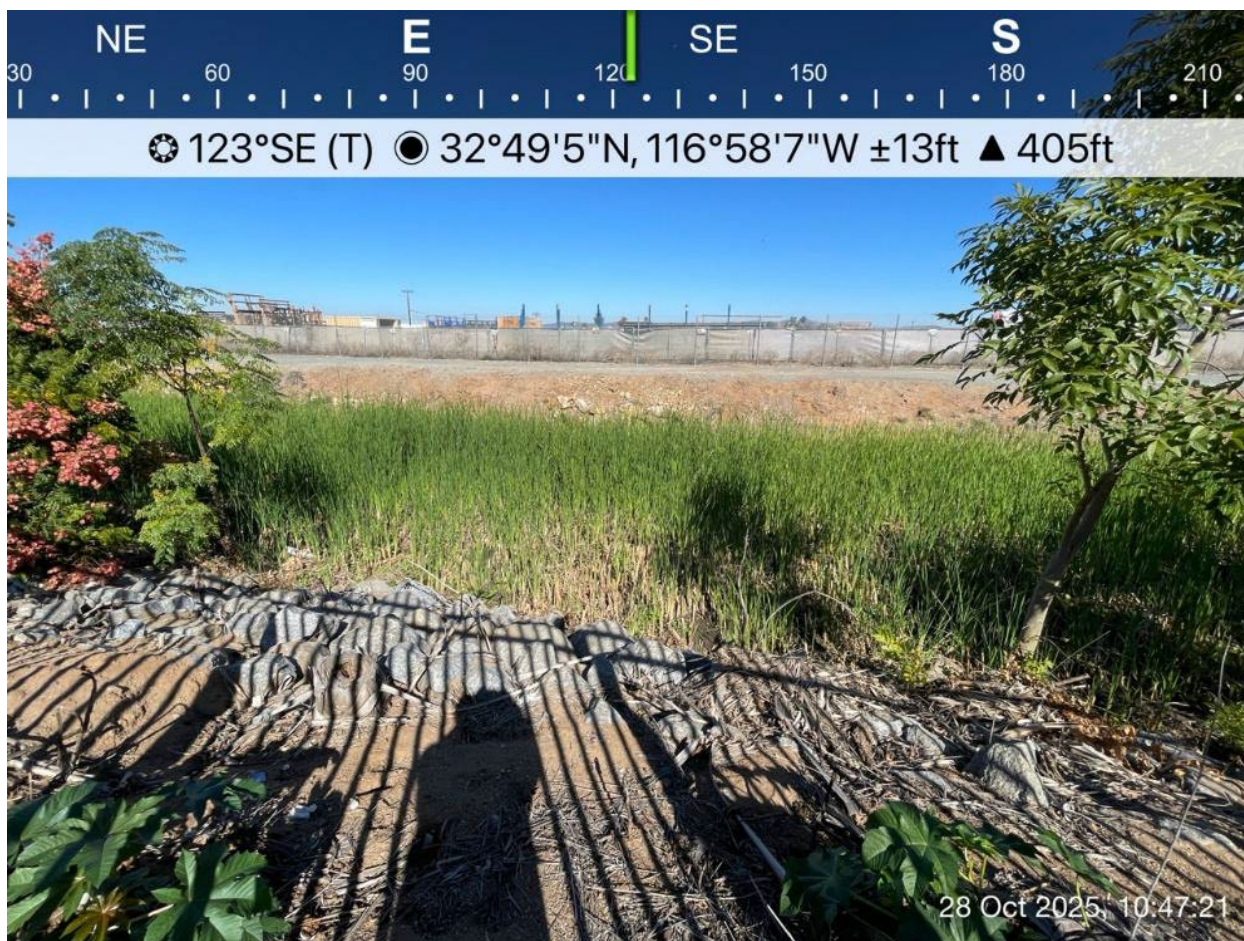
**Photo 1.** Work Location 345+20 and a view of NWW-ALT-01, a canal constructed between W Bradley Avenue and Floyd Smith Drive; facing southeast. October 28, 2025.

| Feature ID | Aquatic Resource Type | Cowardin Type | Latitude/ Longitude | OHWM Indicators | Acres WOTUS | Linear Feet | OHWM Width (Feet) |
|---|---|---|---|---|---|---|---|
| NWW-ALT-01 | Constructed canal/ditch | R4 | 32.817895°, -116.968495° | Break in slope on bank; mud cracks; vegetation absent to graminoids/ forbs; wracking/ presence of organic litter | 0.007 | 78.056 | 4 |

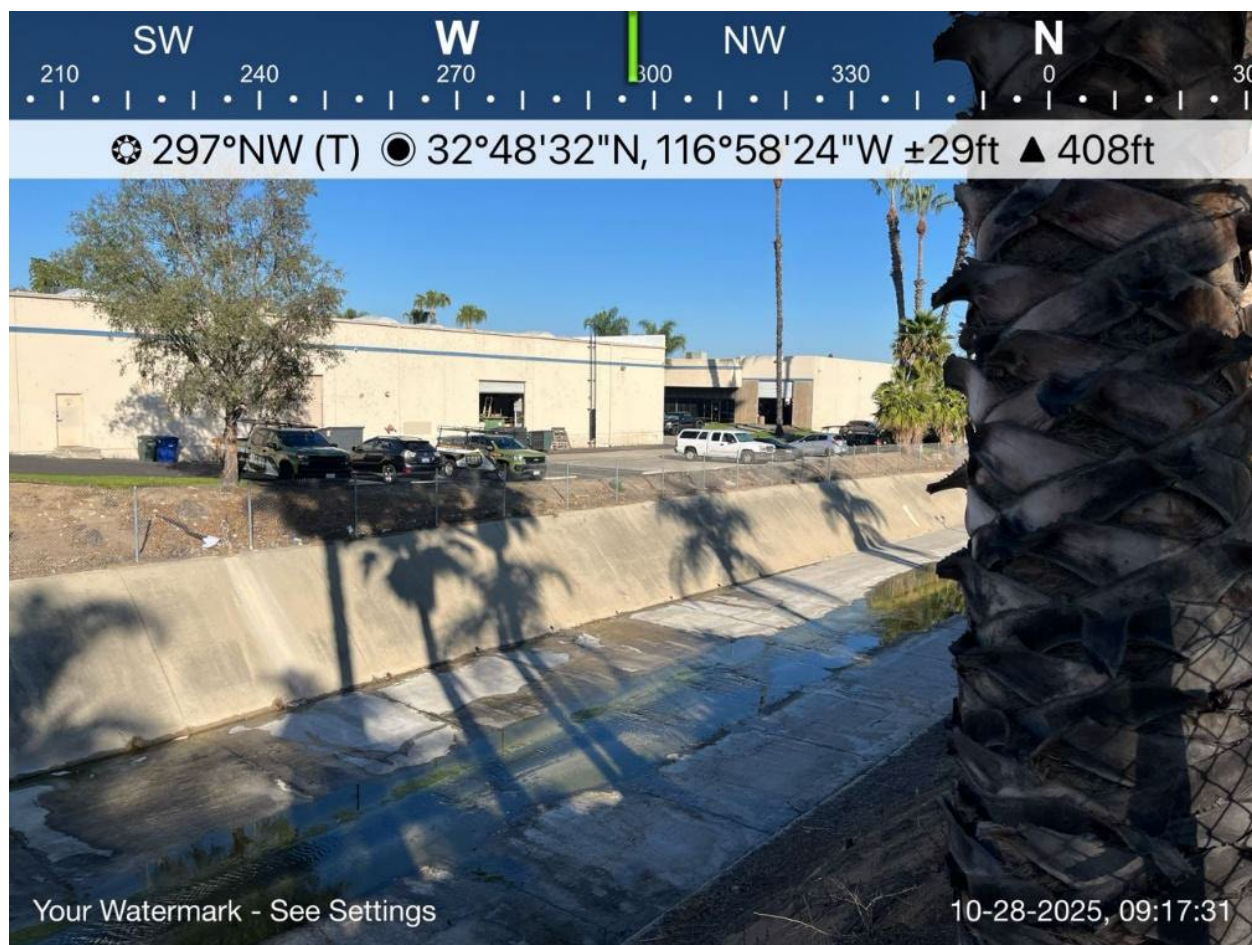
**Photo 2.** Work Location 380+15 and a view of NWW-ALT-02, a channelized waterway; facing west. October 28, 2025.

| Feature ID | Aquatic Resource Type | Cowardin Type | Latitude/ Longitude | OHWM Indicators | Acres WOTUS | Linear Feet | OHWM Width (Feet) |
|---|---|---|---|---|---|---|---|
| NWW-ALT-02 | Channel – natural, modified | R5 | 32.808428°, - 116.973703° | Break in slope on bank; water staining | 0.029 | 96.185 | 15 |

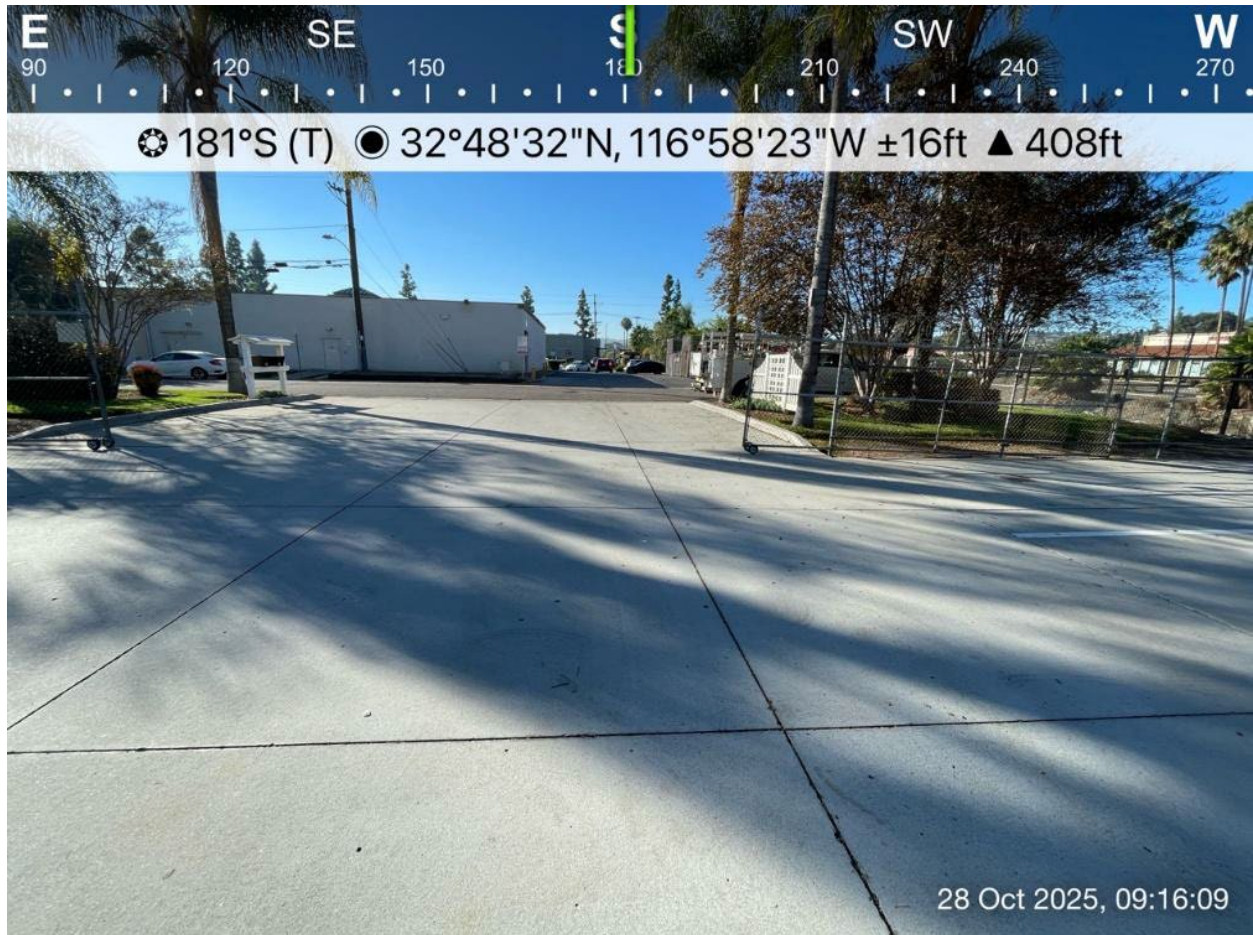
**Photo 3.** Work Location 380+15, facing south, away from NWW-ALT-02. October 28, 2025.

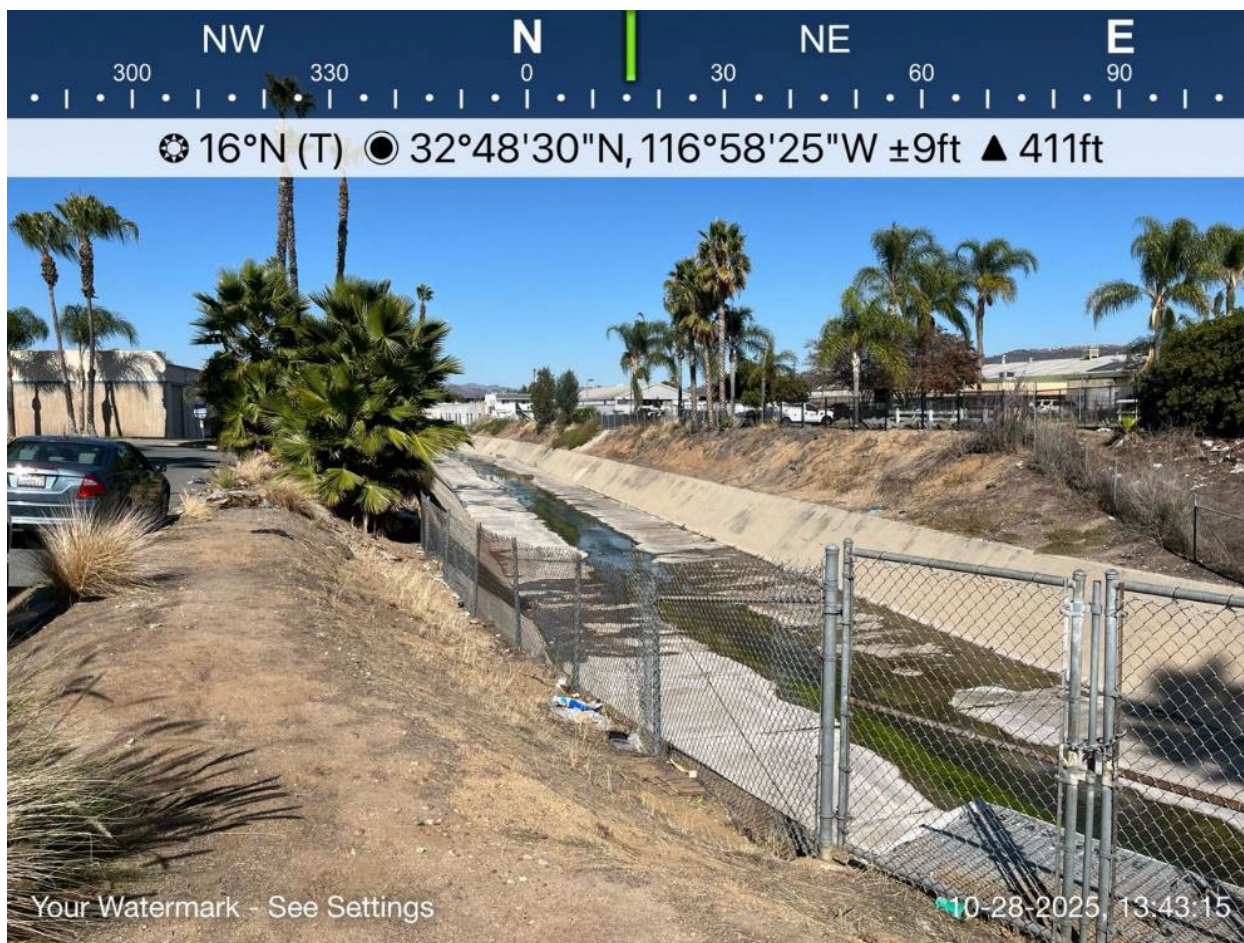
**Photo 4.** Work Location 382+78 and a view of NWW-ALT-02; facing north. October 28, 2025.

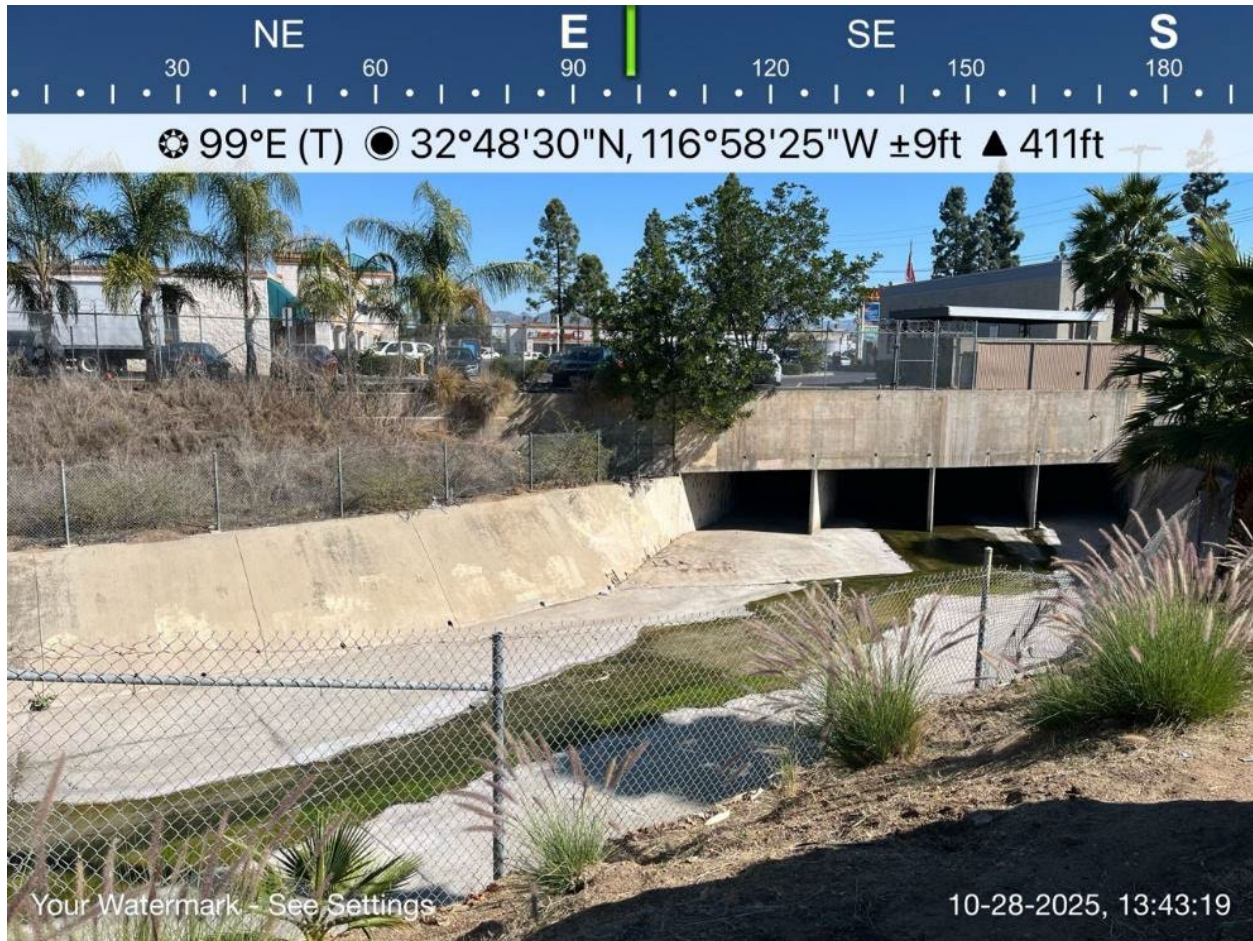
**Photo 5.** Work Location 382+78 and a view of NWW-ALT-02; facing east. October 28, 2025.

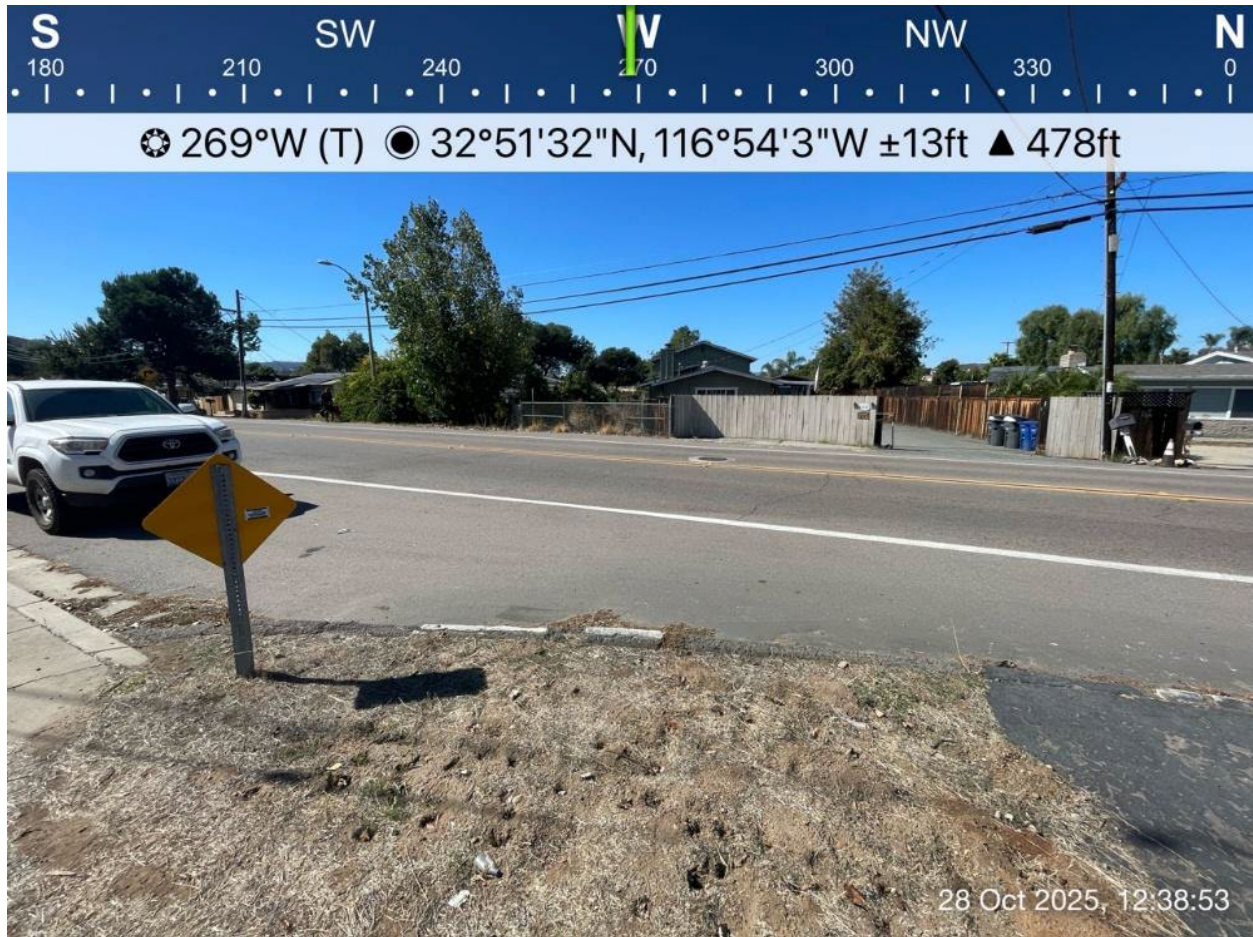
**Photo 7.** Work Location 40+29, with NWW-ALT-03 behind the photographer. View facing west. October 28, 2025.

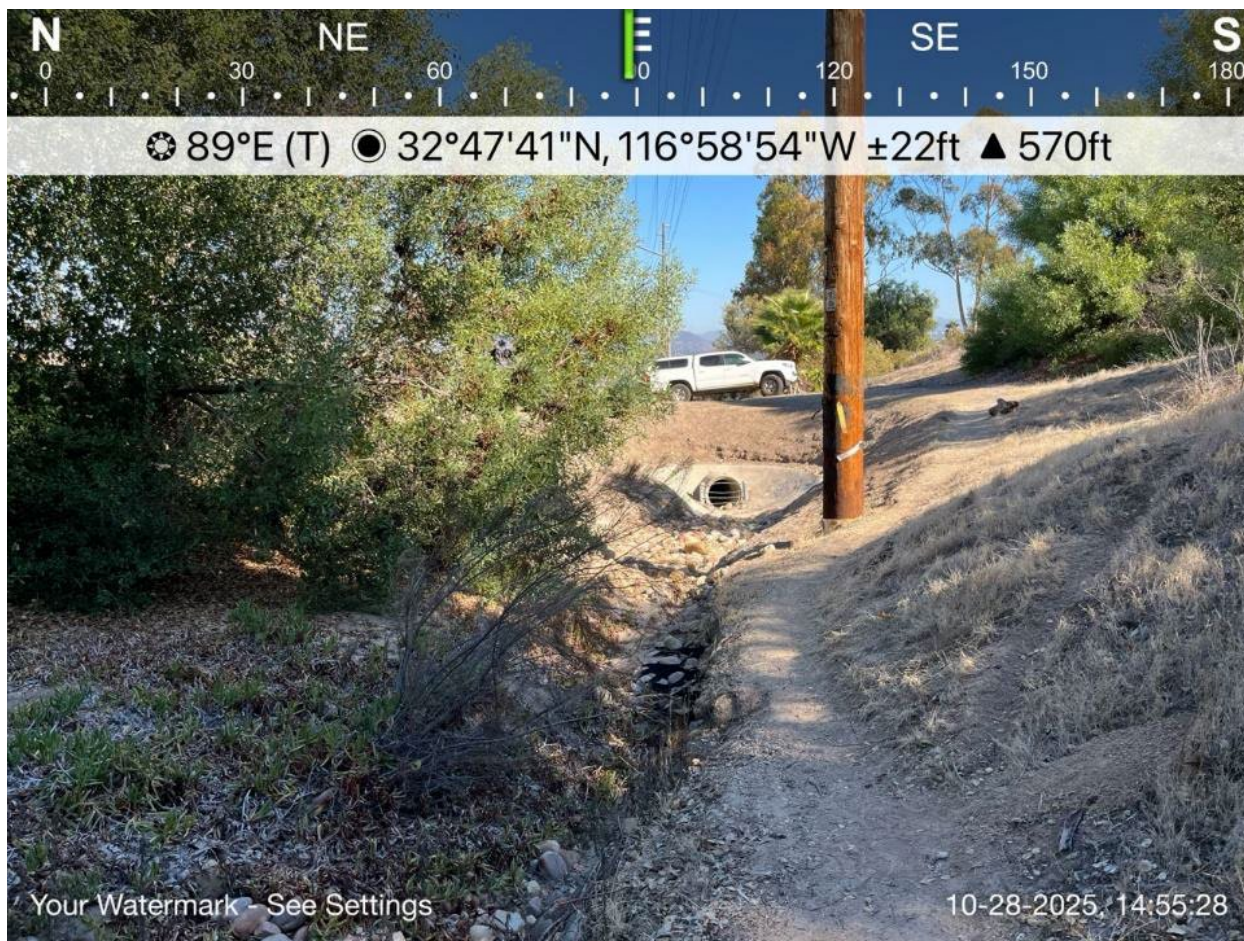
**Photo 8.** Work Location 439+20, NWW-ALT-04; view of culvert inlet that directs water from both NWW-ALT-04 and -05 into an underground stormwater system of pipes that are assumed to flow 0.75-miles to a channelized reach of Forester Creek; View facing east. October 28, 2025.

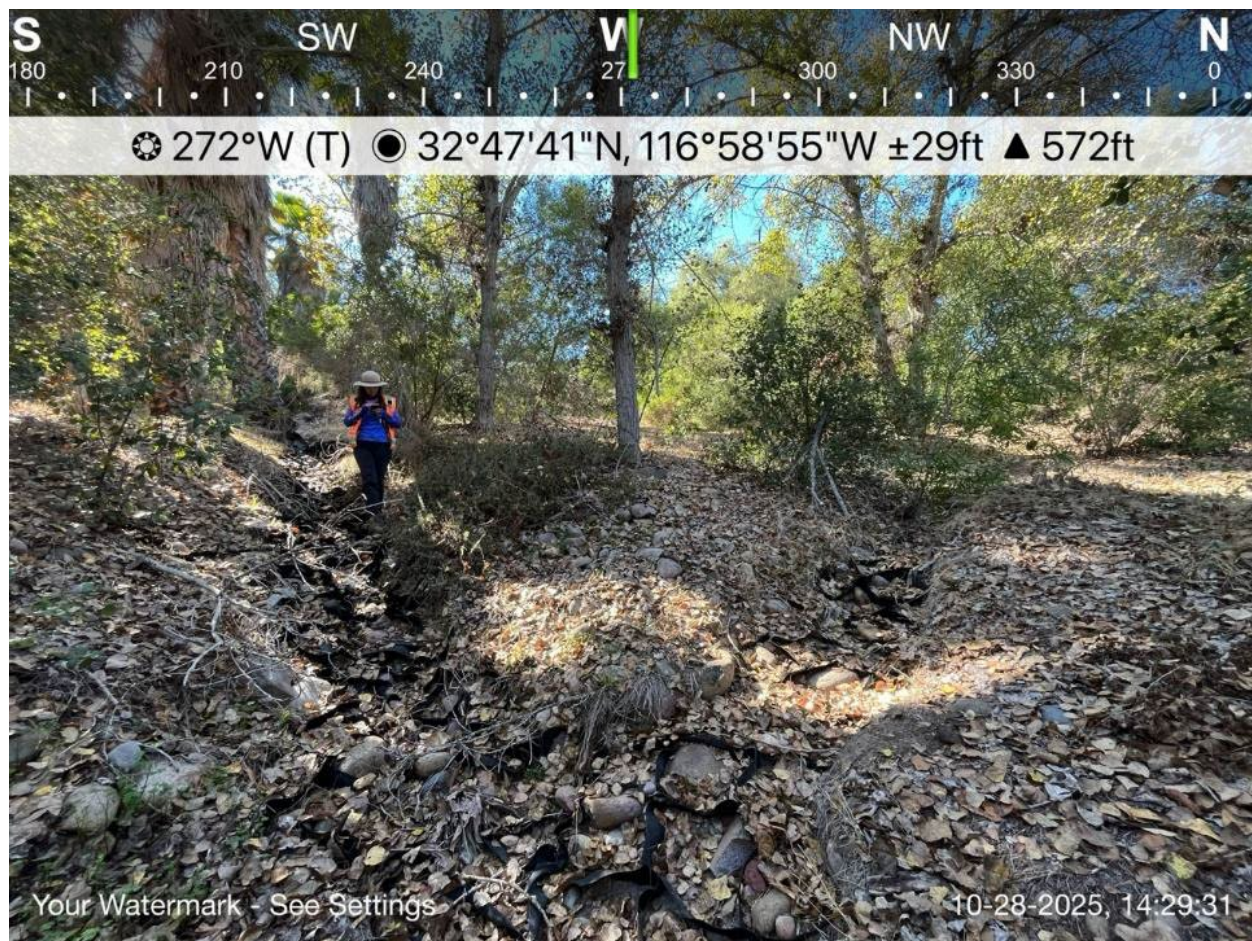
**Photo 9.** Work Location 439+20. Convergence of intermittent channel NWW-ALT-04 and ephemeral channel NWW-ALT-05; both provide surface flow connections to stormwater culverts. Note existing geogrid and rock installed to reduce erosion. View facing west. October 28, 2025.

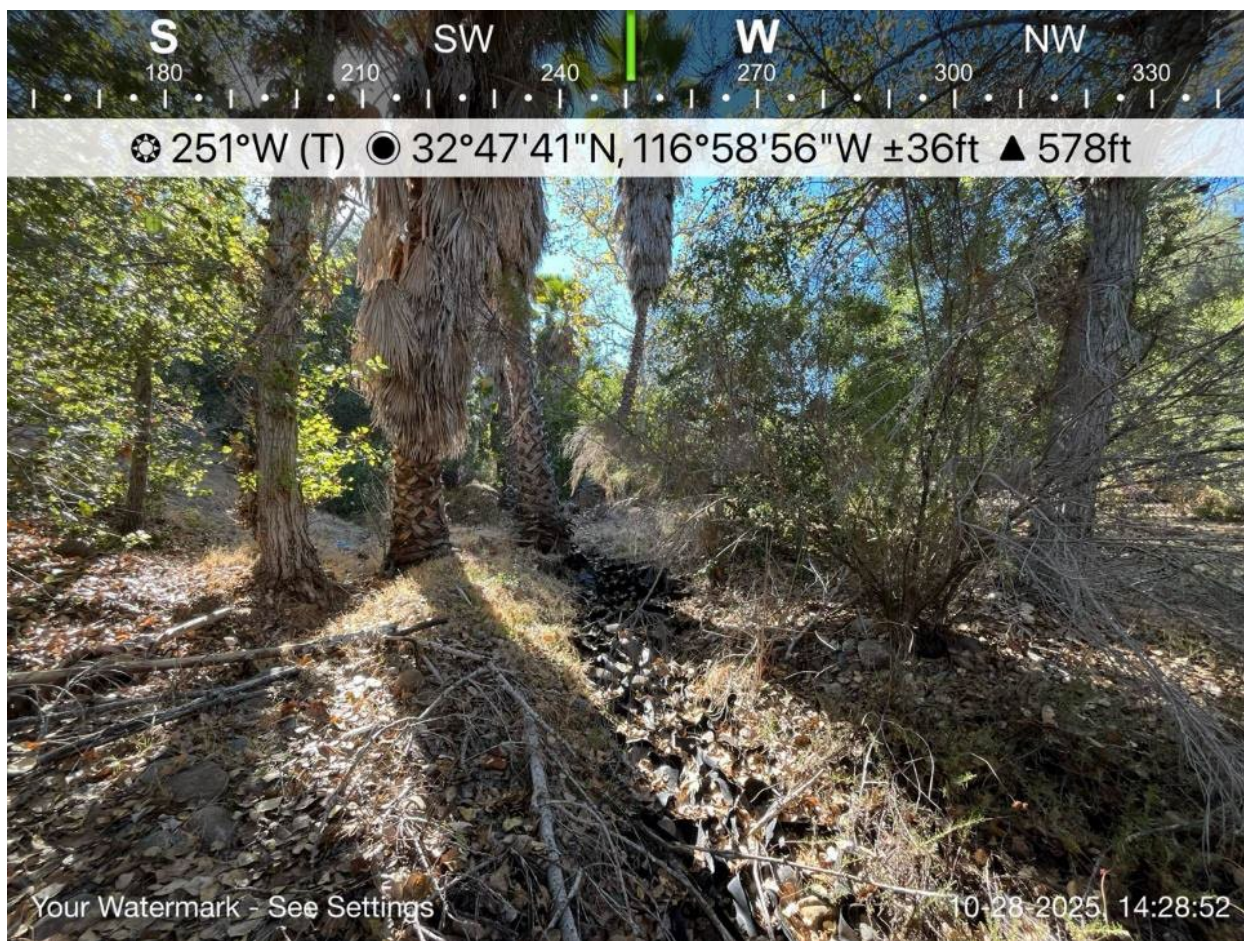
**Photo 10.** Work Location 439+20. NWW-ALT-04 is an intermittent channel aligned along a hillside between a culvert outfall under West Main Street and another stormwater culvert (Photo 9). View facing west by southwest. October 28, 2025.

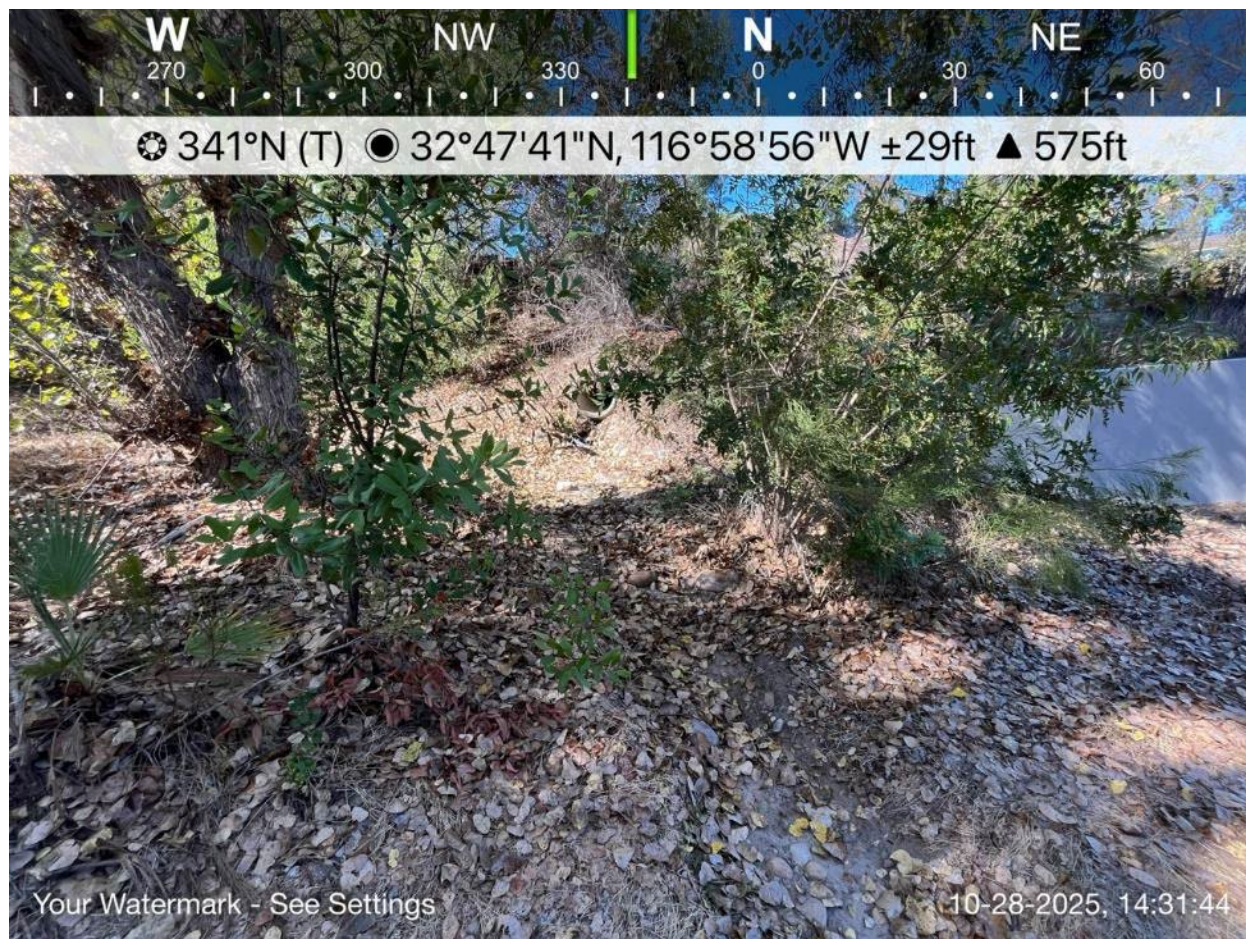
**Photo 11.** Work Location 439+20, NWW-ALT-05, an ephemeral channel aligned between culvert outfall under West Main Street and flowing toward NWW-ALT-04; facing north. October 28, 2025.

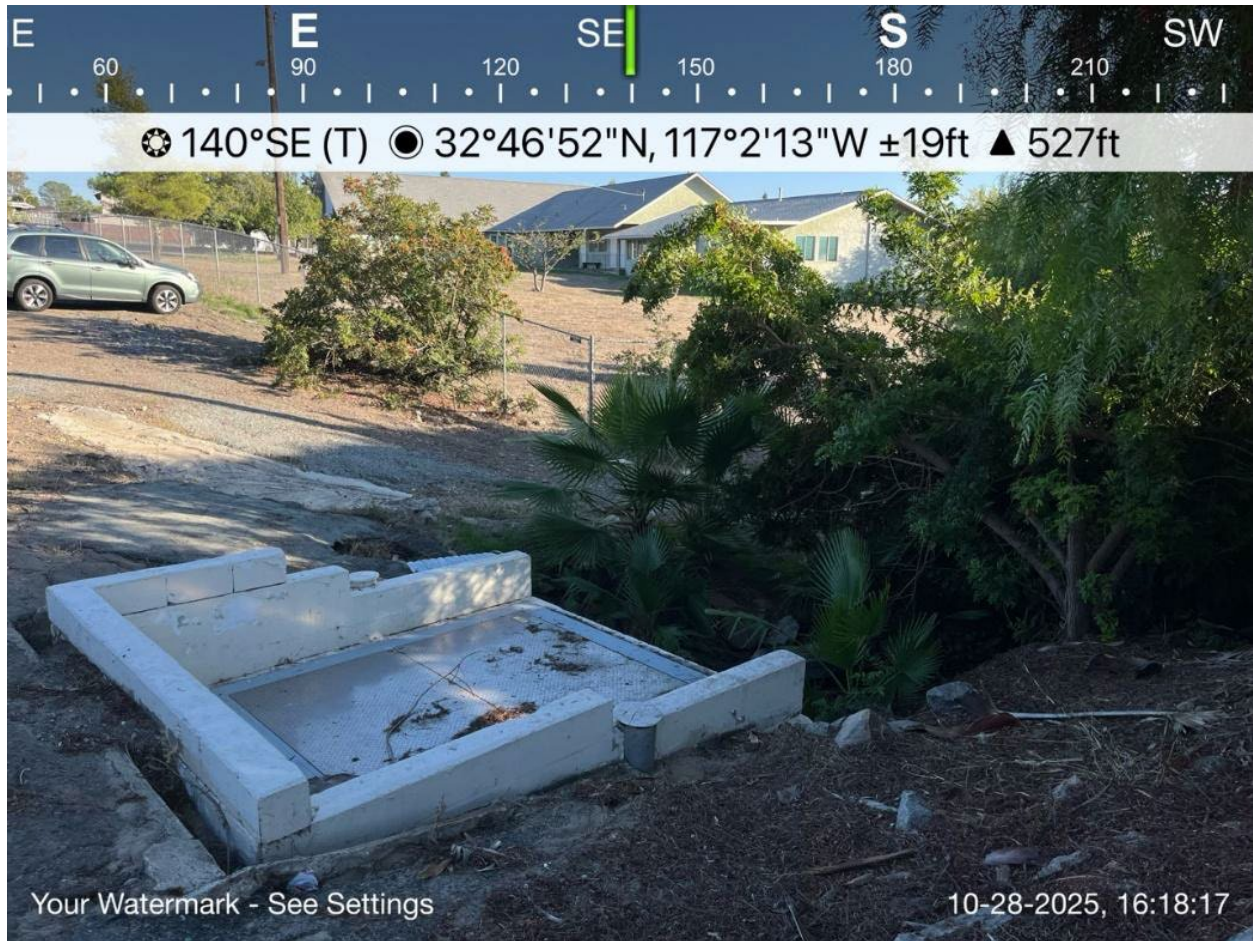
**Photo 14.** Work Location 644+21 and view of NWW-ALT-08; facing southeast. October 28, 2025.
