FINAL EL CUERVO DEL SUR WETLAND HABITAT MITIGATION AND MONITORING PLAN

City of San Diego
Transportation & Storm Water Department
2781 Caminito Chollas
San Diego, CA 92105

February 28, 2014

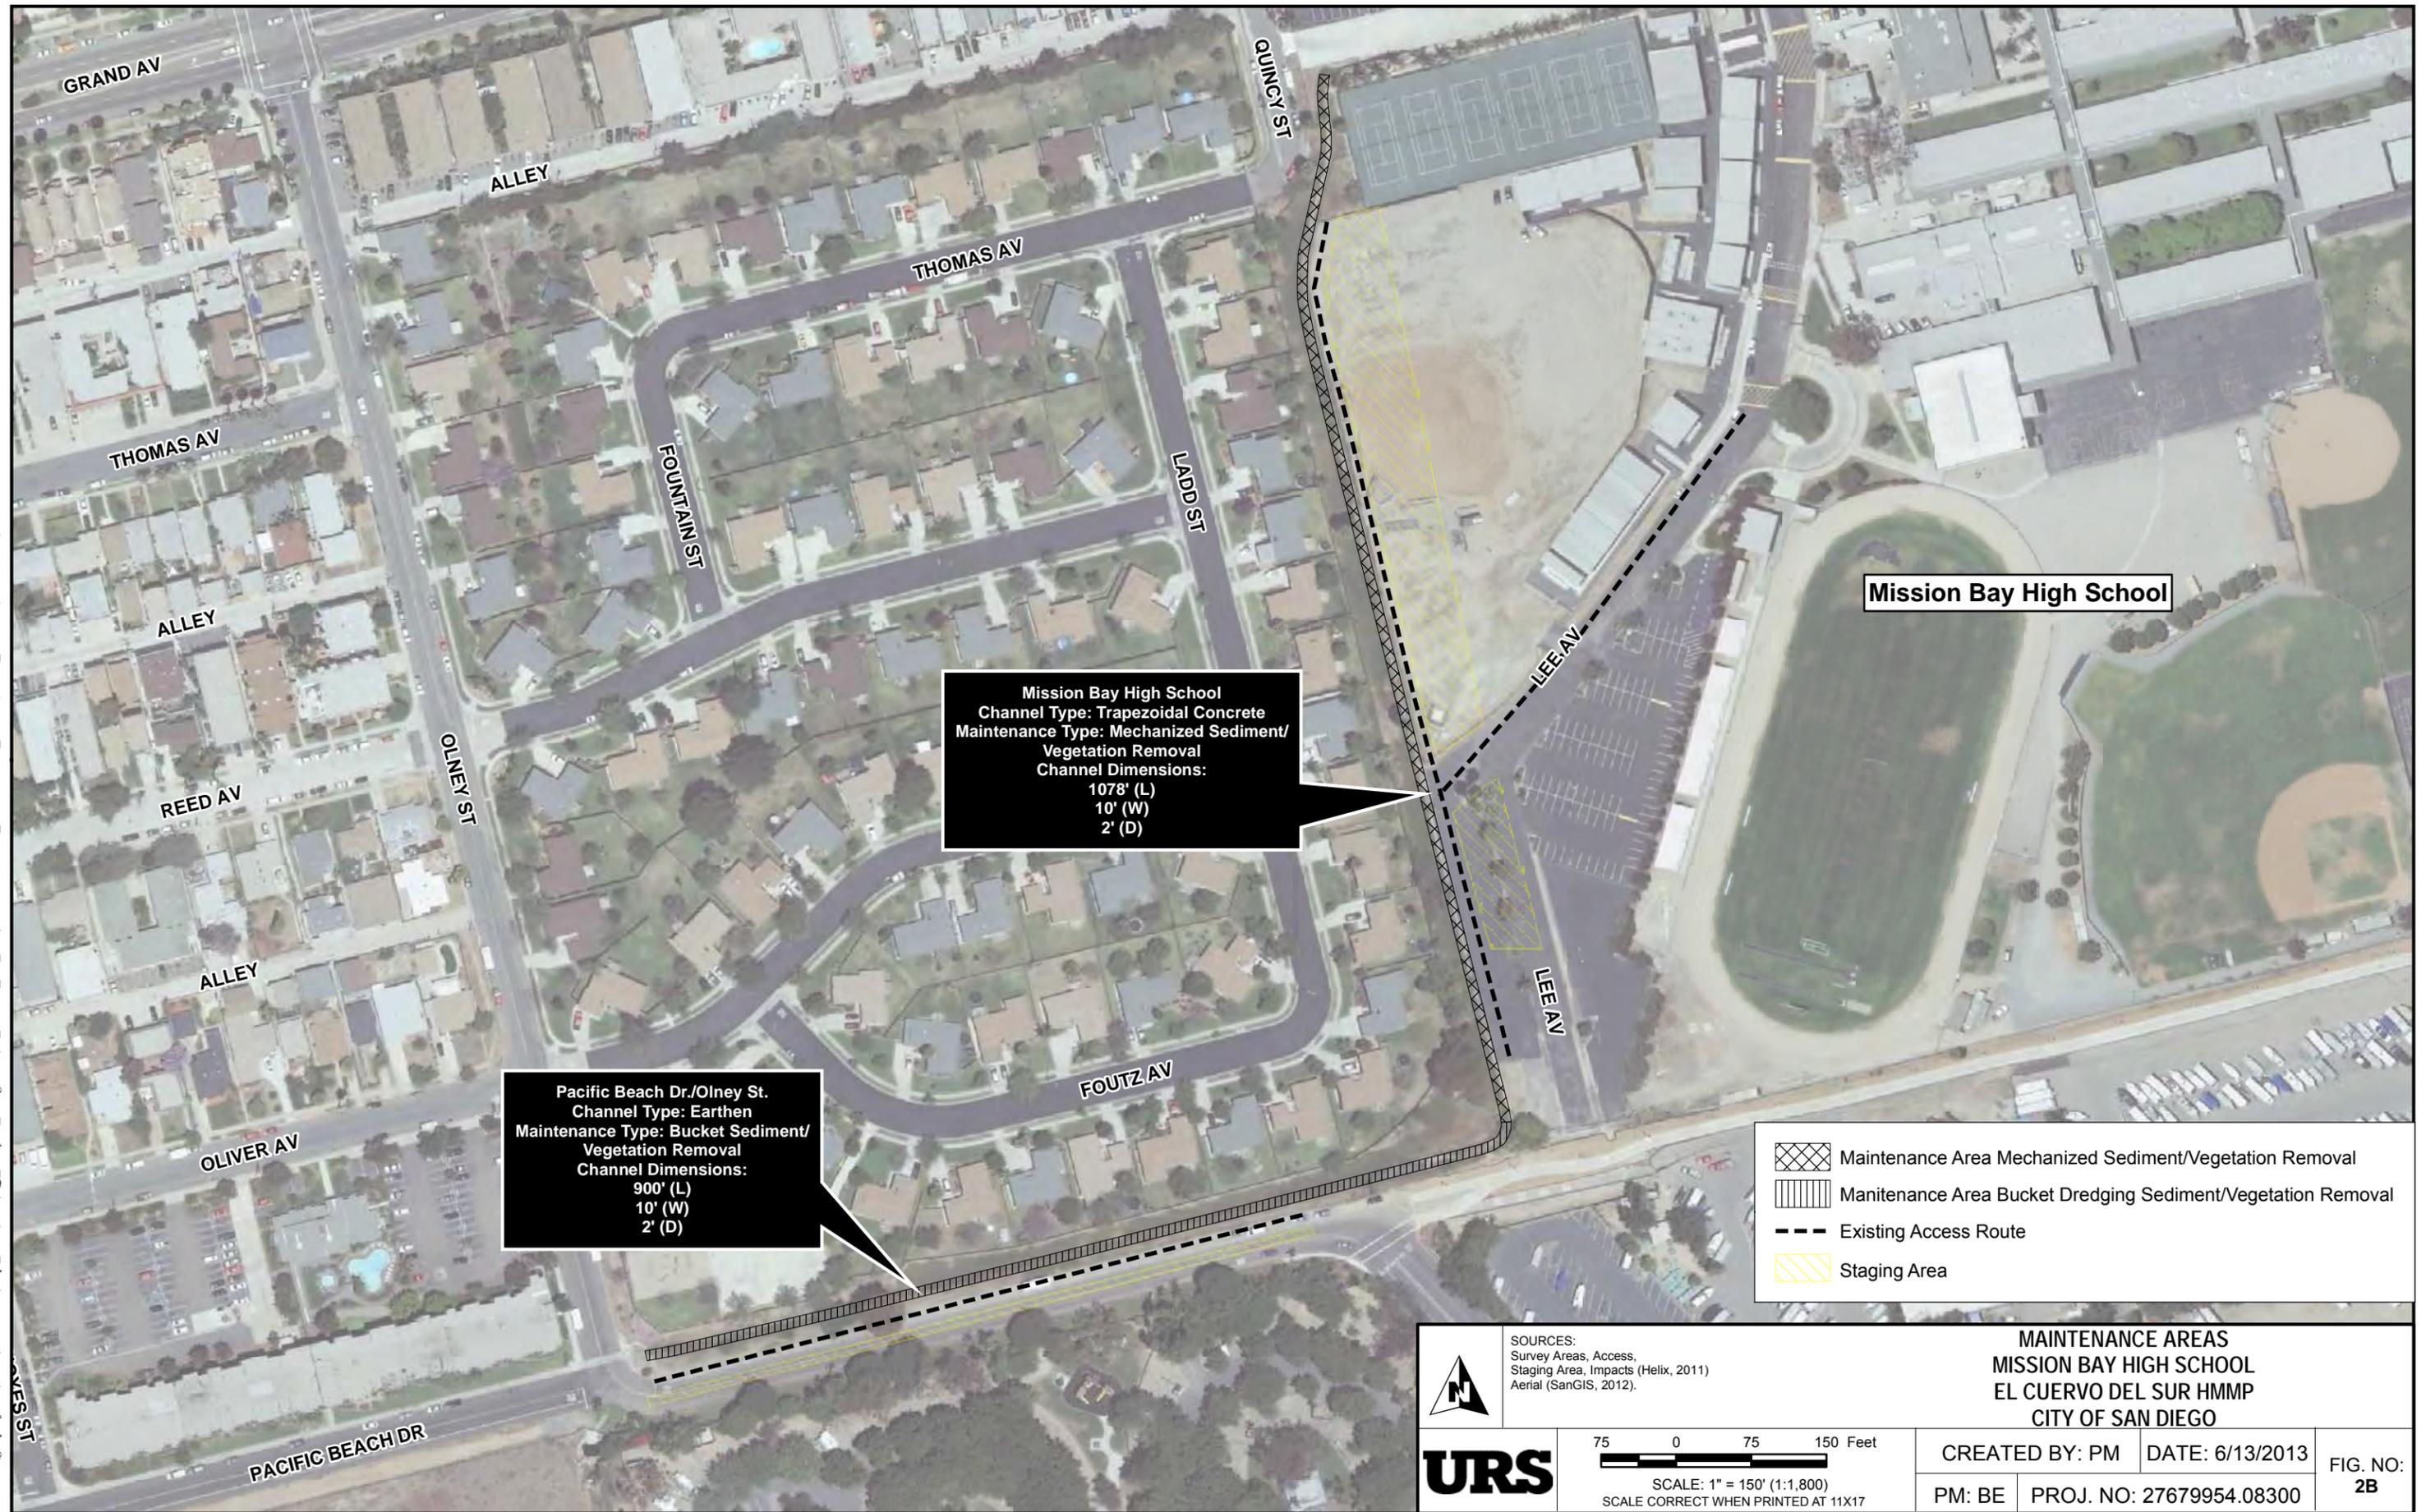
Mission Bay High School
Channel Type: Trapezoidal Concrete
Maintenance Type: Mechanized Sediment/
Vegetation Removal
Channel Dimensions:
1078' (L)
10' (W)
2' (D)

Pacific Beach Dr./Olney St.
Channel Type: Earthen
Maintenance Type: Bucket Sediment/
Vegetation Removal
Channel Dimensions:
900' (L)
10' (W)
2' (D)

The flood control channels that comprise the Mission Bay High School channel maintenance project have been found to support freshwater marsh and non-native grass species in the past. The small overall area of these channels, combined with their linear configuration and urbanized location limits the function and services of any vegetation that grows here, such that these areas would not qualify as wetlands or non-native grassland, pursuant to the City of San Diego's Land Development Code, Biology Guidelines (Dudek 2012). These channels do not support typical functions and services because the plants here grow on accumulated sediment approximately four to six inches in depth. The vegetation is not large enough in

The Pacific Beach Drive/Olney Street flood control channel supports freshwater marsh and non-native grass species. Freshwater marsh with the earthen bottom section of this channel, although limited in function and services provided, does have the potential to be classified as freshwater marsh pursuant to the City of San Diego's Land Development Code (Dudek 2012) and provides habitat for wildlife, including potential nesting and foraging songbirds and small mammals. Despite the limited functions and services of this channel, impacts will be mitigated in accordance with the conditions outlined in the CDP issued for the Master Maintenance Program (CCC 2012) at the ratios described in Section 1.2.2 above.

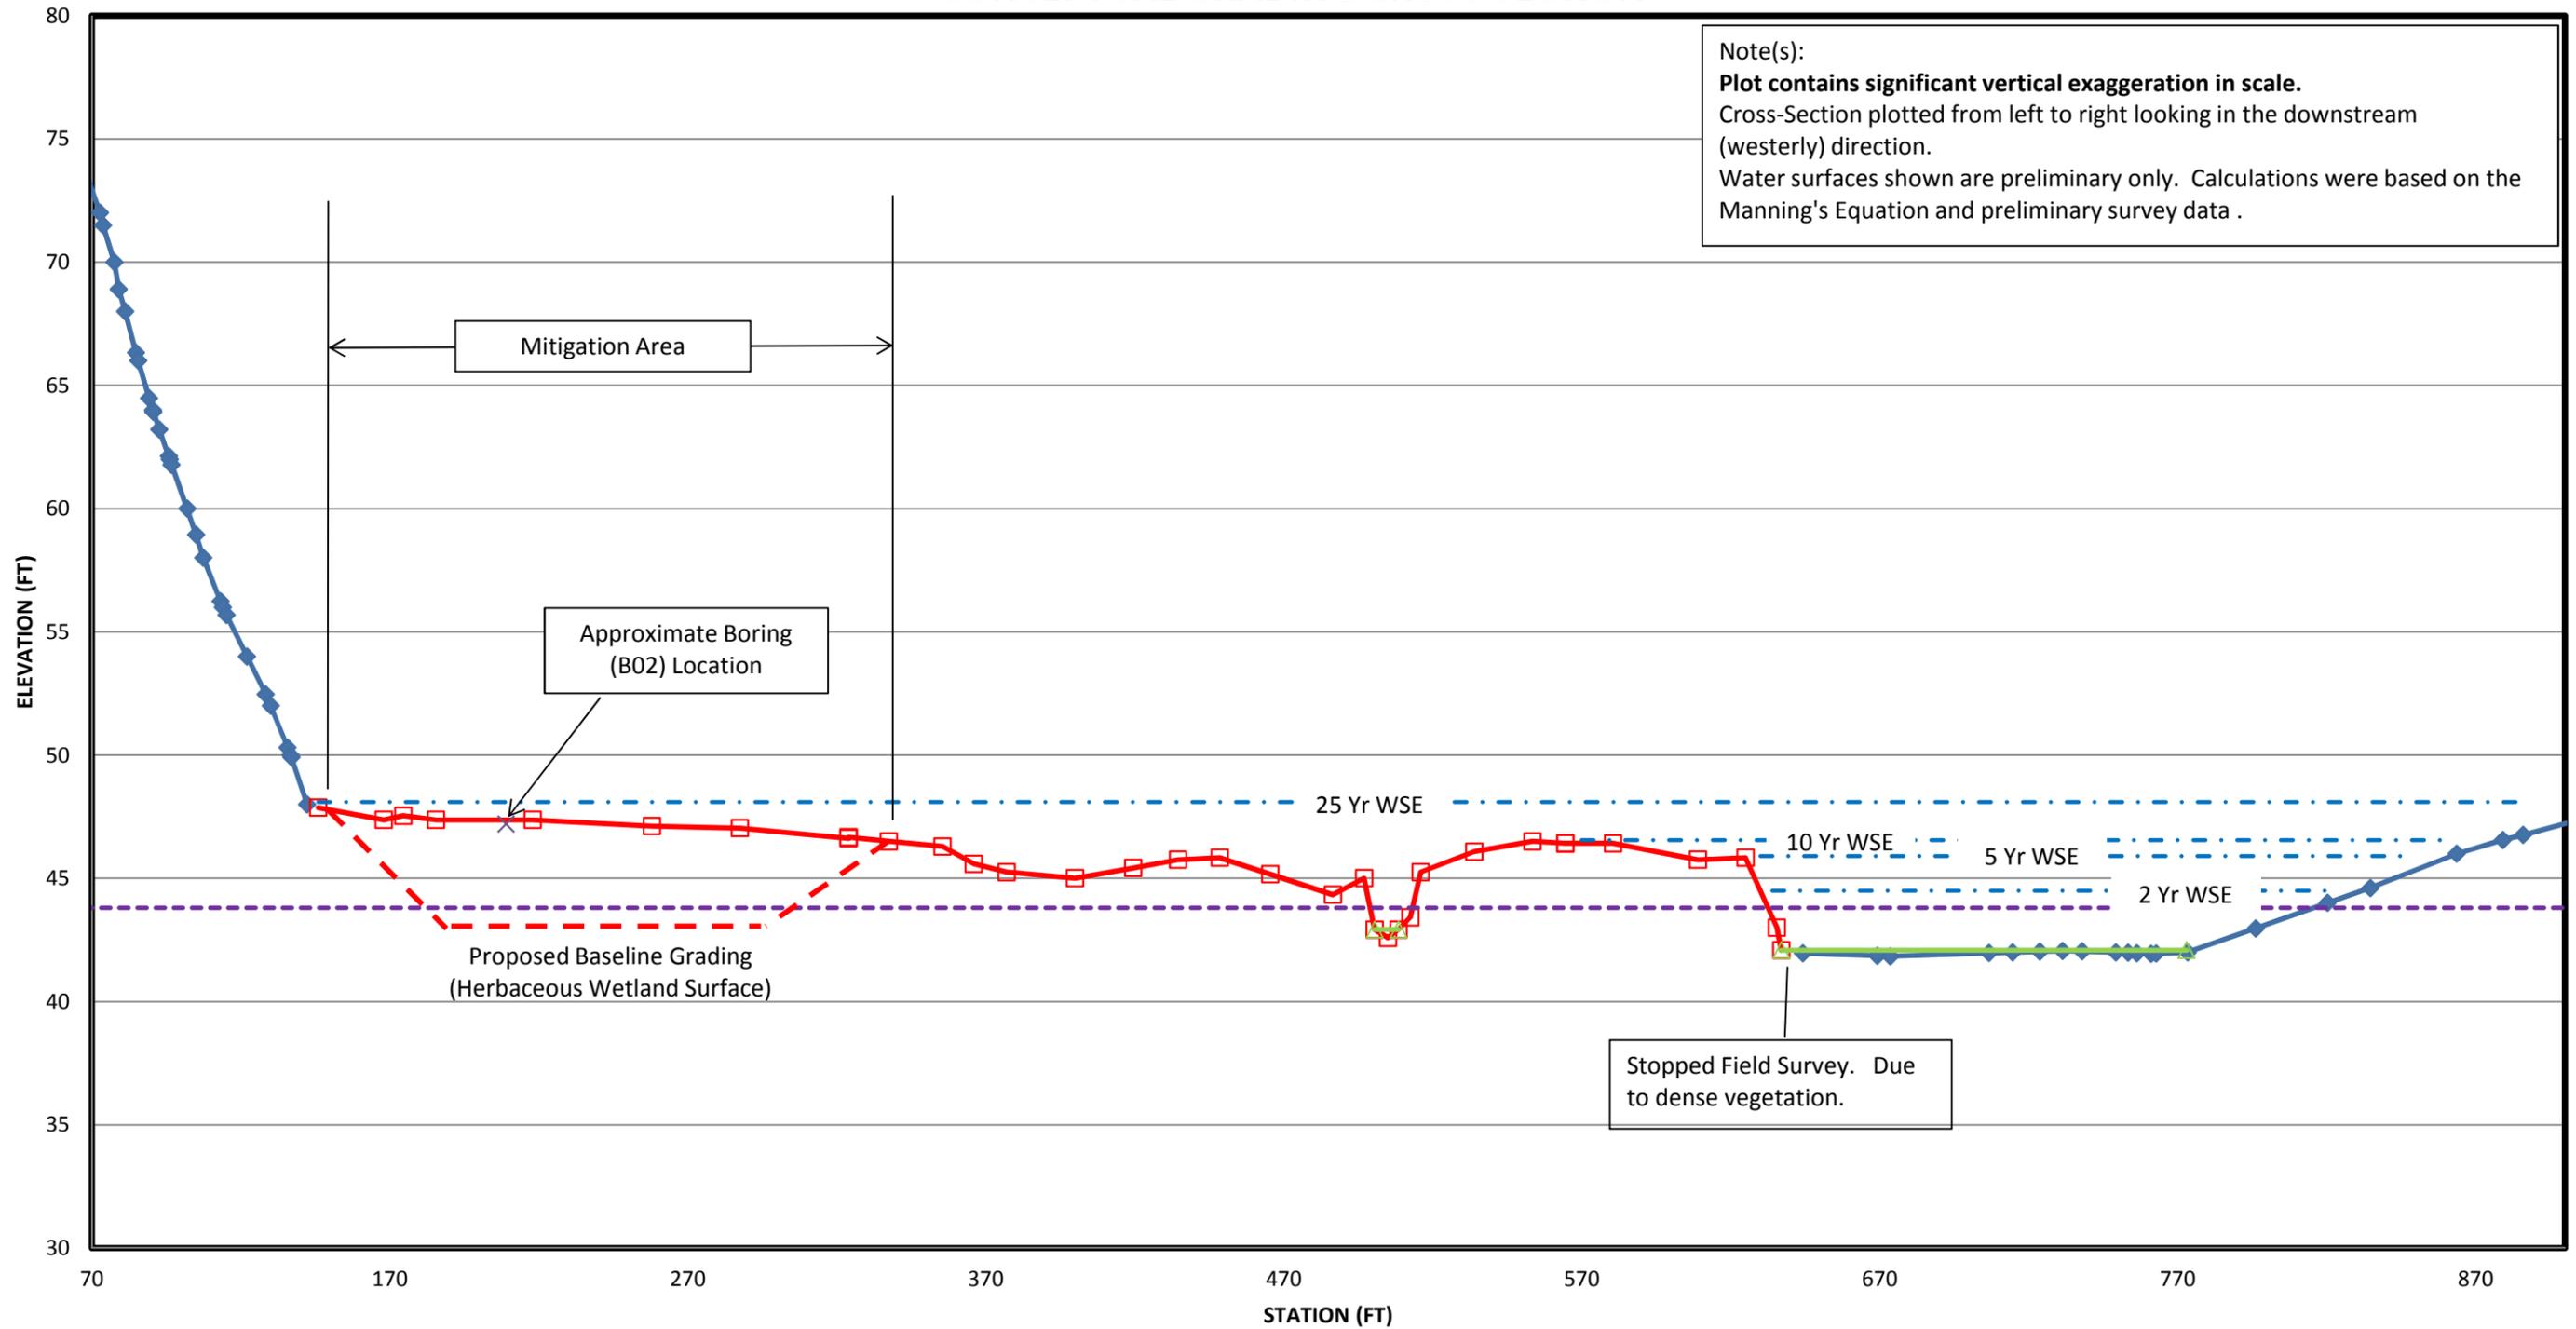
**FIGURE 7. LOS PENASQUITOS CREEK
EL CUERVO DEL SUR
CONCEPTUAL GRADING CROSS-SECTION**

◆ Existing 2-Ft Contour
 ■ Field Survey Existing Ground
 ▲ Surveyed Water Surface Elevation
 - - - Winter High Water Mark (March 2013)
— Storm Event Water Surface Elevation

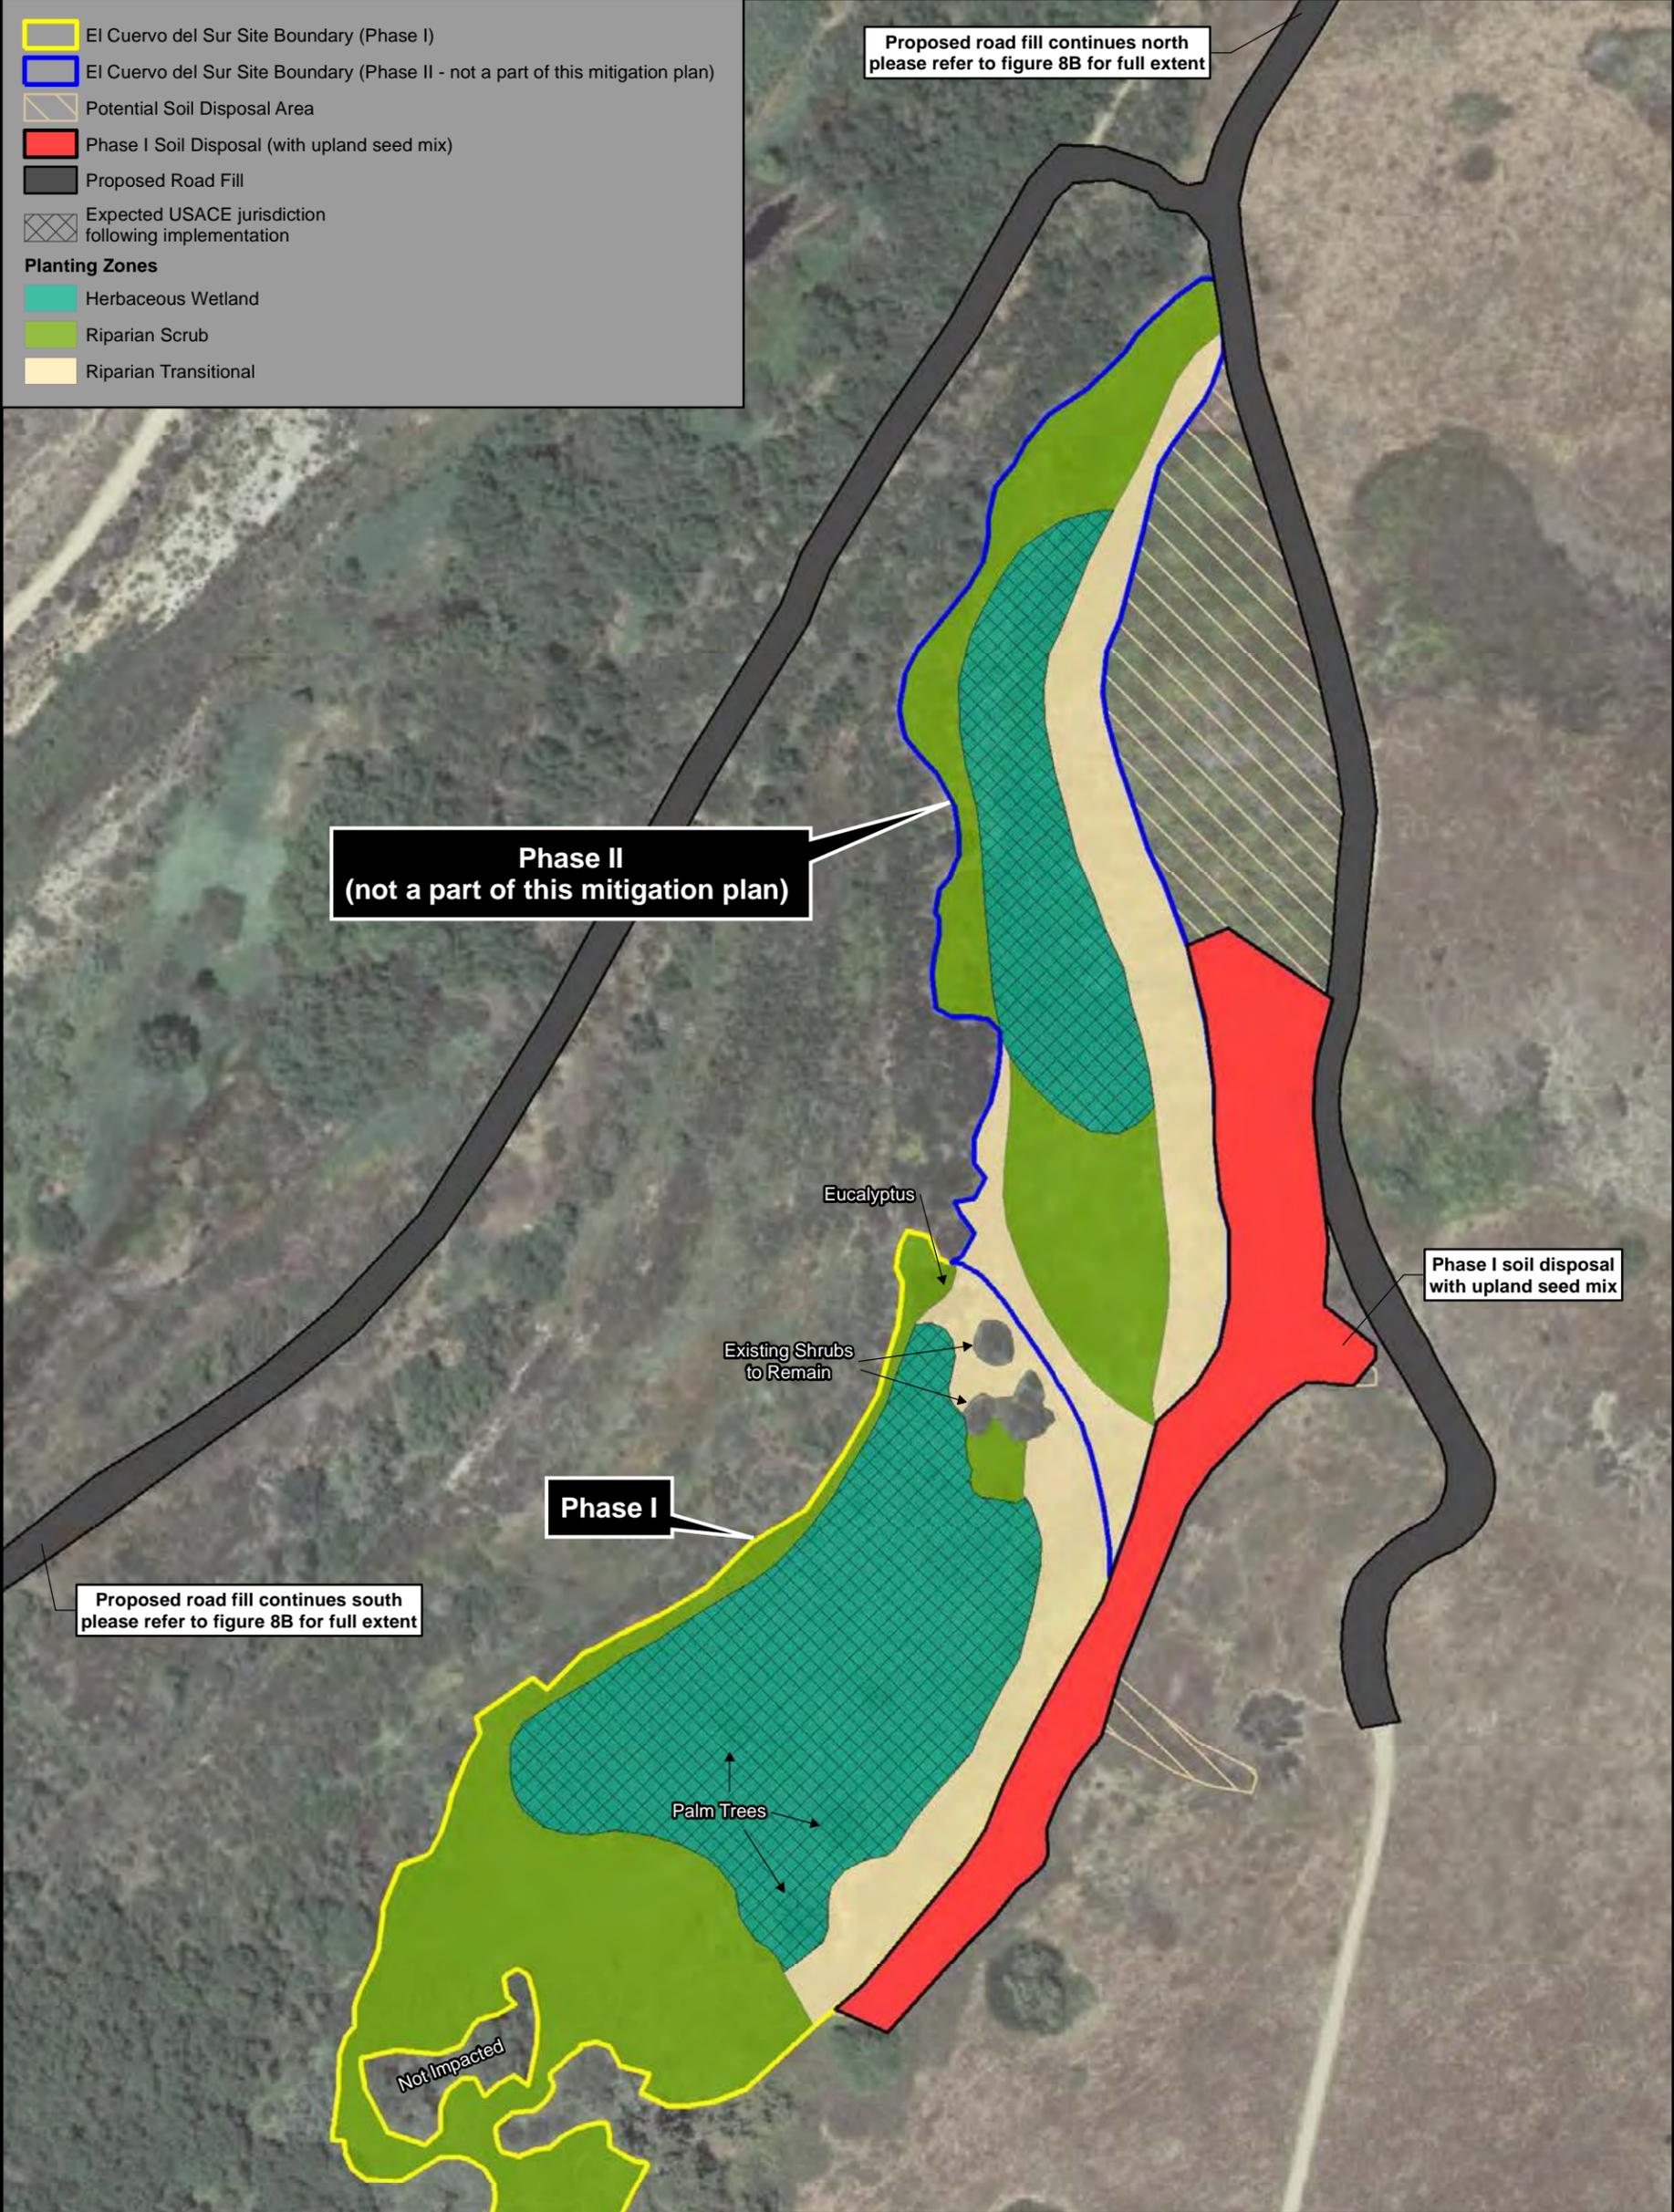
El Cuervo del Sur Site Boundary (Phase I)
 El Cuervo del Sur Site Boundary (Phase II - not a part of this mitigation plan)
 Potential Soil Disposal Area
 Phase I Soil Disposal (with upland seed mix)
 Proposed Road Fill
 Expected USACE jurisdiction following implementation
Planting Zones
 Herbaceous Wetland
 Riparian Scrub
 Riparian Transitional

Planting Zones	Phase I	Phase II
Herbaceous Wetland	1.00	0.41
Riparian Scrub	0.94	0.55
Riparian Transitional	0.36	0.46
Total	2.30 acres	1.42 acres

The goal of the mitigation conceptual design for this Site is to establish wetlands on a currently non-wetland area. The Site has been broken down into two phases (Figure 8). Phase I will completely cover the current mitigation needs (Table 5) and is addressed in this mitigation plan. Phase II is not proposed at this time but could be implemented later under a subsequent HMMP to cover future mitigation needs. The requirements, specifications, and provisions of this plan apply only to Phase I.

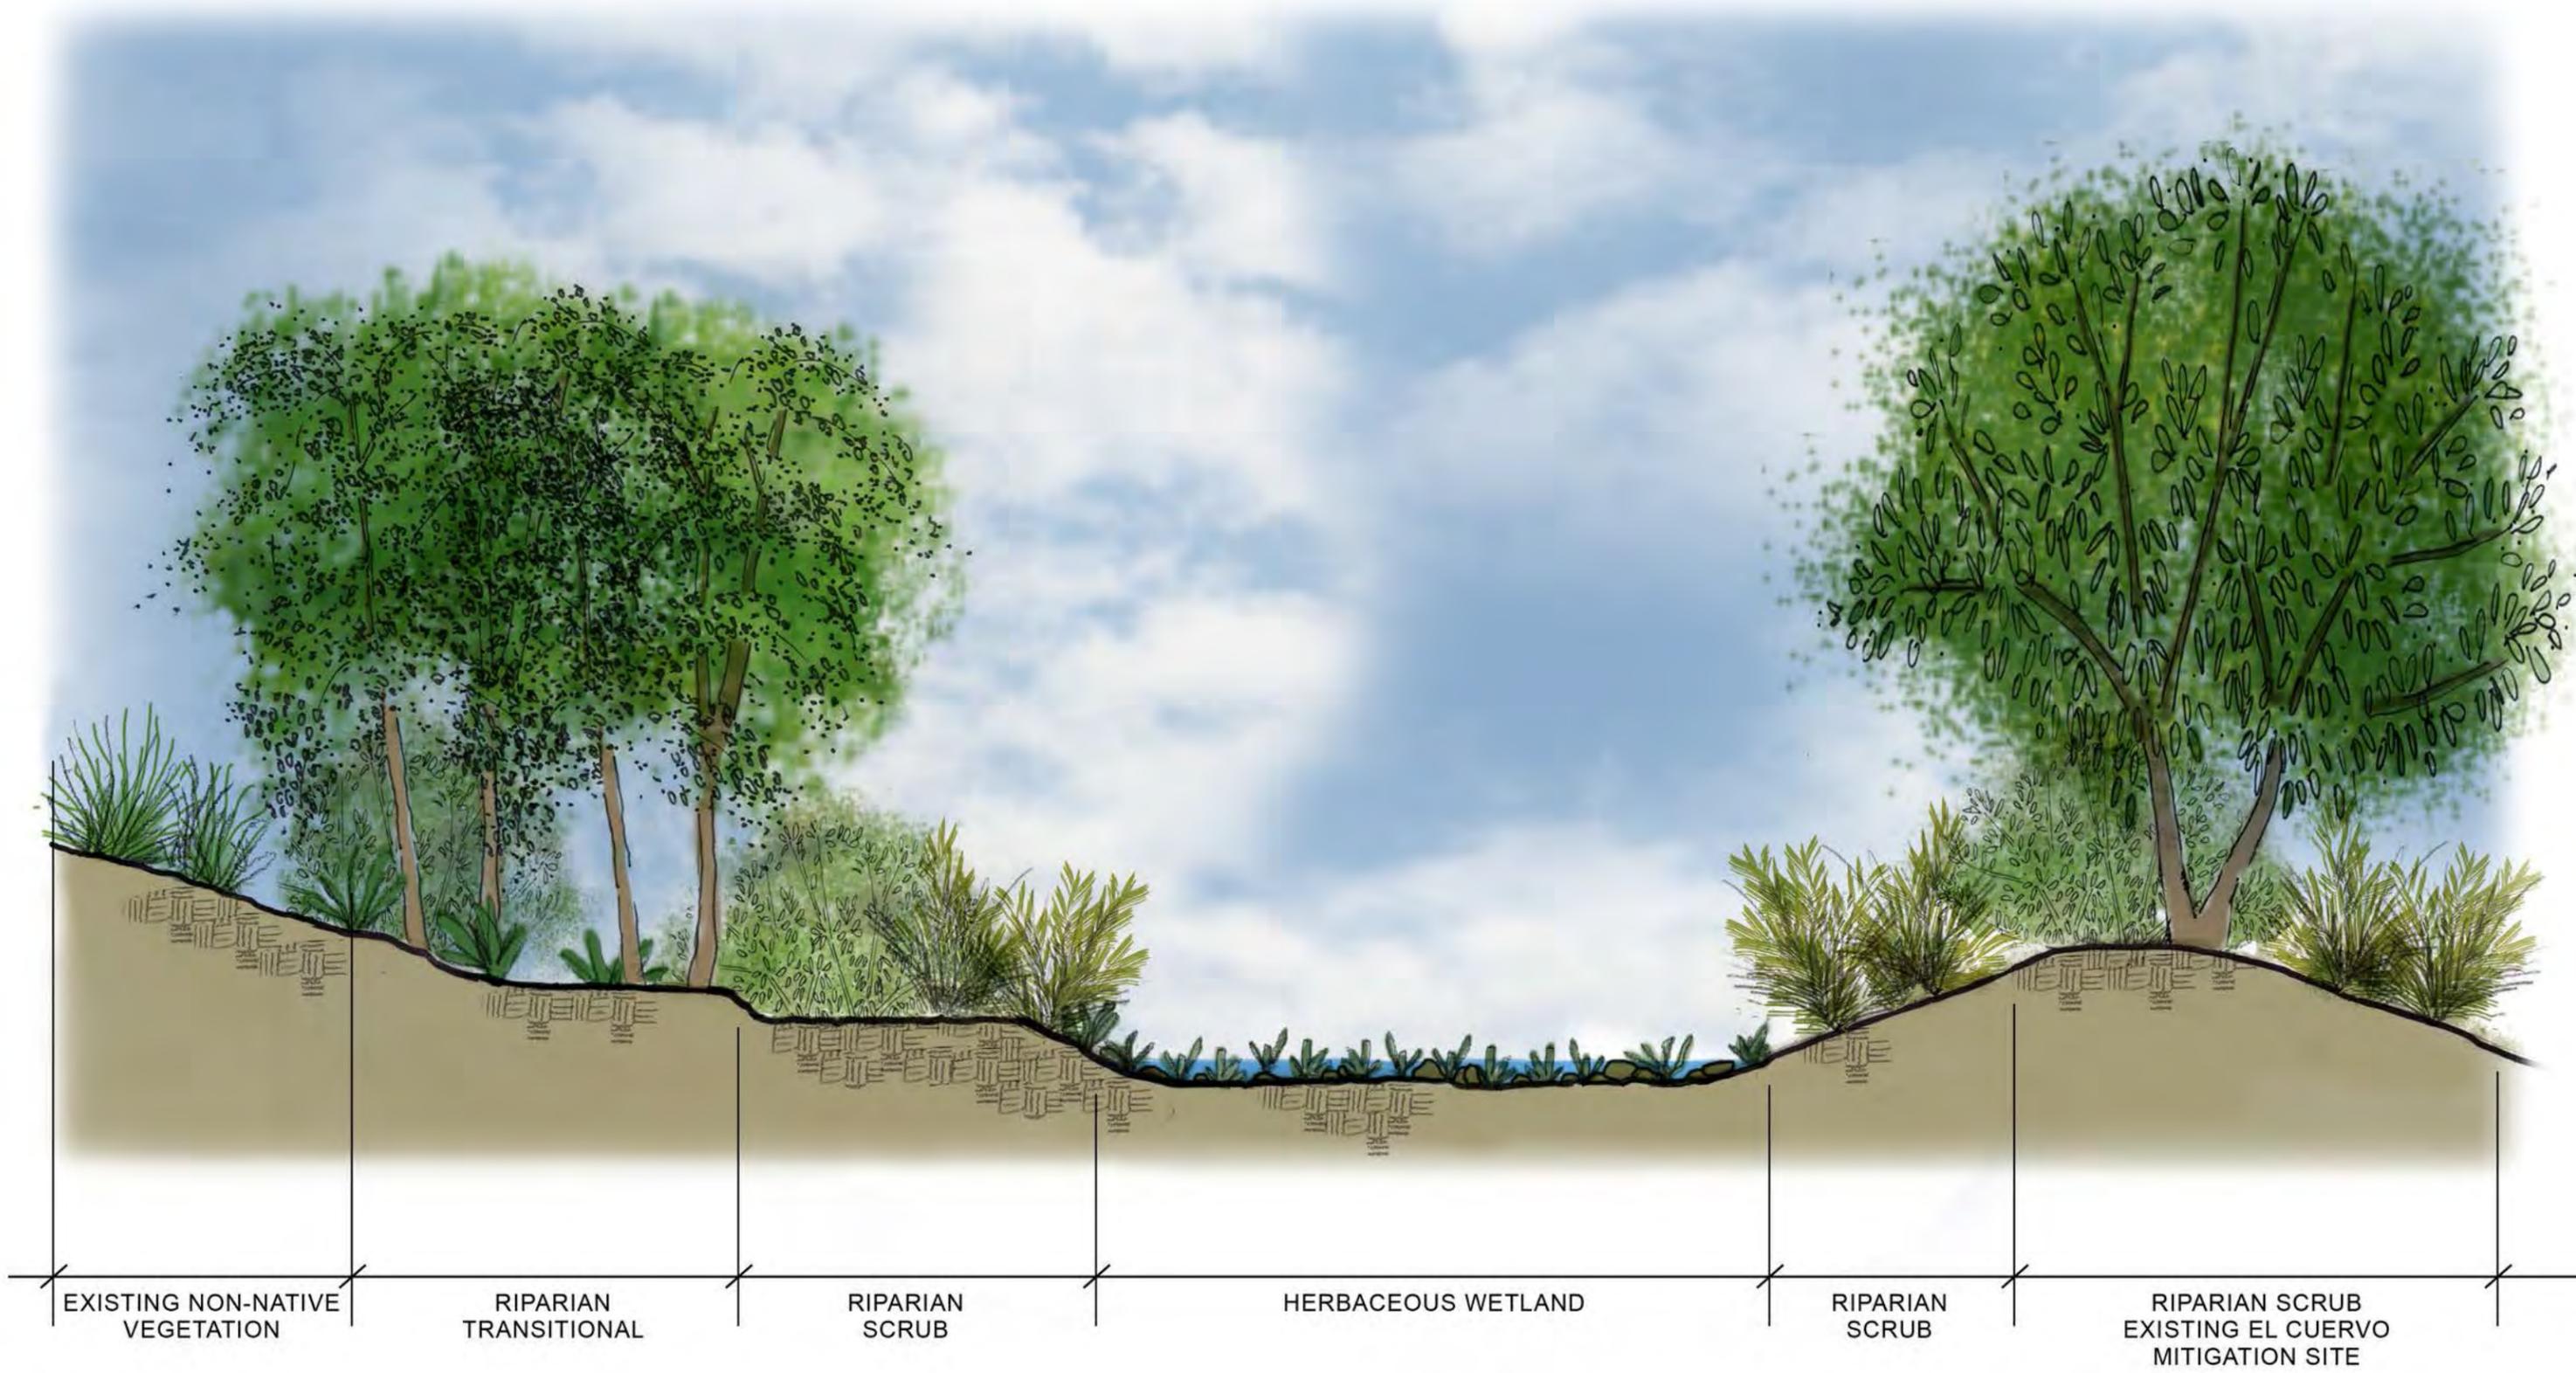
FIGURE 9: CONCEPTUAL MITIGATION DESIGN CROSS-SECTION, EL CUERVO DEL SUR

- El Cuervo del Sur Site Boundary (Phase I)
 - El Cuervo del Sur Site Boundary (Phase II - not a part of this mitigation plan)
- Proposed Contours**
- Proposed Contours - 1ft
 - Finished Grade Spot Elevation
- Existing Contours**
- Existing Contours - 10ft
 - Existing Contours - 1ft
- Planting Zones**
- Herbaceous Wetland
 - Riparian Scrub
 - Riparian Transitional
 - Proposed Soil Disposal Area

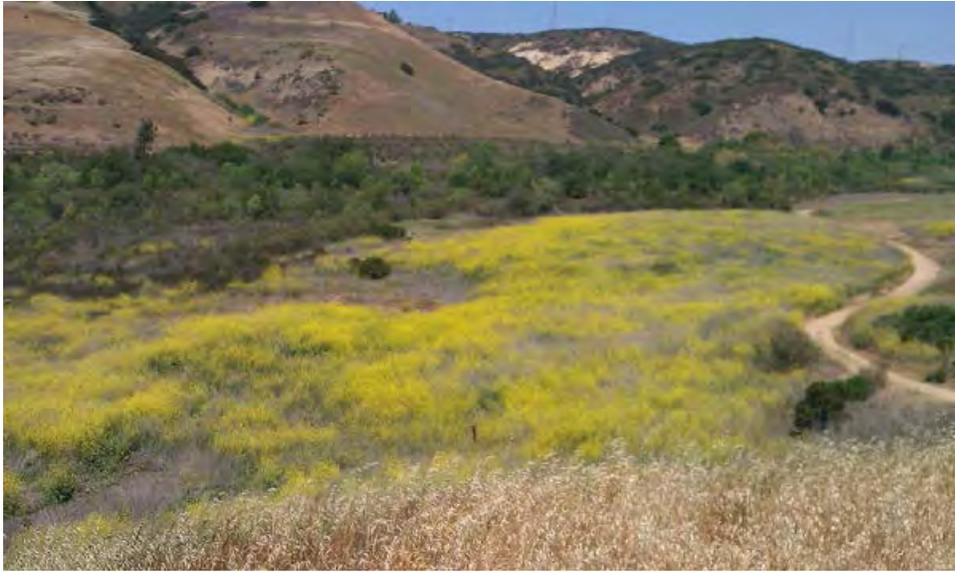
<p>Photograph A</p> <p>Date: 04-26-13</p> <p>Photopoint 1, photos A-D are sweeping overview shots moving from north to southwest across the Site. This photo is looking at the northern half of the mitigation site, bound by the dirt road to the right and existing riparian vegetation in the background. The yellow mustard will be restored or covered by soil.</p>

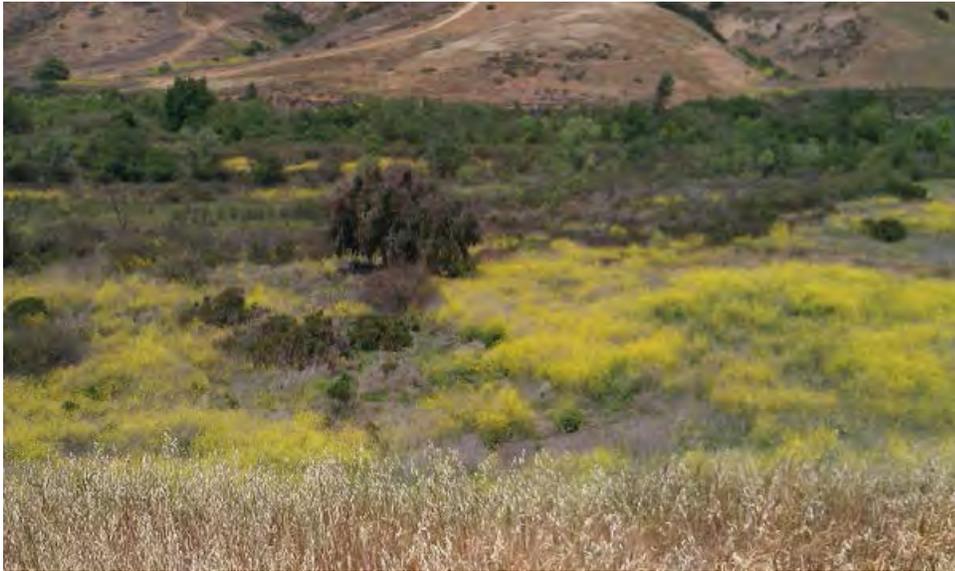
<p>Photograph B</p> <p>Date: 04-26-13</p> <p>Photopoint 1, this photo is looking northwest over the Site. Not the few native shrubs and large non-native eucalyptus tree in the center of the picture. The shrubs will be saved and the eucalyptus tree removed.</p>

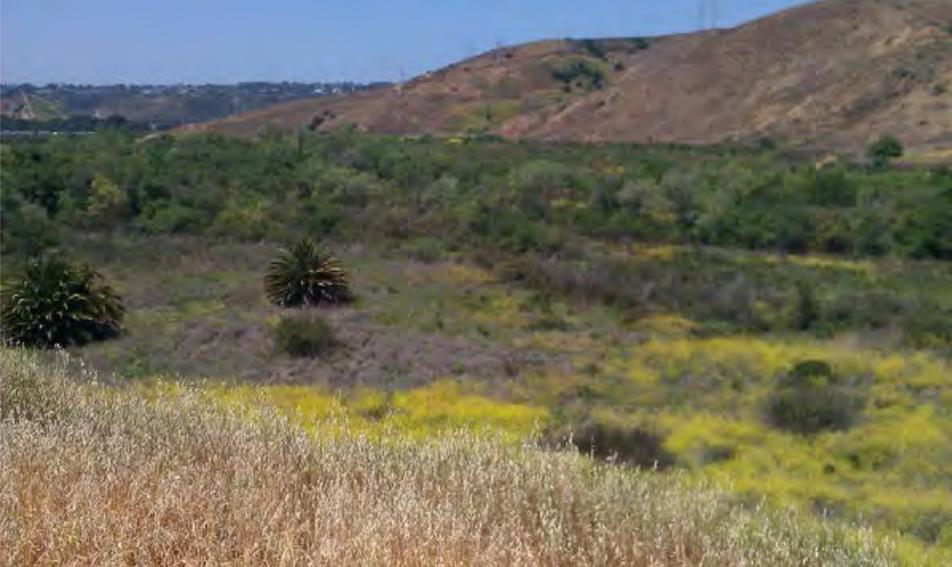
<p>Photograph C</p> <p>Date: 04-26-13</p> <p>Photopoint 1, this photograph is looking west over the Site (flat area in center of picture). Two of the three Canary Island date palms in the mitigation site are visible here. All three of these palm trees will be removed during the mitigation effort.</p>

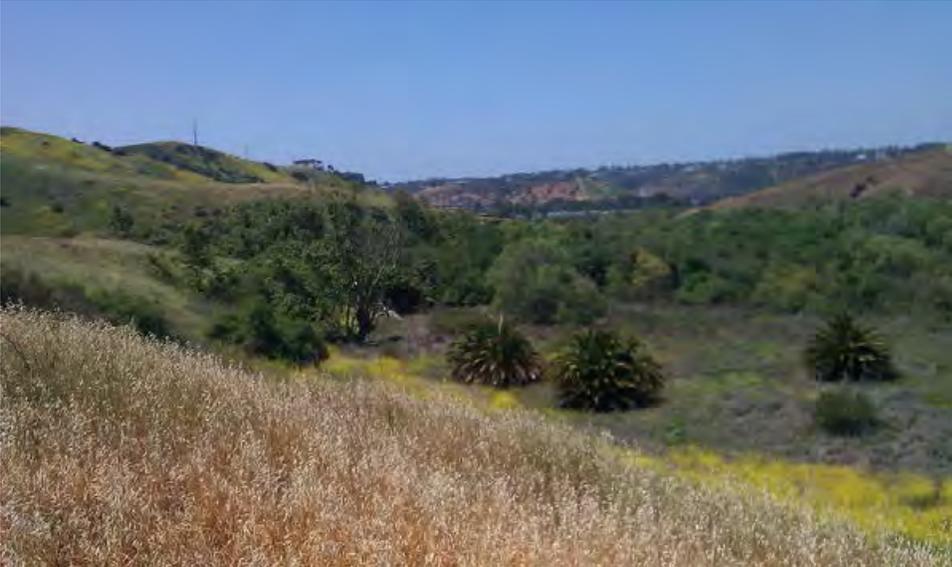
<p>Photograph D</p> <p>Date: 04-26-13</p> <p>Photopoint 1, this is the final picture in the panorama of the Site and shows all three palm trees and the confluence of Lopez Canyon into Los Peñasquitos Creek in the background. The mitigation site extends to the riparian vegetation, but includes the willow just beyond the palm trees, this tree will be saved.</p>

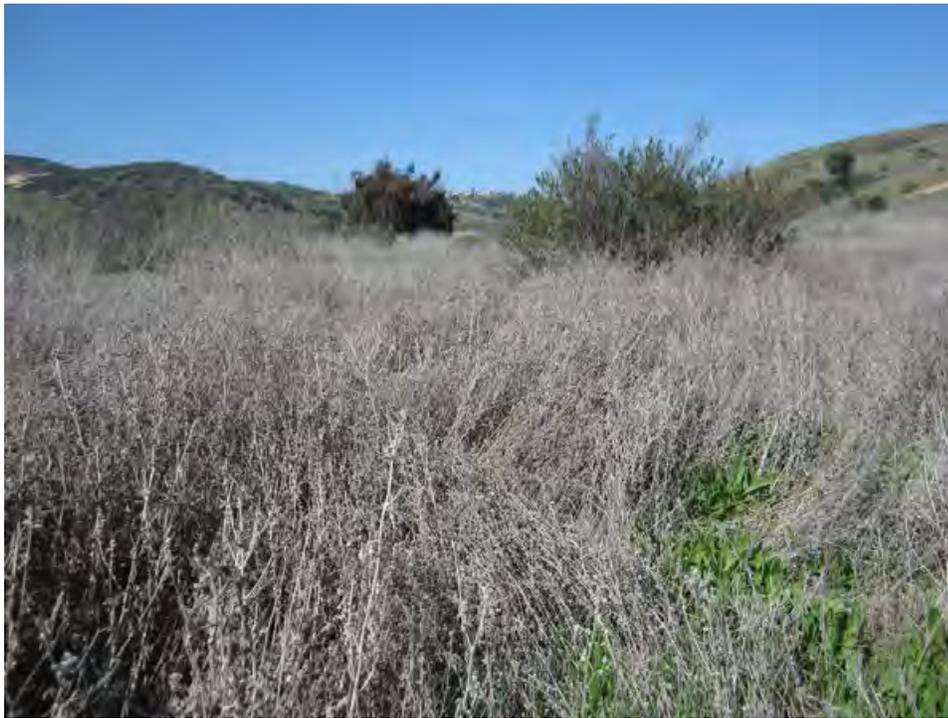
Photograph E

Photopoint 2, looking northeast from the center of the Site. The eucalyptus to be removed is visible in the background, will a native shrub that will be avoided is the closer shrub. The dead vegetation is composed of non-native species.

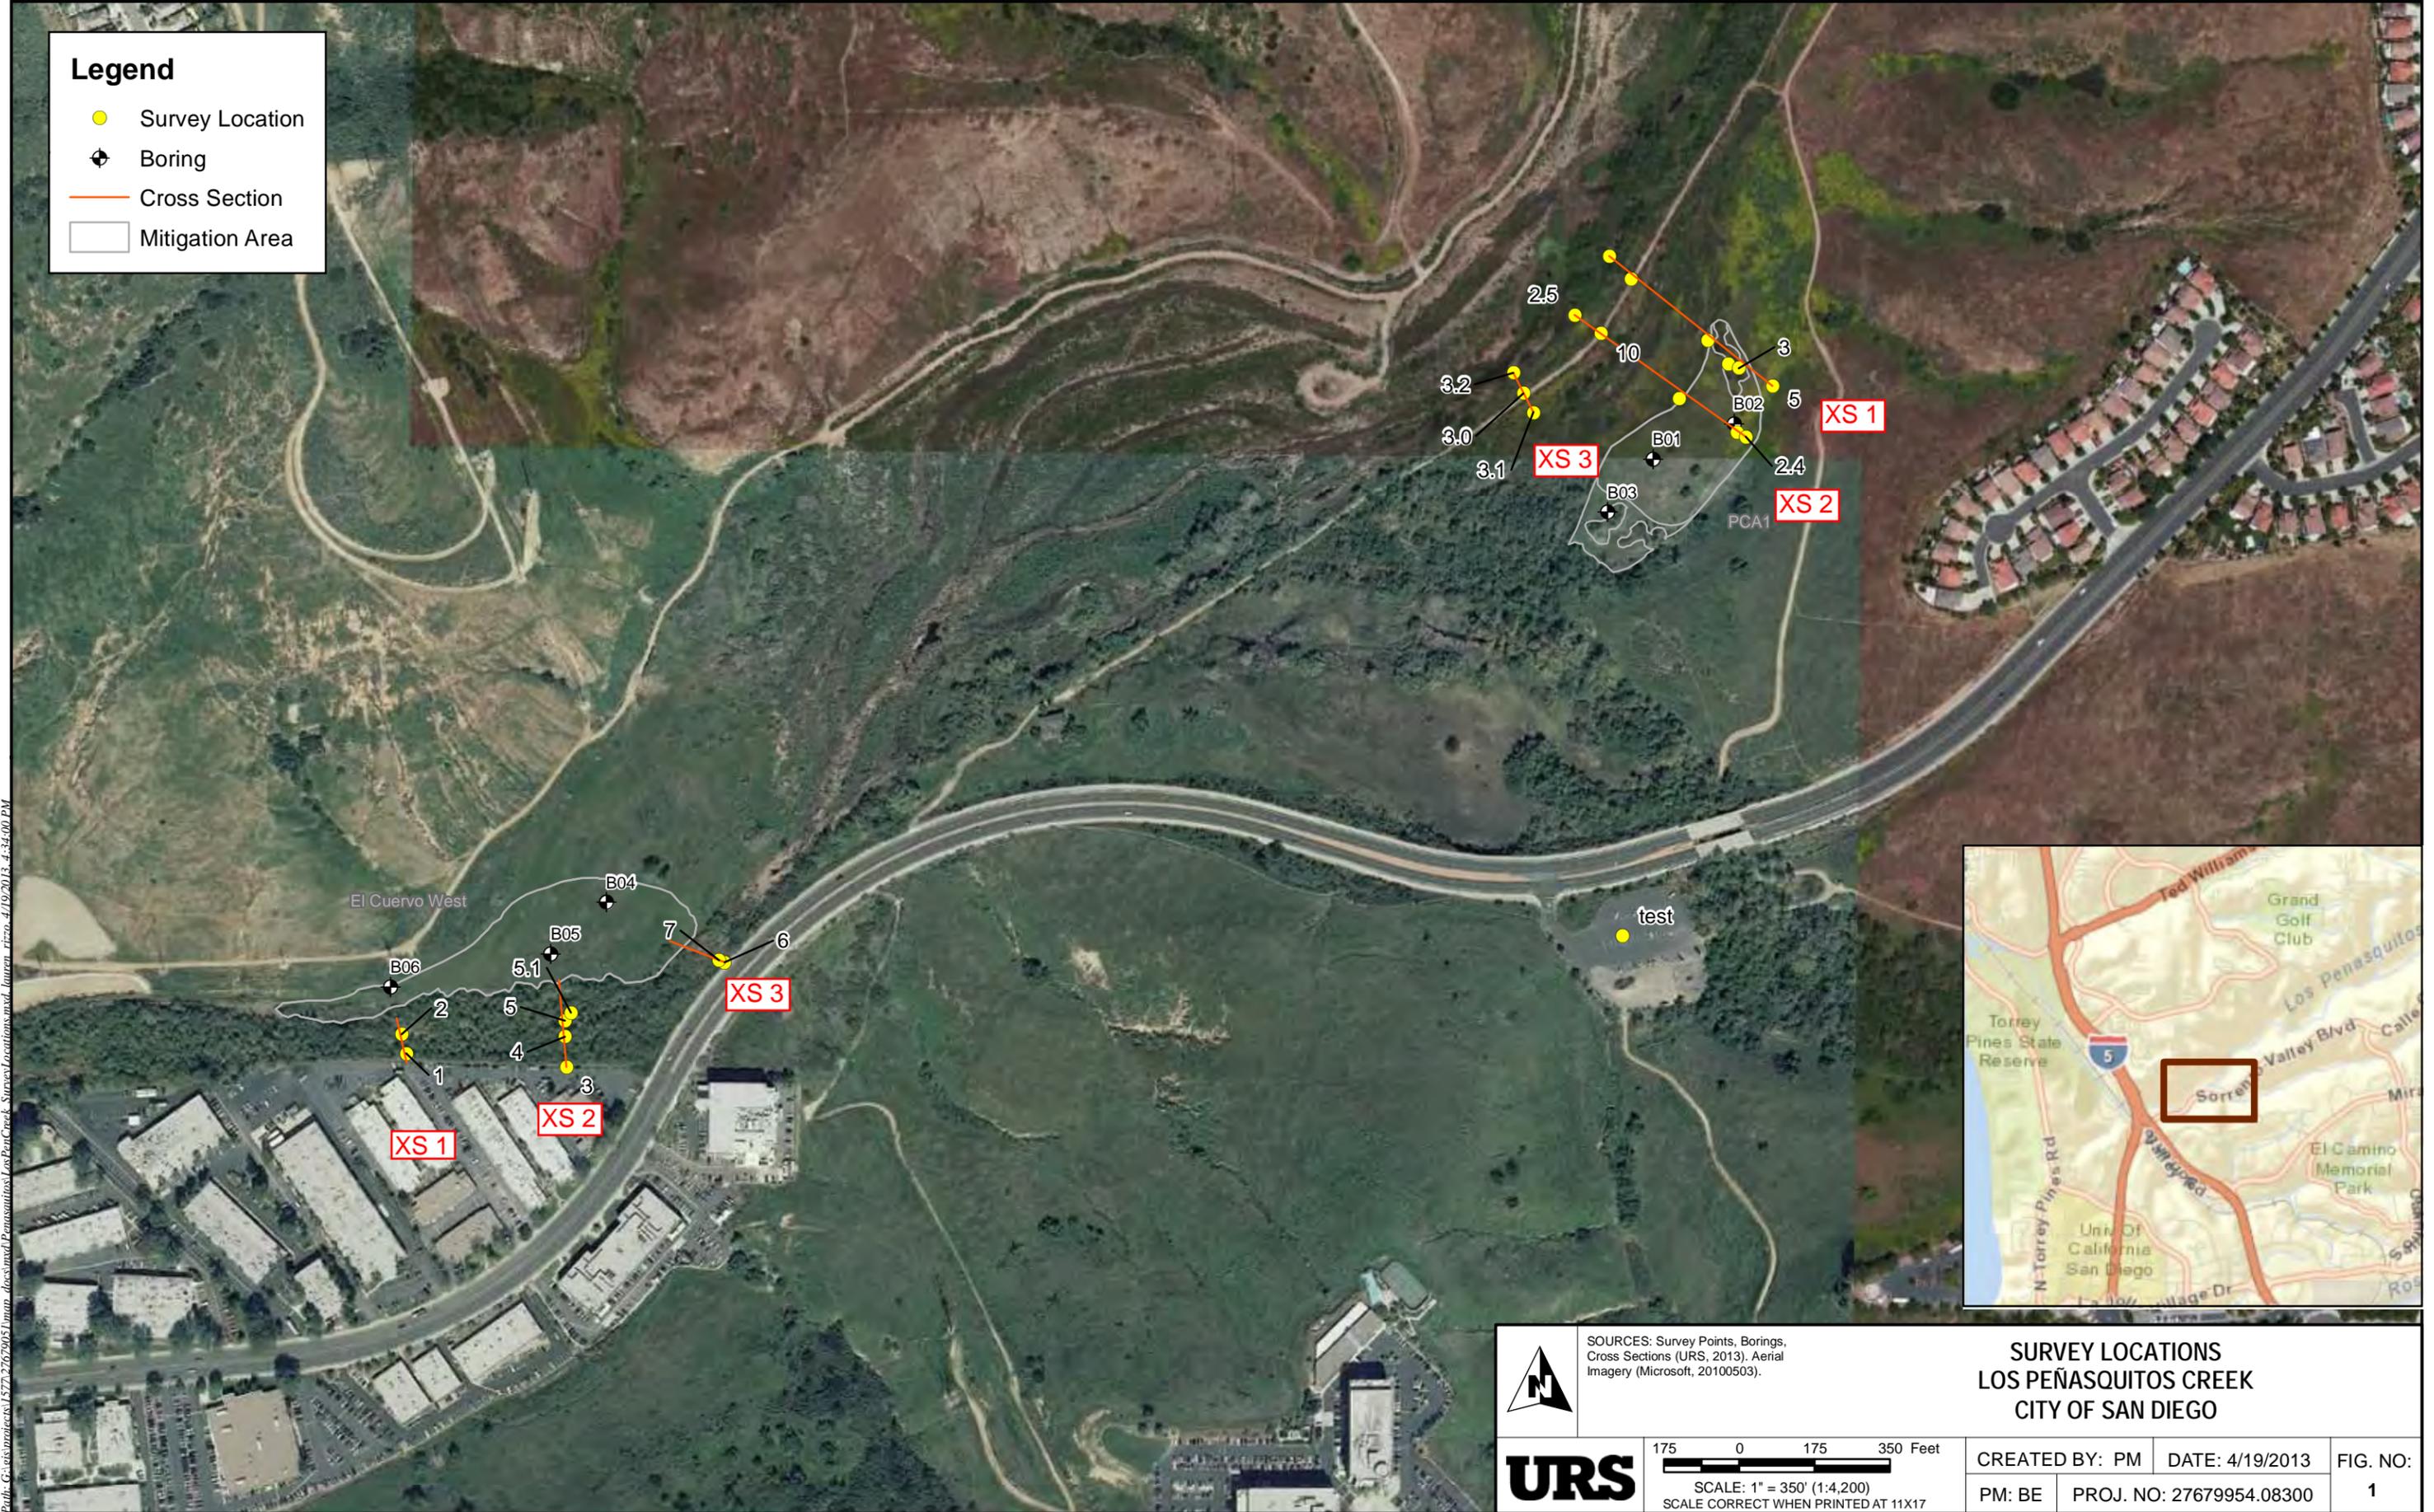
SOURCES: Survey Points, Borings, Cross Sections (URS, 2013). Aerial Imagery (Microsoft, 20100503).		SURVEY LOCATIONS LOS PEÑASQUITOS CREEK CITY OF SAN DIEGO	
	175 0 175 350 Feet SCALE: 1" = 350' (1:4,200) SCALE CORRECT WHEN PRINTED AT 11X17	CREATED BY: PM DATE: 4/19/2013	FIG. NO: 1	
		PM: BE	PROJ. NO: 27679954.08300
